FHWA REPORT NO. FHWA-HIF-18-057

FHWA PROJECT R05 IAP FUNDED PROJECT CASE STUDY

# FLORIDA I-10 PRECAST CONCRETE BRIDGE APPROACH SLAB DEMONSTRATION PROJECT

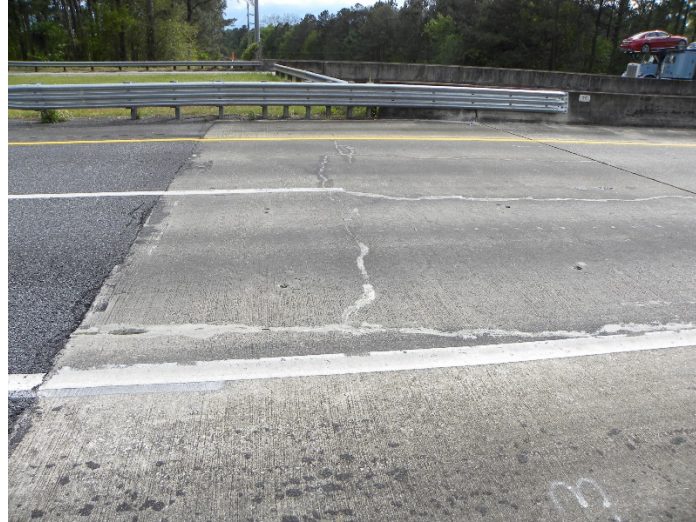
Figure 3. Photo. Condition of the existing bridge approach slab.

This project involved the replacement of the existing east-side BAS in the westbound direction at Bridge No. 500077 on I-10 (Florida SR 8) over Apalachicola North Railroad in Gadsden County. See figure 1 for location. The existing cast-in-place BAS, constructed in 1976 as part of the bridge construction, was exhibiting cracking and settlement. Figure 2 shows a view of the existing BAS, and figure 3 shows the condition of the BAS.

To minimize impacts to the interstate highway traffic, FDOT considered using precast panels to replace the existing BAS, which was 20 ft (6.1 m) long and constructed monolithically across the full width of the roadway. The existing full width of the roadway over the BAS consisted of two 12-ft (3.65-m) travel lanes, a 10-ft (3.1-m) outside concrete shoulder (lane to gutter), and a 5.5-ft (1.67-m) inside concrete shoulder (lane to gutter). The two shoulders incorporated barriers, 16.5 inches (406 mm) thick at the base. The existing cross-section of the BAS is shown in figure 4.

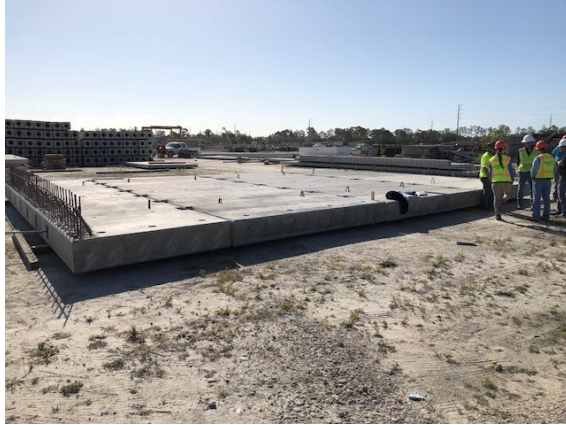
Figure 12. Photo. Mock setup of the four panels at the precast plant.

As required by the project specifications, a panel fit-up test installation was carried out at the precast plant on March 27, 2018, to demonstrate constructability and fit-up for the four panels. The objective of the fit-up installation was to demonstrate how the panels would be installed using the equipment and processes to be used at the project site. However, the panels were fit together using available equipment. The four panels fitted together at the precast plant are shown in figure 12. Figures 13 and 14 show the longitudinal joint details. Figure 15 shows the posttensioning anchorage and the tendon duct details.

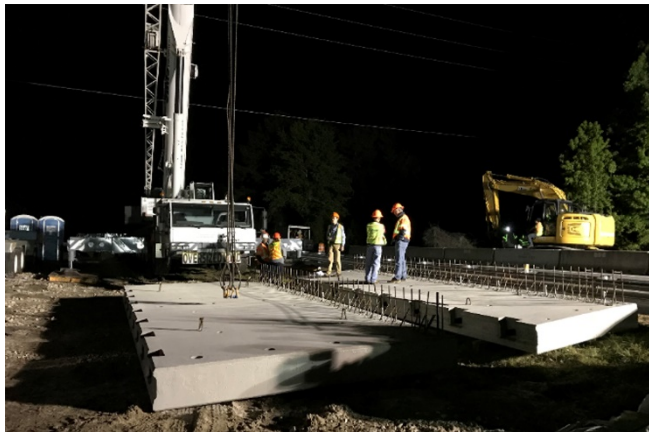
Figure 16. Photo. Panels A and B stored along the median.

Panels were shipped from the precast plant located in Leesburg, Florida. The panels were stored at the precast plant and delivered to the project site a few days before the planned installation of each panel. At the project site, the panels were stored in the median area adjacent to the BAS. Figure 16 shows Panels A and B stored in the median area.

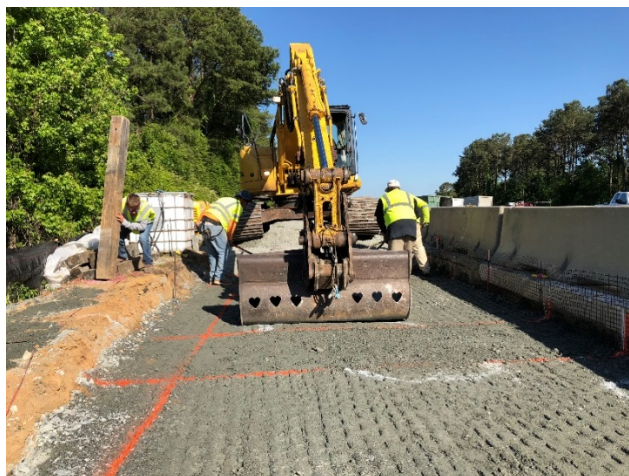
Figure 22. Photo. Base preparation.

4. Grade and compact the subbase and place geogrid, as shown in figure 21, over the subbase.
5. Place new base, compact and grade. See figure 22.
6. Place the polyethylene sheet over the base.

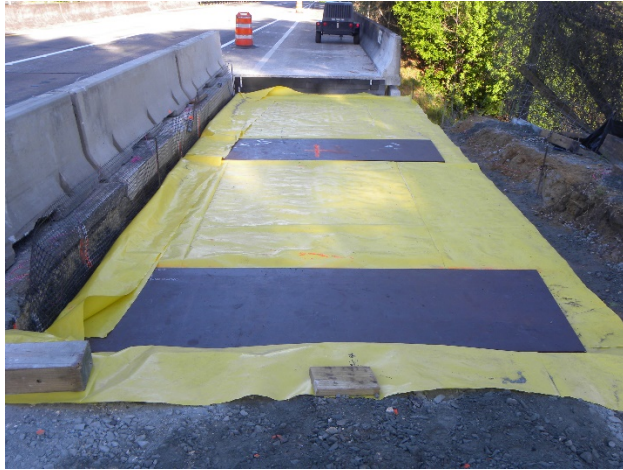
Figure 23. Photo. Bearing plates placed over the polyethylene sheet.

7. Place the leveling lift bearing plates over the polyethylene sheet. Figure 23 shows the bearing plates placed over the polyethylene sheet.
8. Place the panel, supported at the backwall seat and over prepared base layer using the leveling bolts positioned over the bearing plates.

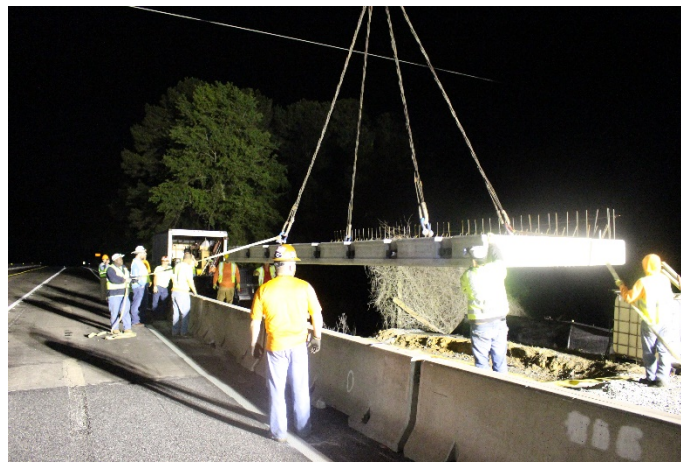
Figure 24. Photo. Panel A being installed.

Panel A for the outside shoulder was planned to be installed during the night of April 17, 2018. However, during a safety review of the crane operation, it was determined that the crane was under-capacity by about 4, 000 lb (1,814 kg), considering the actual panel weight and the swing distance from the median, where the crane was positioned, to the outside shoulder location. As a result, panel placement was postponed pending the availability of a larger capacity crane. Panel A was subsequently installed during the night of April 21, 2018, using a 220,000-lb (99,790-kg) capacity crane. Figure 24 shows Panel A being installed.

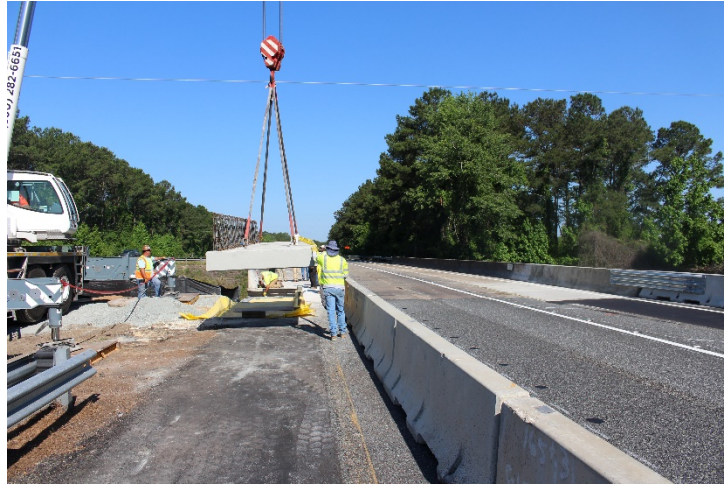
Figure 25. Photo. Panel B being installed.

Panel B for the inside shoulder was installed during the night of May 7, 2018. Figure 25 shows Panel B being installed.

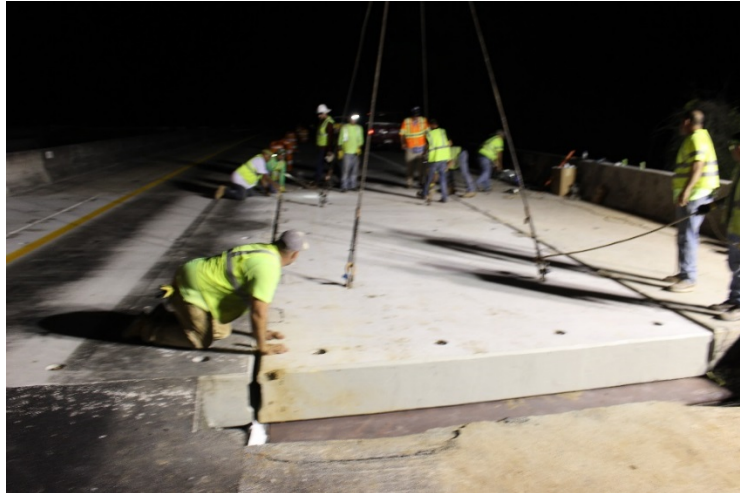
Figure 27. Photo. Panel D being installed.

Panel D for the inside shoulder was installed during the night of June 17, 2018. Figure 27 shows Panel D being installed.

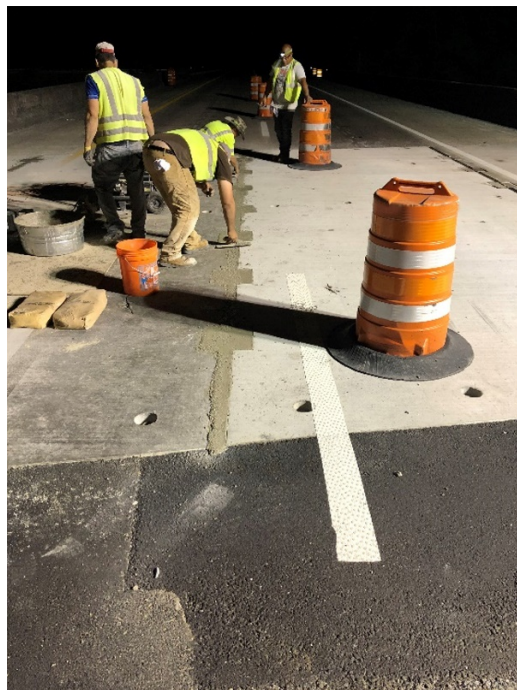
Figure 28. Photo. Longitudinal joint grout installation.

Longitudinal double keyway joints were filled with high-strength grout, as shown in figure 28.

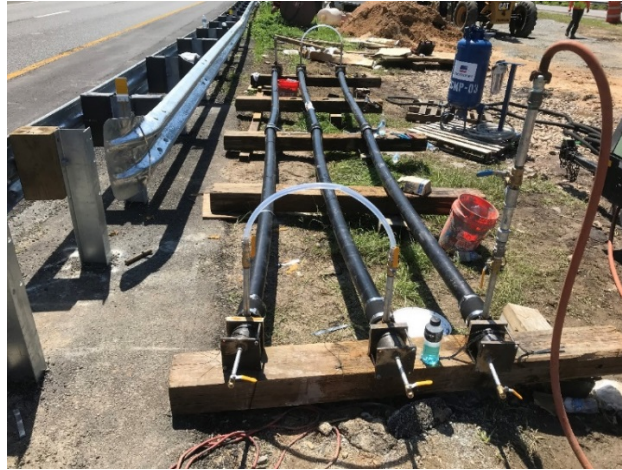
Figure 29. Photo. Mockup to simulate the ducts in the panels and the grouting process.

Next came posttensioning of the tendons. The contract specification required a mockup testing to verify that the tendon duct system was leakproof and that the ducts would be fully grouted with the wax-based filler to ensure adequate corrosion protection to the tendons. Figure 29 shows the mockup to simulate the ducts in the panels and the grouting process.

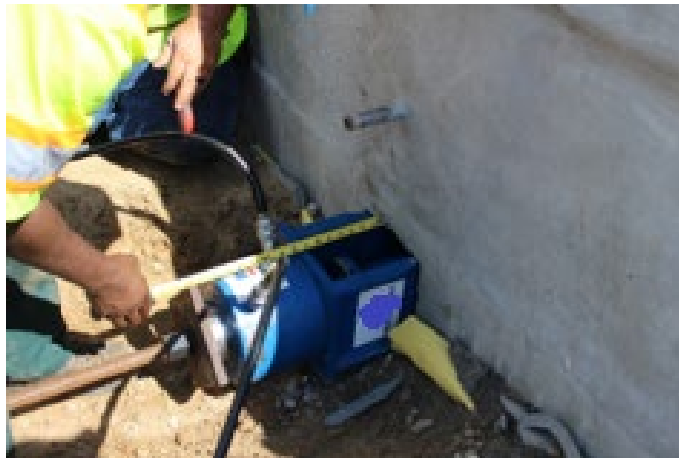
Figure 30. Photo. Posttensioning jack applying load at an anchor plate.

The mockup testing was conducted on June 26, 2018. The tendons were posttensioned on June 27, 2018. Figure 30 shows the posttensioning jack applying load at an anchor plate.
