# Case Study

**AUGUST 2022**  
**FHWA-HIF-22-049**

## CONCRETE OVERLAY **MISSOURI ROUTE D** Concrete on Concrete–Unbonded

*Unbonded concrete overlays of concrete include the placement of a separation layer prior to placement of a new concrete overlay. The separation layer provides a shear plane to prevent cracks in the existing pavement from reflecting through the new concrete surface. This case study summarizes the design, construction, and performance of an unbonded concrete overlay of an existing severely distressed jointed reinforced concrete pavement (JRCP) using a nonwoven geotextile separation layer.*

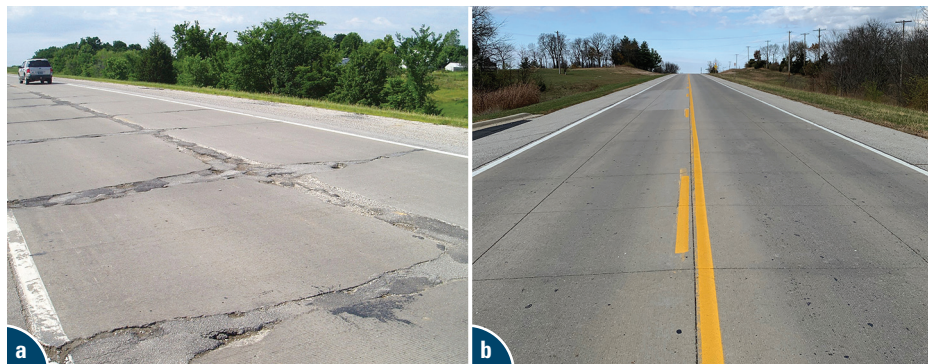
**Figure 1. Missouri Route D: (a) condition of JRCP in 2007 before overlay construction and (b) unbonded concrete overlay in 2020 after 12 years in service**

With a length of 3.7 centerline miles, this project is located on Missouri Route D in Cass County, Missouri, between Lohman and US-54 southeast of Jefferson City. This roadway is classified as a secondary state highway and consists of one lane in each direction with 6-foot shoulders. This segment was originally constructed in 1986 with 8 inches of JRCP over 4 inches of aggregate base. Before the overlay was placed in 2008, the existing pavement was severely distressed with spalling and D-cracking (Figure 1).

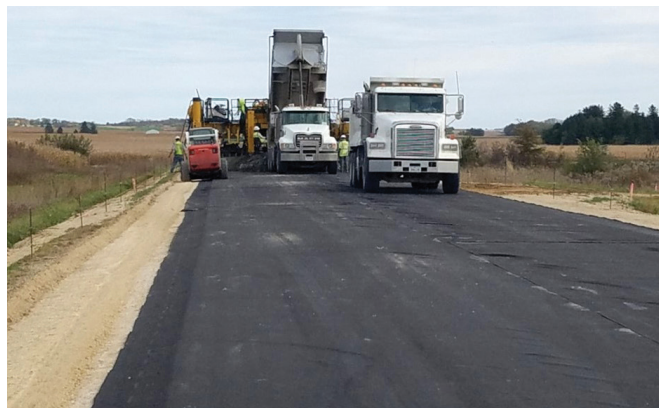
**Figure 2. Placement of a concrete overlay on a nonwoven geotextile separation layer**

(Refer to MoDOT Standard Specification 1011.3.7 for current geotextile requirements in Missouri.) The geotextile was anchored using nails and washers. Daylighting was used to provide an outlet for interlayer moisture (Figure 2).

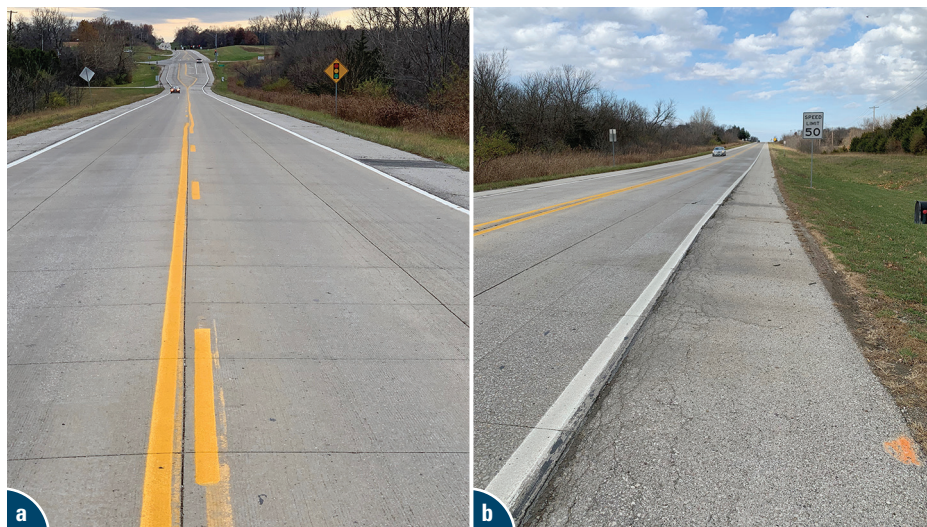
**Figure 3. Current condition of unbonded concrete overlay: (a) 0.25 miles from south end of project looking south and (b) 0.25 miles from south end of project looking north**

As of 2020, repairs have included minor full-depth patching at the transition areas on either end of the overlay. Fewer than 1% of the overlay slabs are cracked, as shown in Table 1. Figure 3 shows the current condition of the roadway.
