NDEVC News

NONDESTRUCTIVE EVALUATION VALIDATION CENTER

FEDERAL HIGHWAY ADMINISTRATION

Volume 2, Issue 1

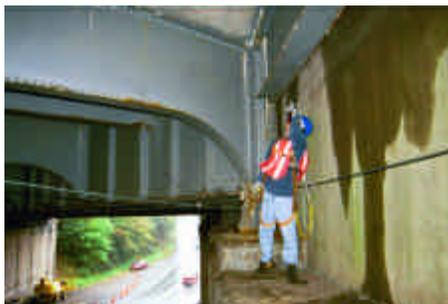
Inspector checking behind the end floor beam.

In-Depth Inspections are close-up, hands-on inspections completed on a portion of a bridge. These inspections are usually implemented with the intent of locating specific deficiencies that may exist in the bridge. In this study, two In-Depth Inspection tasks were performed on steel superstructures.

It appears that an In-Depth Inspection completed by a State bridge inspector may not detect many of the types of deficiencies for which it is frequently prescribed. For example, the correct call rate for identifying crack indications during one of the inspection tasks was only 4 percent. The correct call rate for identifying defective bolts was 24 percent. In another In-Depth Inspection task, only 7 percent of the inspectors correctly identified the crack indication.

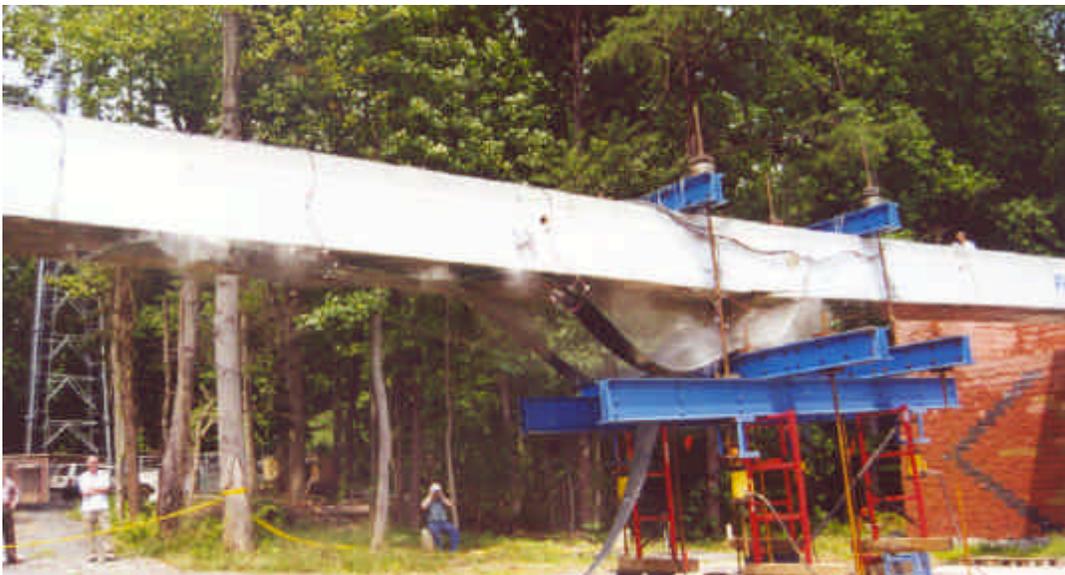
The fiber-composite plates debonded at the conclusion of the test. This photograph was taken at the moment of failure.

The third girder was repaired on site at TFHRC. The repair included removal of deteriorated bottom flange concrete, patching of spalled areas, and application of the composite laminate

repair material. A carbon fiber laminate was used for this test. The application of the laminate included applying multiple layers of the composite in three strips along the bottom flange.

The testing of the girders was completed by the application of loads at two load points, each 1.5 m (5 ft) from midspan. Four 445-kN (100-kip) hydraulic jacks were used. The girder was instrumented to measure horizontal and vertical deflection, as well as strain in the concrete and the laminate.

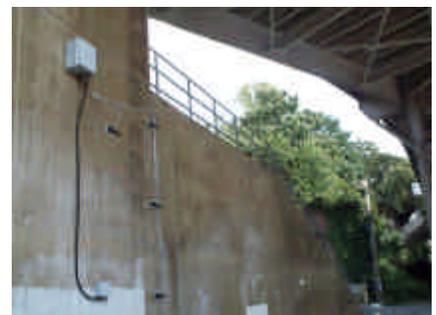
designed and built specifically for this application. The purpose of the system is to measure the long-term movement of the wingwall relative to the abutment. An innovative part of the instrument is a low-cost electromagnetic displacement sensor, designed and built for this application by the NDEVC. The monitoring system has been providing

The NDEVC has recently provided technical assistance to the FHWA D.C. Division Office in relation to a structure in the District of Columbia. A wingwall adjacent to a bridge abutment on the Whitehurst Freeway had been experiencing large amounts of water flow from weep holes in the structure. Since the abutment is adjacent to the C&O Canal, there were concerns that

the water flow was due to a leak in the canal wall. Initial visual observations of the wingwall showed movement relative to the abutment.

To determine future structural movement and to access the effectiveness of any repairs to the canal, a continuous monitoring system was

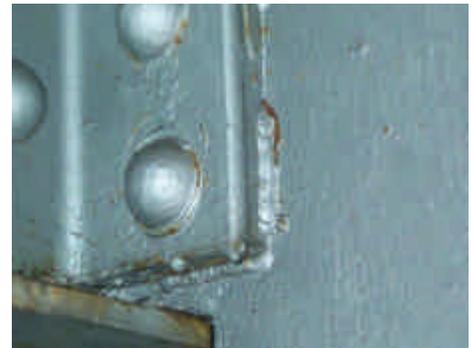
Crack indication in a tack weld.
