Publication No. FHWA-RD-99-158  
July 1999

# Heated Bridge Technology

**Report on ISTEA Sec. 6005 Program**

L. David Minsk  
Consultant

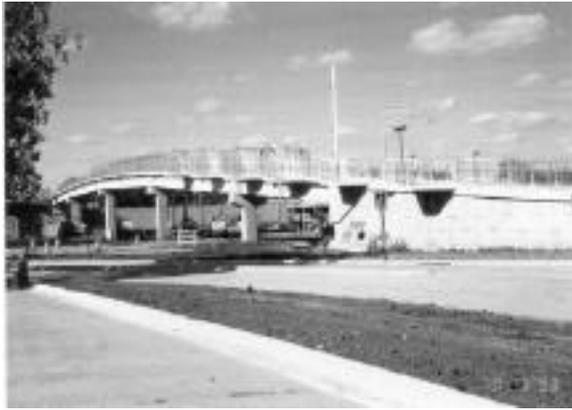
**Fig. 1. The 367 m (1204 ft) long pedestrian viaduct spans railroad tracks.**

This is a five-span pedestrian viaduct over railroad tracks located near the stadium at the University of Nebraska-Lincoln (Fig. 1). It is 367 m (1204 ft) long, running north-south with a 3.7 m (12 ft) wide deck. The elevated portion is a 169.8 m (557 ft) long, 2-girder structure; the mechanically

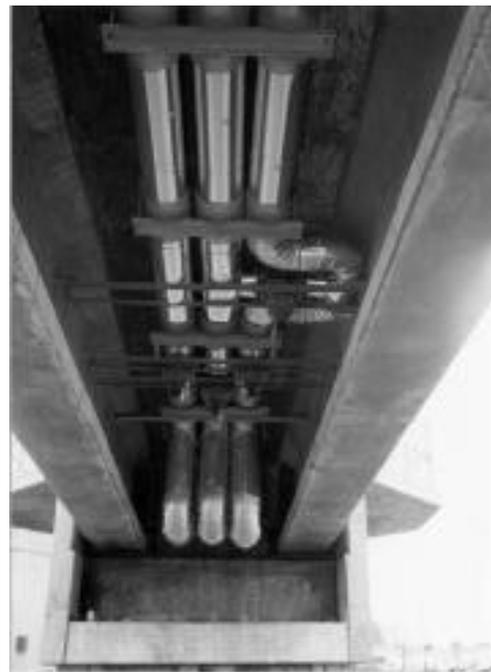
**Fig. 2. Flexible expansion loops in supply/return pipes underneath walkway. View looking up.**

stabilized earth approaches are 70.7 m (232 ft) and 126.5 m (415 ft) long<sup>1</sup>. (Superscripts refer to references found at the end of each state report.) The entire 1599 m<sup>2</sup> (17,211 ft<sup>2</sup>) surface is heated. The design objective is the prevention of any sustained snow or ice accumulation. Delta-Therm designed the hydronic system with a design heat flux of 530 W/m<sup>2</sup> (168 Btu/ft<sup>2</sup>-hr) and a fluid flow rate of 530 L/min (140 gal/min). Two Taco "1600" Series in-line pumps capable of 1207 kPa (175 psi) operating pressure at 394°C (250°F) move the heating fluid through the system. A flow meter was installed in the pump house. The working fluid is a 35 percent propylene glycol-water solution heated by a natural-gas-fired boiler rated at 908 kW (3,098,000 Btu/hr) input and 732 kW (2,498,000 Btu/hr) output. Expansion tank capacity of 802 L (212 gallons) is provided within the boiler house. The liquid temperature is 54°C (129°F) leaving the boiler, below the 60°C (140°F) rating of the 152 mm (6-in) diameter Schedule 40 polyvinyl chloride (PVC) distribution pipe. The distribution and return pipes are insulated with 51 mm (2 in) of fiberglass. They are suspended below the elevated section of the bridge with a flexible expansion loop installed in the pipe near each abutment (Fig. 2).

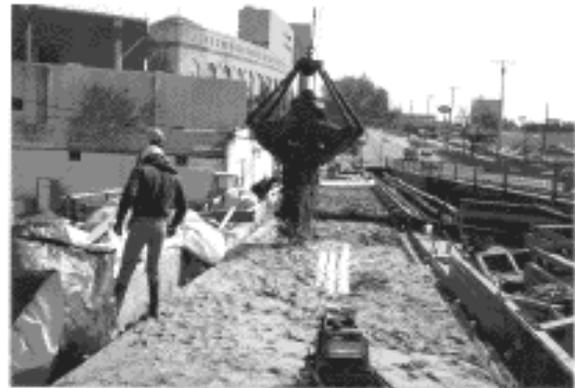
**Fig. 4. Uninsulated PVC supply and return pipes were bedded in sand in approaches on both ends of walkway.**

The investigation that followed found that bonding of the PVC pipe joints was inadequate<sup>2</sup>. As much as 28 percent of the joint area was not bonded with glue in the joints that were removed from the system and studied. This was ascribed to the lack of experience on the part of the installation contractor and the cold conditions during installation. Leaks also occurred at the fittings between the manifolds and hoses before they were encased in the concrete deck/slab, ascribed to improper tightening and lack of any thread sealant. This problem was corrected during construction. Expansion room for the expansion loops was not adequate at the north abutment and expansion loops were not positioned correctly at the south abutment. The installation allowed expansion of about 254 mm (10 in) at the north abutment, whereas a movement of 533 mm (21 in) was calculated. This may have contributed to joint failure. Bell joints were used on the PVC, rather than the specified coupling sleeve type. Tests made at the University of Nebraska Lincoln<sup>3</sup> found that the coefficient of

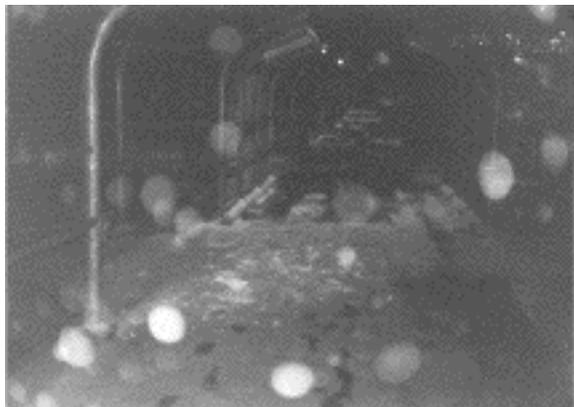
**Fig. 6. Deck condition at hour 9.**

Two snow/heating events were reviewed in a report prepared by the University of Nebraska<sup>5</sup>. The first event began on December 20, 1994; the second began on December 31, 1994, and extended to January 1, 1995. Only the latter will be summarized here. A graph of one of the temperature sensor outputs located on the north approach about 12.5 m (41 ft) from the abutment will help to explain the event (see graph on preceding page). Time zero on the graph is 9:00 am on December 31. The system was turned on at 9:55 am and ran for about 39 hours. The fluid return temperature initially drops because of the surge of cold fluid from the deck hoses, then it begins to rise after about an hour delay which represents the time required for the heated fluid to travel through the entire

system. Initially, the deck upper surface warms slightly and stays about 0°C (32°F), the ice melting point. At hour 24 the surface temperature rises, indicating that all the snow has melted. The core and lower deck surface are higher than 0°C (32°F) during snow melting because heat is flowing from the hydronic hoses in the core to both the top and bottom of the deck, and the latter is not losing heat from snow melting. The sharp drop in return fluid temperature at about hour 32 indicates that the pumps had been shut off and the flow has stopped. The pumps continued to run until they were manually shut off at about hour 39 (11:00 pm Jan 1). Once the fluid flow ended at hour 32, all the deck temperatures began to track the air temperature variation. The deck was clearly surface dry by hour 34.

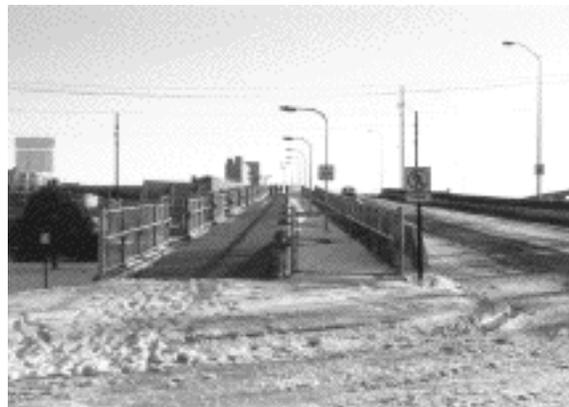
**Fig. 7. Deck condition at hour 31.**

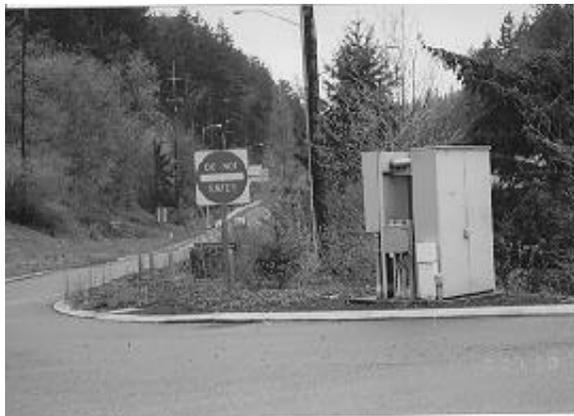
**Fig. 4. South approach road looking east, heating control cabinet at right.**

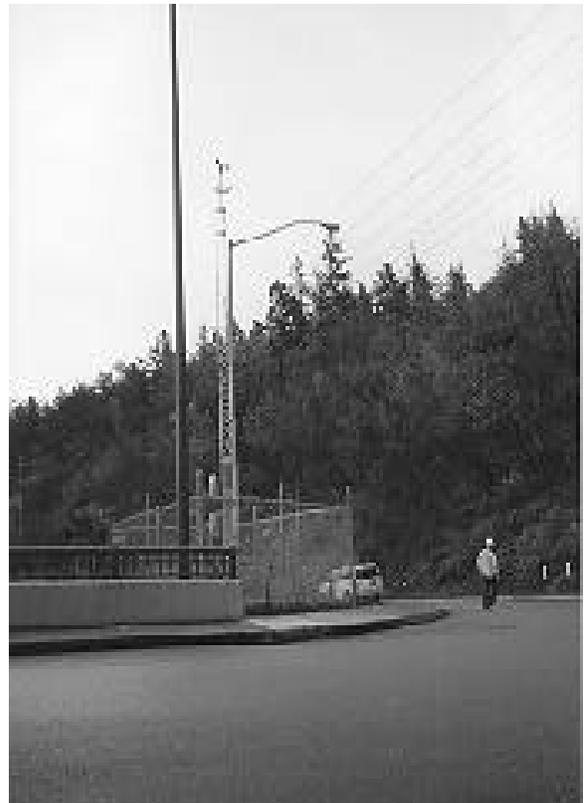
**Fig. 5. Met station is located at south end of heated deck, opposite control cabinet.**

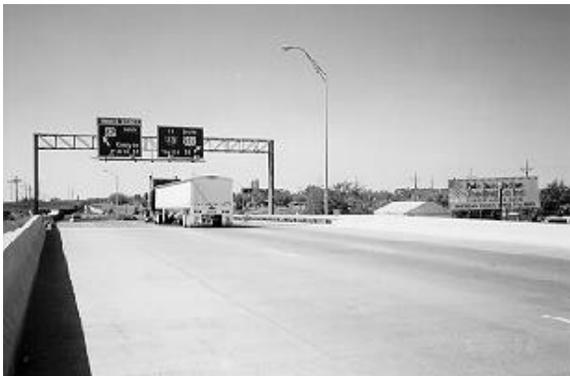
**Fig. 1. One of the two two-lane heated bridges on US 287 over N. 15th Ave. in Amarillo.**

This project involves north- and south-bound two-lane bridges on US 287 in Amarillo over N. 15th Ave. Each bridge is box beam construction, 17.7 m (58 ft) wide and 44.5 m (146 ft) long. The heating system was designed by Value Engineering. The heated area on each is 799 m<sup>2</sup> (8600 ft<sup>2</sup>). The design objective is ice prevention (anti-icing), not snow melting, with a heat flux of 129 W/m<sup>2</sup> (12 W/ft<sup>2</sup>, 41 Btu/ft<sup>2</sup>-hr). This is a hydronic system with geothermal wells providing the heat source. Each structure uses 50 wells arranged in a star pattern with five wells in each point. Wells are located between the bridges and on the east side of each bridge (Fig. 6). Each 102 mm (4 in) diameter well is 53.6 m (176 ft) deep, not reaching ground water, and contains two pipe loops (Fig. 5a-b). Each is a closed system, grouted with non-shrinking bentonite for good soil contact. The northbound structure uses a McQuay heat pump between the wells and a heat exchanger. Though presently there is no heat pump for the southbound structure, provisions have been included to add one if necessary. Trench-type heat exchangers are used (Fig. 5c-d). The deck circulating fluid is 50 percent propylene glycol-deionized water (obtained from a local power station). Approximately 11,355 L (3000 gal) fluid circulates through each bridge deck, 2650 L (700 gal) of which is in a deck. Each bridge has 32 zones of 19-mm (3/4-in) ID tubing that are continuous between supply and return headers. All connections are on the outside of the deck (Fig. 2). Tubing is suspended under reinforcing steel in transverse loops.

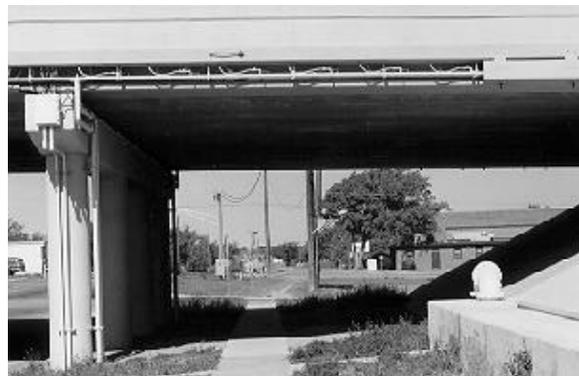
**Fig. 2. Manifold conducting heated solution to embedded heating pipes runs alongside of bridge.**

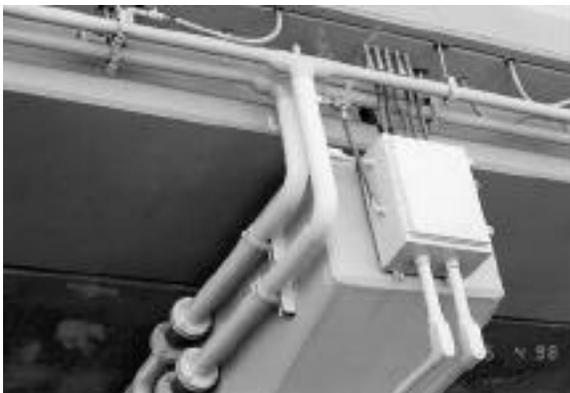
**Fig. 3. Close-up of supply and return manifolds (pipes in center) and thermocouple conduits terminating in enclosure at right.**

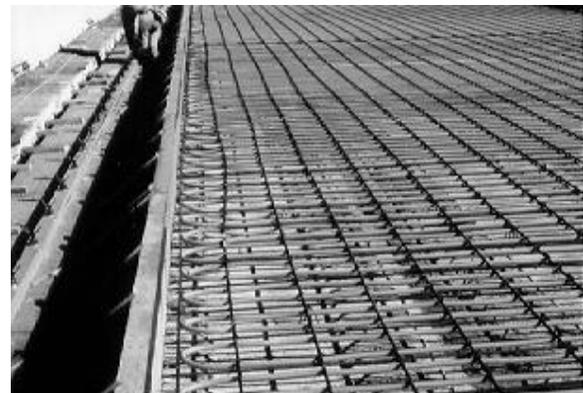
**Fig. 4. Heating hoses in place ready for concrete pour; hoses are on 152 mm (6-in.) centers placed 76 mm (3 in) under top of slab, affixed below #4 rebars.**

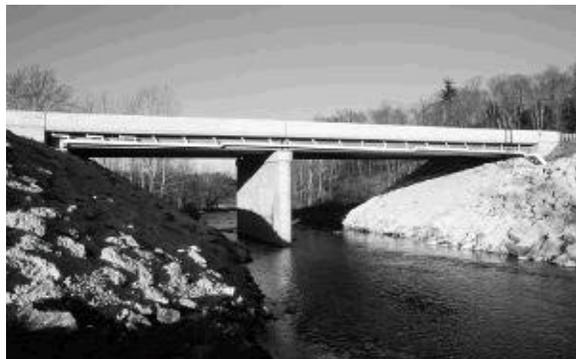
**Fig. 1. Two-span bridge is 35.7 m (117 ft) long and 13.4 m (44 ft) wide.**

This is a two-lane bridge on State Route 60 across Buffalo River, in Amherst County, approximately 24 km (15 mi) north of Lynchburg. The two-span bridge is 35.7 m (117 ft) long and 13.4 m (44 ft) wide.

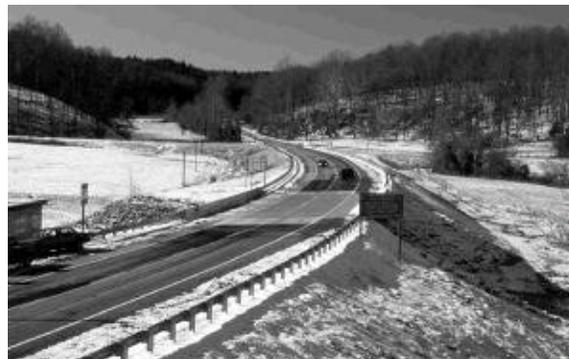
**Fig. 2. Bridge over Buffalo River on Rt. 60 is on a gentle curve.**

and 13.4 m (44 ft) wide. It is a composite structure, with steel beams and portland cement concrete deck. The pcc approach slabs are 6.1 m (20 ft) long and 7.3 m (24 ft) wide. The bridge is on a gentle curve (Fig. 2). The heating system was designed by SETA Technology and is based on a proprietary design (US Patent no. 4,566,527 dated January 28, 1986). It provides for a surface heat output of  $630 \text{ W/m}^2$  (200 Btu/ft<sup>2</sup>-hr), and consists of 241 steel Perkins tubes (commonly called heat pipes) embedded in the bridge deck and the approaches (Fig. 3). A propane-fired boiler located in a shelter near the bridge heats a 50 percent solution of propylene glycol-water which is pumped through a 89 mm (3 1/2 in) diameter pipe centered within a 152 mm (6-in) pipe that serves as the working fluid reservoir as well as the evaporator portion of the heat pipes. The pipe assembly runs horizontally along one side of the bridge below the deck, shown in the left panel of Fig. 4. The

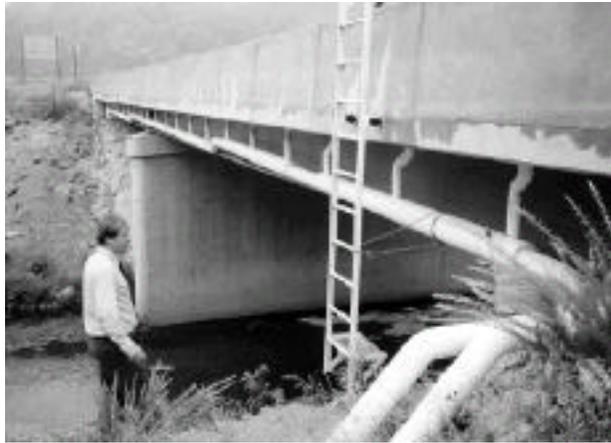
**Fig. 4. Left: Heated polypropylene-water solution flows to heat pipes through an 89 mm (3 1/2 in) pipe inside a 152 mm (6 in) manifold on side of bridge. Right: The working fluid is contained within the larger pipe and is vaporized by heat from the furnace-heated liquid pumped through the smaller pipe. The vapor diffuses into the Perkins tube placed horizontally in the deck, gives up its heat of vaporization, and condenses as it is cooled by loss to the deck. The condensate flows back to the reservoir in the large horizontal pipe and is reheated.**

working fluid contained within the large pipe surrounds the smaller heating pipe and is vaporized by heat. However, individual heat pipes are not connected directly to the heat supply pipe but are ganged into groups; a standard module consists of a short vertical riser connected to a manifold serving 10 heat pipes (Fig. 5). These 22 mm (7/8-in) OD, 13 mm (1/2 in) ID tubes run across the 13.4 m (44-ft) width of the deck on 178 mm (7 in) centers. The pipes in the approach slabs are 7.1 m (23 ft 4 in) long and are on 229 mm (9 in) centers. Portland cement concrete cover over the pipes is 82.5 mm (3 1/4 in). All pipes have a slope of 0.065 (m/m or ft/ft) to return the condensate to the evaporator. Initially, the refrigerant HCFC 123 was used as the working fluid. Other fluids were subsequently substituted (see “*Operating experience*,” below). Bridge construction started in 1995 and was completed in the summer of 1996. Inclusion of the heating system had no significant impact on construction duration.

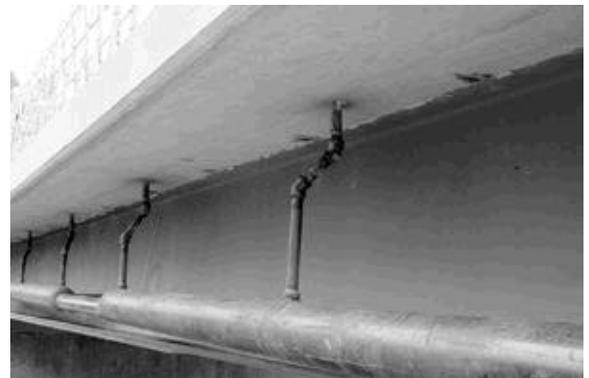
**Fig. 5. Risers deliver heated working fluid to a series of evaporators, each serving 10 Perkins tubes in bridge deck.**

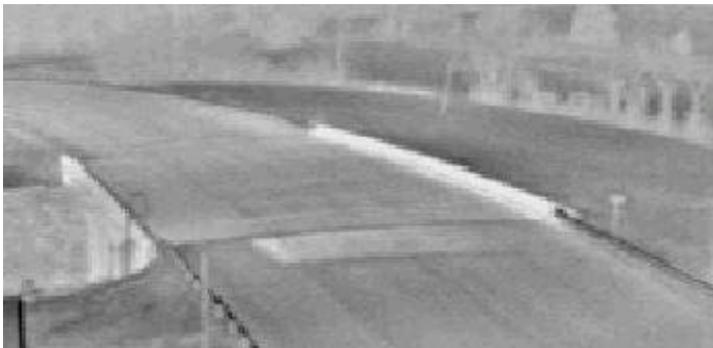
**Fig. 8. Heat pattern in 1998 after all heat pipes were purged and ammonia was introduced as the working fluid. The short section in foreground is the approach, which shows a higher temperature at the left, but the deck now has very uniform heat distribution.**

February 1998. Metallurgical-grade ammonia (99.99 percent pure) replaced HCFC-123 in evaporator no. 4 (third unit from east end of deck) on the 13th. This required changing fittings from brass to stainless steel. All other evaporators are filled with HFC-134a. Heating test was made following this modification. Air temperature was 10°C (50°F), surface temperature of ammonia section was 17°C (63°F), indicating significant improvement in heat intensity and uniformity of distribution. It was found that the failure to activate the heating system automatically was due to a faulty deck surface condition sensor.

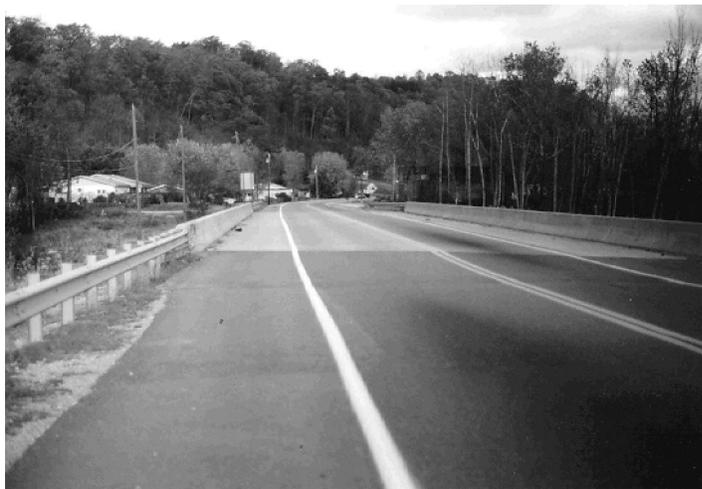
▲ Fig. 2. View of bridge on US 35 over 5&20 Creek. Fig. 3. Meteorological station adjacent to bridge. ➤
