FHWA Publication No.: FHWA-HRT-16-073

# SUMMARY REPORT

## Analysis of Cracking in Jointed Plain Concrete Pavements

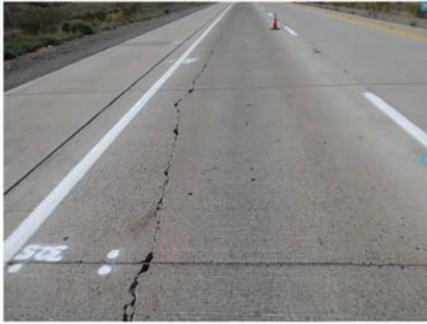
The snapshots featured in figure 21 through figure 30 were selected from 10 different sections in 7 sites (States). They share almost continuous single cracks relatively near the shoulder. These cracks occurred only

Figure 21. Longitudinal cracking near the shoulder in Arizona-0213 section (February 16, 2011).

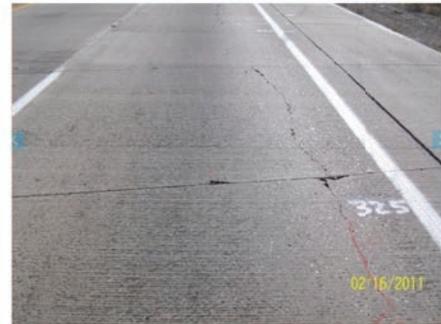
Figure 22. Longitudinal cracking near the shoulder in Arizona-0262 section (February 16, 2011).

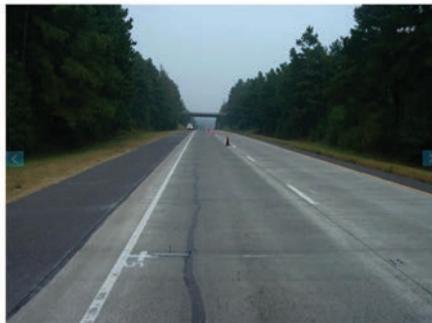
Figure 23. Longitudinal cracking near the shoulder in Arkansas-0213 section (May 24, 2007).

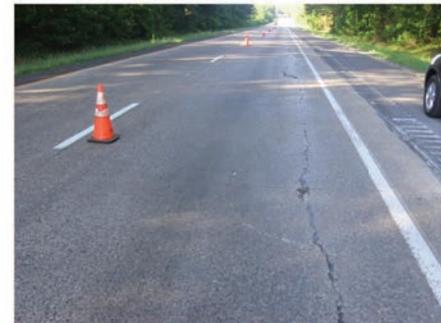
Figure 24. Longitudinal cracking near the shoulder in Arkansas-0217 section (December 4, 2012).

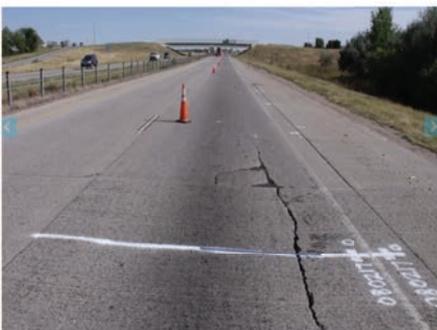
Figure 25. Longitudinal cracking near the shoulder in Colorado-0217 section (September 20, 2011).

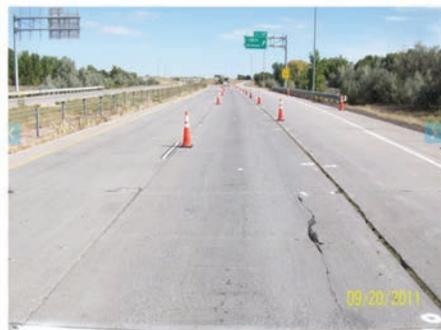
Figure 26. Longitudinal cracking near the shoulder in Colorado-0218 section (September 20, 2011).

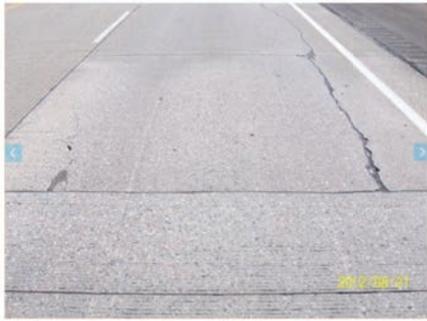
Figure 27. Longitudinal cracking near the shoulder in North Dakota-0217 section (August 21, 2012).

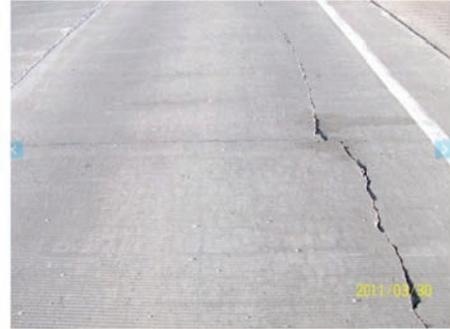
Figure 28. Longitudinal cracking near the shoulder in Iowa-0217 section (March 30, 2011).

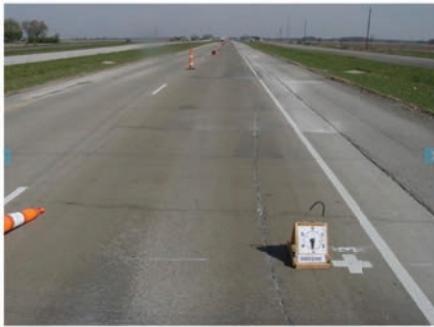
Figure 29. Longitudinal cracking near the shoulder in Ohio-0206 section (September 12, 2006).

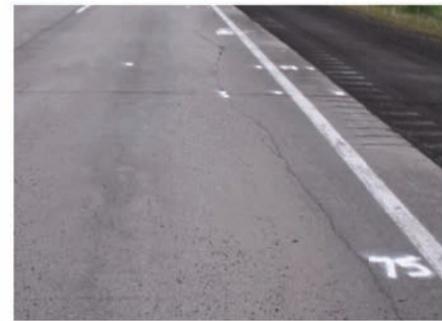
Figure 30. Longitudinal cracking near the shoulder in Washington-0206 section (May 23, 2013).
