# Laboratory and Field Testing of Automated Ultrasonic Testing (AUT) Systems for Steel Highway Bridges

PUBLICATION NO. FHWA-HRT-04-124

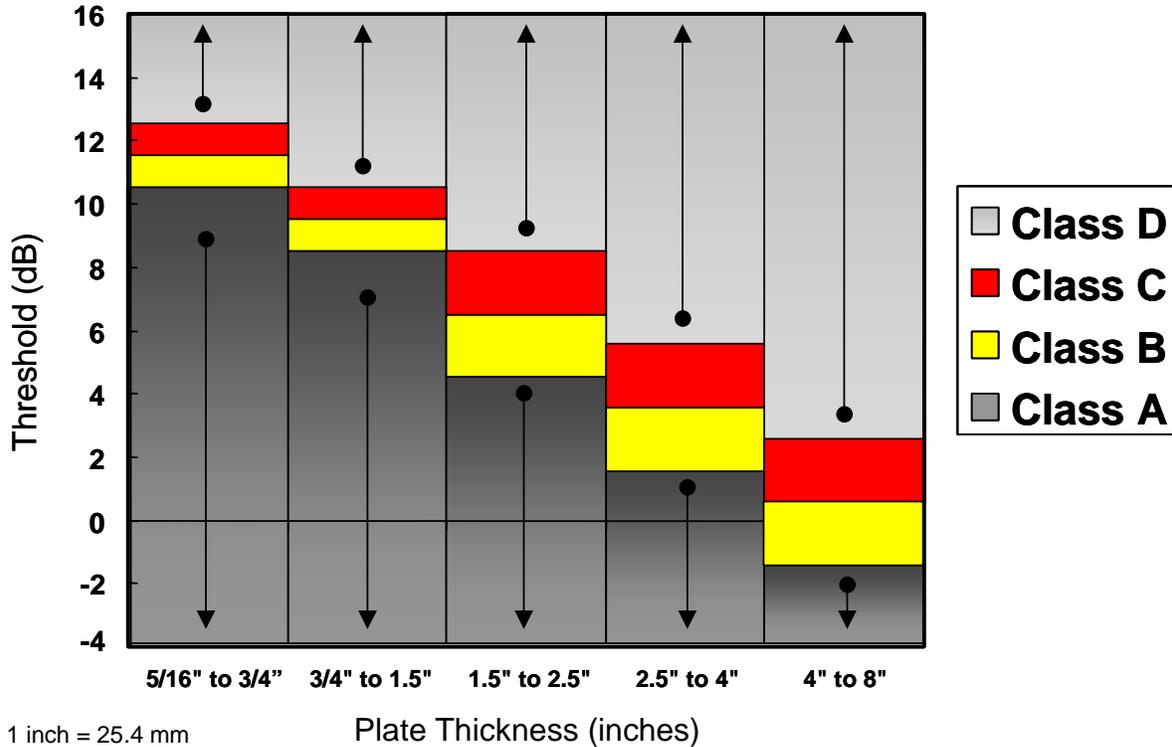
**Figure 1. Rating chart plotted from table 6.3 in the AASHTO/AWS D1.5M/D1.5: 2002 Bridge Welding Code,<sup>(1)</sup> showing class A, B, C, and D decibel levels for 70-degree angle.**

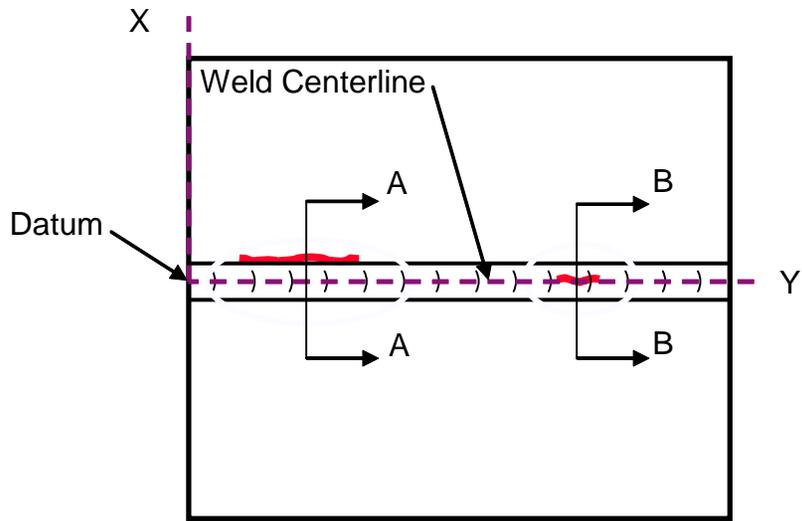
**Figure 7. Laboratory specimen S033:  
Schematic diagram showing two  
implanted cracks.**

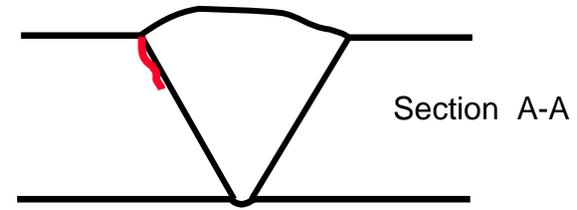
**Figure 8. Laboratory specimen S033:  
Schematic diagram of toe crack.**

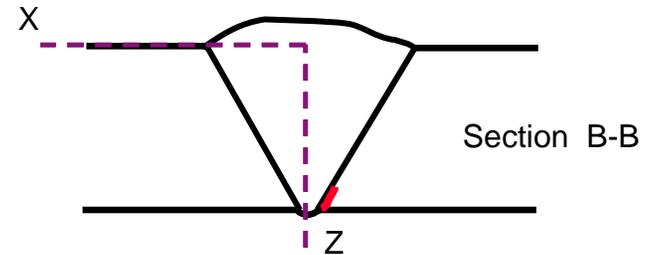
**Figure 9. Laboratory specimen S033:  
Schematic diagram of root crack.**

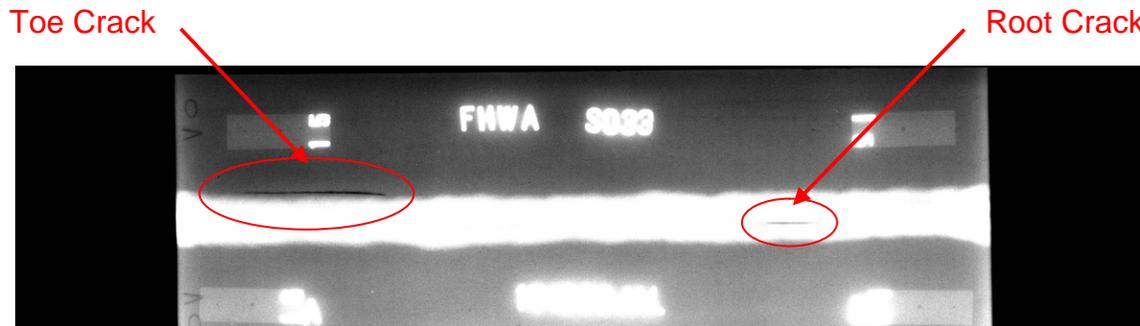
**Figure 10. Laboratory specimen S033: Radiographic image  
shows the two implanted cracks.**

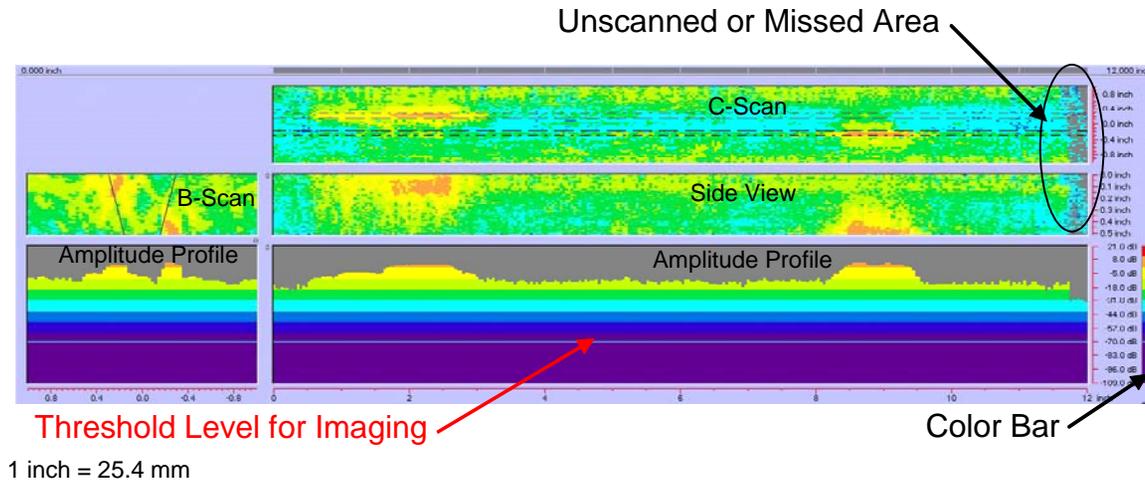
**Figure 11. P-scan images of laboratory specimen S033: Displayed in logarithmic mode during scanning to ensure full coverage of the weld.**

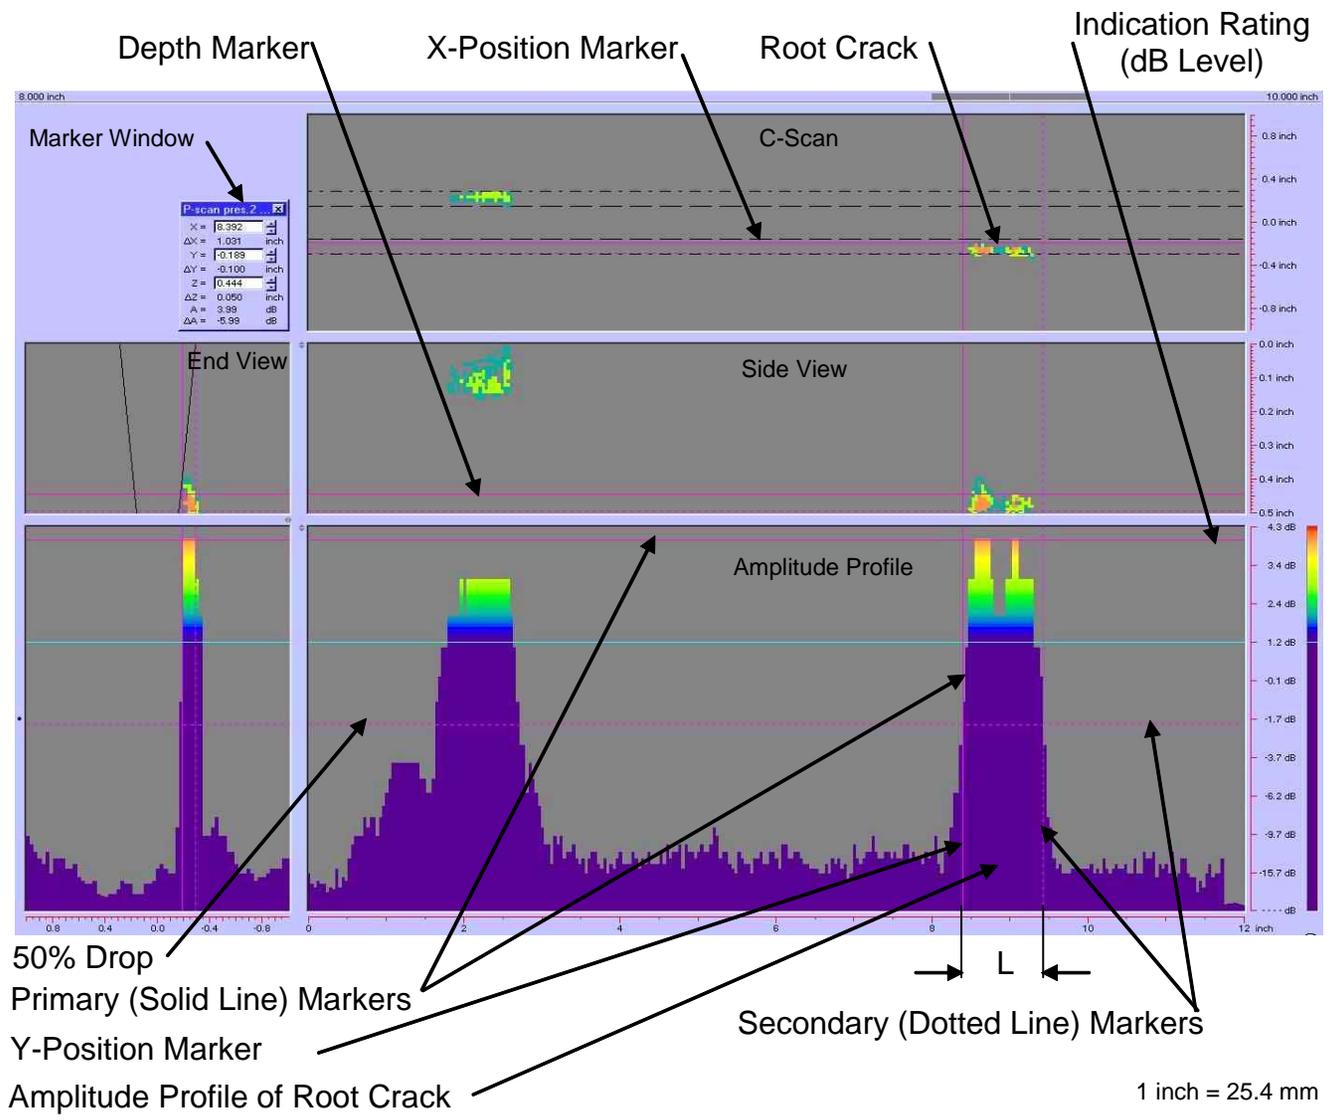
**Figure 14. Flaw-sizing scheme of the P-scan system for the root crack in laboratory specimen S033.**

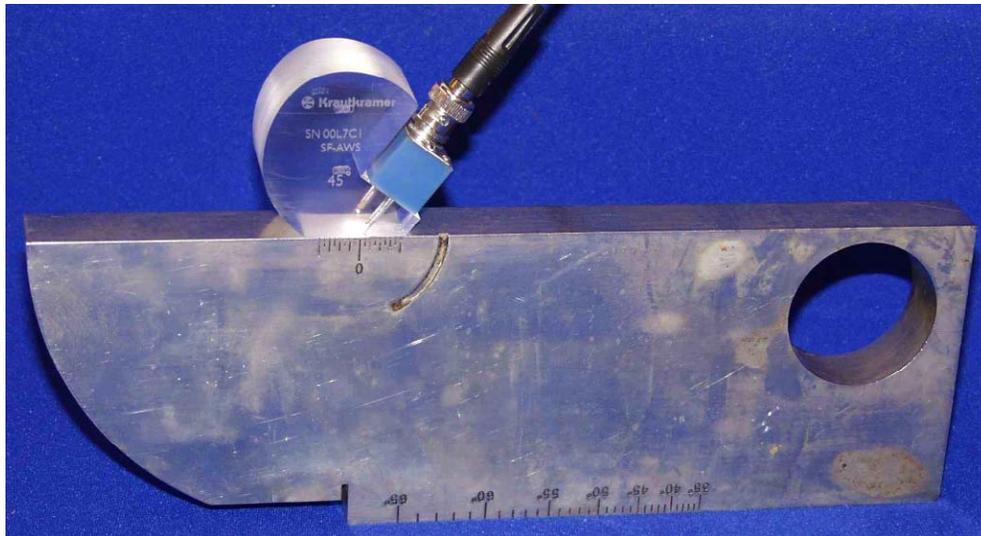
**Figure 19. Sound entry point check: Photograph shows the transducer position on the IIW reference block.**

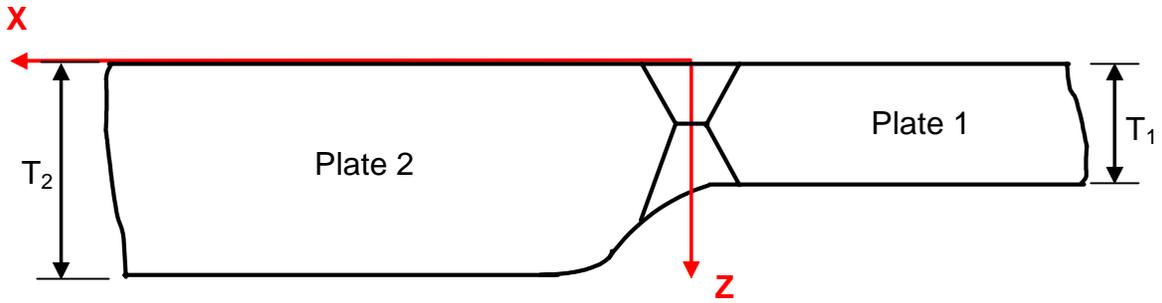
**Figure 29. Schematic diagram of specimen: Thickness transition at butt joint.**

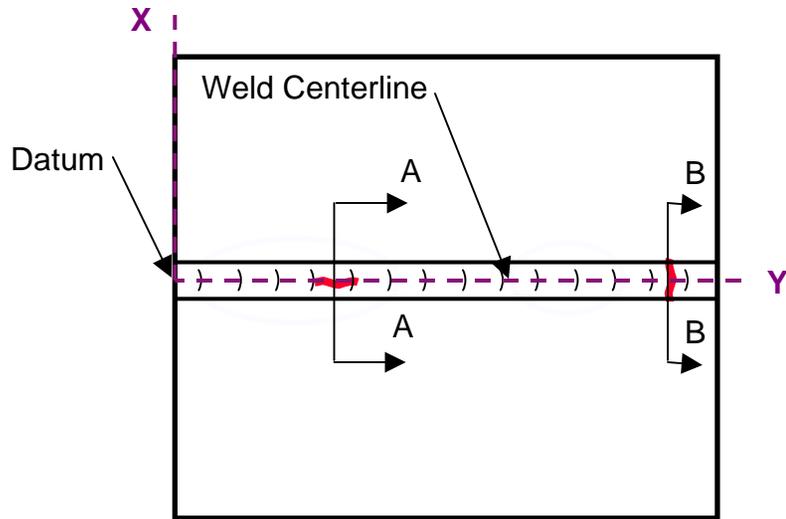
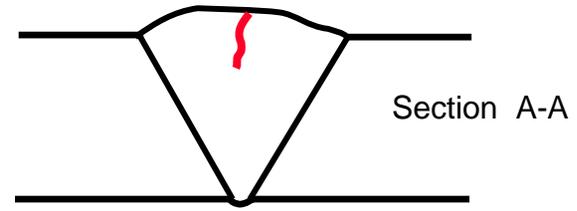
Figure 34. Laboratory specimen S034: Schematic diagram of longitudinal/centerline crack.

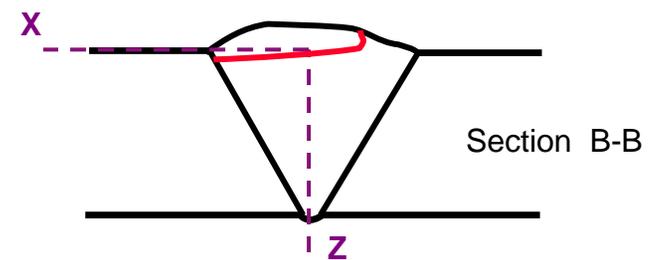
Figure 35. Laboratory specimen S034: Schematic diagram of transverse crack.

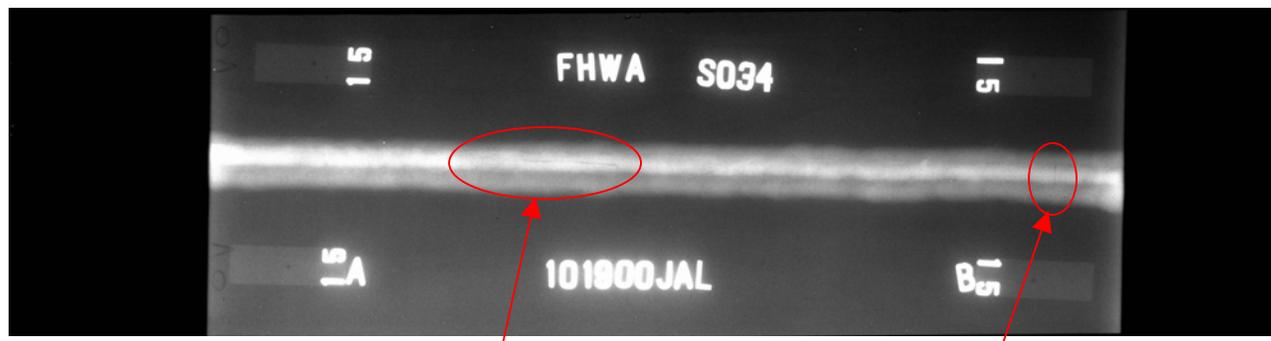
Longitudinal/Centerline Indication

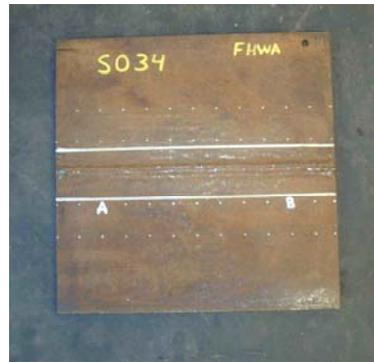
**Figure 37. Laboratory specimen S034: Top view of joint.**

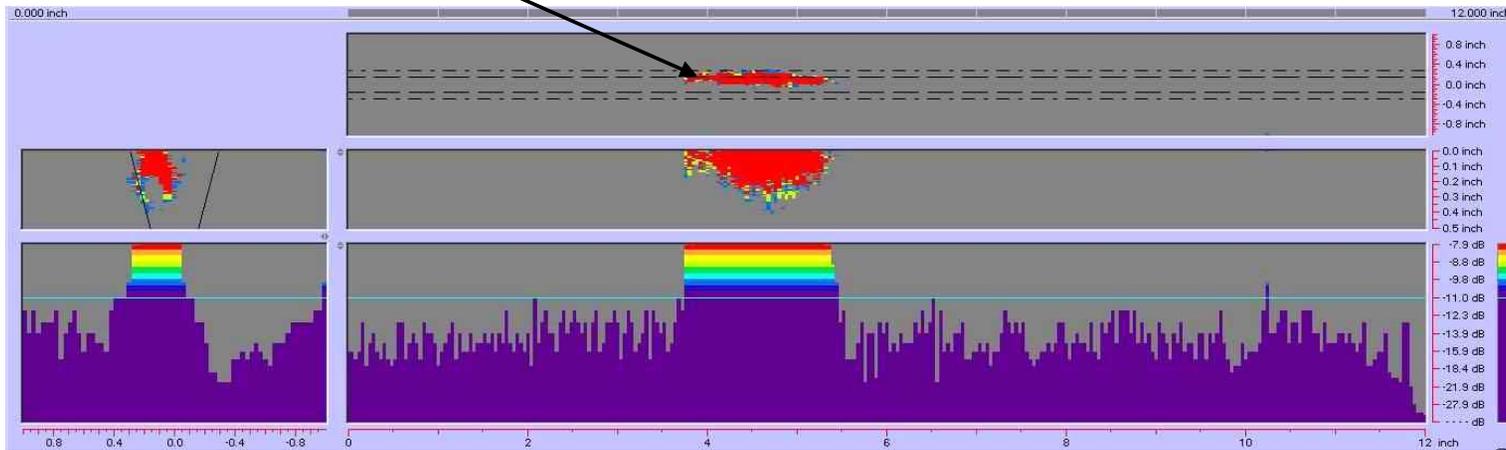
Longitudinal/Centerline Crack

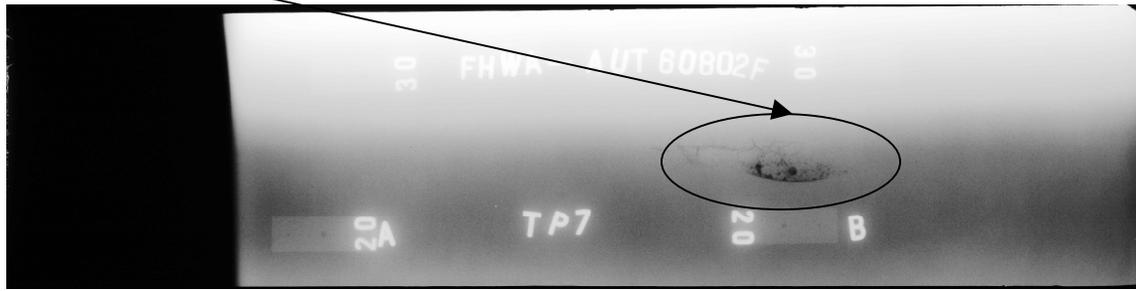
**Figure 66. Laboratory specimen S136: Radiographic image  
showing discontinuities in the weld between markers A and B.**

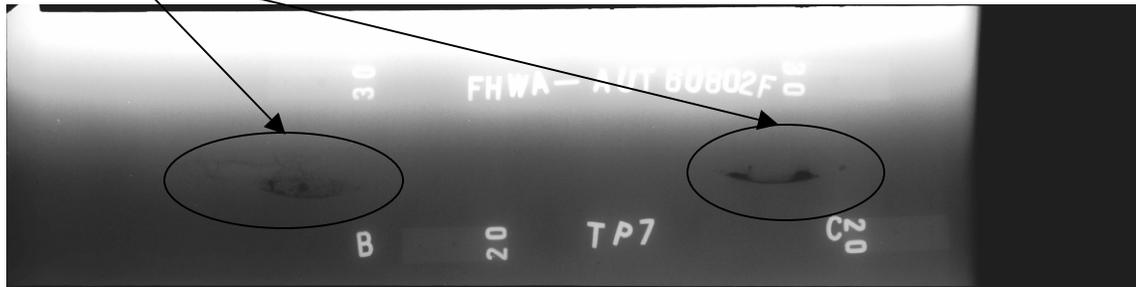
**Figure 67. Laboratory specimen S136: Radiographic image  
showing discontinuities in the weld between markers B and C.**

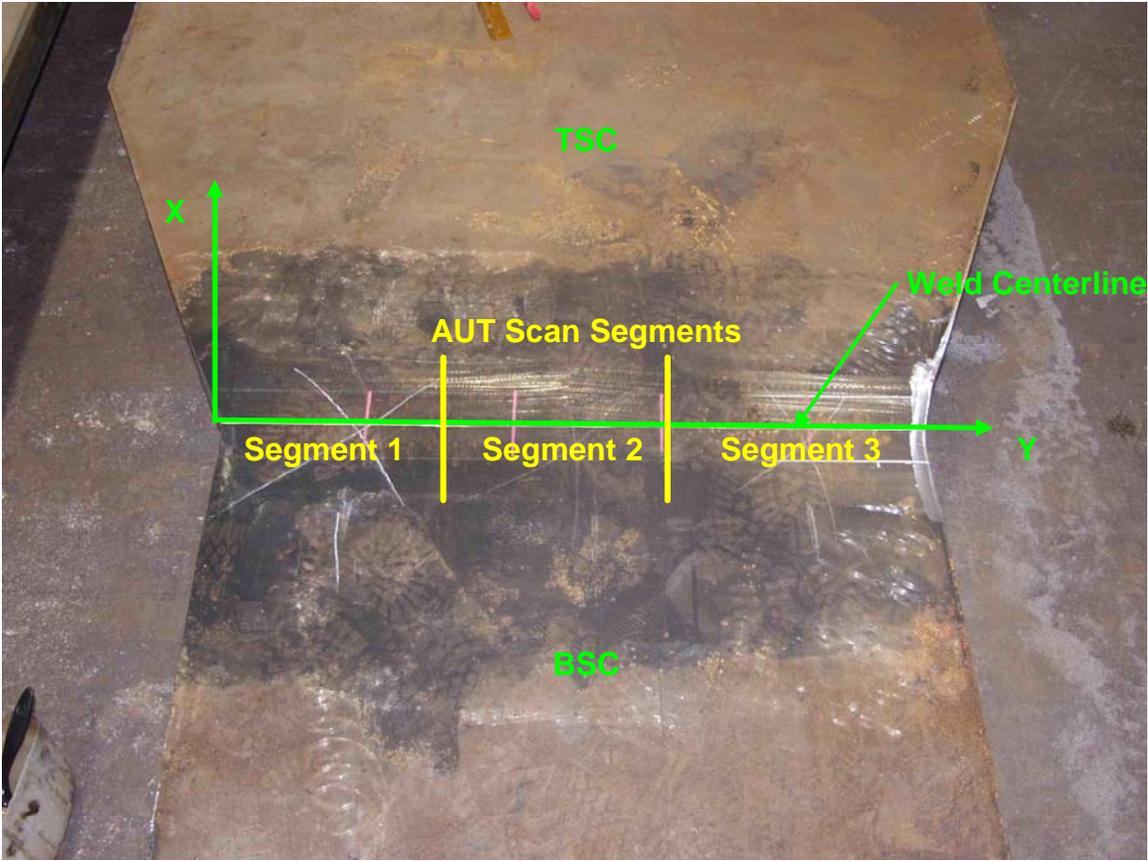
**Figure 72. Field specimen FG38K-TF2-TopF-FCM used in blind testing: Top view of joint.**

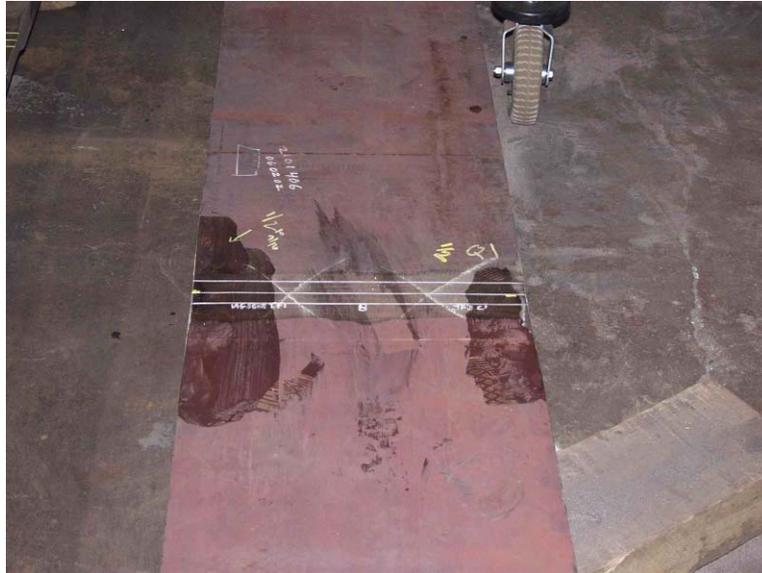
**Figure 83. Field specimen G5G-TF1-TopF:  
Top view of joint.**

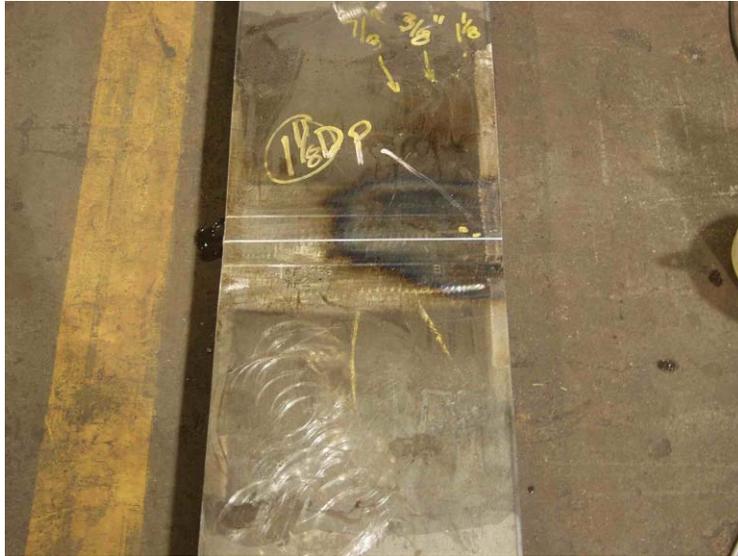
**Figure 97. Field specimen FG26G-TF2-BottF-FCM:  
Top view of joint.**

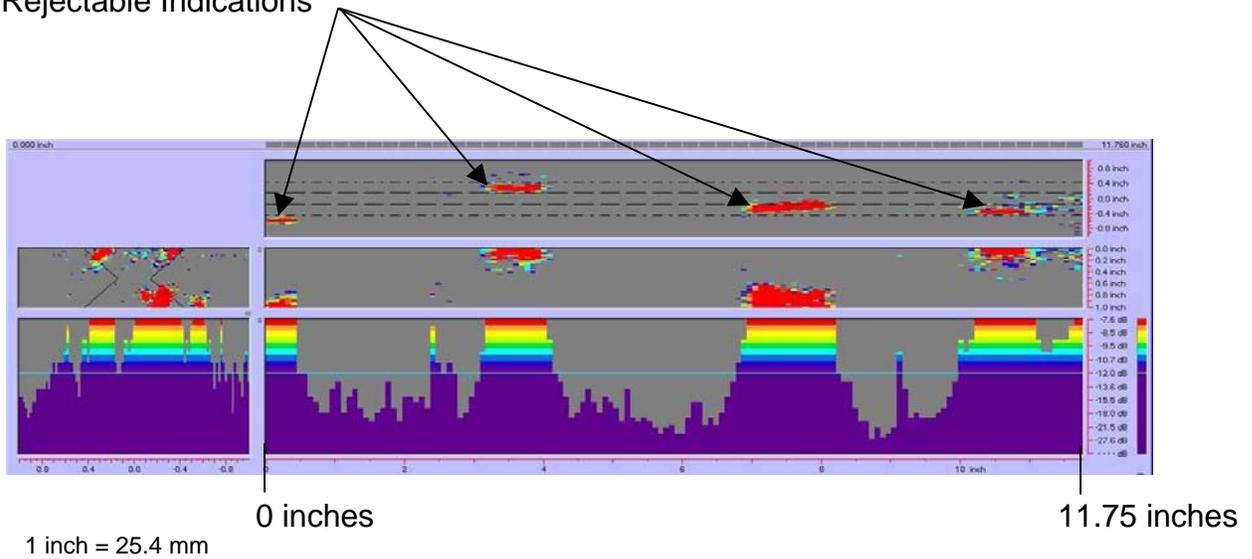
**Figure 119. HSS procedural test plate TP2: P-scan images from BSC side  
of centerline.**

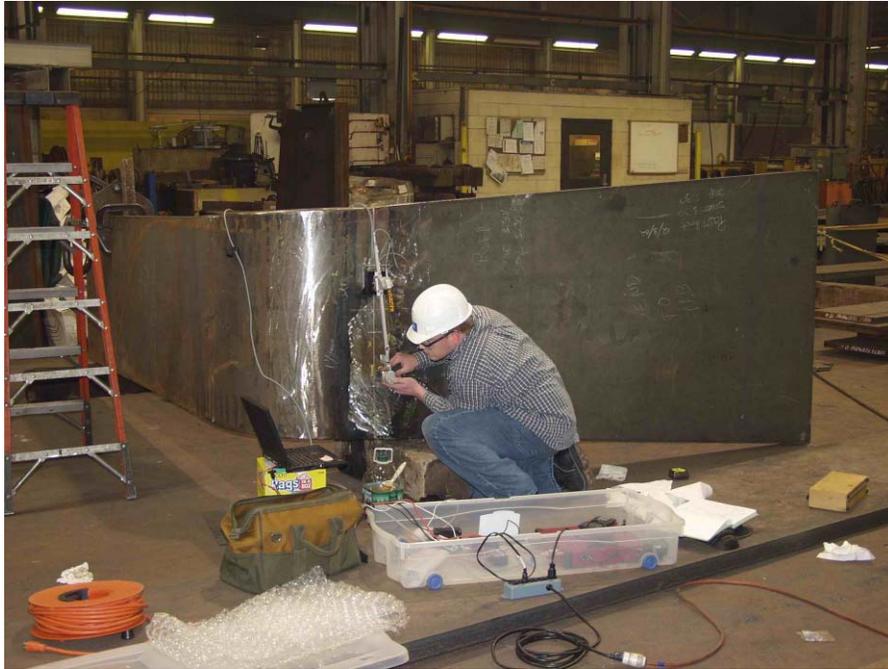
**Figure 120. Field specimen FG40M-TF1-Curved-FCM:  
Top view of joint.**

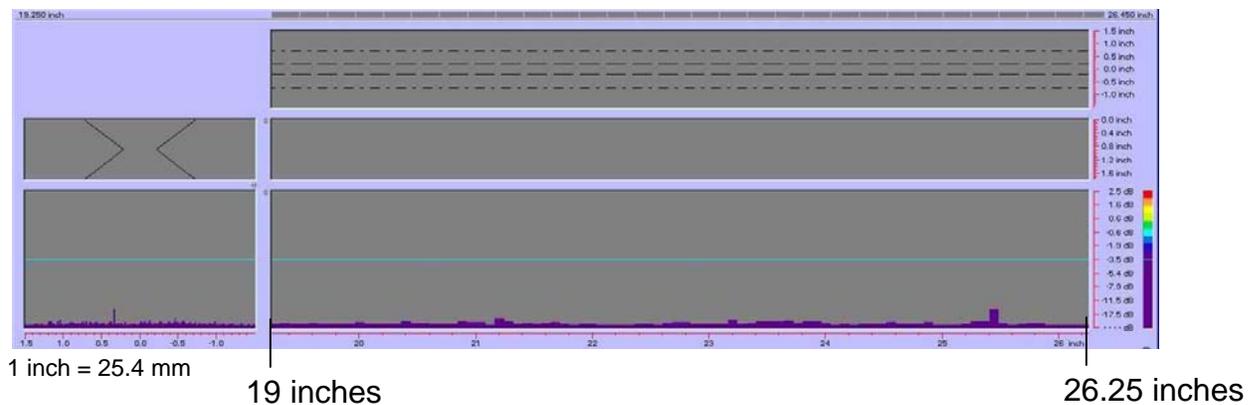
**Figure 144. P-scan images of field specimen G5VHW-CF1-BottF:  
From BSC side of centerline using 70-degree probe.**

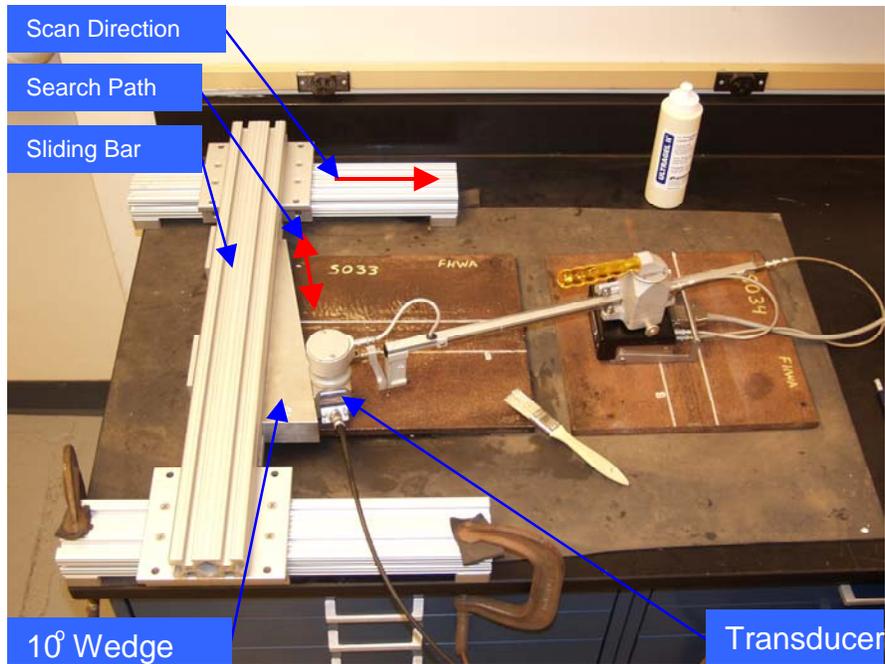
**Figure 145. Transducer articulation testing: Test setup.**
