Structural Behavior of Ultra-High Performance Concrete Prestressed I-Girders

PUBLICATION NO. FHWA-HRT-06-115

AUGUST 2006

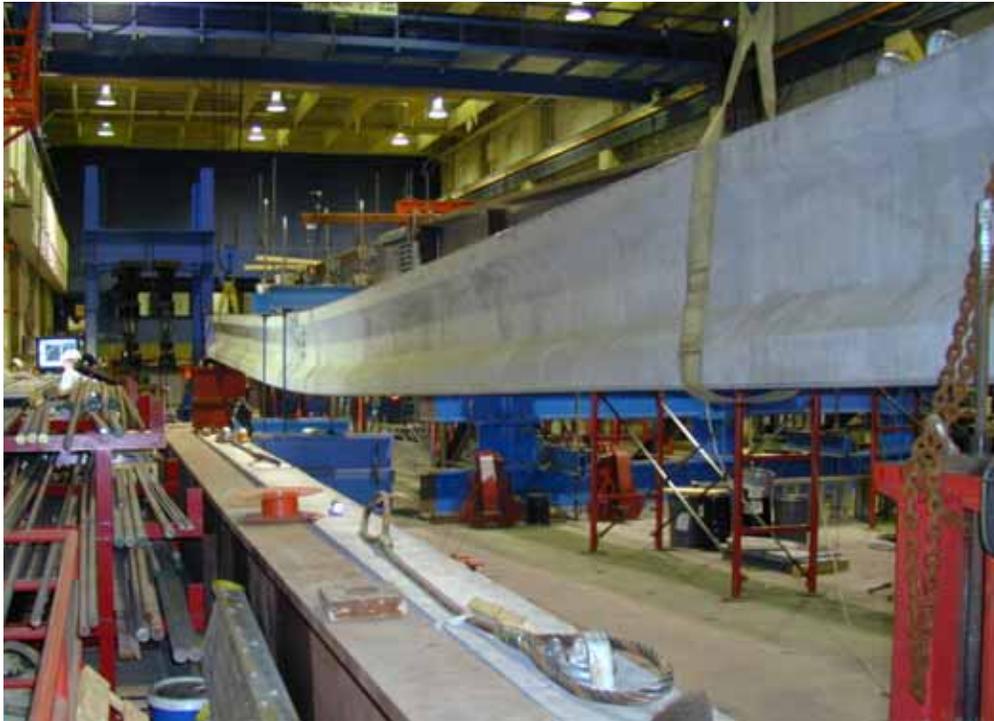
Figure 17. Photo. Girder 80F after approximately 430 mm (17 inches) of deflection.

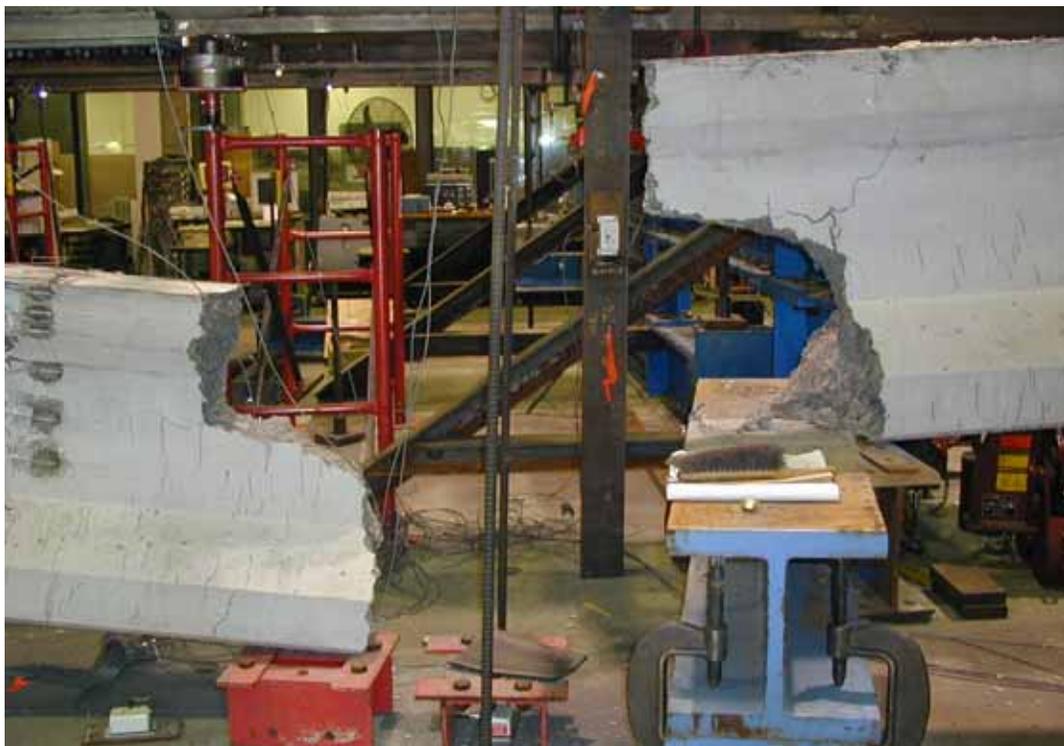
Figure 18. Photo. Girder 80F immediately after failure.

After the maximum load was reached, the girder began to exhibit drastically decreased stiffness. The loading was stopped at this point. As the girder softened the load decreased, because the loading apparatus was hydraulically actuated. Approximately 1 minute before failure, a single gross crack was observed growing up from the bottom flange at the west load point. Unlike any other cracks in the girder, this crack was clearly visible to observers from a distance of 4.6 m (15 ft). Failure of the girder was dramatic, with the girder fracturing into two unconnected pieces. Failure occurred due to a combined tensile failure of the concrete matrix and the prestressing strands. At the failure location, the fibers pulled out and all the strands necked and ruptured. Figure 18 shows the north elevation after failure, and figure 19 shows the west failure surface.

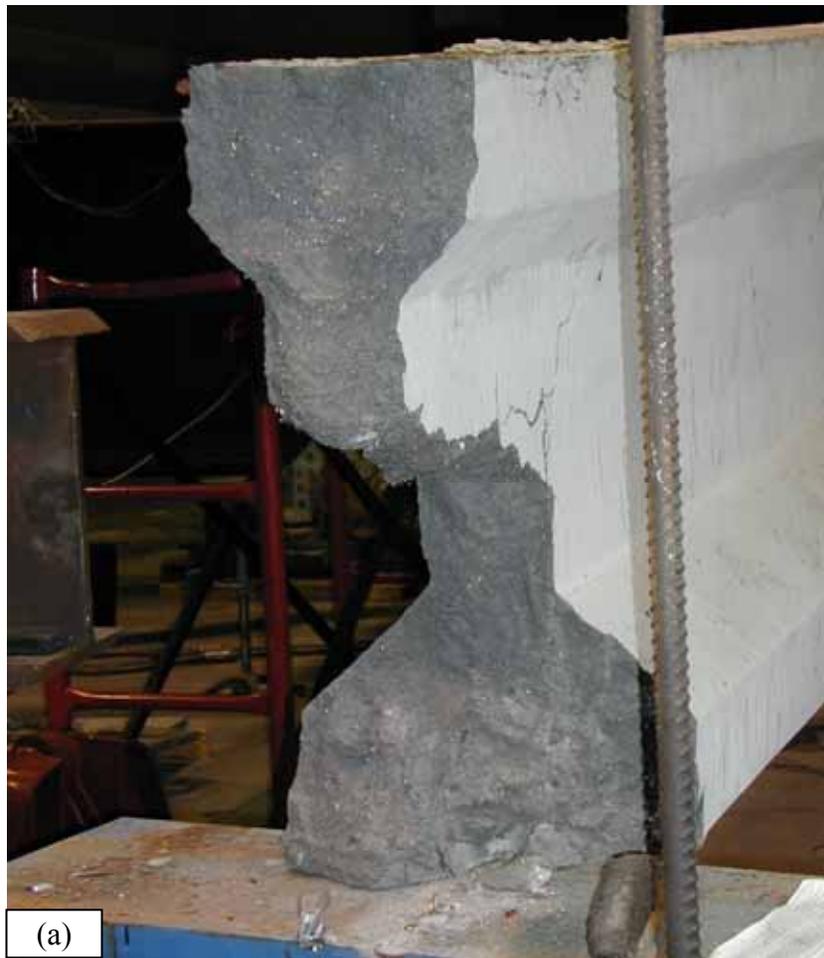
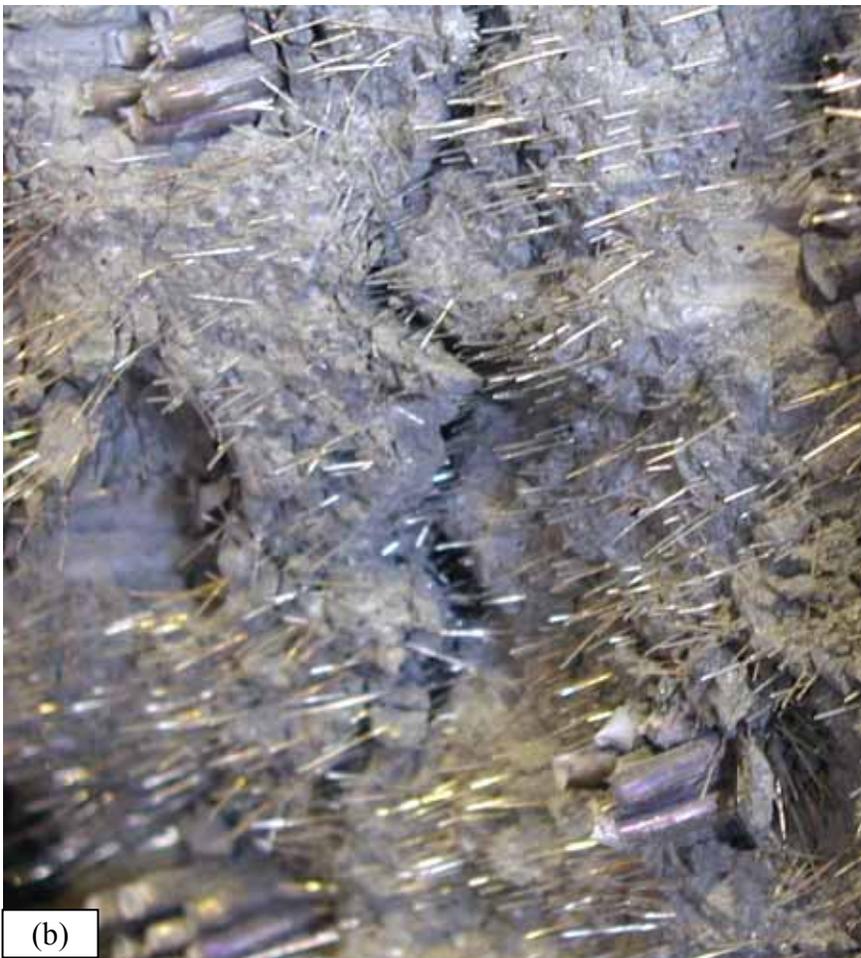
Figure 19. Photo. Failure surface of Girder 80F including (a) overall west failure surface and (b) closeup of west failure surface showing pulled-out fibers and necked strands.

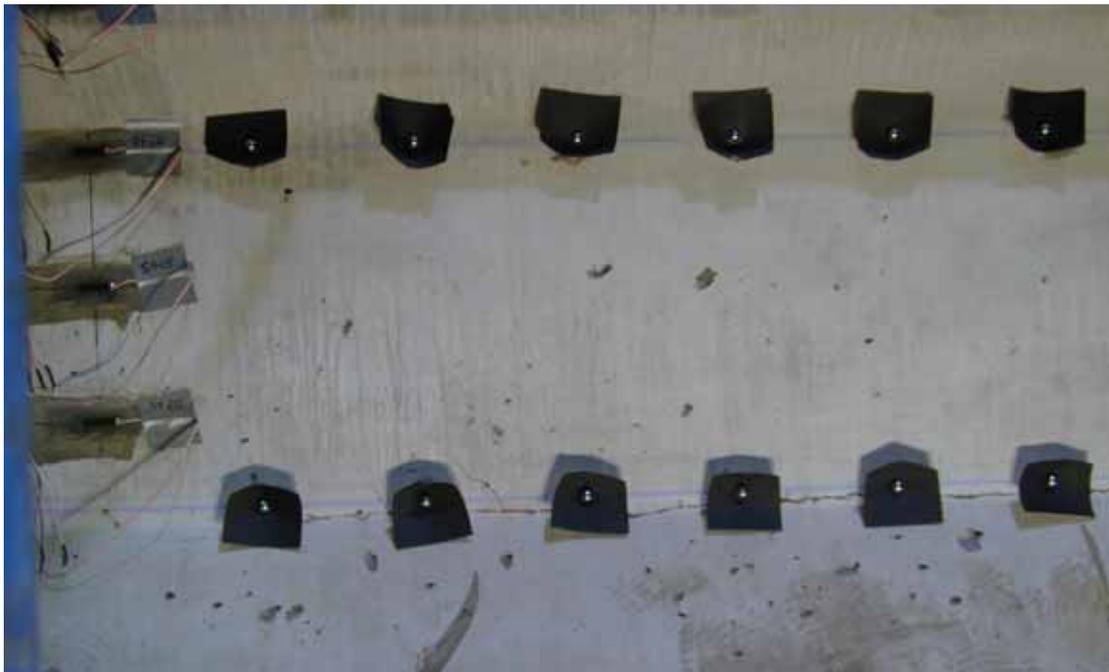
Figure 28. Photo. Crack at south base of Girder 28S web at a load of 2,000 kN (450 kips).

Cracking and other damage to the girder were observed both audibly and visually throughout the test. The first cracking was heard at a load of 1,245 kN (280 kips). The cracking continued throughout the remainder of the test and seemed to primarily emanate from the eastern half of the girder. Throughout the test, the preexisting hairline crack at the base of the web continued to grow larger and longer. At a load of 1,560 kN (350 kips), this crack was clearly visible from 4.6 m (15 ft). Figure 28 shows the size of this crack at a load of 2,000 kN (450 kips). This crack, along with its branch that rose toward the load point beginning around 2,000 kN (450 kips), was the only gross cracking observed before girder failure. However, many other smaller cracks were present. These cracks were initially visible only through the use of an indicating spray but later were visible by short-range unaided viewing.

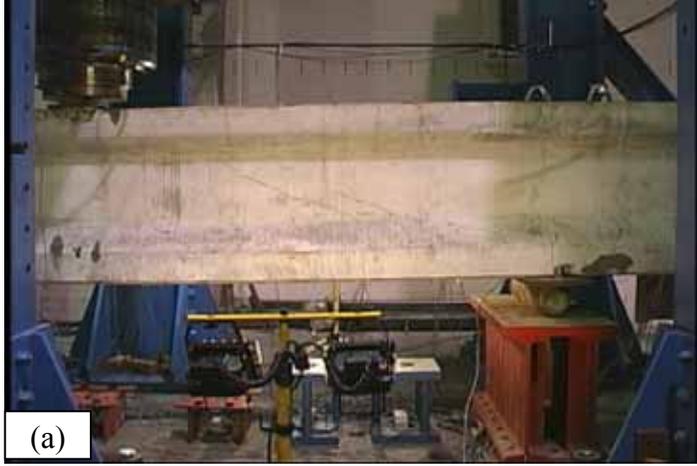
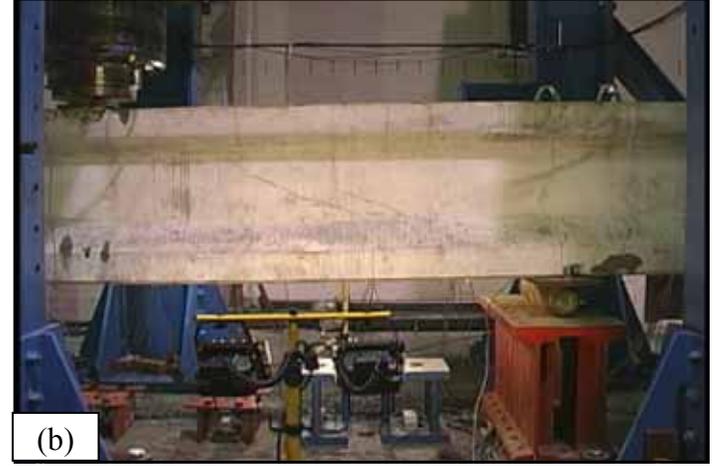
Figure 38. Photo. Failure of Girder 24S (a) 1/15 second before failure, (b) 1/30 second before failure, (c) at failure, and (d) 1/30 second after failure.

Figure 38 shows photographs taken from a digital video of the failure. These two parallel shear cracks released in a brittle fashion, and the girder failed. As previously mentioned, none of the strands slipped until after the failure. The two top flange strands did break in three locations during the failure; however, this secondary failure was related to the large release of energy coming from the concrete tensile (shear) failure. Figure 39 shows the girder after failure. Figure 40 illustrates the crack and failure patterns recorded after the girder had failed.

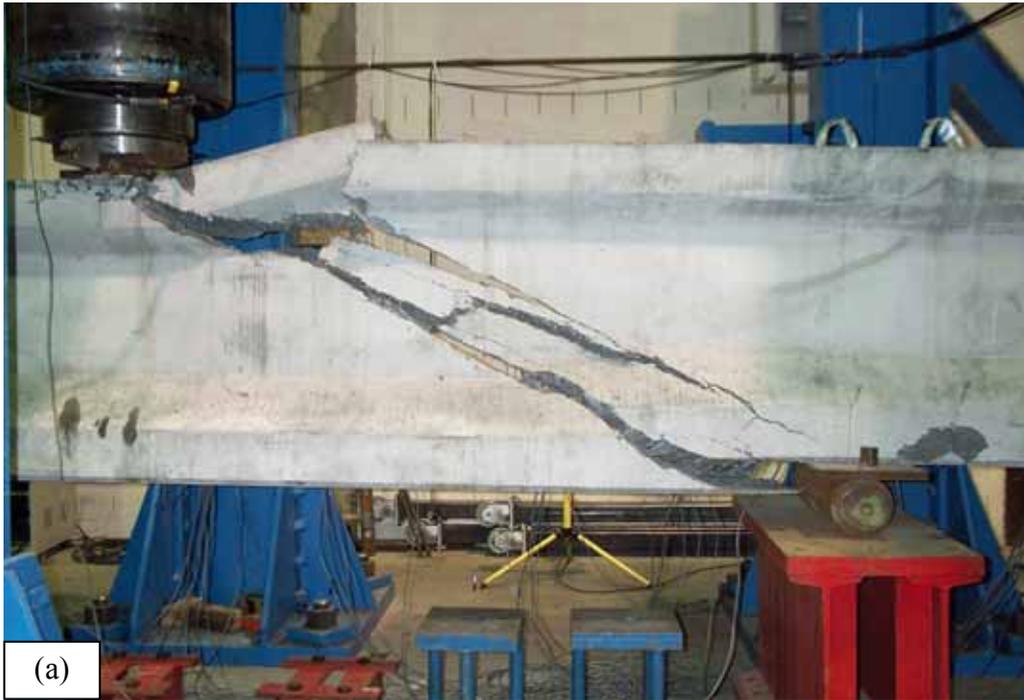
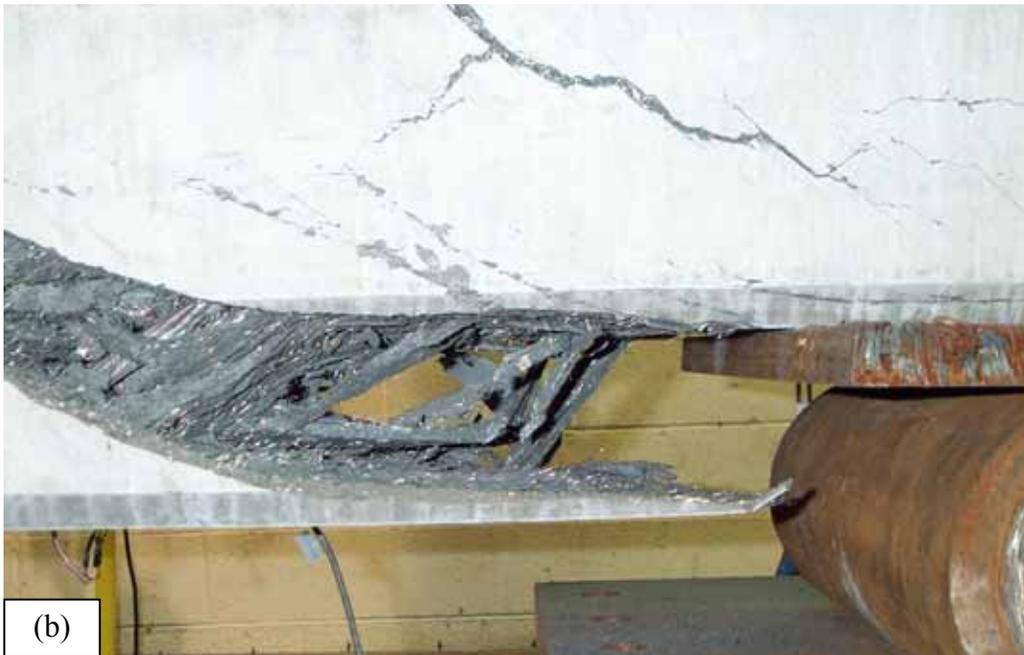
Figure 39. Photo. Failed Girder 24S (a) south elevation and (b) bottom flange near bearing.

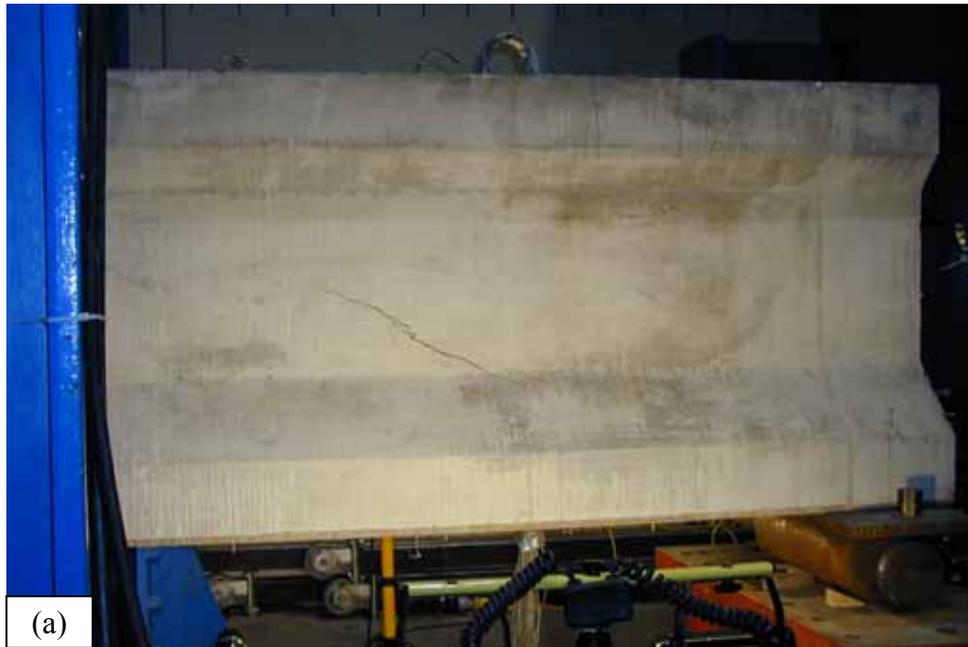
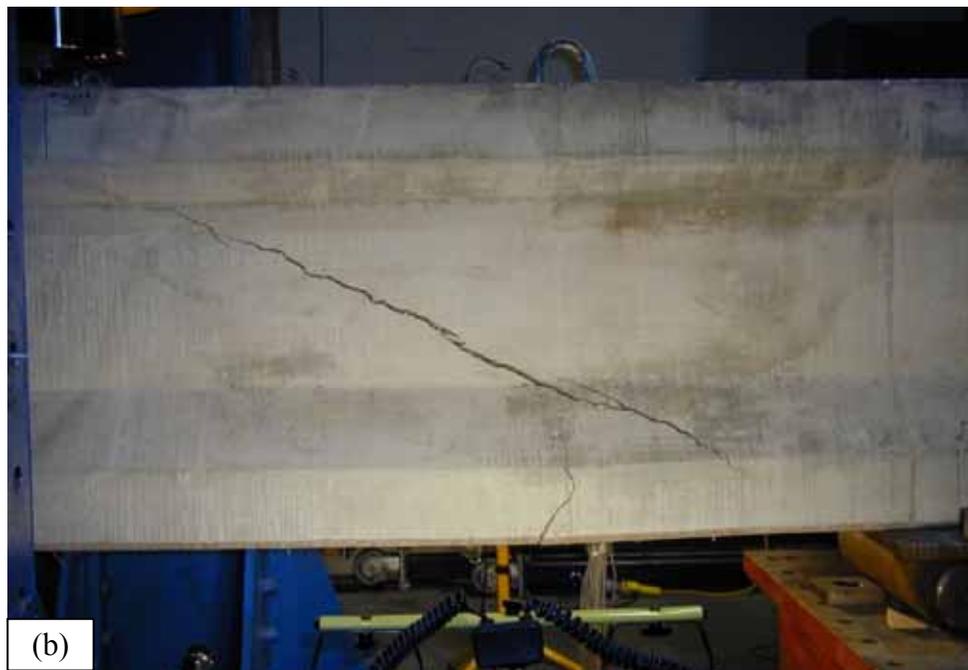
Figure 49. Photo. Girder 14S at (a) peak load and (b) postpeak load of 2,650 kN (595 kips).

Failure of the girder occurred when prestressing strands in the bottom flange began to rupture. The vertical crack in the bottom flange at the end of the debonding length continued to widen as, sequentially, the fully bonded strands broke. As more displacement was imparted into the girder, more strands ruptured until all 12 fully bonded bottom flange strands had ruptured. Figure 50 illustrates the crack and failure patterns that were recorded after girder failure.
