Integrity of Infrastructure Materials and Structures

PUBLICATION NO. FHWA-HRT-09-044

OCTOBER 2009

U.S. Department of Transportation
Federal Highway Administration

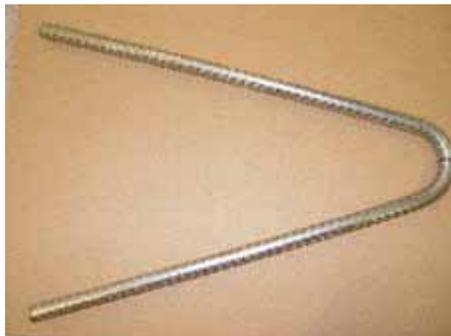
Figure 1. Photo. 2304 SS bar after bending.

For these experiments, 2304 SS bars approximately 0.50 m long were bent to a radius bend four times the diameter of the bar (a 4D-radius) as seen in figure 1. Next, a strain gauge was mounted on the outside diameter of the bent bar approximately 15 cm from the midpoint of the bend. Specimens were then mounted individually in a vise, bent further to the point where the two side lengths were parallel, and restrained in this position using a custom configured C-clamp. Care was exercised to ensure that specimens did not relax when removed from the vise to avoid a situation where the critically stressed region (outside diameter at the center of the bend) went into residual compression. Figure 2 shows a schematic representation of a specimen in the bent and restrained state. The location of the maximum tensile stress, strain gauge, and C-clamp are shown as blue, red, and green, respectively.

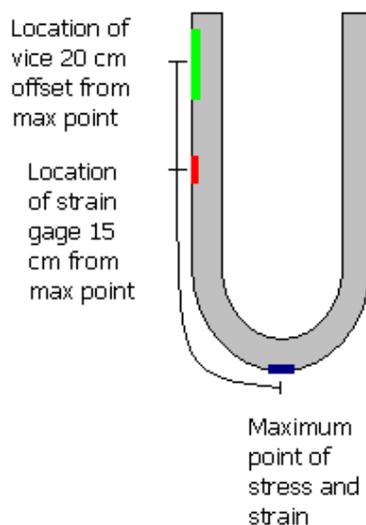
Figure 2. Illustration. A bent specimen in the restrained position.

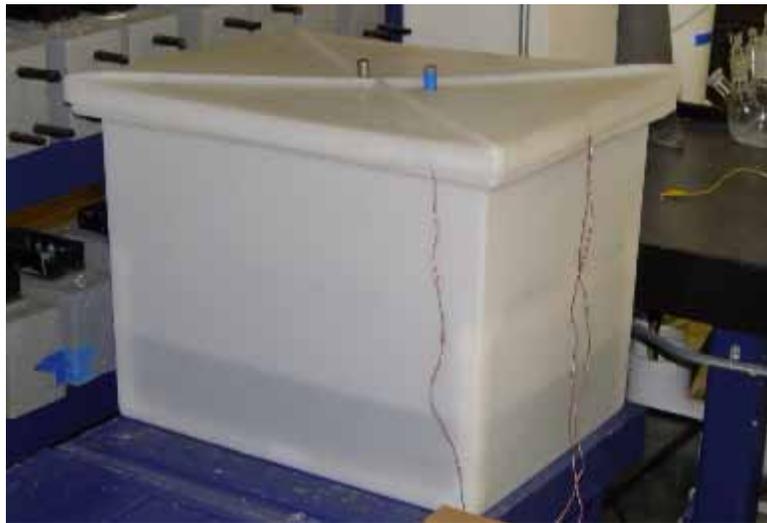
Figure 3. Photo. Test tank with cover.

All exposures were performed in two polyethylene tanks using a simulated pore solution that consisted of 0.30N KOH + 0.05N NaOH (initial pH = 13.44), where N is a chemical concentration unit indicating normal. One tank was maintained at room temperature, and chlorides were added to this in 1–2 weight (wt) percent increments on alternate days. The solution was titrated for OH^- before, and after, Cl^- was added to determine any pH change with time. Figure 3 shows one of the test tanks, and the two ends of a specimen can be seen protruding through the cover. Lead wires from the strain gages appear in the foreground of the figure. Likewise, figure 4 shows a top view of two specimens positioned in a tank with the cover removed. The second tank was maintained at 65 °C and a constant chloride content of 15 wt percent. Each specimen was placed in a separate plastic cylinder that was wrapped with insulation. Temperature was maintained by a heating element and a temperature probe in the plastic cylinder, the latter being connected to a thermostat.

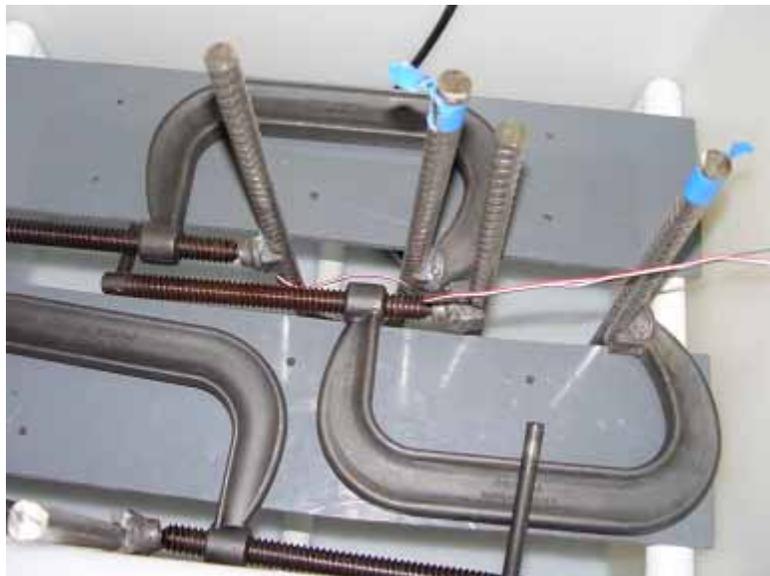
Figure 4. Photo. Top view of two specimens with C-clamps in the test tank.

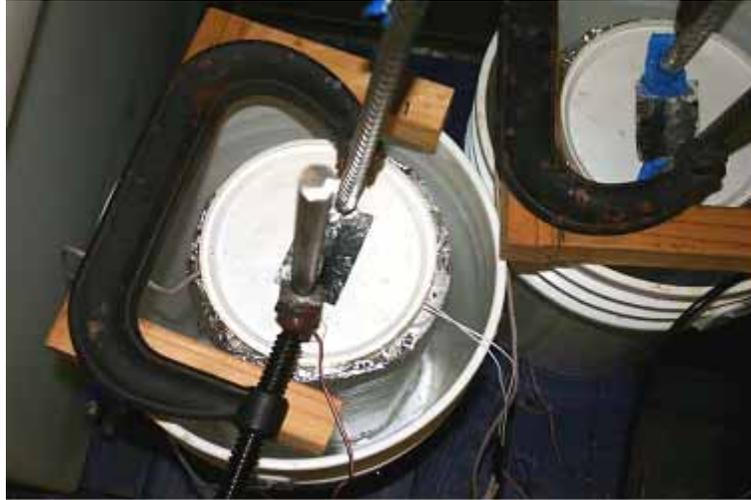
Figure 5. Photo. High temperature experiment arrangement.

Figure 5 shows two specimens positioned in temperature-controlled cylinders. In all cases, the bend was submerged in the simulated pore solution to a depth of 5 cm. The gauges were monitored for any strain decrease that would be indicative of cracking. Specimens were also examined daily. The higher temperature exposures were terminated after about 1 month, but the ambient temperature exposures continued for 1 year.

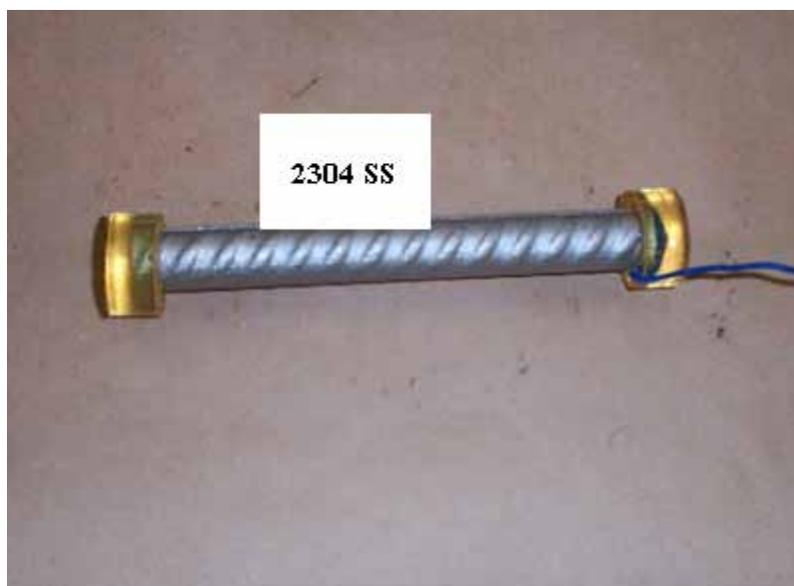
Figure 6. Photo. Straight as-received 2304 SS bar with epoxy-mounted ends and an electrical lead.

The accelerated test method for these experiments consisted of potentiostatic polarization of 10 identical 152-mm-long 2304 SS reinforcing bar specimens at +100 mV_{SCE} using a single locally designed and constructed potentiostat, where *SCE* is the potential versus saturated calomel electrode. A 10-Ω resistor was in series with each specimen, and voltage drop was monitored. Exposure was in synthetic pore solution of the same composition noted above (0.30N KOH + 0.05N NaOH) to which chlorides were incrementally added. This potential (+100 mV_{SCE}) is considered conservative in that it exceeds the free corrosion potential that should occur in actual structures. In the absence of or with low chlorides, even black steel should be passive at this potential such that polarization should occur readily with low current demand. After a steady state was achieved after several days in the synthetic pore solution, chlorides were incrementally added. Corrosion was considered to have initiated once current density increased to 10 μA/cm², as calculated from the voltage drop across the 10-Ω resistor. The Cl⁻ concentration that resulted from this achieved density was taken as the critical value for pitting and corrosion initiation, and it served as an important materials selection and design parameter in LCCA. Exposure of individual specimens was terminated once corrosion was initiated. Figure 6 shows a specimen ready for exposure with epoxy end mounts and an electrical lead, figure 7 shows a schematic representation of the experimental setup, and figure 8 shows the test system.

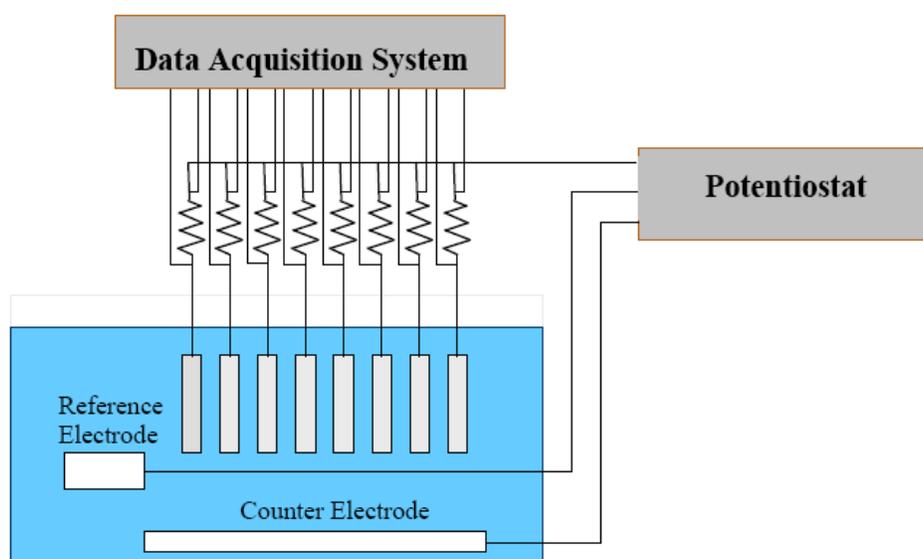
Figure 7. Illustration. Accelerated experimental arrangement.

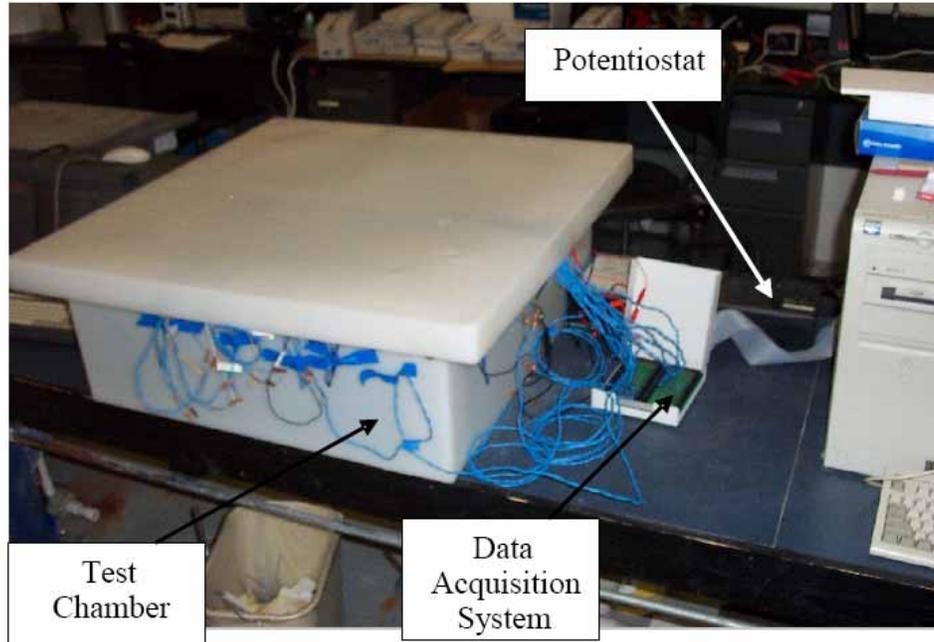
Figure 8. Photo. Test system.

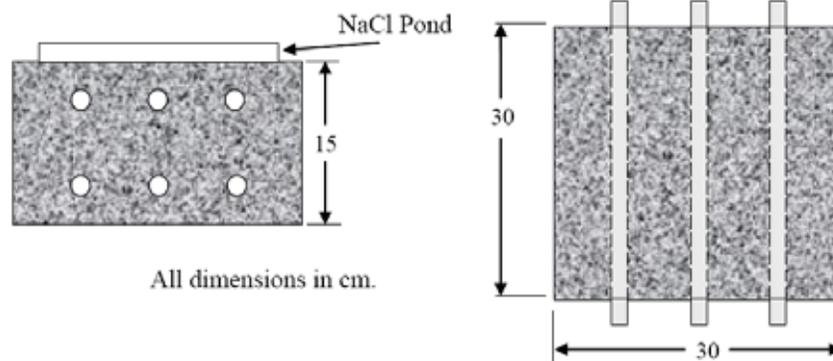
Figure 9. Illustration. Simulated deck slab specimen design.

the exposed concrete surface. The casting procedure involved placing freshly mixed concrete in the specimen molds in two lifts followed by consolidating each lift for 20–30 s on a vibration table. The first lift filled the specimen mold approximately half full, and the second lift completely filled the mold. The surface of the specimens was troweled smooth using a wooden or metal float. After 24 hours, the molds were disassembled. The specimens were removed, placed in sealed plastic bags, and stored for 6 months.

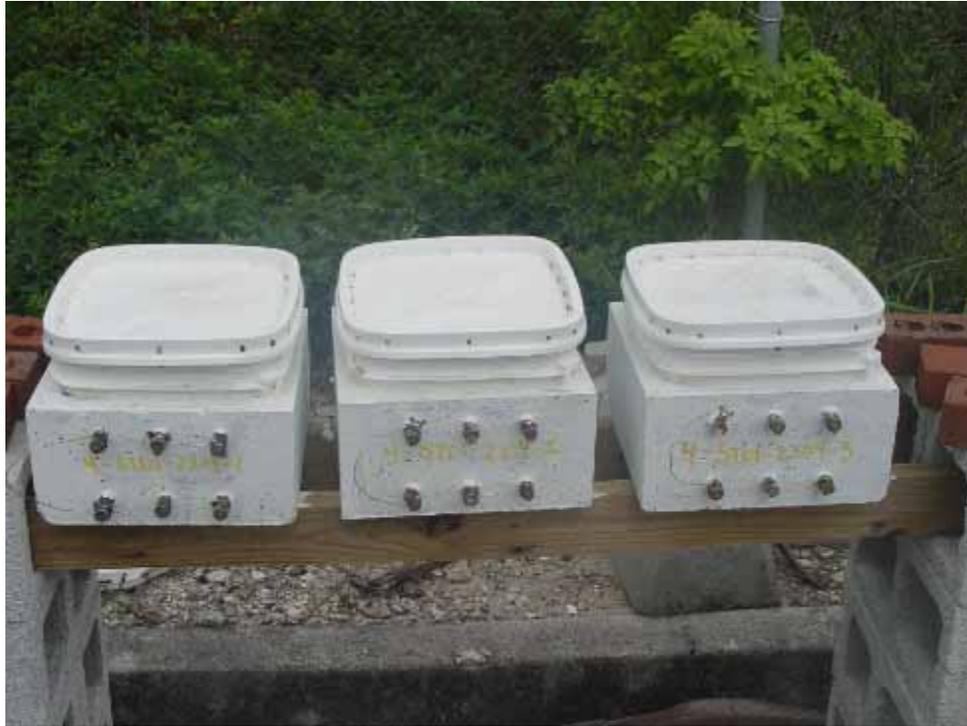
Figure 10. Photo. SDS specimens reinforced with 2304 SS under test.

Upon delivery to Florida Atlantic University (FAU), an electrical connection was established between bars in each of the two layers of each slab using a SS wire in conjunction with a drilled hole and connection screw at one end of each bar. Periodically, a 10- Ω resistor was temporarily inserted in the circuit between the two bar layers, and voltage drop across this was measured. From this procedure, the macrocell current was calculated. The specimen sides were coated with an ultraviolet-resistant paint and inverted relative to their orientation at casting. A plastic bath with a vented lid was then mounted on what was the bottom formed face. Prior to ponding, the specimens were stored outdoors in a covered location for 2 months at the FAU Sea Tech Campus, which is approximately 300 m inland from the Atlantic Ocean southeast of Ft. Lauderdale, FL. The initial week of ponding was with potable water to promote saturation or a high humidity pore structure so that upon ponding, diffusion and not sorption would be the primary Cl^- ingress mechanism. This was followed by cyclic 1 week wet/1 week dry ponding with 15 wt percent sodium chloride (NaCl). The salt water ponding commenced on August 10, 2005. Figure 10 shows the three specimens under test.

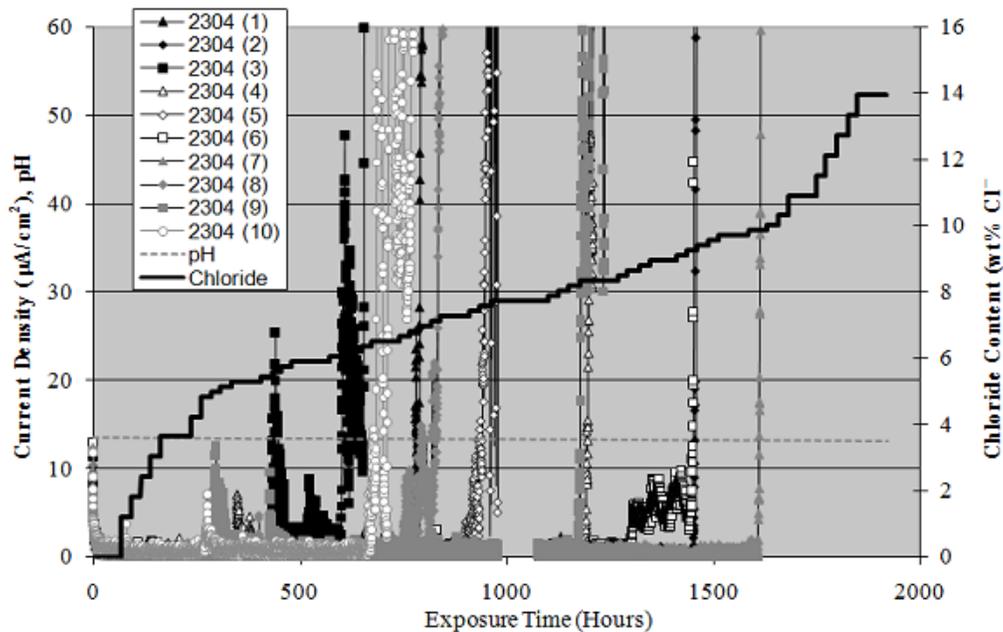
Figure 11. Graph. Accelerated corrosion test data.

Figure 11 plots current density versus exposure time for the 10 identical 2304 SS specimens. The pH data is also shown, which appears as a near horizontal line slightly above a value of 12 and $[\text{Cl}^-]$ versus time according to the incremental additions. Current density was between 10 and 12 $\mu\text{A}/\text{cm}^2$ initially but decreased to zero to 2 $\mu\text{A}/\text{cm}^2$ during the first few days of exposure, presumably reflecting repair of defects in the passive film. For most specimens, a definitive transition from this low current density to much higher values occurred at a particular time, which reflected the onset of active pitting. The time at which this occurred covered a relatively broad range from 295 hours for specimen 9 to 1,608 hours for specimen 7. The data interruption near 1,000 hours resulted from a power outage that lasted several days due to Hurricane Katrina in August 2005.

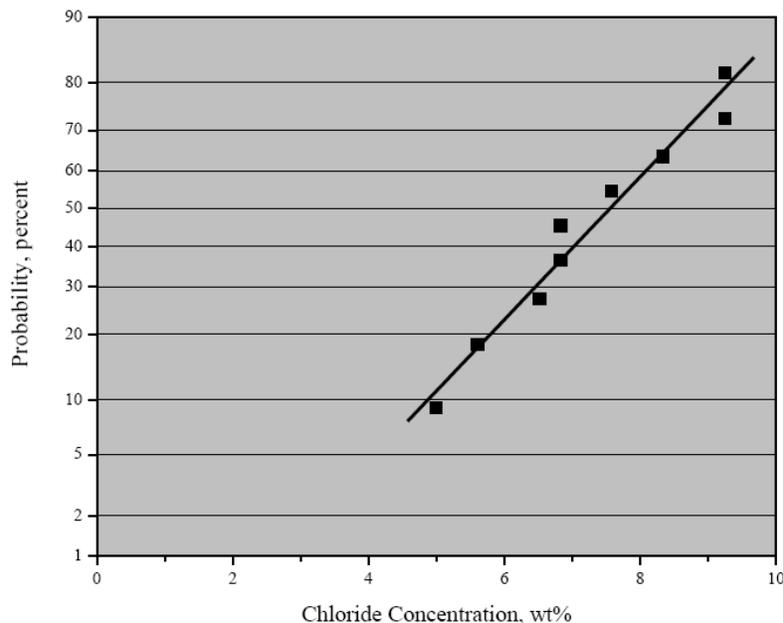
Figure 12. Graph. Cumulative distribution plot of C_T for 2304 SS from accelerated testing.

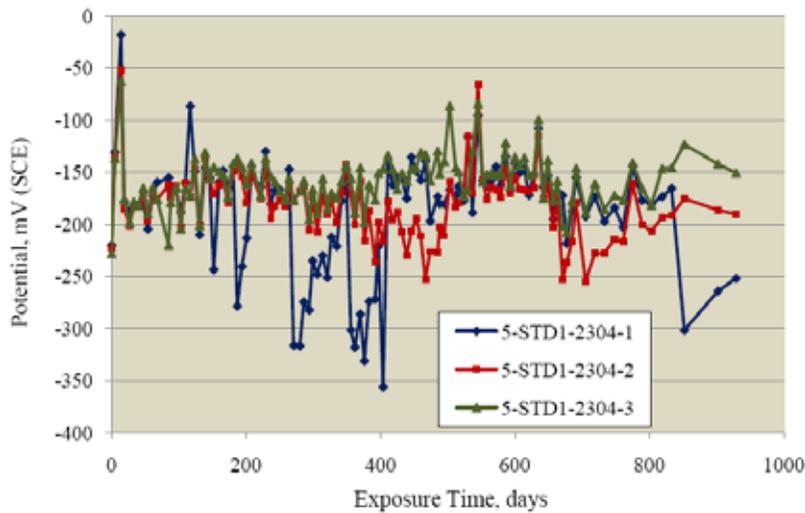
Figure 13. Graph. Potential data for the 2304 SS-reinforced concrete specimens.

The SDS specimens were exposed for 929 days. Figure 13 shows the resultant potential data. For the most part, potentials were in the range -150 to -200 mV_{SCE}; however, specimen 2304-1 in particular had negative excursions which reached -356 mV_{SCE} on one occasion. Figure 14 shows the corresponding macrocell current data. With the exception of one reading for specimen 2304-1, the currents were below the detection limit and considered zero. The one finite current reading of 0.1 μ A for specimen 2304-1 occurred at the same time as the most negative potential excursion for this same specimen (404 days exposure) that was mentioned previously. Apparently, the specimen exhibited momentary corrosion activity followed by repassivation.

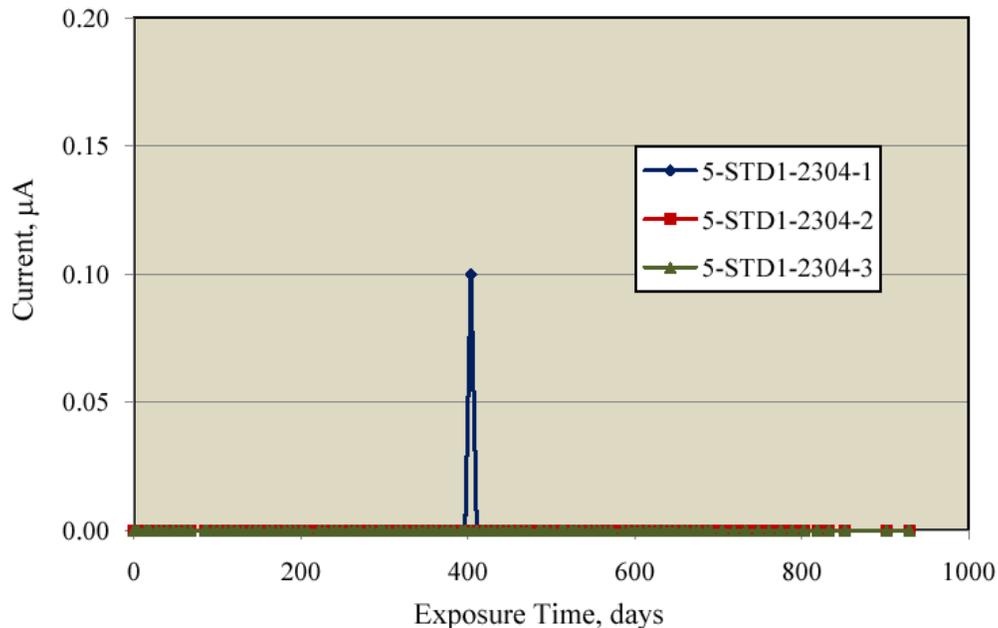
Figure 14. Graph. Macrocell current data for the 2304 SS-reinforced concrete specimens.

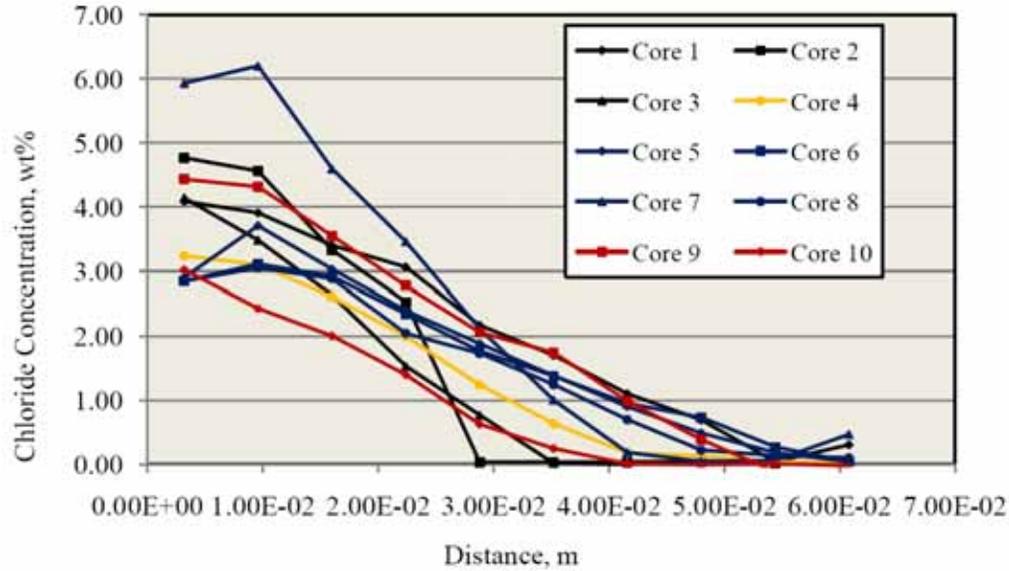
Figure 15. Graph. Concrete chloride concentration profiles determined from 10 cores.

While no cores were taken from the 2304 SS-reinforced SDS specimens, 75-mm-diameter cores were taken from identical companion specimens subjected concurrently to the same exposure. However, the cores were taken at different times. Once acquired, the cores were dry sliced parallel to the top surface at 6.4-mm intervals, and the individual slices were ground to powder. The powder samples were then analyzed for $[Cl^-]$ using the FDOT wet chemistry method.⁽²⁰⁾ Figure 15 shows a plot of $[Cl^-]$ data for these as a function of depth into the concrete.

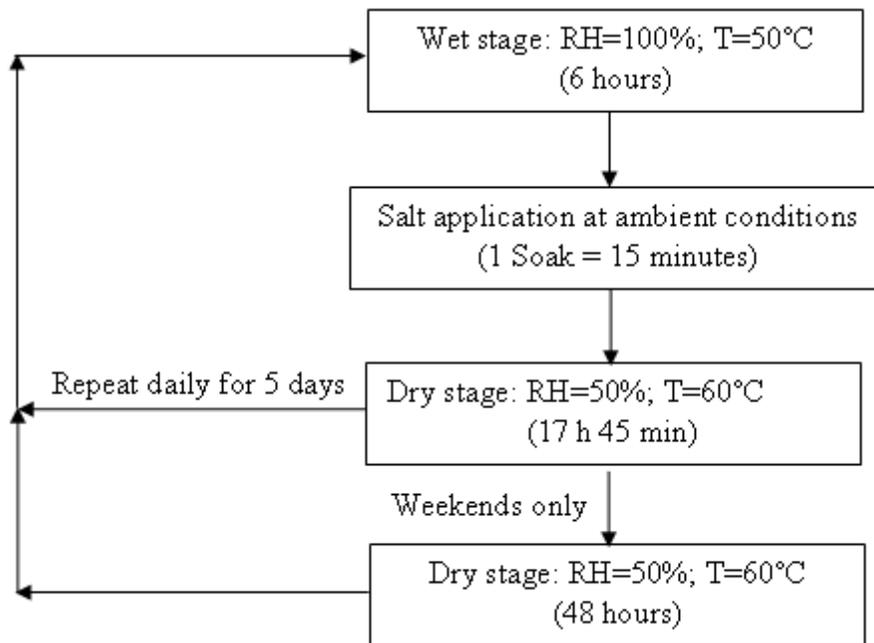
Figure 16. Chart. Standard SAE J2334 cyclic test with five cycles/week.

The Society for Automotive Engineers (SAE) established an accelerated test under dry/wet conditions to test metal coatings under highly corrosive environment known as Standard SAE J-2334.⁽²⁴⁾ The test has been characterized as, “J2334 Best Correlation to 5-Year Data (Field) at 80-Cycles.”⁽²⁵⁾ The cycle is shown in figure 16. The five-cycle per week option maintained the dry condition during weekends. The soak solution specified in the standard is 0.5 percent NaCl + 0.1 percent CaCl₂ + 0.075 percent NaHCO₃.

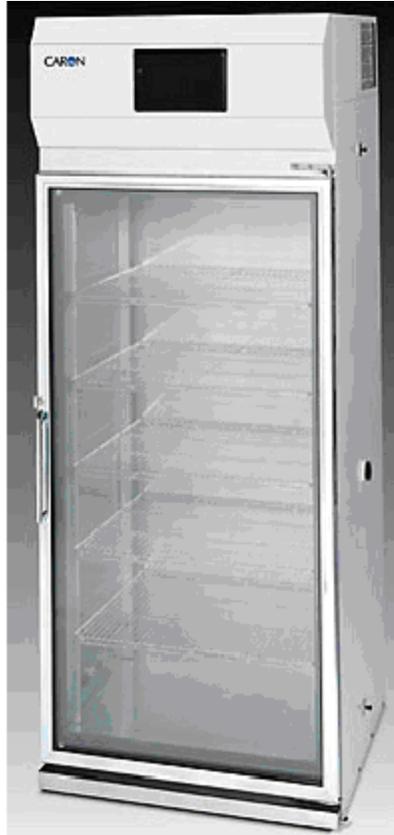
Figure 17. Photo. CARON[®] environmental chamber for cyclic SAE J2334 tests.

The 16 racks, fabricated from polyvinyl chloride (PVC) to accommodate 12 coupons each, were custom made for holding the coupons in the chamber (1 rack for each environment). Six coupons of each material were placed on each rack. One rack held six coupons of A606 steel and six coupons of SAE1010 steel. Two racks (24 coupons) were soaked in the same container. This arrangement allowed all coupons to be soaked within the same 15-minute time period. Images of a rack and soaking container are shown in figure 17 and figure 18.

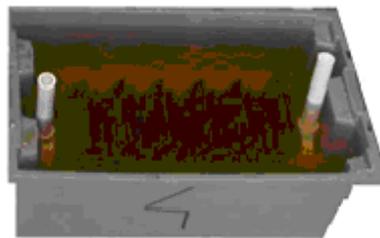
Figure 18. Photo. Specimens on holder rack and in soak tank.

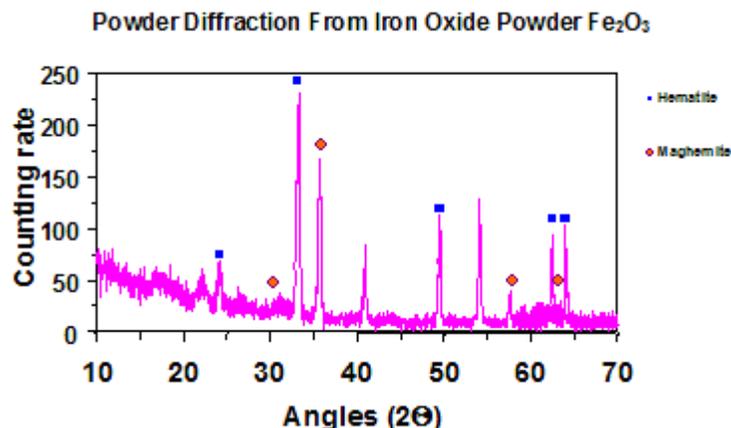
Figure 19. Graph. Example of X-ray powder diffraction spectrum.

The spectrum had a number of counts plotted versus angle of diffraction (see figure 19). Software detected peaks from the spectrum, which were observed as significant increases in counting rate (intensity) in the figure. Each peak at a specific angle had a relative intensity associated. Two parameters (θ and I_x) were used to compare with a database. For this study, only peak angles and their associated relative intensities were required for crystallographic compound searches.

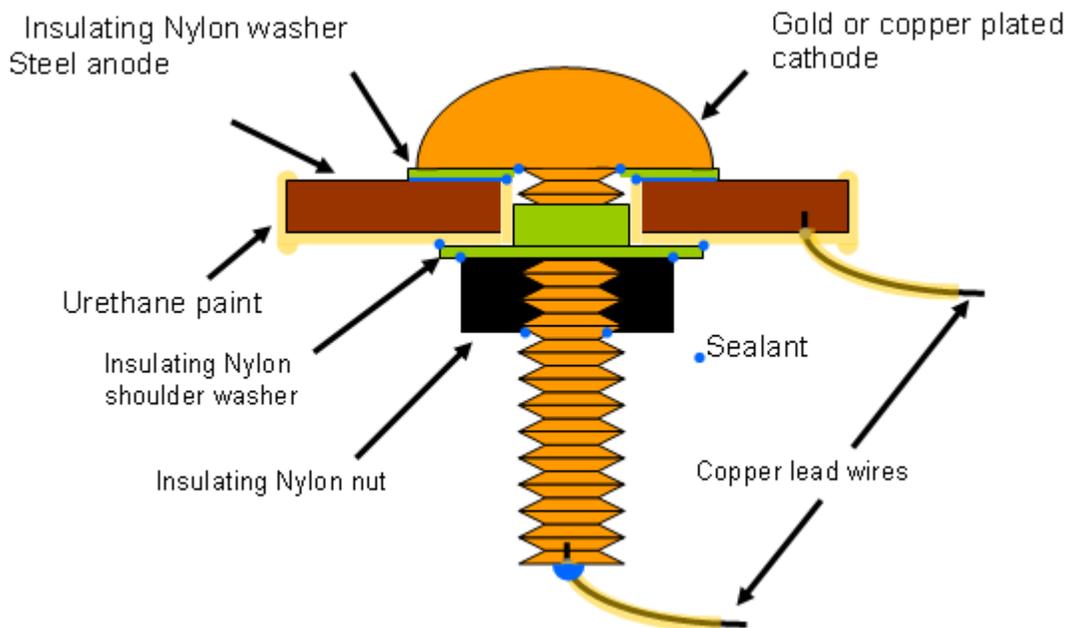
Figure 20. Illustration. Atmospheric corrosion sensor (Model FAU2).

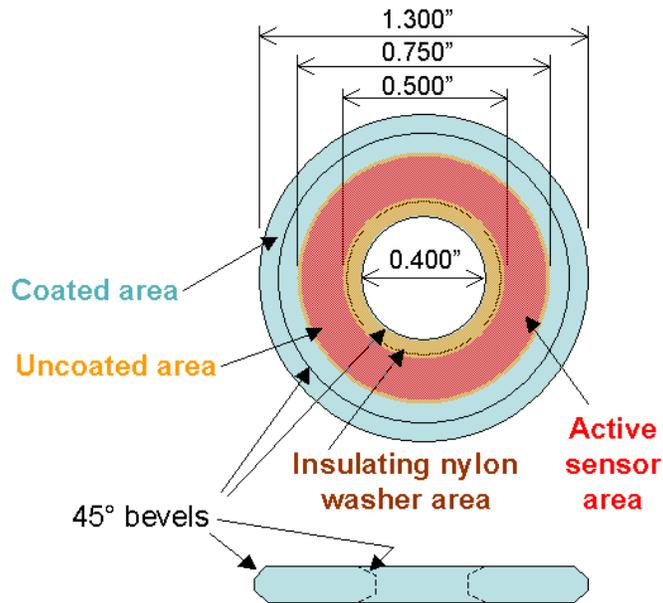
Detail: Steel Anode (revised 1/26/09)

Figure 21. Illustration. Anode detail for atmospheric corrosion sensor.

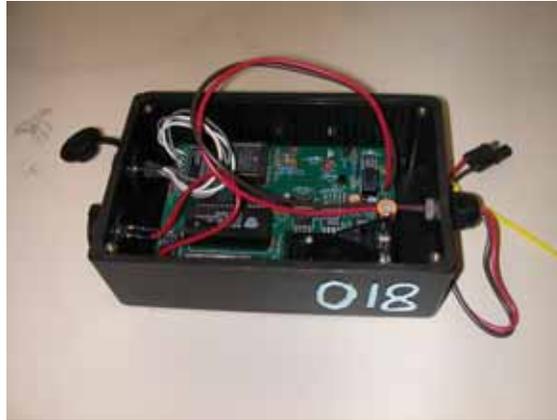
Figure 22. Photo. Data logger incorporating a ZRA.

To obtain the data from the sensors, zero resistance ammeter (ZRA) loggers were developed.⁽¹⁴⁾ A *zero resistance ammeter* is an electronic device that converts current at its input into voltage at its output. This device imposes no (zero) voltage drop to the input circuit. It is designed to measure small currents (on the order of 1–100 μA) without interfering with (polarizing) the circuit being measured. The ZRA was embedded in a data logger circuitry that acquired data every 10 minutes. The data were summed and stored every hour. It collected up to 2 months of data while powered by a single lithium 9V battery. The data loggers had a full range of 100 μA . This maximum current was a design parameter for the sensors. The sensor output was intended to be limited to 100 μA . A picture of a data logger is presented in figure 22.

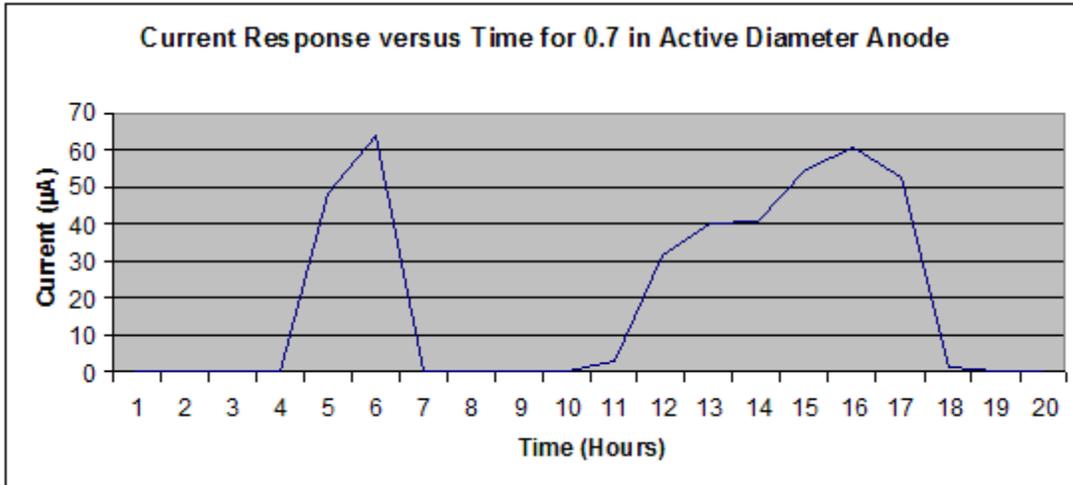
Figure 23. Graph. Sensor output for 0.7-inch active anode steel washer diameter for one SAE J2334 cycle in the standard solution.

Figure 23 shows no off-scale output, whereas figure 24 shows a slight off-scale output (flattened peak) from the 16th to 17th hours during the wet portion of the J2334 cycle. To optimize the output range of the sensors, a 19.05-mm diameter active area was specified for the steel washer (anode) to allow use of a significant portion of the logging scale without exceeding the maximum value of 100 μA .

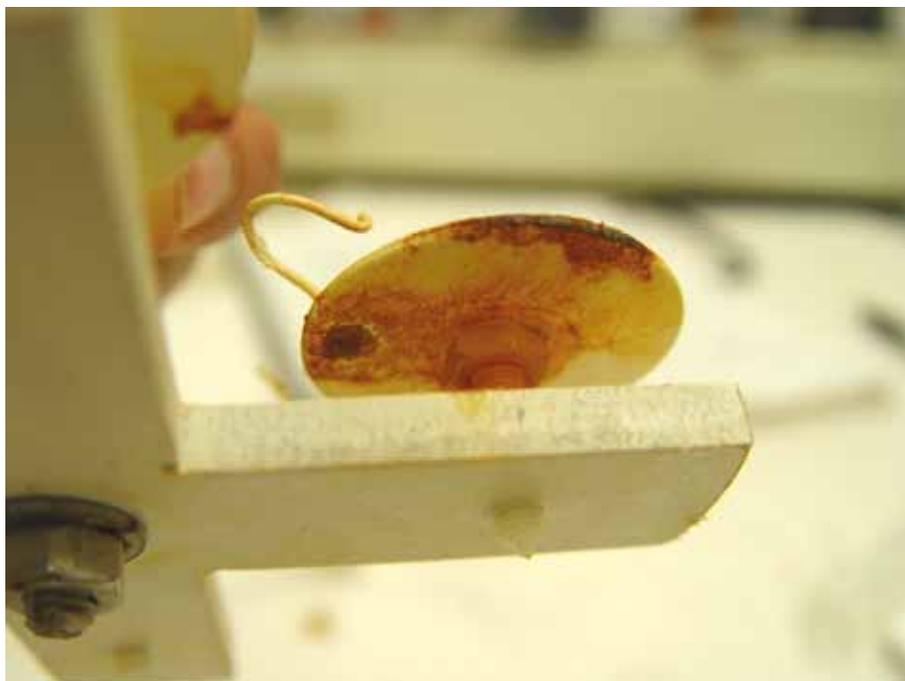
Figure 25. Photo. Bottom side of a sensor mounted on its holder experiencing under-paint corrosion.

For a flat surface desired for the sensors, a disk (washer) was fabricated and then painted (masked) to leave a circular area of bare steel at the center. The paint proved to be an issue during a previous test, as shown in figure 25. Under-paint corrosion occurred, and additional steel surface was subject to corrosion, giving undesirable results. Later, urethane-based powder coating was selected because of its excellent corrosion resistance and salt tolerance.

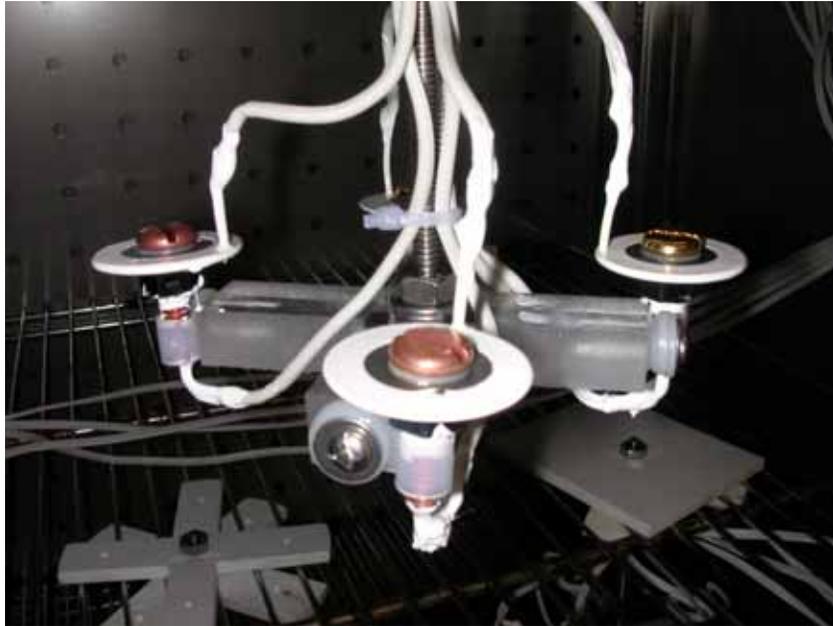
Figure 26. Photo. Four sensors set up on the cross-shaped holding rack.

The number preceding the sensor's name is the number of the solution used for the soaking (e.g., sensor 1-G-Q is an SAE1010 (Q) sensor with a gold (G) screw, and solution 3-1 (1) was used for the soaking).

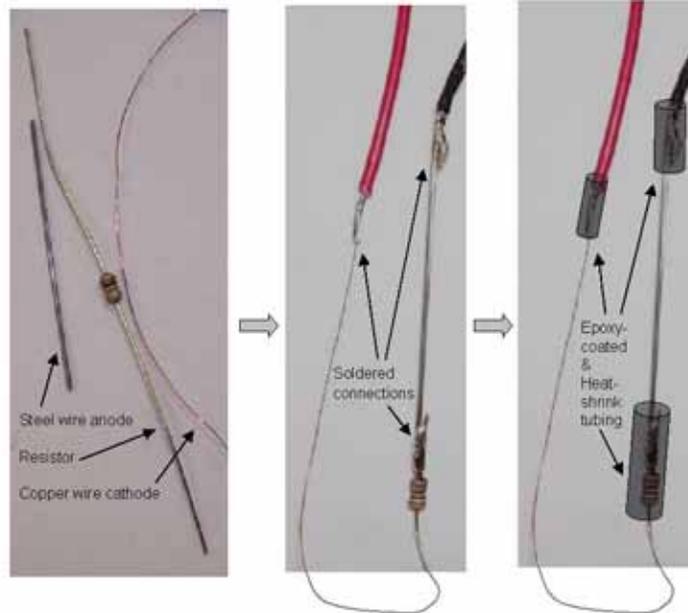
Figure 27. Photo. Components and fabrication of the cable sensor.

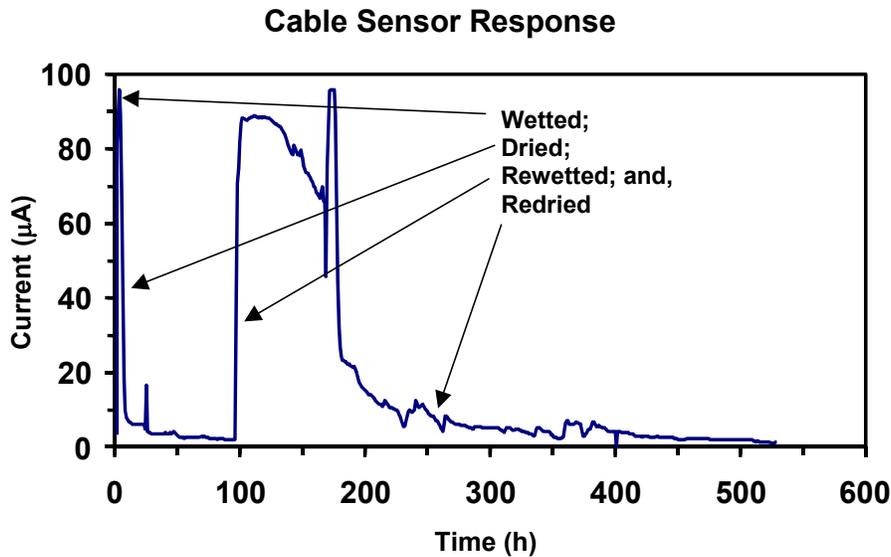
Figure 29. Graph. First test of corrosion sensor wetted, dried out, rewetted, and redried.

salt solution and allowing it to dry. Figure 29 shows the maximum current due to the corrosion of steel less than $100 \mu\text{A}$ (design maximum). The fiberglass sleeving electrically insulated the anode and cathode from each other. It also insulated the sensor for the cable strands, but it allowed water, if present, to soak into the sensor.

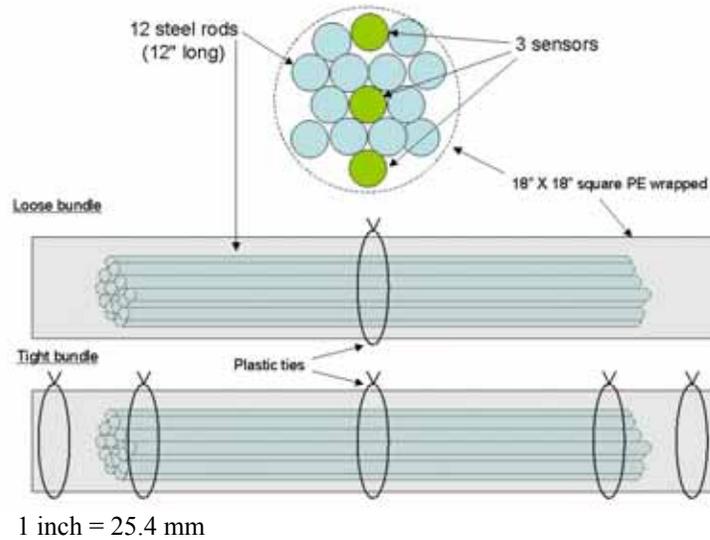
Figure 30. Illustration. Cable specimen showing arrangement of strands and sensors.

Figure 30 shows deployment locations within the multistrand cable specimen. Three tests were performed within a single multistrand specimen. A set of 18 tests were performed with the sensors (after single immersion in $1/10$ Harrison solution) including drying, wet, and cycled exposures. Dilute Harrison solution consisted of 0.35 percent ammonium sulfate, $(\text{NH}_4)_2\text{SO}_4$, and 0.05 percent NaCl. Table 11 provides the test matrix, which was modified to acquire additional data in some cases. The dry tests were soaked for 15 minutes in dilute Harrison solution then equilibrated (dried) on the laboratory bench top (50 percent relative humidity (RH)) while collecting data. The wet tests were soaked for 15 minutes in dilute Harrison solution and then equilibrated in a closed plastic container (100 percent RH) while collecting data. The cycled tests were not initially soaked before starting the cyclic test to observe the response to condensing humidity. They were then soaked for 15 minutes in dilute Harrison solution and returned to the cyclic chamber, and data were collected throughout the process.

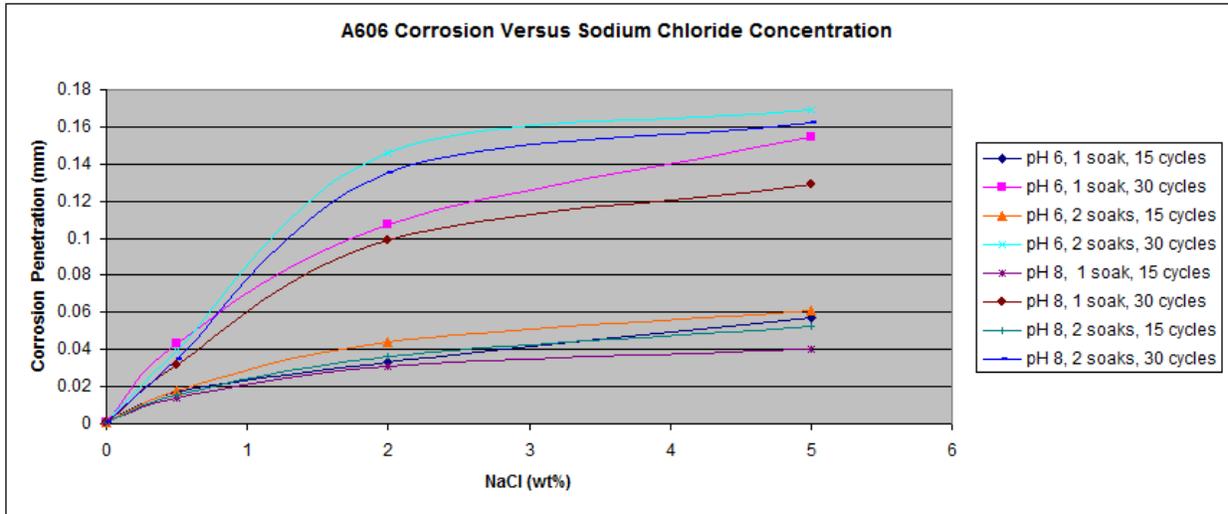
Figure 31. Graph. A606 corrosion as a function of the concentration of NaCl.

For both steel types, wetting times, or the pHs, a higher concentration of chloride led to a higher corrosion rate as shown in figure 31 and figure 32.

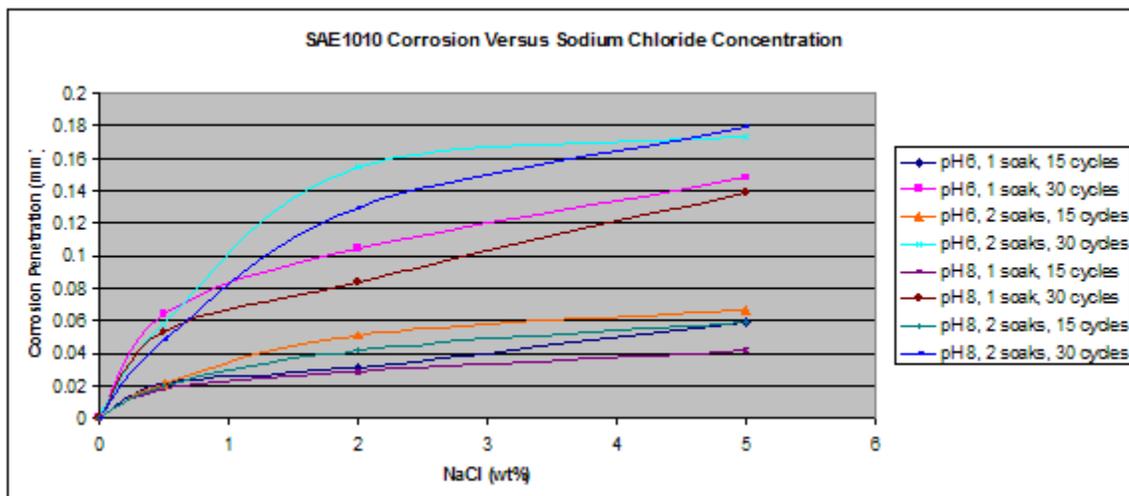
Figure 32. Graph. SAE1010 corrosion as a function of the concentration of NaCl.

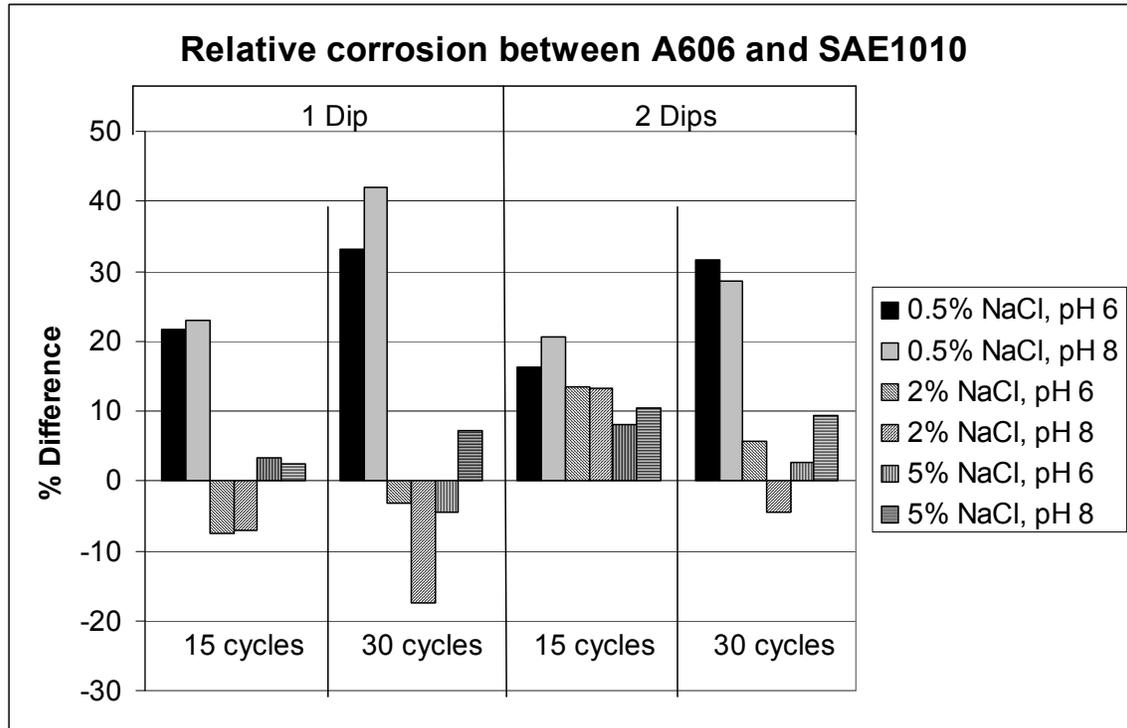
Figure 33. Graph. Relative corrosion between A606 and SAE1010.

The most interesting feature was the weathering ability of A606 as a function of the chloride concentration. The results obtained from the first set test are summarized in figure 33, which shows the relative corrosion of A606 versus SAE1010. Figure 33 shows that while A606 developed its protective layer when using 0.5 percent NaCl at pH 6 and pH 8 (solutions 1-3 and 1-4), the two-soak exposure made it less protective. When using two soaks, the coupons were more exposed to NaCl (especially Cl⁻ and water).

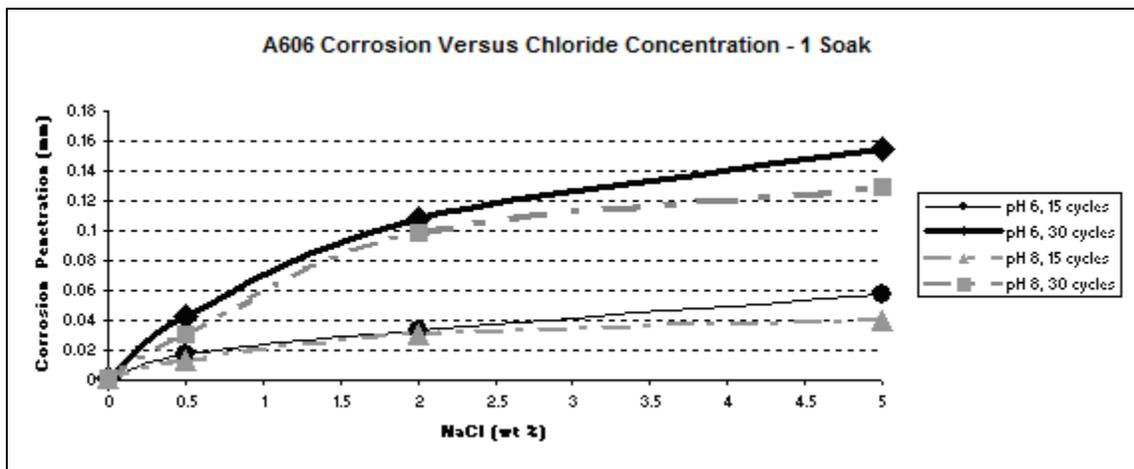
Figure 34. Graph. A606 corrosion as a function of chloride concentration during a one soak/cycle exposure.

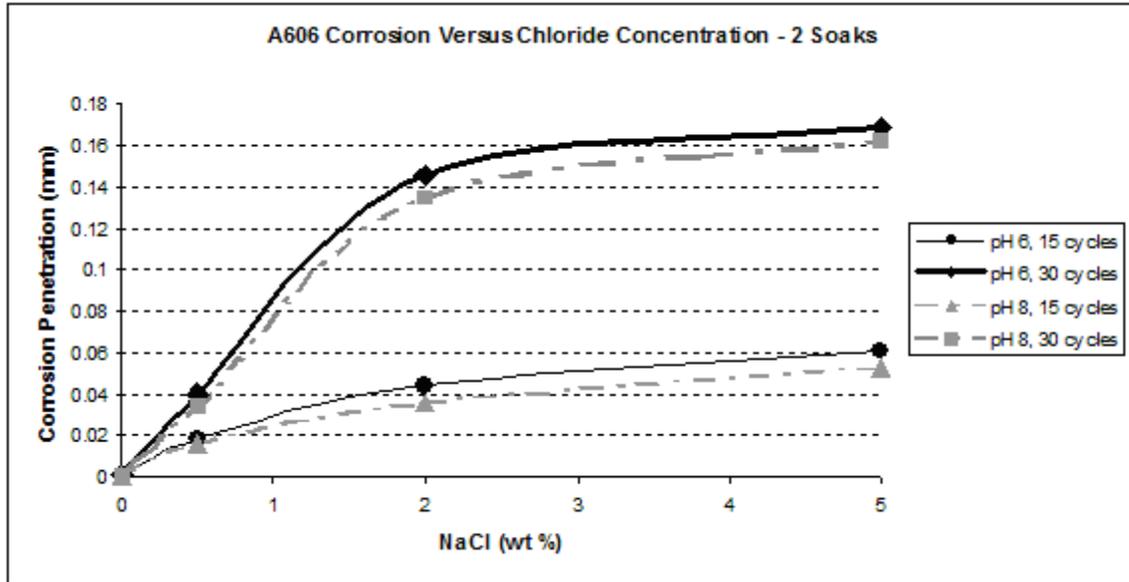
Figure 35. Graph. A606 corrosion as a function of chloride concentration during a two soak/cycle exposure.

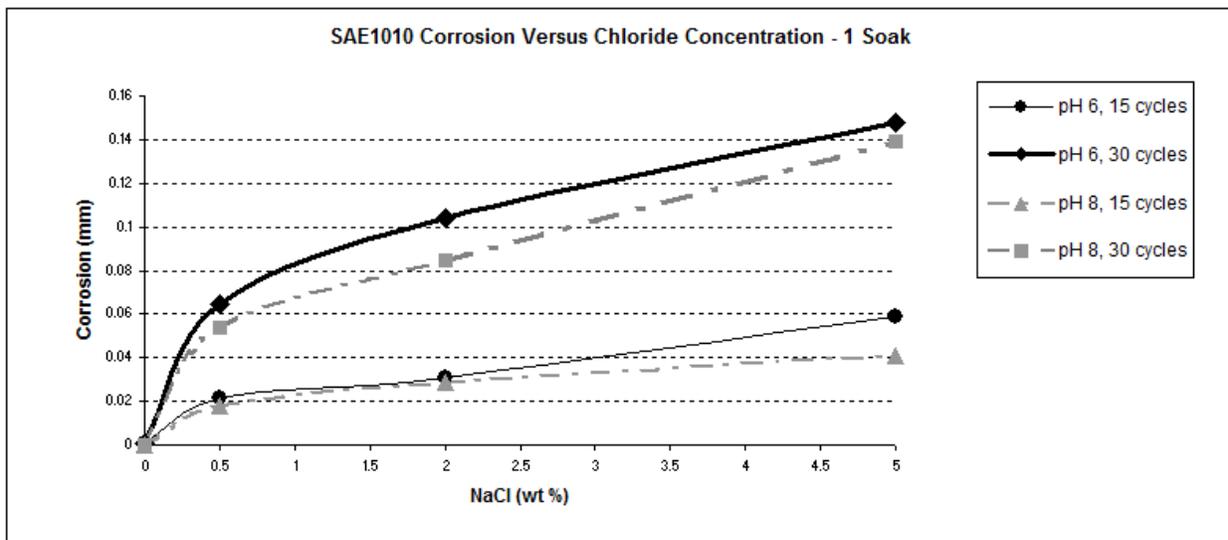
Figure 36. Graph. SAE1010 corrosion as a function of chloride concentration during a one soak/cycle experiment.

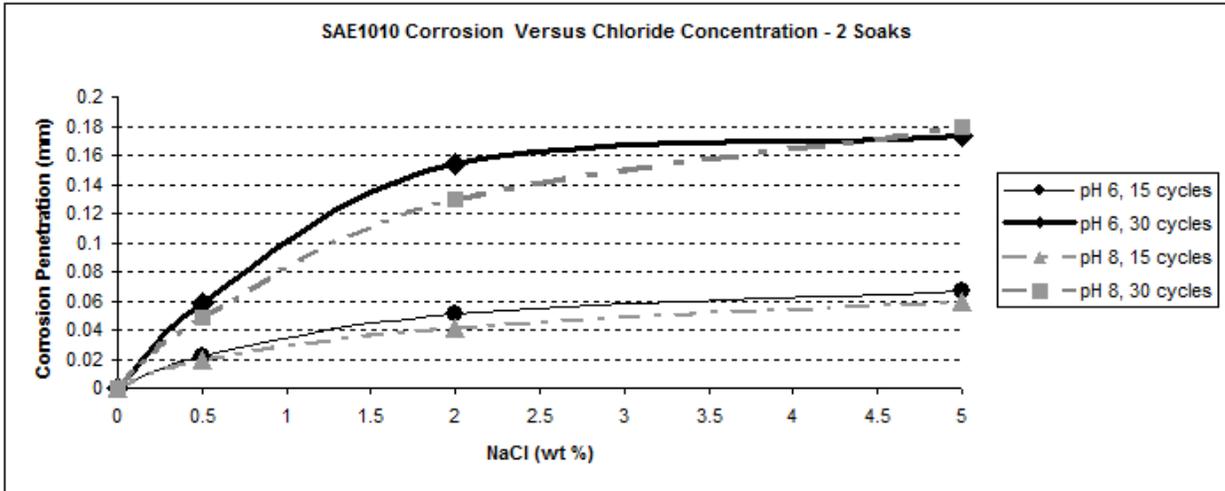
Figure 37. Graph. SAE 1010 corrosion as a function of chloride concentration during a two soak/cycle experiment.

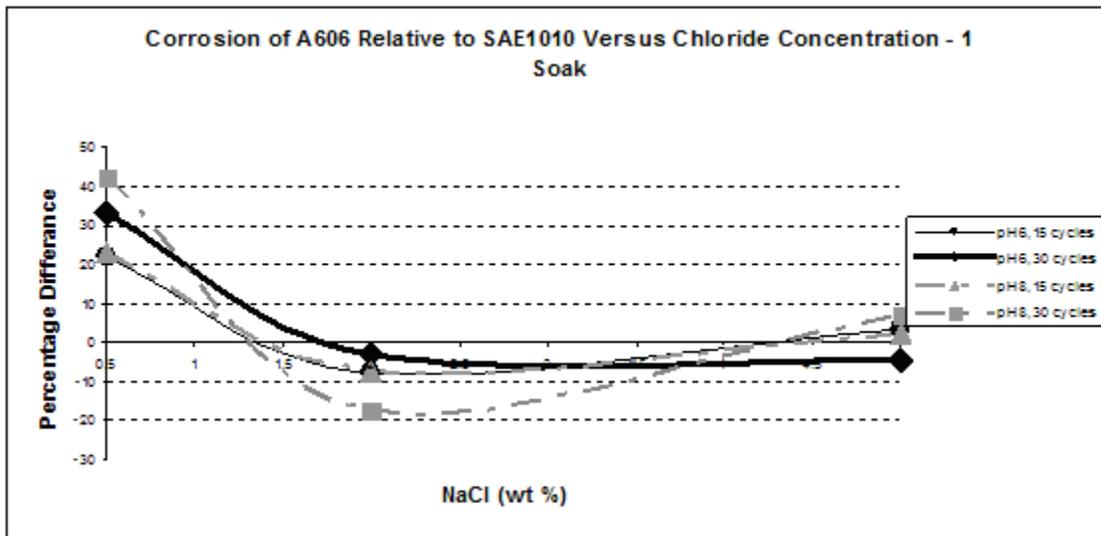
Figure 38. Graph. Relative corrosion versus NaCl concentration during exposure to a one soak/cycle environment.

Regarding the weathering ability of A606, figure 38 suggests that pH had a stronger effect with low NaCl. Conversely, at a high concentration of NaCl (5 percent) and a high number of cycles (30), pH had no effect.
