Integrity of Infrastructure Materials and Structures

PUBLICATION NO. FHWA-HRT-09-044

OCTOBER 2009

U.S. Department of Transportation
Federal Highway Administration

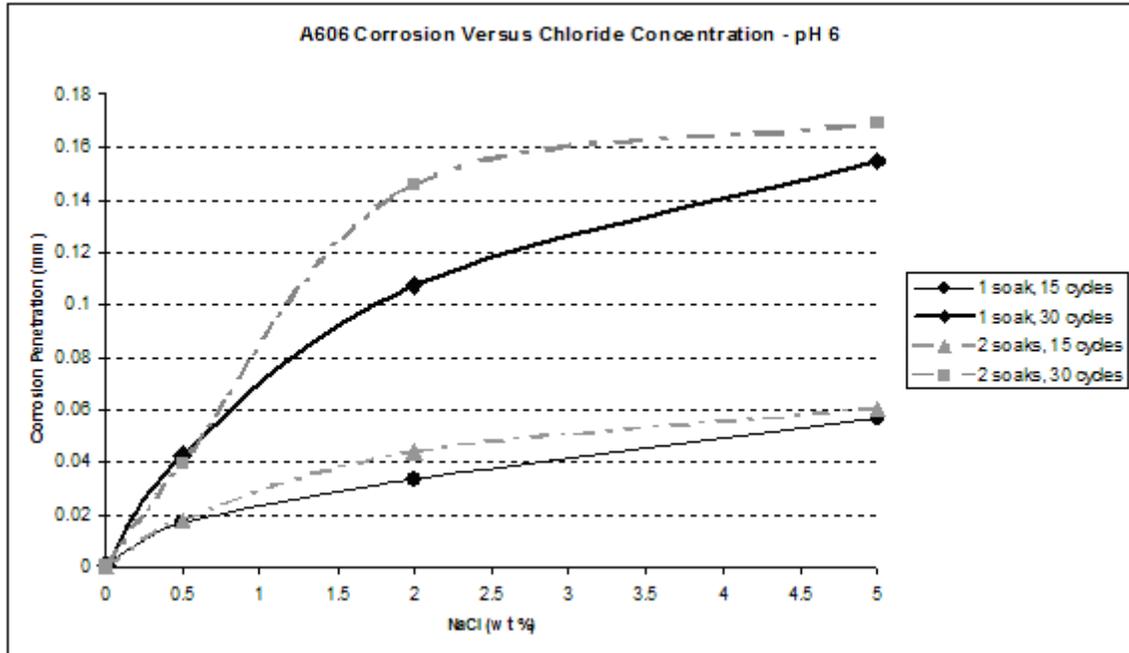
Figure 39. Graph. A606 corrosion as a function of chloride concentration at pH 6.

Environments including one soak/cycle and two soaks/cycle were used to study the influence of the wetting time on the corrosion of the steels and the weathering ability of A606. Results are presented in figure 39 through figure 42.

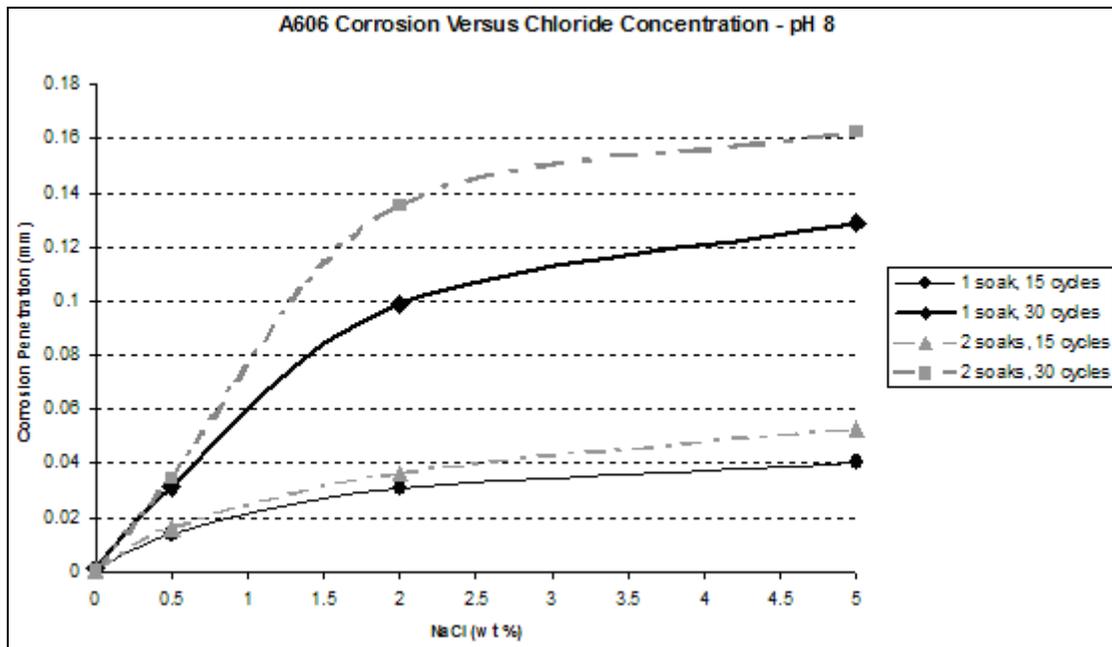
Figure 40. Graph. A606 corrosion as a function of chloride concentration at pH 8.

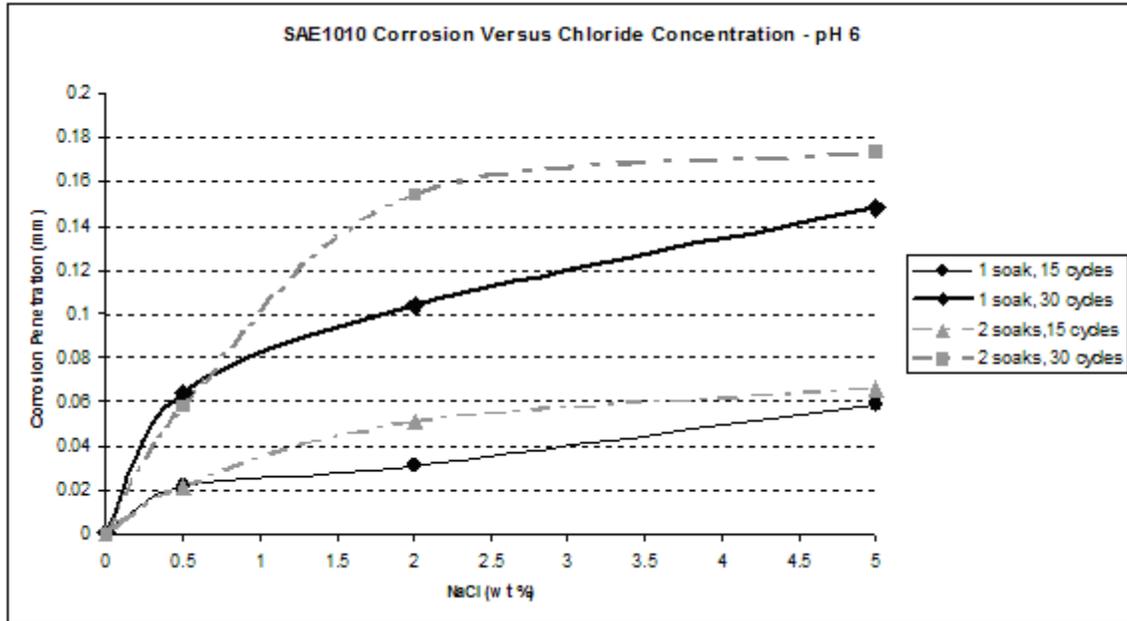
Figure 41. Graph. SAE1010 corrosion as a function of chloride concentration at pH 6.

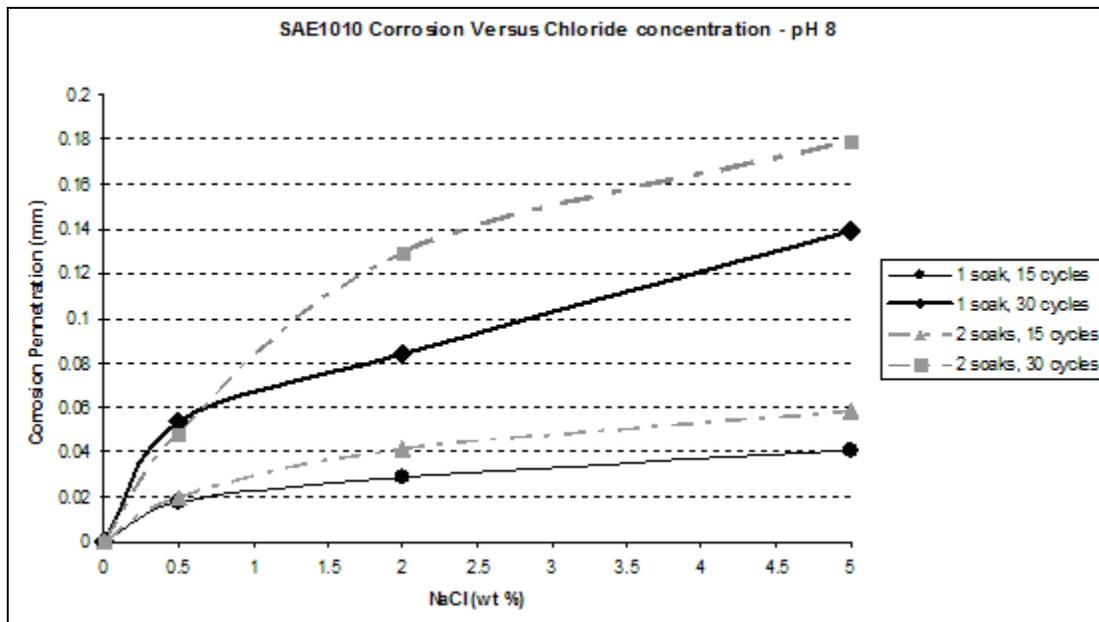
Figure 42. Graph. SAE1010 corrosion as a function of chloride concentration at pH 8.

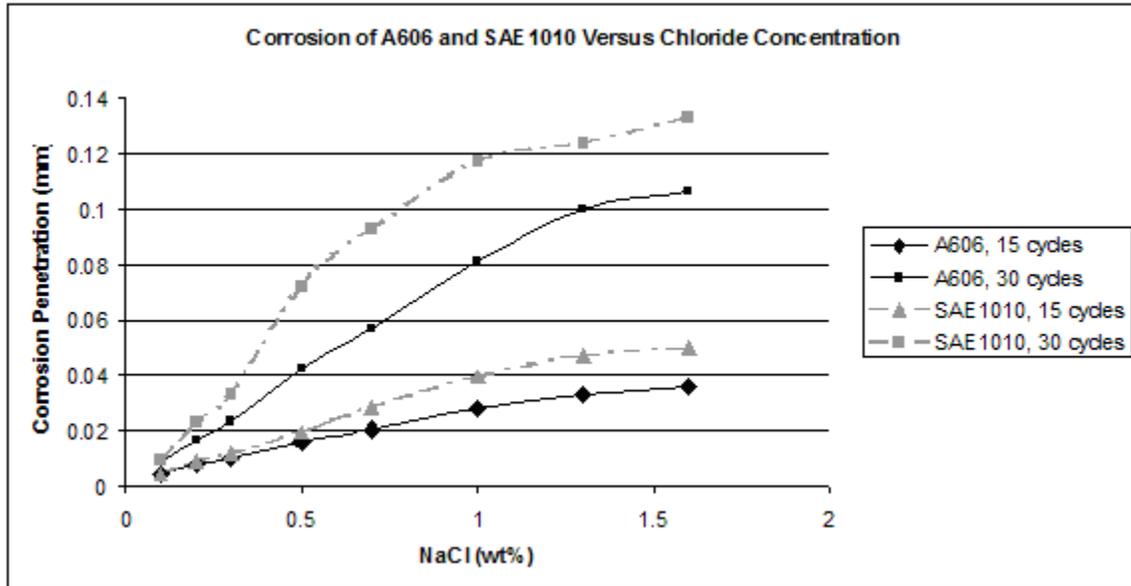
Figure 43. Graph. Corrosion of A606 and SAE1010 versus chloride concentration for the second test set.

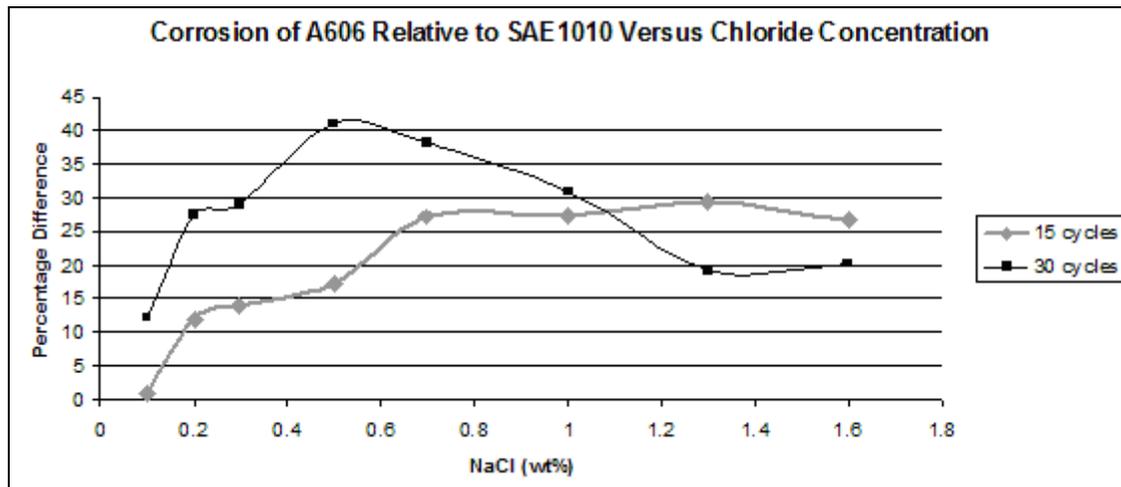
Figure 44. Graph. Relative corrosion versus chloride concentration.

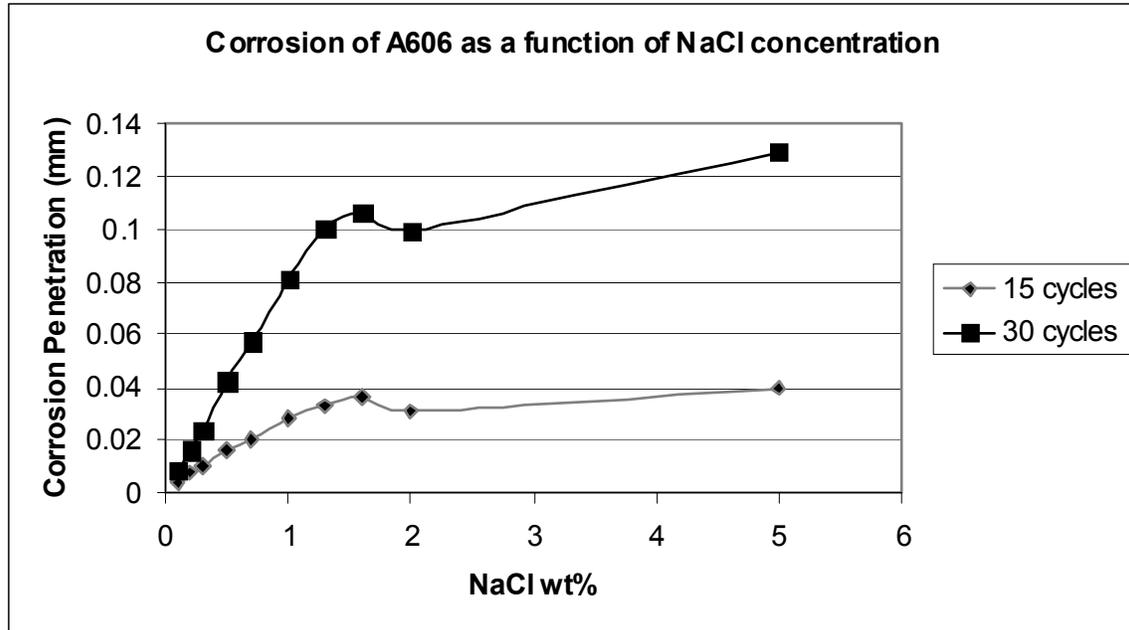
Figure 47. Graph. Corrosion of A606 versus NaCl concentration.

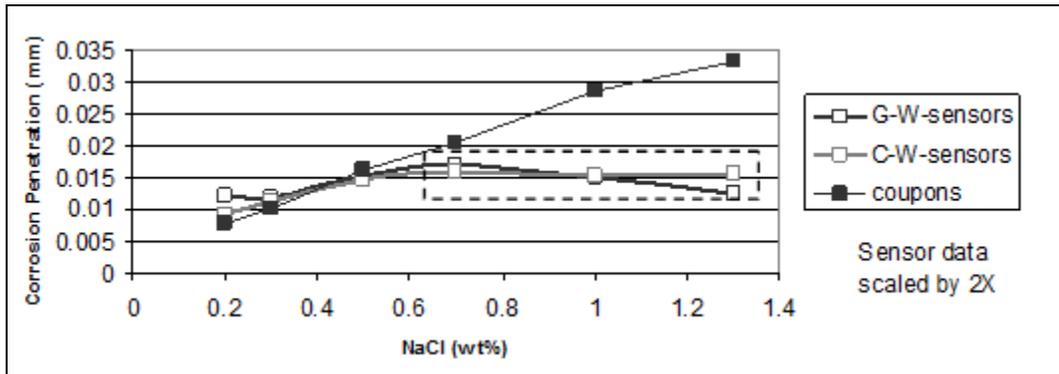
Figure 48. Graph. Corrosion (weight loss) of A606 coupons and calculated mass-loss for A606 sensors versus NaCl concentration for 15-cycle exposure.

Plotting the sensor data and the coupons data gives figure 48 and figure 49. For both figures, the dashed boxes identify over-range sensor data.

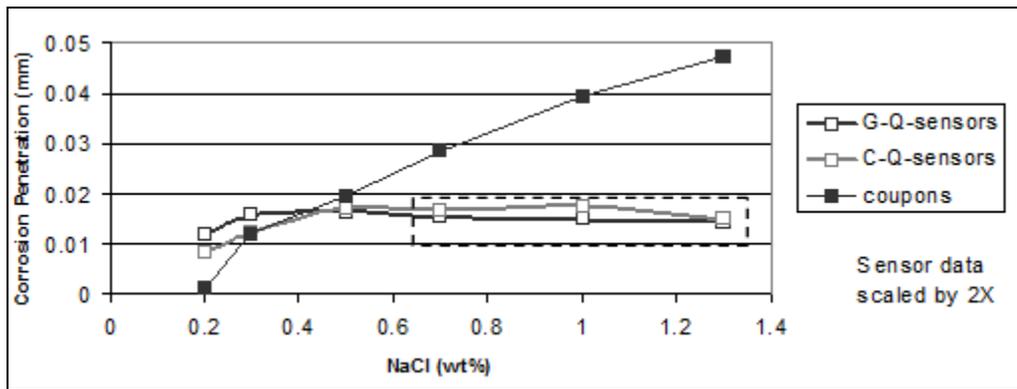
Figure 49. Graph. Corrosion (weight loss) of SAE1010 coupons and calculated mass-loss for SAE1010 sensors versus NaCl concentration for 15-cycle exposure.

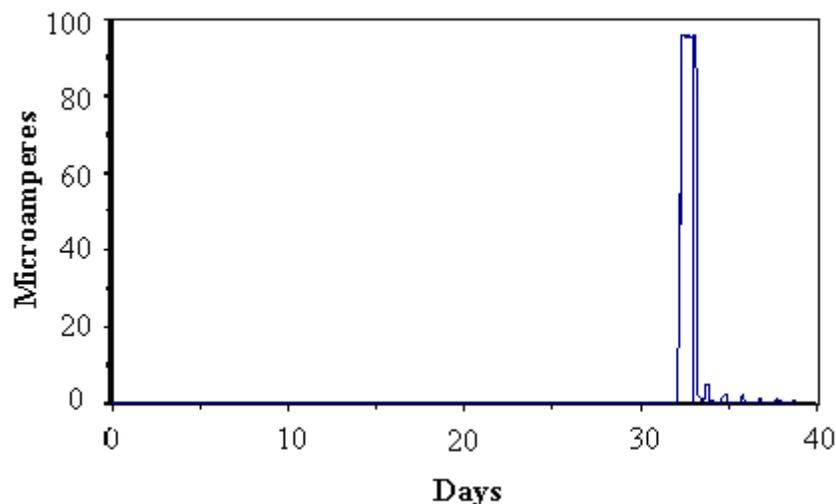
Figure 50. Graph. Response of cable sensor before and after dilute Harrison solution.

Figure 50 presents the sensor responses of dry specimens exposed to SAE J2334 cyclic conditions (except no soaking) followed by a experiencing a single soak in dilute ($1/10$ concentration) Harrison solution after 32 days and continuing the cycling without additional soaks. In each case, the sensors yielded little or no response until wetted by the dilute Harrison solution after 32 days. Each sensor showed a large increase in response after wetting. The responses observed were expected for wetted sensors. The specific nature of the response varied somewhat depending upon wetness saturation of the sensor within the specimen. In figure 50, the large response after wetting was followed by a large decrease corresponding to drying of the sensor. Subsequently, small responses that corresponded to the high humidity phase in the exposure chamber were observed every 24 hours.

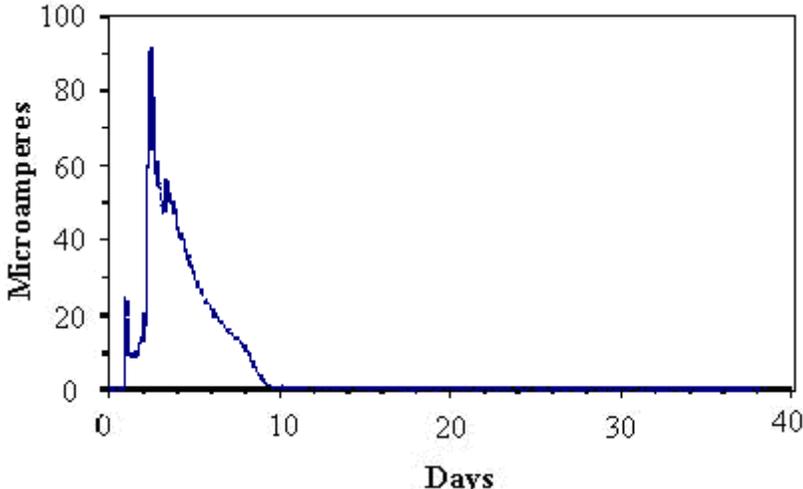
Figure 51. Graph. Response of cable sensor during constant 50-percent RH exposure after dilute Harrison solution.

Figure 51 presents typical cable sensor responses of specimens soaked for 15 minutes in dilute ($1/10$ concentration) Harrison solution followed by equilibration under static conditions of 50 percent RH. Figure 52 presents the typical responses for similar tests for 100 percent RH. The responses showed that the more tightly wrapped specimens and those under the higher relative humidity maintained higher levels of current for longer times than loosely wrapped specimens or those under lower RH. These responses were consistent with corrosion that occurred in the presence of sufficient moisture.

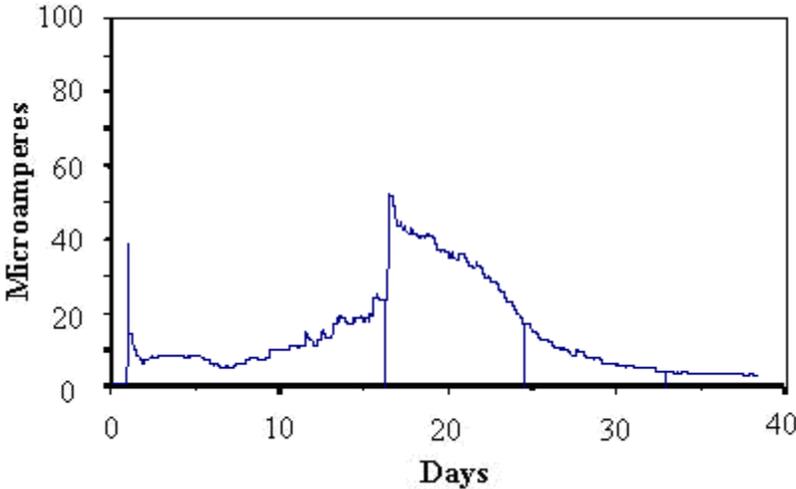
Figure 52. Graph. Response of cable sensor during constant 100-percent RH exposure after dilute Harrison solution.

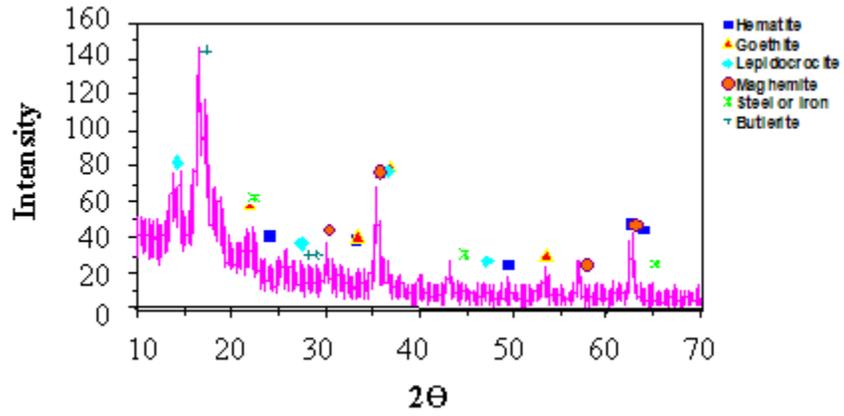
Figure 53. Graph. XRD pattern of steel rods in cable sensor bundle after single soak in dilute Harrison solution and exposure in cyclic chamber for 40 days.
