Foundation Reuse for Highway Bridges

Report No. FHWA-HIF-18-055	2. Government Accession No.:	3. Recipient's Catalog No.	
4. Title and Subtitle: Foundation Reuse for Highway Bridges		5. Report Date: November 2018

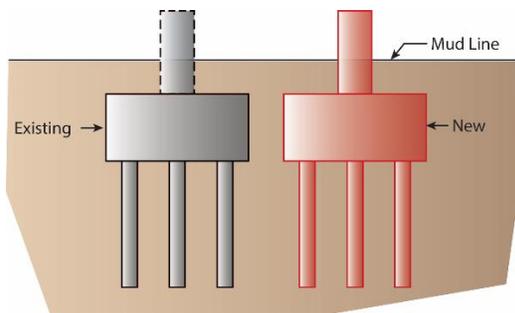
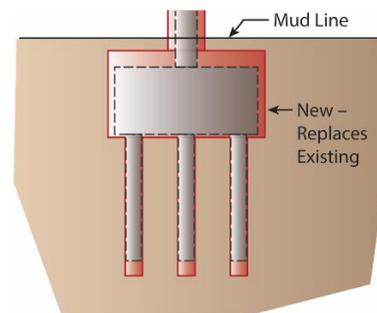
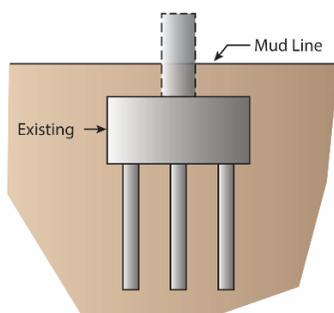
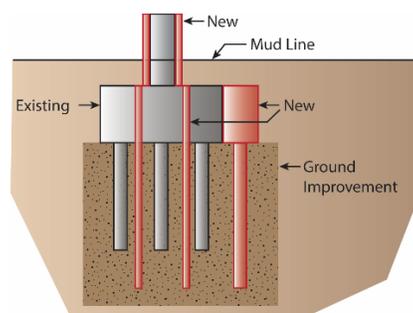
Figure 1. Illustration. Foundation reconstruction options

A. Option 1: Install new foundation on new alignment

B. Option 2: Install new foundation on the existing alignment

C. Option 3: Reevaluation and reuse existing foundation

D. Option 4: Reuse existing foundation by strengthening it

Option 1 involves the construction of a new foundation on a new alignment while avoiding the existing foundation. Construction of the new elements does not interfere with the existing foundation or impact user mobility (although there may be mobility impacts while switching to

the new alignment). In Option 2, the existing alignment is maintained, although on new substructure elements. The new substructure elements may be constructed with the original bridge in service, or after closure to traffic. This option may require demolition of existing substructure elements prior to reconstruction. In Option 3, the existing foundation is reused as is, with or without minor repairs such as patching or chloride removal. In Option 4, foundations are reused with some form of retrofitting or strengthening. Both Options 3 and 4 illustrate the case of *foundation reuse*. These options may contain substructure elements not depicted in figure 1 that may or may not be suitable for reuse. A detailed case study on the reuse of fifteen bridge foundations primarily using Options 3 and 4 is presented later in this chapter.

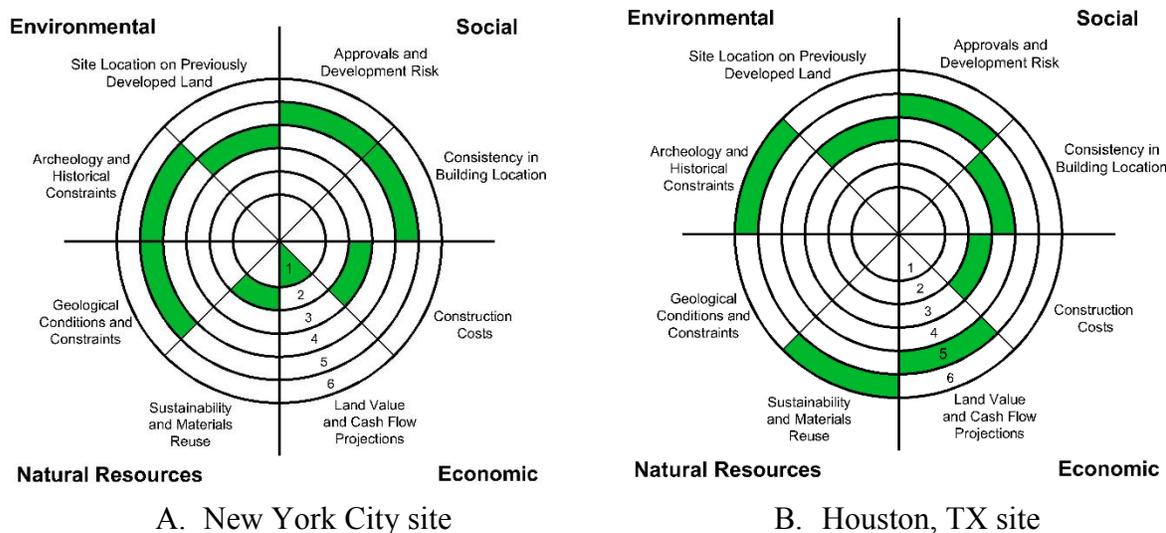
Eight drivers for foundation reuse in buildings were investigated using the Sustainable Project Appraisal Routine (SPeAR®) diagram shown in figure 2 (Strauss et al. 2007). These eight drivers are: (i) site location on previously developed land, (ii) archeology and historical constraints, (iii) geological conditions and constraints, (iv) sustainability and materials reuse, (v) land value and cash flow projections, (vi) construction costs, (vii) consistency in building location, and (viii) approvals and development risks. Each of these drivers is represented by a segment in the SPeAR® diagram and assigned a rating from 1 to 7, with lower score indicating greater value for reuse over replacement. The appeal of reuse over replacement increases as the diagram for a site resembles a bull’s eye more closely. Figure 2 shows modified SPeAR® diagrams for New York and Houston provided by Strauss et al. (2007) that suggest reuse of building foundations is more favorable for a specific New York site than a specific Houston site.

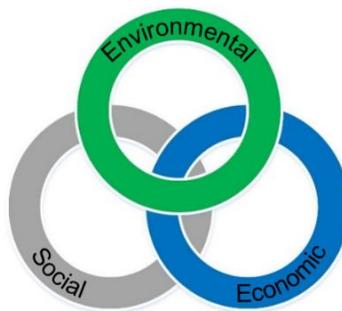
Figure 3. Diagram. Three drivers for foundation reuse (Adapted from FHWA INVEST website)

Reuse of bridge foundations potentially offers numerous economic, environmental, and social benefits that can drive the decision-making process. In many cases, competing replacement/reuse alternatives may offer various benefits that may be difficult to objectively compare and quantify. To have a better understanding of the advantages of foundation reuse, the underlying drivers can be lumped into three categories: economic, environmental, and social. These three categories form the “triple bottom line” of sustainability described by the INVEST program (FHWA 2017), as shown in figure 3. The individual benefits derived from foundation reuse can impact one or more of these categories.

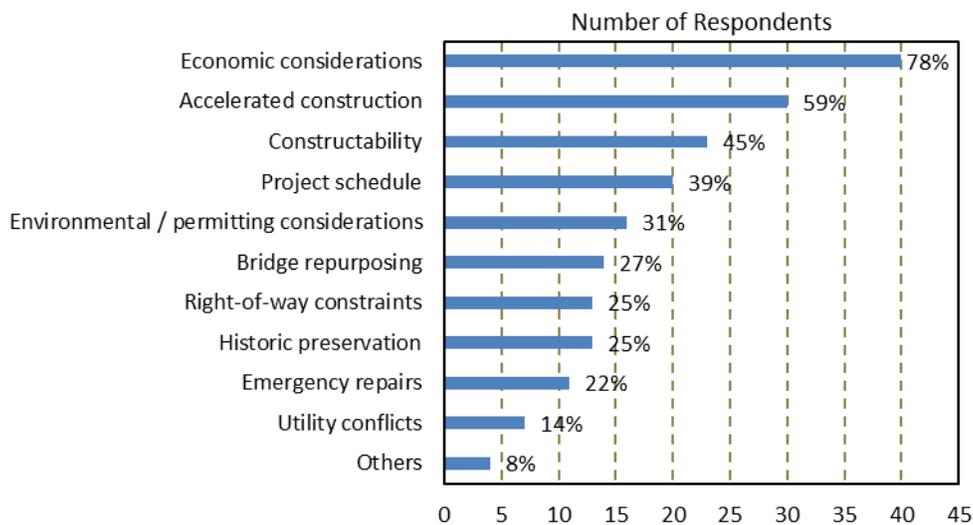
Figure 4. Graph. Survey on motivations for foundation reuse

right of way constraints, historic preservation, emergency repairs, and utility conflicts were identified as key motivations for foundation reuse, as shown in figure 4. These motivations can be grouped into six drivers for foundation reuse: costs (agency and user costs), sustainability (resources and asset management, social and environmental impacts), site constraints (right of way constraint, constructability, and utility conflicts), mobility, historic/aesthetic preservation, and environmental impacts and permitting. These drivers can be assigned importance weights based on the survey results in figure 4 and can be plotted as modified SPeAR® diagram (Laefer 2011) in figure 5. These six drivers are assigned weights in figure 5 from 1 to 6 (note that sustainability is shown twice, as an economic and environmental driver). The SPeAR® diagram in figure 5 may be plotted for various reuse and reconstructions options at a bridge site (possibly from multiple of the Options 1 to 4 in figure 1) to display the overall attractiveness of an alternative based on the six drivers. The SPeAR® diagram with highlighted areas closest to the bull’s eye will represent the most attractive option considering these six drivers.

The results in figure 4, from NCHRP Synthesis 505 (Boeckmann and Loehr 2017), show that economic considerations were the most common motivation, with 40 agencies (78 percent of responses) reporting them as a factor. Direct cost savings due the reuse of an existing foundation can be achieved during all three phases of a project:

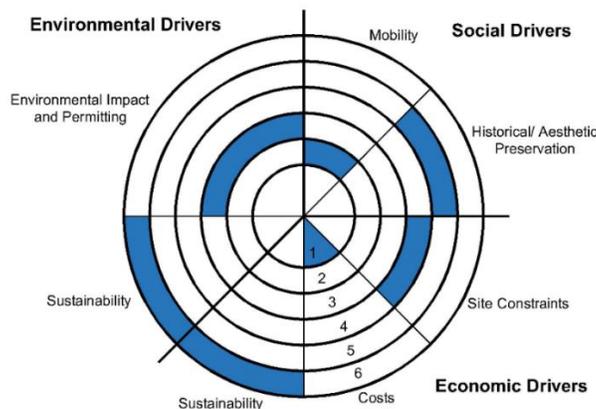
Figure 5. Diagram. Modified SPeAR diagram for bridges. (Adapted from Laefer 2011)

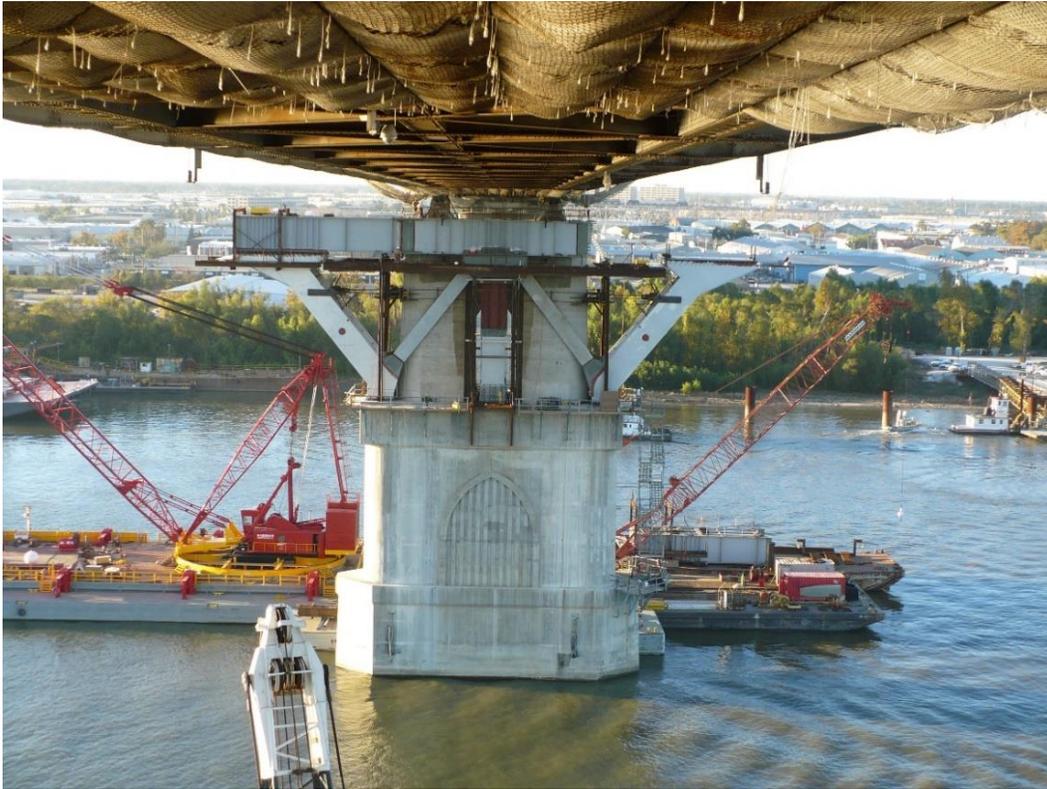
Figure 13. Photo. W-Frame under construction above encased pier

During the planning of superstructure widening, three superstructure options that utilized the existing foundations were investigated (cantilever widening, cable-stayed widening, and parallel truss widening). The selected option was parallel truss widening, where new trusses were installed outside of the original trusses and connected to widened portions of the piers using a steel transfer frame. The new trusses were connected to the existing trusses using new transverse elements, and the space in between the new and old trusses was used for the widened roadway. Figure 13 shows a view of the pier during widening, while figure 14 shows a view of the bridge after widening.

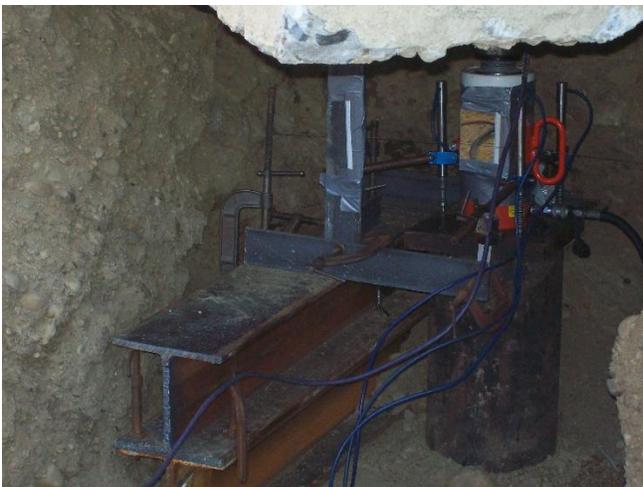
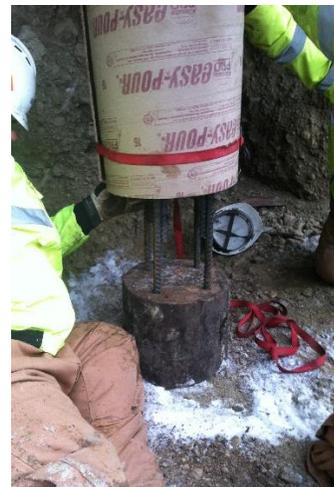
The Haynesville Bridge carries U.S. Route 2A over the Mattawamkeag River in Haynesville, Maine. The bridge is a 3-span steel girder bridge with two mass concrete stub abutments on treated timber piles and two solid wall piers on untreated timber piles. MaineDOT decided to replace the superstructure while reusing the substructures and pile foundations without modification. The piles were reused after a static load test was performed under each abutment. A resistance factor of 0.7 was applied to the nominal capacity of piles under the tested abutments, and 0.65 to all piles beneath the untested pier abutments, which is consistent with LRFD criteria. Figure 15 shows static load testing with a hydraulic jack after excavation of a pile cap and cutting of one of the timber piles.

A. Load test setup for north abutment

B. Repairing of a test pile with concrete

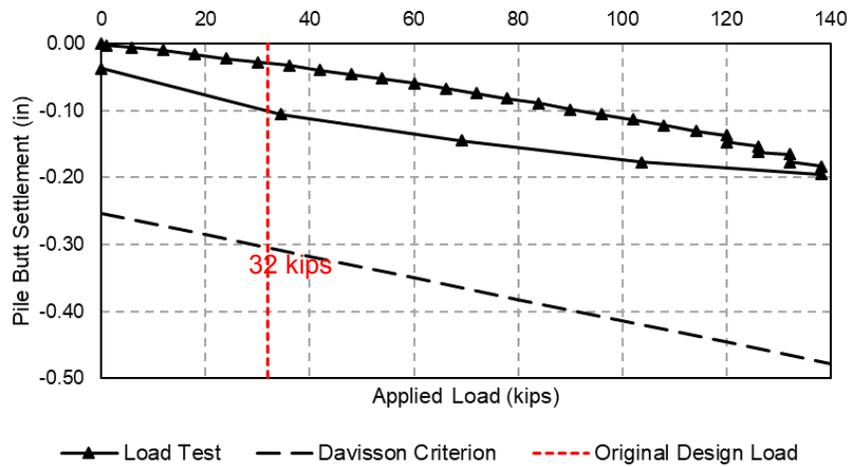
Figure 16 shows the results of the static testing on one of the test piles, along with its failure criterion. Both the loading and unloading of the test piles were recorded, and the permanent deflection was calculated. The original design capacity of 32 kips is shown, although this capacity was for allowable strength design and would be overly conservative for LRFD codes

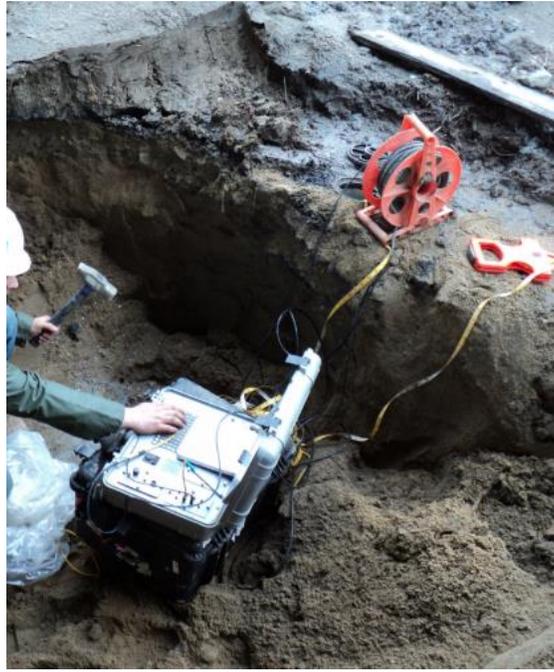
In the bridge, 11 out of 19 piers and 1 of the abutments were supported by steel H-piles driven to bedrock. The other eight piers and remaining abutment were supported by spread footings on bedrock. The preliminarily estimated pile loads exceeded the factored axial resistance for most pier locations. Hence, the addition of micropiles was recommended. However, the final design of the bridge rehabilitation resulted in reduced loading that did not exceed the capacity of the H-piles. The bearing capacity of the piles was determined from subsurface investigation, review of as-built plans, and original construction logs. The consulting engineer recommended the structural resistance of the H-piles to be calculated with a reduced cross-section to account for potential corrosion during the intended 75-year service life extension. Parallel seismic nondestructive testing from a nearby borehole confirmed that the piles were approximately as deep as the bedrock, thereby providing confidence the piles had been driven to practical refusal on bedrock. Figure 17 illustrates the parallel seismic testing set up at the bridge site.

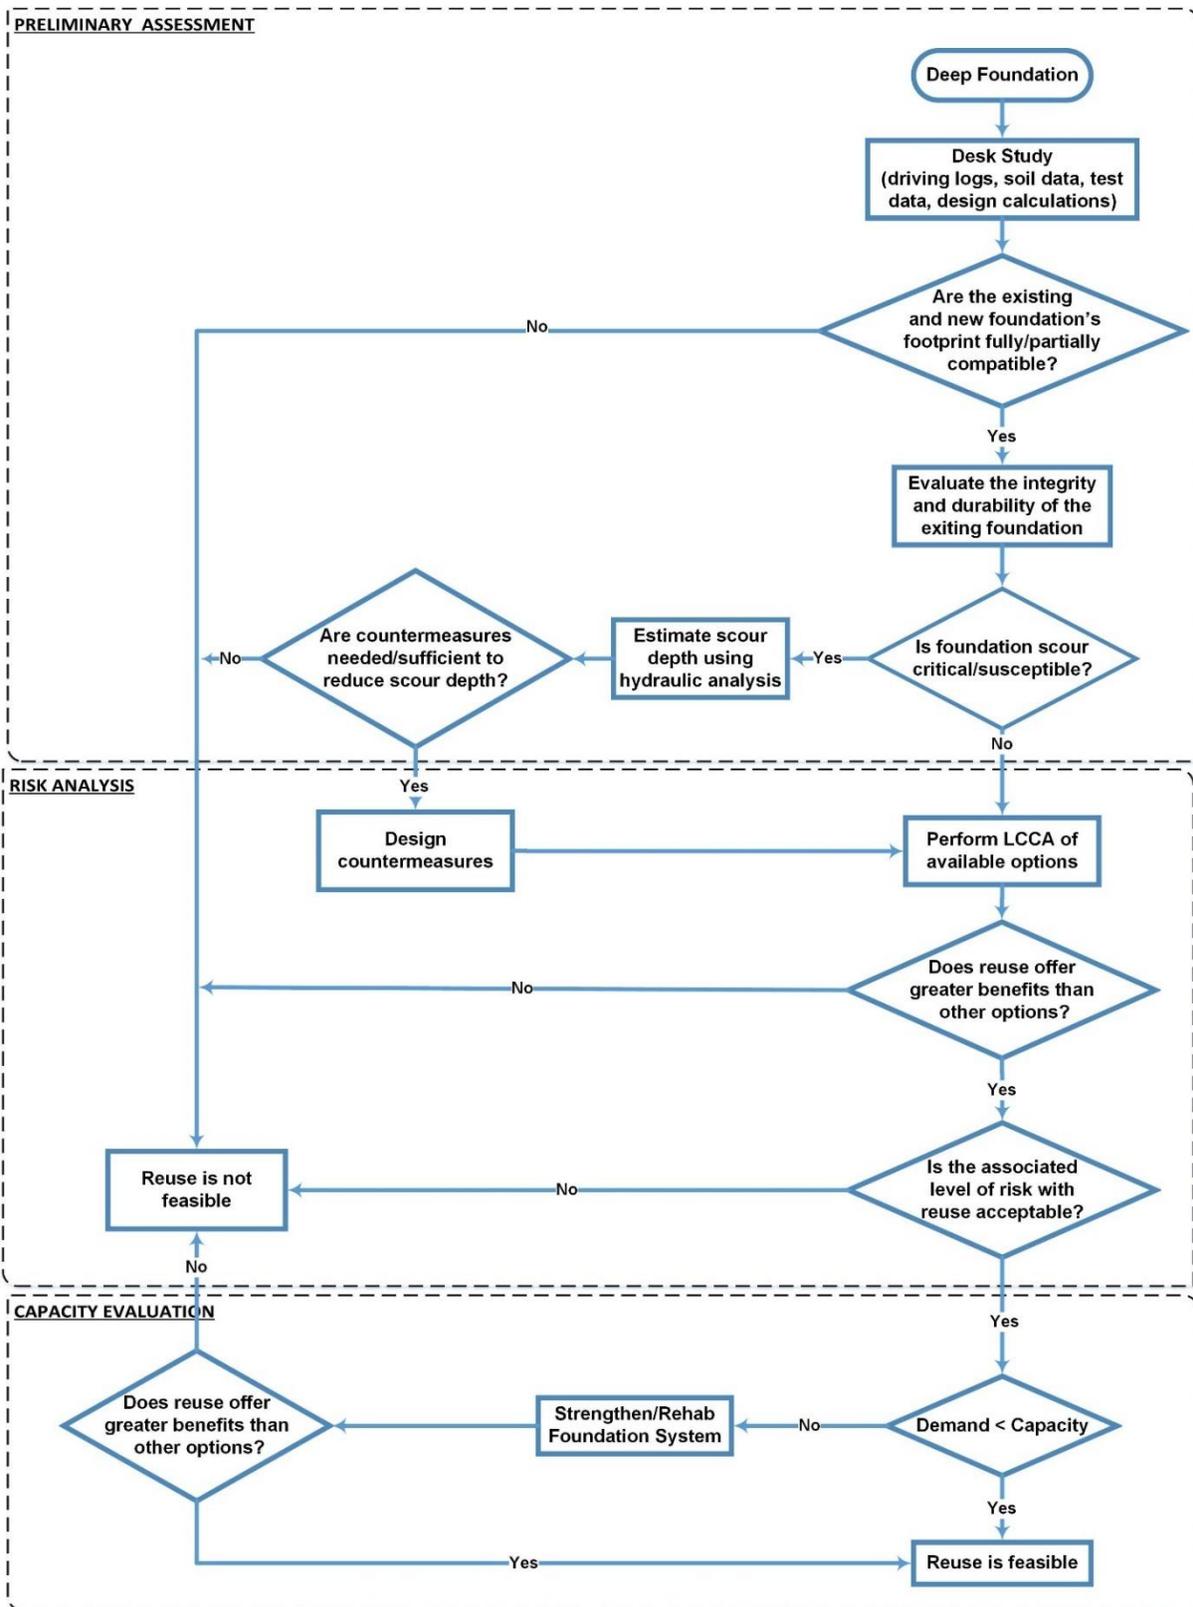
Figure 22. Chart. Decision Making Procedure for Reuse of Bridge Foundations

The flowchart in figure 22 shows this decision-making process:

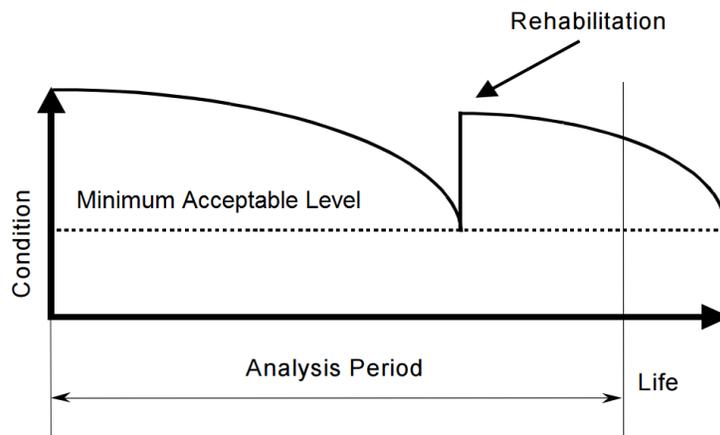
Figure 26. Illustration. Lifetime of a design option

Figure 26, adapted from Walls and Smith (1998), depicts a sample lifespan and condition comparison. This sample lifespan includes mid-life rehabilitation but does not include the entire lifespan or end-of-life costs.

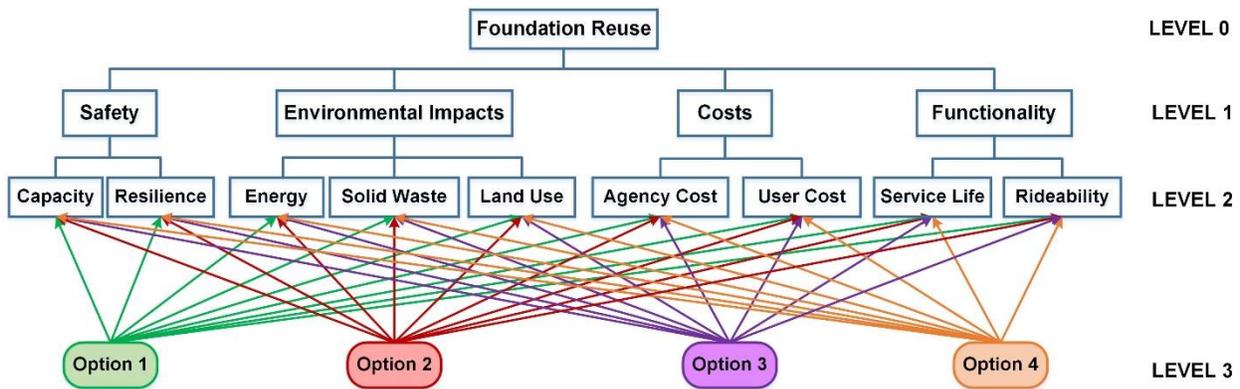
Figure 27. Chart. A sample analytical hierarchy process diagram for foundation reuse

1. Safety of the whole bridge (S)
2. Cost effectiveness of the option (C)
3. Minimum impact on the environment and ecosystems (E)
4. Functionality of the whole bridge (F)

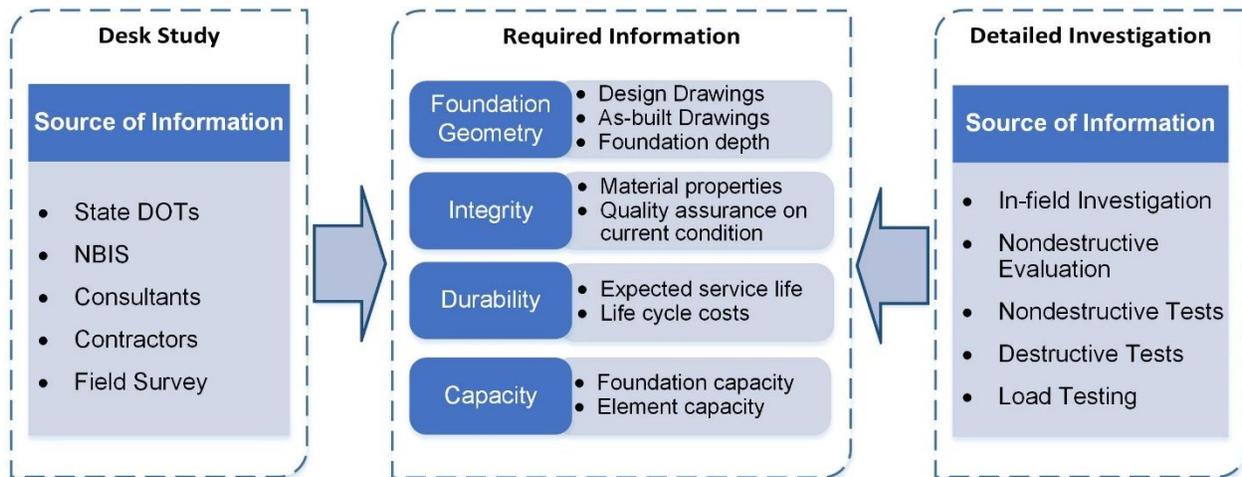
Figure 28. Illustration. Required information for a comprehensive reuse assessment

Detailed investigation is carried out based on the findings of the desk study. The knowledge from these two studies is combined to assemble all the required information for the foundation reuse, as illustrated in figure 28.

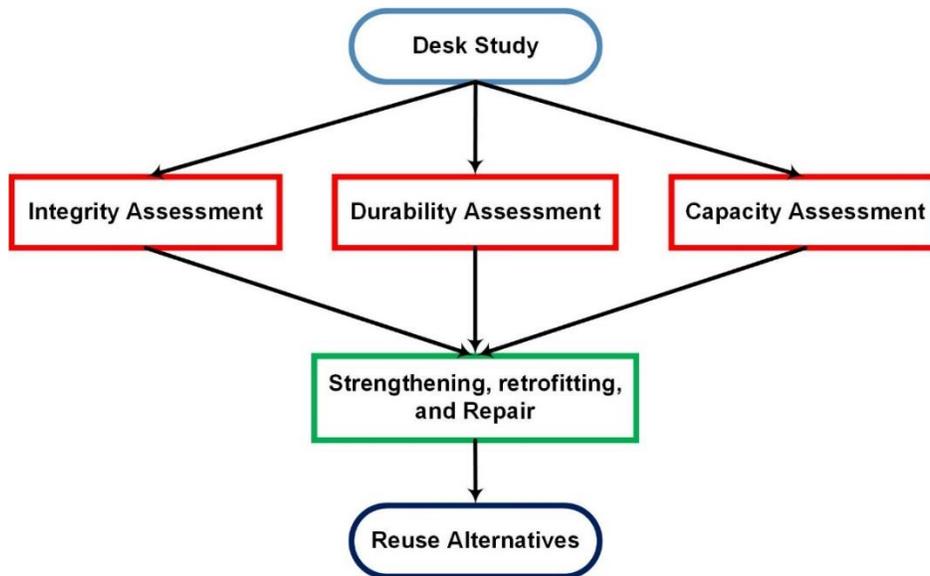
Figure 29. Chart. Reuse assessment procedure

While there is some hierarchy to the assessments, in many cases the testing required for each assessment can be performed simultaneously, or out of order. If one assessment phase is expected to control the suitability of the foundation for reuse, it may be prudent to investigate that aspect prior to performing other aspects. In many cases, foundations will be suitable for reuse, but will require repair, strengthening, or retrofitting. Repaired or strengthened sections may have their own durability considerations that impact the overall durability of the foundation. Typically, several reuse alternatives can be developed early in the reuse process that can be compared in terms of suitability and feasibility. A flowchart of the assessment procedure for reuse of foundations is shown in figure 29.

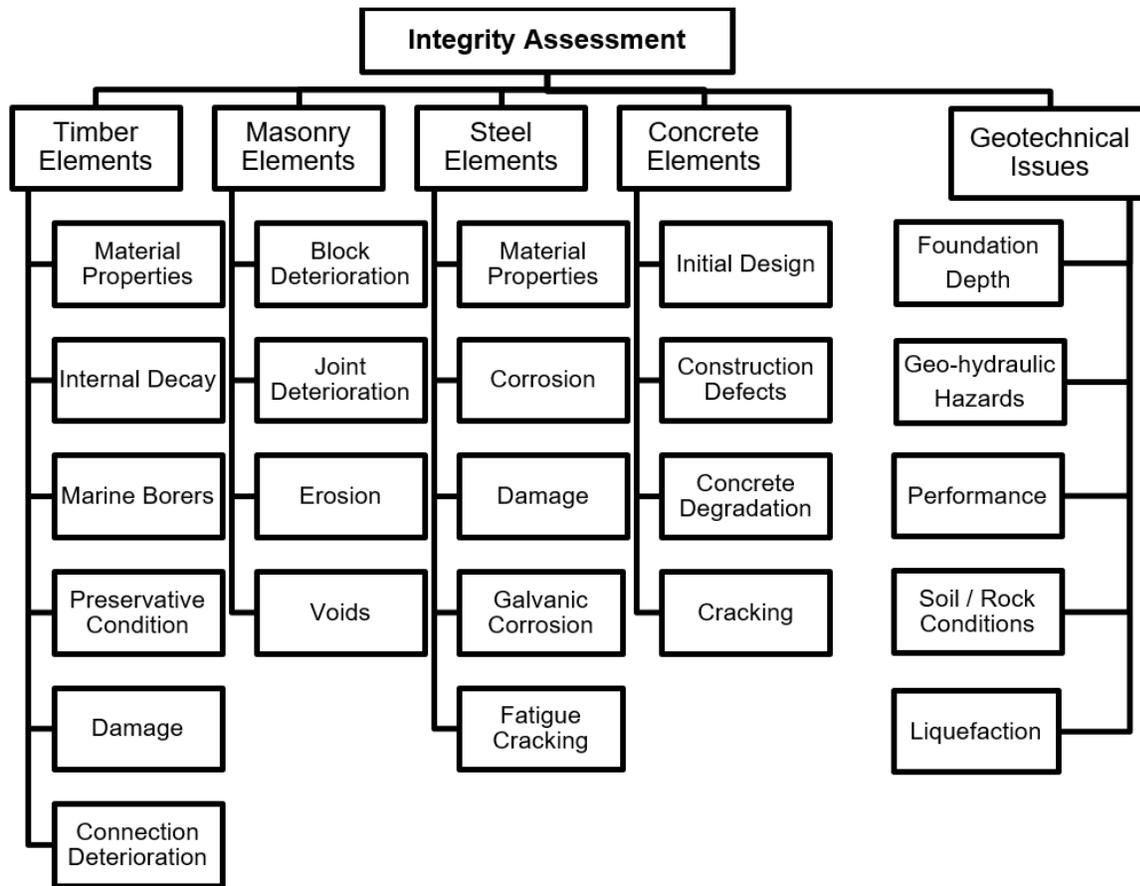
Figure 30. Illustration. Components of integrity assessment

Answering these questions involves evaluation of structural components above and below the ground surface. These elements may be constructed from a variety of materials, including concrete, steel timber, and masonry. In addition, the integrity assessment involves evaluation of relevant geotechnical issues, including past performance, geo-hydraulic hazards, soil properties, and liquefaction potential. The flowchart in figure 30 shows aspects of integrity assessment that may be considered during a reuse investigation for different material types.

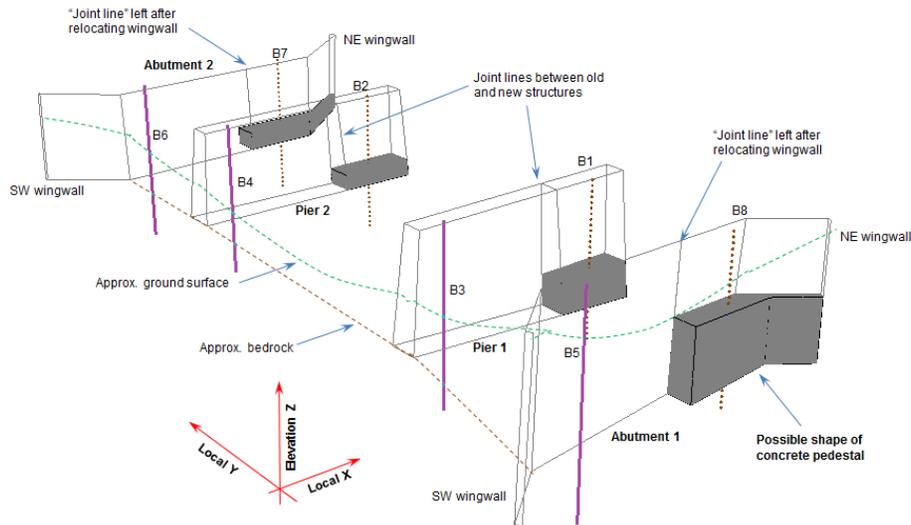
Figure 31. Illustration. Coreholes in abutments and piers in the Lake Mary Bridge

As part of this investigation, detailed nondestructive and geophysical investigation of bridge components has been performed. Various wireline logging runs have been performed in each corehole. Logging probes used included: Acoustic Televiwer, Optical Televiwer, Full Waveform Sonic, Compensated Density, Electric Log with spontaneous potential (SP)/ single point resistance (SPR), and caliper logs. Figure 31 shows the locations of coreholes. Logging results have shown the presence of voids in the masonry piers and abutments.

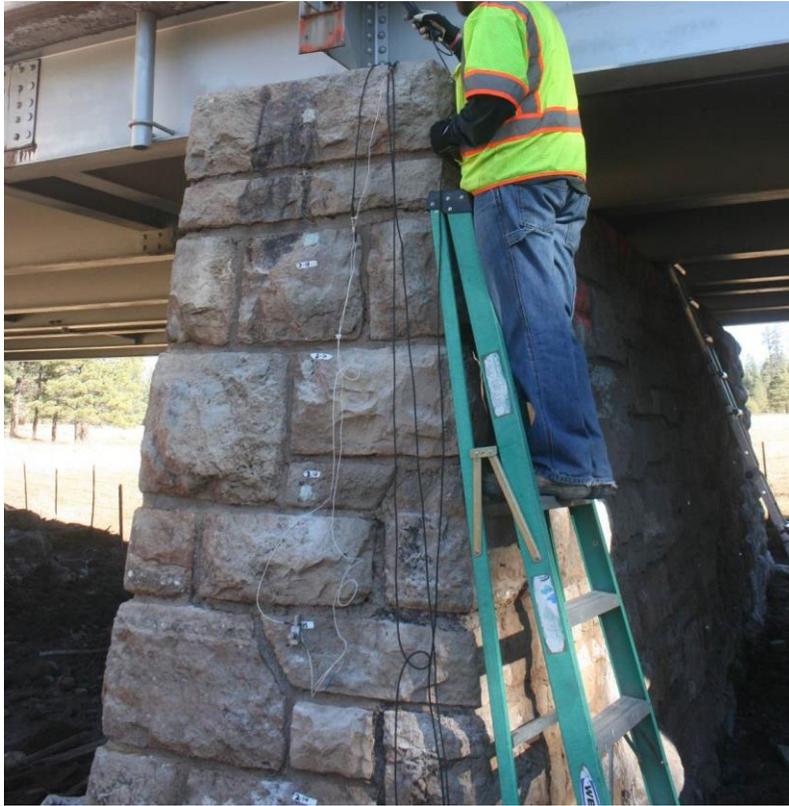
Figure 37 shows a technician performing ultrasonic (US) testing on one of the masonry piers by striking the top of the pier with a hammer while accelerometers are connected to the side of the pier. Figure 38 shows the drilling of a corehole being performed from the bridge deck, while only a single driving lane in closed.

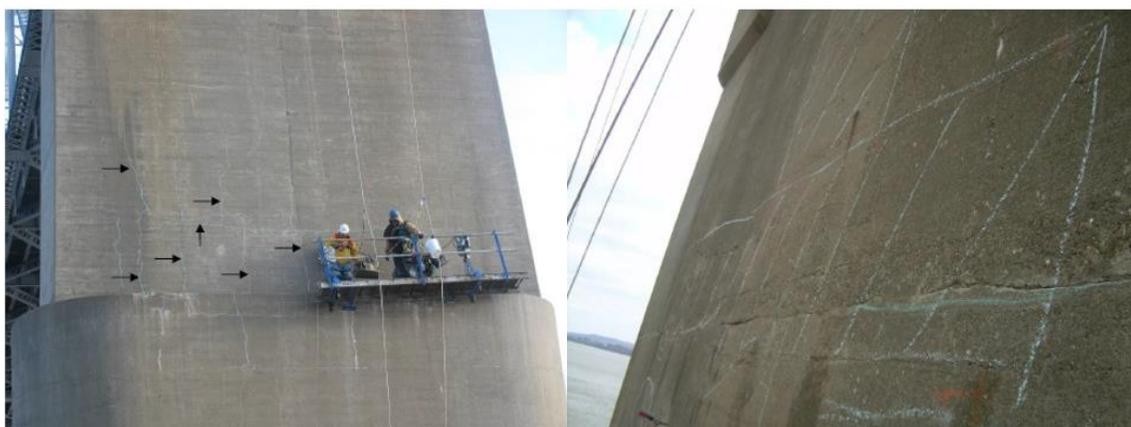
The initial condition assessment found horizontal cracking, vertical cracking, and lift lines in the piers being investigated for reuse. Varying amounts of spalling were observed, and zones of delaminated cover concrete were identified through hammer sounding. During this evaluation, six 4-inch (100 mm) diameter cores were taken for compression testing from the face of four piers, including three of the four piers eventually reused. An additional eight cores from the faces of the piers were taken for petrographic analysis. Petrographic analysis was also performed on seven cores taken vertically from the pier. The cores were drilled from the bridge deck ledges in the substructure. Logging of the vertically drilled cores was not performed. GPR and IR were performed to determine the location of reinforcement, cracking and delaminations. Pictures taken of the conditions at time of testing are provided in figure 39.

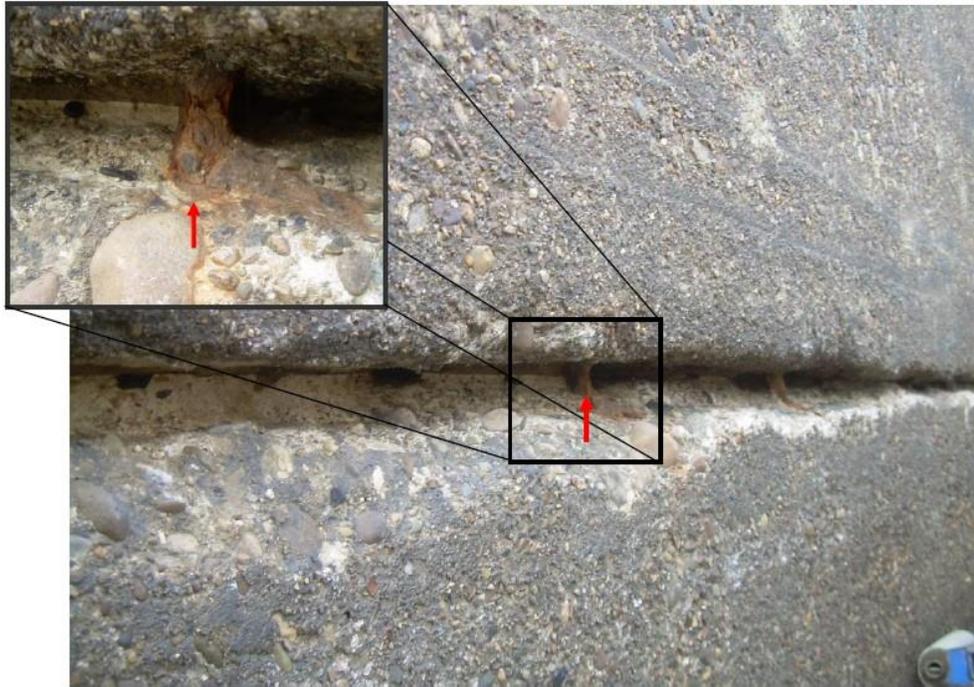
The initial evaluation also identified areas of minor paste erosion near the water line, possibly due to the presence of lower quality or weaker concrete. Lift lines were observed that indicated cold joints were present from the initial construction. Deterioration of the concrete above and below some of the cold joints had led to exposed steel rebar that became a focal point for corrosion, as shown in figure 40.

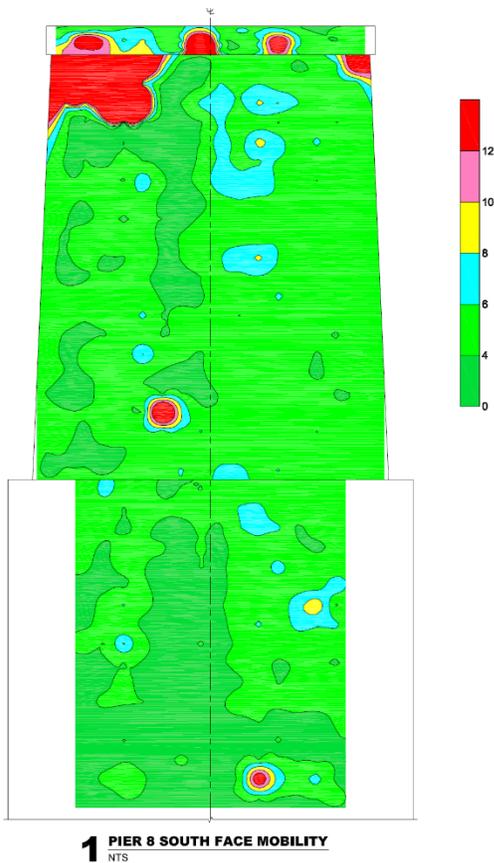
1 PIER 8 SOUTH FACE MOBILITY
NTS
©2009 CTL Group
Figure 41. Photo. Impulse response test results

Concrete cores were extracted from both the faces of the concrete piers and from core holes drilled vertically through the deck, pier, and underlying rock. In all, 54 compression tests were performed on 2 in (50 mm) diameter cores removed from the vertical coreholes, and six compression tests were performed on 4 in (100 mm) diameter cores removed from the pier faces. The cores taken from the vertical coreholes had an average unconfined compressive strength of 9,250 psi (64.8 MPa), with a standard deviation of 1,780 psi (12.3 MPa). The test breaks for all the cores were generally above 6,000 psi (41.4 MPa), with 1 test breaking at 4,810 psi (33.2 MPa). The six 4 in (100 mm) cores had unconfined compressive strengths ranging from 7,000 psi (48.3 MPa) to 13,750 psi (94.8 MPa), with an average of 10,297 psi (71 MPa). Static modulus of elasticity testing was performed on two samples taken from the pier faces, which were found to have moduli of elasticity of 864,000 ksf (41.4 GPa) and 907,200 ksf (43.4 GPa). These values exceeded the material properties used in design, but ultimately the design modulus of elasticity was taken from the unconfined compressive strength. Table 19 summarizes the tests performed, issues evaluated, and extent of testing for this bridge.

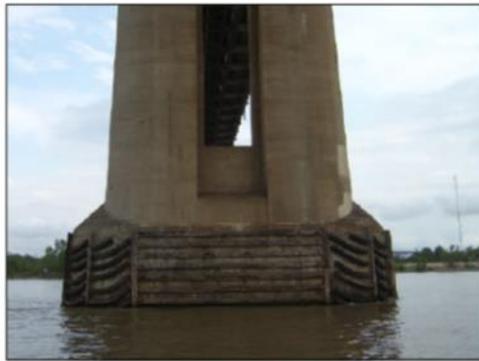
A diving inspection was performed to evaluate the condition of the pier below the water line. Due to the fast-moving currents and low visibility, the visual component of the diving inspection was of little use. Acoustic sonar imaging was performed to visualize the condition of the pier as well as the soil surrounding the pier. Examples of the images obtained through acoustic imaging are provided in figure 44.

A. North face with regular image

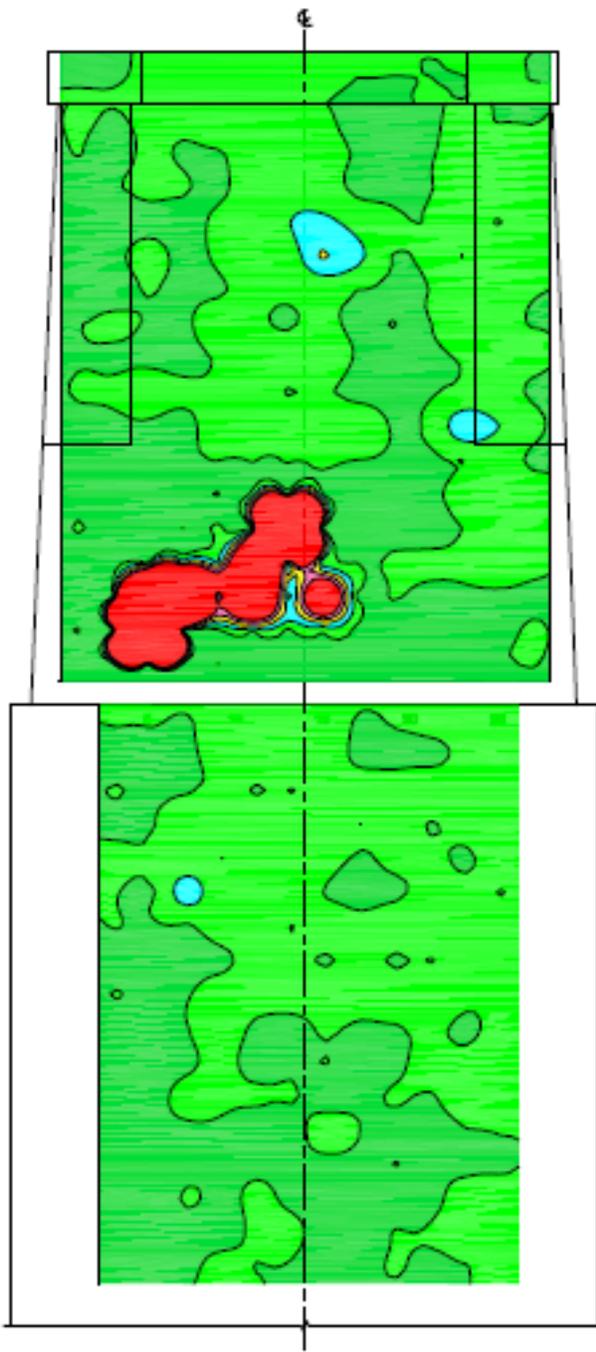
1 PIER 5 NORTH FACE MOBILITY
NTS

Figure 53. Image. Delamination and cracking survey provided
