TECHBRIEF

Evaluation of Member and Load-Path Redundancy on the US-421 Bridge Over the Ohio River

FHWA Publication No. FHWA-HRT-13-105 NTIS Accession No. of the report covered in this TechBrief: PB2013-110588 FHWA Contact: Justin Ocel, HRDI-40, (202) 493-3080, justin.ocel@dot.gov

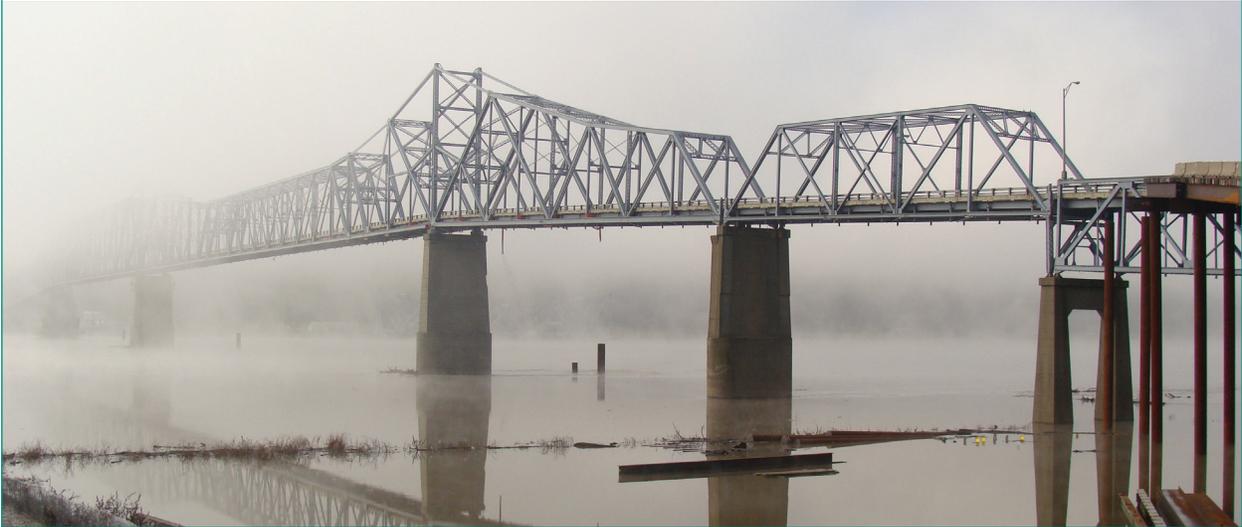
Figure 1. Overall view of bridge from Indiana shore.

The US-421 bridge spans over the Ohio River between Madison, IN, and Milton, KY, and is referred to as the Milton-Madison Bridge. It was constructed in 1921 and consisted of 19 spans of riveted, built-up members. An overall view of the bridge is shown in figure 1.

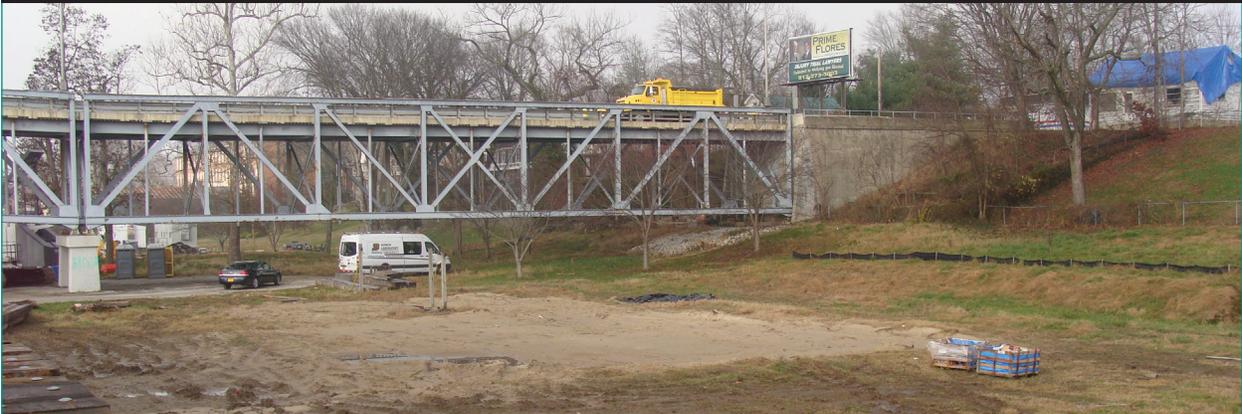
Figure 2. View of the test span.

Figure 1 does not capture the approach-span trusses leading up to the river span. The first approach-span truss on the Indiana shore is the focus of this research effort. A picture of a test truss is shown in figure 2; the lower chord is close to the ground and spans over a city park property, making access for instrumentation easy. The test truss spans 149 ft and is in a Pratt configuration as shown in figure 3. The truss had some corrosion throughout, which was quite severe in some places and left holes and partially severed members, as seen in figure 4.

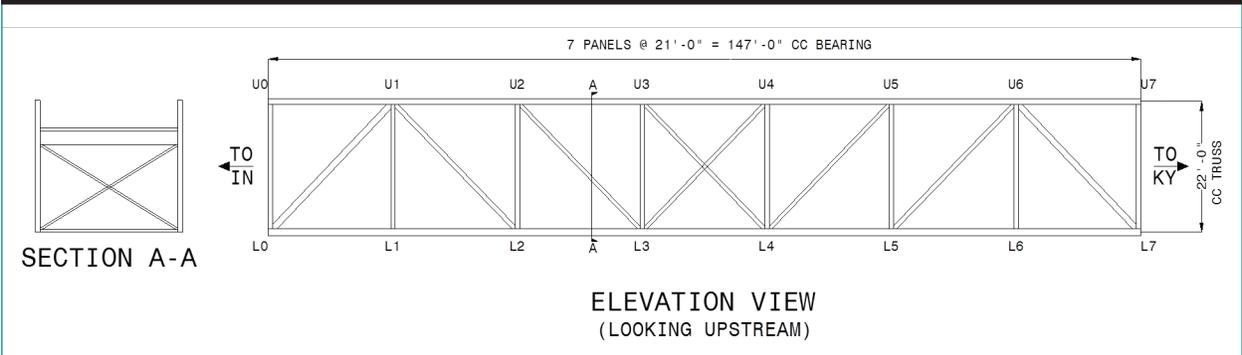
Figure 3. Elevation view of truss.

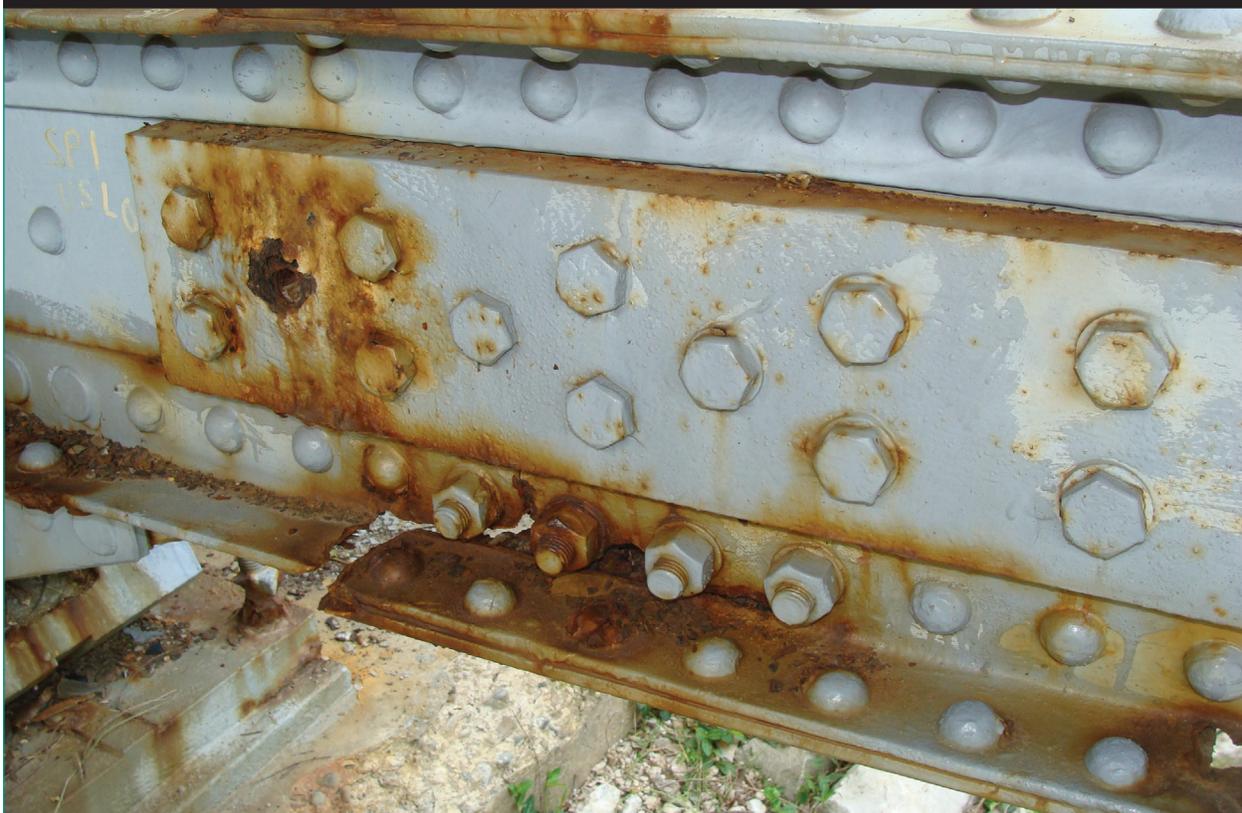
Figure 4. Severe corrosion in lower chord near abutment.

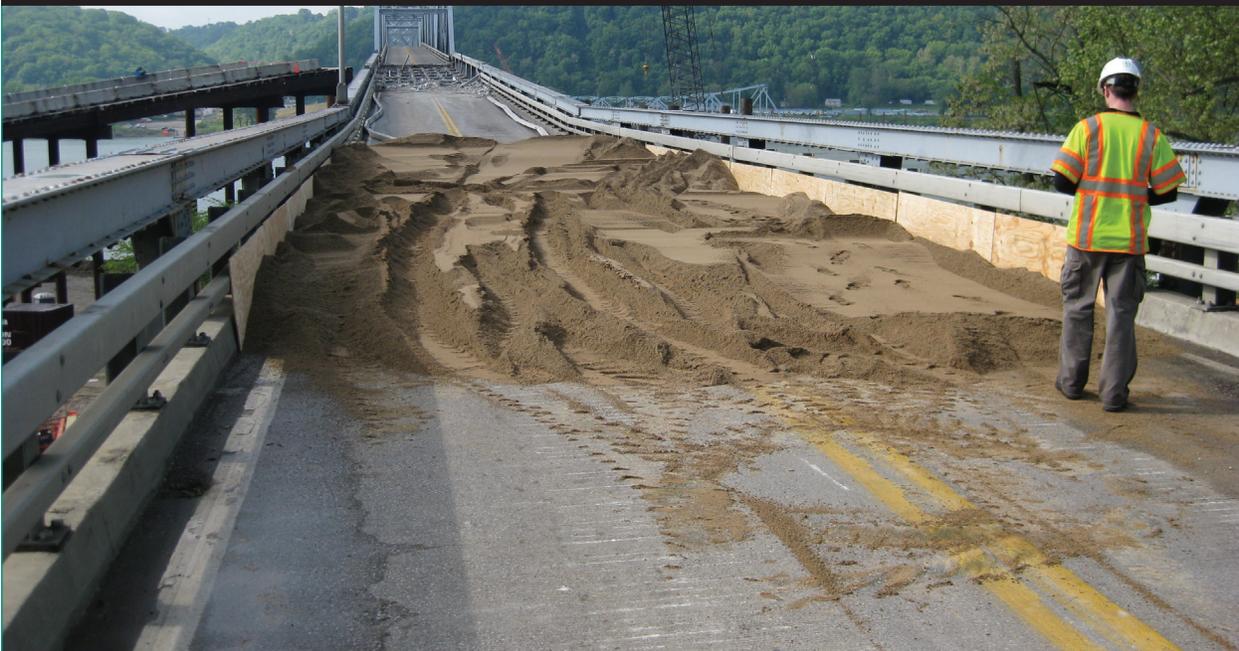
Figure 5. Sand placed on deck before simulated fracture event.

As far as this project was concerned, the controlled demolition plan was to completely sever the L3-L4 bottom chord on the upstream truss while monitoring the strain gauges. Sand was placed on the bridge to represent about $\frac{2}{3}$ the original design live load. It was difficult to select this loading, as there is no guidance regarding what amount of live load a fractured bridge should be able to sustain. After much consideration, the selected load was deemed reasonable, as it is much higher than any loads seen during long-term monitoring and was thought to be a reasonable upperbound load. This resulted in 145 kips of sand distributed over the deck. However, this load was focused over the three interior panels of the truss (i.e., between nodes U2 and U5) and resulted in stresses in members that were approaching the original design loading. Figure 5 is a photo of the sand atop the bridge.

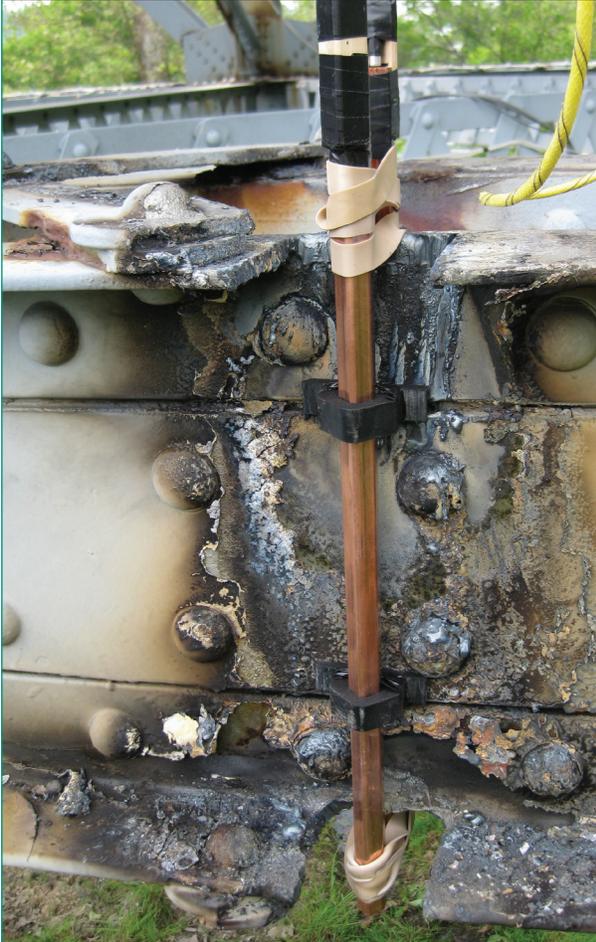
Figure 6. Shape charges applied to one web plate of chord member.

The chord member was fabricated from built-up channels that were laced together. Each built-up channel was comprised of two angles and a plate that served as the web. In some locations, two web plates were utilized. Each built-up channel was severed separately to evaluate the internal redun-

dancy of the member (i.e., each half of the member was cut separately). To facilitate this, the lacing was flame cut between the two sets of shape charges to ensure that no load was carried through the lacing. Shape charges, as shown in figure 6, were used to instantaneously sever the entire built-up channel, in order to represent a fracture event as much as possible. Figure 7 is a photograph taken after one half of the lower chord was severed.

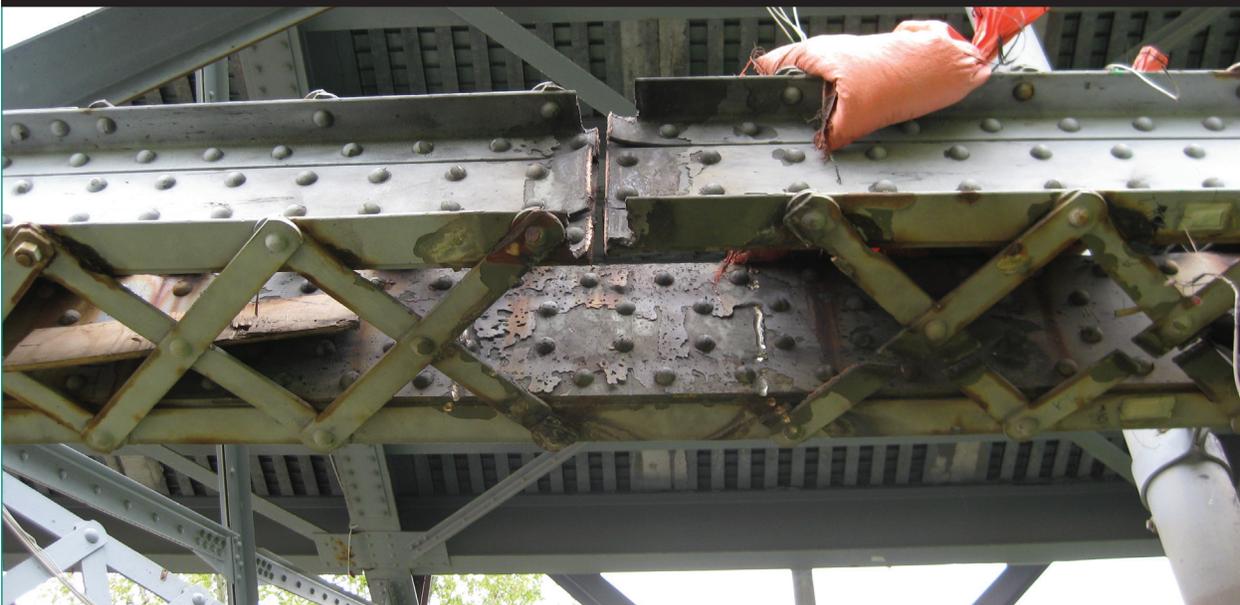
Figure 7. Web plate fracture after first explosive event.

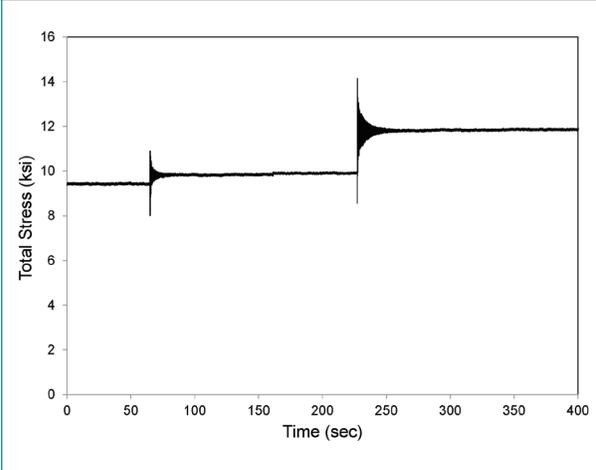
Figure 8. Data record of L3-L4 downstream chord during both explosion events.

Figure 8 shows a record from one of the strain gauges installed on the L3-L4 chord on the downstream truss during the two explosive events on the same member of the upstream truss. The plots include the effects of dead load and sand loads. Therefore, this plot shows the total stress in the member. The dead-load stresses were obtained from the computer model, while the stress from the sand load was measured. With the sand in place, the member was subjected to 9.4 ksi prior to the simulated fracture. After the first half of the upstream chord was severed, the stress increased to 9.9 ksi. After the member was completely severed, the stress further increased to 11.9 ksi. The dynamic amplification due to the instantaneous load release following the simulated fracture events was also observed.

For all members that were instrumented, the dynamic amplification from the first blast ranged from 1.08 to 1.30. For the second blast event, the amplification factors ranged from 1.17 to 1.41.
