An FHWA Special Study: Post-Tensioning Tendon Grout Chloride Thresholds

PUBLICATION NO. FHWA-HRT-14-039

MAY 2014

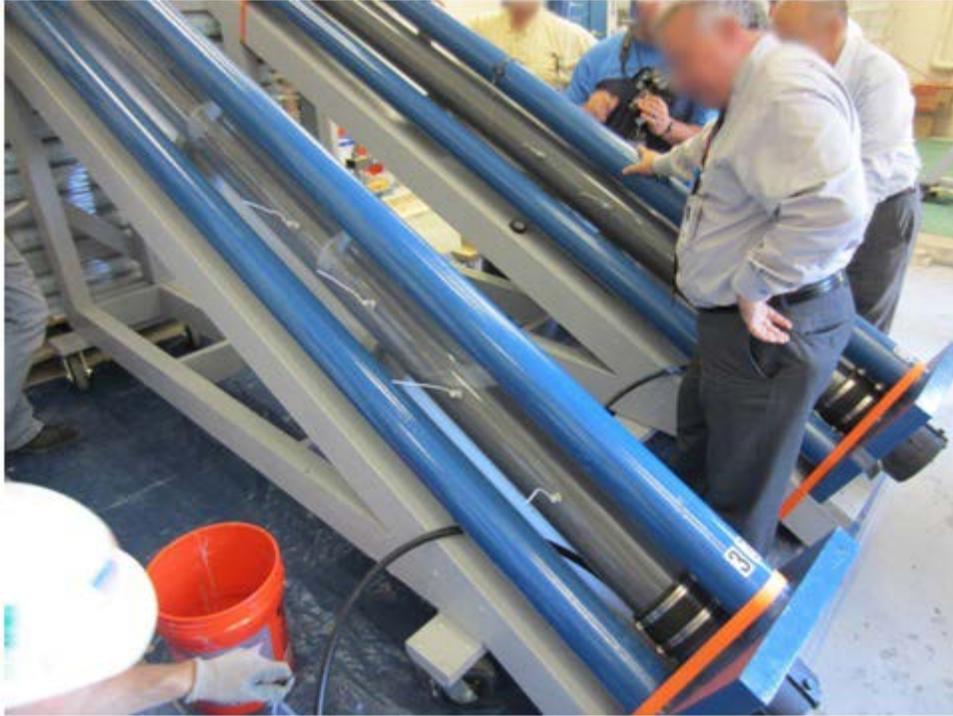
Figure 39. Photo. Grout pumping into a multi-strand specimen.

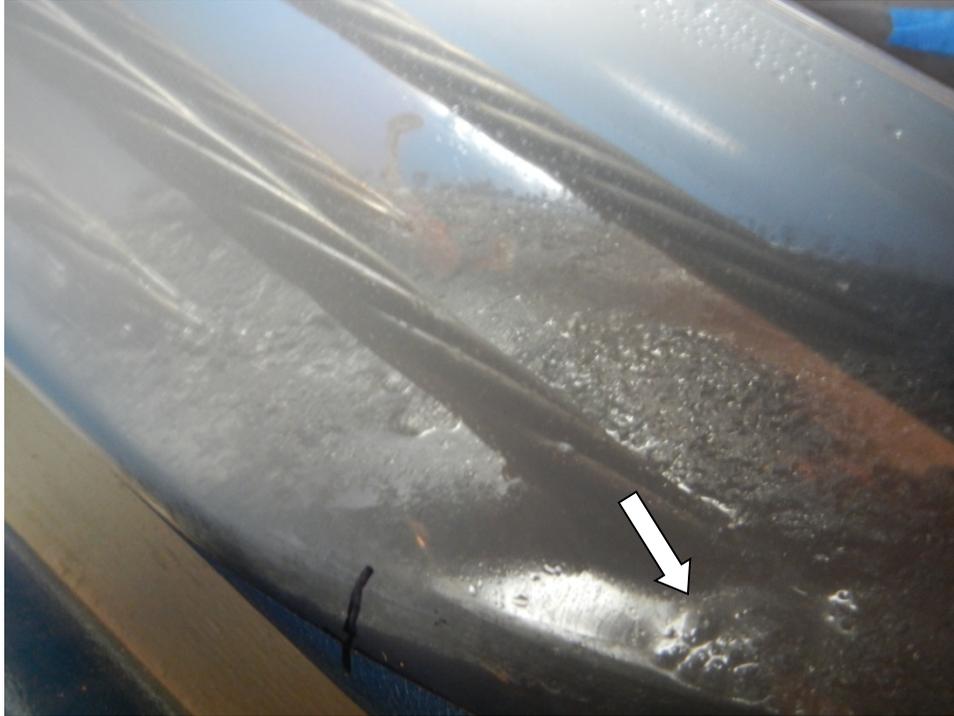
Figure 156 through figure 163 show stressed strands in the voids. The photographs were taken 1 week after recharging water was added to the voids. It was observed even during early days of testing that three specimens containing 0 percent chloride (see figure 156), 0.4 percent chloride (see figure 159), and 2.0 percent chloride (see figure 163) showed black deposit on the void/grout interface where stressed strands passed through. The unknown deposit material is indicated with arrows in the figures. The specimens covered with the deposit layer also appeared to hold water longer than specimens without it. This mysterious layer turned out to be important, as the autopsy revealed that some strands in contact with the deposit layer suffered from severe corrosion. Three wires of 0.4 percent chloride specimen and one wire of 2.0 percent chloride specimen were corroded in two during the 6-month accelerated corrosion testing. The 0 percent chloride specimen had severely corroded strands at the interface during the same period. The other specimens showed only minor corrosion on the stressed strands near the interface. The encountered excessive corrosion problem was never expected. Consequently, data analysis became complicated as to what to include and what to exclude among the weekly collected electrochemical data.

Figure 156. Photo. Void condition of 0 percent chloride specimen.

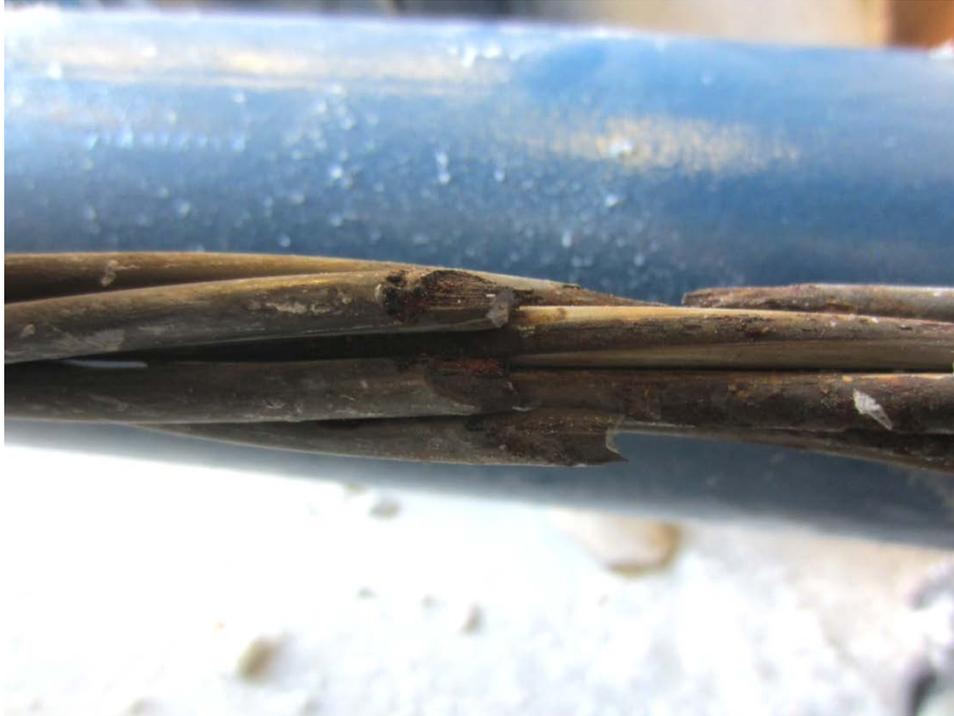
Figure 220. Photo. Close-up view of the severely corroded strand shown in figure 219.

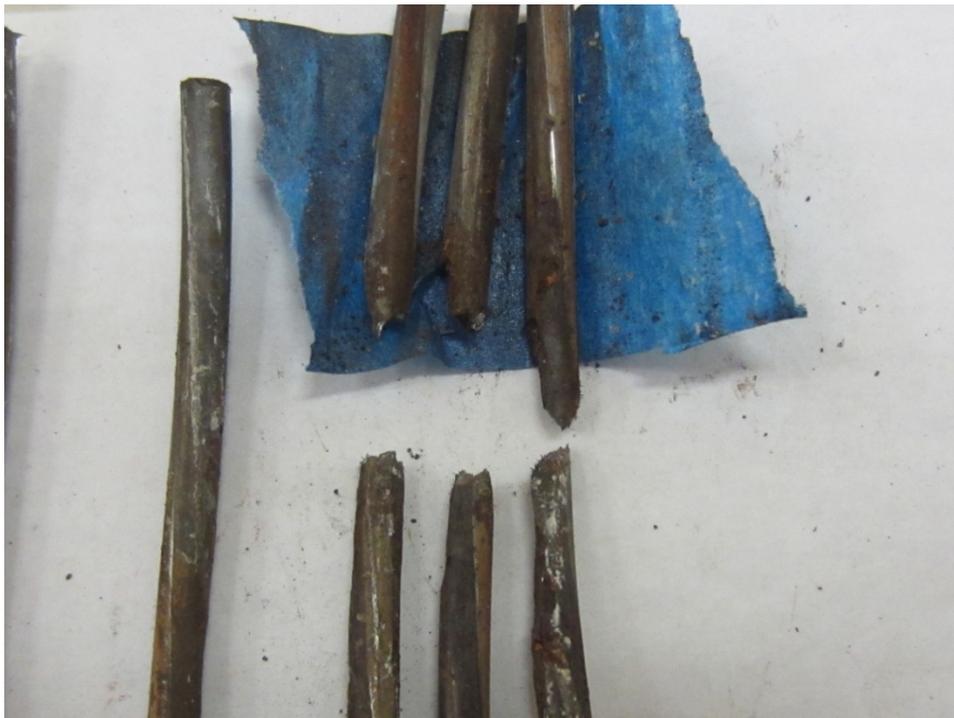
Figure 221. Photo. Close-up view of the broken wires shown in figure 220.

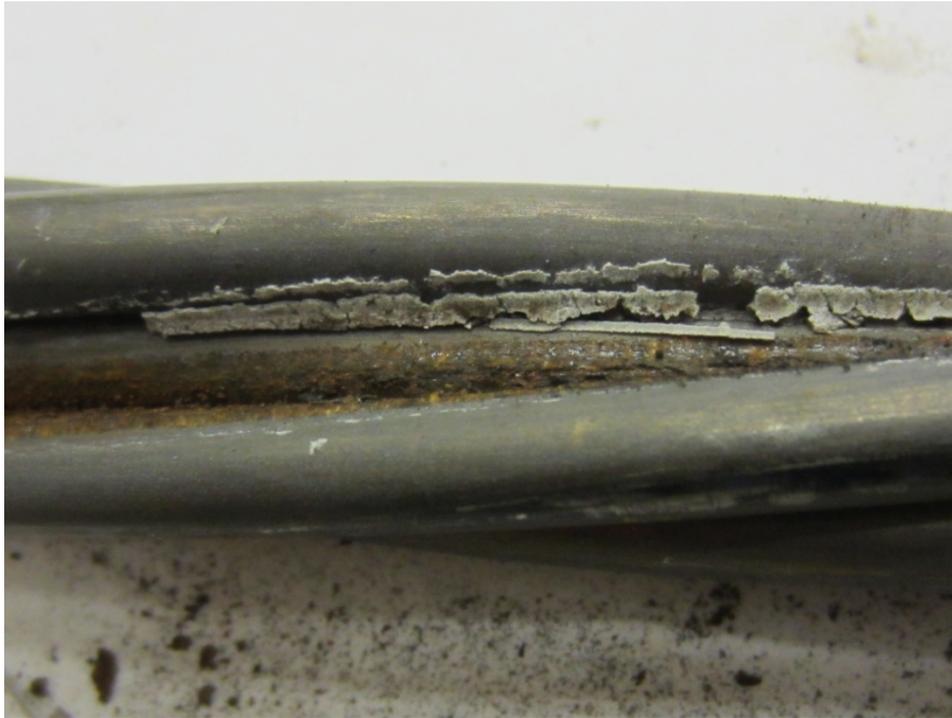
Figure 235. Photo. Grout fragment found inside an interstice surrounded by corroding wires.

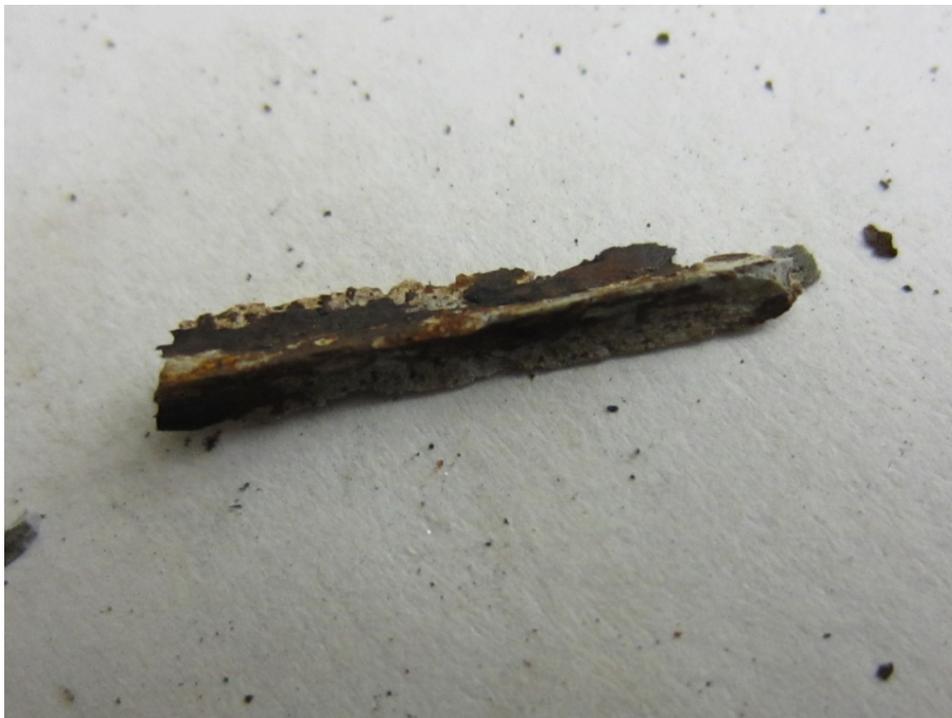
Figure 236. Photo. Heavily rust-stained grout fragment that fell from the strand shown in figure 235.

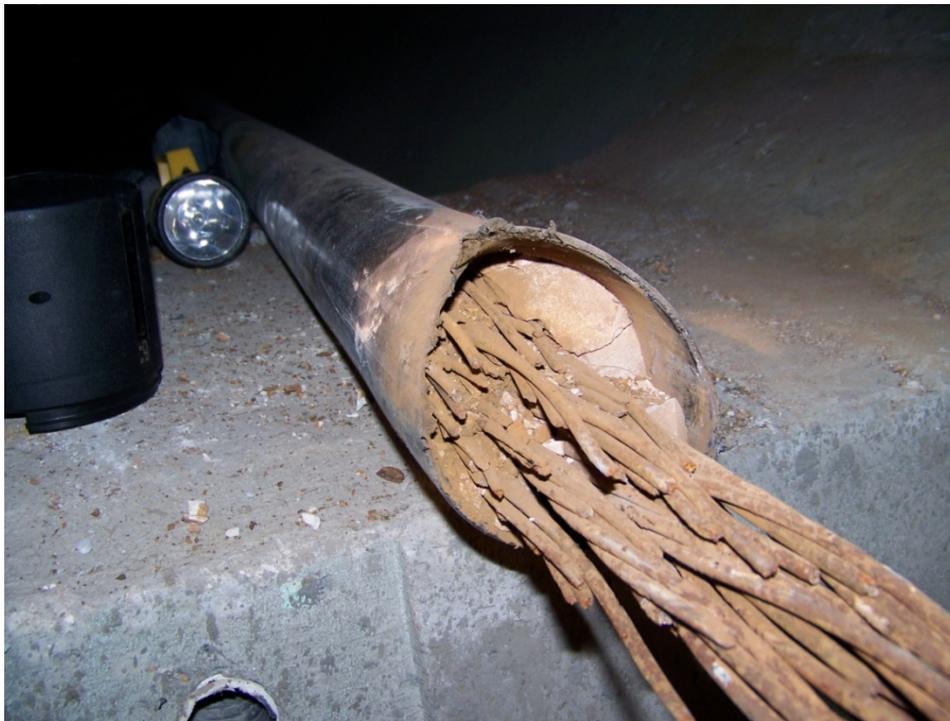
Figure 264. Photo. Failed external PT tendon of Verina-Enon bridge in Virginia.

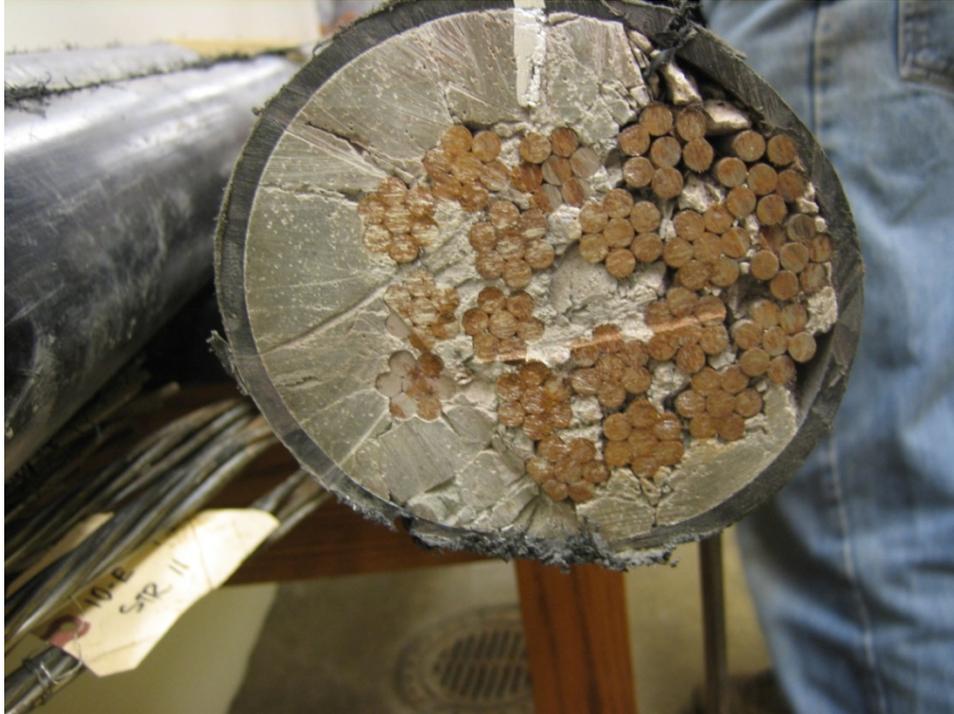
Figure 265. Photo. Other matching end of the retrieved tendon sample shown in figure 264.

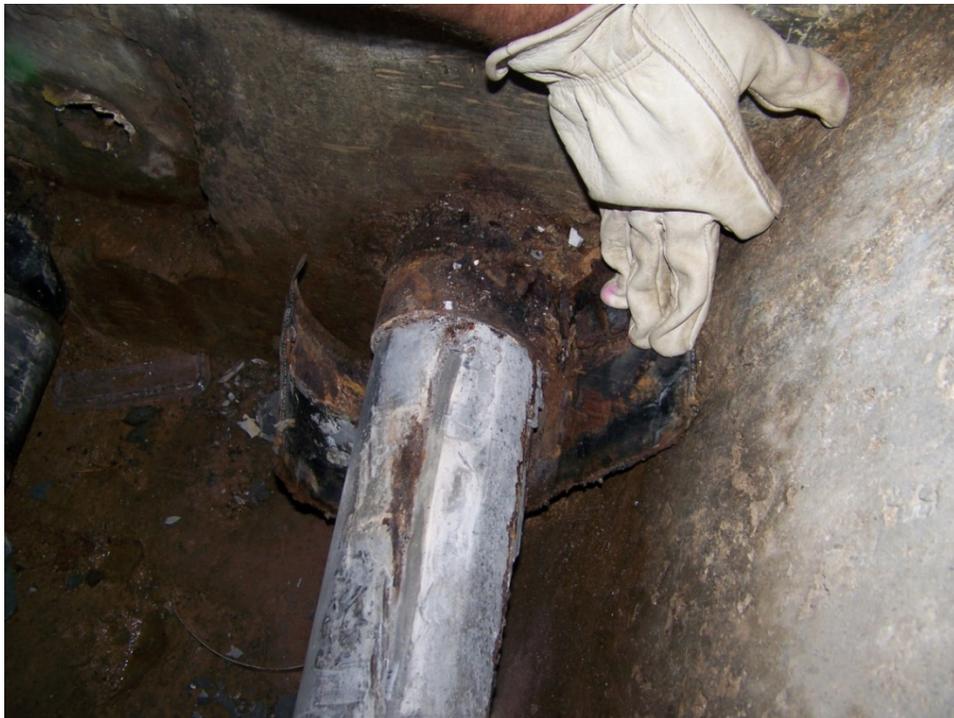
Figure 266. Photo. Corroding PT tendon of Verina-Enon bridge in Virginia.
