An FHWA Special Study: Post-Tensioning Tendon Grout Chloride Thresholds

FHWA Publication No.: FHWA-HRT-14-040

This document is a technical summary of the Federal Highway Administration report, *An FHWA Special Study: Post-Tensioning Tendon Grout Chloride Thresholds* (FHWA-HRT-14-039).

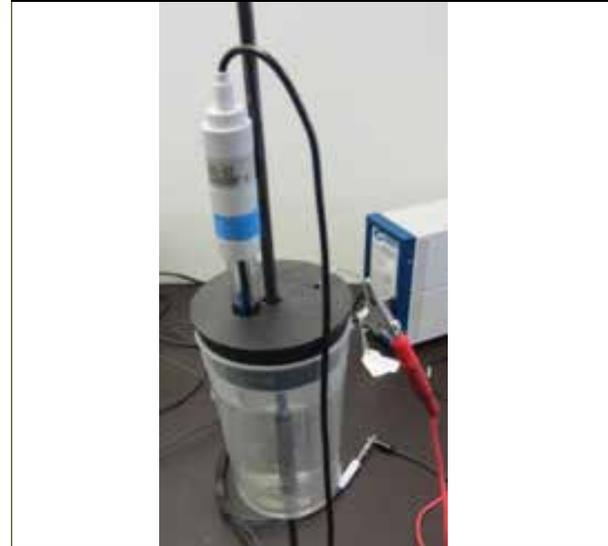
Figure 1. Single-wire specimen.

A 6-month accelerated corrosion testing program employed three types of laboratory specimens as shown in figure 1 through figure 3. The first type was single king (i.e., center) wire specimens that were extracted from the regular PT strands. More than 50 specimens were tested in aqueous solutions having a low pH of 9 to simulate carbonated grout and a high pH of 13.6 to simulate highly alkaline normal grout, each with 10 chloride concentrations. Some of them were stressed at 60 percent guaranteed ultimate tensile strength (GUTS), and the others were placed in a no stress condition. The second type was 12-inch-long single-strand specimens embedded in grout. A total of 40 specimens were fabricated, and some were stressed at 60 percent GUTS and/or contained an artificial grout void. The effects of stress, grout void, and chloride concentration were to be evaluated in an ideal condition.

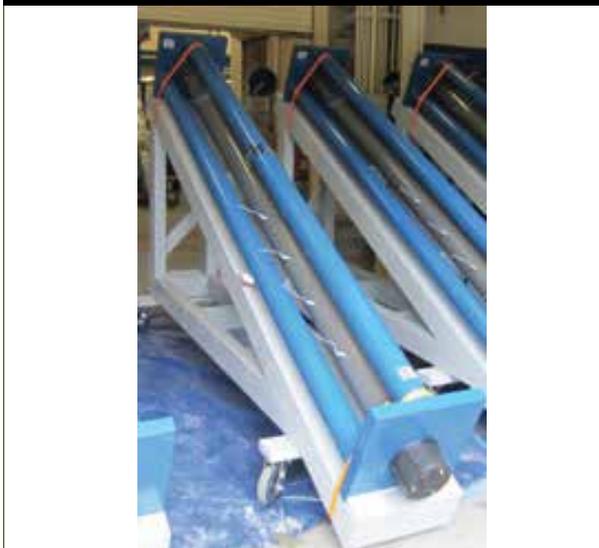
Figure 3. Multi-strand specimens.

The third type was 10-ft-long multi-strand specimens encased in steel loading frames. A total of eight specimens were prepared to evaluate the effects of stress, void, and chloride concentration in the macro-cell corrosion condition, which has been responsible for the observed severe corrosion problems in the field. To create simulated macro-cell corrosion, each specimen

contained four strands stressed at 60 percent GUTS and was passed through an artificial void near the top anchor plate. This served as the macro-anode. Additionally, a bundle of five 7-ft-long unstressed strands were completely buried in grout, which served as the macro-cathode. The grout mixes were admixed with eight acid-soluble chloride concentrations ranging from 0 to 2.0 percent by weight of cement.

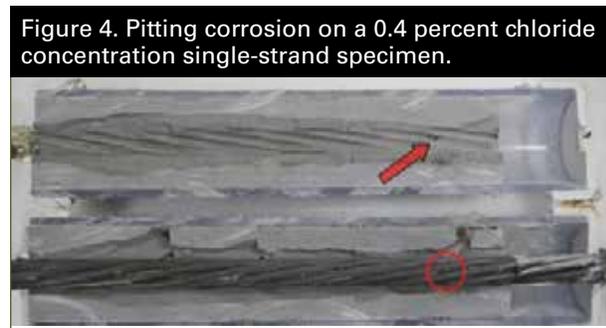
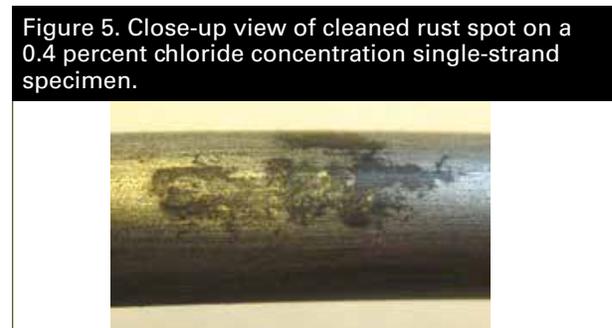
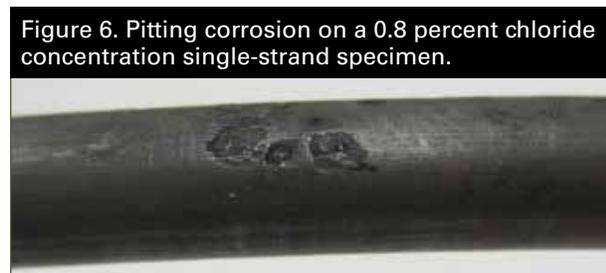
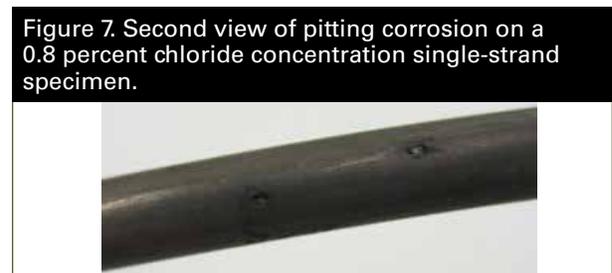
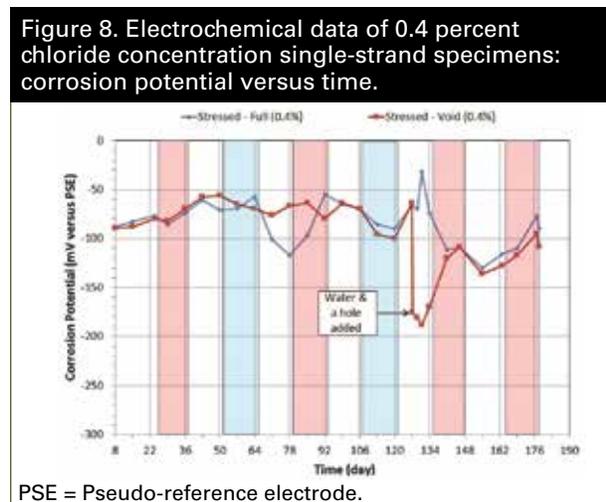
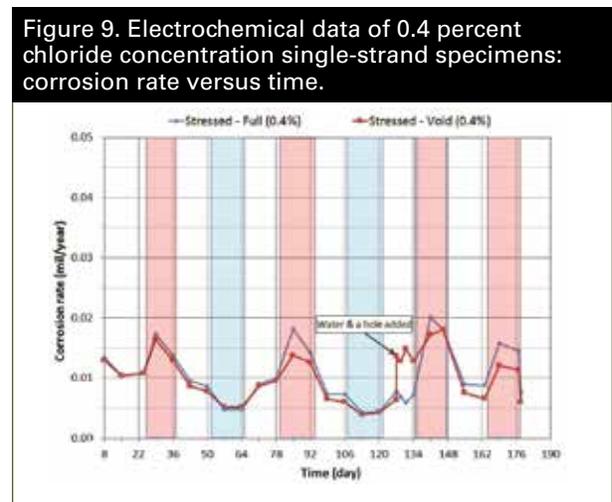
The first rust spot (considered a sign of corrosion initiation) observed on the single-strand specimens began to appear when chloride concentration was 0.4 percent. Measurable pits deeper than 2 mil (considered a sign of corrosion propagation and also the lowest measurement limit of a digital pit gauge) were observed when chloride concentration was 0.8 percent. Figure 4 through figure 7 show physical conditions of the corroding wires removed from 0.4 and 0.8 percent chloride concentration specimens,

respectively. The red arrow in figure 4 indicates a rust stain matching with the corrosion spot marked in the red circle. As chloride concentration increased, severity of the corrosion worsened, particularly for the stressed specimens with void. Mean pit depths ranged between 3.6 and 6.2 mil. A combination of a void, recharged water, and elevated chloride concentration can be detrimental, evidenced by the markedly higher number of pits found on the stressed 2.0 percent chloride specimen with void.

Corrosion potential and corrosion rate data of single-strand specimens containing 0.4 and 0.8 percent chloride concentrations are shown in figure 8 through figure 11.

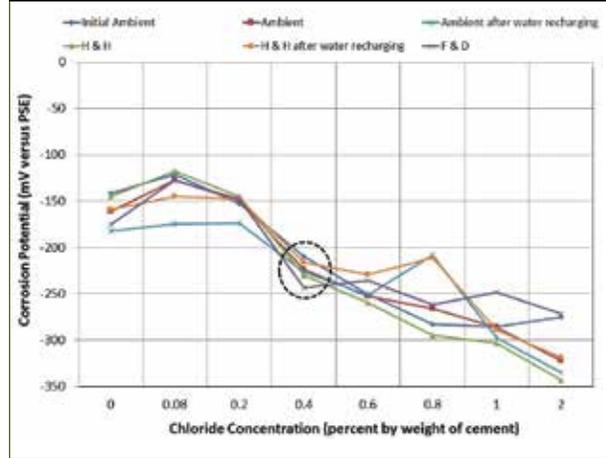
Figure 12. Electrochemical data of multi-strand specimens: mean corrosion potentials.

For multi-strand specimens, chloride concentration was a more influential parameter for corrosion potential than exposure condition. As the macro-cell corrosion setup intended, stressed strands exhibited more negative corrosion potentials than unstressed ones, making the stressed strands anodic to the unstressed ones at any chloride concentration. It is unclear if presence of stress or localized corrosion at the void/grout interface or both made the entire stressed strands active. When chloride concentration increased to 0.4 percent, mean corrosion potentials of the stressed strands decreased to the 90th percentile of corrosion probability. Mean macro-cell corrosion current density also began to increase at 0.4 percent chloride. Figure 12 and figure 13 show the

mean corrosion potential data of the stressed strands and mean macro-cell corrosion current density data, respectively.

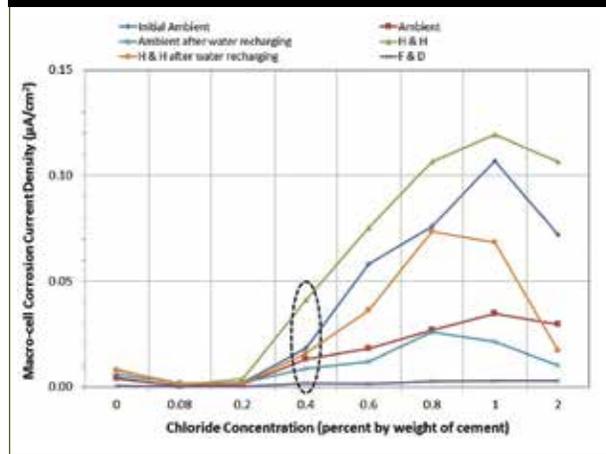
Figure 13. Electrochemical data of multi-strand specimens: mean macro-cell corrosion current densities.

Even though it was not included, the unstressed strands exhibited active corrosion potential at 2.0 percent chloride concentration. The H & H and F & D cycles produced the highest and the lowest mean macro-cell corrosion current densities, respectively, independent of chloride concentration. Water recharging did not influence the mean corrosion potentials and mean macro-cell current densities significantly.

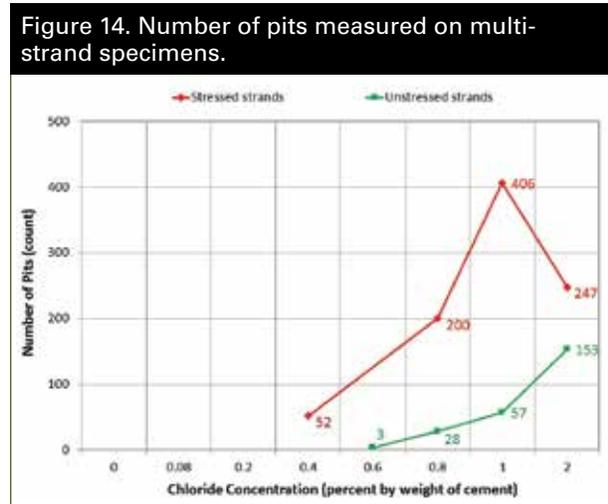
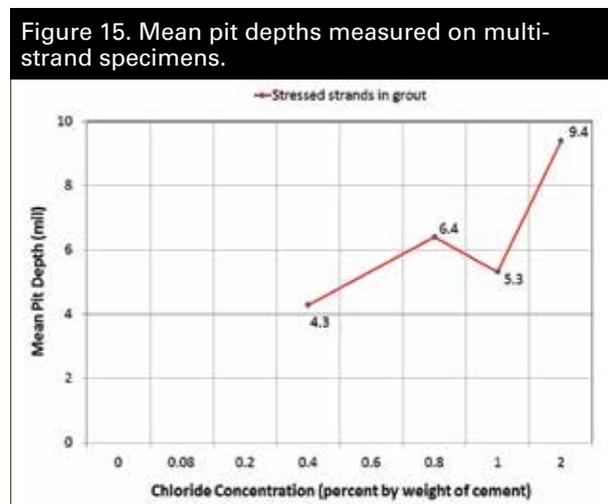
acid cleaning at 0.8 percent chloride concentration. This observation could be made with both of the void/grout interface segments and in-grout segments. Mean pit depths measured on the stressed in-grout strands increased from 4.3 to 9.4 mil when chloride concentration increased from 0.4 to 2.0 percent. For unstressed strands, superficial rust began to show up at 0.6 percent chloride concentration, and none of the pits exceeded 2 mil regardless of chloride concentration. Figure 14 and figure 15 show the numbers of pits counted in the in-grout segment of stressed and unstressed strands and mean pit depths of the stressed strands as a function of chloride concentration, respectively.

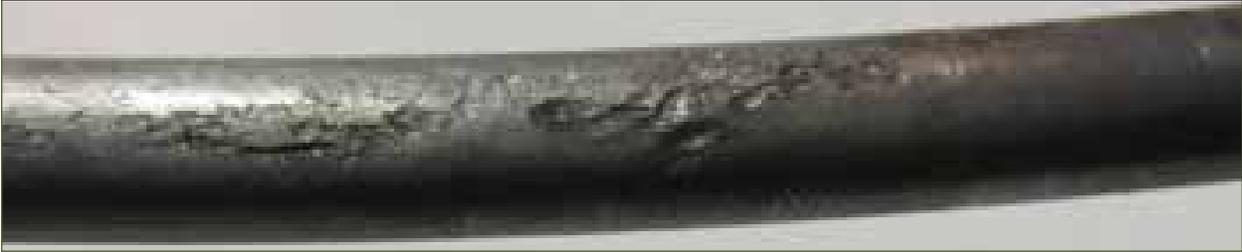
Figure 16. Pitting corrosion observed on a stressed wire of 0.4 percent chloride concentration multi-strand specimen.

concentration was less than 1.0 percent. At 2.0 percent chloride concentration, mean pit depth increased to 11 mil. The largest measured pit depths were 60 and 36 mil for the interface segments and in-grout segments, respectively. Figure 16 and figure 17 show pitting corrosion damage found on 0.4 and 0.8 percent chloride concentration multi-strand specimens, respectively. At 0.4 percent chloride concentration, the mean pit depth was 4.1 mil with a maximum pit depth of 9.0 mil. At 0.8 percent chloride concentration, mean pit depth was 5.9 mil with a maximum pit depth of 11 mil.

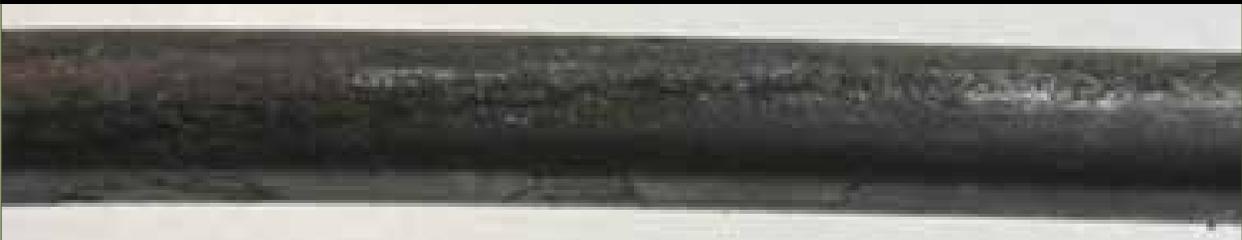
Figure 18. Crevice corrosion between two stressed wires on 0.4 percent chloride concentration multi-strand specimen.

Crevice corrosion, another form of localized corrosion, was also observed on many of the multi-strand specimens containing 0.4 percent and higher chloride concentrations. Similar to the observed pitting corrosion, crevice-induced corrosion got worse as chloride concentration increased. Figure 18 and figure 19 show typical crevice corrosion damage found on 0.4 and 0.8 percent chloride specimens, respectively. At 0.4 percent chloride concentration, mean pit depth was 4.5 mil with a maximum pit depth of 8 mil. At 0.8 percent chloride concentration, mean pit depth was 4.5 mil with a maximum pit depth of 6 mil.
