Fatigue Performance of High-Frequency Welded Steel I-Beams

PUBLICATION NO. FHWA-HRT-17-110

FEBRUARY 2018

U.S. Department of Transportation
Federal Highway Administration

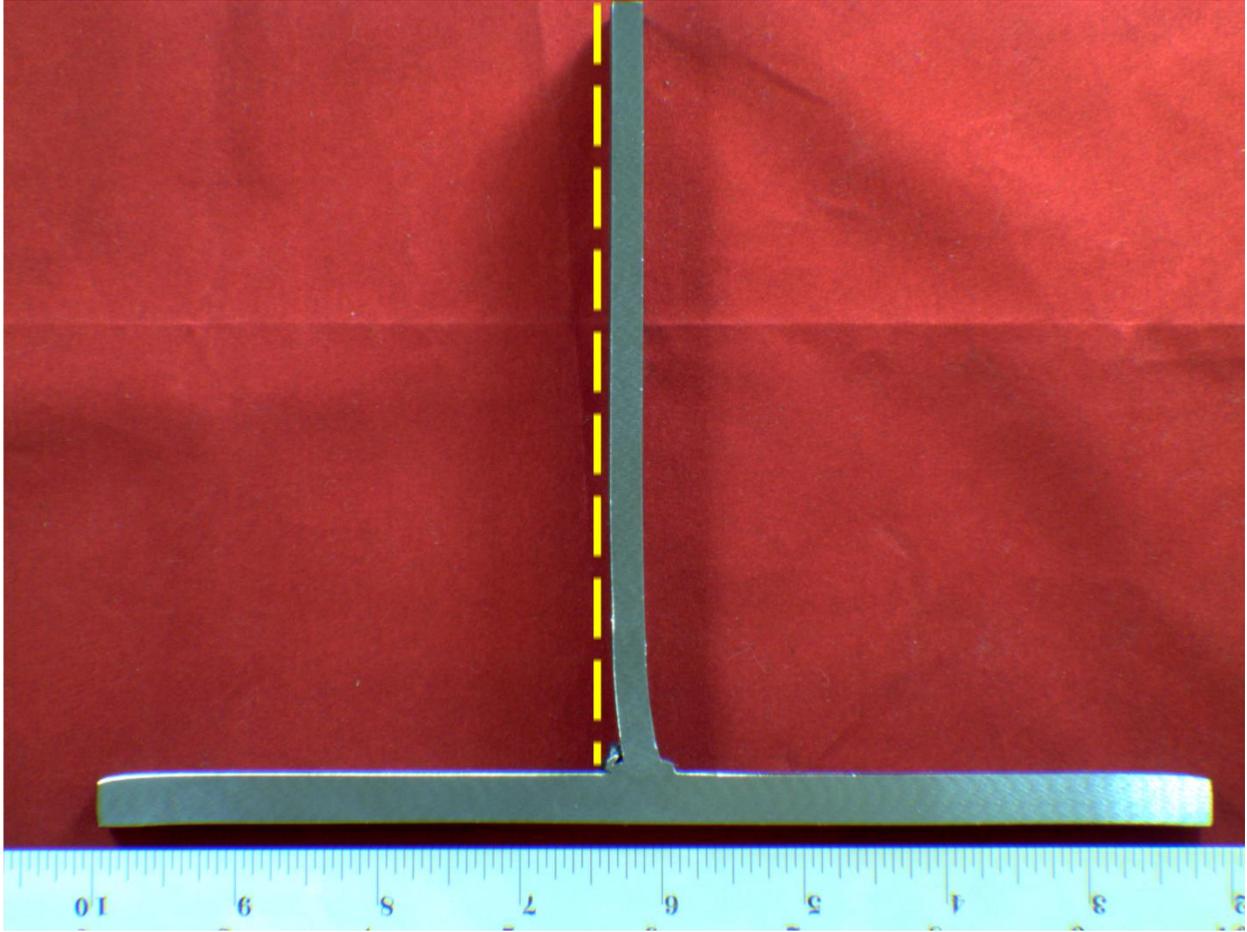
Note: Scale is in units of inches.

Figure 1. Photo. Beam cross section.

Six HF-welded, doubly symmetric I-beams consisting of ASTM A769 grade 50 steel were attained to be fatigue tested.⁽²⁾ The specimens were identified sequentially as beam 1 through beam 6. The nominal geometric properties of the steel I-beams are given in table 1. A picture of a representative partial beam cross section (one flange and most of the web) is shown in figure 1. Most noticeable in this picture is the horizontal offset of the web; while it is joined at the midwidth of the flange, the forging force during welding caused a shift in the web to the left. This distortion of the cross section was observed in all the beams and did cause stability issues that will be described in more depth later. The weld itself, shown in figure 2, appeared very uniform, though the manufacturer of this I-beam did not remove the flash that is ejected from the forging event, and this is noted in the figure and highlighted, as it did affect results described later.

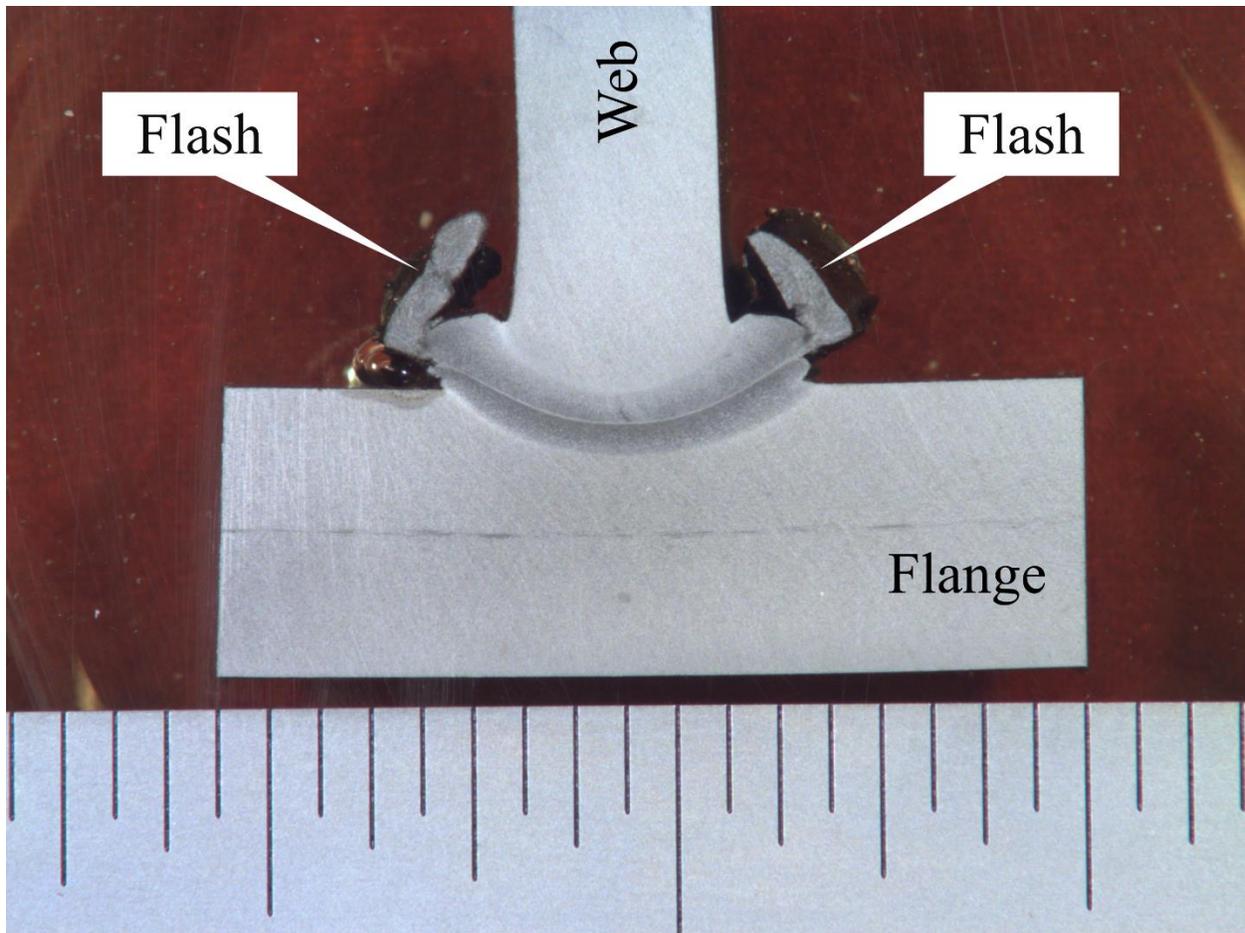
Note: Scale is in increments of $\frac{1}{16}$ inch.

Figure 2. Photo. Macroetch of weld.

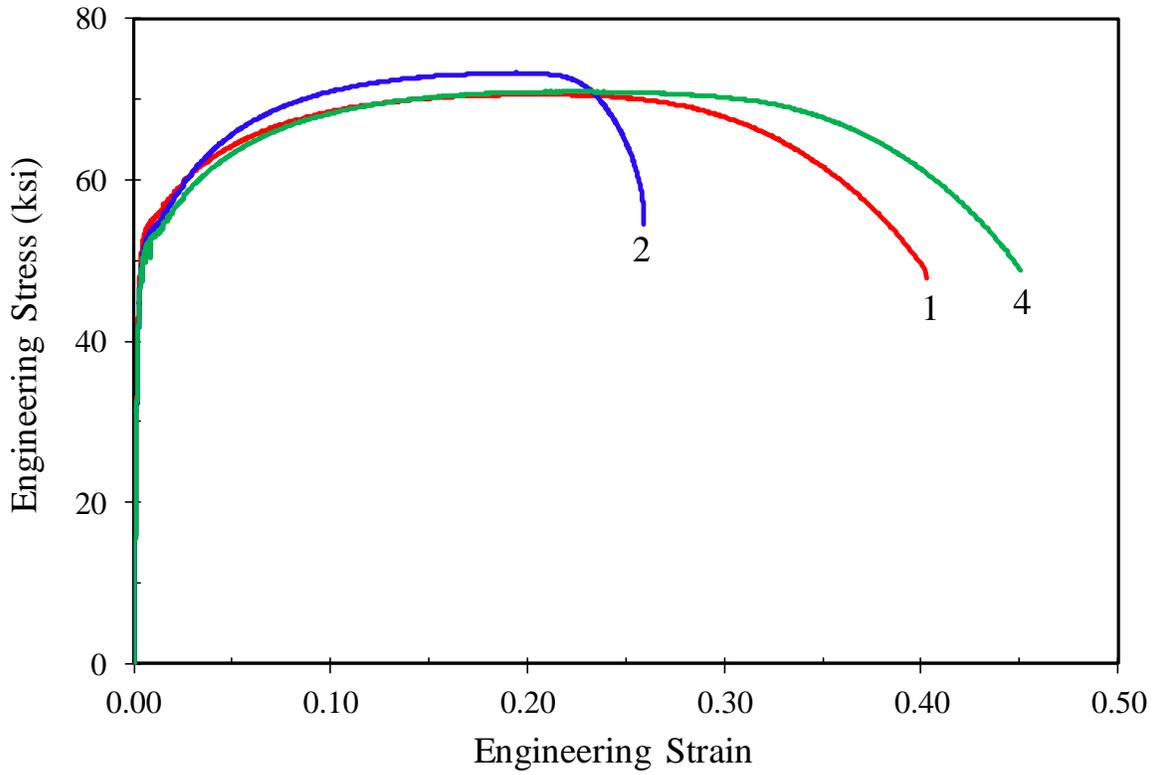
Figure 3. Graph. Tension test results.

Figure 3 shows plots of the tension test results from the three valid specimens tested, and succinct results are presented in table 2. Based on testing averages, the beam specimen steel exhibited a 0.2-percent offset yield strength of 51.6 ksi and an ultimate strength of 71.8 ksi. The fracture location for specimen 2 was very close to one of the extensometer contact points; thus, the elongation percentage at failure for this specimen was not captured accurately by the extensometer readings. This is illustrated by the behavior shown for specimen 2 in the plot of figure 3. The average elongation percentage for the two specimens with valid fracture locations was 42.6 percent, and the average reduction in area was 71.8 percent.

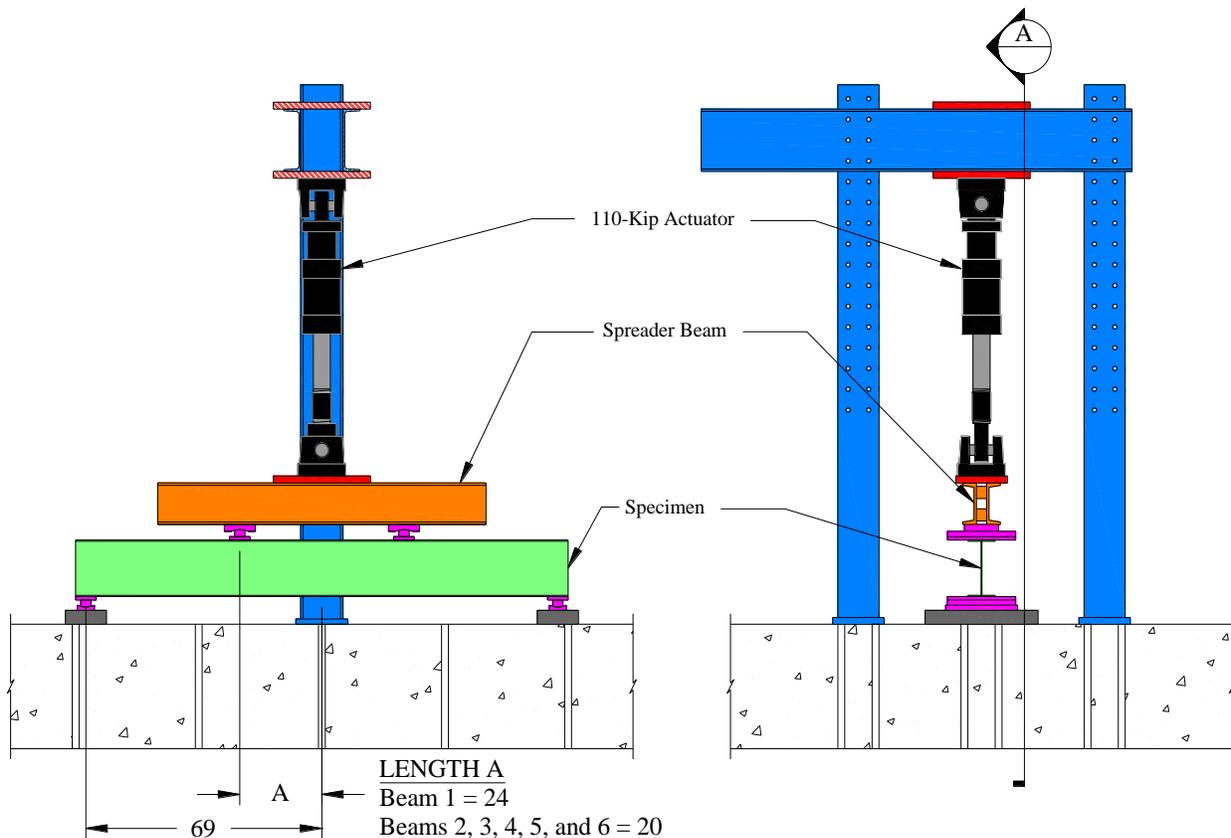
Source: FHWA.
 Note: Units = inches.

Figure 4. Illustration. Fatigue testing load frame setup.

A 110-kip servo hydraulic actuator was used to load the simply supported beam specimens in four-point bending as illustrated in the load frame setup of figure 4. Beams were cyclically loaded with a sine wave function at rates between 1.5 and 1.75 Hz. A minimum load between 3.5 and 4 kip was used during cycling to prevent shifting and any unwarranted dynamic effects from occurring during testing. The maximum beam displacement was monitored throughout the test using a linear variable differential transducer within the actuator. Limits were set such that the actuator would turn itself off when the beam displacement increased 0.02 inch more than when the limit was turned on. Generally, it was possible to find budding cracks near the web-flange junction within the constant moment regions. Once cracks were discovered and marked, beams were cycled to failure. Typically, less than 5,000 additional cycles were enough at this point for a crack to extend well into the web of the beam specimen or for stability issues to occur due to asymmetrical loading caused by the ever-increasing loss of specimen cross section at the crack locations.

The beam supports were 6 inches wide in the direction of the beam length, resulting in a span of 138 inches between support centers (figure 4). For the first beam test (i.e., beam 1), the span between the centers of the spreader beam load bearings was 48 inches. However, due to initial imperfections in the specimens, web slenderness, and an insufficient amount of torsional stiffness in the spreader beam, there sometimes were elastic stability issues that caused the actuator to move out-of-plane. To combat this, lateral braces at the beam supports were constructed using a steel bar and C-clamps as shown in figure 5. Wooden stiffeners were used at the supports to provide additional torsional and overturning stiffness at these locations as can also be seen in the same figure. A lateral torsional support was provided by bracing the beam compression flanges at midspan using a slender steel plate strip that was clamped to the compression flange on one end and to a load frame column on the opposite end as shown in figure 6. After testing of beam 1 was complete, the center-to-center distance between spreader beam load bearings was decreased to 40 inches to further remedy the stability issue encountered.

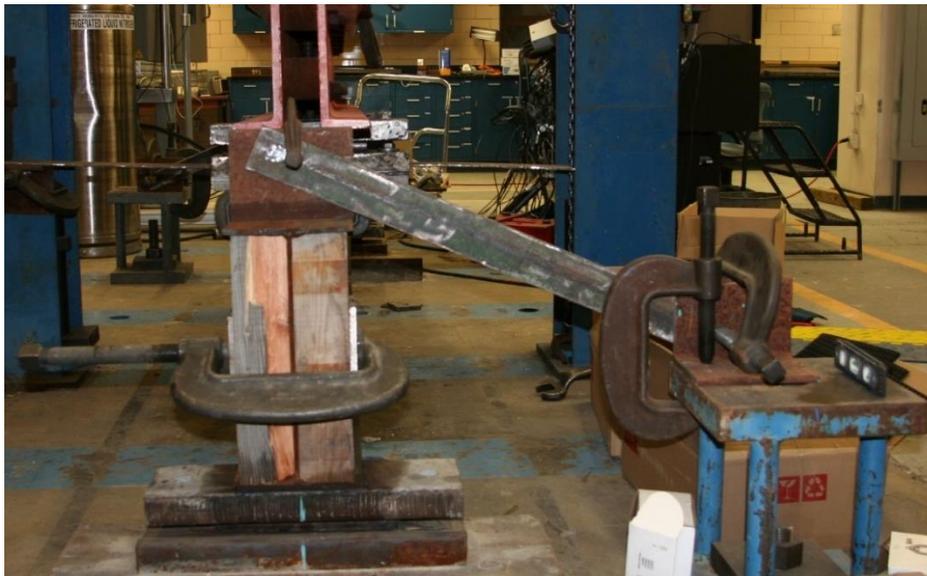
Figure 5. Photo. Support lateral torsional bracing.

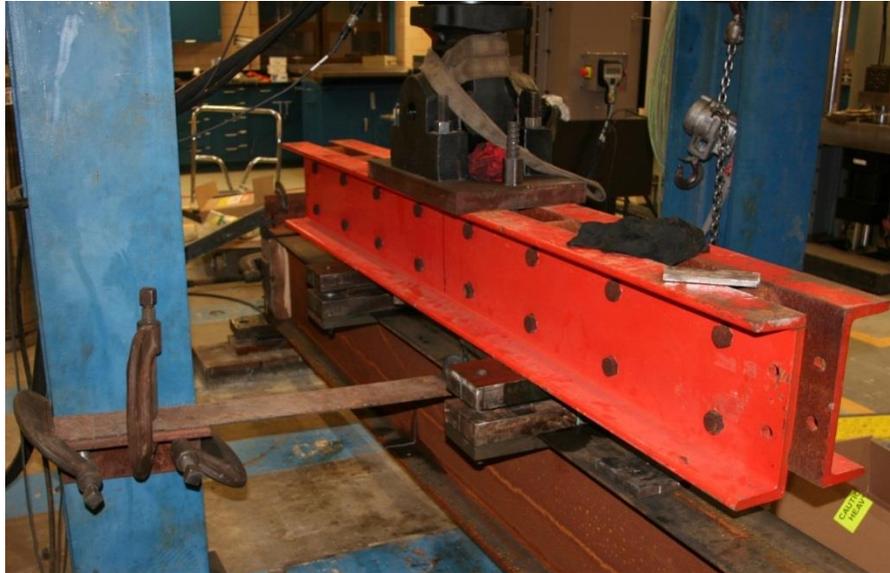
Figure 6. Photo. Midspan lateral torsional bracing.

When conducting the first two beam tests (i.e., beams 1 and 2), the spreader beam bearings were detailed, as shown in figure 7, by clamping the specimen between two thick plates. Clamping the plates prevented the loading points from moving under the cyclic loading, and wooden stiffeners were used to prevent distortion to the beam from the clamping force. This setup proved adequate for testing beam 1. However, during testing of beam 2, an audible squeaking developed at one of the spreader beam load bearings on several occasions from slight movement between the specimen tension flange and the bottom clamping plate. The squeaking was eliminated by tightening the high-strength rods, thus increasing the clamping effect. This eventually led to a fretting failure of beam 2 as will be discussed later. Since fretting was undesirable, the load-bearing setup was simplified for beams 3 through 6. The revised setup eliminated the wood stiffeners, high-strength rods, and lower clamping plate and instead modified the upper plate so it could directly clamp to the specimen compression flange as seen in figure 6.

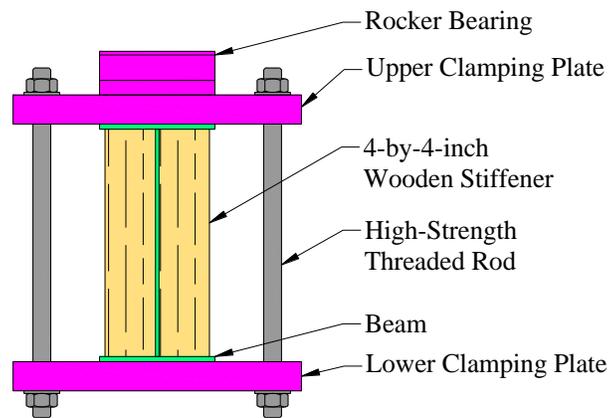
Figure 7. Illustration. Bearing setup for beams 1 and 2.

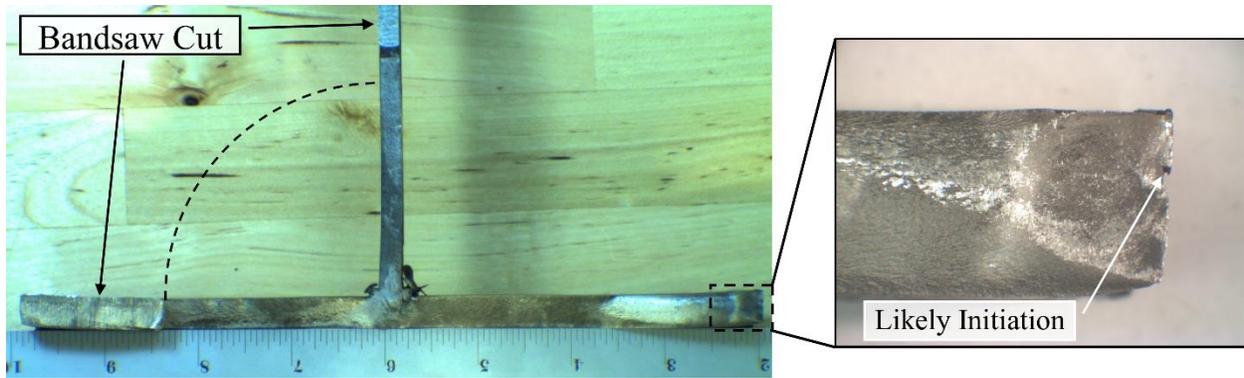
Figure 8. Photo. Beam 1 fracture surface.

The displacement limit for beam 1 tripped at around 702,000 load cycles. Once restarted, a large crack was noted approximately 3 inches inside the load-bearing clamping plate edge. Cycling was discontinued at 705,098 cycles when the actuator pushed sideways inside the load frame due to the now asymmetrical cross section. Figure 8 shows a picture of the entire fracture surface. As can be seen from the overall perspective, the right side of the flange had completely fractured, though the left side of the flange and web were only partially fractured. Also shown on the overall perspective is a dashed arc that indicates nearly equal crack growth across the left half of the flange and up the web, indicating that this crack likely initiated at the right flange tip. The fracture surface at the right flange tip had impact damage from the fatigue cycling, and a zoomed-in view notes the likely crack origin was a small flaw from the shear-cut edge.

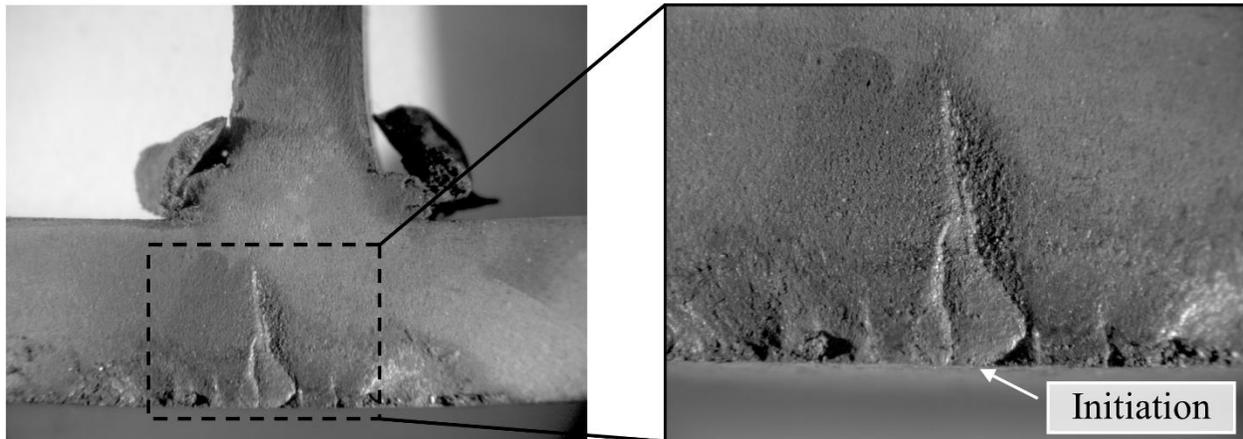
Figure 9. Photo. Beam 2 web-flange junction fracture surface.

The displacement limit for beam 2 tripped at 885,073 load cycles. Once restarted, a crack was observed in the tension flange near the inside edge of the load-bearing clamping plate. Instability of the actuator occurred shortly thereafter at 885,955 cycles, at which point the cycling was stopped. The observed crack plane was directly parallel to the edge of the clamping plate. As mentioned previously, the clamp-type load bearing for beam 2 oftentimes had to be tightened to halt a squeaking noise that developed as loading commenced. Failure was determined to be caused by fretting of the clamping plate. Figure 9 shows a photo of the web-to-tension flange junction where the crack was observed. The photo indicates that the ratchet marks on the bottom of the flange were likely five to six small fretting cracks that coalesced together, and the fatigue crack grew upward toward the web-to-tension flange junction.

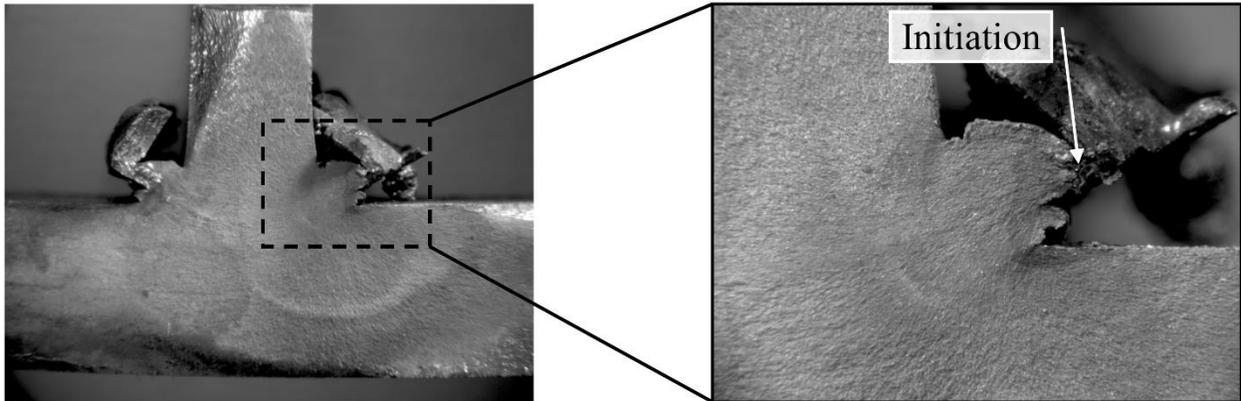
Figure 10. Photo. Beam 3 web-flange junction fracture surface.

The displacement limit for beam 3 tripped at 2,157,969 load cycles. Once restarted, cracks were observed at multiple locations. The largest of the cracks occurred in the web-flange junction approximately 10 inches inside of the inside edge of the left load-bearing plate. Failure

progressed most rapidly at this location. An additional smaller web-flange crack was observed almost directly under the left support. A third crack was observed on the edge of the flange approximately 2 inches from the right load-bearing plate within the constant moment region of the beam. Actuator instability occurred at 2,167,158 load cycles, and the test was terminated. Figure 10 shows a zoomed-in view of the web-to-tension flange junction of the largest crack. Semicircular fatigue crack growth rings obviously emanate from the weld flash on the right-hand side of the weld, indicating the flash was the initiation point.

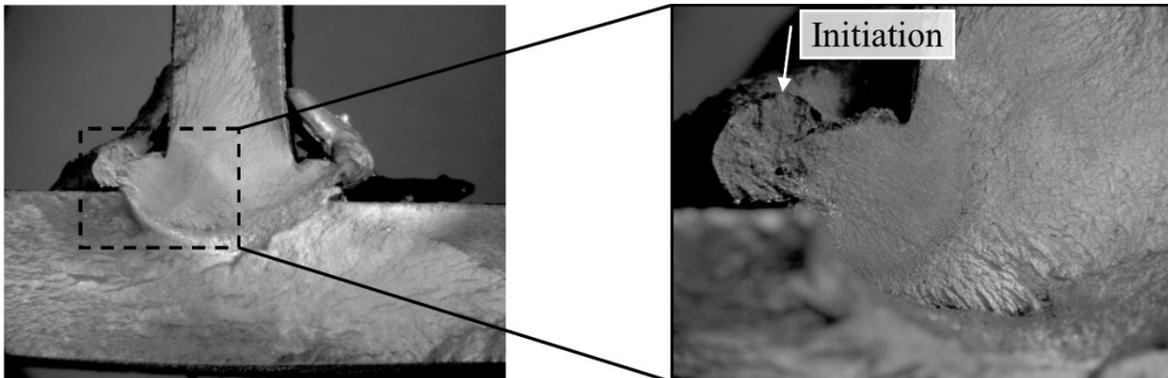
Figure 11. Photo. Beam 4 web-flange junction fracture surface.

The displacement limit for beam 4 tripped at 1,483,802 load cycles. Once restarted, complete fracture of one-half of the flange was observed approximately 18 inches inside of the centerline of the left load bearing. The test was stopped due to pending instability of the actuator at 1,484,999 load cycles. Figure 11 shows a zoomed-in view of the web-to-tension flange junction. The overall crack was a coalescence of three smaller cracks at slightly different locations along the beam length. Two of the small cracks initiated at each tension flange tip and grew inward to the weld, and the third crack initiated at the web-to-tension flange weld. The view in the picture focuses on the weld, and the other cracked planes appear out of focus because they are not coincident. Fatigue growth rings indicate the crack in the weld initiated from the weld flash.

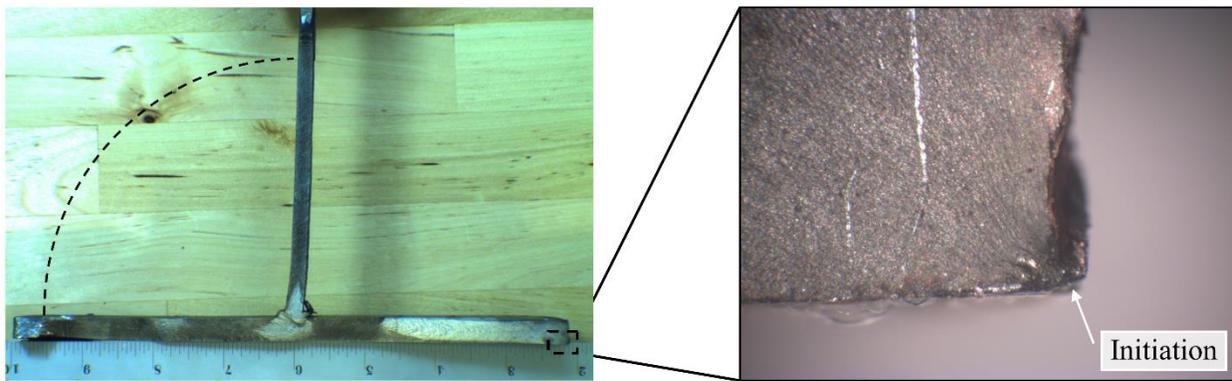
Figure 12. Photo. Beam 5 fracture surface.

The actuator turned itself off at 856,622 load cycles when testing beam 5. At this time, a full flange fracture was observed that extended approximately one-third of the way up the web. A view of the full fracture surface is shown in figure 12. Large fatigue growth striations can be seen near the left flange tip and near the crack tip in the web. A dashed arc is drawn between these last striations, indicating a growth origin near the weld. However, complete fracture of the right side of the flange indicates the crack originated from the right flange tip, grew toward the weld, and then continued to grow into the left side of the flange and up the web. A zoomed-in view of the flange tip is provided, indicating that the initiation of the crack was a discontinuity from shear cutting at the lower left corner of the flange tip. Finally, the left flange tip was necked through the plate thickness, indicating this was a ductile overload fracture, and was the last event that had tripped the limit.

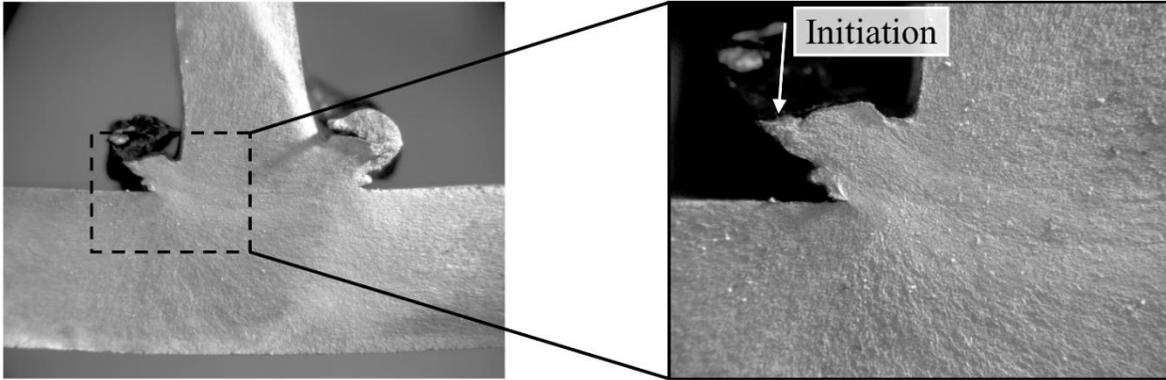
Figure 13. Photo. Beam 6 web-flange junction fracture surface.

The displacement limit for beam 6 was tripped at 1,057,914 load cycles. A crack was detected, this time at the web-flange junction approximately 15 inches on the inside edge of the load-bearing plate. Restarting the test to further propagate the crack resulted in actuator instability at 1,061,520 load cycles. The test was stopped at this point. Figure 13 shows the web-to-tension flange junction where the crack was first observed. Fatigue crack growth indicates initiation started in the weld flash on the right side.

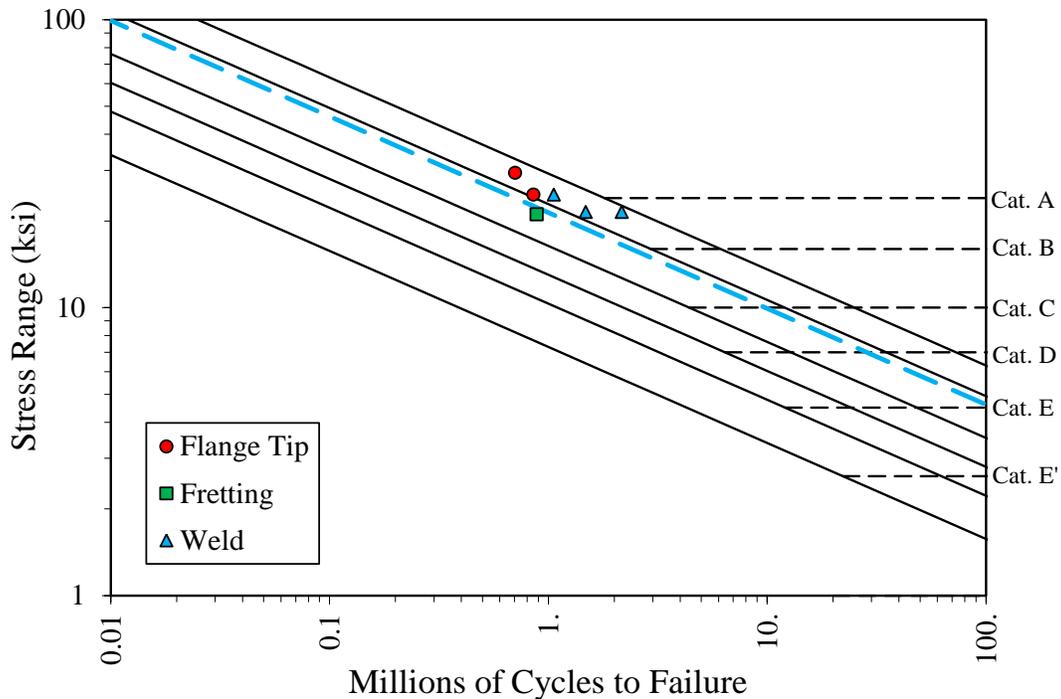
Cat. = category.

Figure 14. Graph. Beam test results with AASHTO fatigue life curves.

The fatigue data are plotted in stress versus cycles to failure format consistent with the AASHTO fatigue design philosophy in figure 14. The three weld failures are plotted as blue triangles falling between category A and B performance. However, to be consistent with the AASHTO methodology, a lower-bound resistance is shown as the heavy, blue dashed line in the figure representing the lower 95-percent confidence limit. The lower-bound resistance is less than category B. For completeness, the one fretting failure and two flange tip failures are also plotted on the graph.
