Performance of Grouted Connections for Prefabricated Bridge Deck Elements

Publication FHWA-HIF-19-003

November 2018

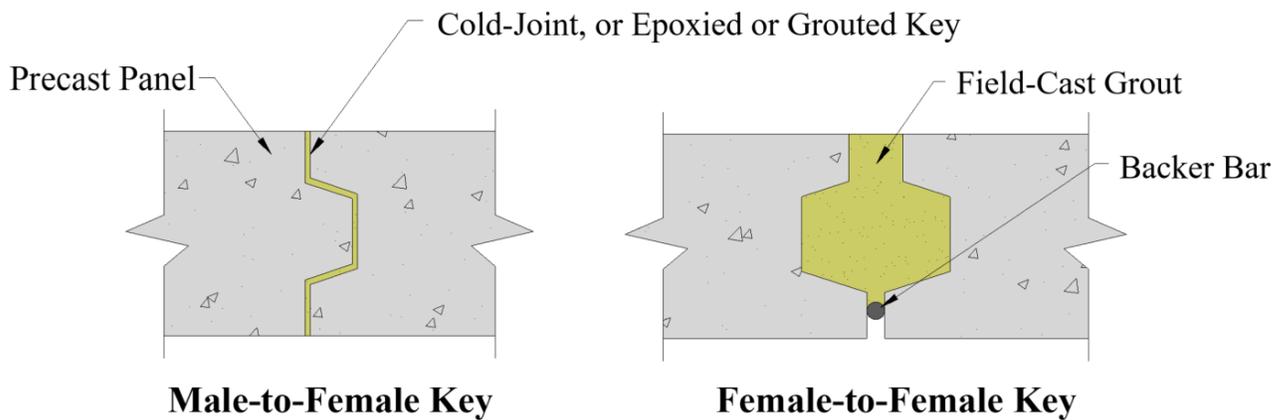
The shape of the shear key affects the shear transfer between panels and the cracking behavior of the connection. Male-to-female shear keys (shown in figure 10) were used in some early prefabricated deck systems, and most did not include reinforcement crossing the joint. (Badie and Tadros 2008) This type of shear key requires a minimal gap between the panels to transfer shear loads. The space between the key would be filled with a compressible seal, epoxy, or grout. This type of connection is not typically used in more recent deployments due to poor performance observed in some in-service bridges. These systems were observed to have fit-up issues which resulted in difficulty grouting and subsequent leakage through the connection. (Kropp, Milinski, and Gutzwiller 1975; Issa et al. 1995)

Female-female key shapes (shown in figure 10) have become preferred in recent deployments of prefabricated bridge deck systems given that wider construction tolerances can be used. (Culmo 2009; Sullivan 2007) found that grouted female-female connections were easier to construct and more durable than epoxied male-female connections. Typical shapes used for female-female shear keys are shown in figure 11 and include semi-circular, trapezoidal, triangular, and rectangular. (Badie and Tadros 2008)

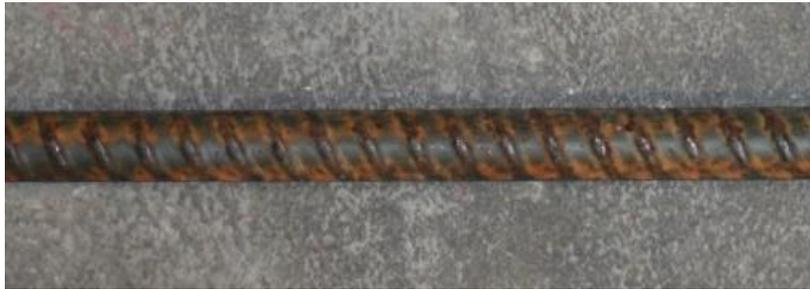
Figure 14. Photo. Black reinforcing bar; Denoted by “B.”

Three types of reinforcement popular for bridge deck construction were investigated in this research: black bars denoted by “B” (figure 14), epoxy coated bars denoted by “E” (figure 15), and pultruded glass fiber-reinforced polymer (GFRP) bars denoted by “G” (figure 16). All metallic bars were U.S. Grade 60 mild steel deformed reinforcing bars conforming to ASTM A615. (ASTM A615/A615M-16, 2016)

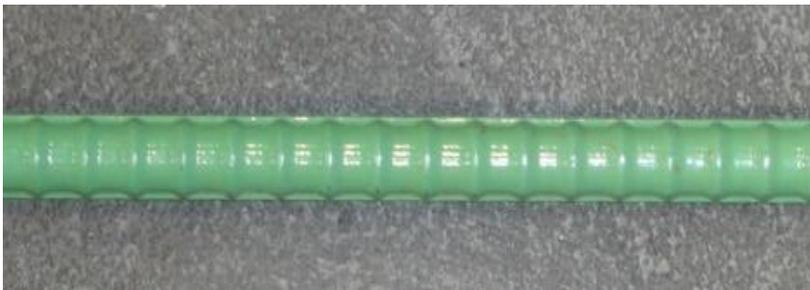
Figure 15. Photo. Epoxy-coated reinforcing bar; Denoted by “E.”

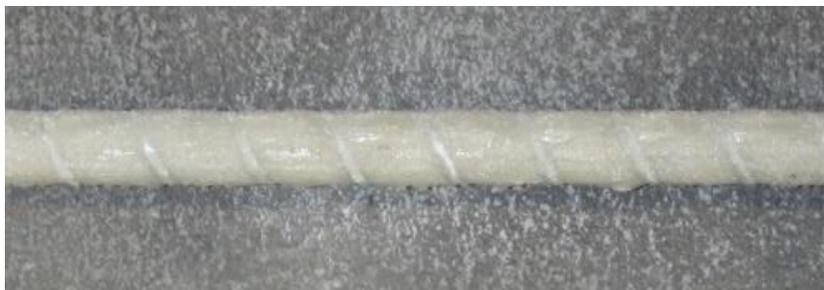
Figure 16. Photo. GFRP reinforcing bar; Denoted by “G.”

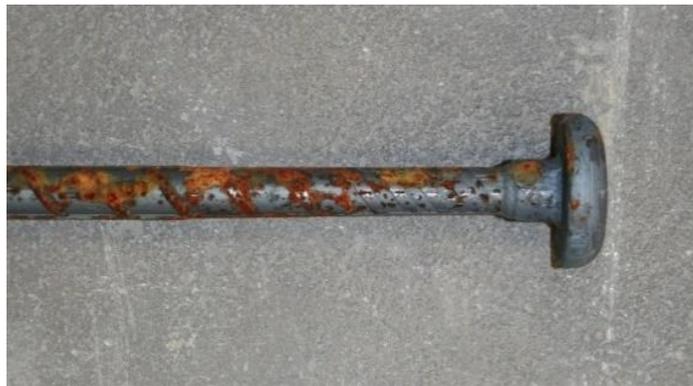
Figure 17. Photo. Headed reinforcing bar; Denoted by “H.”

Reinforcement continuity between precast deck panel halves was achieved using non-contact lap splices. Three non-contact lap splice reinforcement details were studied: straight bars, headed bars (figure 17), and bars with a 180-degree hook (figure 18), which are otherwise referred to as “U-bars.” The headed bars and U-bars details used black steel. The notation used to identify these details are “H” and “UB,” respectively. U-bars had an internal bend diameter D equal to 2.75 inches (70 mm); this bend diameter is equal to 4.4 bar diameters. The AASHTO LRFD specifies that the minimum diameter of bend of 6 bar diameters for #5 bars and smaller. (American Association of State Highway and Transportation Officials 2016) Thus, this is a smaller bend diameter than allowed by the AASHTO LRFD.

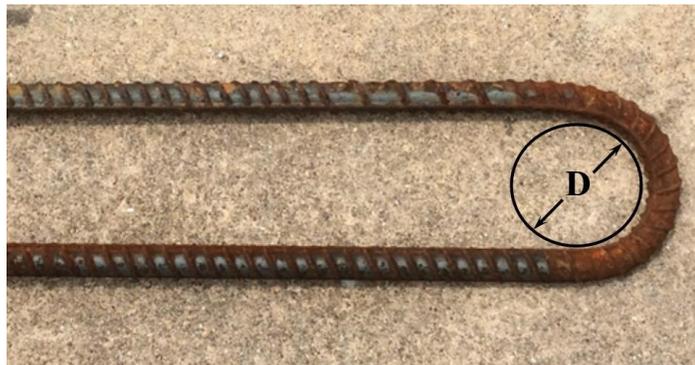
Figure 18. Photo. Black U-shaped reinforcing bar; Denoted by “UB.”

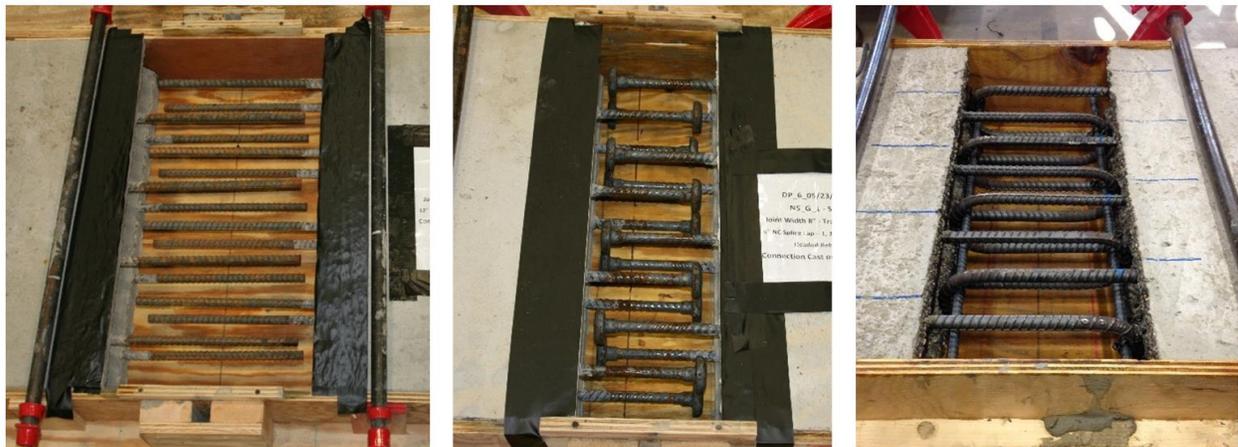
A. Straight bars

B. Headed bars

Figure 19. Photos. Non-contact lap splice details investigated.

Examples of the three non-contact lap splice details investigated are shown in figure 19. The lap splice length is defined as the length over which two adjacent reinforcing bars overlap. This length is measured from end to end for straight bars, from the inside of the head for headed bars, and from inside the bend for U-bars. The lap splice length required to transfer stress between adjacent bars has been shown to be highly dependent on the tensile strength of the embedment

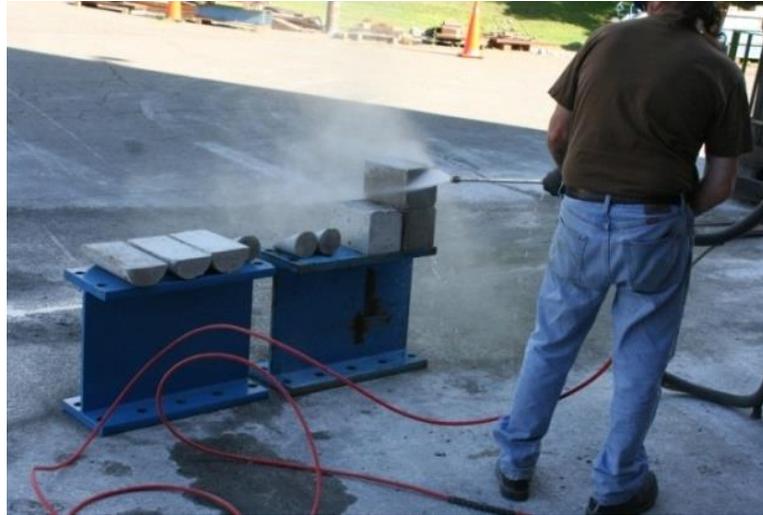
seconds at a distance of between 6 inches and 12 inches (152 mm and 305 mm) as shown in figure 21. The finished surfaces were free of any loose particles and were slightly rough to the touch. A representative photo of a PW surface is shown in figure 22.

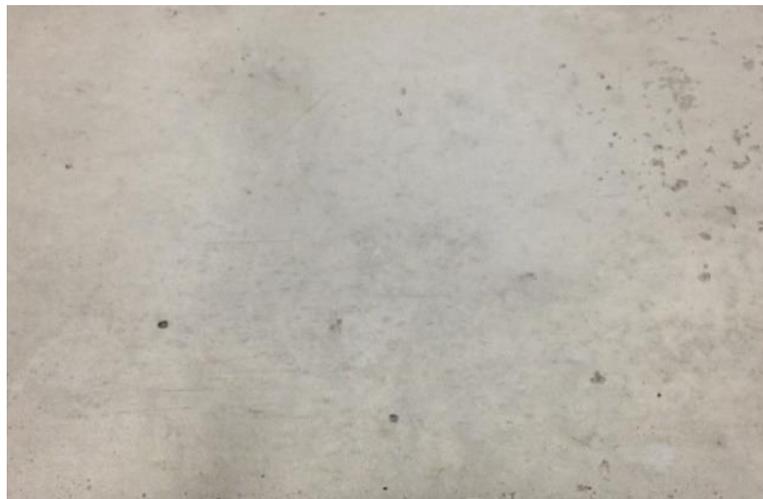
Figure 22. Photo. Final pressure wash surface preparation.

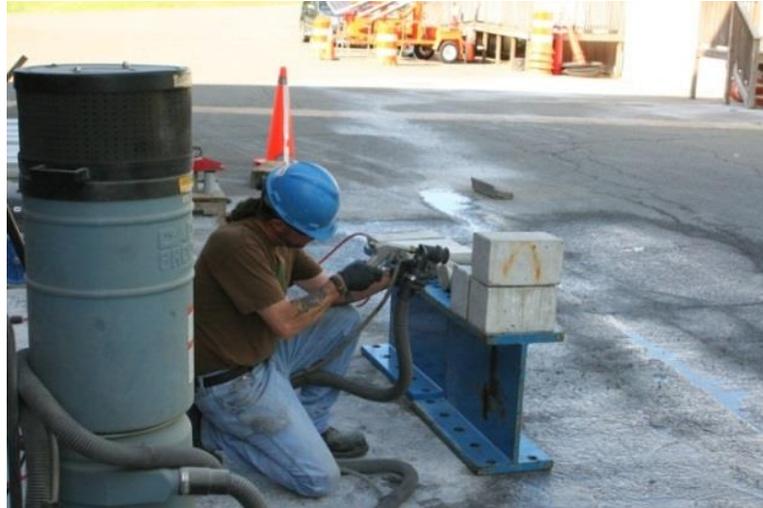
Figure 23. Photo. Sand blasting procedure.

depending on the surface area, to achieve a uniform roughened surface. This procedure is shown in figure 23. Surfaces were pressured washed to remove any media from the surface after sand blasting was completed. A representative photo of a SB surface is shown in figure 24.

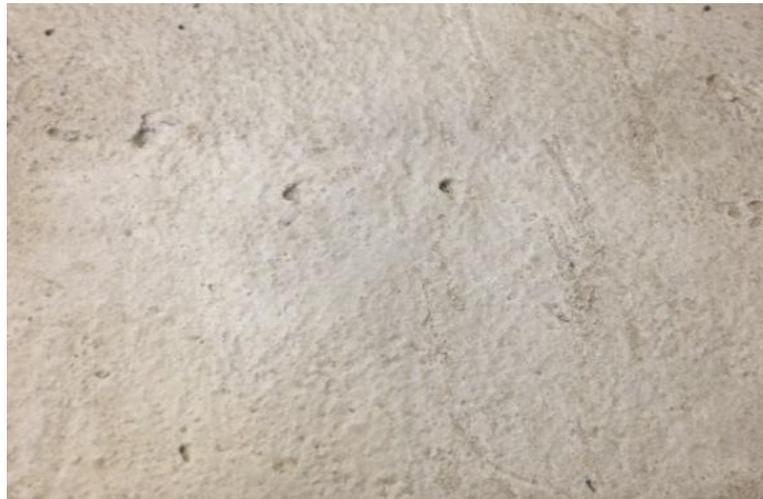
Figure 24. Photo. Final sand blasted surface preparation.

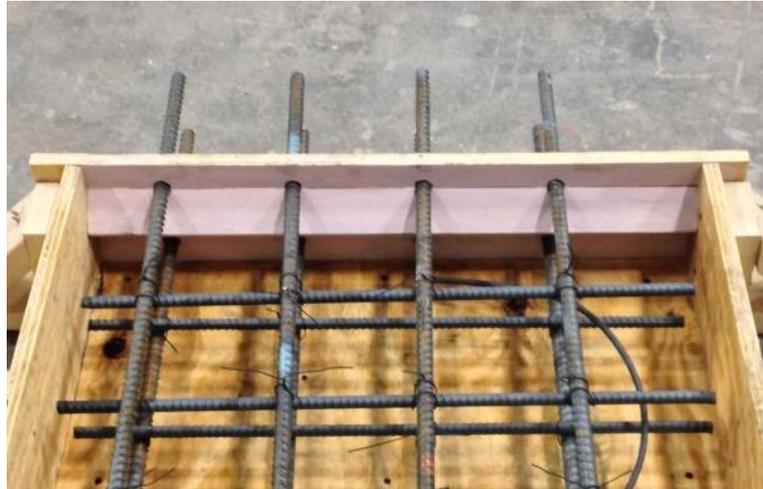
Figure 25. Photo. In-form retarder used on specimen formwork.

The exposed aggregate surface, denoted by EA, was prepared using a combination of an in-form retarder and pressure washing. Prior to placing the concrete, relevant form surfaces (shown in figure 25) were covered with a thin layer of a commercially available in-form set retarder. The

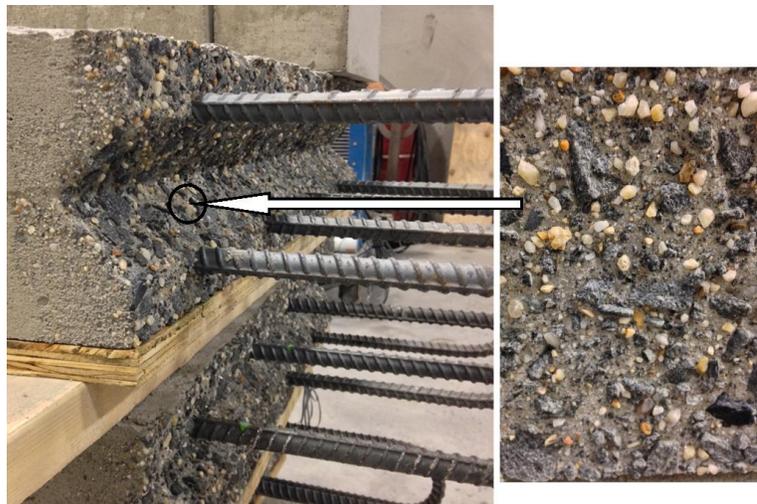
Figure 26. Photo. Final exposed aggregate surface preparation.

retarder was applied with a brush 20-60 minutes prior to placing concrete to ensure the layer was dry. Within 24 hours after placement, specimens were removed from the formwork and the relevant surfaces were pressure washed to remove cement paste. Figure 26 shows a photo of the finished EA surface preparation.

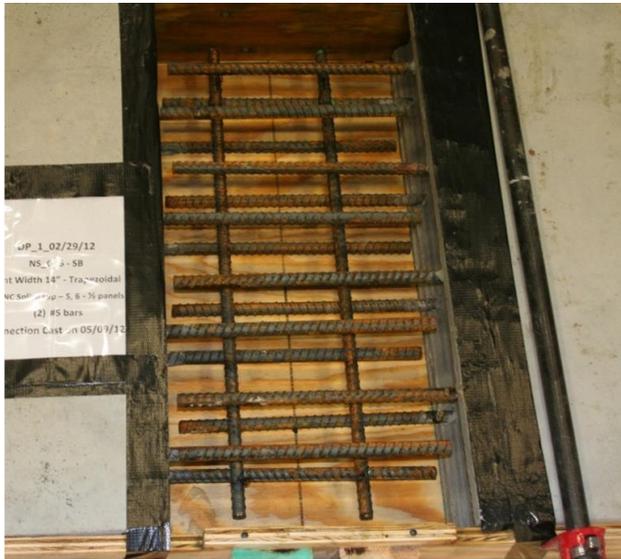
A. Example of transverse reinforcement for straight lap spliced bars

investigated whether these bars resulted in better connection performance. Select specimens with straight or headed bars utilized either a single transverse bar or two transverse bars; these bars were either #4 or #5 black bars composed of U.S. Grade 60 ASTM A615 steel. On the other hand, each specimen with U-bars employed two U.S. Grade 60 ASTM A615 #4 bars. Examples of the transverse reinforcement used in the connection region are shown in figure 28. Transverse reinforcement was placed inside the longitudinal reinforcement on the tension-side of the connection in the specimens with straight or headed bar lap splices, and it was placed inside the 180-degree hook in the U-bar specimens.

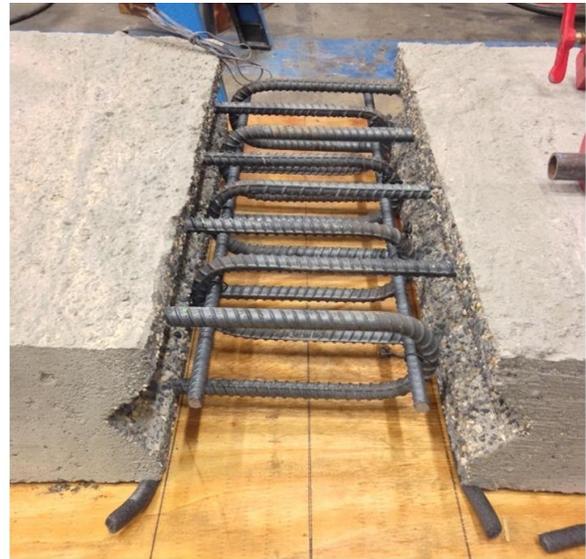
B. Example of transverse reinforcement for lap spliced U-bars

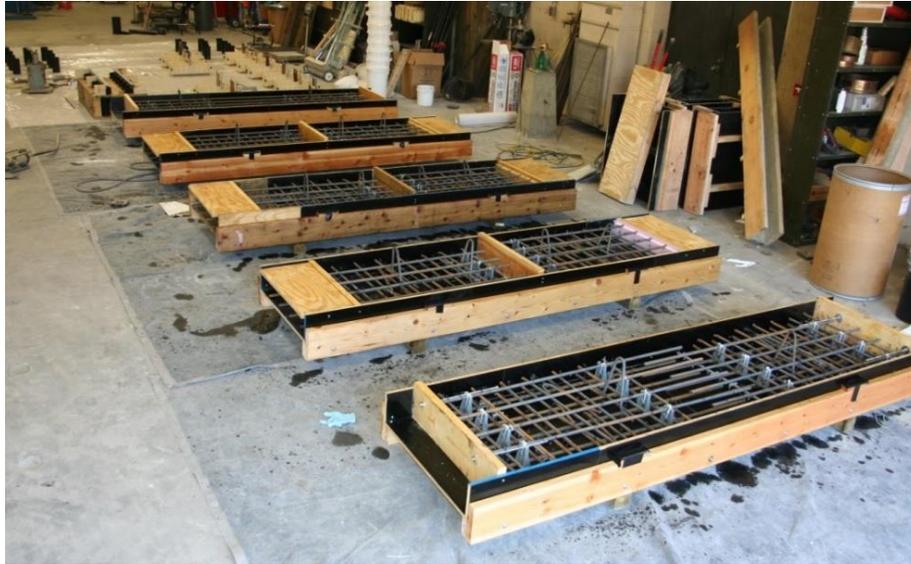
Figure 32. Photo. Deck panel formwork ready for concrete.

The construction of precast deck panels and connection grouting was completed in the TFHRC Structures Lab. Figure 32 shows a photo of the deck panel specimens prior to placing concrete. Deck panels were cast in 12 batches with 6,000 psi (41.3 MPa) portland cement concrete. Table 12 lists the mix details for the concrete used in deck panel construction. Prior to placing concrete, the slump was measured in accordance with ASTM C143 and compression test cylinders were prepared according to ASTM C39. The average slump for all batches was 4.9 inches (12.4 cm), and the average 28-day strength was 6,700 psi (43.2 MPa). Once placed, concrete panels were allowed to cure in the laboratory for at least 24 hours prior to being removed from the formwork. Once removed, precast panels were stored until being prepped for constructing deck-level connections.

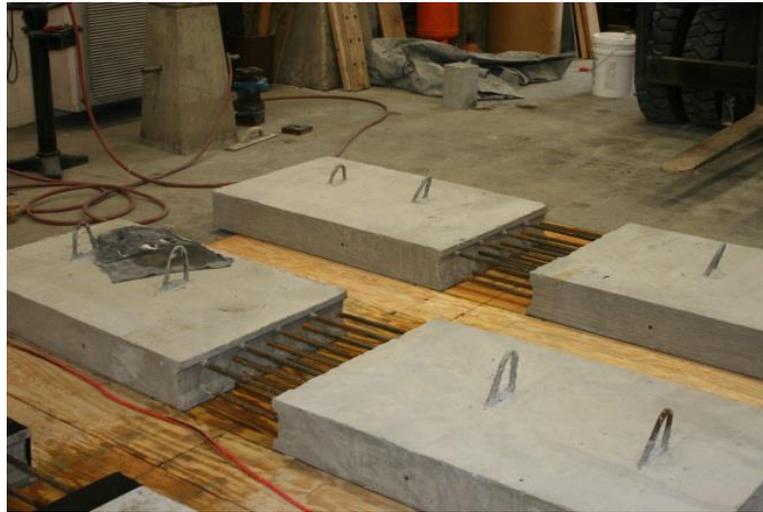
Figure 33. Photo. Placement of individual deck panels.

Deck specimens were constructed by placing two individual precast deck panels together to interlace the protruding rebar dowels between panels as shown in figure 33; the pocket shown is referred to as the “connection region.” The connection region was blocked off and sealed on the lower and side faces prior to grouting (shown in figure 34). Each grout material was mixed according to manufacturer specifications and placed using a bucket or wheel barrel as shown in figure 35. Grout materials were allowed to cure for at least 24 hours under controlled laboratory conditions prior to removal of forms. Figure 36 shows a photo of deck-level connection specimens after casting connection grout. During casting, 2-inch by 2-inch (50-mm by 50-mm) compression test cubes were cast according to ASTM C109 for G1, M1, and E1 grouts. The

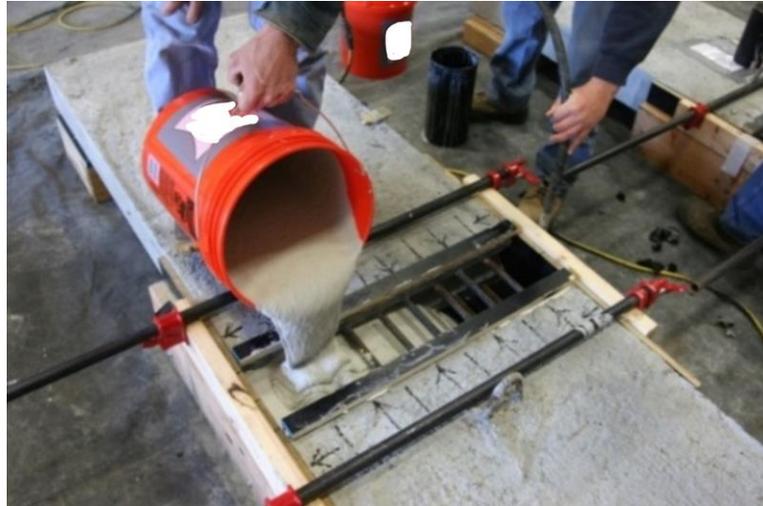
Figure 35. Photo. Grout placement into a connection region.

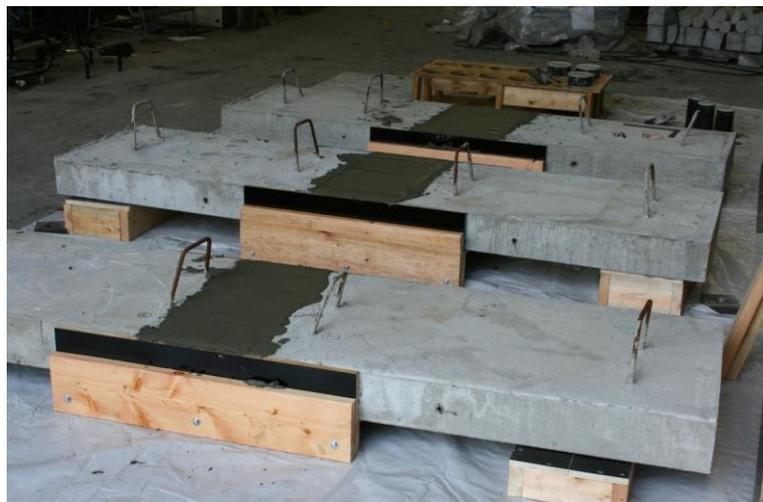
Figure 36. Photo. Specimens with completed connections.

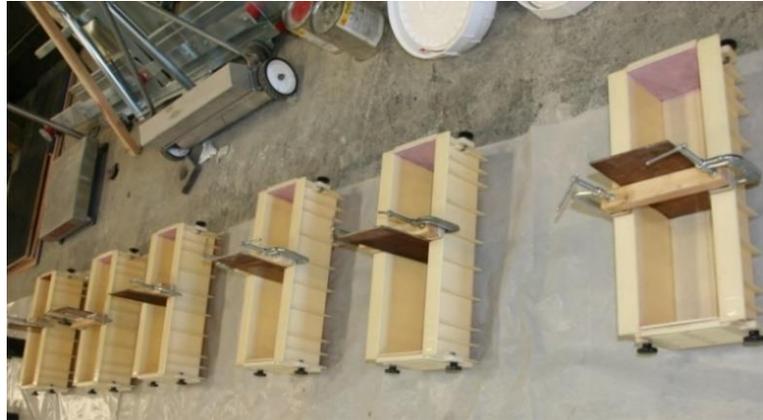
Figure 42. Photo. Formwork for flexural beam bond test specimens.

The formwork for beam, splitting cylinder, and slant shear bond test specimens are shown in figure 42 through figure 44, respectively. Each specimen consisted of a precast concrete half and a grout half. The first step in the construction process of the bond test specimens was casting the concrete half using the same concrete mix that was used for deck panel specimens (table 12). For

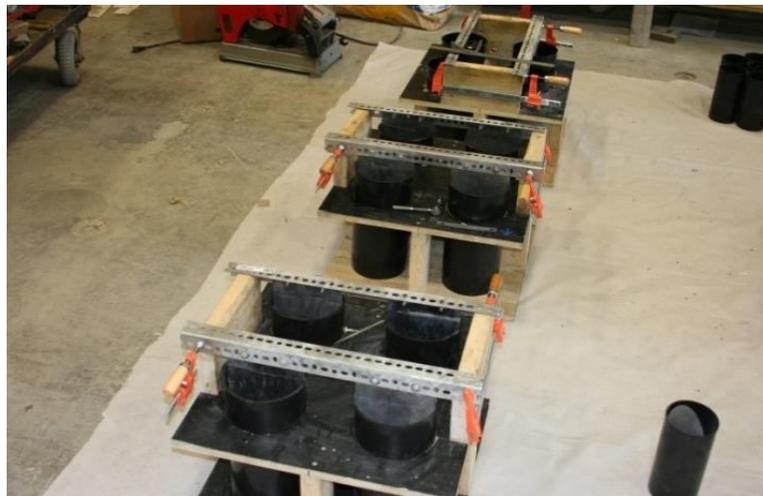
Figure 43. Photo. Formwork for splitting cylinder bond test specimens.

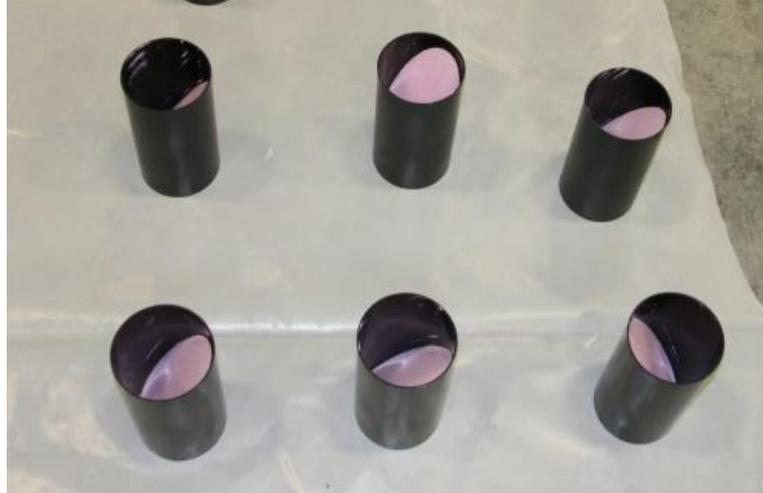
Figure 44. Photo. Formwork for slant shear bond test specimens.

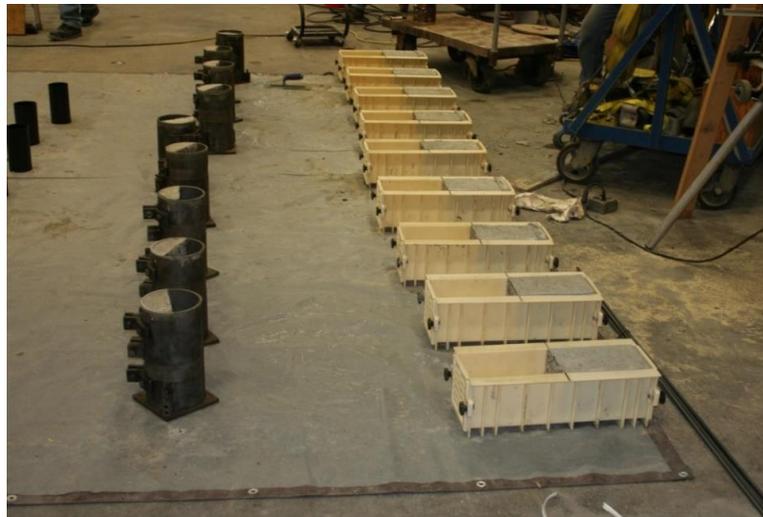
Figure 45. Photo. Bond characterization specimens prepared for grout placement.

Prior to casting grout, surfaces that were to be in contact with grout were prepared using the precast concrete surface preparation techniques described previously. After surface preparation, specimen halves were placed back into molds in preparation for grout placement as shown in figure 45. Grouting of bond test specimens was concurrent with casting the connection grout in deck-level connection specimens.

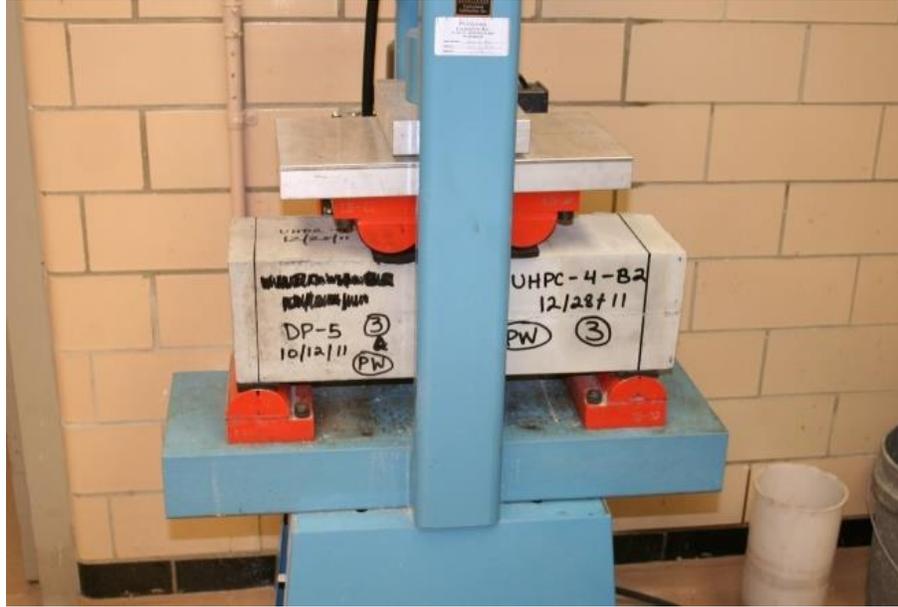
Figure 46. Photo. Flexural beam bond testing (based on ASTM C78).

Flexural beam bond tests were conducted according to ASTM C78, *Standard Test Method for Flexural Strength of Concrete (Using Simple Beam with Third-Point Loading)* as shown in figure 46. Prior to testing, cross-section dimensions were measured and recorded at the concrete-grout interface. Specimens were loaded in third-point bending with a shear span of 6 inches (153 mm). Load was applied at a rate that constantly increased the extreme fiber stress between 125 and 175 psi/min (0.86 and 1.21 MPa/min) until rupture occurred. The corresponding loading rate was determined using the equation shown in figure 47 and was approximately between 1,500 and 2,100 lb/min (20 and 28 kN/min). After failure, the maximum load and the crack distance from the concrete-grout interface (mid-span) were recorded.

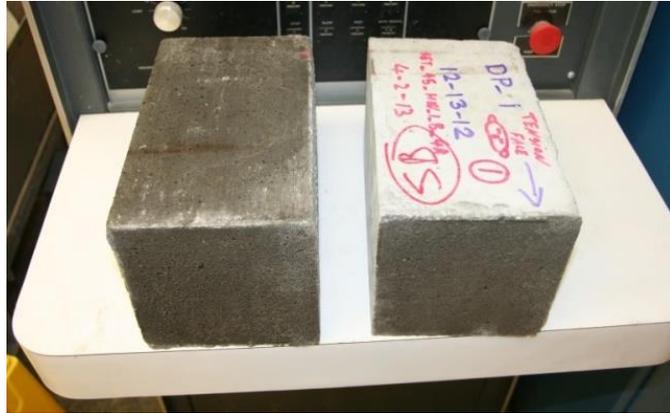
Figure 51. Photo. Failure of flexural beam bond test specimens: Mode 1 – bond failure.

Flexural beam bond test specimens exhibited three distinct failure modes. Mode 1, shown in figure 51, represents the case where a poor bond existed between concrete and grout. Mode 1 failure was governed by bond failure at the interface of the two materials. Specimens that failed in this mode had little to no tensile bond resistance. Mode 2, shown in figure 52, was characterized by a failure surface that exhibited a combination of interface bond failure and tensile rupture of the bonded materials. This case indicates inconsistent bond across the interface but improved tensile resistance compared with specimens exhibiting Mode 1 failure. Mode 3, shown in figure 53, represents the case where the bond between the two materials was strong, and the tensile capacity of one material was reached.

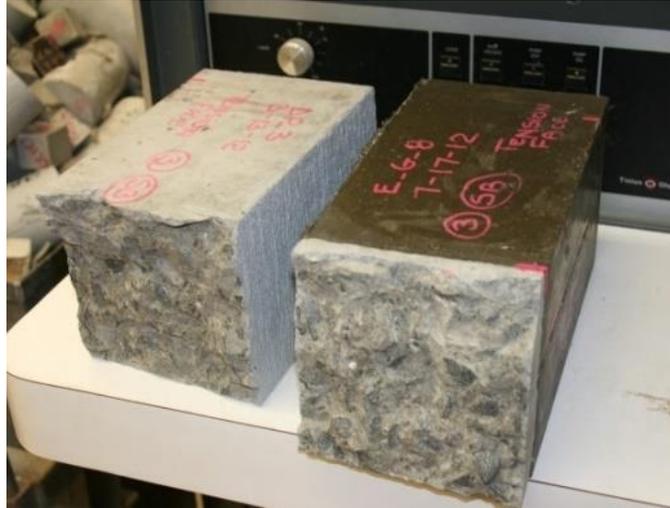
Figure 53. Photo. Failure of flexural beam bond test specimens: Mode 3 – substrate/grout failure.

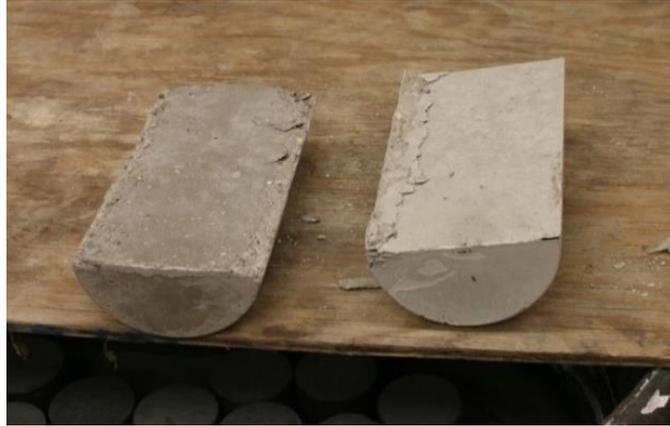
Figure 60. Photo. Failure of splitting cylinder bond test specimens: Mode 1 – bond failure.

Similar to flexural beam bond tests, splitting cylinder specimens exhibited three distinct failure modes. These modes were the same as those described for flexural beam tests, and are shown in figure 60 through figure 62. Table 20 provides a list of observed modes for the different specimen configurations. With the exception of specimens cast with an epoxy grout, specimens with PW and SB surface preparations failed by debonding (Mode 1), which indicates a poor bond between the precast concrete and the grout materials, regardless of grout material and age. Similar to flexural beam tests, EA surface preparation resulted in improved bond from the standpoint of failure mode. Furthermore, epoxy grout consistently exhibited a good bond to the concrete.

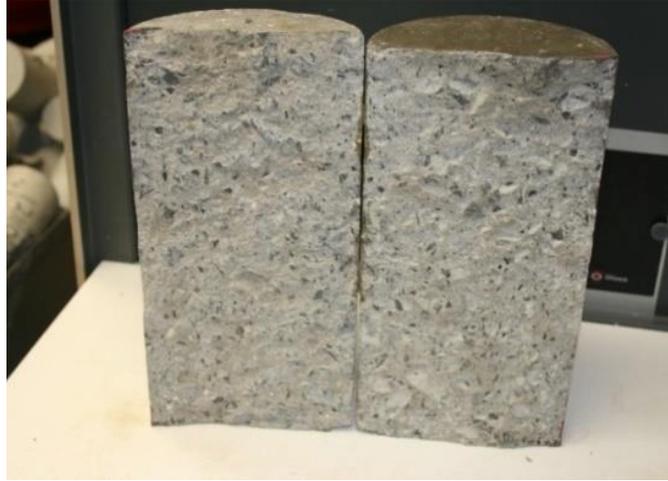
Figure 62. Photo. Failure of splitting cylinder bond test specimens: Mode 3 – substrate/grout failure.

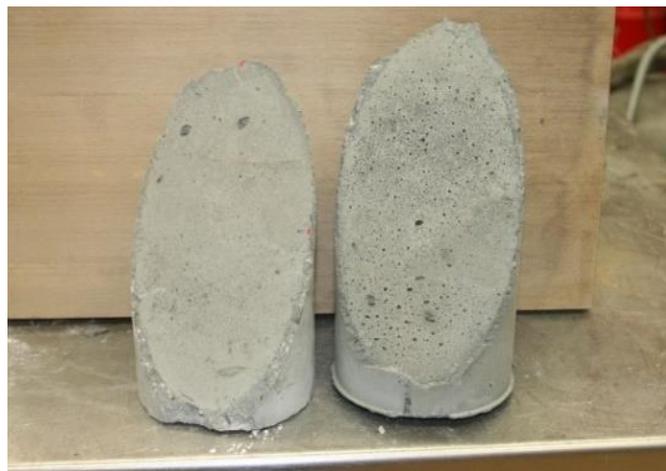
Figure 69. Photo. Failure of slant shear bond test specimens: Mode 1 – bond failure.

Figure 69 through figure 72 depict the different failure modes associated with slant shear bond tests. Modes 1 through 3 are the same as those defined for flexural beam and splitting cylinder bond tests. A fourth mode was required to identify specimens that failed by the crushing of concrete. This mode indicates excellent bond strength and was observed in specimens with EA surface preparation and E1 or U2 grouts (table 21). Similar to the other test methods, cementitious grouts (G1 and M1) and UHPC (U2) exhibited interface bond failure modes when PW and SB surface preparations were applied. Bond was improved in G1 and M1 by using exposed aggregate.

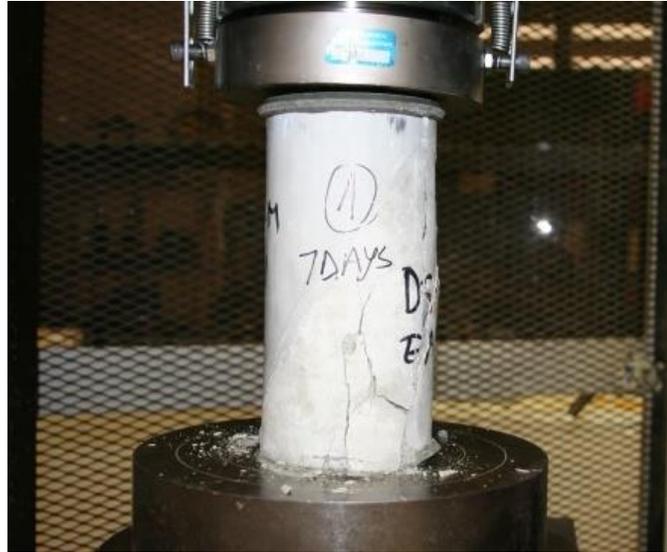
Figure 72. Photo. Failure of slant shear bond test specimens: Mode 4 – concrete crushing.

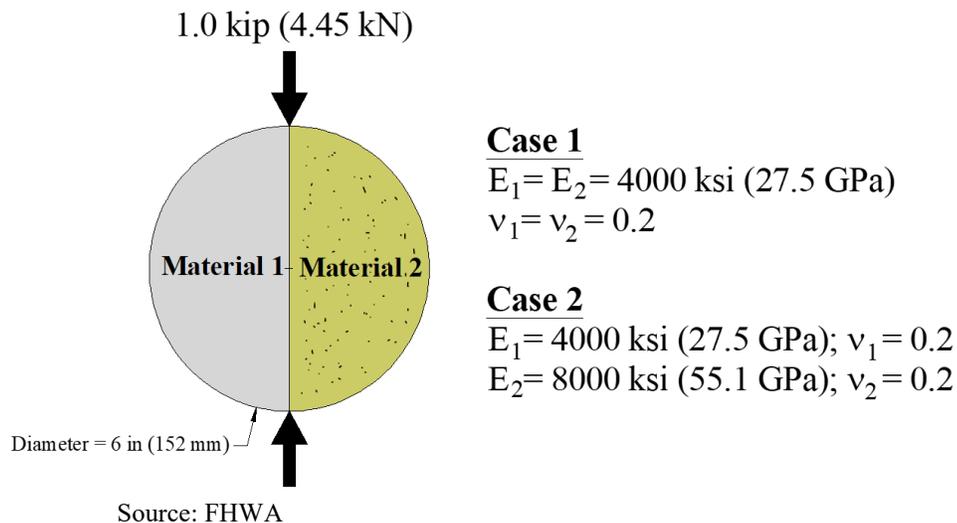
Figure 82. Illustration. Splitting cylinder bond test finite-element model and material properties.

A simple 2D linear-elastic finite-element (FE) model was created using Abaqus CAE, a commercially-available finite-element software package, to investigate the effect of material stiffness on the stress distribution across the interface. Figure 82 shows a representation of the FE model and the material properties for the two cases investigated. Case 1 represents a cylinder of uniform material or two materials with similar elastic moduli. In Case 2, the elastic modulus of the right-hand material, E_2 , has been doubled. This case is representative of a cylinder comprised of conventional concrete and UHPC and cured for 28 days based on the properties similar to those determined by Swenty and Graybeal (2013).

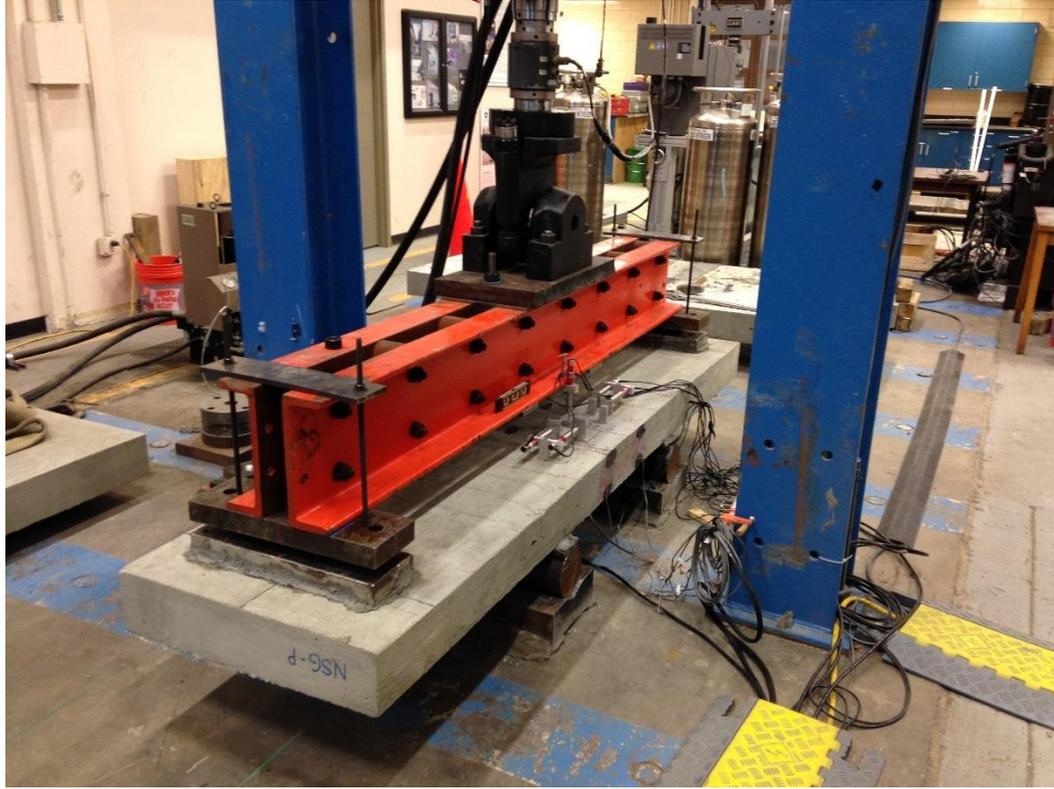
Figure 87. Photo. Deck panel specimen during loading.

The test setup is shown in figure 86. Specimens were tested in four-point bending using a 110-kip (490 kN) servo-controlled hydraulic actuator as shown in figure 87. The tension face of the specimen was positioned upward to facilitate inspection during testing. The grouted connection region was located within the constant moment region between the center supports. Prior to initial application of the load, each specimen was inspected for cracks that may have been caused by shrinkage or handling. Specimens were subjected to three different loading protocols: crack cyclic loading, post-cracking fatigue loading, and monotonic ultimate loading, which were applied in succession. If a specimen failed, which was defined as an abrupt loss of load-carrying capacity during one of the loading protocols, then subsequent loading was not pursued.

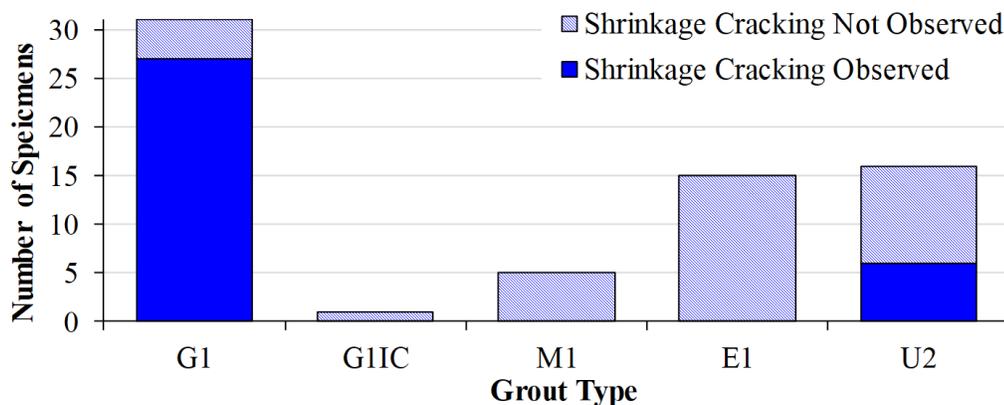
Figure 93. Graph. Observed shrinkage cracking in connection grout.

Specimens with U2 grout exhibited shrinkage cracking in the connection region in 6 out of 16 specimens. Figure 96 shows a photo representative of the shrinkage cracking observed in specimens with U2 grout. Shrinkage cracks were fine and mostly occurred near free edges and adjacent to the concrete-grout interface but not at the concrete-grout interface. Furthermore, it is likely that these cracks were localized near the surface of the UHPC material.

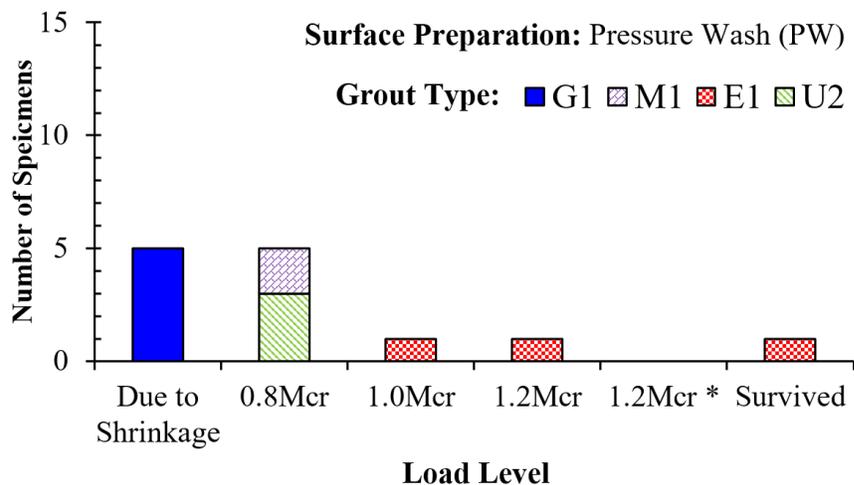
Figure 97. Graph. Observed interface cracking at different cracking cycle load levels for specimens with the pressure washed surface preparation.

The results from these inspections are shown in figure 97 through figure 100. These figures report the number of specimens that exhibited interface cracking for a given load level. Results are presented as functions of connection grout type and surface preparation for different load levels. The majority of specimens employing G1 grout were observed to have interface cracking caused by shrinkage regardless of the precast concrete surface preparation. All specimens employing M1 grout displayed interface cracking after the $0.8M_{cr}$ cycles. Based on the results from bond characterization testing, this is not unexpected, given that G1 and M1 grouts exhibited poor bonding to precast concrete regardless of surface preparation. However, two specimens employing G1 grout did not exhibit interface cracking. Instead, cracking occurred with precast concrete near the grout-concrete interface. Approximately one-third of specimens employing E1 grout displayed interface cracking after $0.8M_{cr}$ cycles; these specimens all had SB surface preparation. The remaining two-thirds of E1 specimens exhibited interface cracking between the $1.0M_{cr}$ cycles and the end of the cyclic crack loading protocol. However, there was no distinct correlation between the load level where the apparent interface cracking occurred and the precast concrete surface preparation. The majority of specimens employing U2 grout exhibited interface cracking after the $0.8M_{cr}$ cycles. There were three specimens with U2 grout that had EA surface preparation. Two of these specimens survived the loading protocol without exhibiting interface cracking, while the third exhibited interface cracking at $1.2M_{cr}$. This observation was consistent with results from bond characterization testing that indicated the U2 grouts exhibited an improved bond to concrete when EA surface preparation was employed.

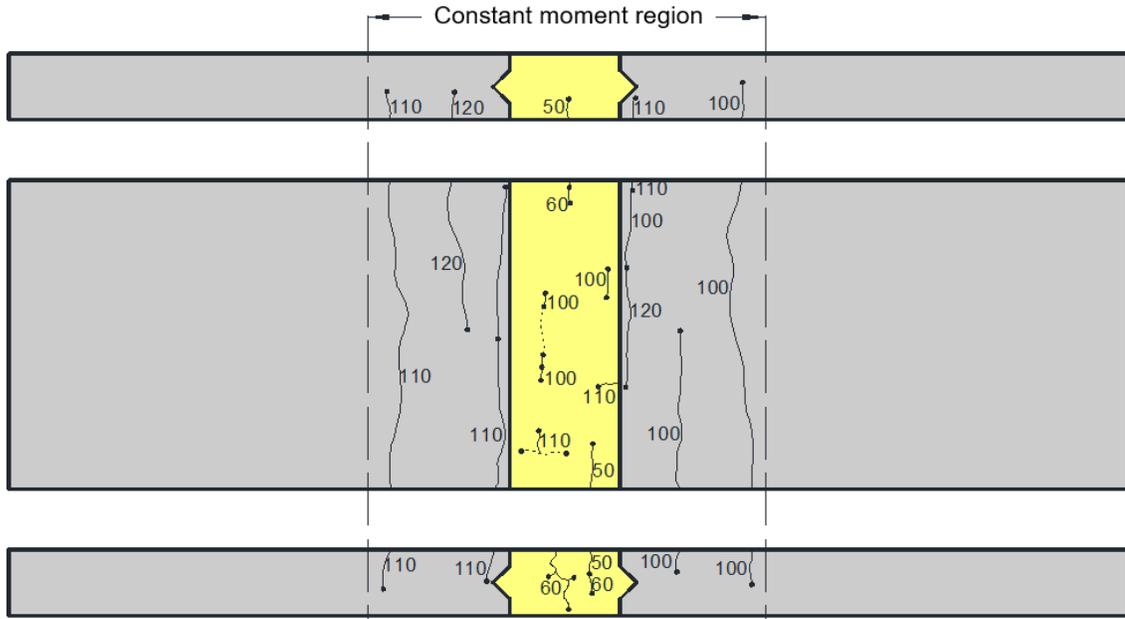
Figure 102. Illustration. Damage progression during pre-cracking cyclic loading for specimen G11C-8.5-UB-EA-Tr-T-74.

- - - - Denotes cracks formed by shrinkage (observed prior to mechanical loading)
- Denotes cracks formed by cyclic loading; number indicates % of M_{CR}

Note: Cracks are only shown in the constant moment region

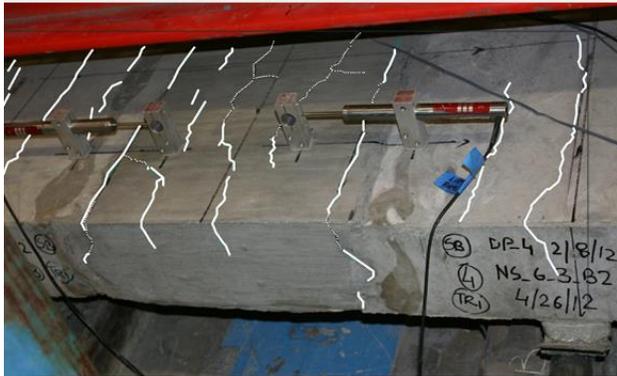
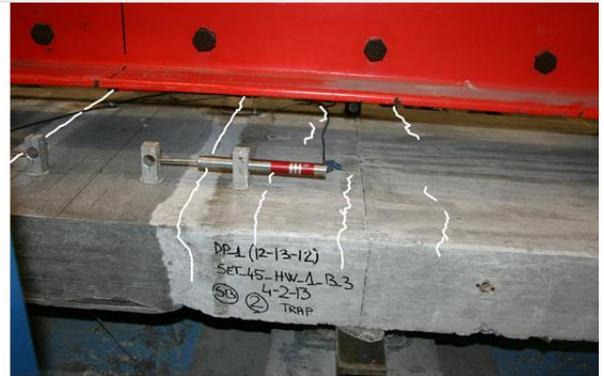
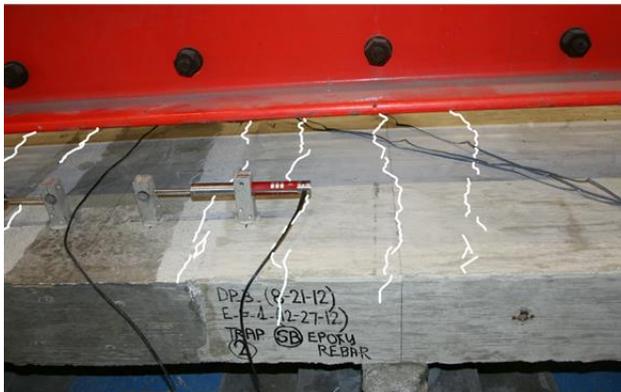
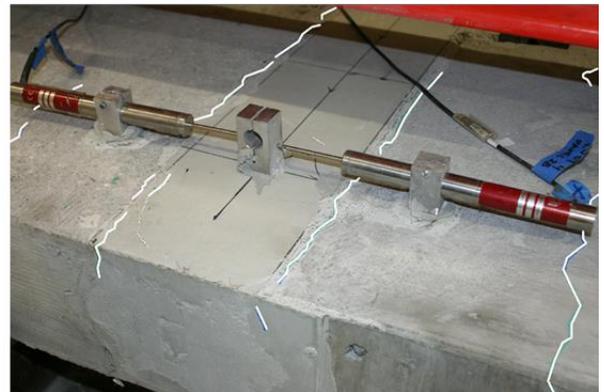
A. G1 connection grout

B. M1 connection grout

C. E1 connection grout

D. U2 connection grout

Figure 104. Photos. Representative photos of deck-level connection regions pre-cracking cyclic loading.

Figure 104 compares the apparent damage among different specimen types after completion of the loading protocol; a representative photo was selected for each grout type used. As noted previously, all specimens exhibited flexural cracks in the precast concrete deck panels at the end of the cyclic cracking loading protocol.

Many specimens employing G1 grout exhibited cracking at the grout-concrete interface. In some cases, cracking was apparent along the entire depth of the concrete-grout interface, which indicates that cracks were in part caused by shrinkage. Upon completion of the loading protocol, most of these specimens exhibited significant cracking within the G1 connection grout material.

Specimens employing the remaining three grout types, M1, E1, and U2, had minimal or no visible cracks within the grouted connection region. As previously noted, some of these specimens exhibited cracking along the concrete-grout interface. Figure 105 shows an example of specimen U2-5.5-B-EA-Tr-75, which did not exhibit interface cracking. Instead, cracking occurred in the precast concrete adjacent to the interface, which indicates a sound bond between the precast concrete and UHPC. Figure 106 compares the apparent damage in specimens with G1 connection grout with and without IC. This figure shows that using IC resulted in reduced cracking after low-level mechanical loading.

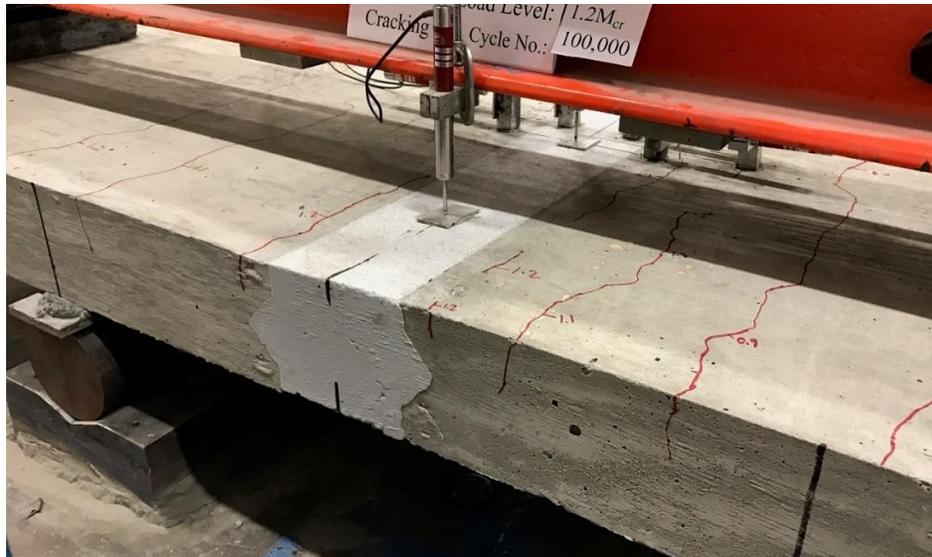
Figure 105. Photo. Specimen U2-5.5-B-EA-Tr-75 after cyclic crack loading.

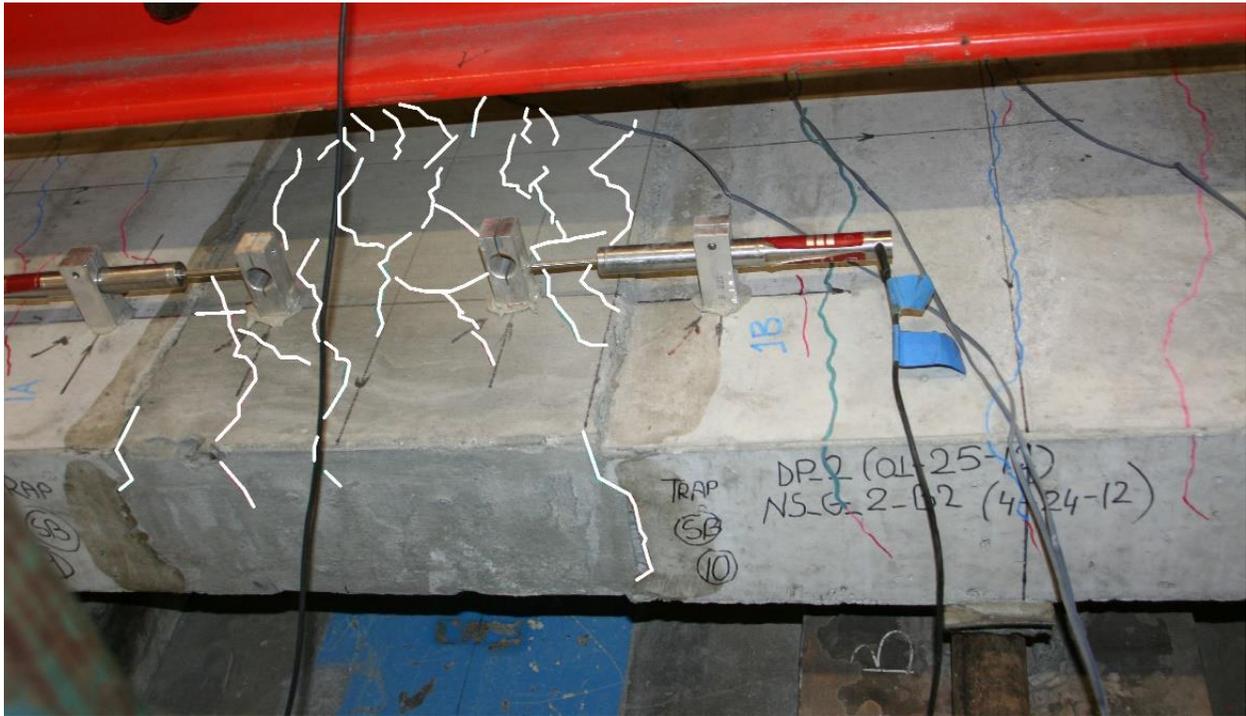
Figure 117. Photo. Representative photo of deck-level connection specimen with G1 grout after completion of fatigue loading (Specimen G1-12-B-SB-Tp-34 shown).

The 18 specimens that survived fatigue loading had significant cracking within the G1 grout upon completion of the fatigue loading protocol. Visual observations captured throughout the course of testing were used to identify a well-defined damage sequence. Figure 115 through figure 117 show the progression of damage that occurred within the grouted connection region of specimens employing G1 grout; note that the specimen shown in these figures, G1-12-B-SB-Tp-34, was representative of those employing G1 grout that survived fatigue loading. Prior to the fatigue loading, flexural and splitting cracks were observed within the G1 grout (see figure 115). As fatigue loading began and as the cycle count increased, existing cracks propagated and joined with adjacent cracks, and new flexural cracks formed. This behavior can be observed by comparing the crack patterns in figure 115 with those in figure 116. Existing cracks continued to grow until completion of the fatigue protocol (see figure 117).

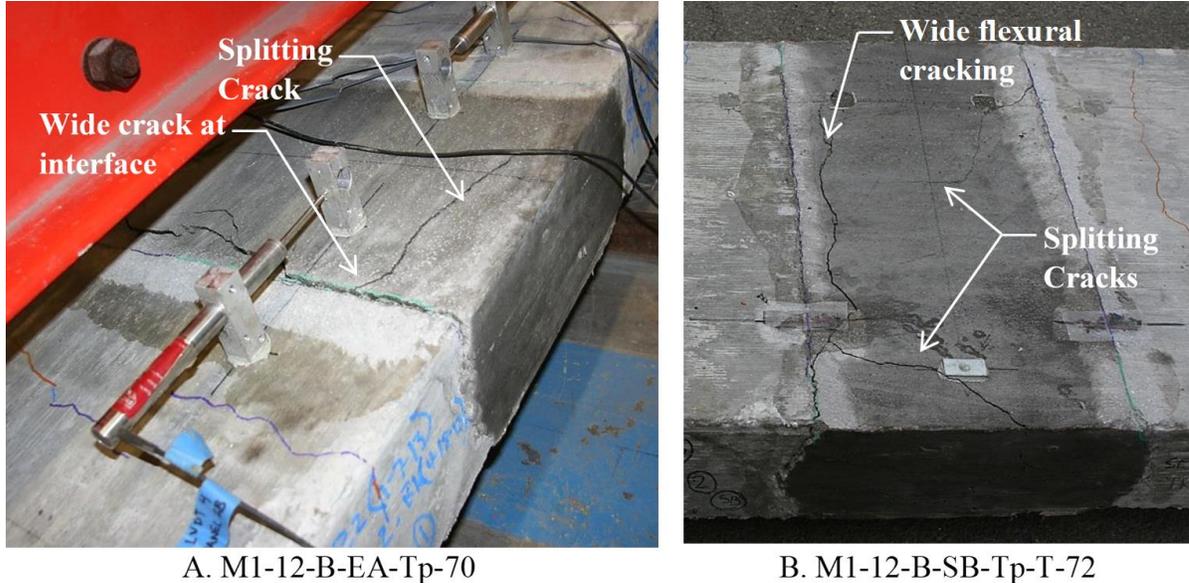
Figure 120. Photo. Representative photos of fatigue failure of specimens with M1 grout.

All five specimens with M1 grout employed 12-inch (305-mm) lap splice lengths. Similar to observations from the fatigue testing of similar specimens with G1 grout, there was no apparent justification for the number of cycles sustained prior to failure. Figure 121 shows the relationship between $\sqrt{f'_c}$ and the number of overload cycles sustained by each specimen with M1 grout. The trend shown has a distinct positive slope, which indicates some level of correlation between $\sqrt{f'_c}$ and the number of overload cycles sustained. The coefficient of determination was 0.517, which is almost directly between 0 and 1, and which indicates that the correlation is neither weak nor strong. Thus, it is likely that grout strength had some influence on the fatigue behavior of the specimens with M1 grout, but grout strength did not drive the performance.
