Performance of Grouted Connections for Prefabricated Bridge Deck Elements

Publication FHWA-HIF-19-003

November 2018

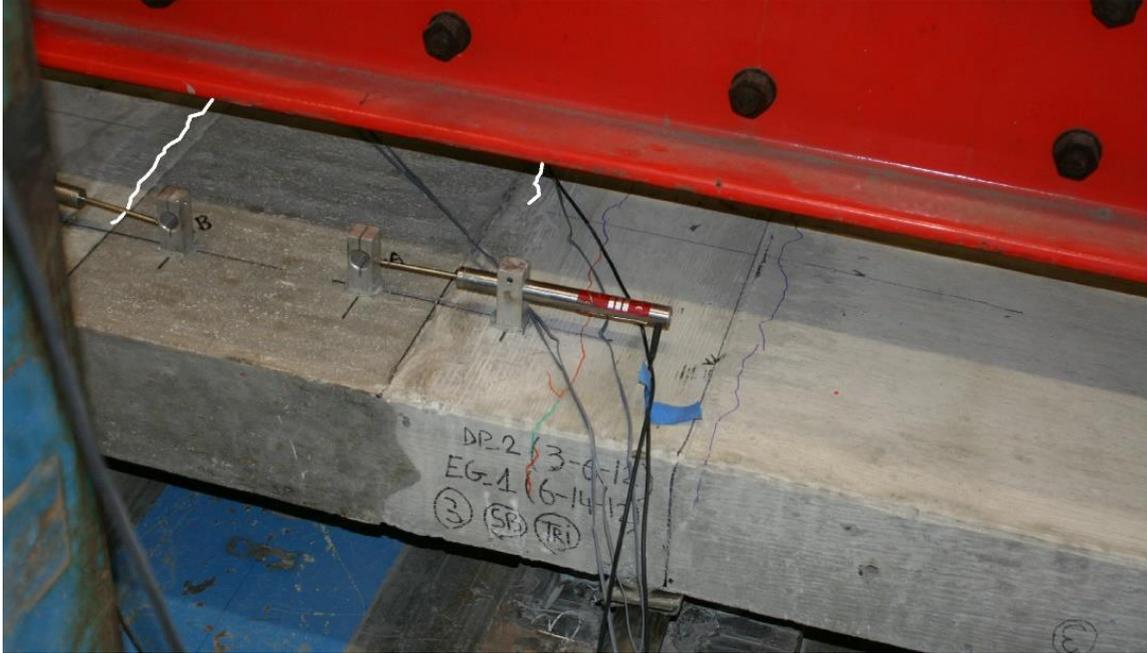
Figure 122. Photo. Representative photo of deck-level connection specimen with E1 grout after completion of cyclic crack loading (Specimen E1-12-B-SB-Tr-36 shown).

All specimens employing E1 grout survived the fatigue loading protocol. It should be noted that 5.5-inch (140-mm) and 12-inch (305-mm) lap splice lengths were tested. Observations made during and after fatigue testing indicated that little to no apparent damage occurred within the grouted connection region other than interface cracking. Figure 122 through figure 124 show a set of representative photos depicting the observed progression of damage in specimens with E1 grout during fatigue loading. Prior to fatigue loading, cracking along the concrete-grout interface or cracking in the precast concrete near the concrete-grout interface were the only signs of apparent damage within the connection region (see figure 122). As fatigue loading began and as the cycle count increased, existing cracks propagated along the interface and new cracks formed in the precast concrete deck panels; cracks did not form within the E1 grout (see figure 123). This behavior can be observed by comparing the crack patterns in figure 122 with those in figure 123. The propagation of interface cracks was primarily caused by overload cycles, and once a crack ran the complete length of the interface, very little damage occurred thereafter. Figure 124 shows a representative photo of a specimen with E1 grout upon completion of the fatigue loading protocol.

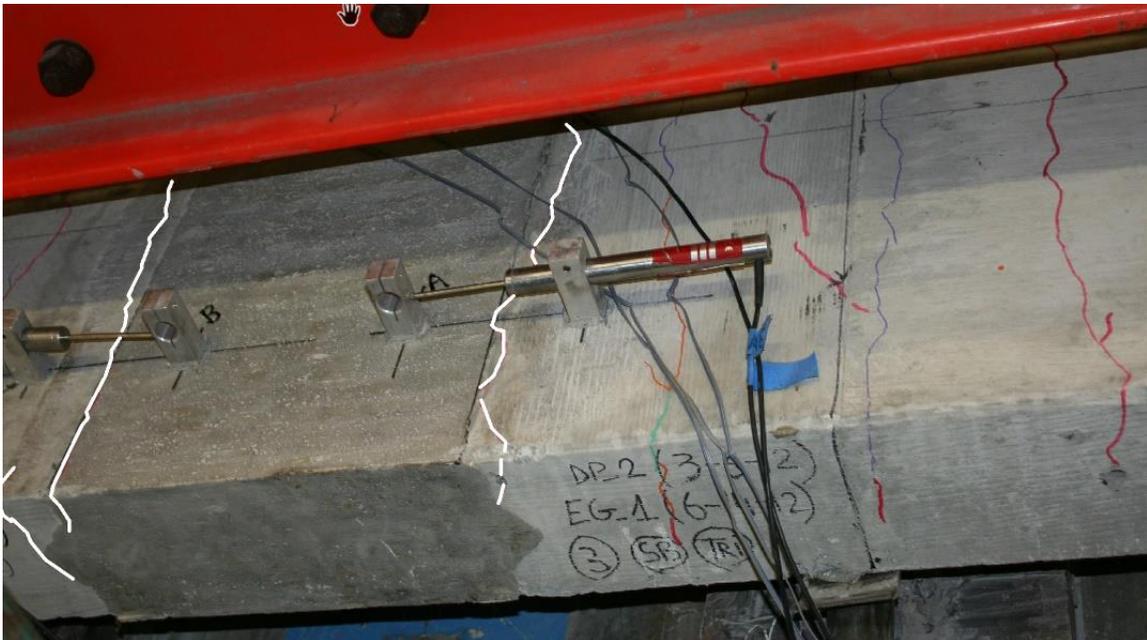
Figure 123. Photo. Representative photo of deck-level connection specimen with E1 grout during fatigue loading (Specimen E1-12-B-SB-Tr-36 shown after 263,943 cycles).

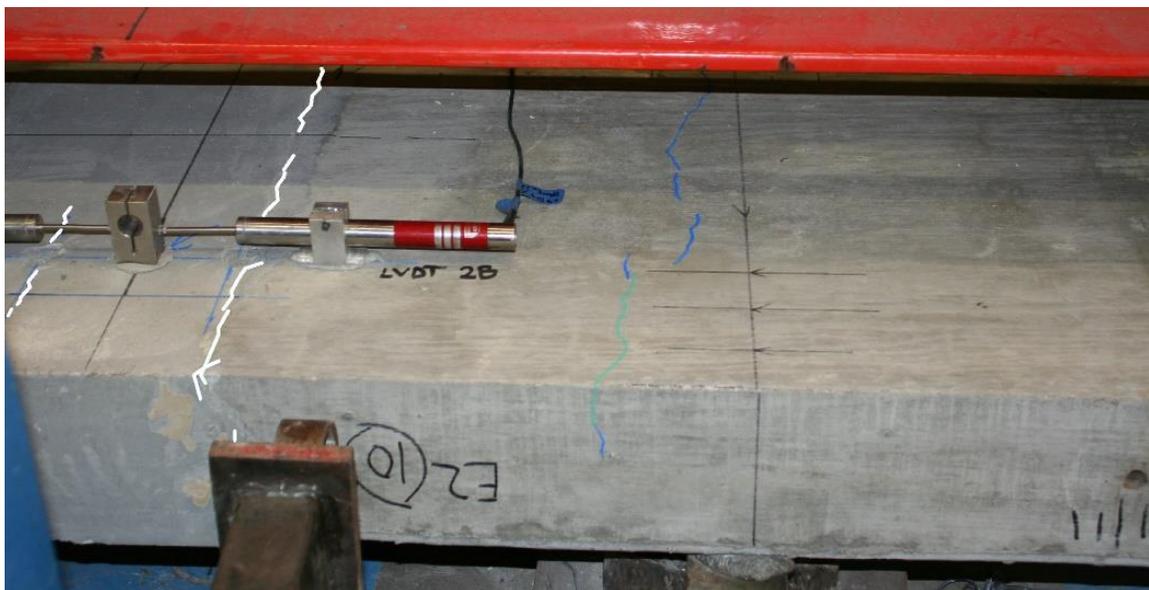
Figure 125. Photo. Representative photo of deck-level connection specimen with U2 grout after completion of cyclic crack loading (Specimen U2-5.5-B-SB+E1-Tr-12 shown).

Figure 128 shows the relationship between flexural stiffness degradation and number of load cycles for a single specimen with the U2 connection grout; data from the specimens with U-bars is also shown for comparison. The data presented in this graph reflect measurements taken only during the low-level fatigue cycles. Similar to previous results, abrupt loss of stiffness was observed after the first set of overload cycles as a result of newly formed cracks and propagation of existing cracks. In the specimen employing the U2 grout, new cracks formed within the precast concrete deck sections. A crack microscope was used to further inspect the UHPC connection grout after fatigue loading. The inspection revealed that a few fine microcracks were present with crack widths smaller than 0.001 inch. (0.025 mm). For comparison, the specimen employing the G1 grout exhibited a significant amount of cracking within the connection grout and had crack widths greater than 0.01 inch. (0.25 mm).

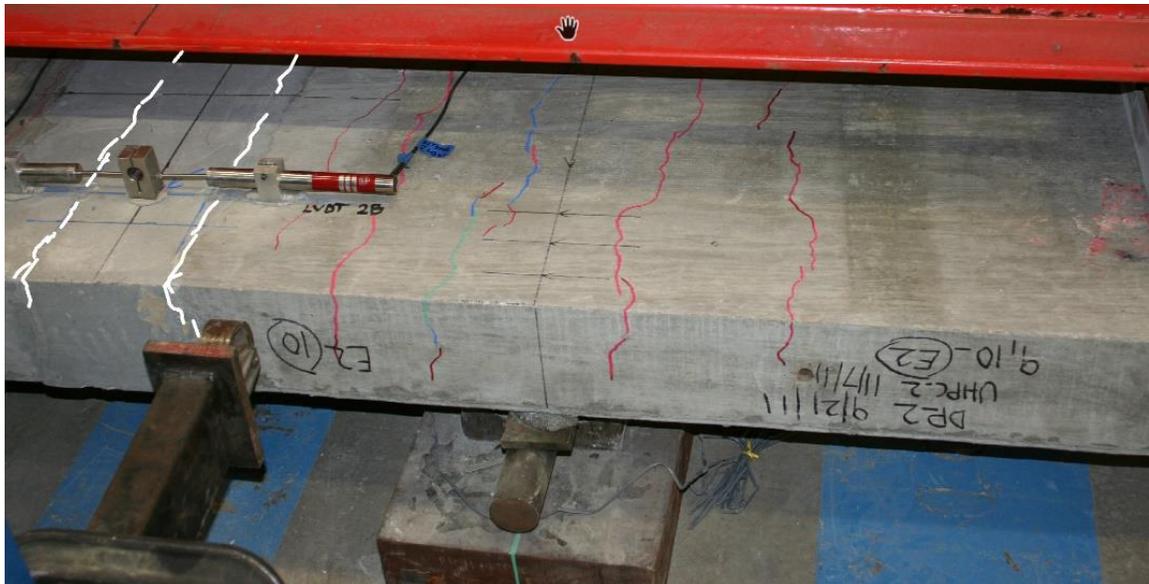
Figure 126. Photo. Representative photo of deck-level connection specimen with U2 grout during fatigue loading (Specimen U2-5.5-B-SB+E1-Tr-12 shown after 1,291,897 cycles).

Similar to specimens with E1 grout, all specimens employing U2 grout survived the fatigue loading protocol. Specimens with U2 grout employed only a 5.5-inch (140-mm) lap splice length. Observations made during and after fatigue testing indicated that little to no apparent damage occurred within the grouted connection region other than interface cracking. Figure 125 through figure 127 show the observed progression of damage in a representative specimen with U2 grout during fatigue loading. Prior to fatigue loading, damage within the connection region was limited to cracking along the concrete-grout interface, cracking in the precast concrete near the concrete-grout interface, and/or minor cracking within the U2 grout in some specimens (see figure 125). As fatigue loading began and as the cycle count increased, existing cracks propagated along the interface, new cracks formed in the precast concrete deck panels, but no new cracks formed in the U2 grout. This behavior can be observed by comparing the crack patterns in figure 125 with those shown in figure 126. The propagation of interface cracks was primarily caused by overload cycles, and once a crack ran the complete length of the interface, very little damage occurred thereafter. Figure 127 shows a representative photo of a specimen with E1 grout upon completion of the fatigue loading protocol.

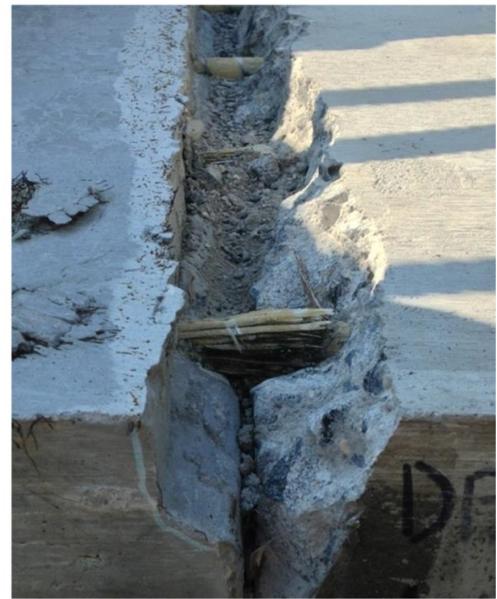
B. Inspection after concrete removal
