Instrumentation and 5-Year Performance Monitoring of a GRS-IBS in St. Lawrence County, NY

PUBLICATION NO. FHWA-HRT-20-040

This report summarizes the instrumentation and monitoring program for a Geosynthetic Reinforced Soil–Integrated Bridge System (GRS-IBS) project constructed under FHWA’s Every Day Counts program. This instrumentation and monitoring were undertaken to better understand the substructure–superstructure interaction of the bridge. The GRS-IBS in St. Lawrence County, NY was chosen for long-term monitoring because its span length, skew, and superelevation were relatively unique at the time.

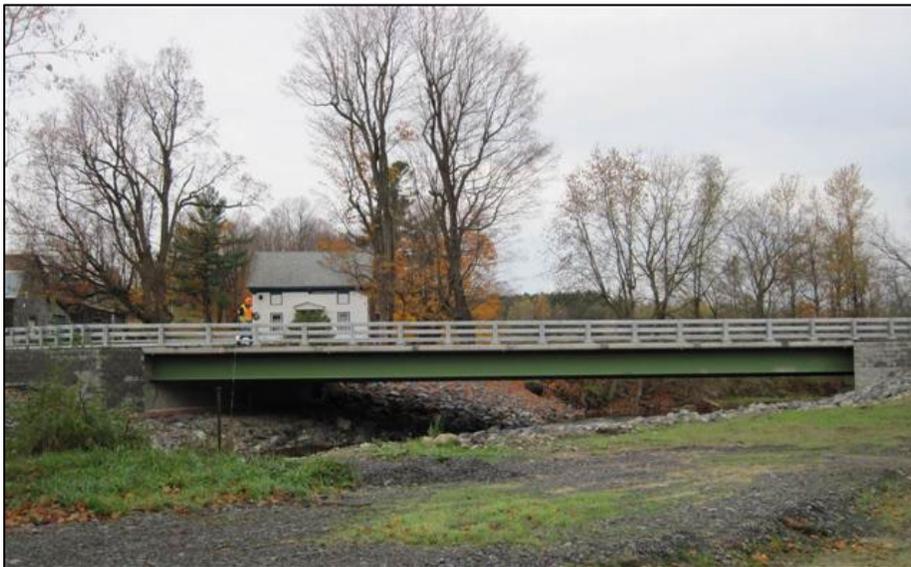
Figure 1. Photo. CR47 GRS-IBS over Trout Brook.

One of the first GRS-IBS projects to be instrumented and evaluated in EDC-1 was a replacement bridge along County Road (CR) 47 over Trout Brook in the town of Stockholm within St. Lawrence County, NY, hereafter referred to as “the CR47 GRS-IBS.” This GRS-IBS is aligned on a 30-degree skew with a 3.65-percent superelevation (east-to-west downward slope) and a 0.5-percent grade. The south abutment is at a slightly higher elevation than the north abutment. The new superstructure consists of 105-ft steel multigirders and prefabricated concrete deck panels. The heights of the north and south geosynthetic–reinforced soil (GRS) abutments were 11.0 and 11.6 ft, respectively. Construction of this replacement bridge began in May 2013, and the bridge was opened to traffic in October 2013. The design and construction of the bridge was performed per interim FHWA guidelines (Adams et al. 2011). Current FHWA guidance, however, is provided by Adams and Nicks (2018). Figure 1 shows the completed bridge.

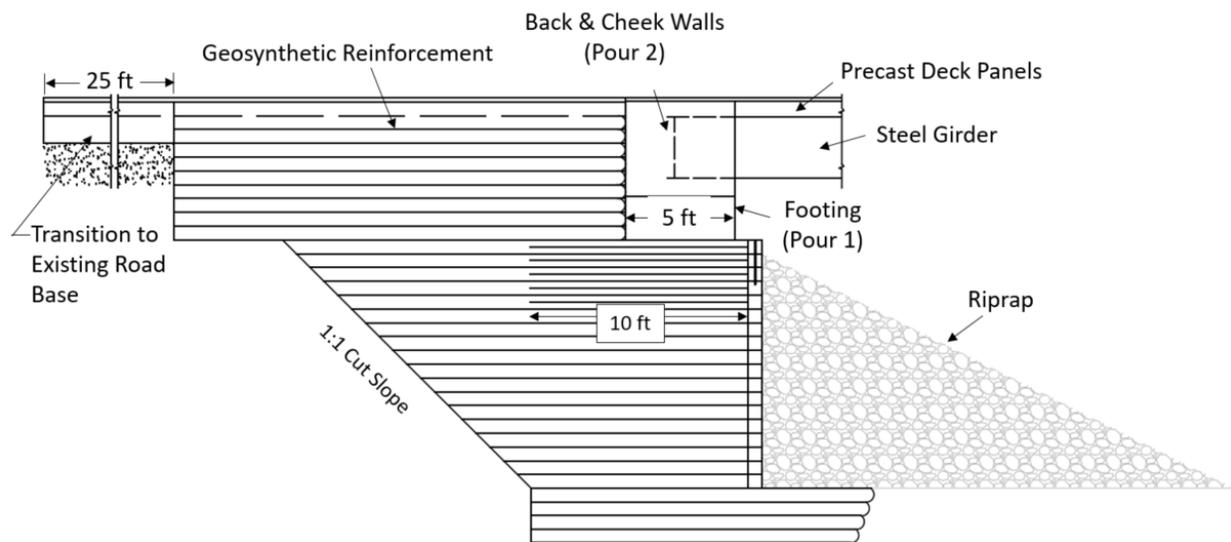
Figure 2. Illustration. Design cross section for the CR47 GRS-IBS over Trout Brook.

The abutments of the CR47 GRS-IBS were constructed with a compacted, clean, crushed aggregate that had grain sizes ranging from 0.25 to 1 inch and was layered with a woven 4,800 lb/ft geotextile placed at a nominal 8-inch spacing. The aggregate was classified as a poorly graded gravel (GP), an A-1-a, or a No. 1 according to the Unified Soil Classification System, the American Association of State Highway Transportation Officials Classification System, and the New York State Department of Transportation, respectively (ASTM D2487 2017; AASHTO 2017; NYSDOT 2014). The assumed unit weight and friction angle of the structural backfill for the design were 110 lb/ft³ and 40 degrees. The facing blocks consist of 7⁵/₈- by 7⁵/₈- by 15⁵/₈-inch solid concrete masonry units (CMUs). The geotextile reinforcement extended through each dry-stacked course of block, creating a frictional connection with the CMUs. The abutments were founded on a reinforced soil foundations (RSFs) underlain by a dense glacial till. Figure 2 is a cross section of the layout of the south abutment.

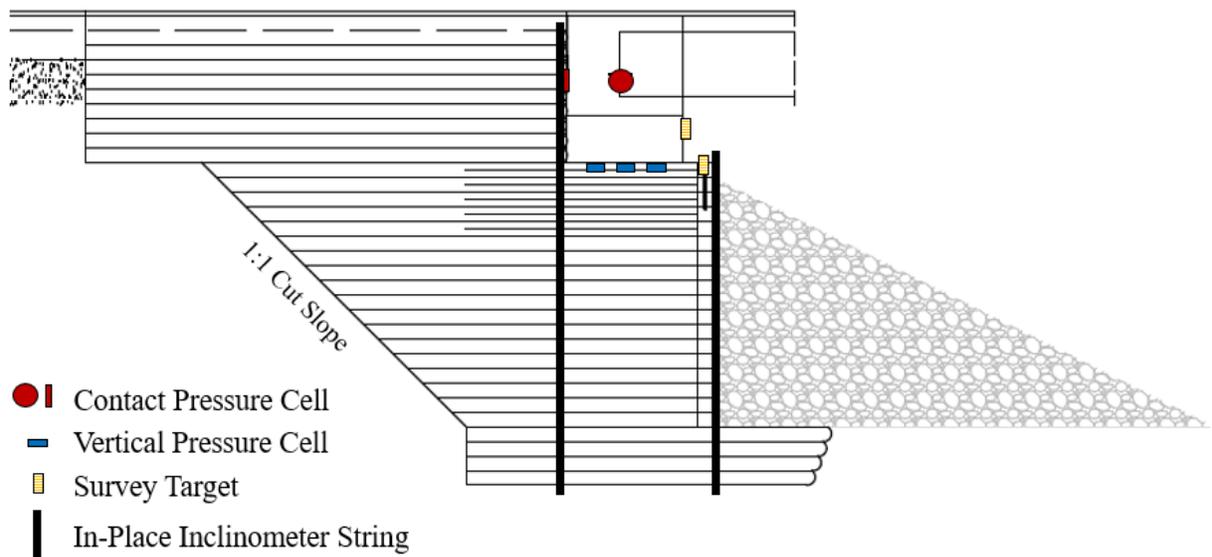
Figure 3. Illustration. Cross section of instrumentation for the south abutment of the CR47 GRS-IBS.

FHWA designed the instrumentation program based on the factors of interest (e.g., skew, superelevation, and span length) and the budget available. Layouts of the sensors installed on the CR47 GRS-IBS are shown in figure 3 through figure 5; note that the north abutment of the bridge only had one in-place inclinometer (IPI) installed behind the backwall. To evaluate the impact of skew, the contact pressure between the reinforced backfill and the cheek walls of the superstructure backwall was monitored. Considering the span length of the bridge and the weather in St. Lawrence County, NY, the contact pressure and lateral deformation between the reinforced backfill and the backwall were monitored for thermal interaction. Finally, the vertical pressure was monitored at the front, middle, and back of the footing to evaluate the grade of the bridge. IPIs and survey targets on the face of the abutments were installed to measure lateral and vertical deformations over time.

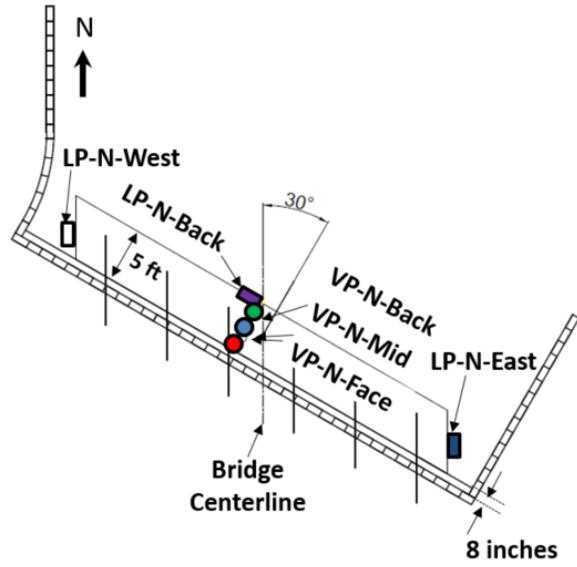
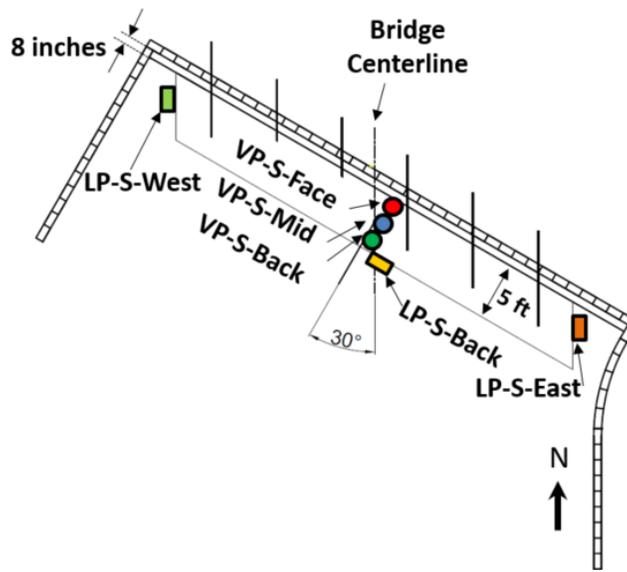
Figure 4. Illustrations. Location and nomenclature of abutment instrumentation.

N = north; LP-N-West = lateral pressure cell installed on the west cheek wall of the north abutment; LP-N-Back = lateral pressure cell installed on the backwall of the north abutment; VP-N-Back = vertical pressure cell installed furthest from the face of the north abutment; VP-N-Mid = vertical pressure cell installed under the middle of the footing on the north abutment; VP-N-Face = vertical pressure cell installed closest to the face of the north abutment; VP-N-East = vertical pressure cell installed on the east cheek wall of the north abutment.

A. North abutment.

N = north; LP-S-West = lateral pressure cell installed on the west cheek wall of the south abutment; VP-S-Face = vertical pressure cell installed closest to the face of the south abutment; VP-S-Mid = vertical pressure cell installed furthest from the face of the south abutment; VP-S-Back = vertical pressure cell installed furthest from the face of the south abutment; LP-S-Back = lateral pressure cell installed on the backwall of the south abutment; LP-S-East = lateral pressure cell installed on the east cheek wall of the south abutment.

B. South abutment.

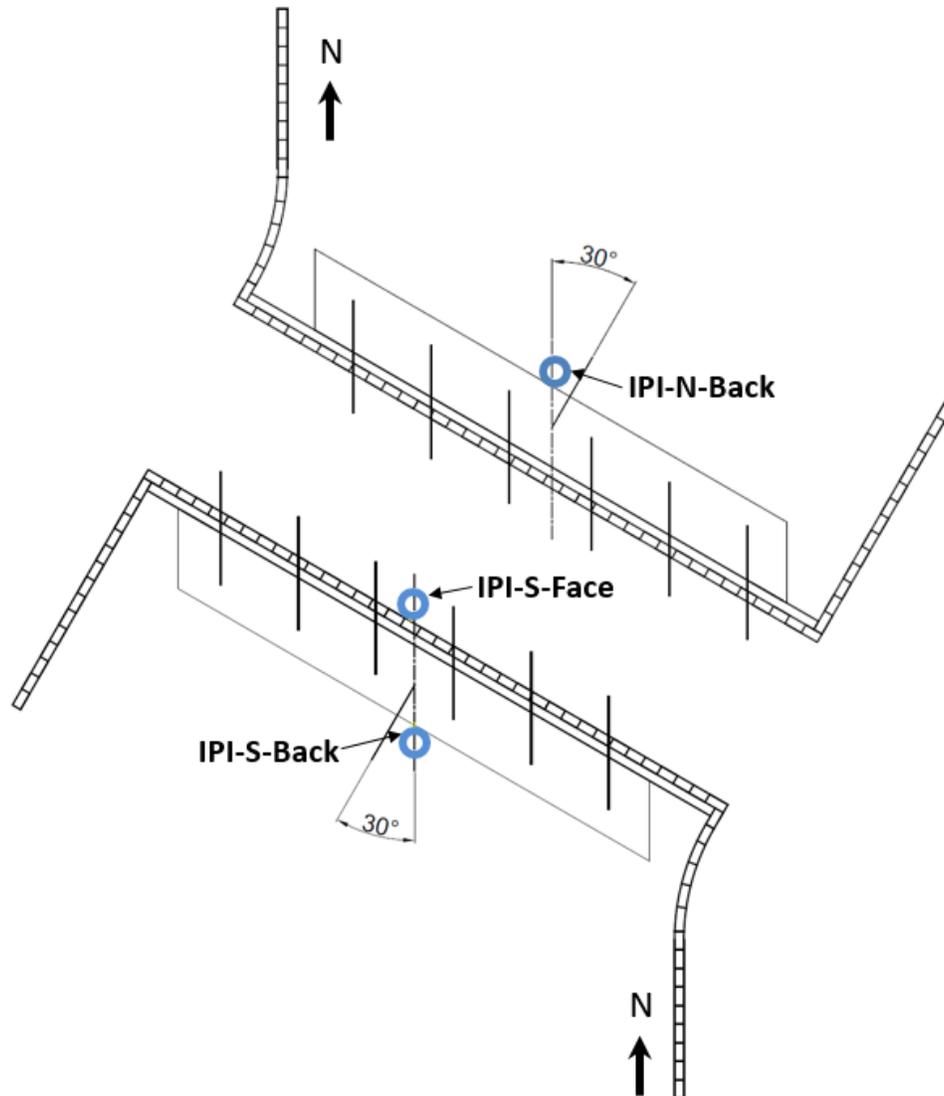
Figure 5. Location and nomenclature of IPIs.

N = north; IPI-N-Back = IPI installed on the backwall of the north abutment; IPI-S-Face = IPI installed on the face of the south abutment; IPI-S-Back = IPI installed on the backwall of the south abutment.

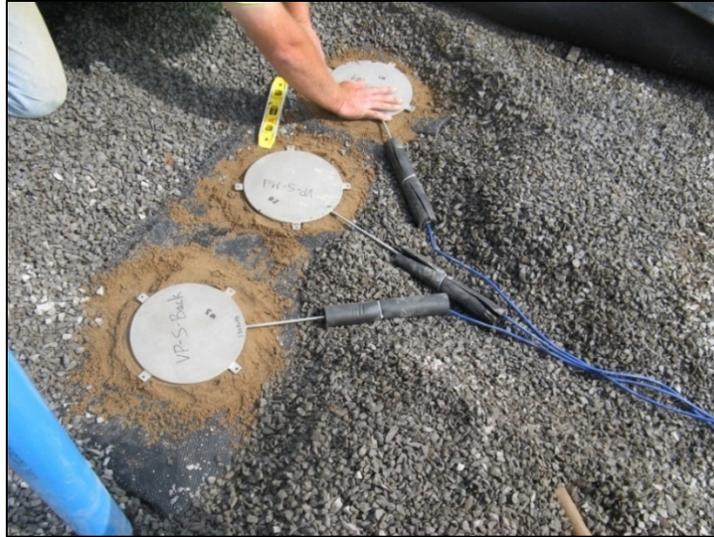
Figure 6. Photo. VPCs on sand bedding.

Prior to constructing the formwork for the beam footing at each abutment, three vibrating-wire vertical pressure cells (VPCs) (with 9-inch diameters and capacities of 50 psi) were installed on the top layer of the GRS abutment, immediately beneath the concrete footing (figure 3). The VPCs measured the vertical stress at the top of the GRS abutment due to the weight of the superstructure. Figure 6 illustrates the installation of the VPCs prior to casting the concrete footing. The VPCs were positioned perpendicular to the abutment wall faces at an offset angle, equal to the skew, from the centerline of the bridge (figure 7) and layered in a sand bedding to provide an even contact area and eliminate the possibility of point loading from the crushed, aggregate fill (figure 8). The cables for the VPCs were embedded in a sand-filled trench (figure 7), which helped protect the cable from potential damage from compaction equipment during approach construction. The VPCs were then covered with a sheet of geotextile and their locations marked to help prevent damage during footing construction (figure 9). Pressure data were collected during the construction of the footing, which was cast in multiple stages.

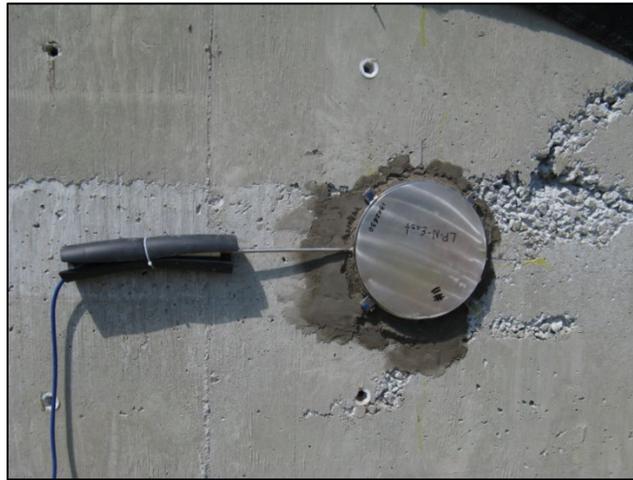
Figure 10. Photo. CPCs with grout bed mounted on the northwest cheek wall.

Three contact pressure cells (CPCs) (with 9-inch diameters and capacities of 25 psi) were installed on each abutment to measure lateral earth pressures behind the backwall and on the cheek walls. For consistent pressure measurements, the position of each CPC was kept the same distance (44.5 inches) below the top of the bridge deck to the center of the CPC. Once the forms for the backwall and cheek walls were stripped, each CPC was attached by fastening four mounting tabs with plastic masonry anchors and screws. Prior to attaching the CPCs, a layer of cement grout was applied to each wall to provide a flat bearing area for the CPC (figure 10). It should be noted that the CPC mounted on the northwest cheek wall on the north abutment was damaged and is no longer operating. This cell may have been damaged during installation of the guide-rail post. Figure 11 shows the general locations of the CPCs attached to each abutment backwall and cheek wall.

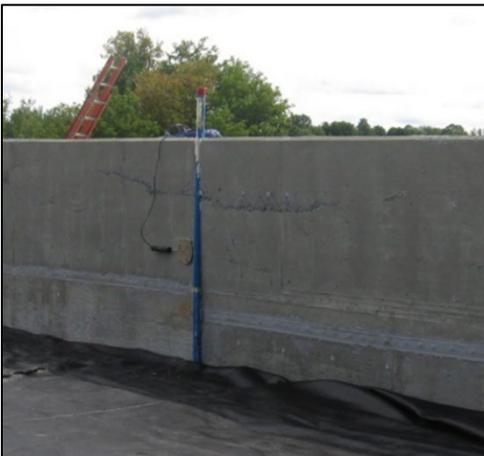
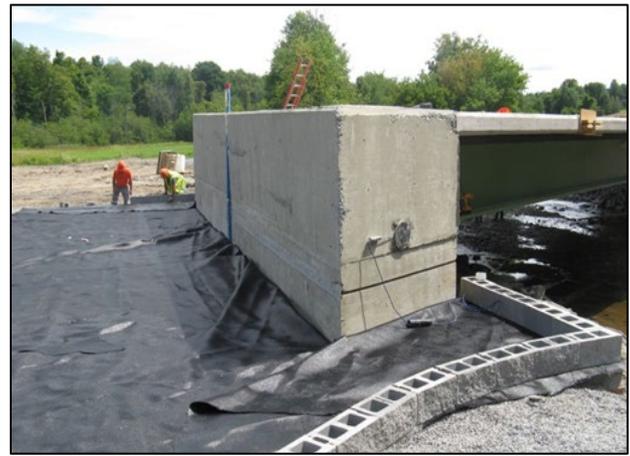
A. CPC on the backwall.

B. CPC on the cheek wall.

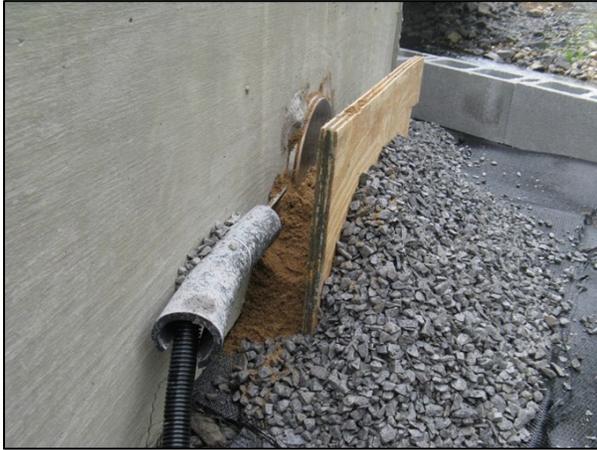
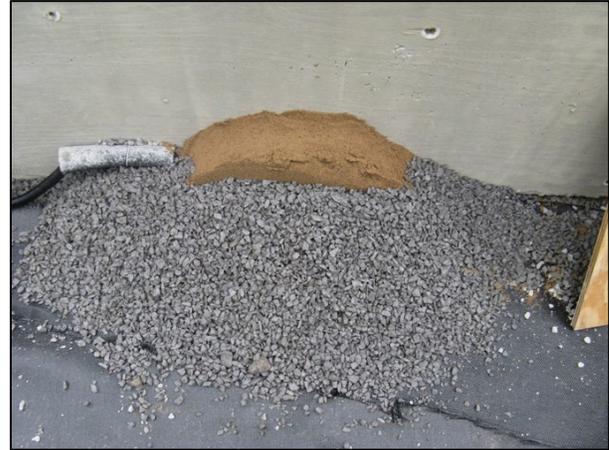
Once the CPCs were attached, it was necessary to protect them from fill placement and compaction during approach construction. A protective sand layer was placed in front of each cell using a plywood sheet as a form (figure 12-A); the sheet was removed once fill material was placed (figure 12-B).

A. Plywood sheet protection.

B. Sand layer protection.

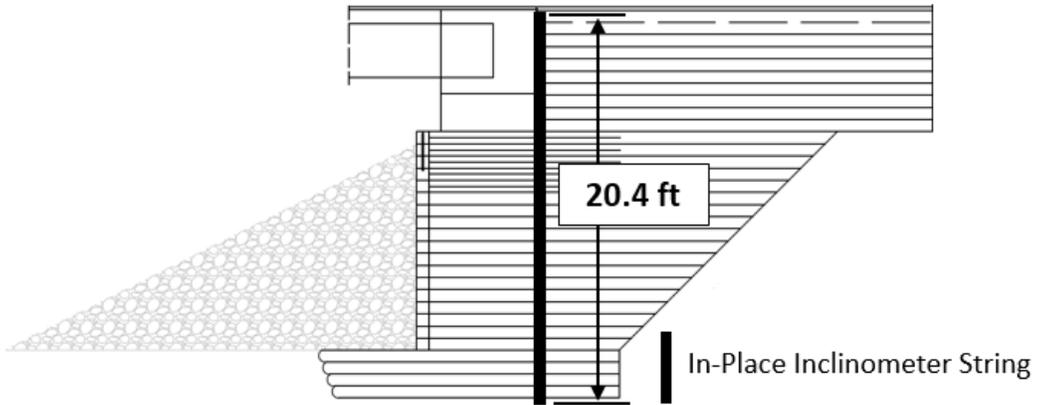
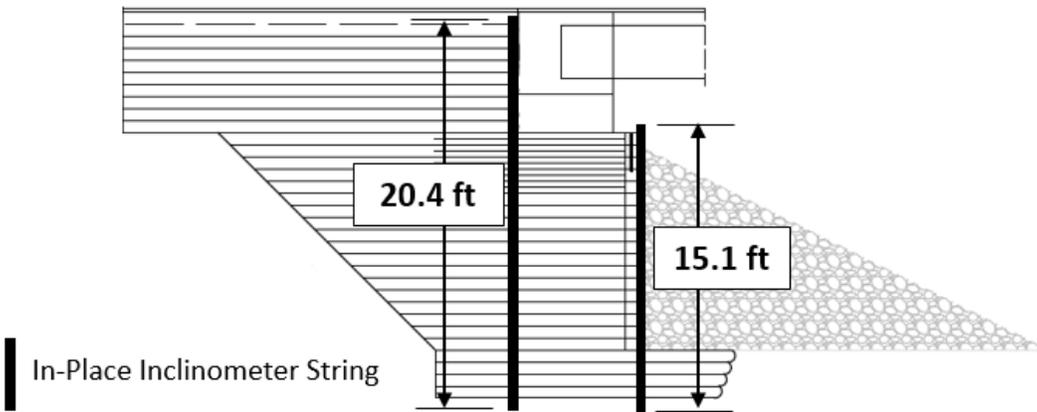
IPIs using micro-electro-mechanical systems (MEMS) were installed to monitor the lateral movement at the GRS fill–footing interface on each abutment (figure 13). The south abutment had an additional IPI attached to the CMU face to measure lateral deformation in that location. There were seven sensors located at depths of 2, 5.28, 8.56, 11.84, 15.12, 18.4, and 20.35 ft for the IPIs located behind the backwall on the north and south abutments. For the IPIs at the face of the south abutment, there were five sensors at depths of 0.2, 3.48, 6.76, 10.04, and 13.32 ft from the top of the abutment wall face. The casing that housed the IPIs was installed as the abutment was constructed.

A. North abutment.

B. South abutment.

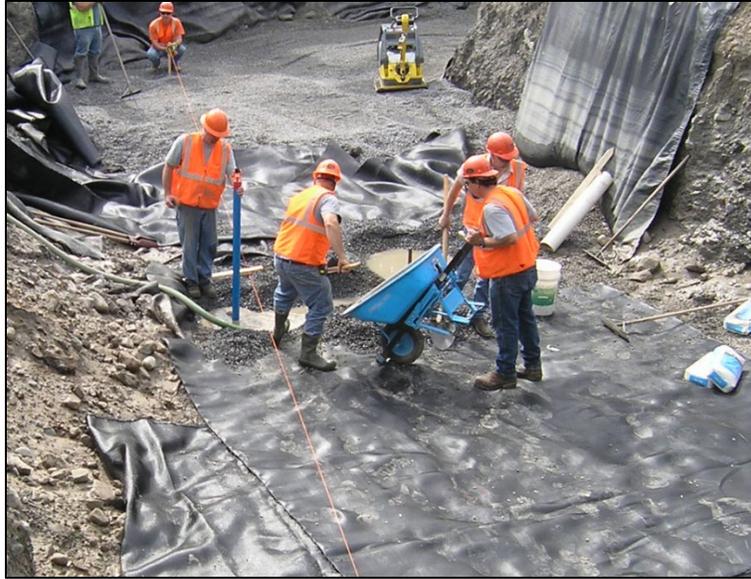
Figure 14. Photo. IPI casing installed and grouted in the south abutment foundation.

The County construction crew working on the bridge installed 5-ft sections of the IPI casing. The first section was anchored and grouted 2 ft below the foundation elevation in dense glacial till (figure 14). Before installation, a bottom cap was connected to the first casing section to keep the inside free of debris. For ease of assembly, 2.75-inch-outer-diameter quick-connect inclinometer casing was used. This type of casing has built-in couplings that snap together with no need for solvent cement or tape.

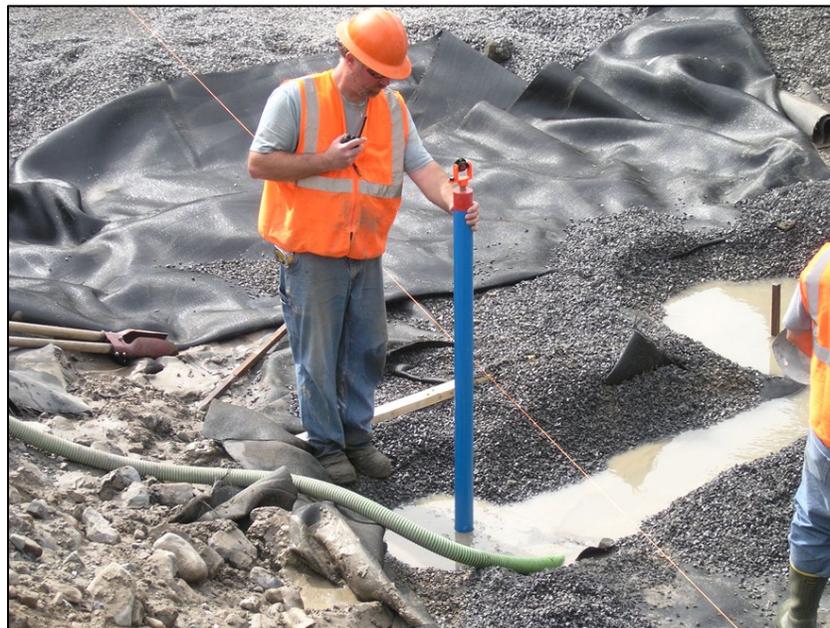
Figure 15. Photo. Aligning the IPI casing with the centerline of the bridge.

Since the bridge was skewed, the grooves of the IPI casing were aligned perpendicularly to the superstructure and along the centerline to capture the movement of the bridge. A survey prism was placed on the casing section along with a transit for aligning the casing with the centerline (figure 15). The County crew continued installing the IPI casing in 5-ft sections during the construction of the abutments. The geotextile was slit and threaded over the casing (figure 16). Using this method of installation, the backfill surrounding the casing could be well compacted.

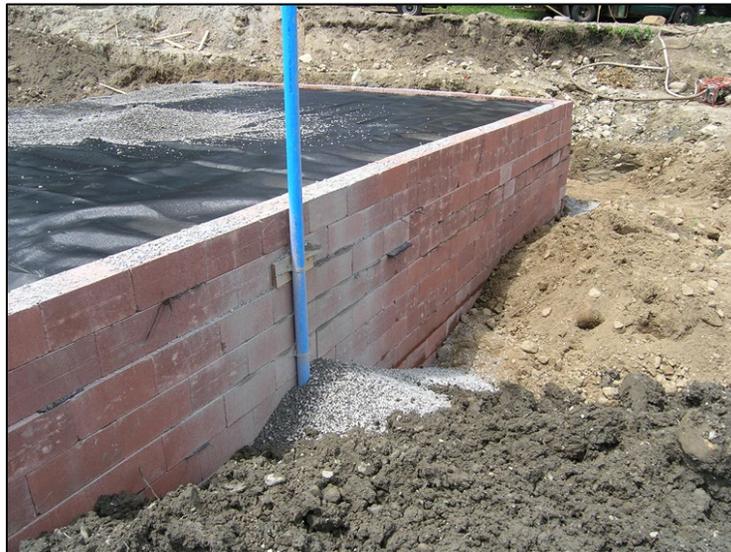
Figure 17. Photo. Steel straps and a protective aggregate layer securing the IPI casing to the south abutment wall.

The final sections of the IPI casing were added upon completion of the GRS wall. The casing for the IPI used to monitor the face of the south abutment was secured to the wall with pipe straps to keep it aligned vertically during construction (figure 17). The IPI casing was protected from damage during the placement of the riprap against the abutment wall face. The casing was surrounded by a layer of aggregate during the fill placement, and a section of steel channel was used to shield the casing in the zone of channel protection (figure 18).

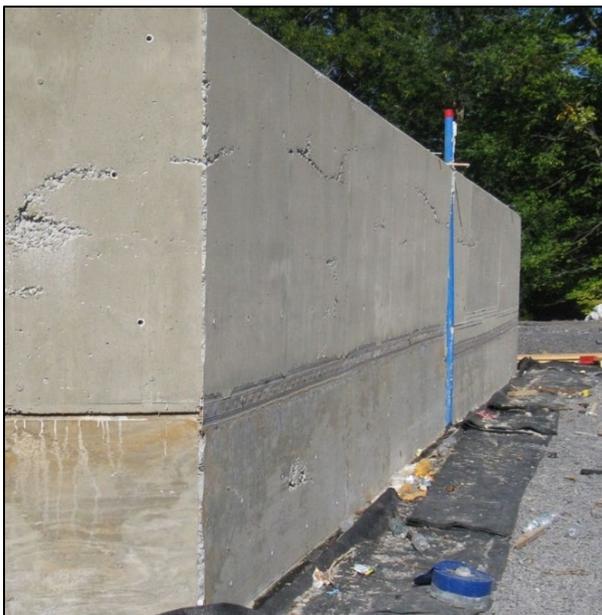
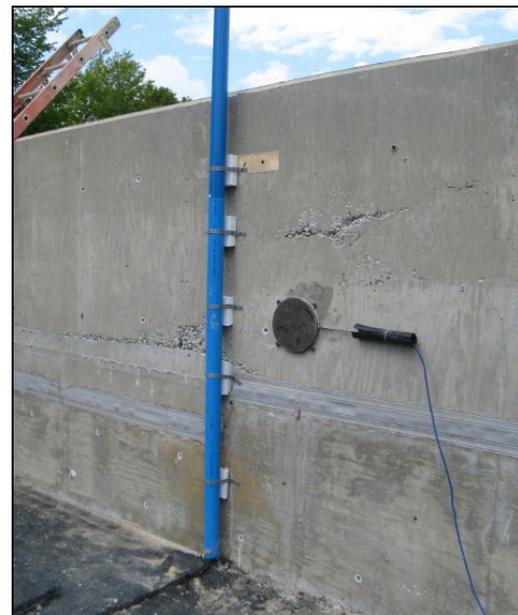
On the north abutment, the position of the IPI casing within the GRS fill (IPI-N-Back) intersected the plane of the backwall, making it necessary for the casing to be partially cast into the backwall (figure 19-A). The IPI casing along the south abutment's backwall (IPI-S-Back) was about 2 inches away from the final line of the backwall. To keep the casing in contact with the wall and not cause any uneven bending during the approach fill placement, polyvinyl chloride (PVC) spacers were placed along the length of the casing and the casing was secured with pipe straps (figure 19-B).

A. Embedded IPI-N-Back casing.

B. IPI-S-Back casing with PVC spacers.

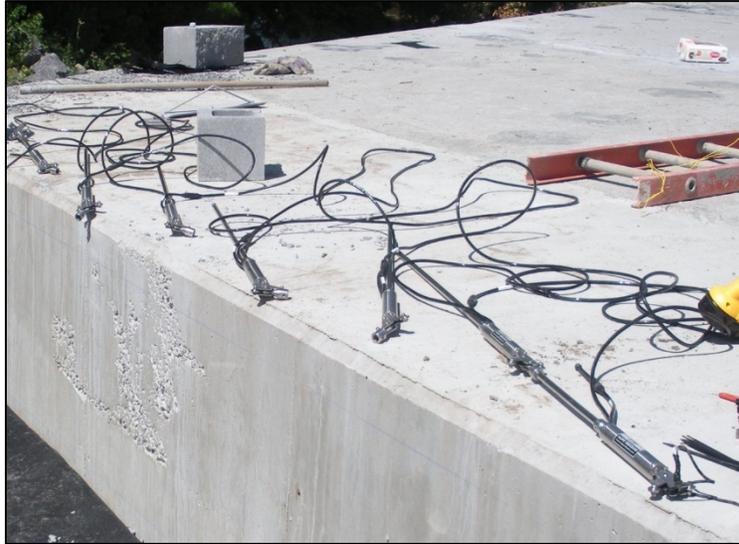
Figure 20. Photo. IPIs and jumper cables.

For continuous monitoring, MEMS IPI uniaxial sensors were installed to capture deformation along the length of the casing. IPIs were connected in series with jumper cables between each sensor instead of using one signal cable for each sensor (figure 20). This connection allowed for having only one cable connected to the RDAS data logger for each string of sensors.

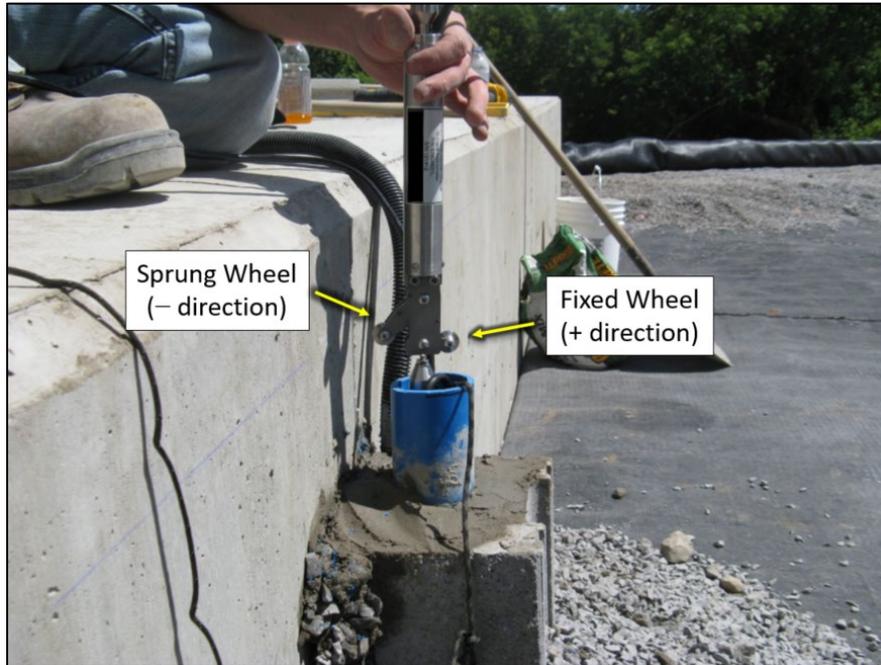
Figure 21. Photo. IPI wheel assembly on the south abutment (fixed wheel is on the right, toward the abutment).

The wheel assembly is part of the IPI. It contains a fixed and sprung wheel. The fixed wheel points in the direction of movement defined as the positive direction; in this case, the fixed wheel was pointed away from the stream channel for each string of IPIs (figure 21). After placement, a hanging bracket that allowed the string to be hung on the casing was connected to the top sensor, keeping the bottom sensor from contacting the casing bottom (figure 22).

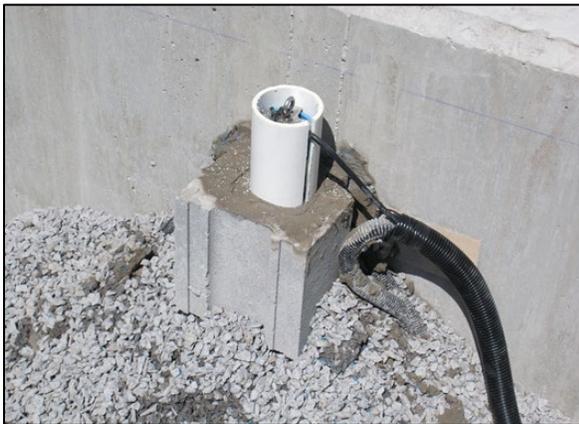
A. Hanging bracket.

Figure 22. Photos. Hanging bracket on top of the IPI-S-Back casing and protective PVC sleep and cap.

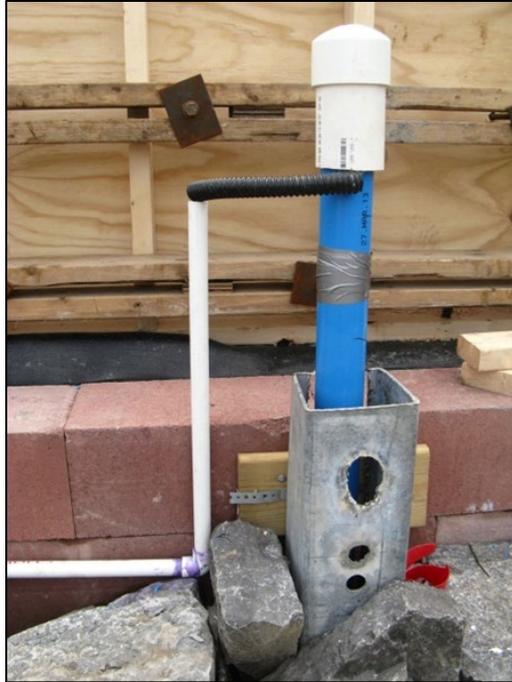
Figure 23. Photo. Protective cap on the IPI-S-Face casing.

With each IPI string in place, a protective 4-inch PVC sleeve and cap was attached to the top of the casing. A slot was also cut into the PVC sleeve for the data cable to exit on the south abutment backwall. The sleeve was used to keep fill material from entering the casing and protect the top of the IPI string during the completion of construction. The IPI casing was embedded in the back of the north abutment, so for this set up, only the PVC cap was necessary. Similarly, only the protective cap was placed on the south abutment wall face's IPI (IPI-S-Face) because it was covered with steel pipe (figure 23).

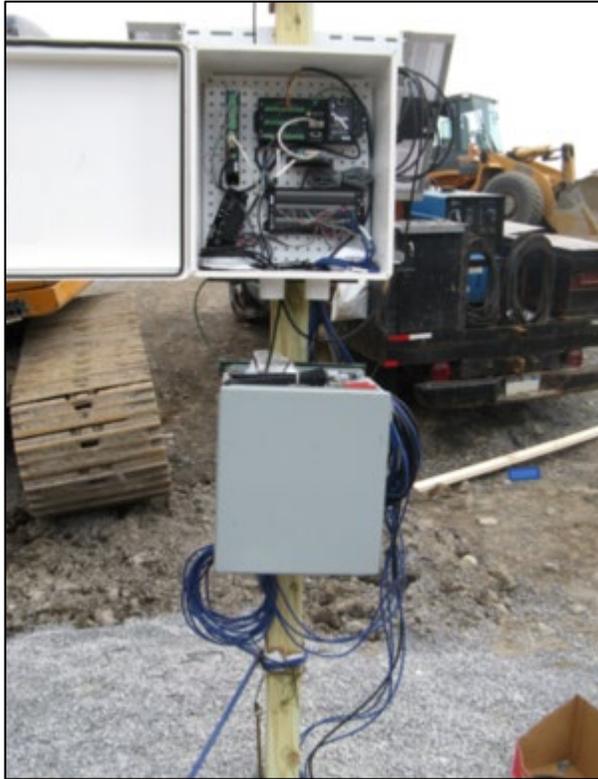
Figure 24. Photo. RDAS components.

The RDAS base station was located on the south abutment side. The main components of the RDAS include the data logger, multiplexer, and cellular modem, all housed in a weather-proof box (figure 24). A deep-cycle marine battery housed in a separate metal battery box connected to a 50-watt solar panel was used to charge the battery. A cellular modem used an external antenna to connect and transmit data. The entire system was attached to a 4- by 4-inch post adjacent to the abutment (figure 25).

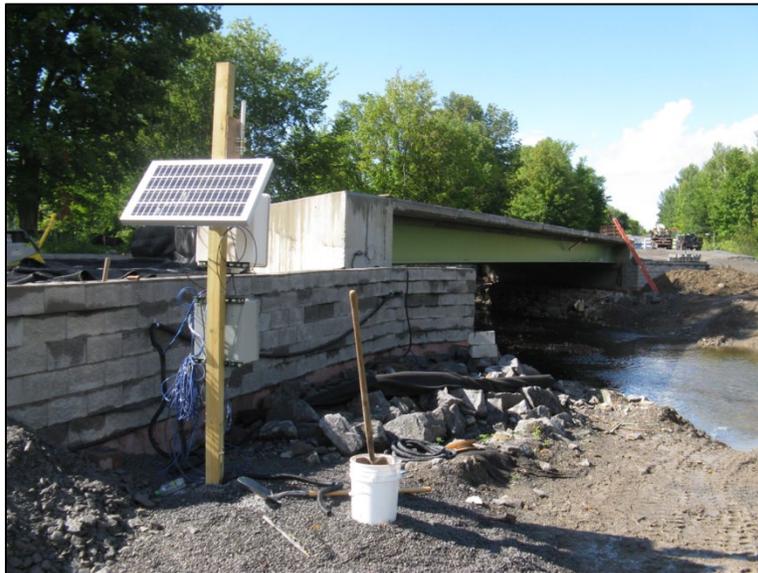
Figure 25. Photo. RDAS components mounted to a wooden post installed near the wing wall.

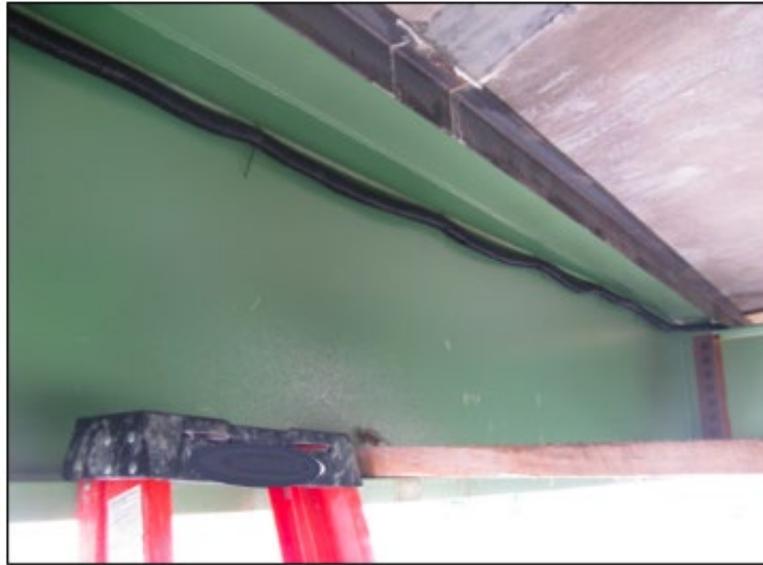
Figure 26. Photo. Flexible conduit carrying north abutment instrumentation cables.

All instrumentation on the north abutment (i.e., pressure cells and IPIs) was directly connected to the RDAS by cables that were placed in a flexible conduit, routed under the bridge, and secured by zip ties to sections of rebar that were tack welded to the girder. Figure 26 shows the conduit under the bridge containing signal cables from the north abutment pressure cells and IPI. It was important to have extra cable lengths available for the instrumentation sensors; this flexibility allowed for repositioning of the RDAS wooden post during construction and accommodated the increase in grade of the wing walls.

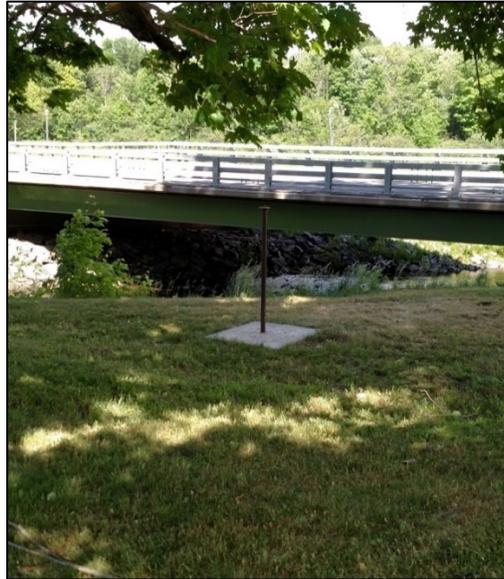
Figure 27. Photo. Total-station mounting post.

The survey-monitoring program consists of reflective targets and permanent total-station mounting posts. The total-station mounting posts were installed as the reference point for collecting all survey data (figure 27). The tops of the survey posts have threaded base plates that fit directly to the total station. The posts were set in concrete about 5 ft deep, beneath the assumed frost depth, and located in stable ground outside the potential flood zone.

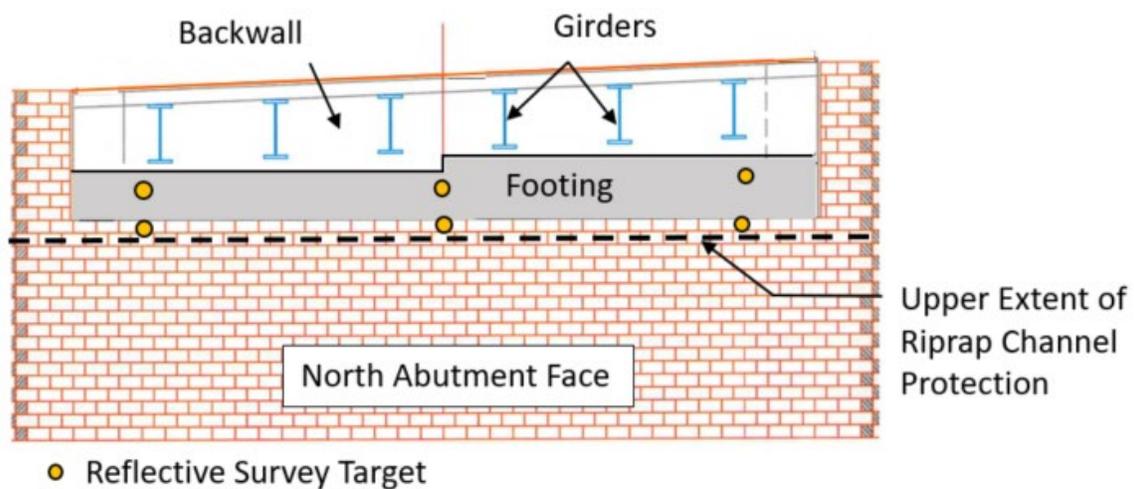
Figure 28. Illustration. Location of survey targets on the north abutment wall and beam footing.

The total station has a 2 degree-angle and ± 0.079 inch-distance accuracy. The reflective survey targets were mounted on the abutment wall faces and footings to measure both wall and beam settlement. Three targets were attached to the GRS wall and three to the footing (figure 28). Survey targets on the lower portion of wall were not included because the wall was protected with riprap. The targets were mounted on an aluminum swivel arm, which allowed them to be aimed normal to the total station (figure 29). The aluminum swivel arm was fastened to the CMU block and concrete footing using plastic masonry anchors and construction adhesive. To capture the initial settlement during the casting of the beam footings, temporary targets were placed on the wooden formwork, and base line survey shots were collected (figure 30). These were later removed and attached permanently to the concrete footing.

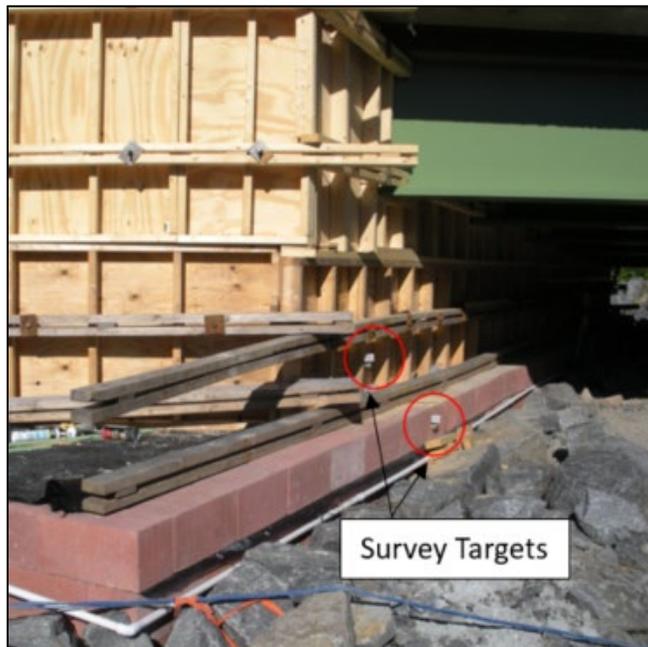
Figure 30. Photo. Survey targets attached to footing formwork and a GRS facing block.

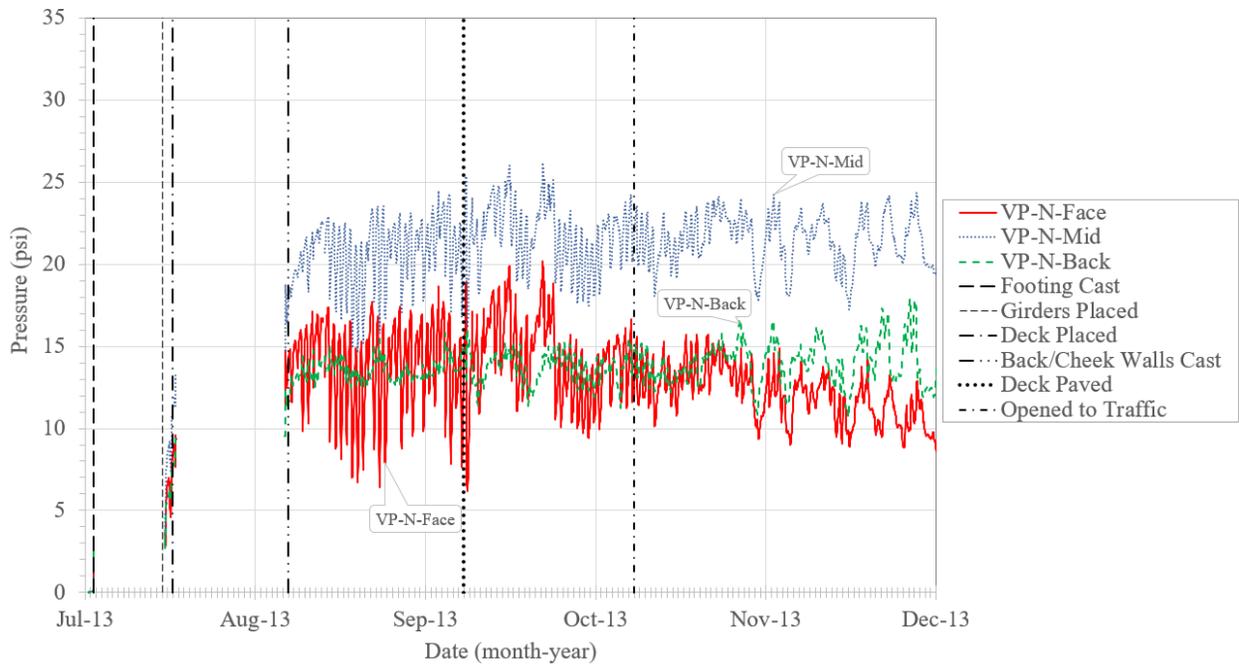
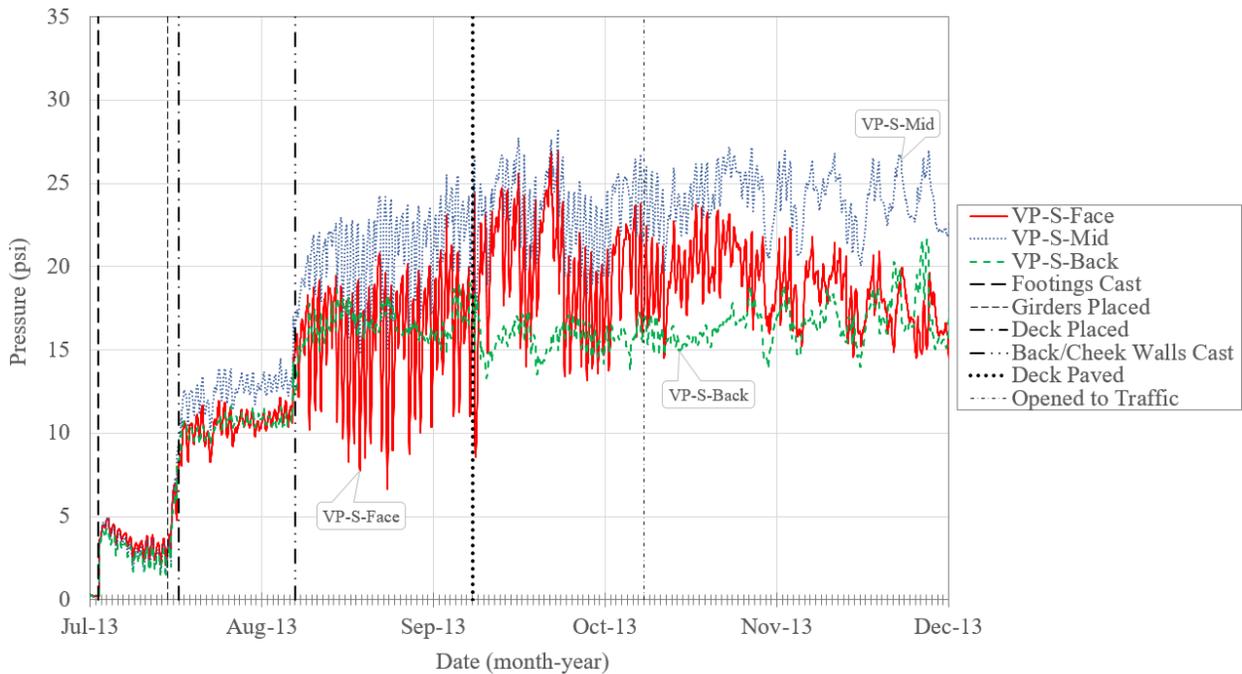
Figure 31 shows the measured vertical pressures during construction. The increase in pressure due to the deadweight of the bridge components can be clearly seen. Note that a software bug caused an error in the RDAS, so the pressure cell readings could not be read during construction for the north abutment (figure 31-A), but after the RDAS was reconfigured and the program was modified, the sensors were back online shortly after the deck was placed. The measured vertical pressures at the face and back of the footing are similar for both abutments, with the highest pressures measured in the middle of the footing on both abutments. For all VPCs, the daily fluctuation in measured vertical pressure dramatically increased after casting the back and cheek walls. These daily fluctuations represent the integration of the superstructure with the footings.

A. Vertical earth pressures during construction of the north abutment.

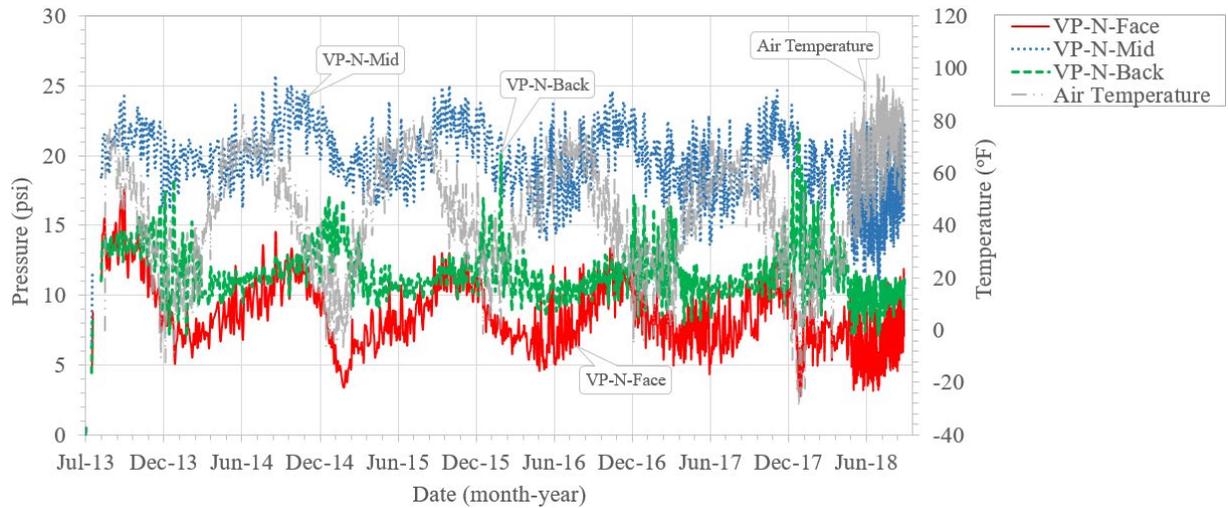
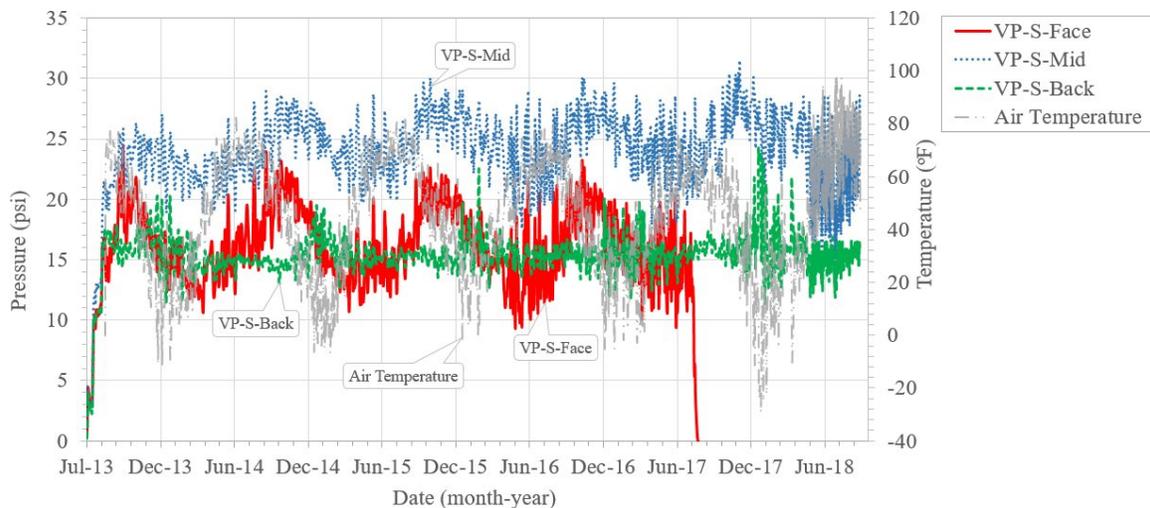
The measured vertical pressures for the north and south abutments throughout the 5-year monitoring period, July 2013 to August 2018, are shown in figure 32 along with the ambient air temperature (note the cell at the face of the south abutment malfunctioned in 2017). The plots show a seasonal fluctuation in vertical pressure due to the temperature (figure 32). As temperature increases and decreases, the superstructure expands and contracts, respectively, causing pressure fluctuations beneath the width of the concrete footing. The pressure signatures on each abutment are similar with slightly greater pressures on the south abutment. For both abutments, the highest pressures were recorded beneath the middle of the footing with face and back cell readings more equal.

A. Vertical earth pressures under north abutment footing.

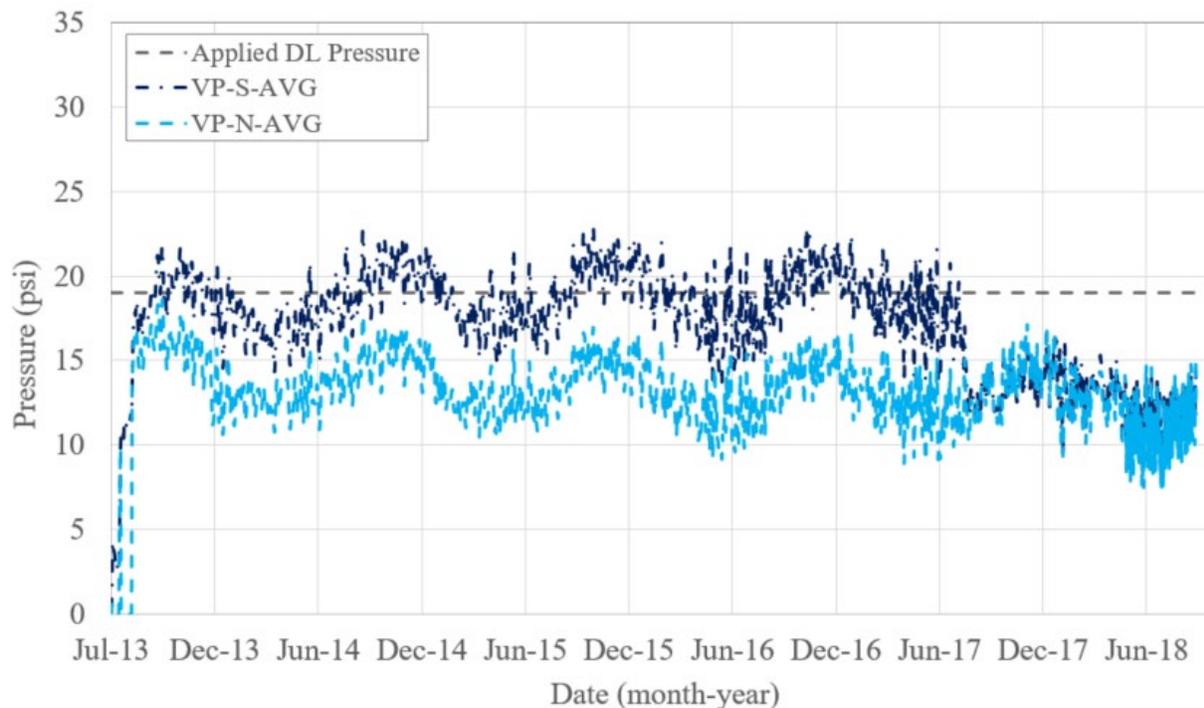
Figure 33 shows the average of the three VPCs beneath the footings of the north abutment (VP-N-AVG) and south abutment (VP-S-AVG). The average vertical pressures on the south abutment were about 5 psi higher than those on the north abutment. The south abutment reads closer to the engineer’s calculated DL pressure of about 19 psi (table 2). Note the average pressures for the south abutment after August 2017 are similar to those for the north abutment (once the cell at the face malfunctioned, it was not included in the dataset). Given that the backfill used is open-graded, there may be arching or inconsistent contact pressures across the VPCs (Nicks and Adams 2019), but the results provide a reasonably good estimate of the load.
