Instrumentation and 5-Year Performance Monitoring of a GRS-IBS in St. Lawrence County, NY

PUBLICATION NO. FHWA-HRT-20-040

This report summarizes the instrumentation and monitoring program for a Geosynthetic Reinforced Soil–Integrated Bridge System (GRS-IBS) project constructed under FHWA’s Every Day Counts program. This instrumentation and monitoring were undertaken to better understand the substructure–superstructure interaction of the bridge. The GRS-IBS in St. Lawrence County, NY was chosen for long-term monitoring because its span length, skew, and superelevation were relatively unique at the time.

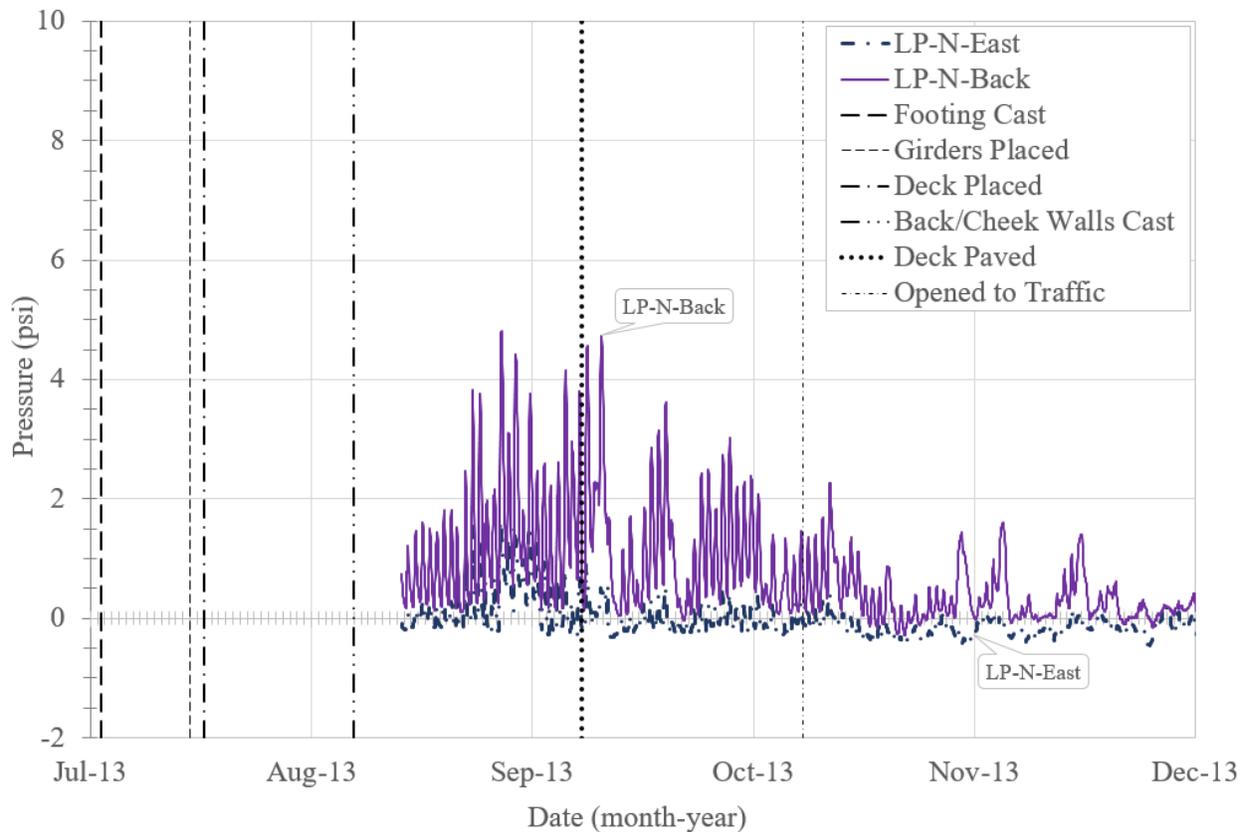
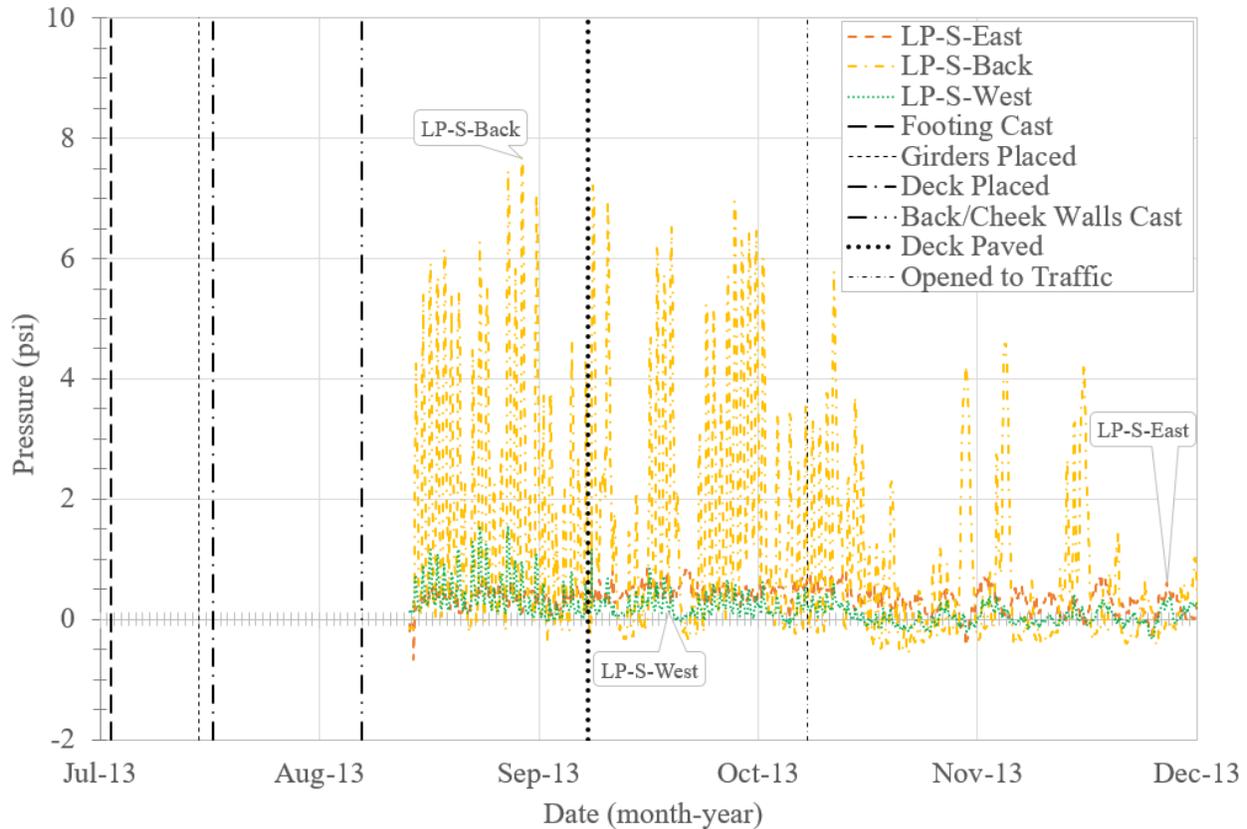
The CPCs were installed after the back and cheek walls were cast. Data collection began prior to construction of the integrated approach and pavement of the deck. The results show that initial backwall pressure readings spiked during the construction of both abutments and then leveled out more after the bridge was opened to traffic (figure 34); temperatures were also cooling off during that time of the year. Note the CPC installed on the west cheek wall of the north abutment malfunctioned at the beginning of data collection, so data are not available. Similar to the VPC readings, the CPC readings on the south abutment were higher than the north abutment, suggesting more thermal activity on the south bridge end, but the root cause is currently unknown.

A. Lateral earth pressures on backwall and east cheek walls of the north abutment during construction.

The pressure cells on the cheek walls measured significantly less lateral earth pressure values (<1 psi) than on the backwalls (figure 34). The results for the south abutment also indicate that there is not a big difference in lateral earth pressure activity between the east and west cheek walls; however, the pressures on the west cheek wall were slightly higher than those on the east cheek wall, particularly during construction activities. Regardless, the measured lateral cheek wall pressures correlate with at-rest (K_0) conditions; using the assumed 40-degree friction angle and 110 lb/ft³ unit weight, the theoretical at-rest earth pressure equals 0.82 psi.

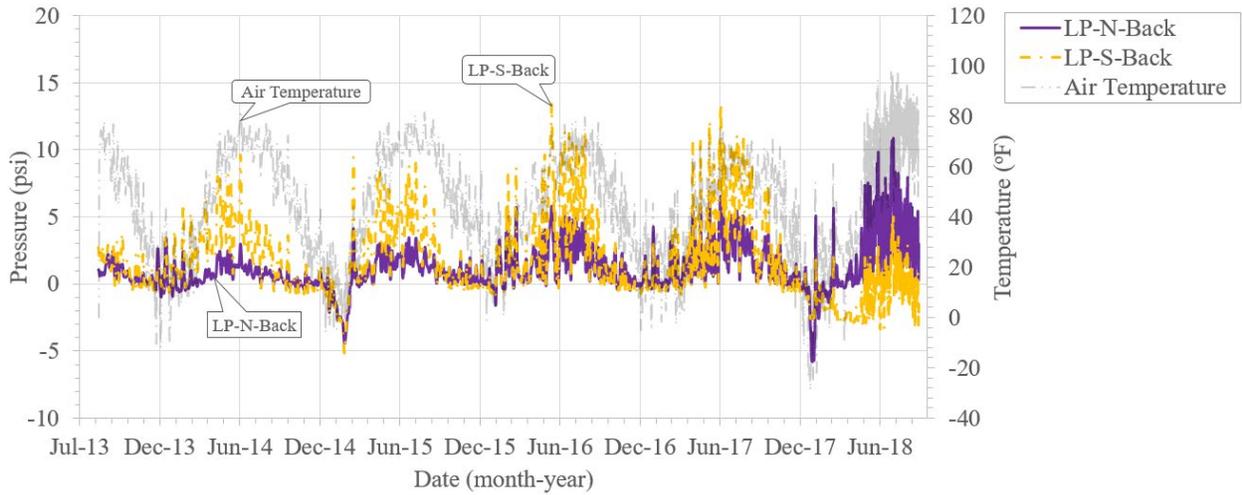
Figure 35. Chart. Lateral earth pressures and temperatures behind backwalls.

backwall pressures during the highest air temperatures are within the realm of the theoretical lateral stress under passive (K_p) conditions; for full K_p conditions, the predicted lateral earth pressure is 10.5 psi.

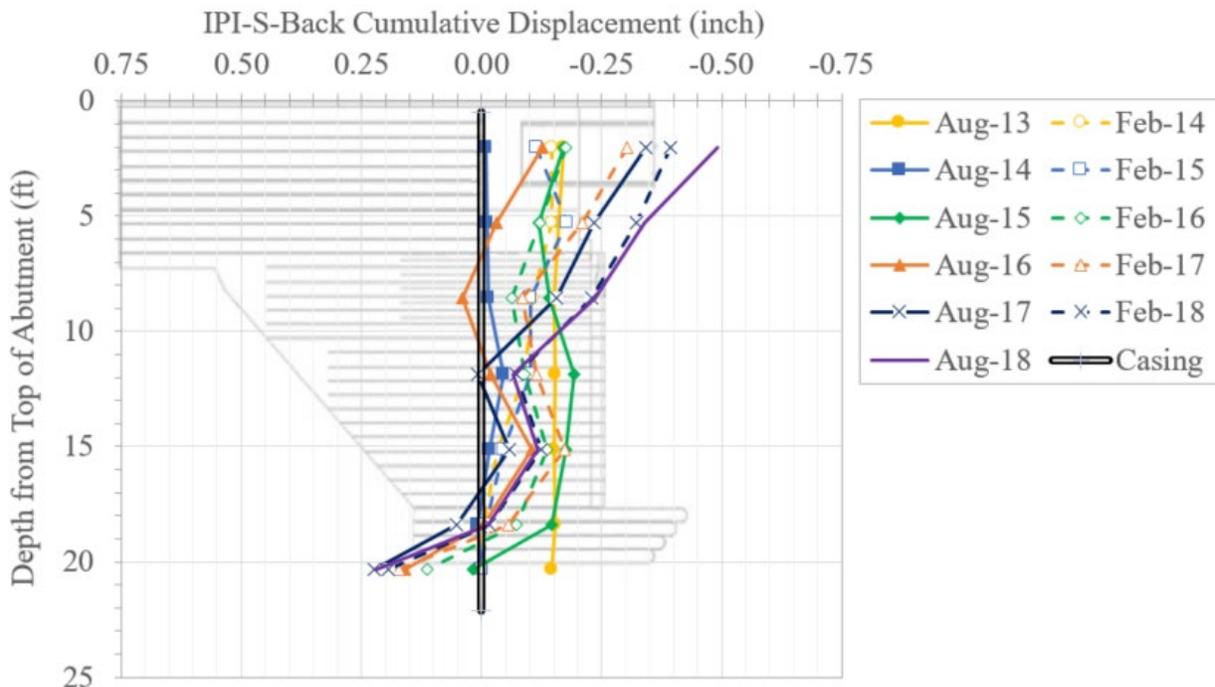
Figure 38. Chart. Cumulative displacement for IPI-S-Back.

IPIs were installed directly behind the backwall of the superstructure on both abutments and on the south abutment wall to evaluate lateral deformations. In addition, comparing lateral deformations with earth pressures helped paint a bigger picture of the CR47 GRS-IBS's substructure–superstructure interactions during this 5-year period. A common way to display inclinometer measurements is through a cumulative displacement plot with depth. With cumulative displacement, the displacement at the top is assumed to equal the sum of the displacements measured from all sensors. Figure 38 through figure 40 show the resulting lateral deformation profiles based on cumulative displacement for IPI-S-Back, IPI-S-Face, and IPI-N-Back, respectively. Only data from August (summer) and February (winter) of each year are plotted to illustrate the movement of the abutment due to the thermal movement of the superstructure. The readings indicate a thermal response, moving outward in the positive direction (toward the abutment) and inward in the negative direction (toward the stream) as the superstructure expands and contracts, respectively.

The cumulative displacement profiles for the IPIs installed behind the backwall and at the face of the south abutment are questionable (figure 38 and figure 39); it is suspected that errors were produced by the south abutment IPI sensors. For example, the bottom IPI sensors show movement even though they were installed in the dense till foundation. Additionally, the pattern of the movement of the IPI sensors do not show the thermal movement of the abutment due to expansion and contraction of the superstructure, only contraction, which is questionable. Such results likely indicate random sensor drift with compounded error added upward toward the top of the abutment.

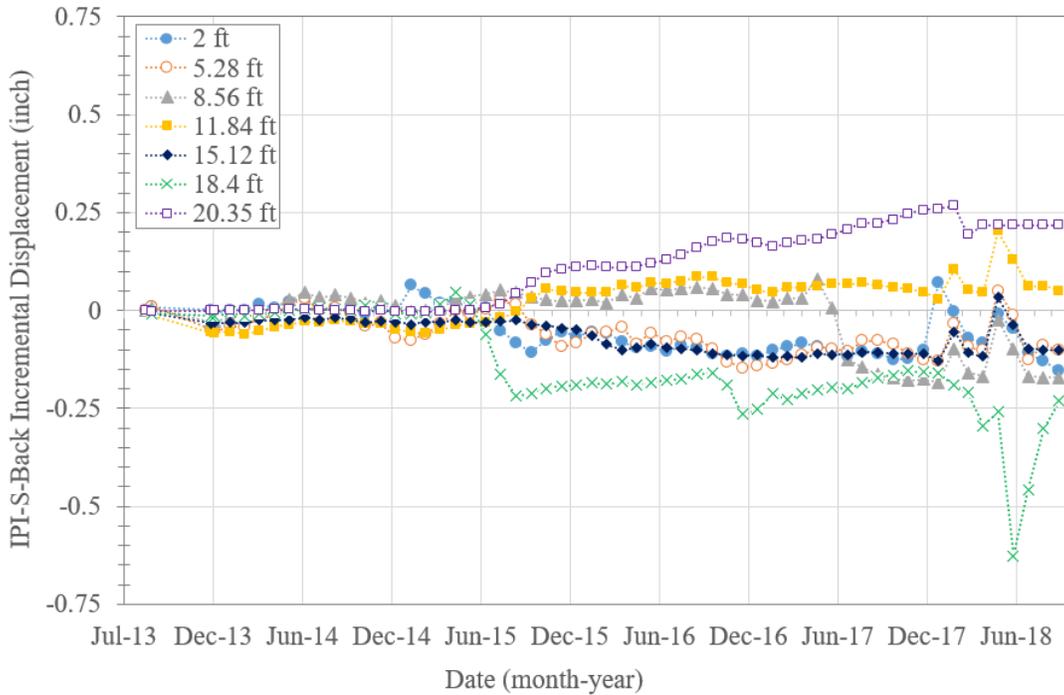
Figure 41. Chart. Incremental displacement for IPI-S-Back.

With cumulative displacement profiles, if any sensor is off, the systematic error compounds as displacement is calculated up the height of the inclinometer. As an alternative to this approach, incremental displacement was evaluated over time for each individual sensor in IPI-S-Back, IPI-S-Face, and IPI-N-Back (figure 41, figure 42, and figure 43, respectively). The data show the movement of the sensors at each depth is relatively similar until about 2015, when more apparent deviations began to occur due to sensor instability (drift). The largest and most active incremental movements occurred 2 ft from the top of the roadway for IPI-N-Back (figure 43), with an approximate movement of 0.5 inch between December 2017 and June 2018. While seasonal cyclic movement is observed at the top of the north abutment backwall, with movement toward the bridge during winter months (contraction) and vice versa during summer months (expansion), the trend seems to show the IPI progressively moves in the positive direction toward the abutment/approach (i.e., away from the stream). However, the IPI sensor at 5.28 ft below the top sensor shows a slight negative movement toward the stream, suggesting the bridge footing might have rotated slightly.

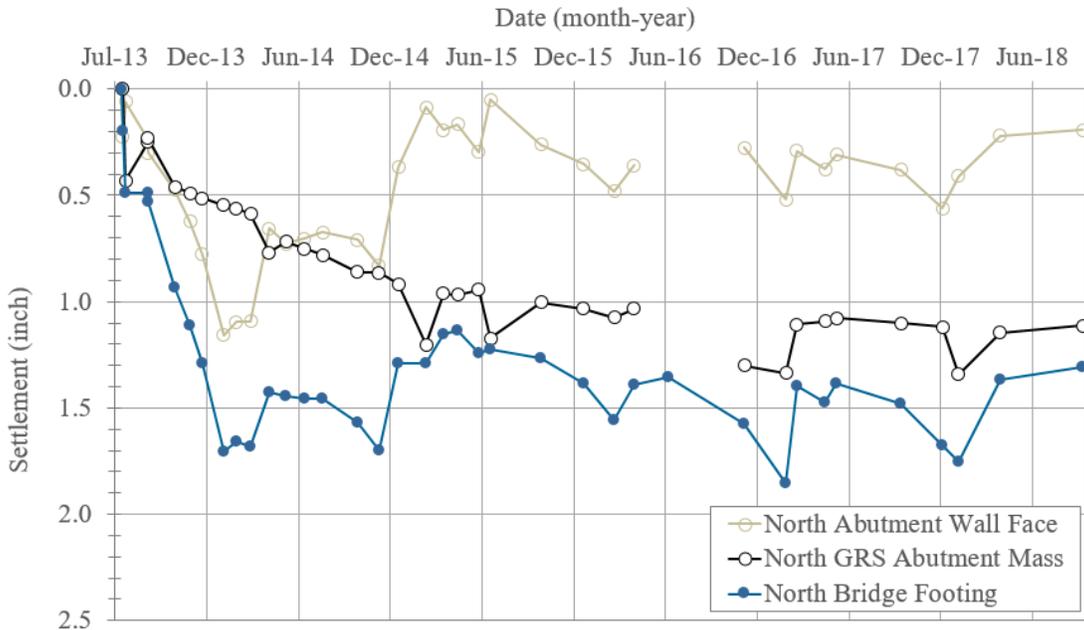
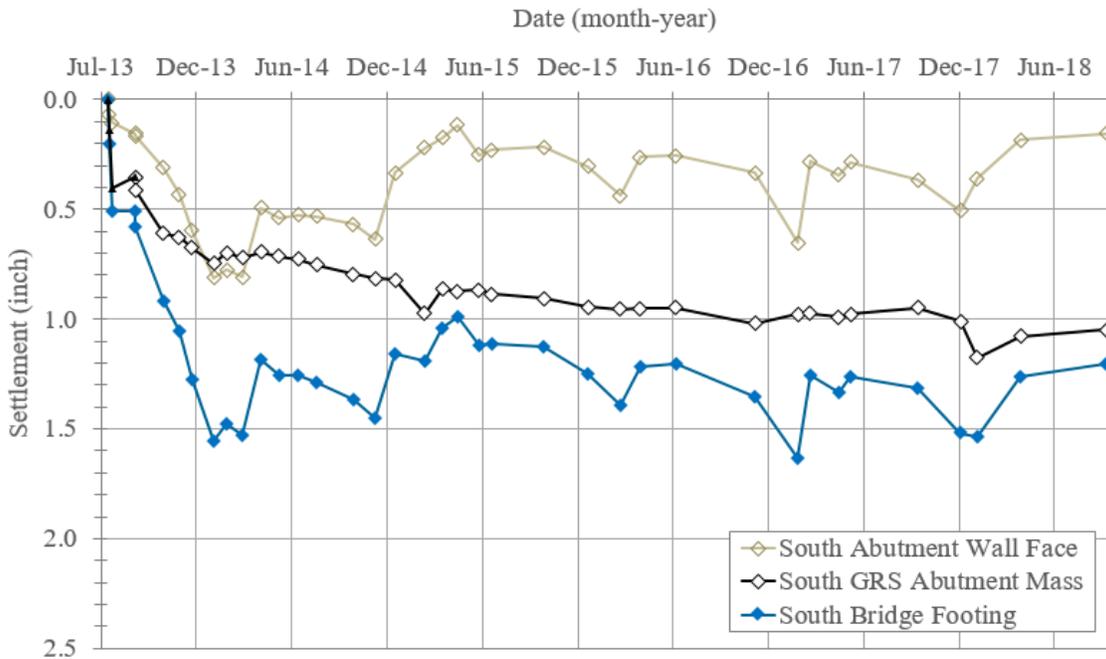
Figure 45. Charts. Vertical settlement of the north and south abutments.

Survey targets were installed on the wall face and on the footings of both abutments to measure total settlement and compression of the reinforced backfill within the GRS abutment. Since the modular block wall facing is relatively incompressible, the settlement it experiences is isolated to the native foundation soils beneath the abutment and RSF. The footing, on the other hand, experiences the total settlement, a combination of both the settlement of the native foundation soils and compression of the reinforced backfill within the GRS abutment. By finding the difference between the footing and wall measurements, the compression of the GRS abutment can be isolated from that of the foundation settlement. Figure 45 shows the bridge footing (total settlement), wall face (foundation settlement), and computed settlement of the GRS-abutment mass for the north and south abutments. The 5-year settlement record shows some seasonal fluctuations, which are perhaps due to the swelling or freezing of foundation soils. Figure 46 illustrates the compression of the GRS abutment mass due to the deadweight of the superstructure in terms of strain (as a function of the wall heights of the north and south GRS abutments, which are of 11.0 and 11.6 ft, respectively).

A. North abutment settlement.

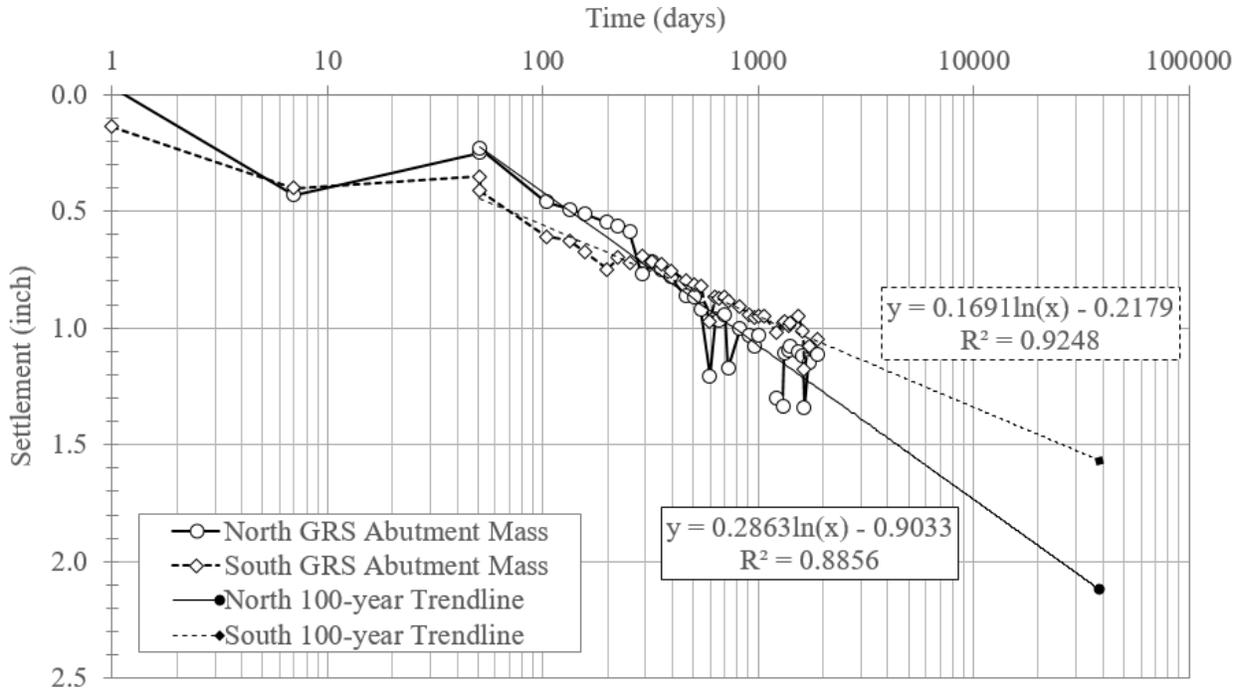
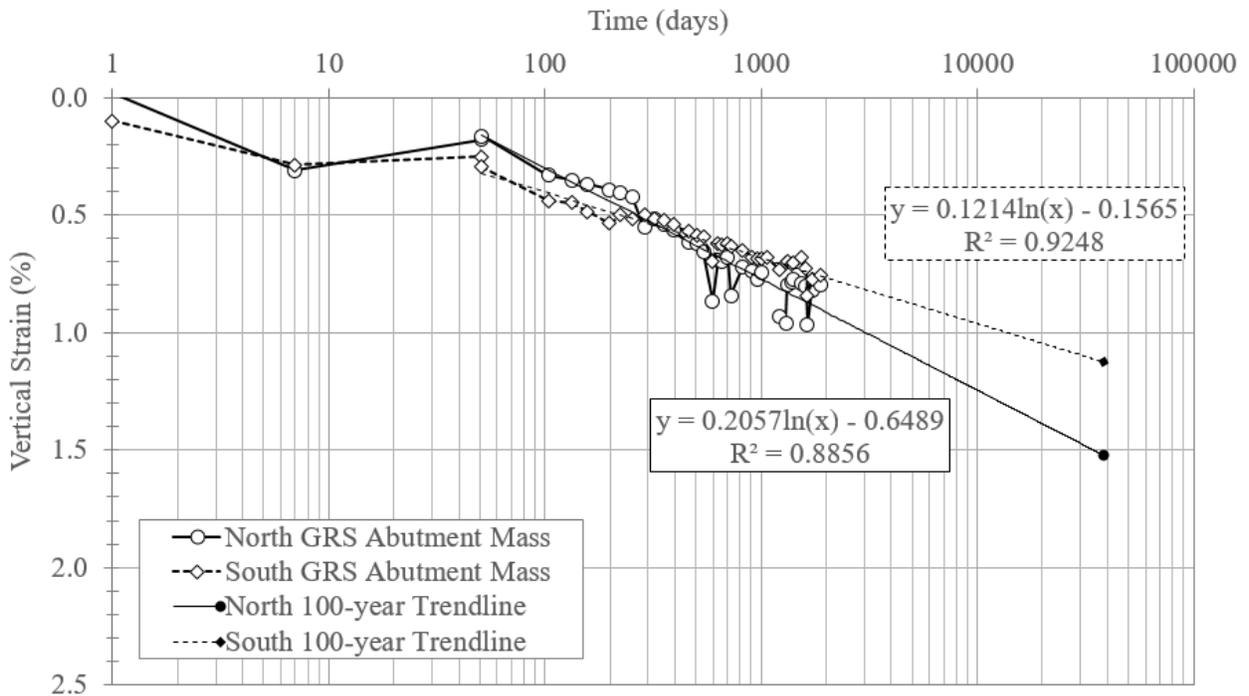
Figure 47. Charts. 100-year forecast for settlement and vertical strain of the north and south abutments.

There is some differential settlement between the north and south abutments, but the magnitude is small and well below tolerable angular distortion for the superstructure. The differential settlement for the GRS abutment masses and the footings between the north and south abutments is shown in figure 48. After 5 years, the angular distortion (i.e., the ratio of the differential settlement to the span length [105 ft]) is about 0.0003. This angular distortion value is one order of magnitude below the American Association of State Highway and Transportation Officials angular distortion criteria limits of 0.008 for simple span bridges (AASHTO 2017). For the projected 100-year settlements (figure 47-A), the forecasted maximum angular distortion is 0.0004.

A. 100-year settlement forecast.
