# Nondestructive Evaluation of Concrete Bridge Decks with Overlays

PUBLICATION NO. FHWA-HRT-21-023

MARCH 2021

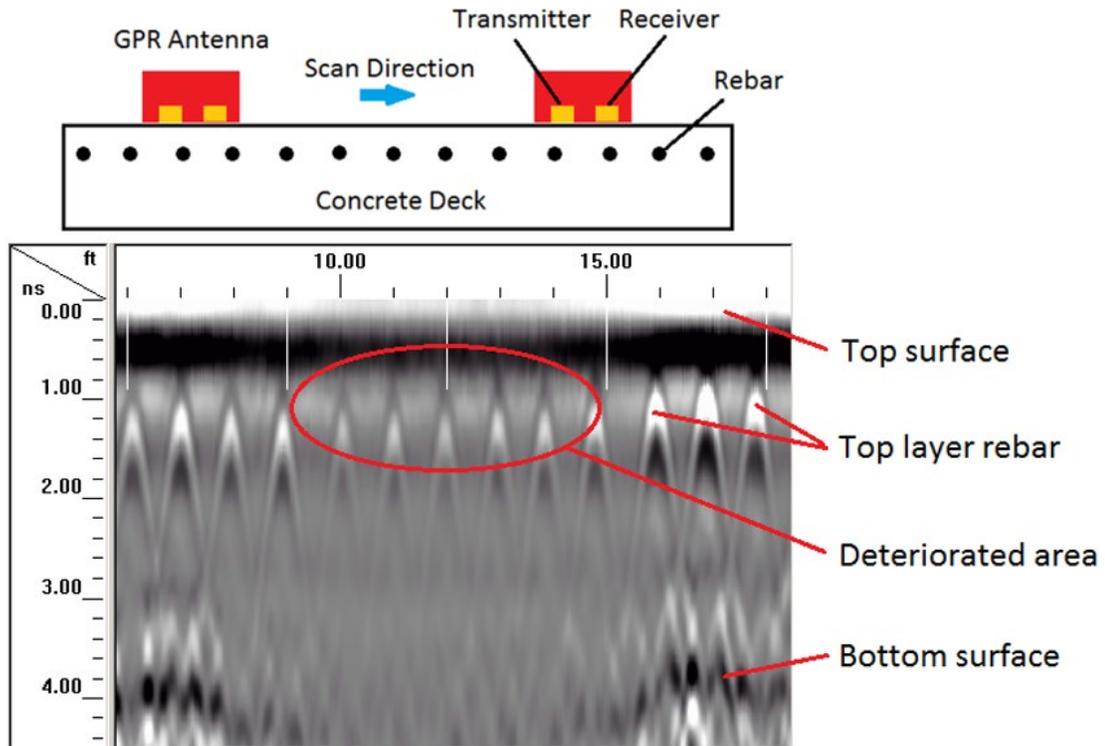
**Figure 7. Graph. Deterioration map of a concrete bridge deck.**

Corrosive concrete environments are usually high in free chloride ions that attenuate EM waves, which is why condition assessments of concrete bridge decks using GPR are based on evaluating the attenuation of EM waves at the uppermost rebar level. GPR scanning of a reinforced concrete bridge deck and the B-scan results are shown in figure 6. While A-scans are waveforms acquired at each scan point, B-scans offer a 2D cross-sectional view of the concrete bridge deck. GPR data are collected along equally spaced profile lines perpendicular to the direction of the uppermost rebar level of the concrete bridge deck.<sup>(35)</sup> A contour map of deterioration can be drawn based on the EM wave reflection at each rebar location. An example deterioration map for a concrete bridge deck is shown in figure 7.

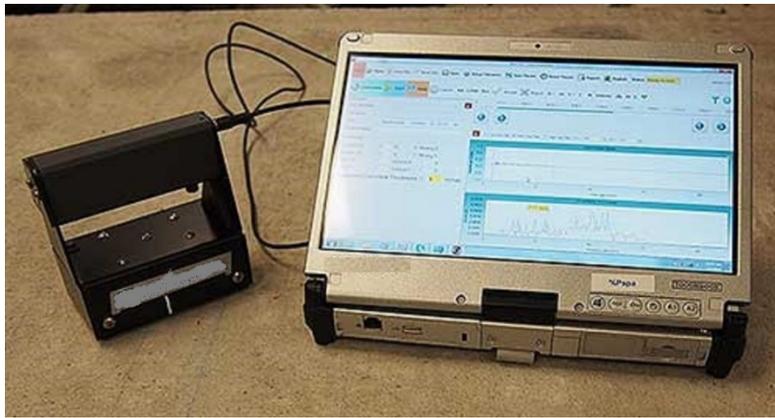
**Figure 8. Photo. IE testing system.**

The IE method uses multiple stress wave reflections to detect defects in concrete bridge decks by striking the concrete bridge deck with an appropriate transient impact and measuring the surface motion at a selected location. Figure 8 shows a custom-built pneumatic acoustic array with eight impact–receiver pairs for IE tests. Figure 9 shows a schematic diagram of an IE test where the concrete bridge deck surface is struck by a transient impact, which can be wire-mounted steel spheres, solenoid-type impactors, or automated projectile sources, and the surface motion is measured by a physically coupled accelerometer or an air-coupled microphone. The frequency spectrum of the surface motion can be used to identify the peak frequency, which represents the transient resonances caused by multiple reflections of stress waves between the top of the slab surface and the reflector (e.g., delamination, slab bottom surface). The reflector is defined as the interface between two media with a relatively large acoustic impedance difference, such as concrete–air interface for delaminations and voids.

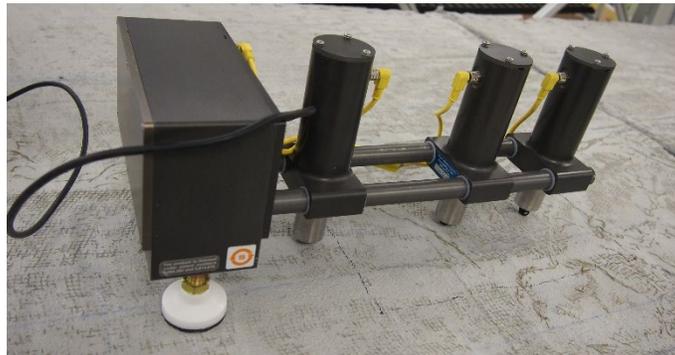
**Figure 10. Photo. PSPA.**

In real-world applications, the phase velocities of high-frequency surface waves in different concrete bridge decks inevitably show different extents of variations. An average velocity is used to calculate the concrete modulus. A significant variation of the phase velocity is an indication of a defect (e.g., delamination, void). A portable seismic property analyzer (PSPA) (figure 10) is a USW device that can be used to generate a modulus map to assess concrete bridge decks (figure 11).

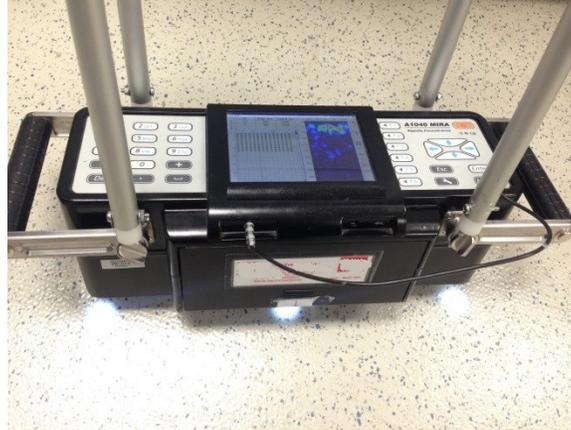
**Figure 17. Photo. Top view of a UT-MIRA tomographer.**

UT-MIRA uses shear waves polarized in the horizontal plane (shear horizontal (SH) waves) to detect objects under the concrete surface in a pulse–echo manner. A UT-MIRA tomographer in shown in figure 17 and figure 18. SH waves with a center frequency between 25 and 80 kHz can be generated by a short-burst, high-amplitude pulse through a dry-point contact. When SH waves are reflected by an object, the time from the start of the motion to the arrival of the echo is measured. If the wave speed is known, the depth of the object can be calculated as shown in figure 19.

A UT-MIRA tomographer has a matrix antenna of 48 transducers with dry-dot contact and ceramic wear-resistant tips. The antenna is a 12×4 matrix of 12 blocks with 4 transducers in each block. Each transducer can be depressed up to  $\frac{1}{3}$  inch with an independent spring for complete contact of the antenna with the concrete surface. When one block of four transducers acts as the transmitter, the other blocks act as receivers. This pitch–catch configuration is repeated until each of the 11 blocks of transducers has acted as a transmitter. Data are analyzed using the synthetic aperture focusing technique (SAFT) to present a 2D cross-sectional image below the antenna (figure 20).<sup>(43)</sup> All data can be transferred to a computer and three-dimensional (3D) visualization software used to view different slices of the internal structure (figure 21).

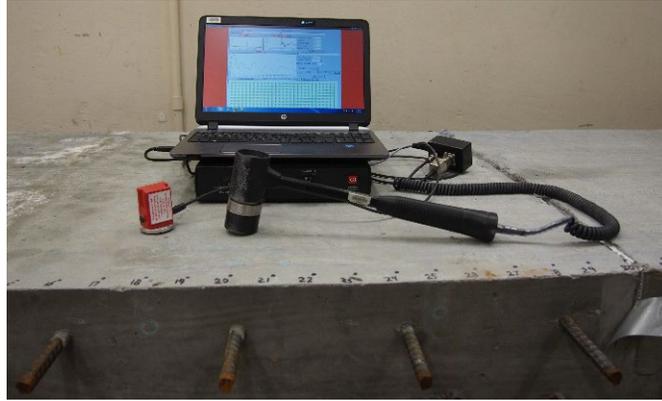
**Figure 22. Photo. IR testing.**

The IR method uses a sledgehammer with an embedded load cell to strike the concrete surface and a nearby geophone coupled to the concrete surface to record the surface motion and locate delaminations and voids in concrete bridge decks (figure 22). The fast Fourier transforms of the recorded impact force and velocity provide the force and velocity spectra, respectively, and then the velocity spectrum can be divided by the force spectrum to get the surface mobility spectrum (i.e., flexibility spectrum). The inverse ratio is the dynamic stiffness spectrum (i.e., mechanical impedance).

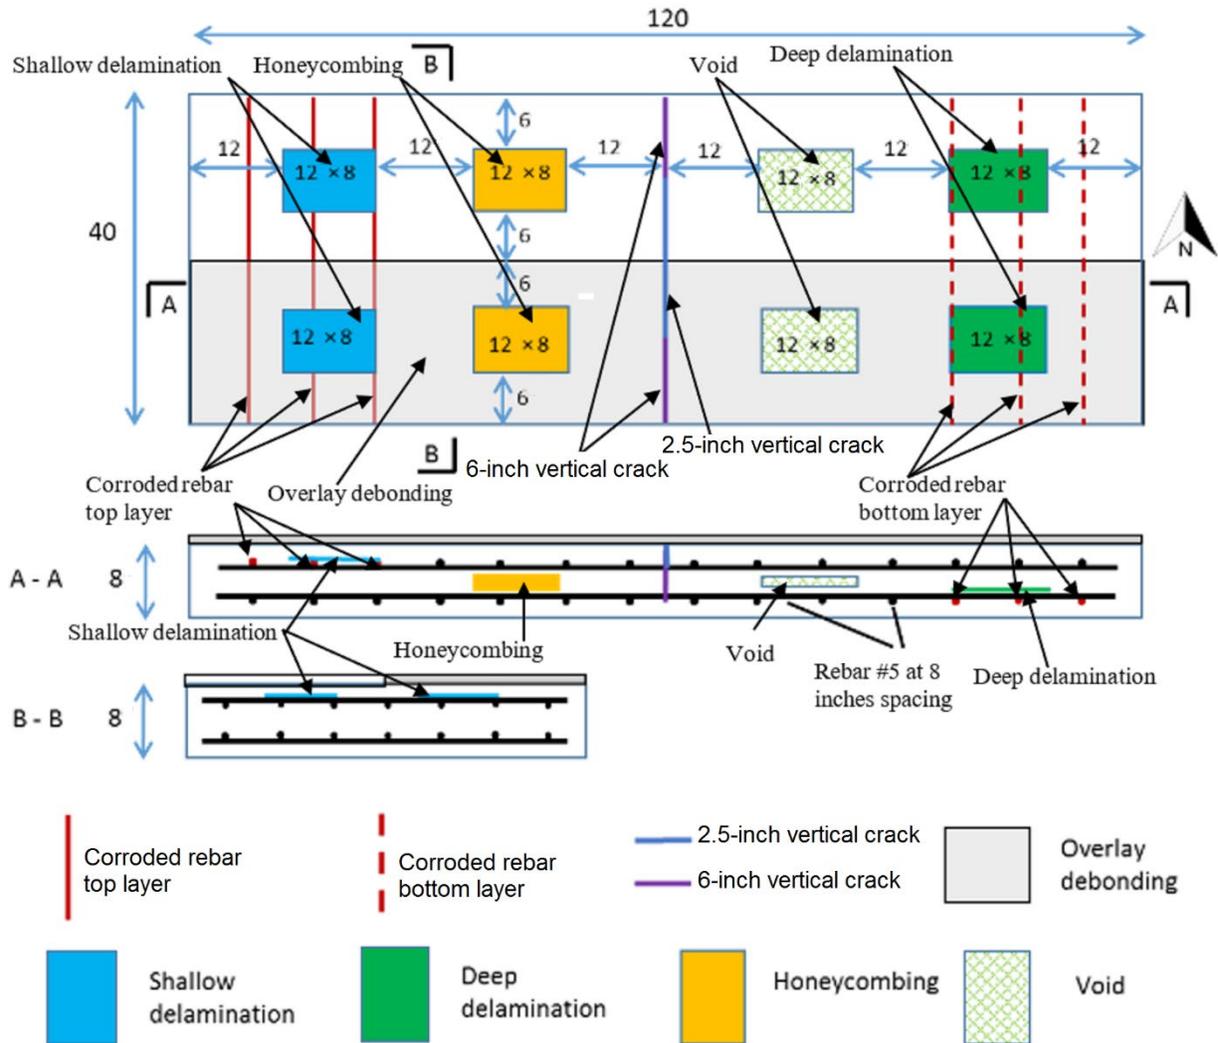
Eight identical concrete specimens were designed and built with various artificial defects, including delamination at the upper and lower rebar levels, honeycombing, voids, vertical cracks, and precorroded rebar within an elevated chloride content environment. The procedures for designing and building the concrete specimens and creating artificial defects are covered in chapter 5. The design of the small-scale specimens with artificial defects is shown in figure 24. To simulate actual concrete bridge decks, the specimens have dimensions of 120×40×8 inches, use a normal-weight concrete mix with a water to cement ratio of 0.37 and a 28-d minimum compressive strength of 4,000 psi, and have two mats of uncoated steel reinforcement with No. 5 bars at a spacing of 8 inches in both transverse (the topmost layer) and longitudinal directions. To simulate real-world conditions, the specimens have 11 artificial defects, including 2 shallow delaminations, 2 deep delaminations, 2 areas of honeycombing, 2 voids, 1 vertical crack, and 2 pieces of corroded rebar mat within an elevated chloride content environment.

Source: FHWA.  
Note: Units are in inches.

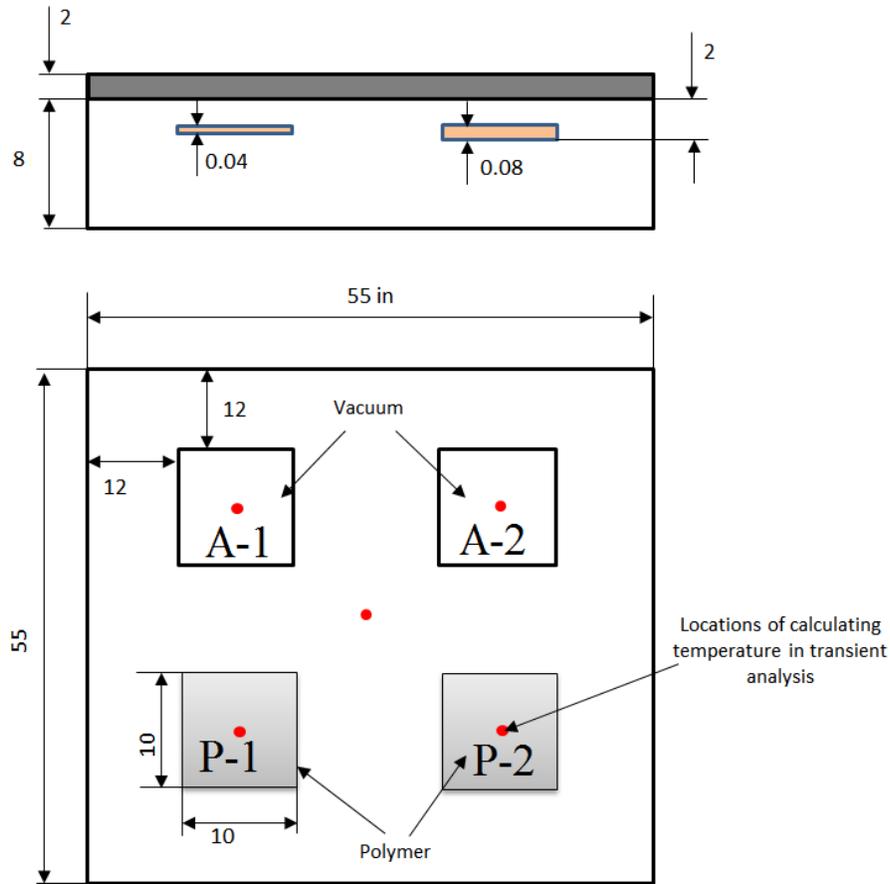
Three FE models with slight differences were investigated. In the first FE model, the delaminations were set 2 inches from the top surface of the concrete without overlay to simulate shallow delaminations. In the second FE model, the delaminations were set 2 inches from the top surface of the concrete with 2 inches of asphalt overlay with no waterproof membrane. In the third FE model, the delaminations were set 6 inches from the top surface of concrete without an overlay to simulate deep delaminations.

Source: FHWA.  
 Note: Measurements are in inches.

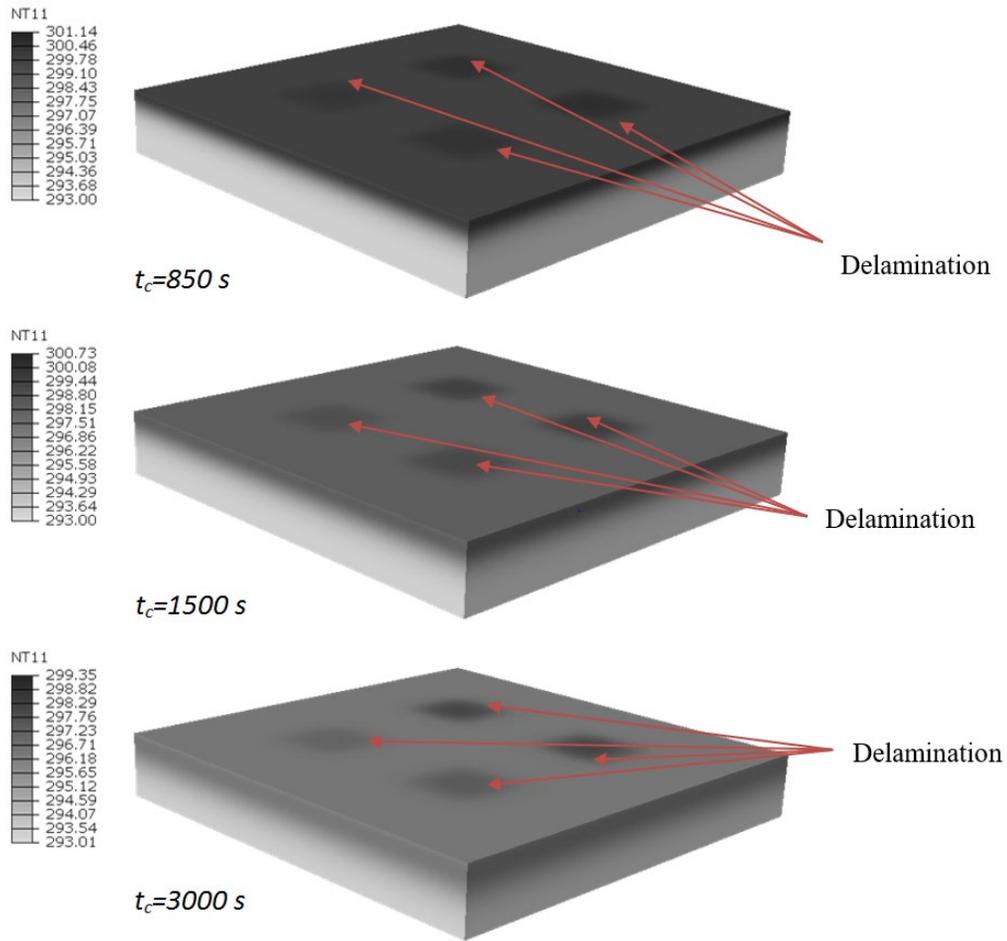
In the first FE model, a heat influx of  $1,200 \text{ W/m}^2$  was applied to the top surface of the concrete for the first 1,000 s, and then the concrete was cooled for 3,000 s. The contour map of temperatures at different times in the cooling period for shallow delaminations is shown in figure 41. Time histories of the temperatures acquired from shallow delamination defect points on the top surface of the concrete are shown in figure 42. The greatest temperature difference was approximately  $3.6^\circ\text{F}$  from the 0.08-inch air voids, and the lowest temperature difference was approximately  $1.4^\circ\text{F}$  from the sandwiched structure with 0.04-inch foam insulation.

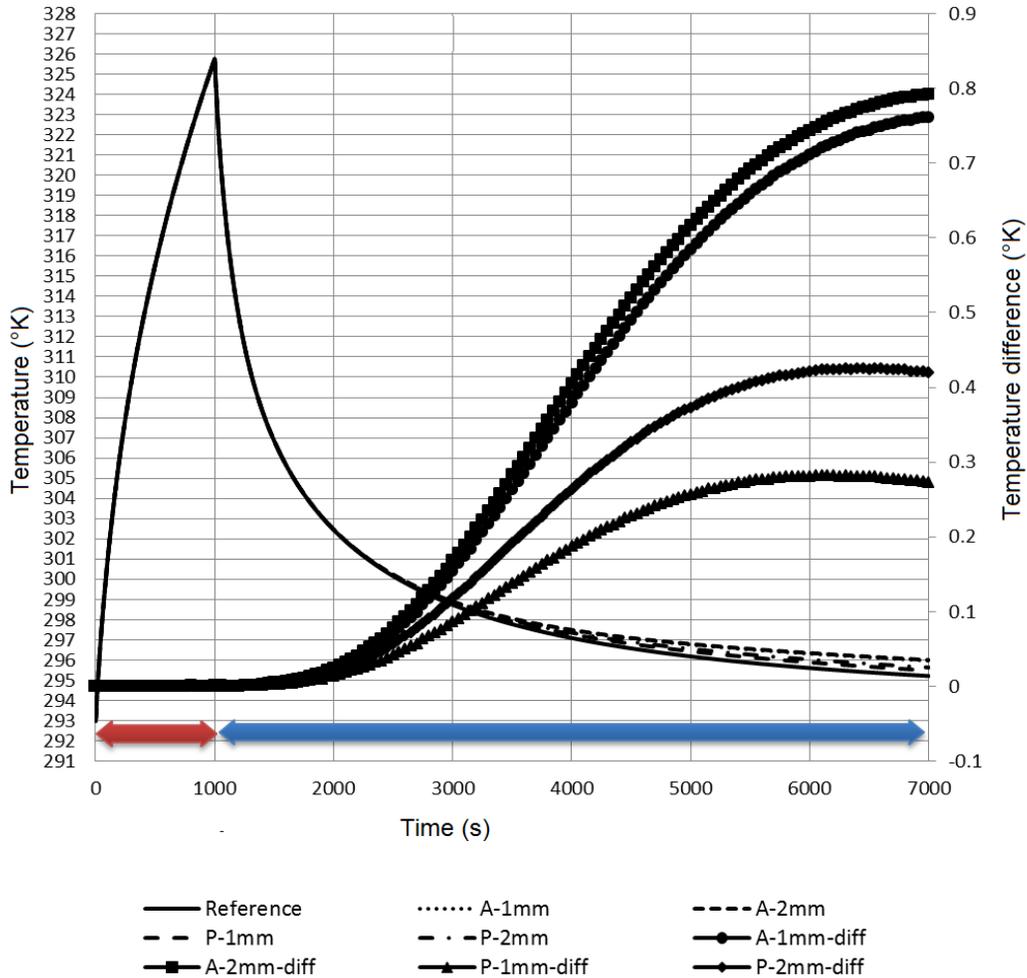
In the second FE model, a heat influx of  $1,200 \text{ W/m}^2$  was applied to the top surface of the 2-inch asphalt overlay for the first 1,000 s, and then the concrete was cooled for 6,000 s. The time histories of the temperature data acquired from shallow delamination defect points on the top surface are shown in figure 43. The greatest temperature difference was approximately  $1.4^\circ\text{F}$  from the 0.08-inch air voids, and the lowest temperature difference was approximately  $0.6^\circ\text{F}$  from the sandwiched structure with 0.04-inch foam insulation.

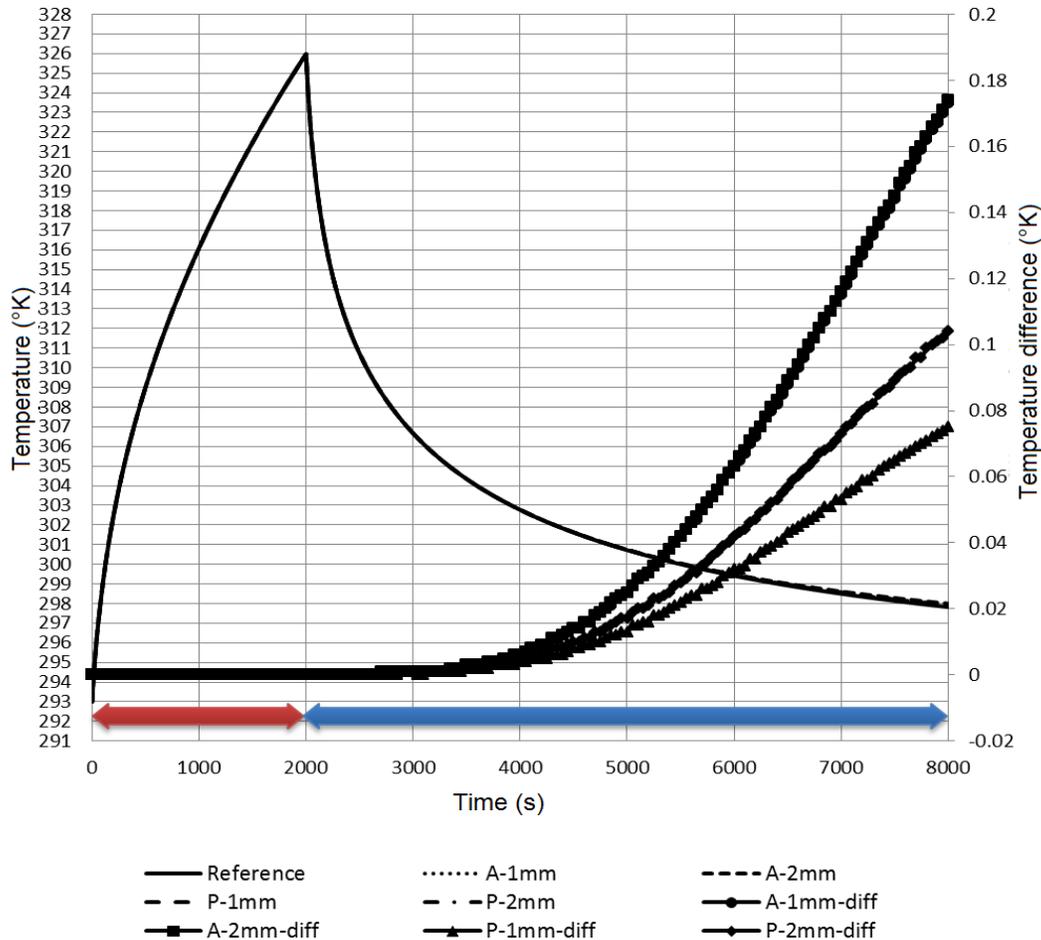
In the third FE model, a heat influx of  $1,200 \text{ W/m}^2$  was applied to the top surface of the concrete for the first 2,000 s, and then the concrete was cooled for 6,000 s. The time histories of the temperature data acquired from shallow delamination defect points on the top surface are shown in figure 44. The greatest temperature difference was approximately  $0.32^\circ\text{F}$  from the 0.08-inch air voids, and the lowest temperature difference was approximately  $0.14^\circ\text{F}$  from the sandwiched structure with 0.04-inch foam insulation. The temperature differences were still increasing at the end of the analysis.

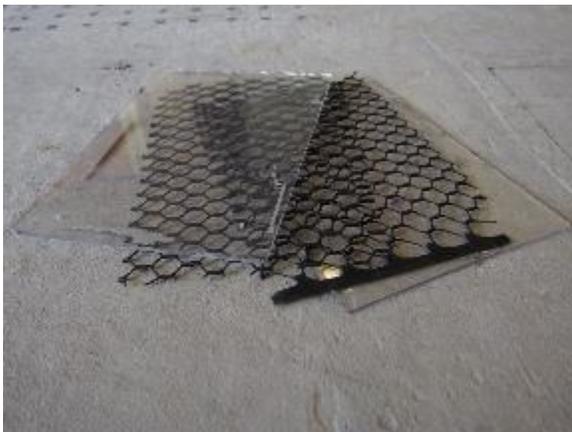
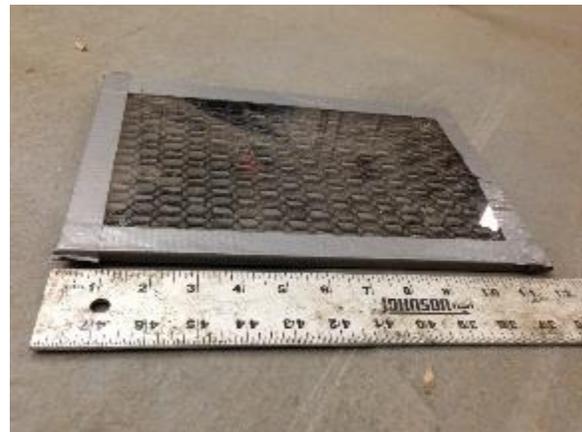
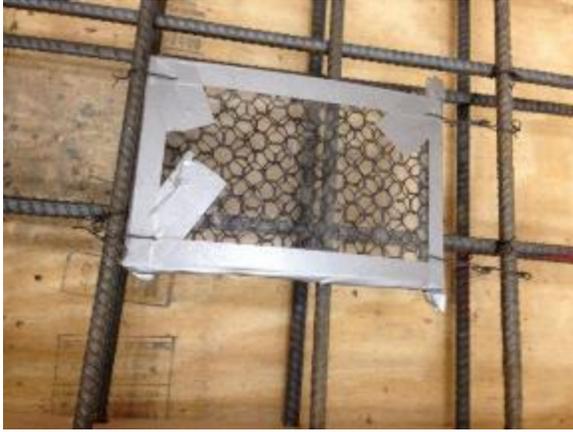
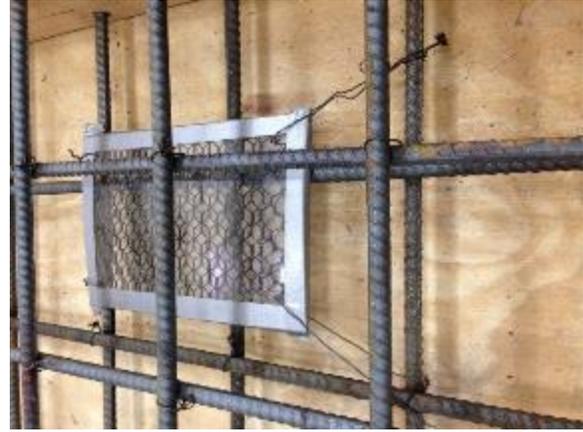
**Figure 45. Photos. Artificial delamination.**

Delaminations were simulated by a thin, 12×8-inch rectangle built with transparent thermoplastic and plastic gutter guard, as shown in figure 45-A and figure 45-B. Two transparent thermoplastic sheets with a thickness of 0.093 inch were cut to size, two layers of plastic gutter guard were placed between the sheets to create an air gap, and then the edges were sealed with duct tape. The transparent thermoplastic sheets were secured to the rebar cage using baling wire and rebar ties to ensure they stayed in place during the concrete pouring and vibrating operations, as shown in figure 45-C and figure 45-D. These artificial delaminations simulated shallow and deep delaminations by placing them at the top and bottom rebar levels, respectively.

A. Transparent thermoplastic and plastic gutter guard.

B. Assembled artificial delamination.

C. Artificial shallow delamination.

D. Artificial deep delamination.

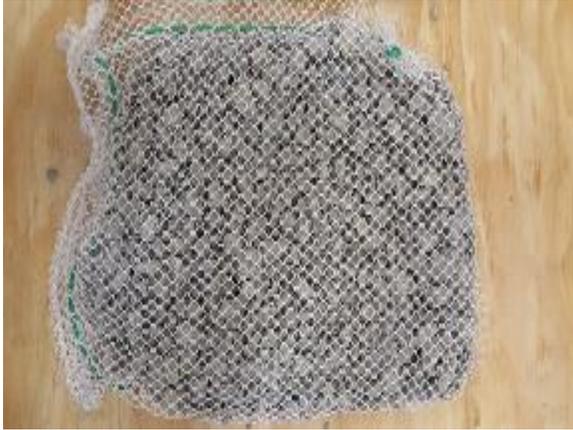
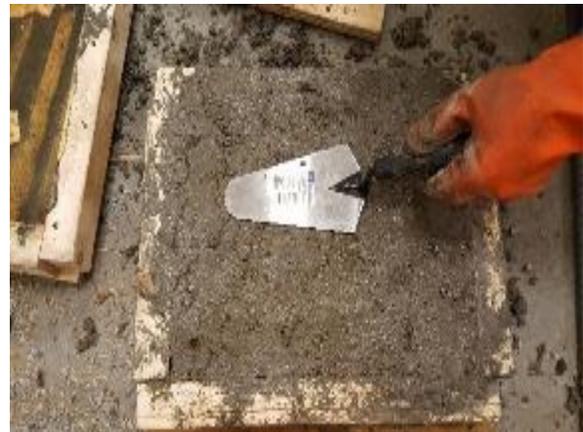
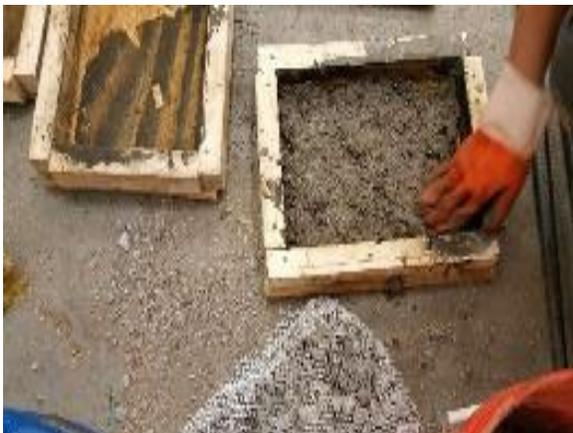
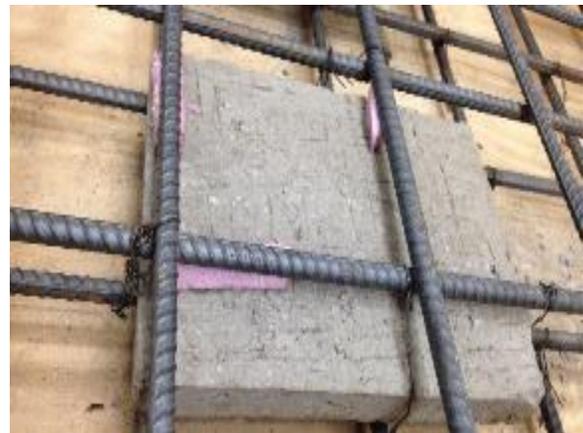
Honeycombing was simulated by a bag of loose aggregate, as shown in figure 46-A. Mesh laundry bags were cut into smaller bags, 12 lb of aggregate was placed in each bag, and then the edges were stitched with baling wire. Wood molds were built with an inner dimension of 14×10×2 inches. A thin layer of concrete containing anticrack fiber was placed on the bottom of each mold, a bag of aggregate was positioned in the mold with all four sides 1 inch from the edge of the mold, and then the sides and the top were covered with concrete, as shown in figure 46-B through figure 46-E. The cured blocks were secured to the rebar cage using baling wire and foam pieces to ensure they stayed in place during concrete pouring and vibrating operations, as shown in figure 46-F.

A. Coarse aggregate in a mesh laundry bag.

E. Aggregate bag covered with concrete.

C. Mold with a thin layer of concrete.

F. Installed artificial honeycombing.

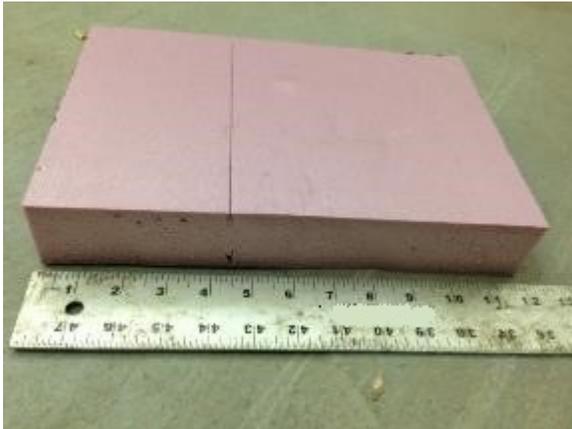
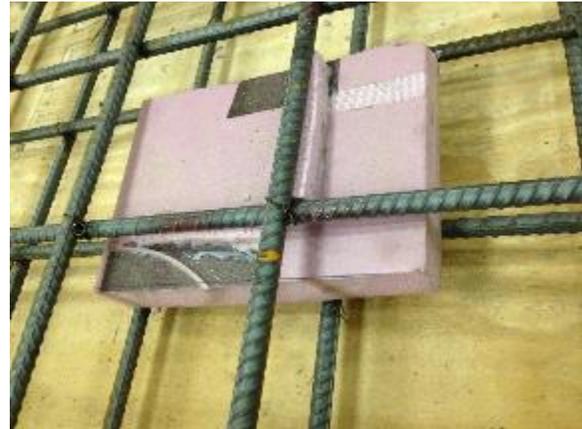
Foam insulation boards with a dimension of 12×8×2 inches were used to simulate voids within concrete, as shown in figure 47-A. The foam insulation boards were secured to the rebar cage using foam pieces on the top and bottom to ensure they stayed in place during concrete pouring and vibrating operations, as shown in figure 47-B.

A. Foam insulation board.

B. Installed artificial void.

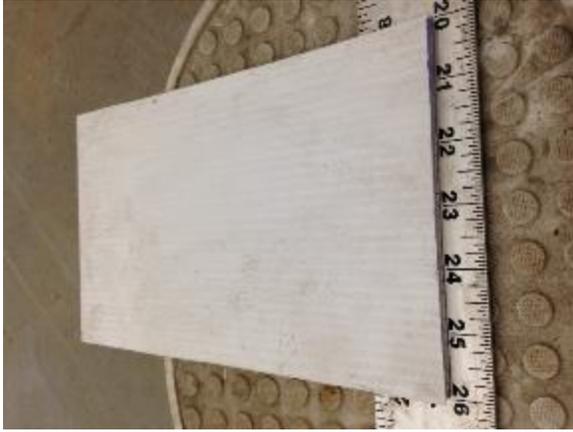
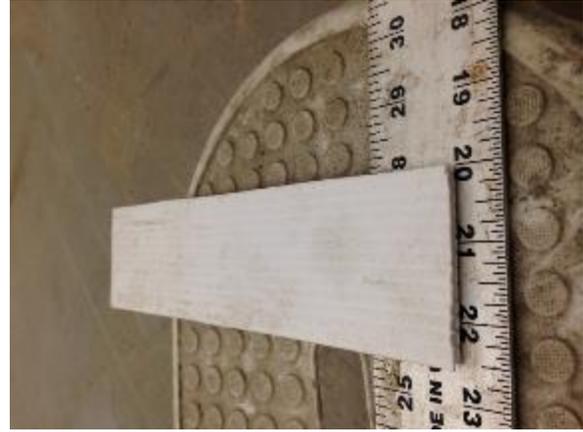
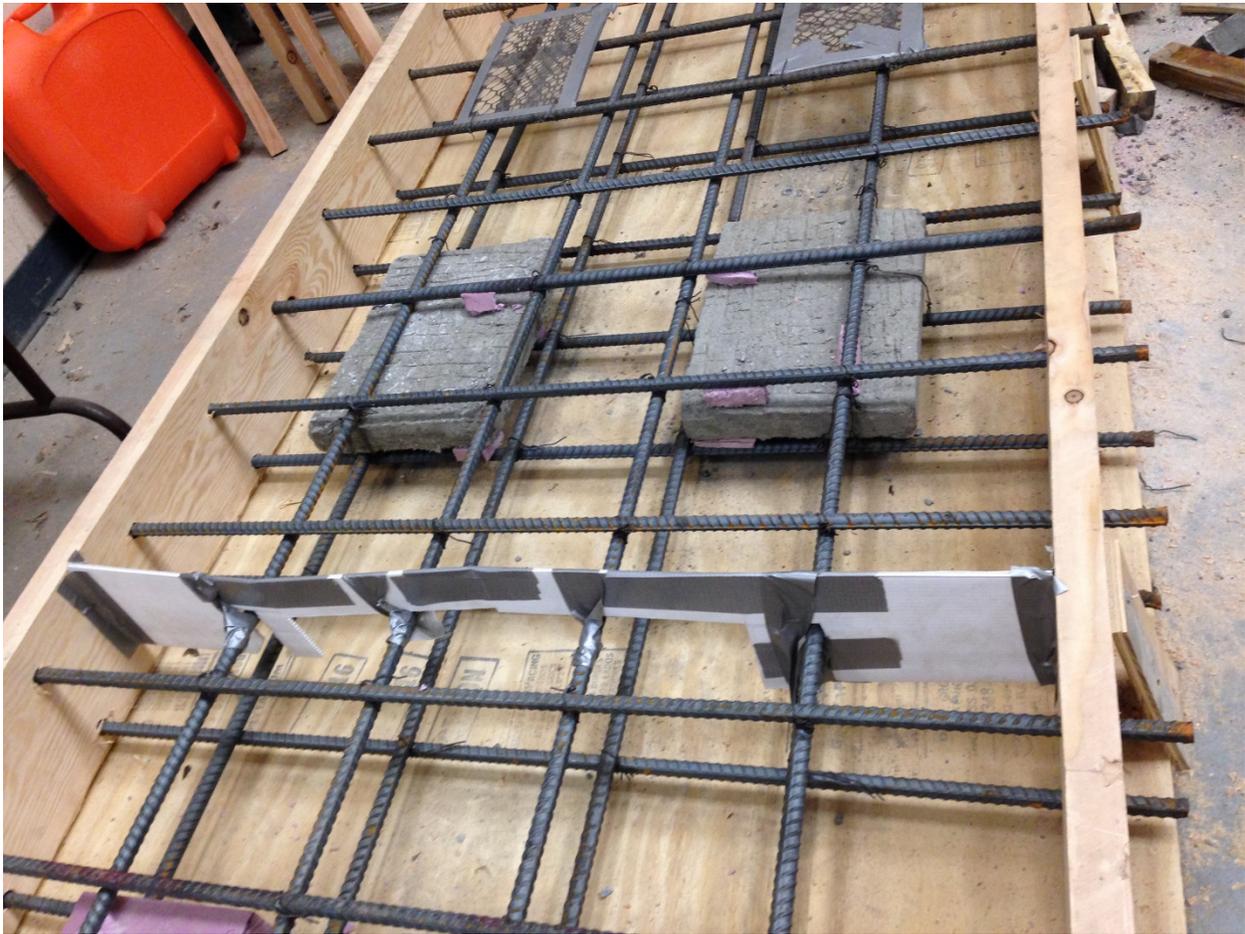
Corrugated plastic sheets with a height of either 6 or 2.5 inches, a thickness of 0.16 inch, and a length of 10 inches were used to simulate vertical cracks, as shown in figure 48-A and figure 48-B. The sheets were secured to the mold using wire and duct tape to ensure they stayed in place during concrete pouring and vibrating operations, as shown in figure 48-C.

A. 6-inch corrugated plastic sheet.

B. 2.5-inch corrugated plastic sheet.

C. Installed corrugated plastic sheet.

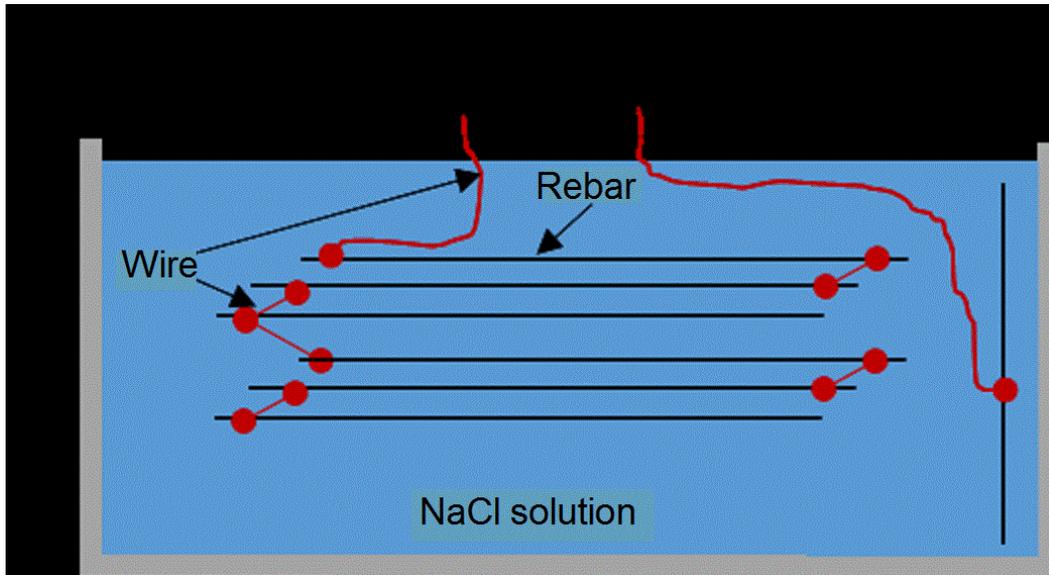
An accelerated corrosion setup was used to introduce corrosion to the new, intact rebar, as shown in figure 49. The rebar was precorroded by placing it in a tub of saturated NaCl solution and applying 1-A direct current (DC) with the positive pole connected to a rebar set and the negative pole connected to a single rebar. Both the set and the single rebar were submerged in the NaCl solution, as shown in figure 50-A through figure 50-F. After 2 weeks, the rebar was severely corroded.

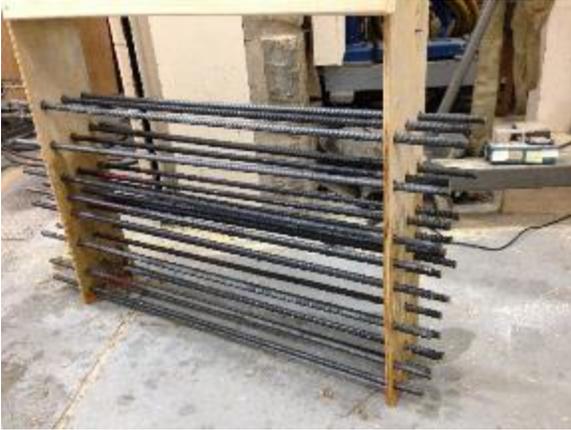
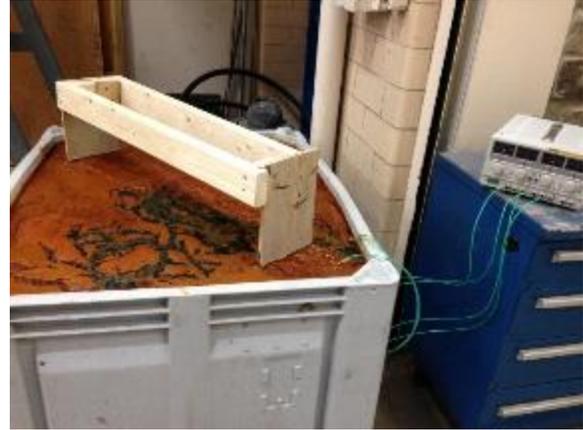
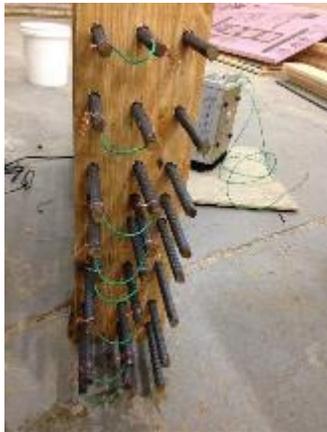
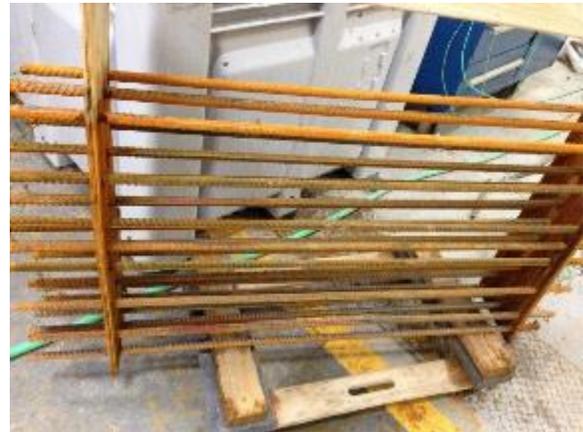
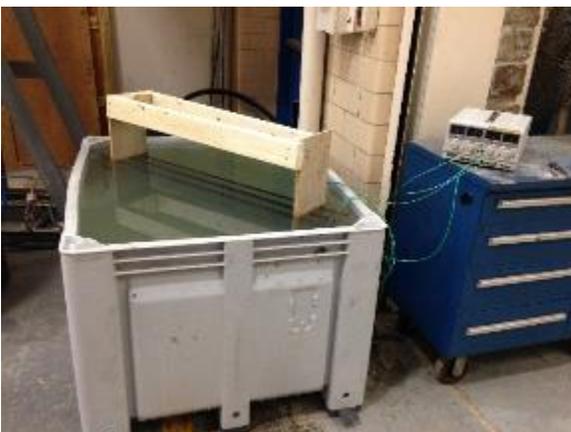
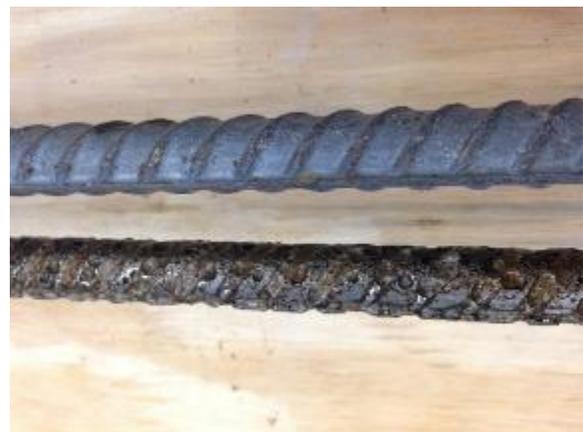
A. Rebar in a frame.

D. Rust in the tub after accelerated corrosion.

B. Rebar connected with wires.

E. Corroded rebar.

C. Accelerated corrosion.

F. Intact versus corroded rebar.

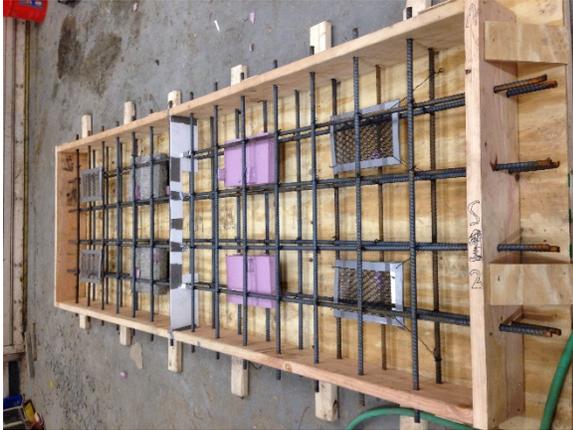
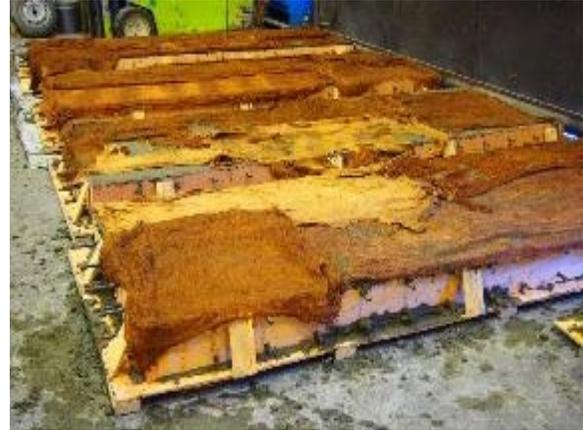
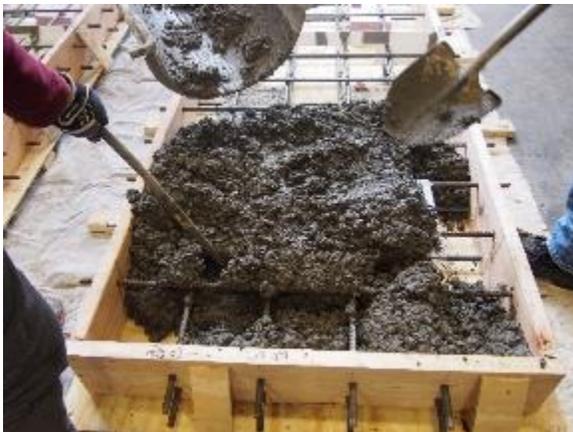
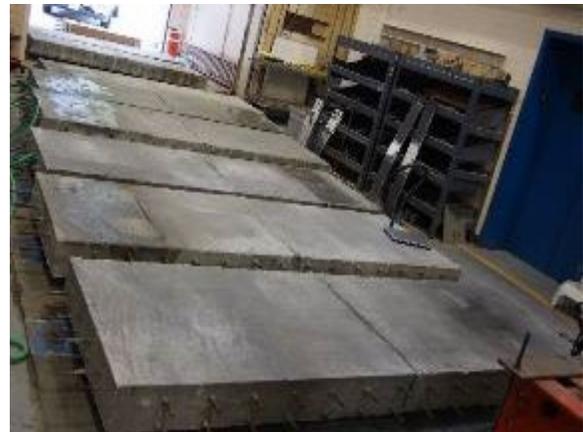
**Figure 51. Photos. Installed artificial defects and construction of specimens.**

A rebar cage and formwork with artificial defects before and after casting is shown in figure 51-A through figure 51-D. Measured depths of the defects after assembly are listed in table 6. The specimens were cast with a dimension of 120×40×8 inches using a wooden formwork and normal-strength concrete, which has a 28-d average compressive strength of 4,665 psi from laboratory tests of concrete cylinders. Eight specimens were named and marked S1 to S8.

A. Assembled rebar with defects.

C. Curing concrete.

B. Pouring concrete.

D. After curing and removing form.

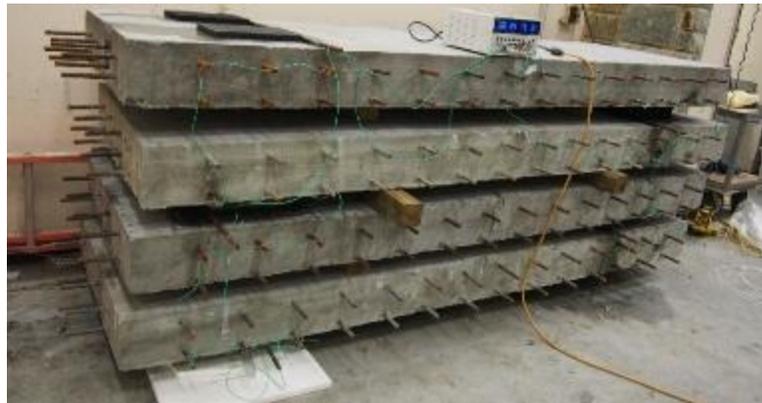
**Figure 53. Photo. Accelerated corrosion of precorroded rebar.**

The artificial defects created with the preceding procedures can be detected only by stress-wave-based methods (e.g., IE and UT) and not by corrosion-related methods (e.g., GPR, HCP, and ER). Unlike the corrosion mechanism in concrete bridge decks, there is not an elevated chloride content environment in the concrete surrounding the six pieces of precorroded rebar in each specimen, and no active corrosion takes place in the rebar after the specimens are cured. To simulate active corrosion, an accelerated corrosion setup was used to introduce active corrosion to the precorroded rebar for HCP tests and an elevated chloride content environment to the concrete surrounding the precorroded rebar for GPR and ER tests (figure 52). The positive end of the DC power supply—which was set to 2 amps—was connected to the precorroded rebar, and the negative end was connected to the rebar that was placed on the concrete surface near the target rebar and attached to sponges saturated with an NaCl solution. After 1 week of accelerated corrosion, active rebar corrosion was visible, and some specimens had small cracks due to the expansion of the actively corroded rebar (figure 53, figure 54-A, and figure 54-B).

An elevated chloride content environment was introduced to the specimens through the accelerated corrosion procedure shown in figure 52 and figure 53. The resulting GPR C-scans, B-scans, and condition maps after depth correction are shown in figure 66 through figure 68, respectively. GPR detected shallow and deep delaminations, voids, and honeycombing in all eight specimens in C- and B-scans. The attenuation of the signals reflected by the top layer rebar was used to image the condition maps of the concrete specimens with an elevated chloride content environment after accelerated corrosion, as shown in figure 68-A through figure 68-H. The condition maps imaged the elevated chloride content environment for the three pieces of corroded rebar in the top layer in all specimens. Some results of the condition maps in the areas of shallow delamination were inaccurate because the EM wave attenuation was less than the actual value due to the superimposed reflections from shallow delaminations and the rebar.

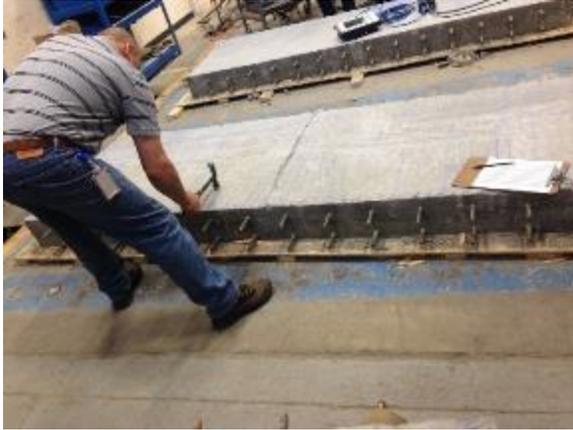
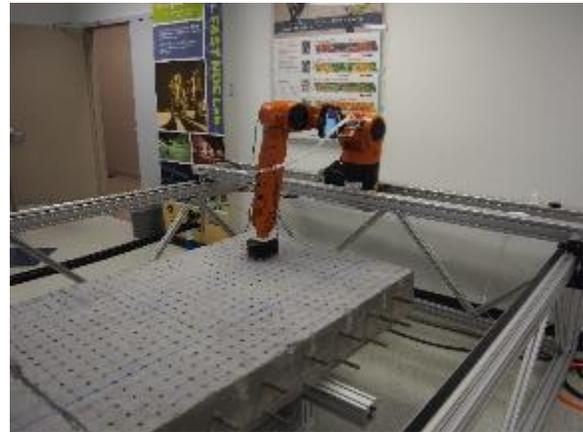
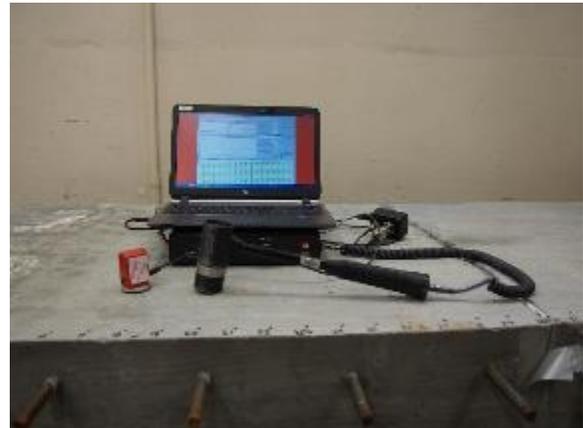
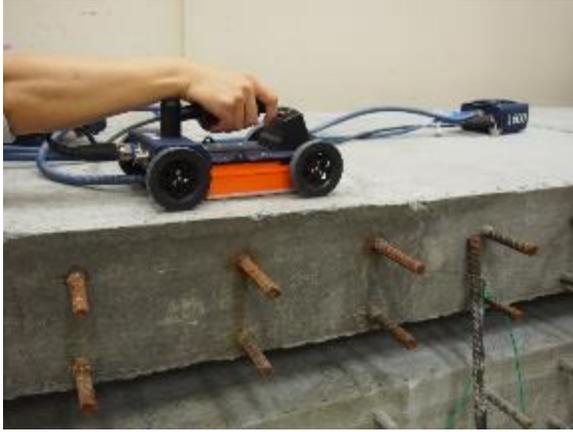
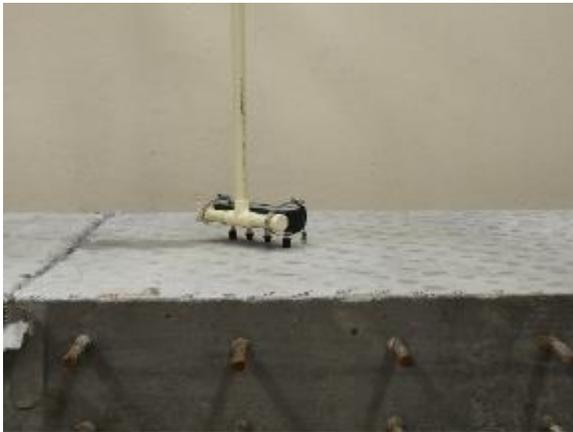
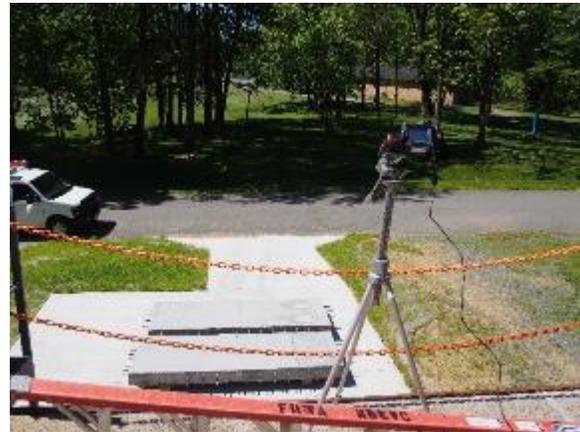
**Figure 55. Photos. NDE tests of specimens without overlays.**

The surface of each specimen was cleaned before the NDE tests. No other activities on the specimens were occurring at the same time for each test. The concrete surface was saturated 30 min before the HCP test. The specimens were placed outdoors without any shade on the specimen surface for IRT tests, and the tests were performed on a sunny day with one thermal picture every 30 min between 10:00 a.m. and 4:00 p.m. The NDE tests were carried out for the eight specimens without and with overlays. Photos of NDE tests on specimens without overlays are shown in figure 55-A through figure 55-J.

A. Sounding.

E. UT-EyeCon attached to robotic arm.

F. IR.

G. GPR.

H. ER.

J. IRT.

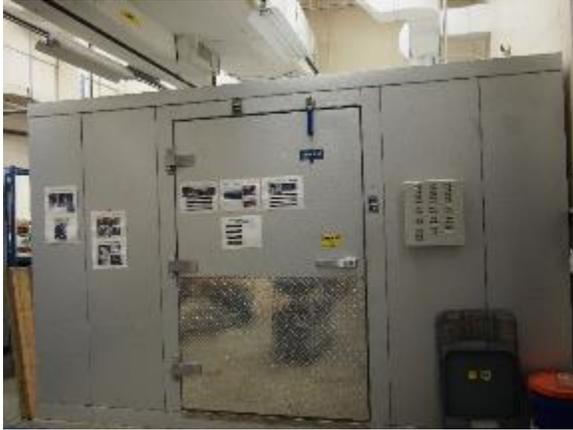
A. Chamber with door closed.

Stress-wave-based NDE technologies (e.g., IE and UT) were effective at detecting subsurface defects in concrete bridge decks with asphalt overlays in cold weather, so a temperature chamber was used to achieve low temperatures for specimens with asphalt overlays, as shown in figure 56-A and figure 56-B.<sup>(54)</sup> To ensure the entire specimen reached the target temperature, each specimen was placed in the chamber overnight, and a thermal probe in a 6×6-inch asphalt cylinder was used to monitor the chamber temperature, as shown in figure 56-B. USW, IE, and UT tests of the three specimens with asphalt overlays were conducted in the chamber. To minimize the variation of the specimen temperatures after the door was open for testing, the testing time was reduced by increasing the USW test spacing to 8 inches, the IE test spacing in the longitudinal direction to 40 inches in the debonded area, and the UT-MIRA test spacing in the transverse direction to 8 inches.

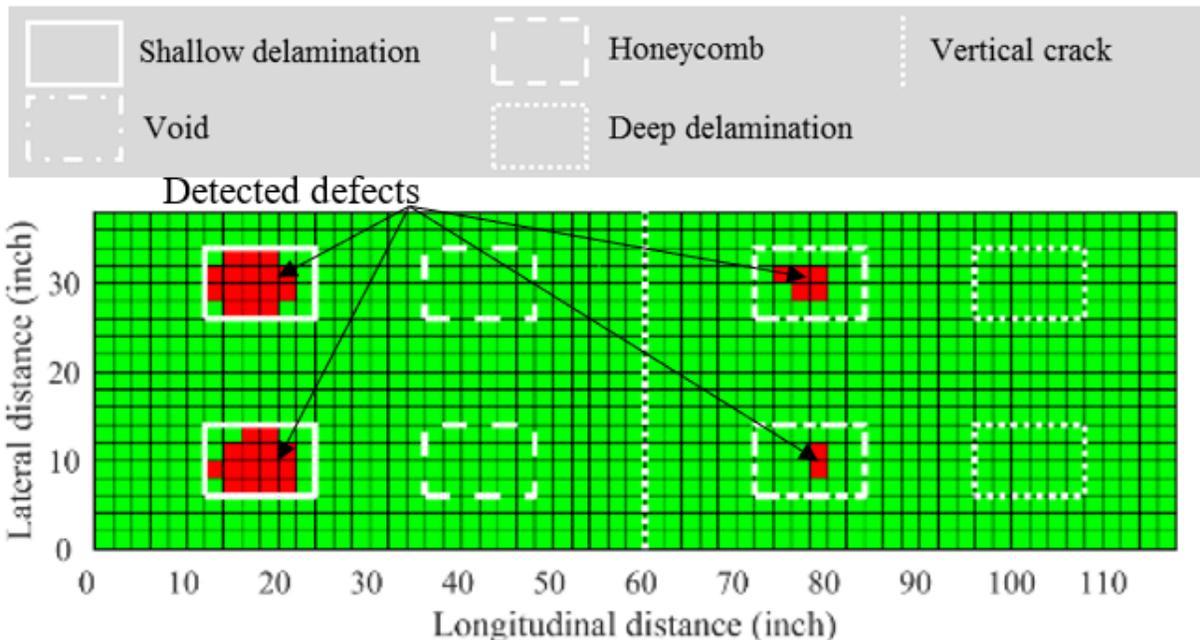
A. S1.

The sounding method involved tapping the concrete surface with a hammer and listening to the sound. Intact areas make clear ringing sounds, whereas defected areas produce dull, hollow sounds. The condition maps based on the sounding method are shown in figure 57-A through figure 57-H with intact areas in green and defected areas in red. The sounding method detected all shallow delaminations in eight specimens, but did not detect any deep delaminations due to their increased depths. As shown in table 6, the depths of the voids and honeycombing were close, but the sounding method only detected voids in specimens S1–S3 and did not detect any honeycombing. The voids made from foam insulation allowed for more give in the concrete than the honeycombing made from aggregate; thus, it was easier for the areas with voids to produce a dull, hollow sound than areas with honeycombing. The sounding method only identified voids in specimens S1–S3 but not in the other five specimens. The sounds from the areas with voids were similar to the sounds from the intact areas, making it challenging for the operator to identify the voids in specimens S1–S3. The sounds from the areas with voids in the other five specimens were indistinguishable for the operator. The sounding method is subjective and the results depend on the operator’s experience and skill.
