# Nondestructive Evaluation of Concrete Bridge Decks with Overlays

PUBLICATION NO. FHWA-HRT-21-023

MARCH 2021

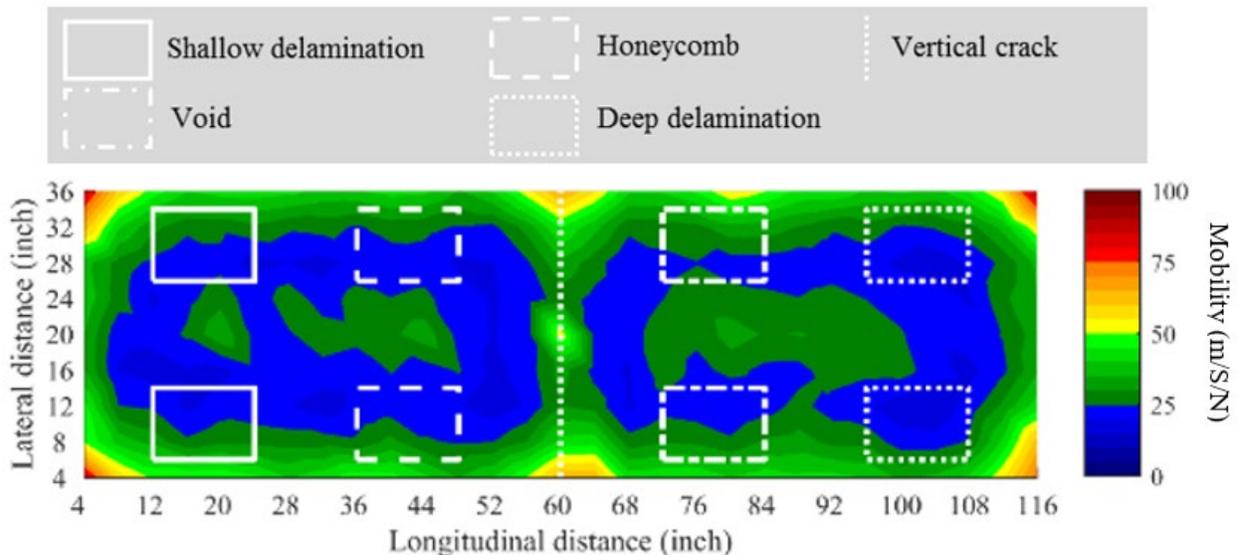
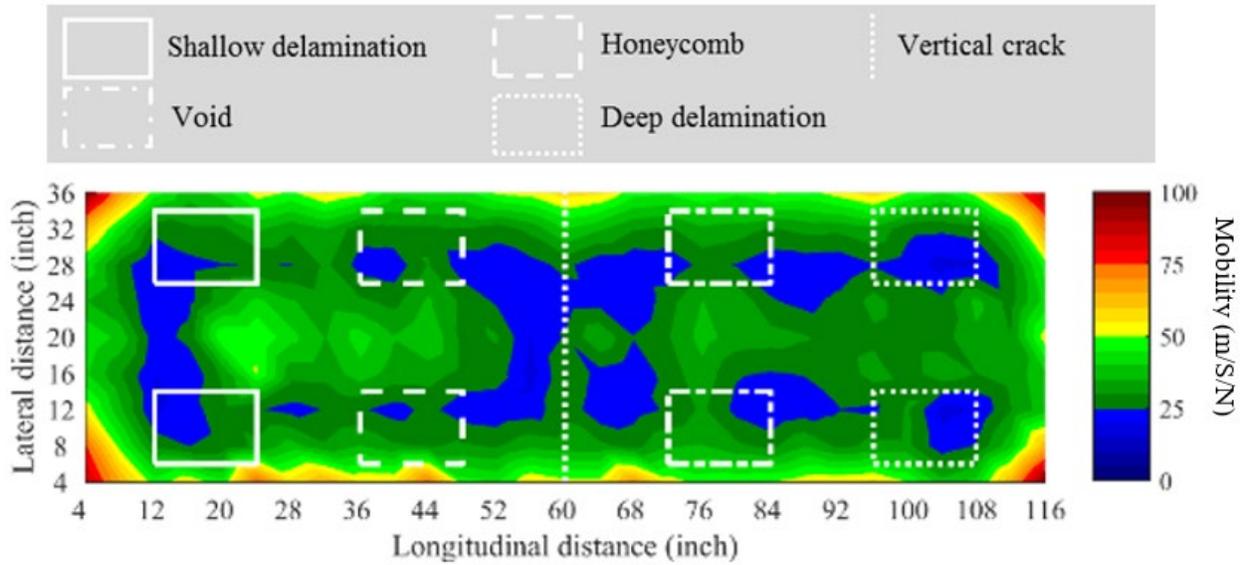
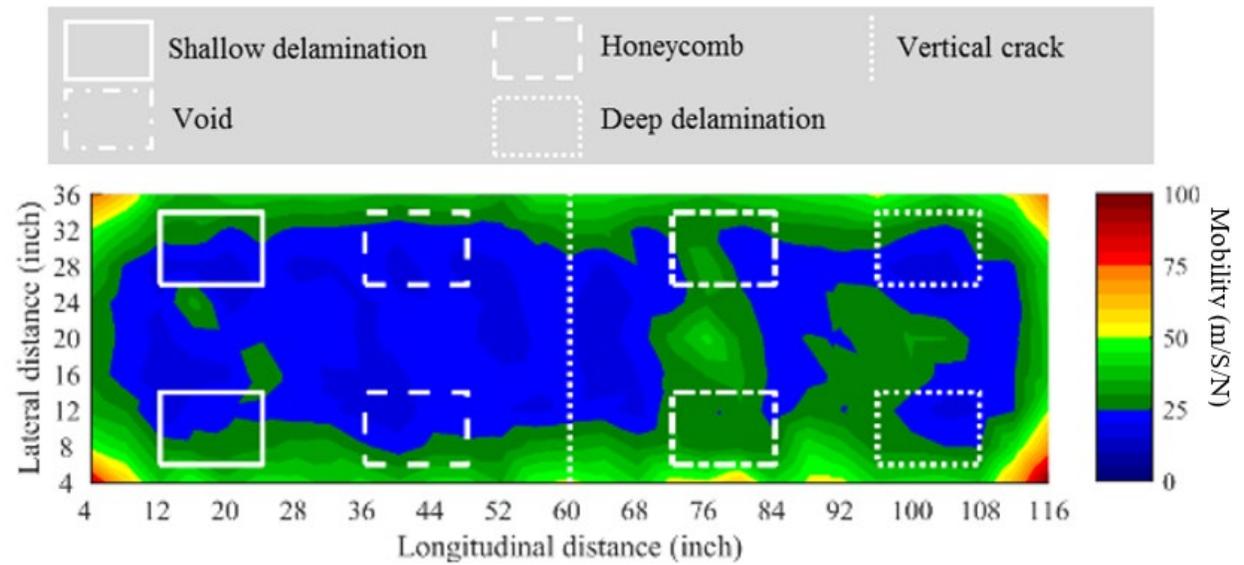
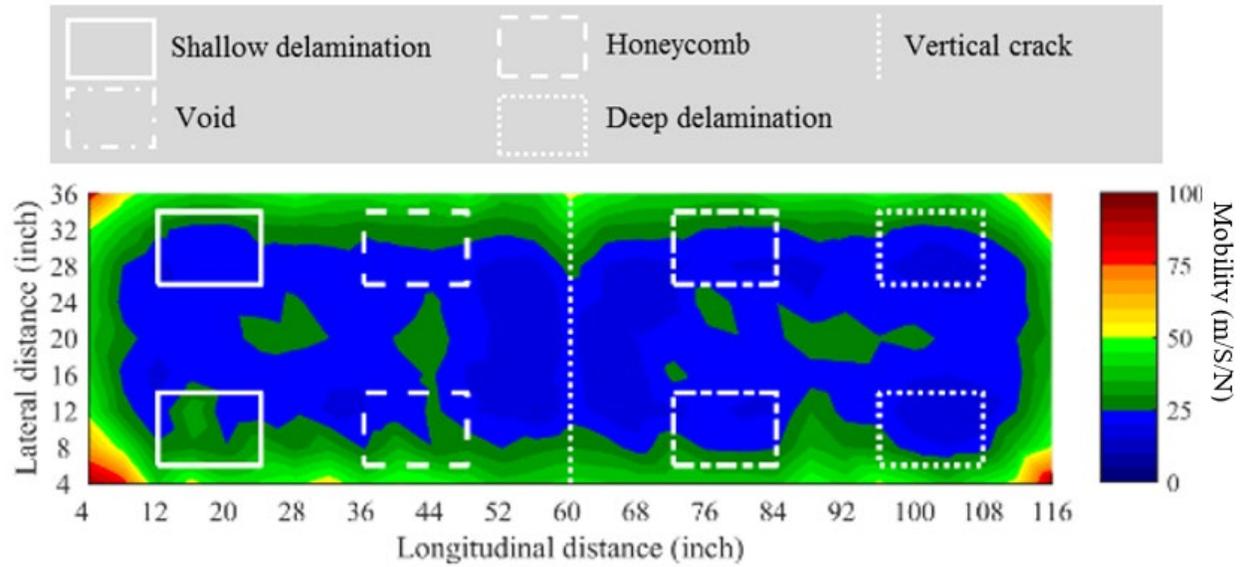
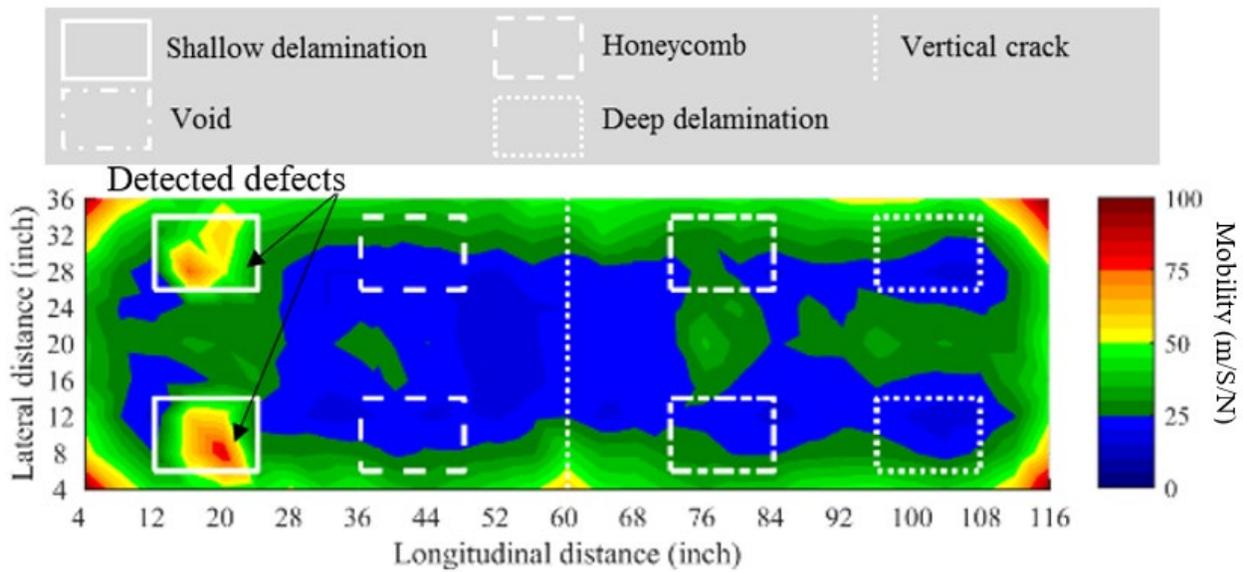
The IR method used the mobility spectrum—the velocity spectrum divided by the force spectrum—to detect delaminations and voids in concrete bridge decks. The IR method detected delaminations and voids in terms of lower mobility in concrete bridge decks. However, the results were affected by the depth-to-size ratios of the defects, and defects with large depth-to-size ratios could not be detected. At each test location, the impact force was applied by a hammer and measured by an attached load cell, and then the velocity response of the concrete bridge deck was recorded by a geophone. The condition maps based on the mobility measured by the IR method are shown in figure 64-A through figure 64-H. The IR method detected shallow delaminations in specimens S5–S8 but not in specimens S1–S4 because the shallow delaminations in specimens S1–S4 were at a 28-percent greater depth. The IR method could not detect the other defects in the specimens because the defects had larger depth-to-size ratios than the detectable shallow delaminations.

Source: FHWA.  
1 m/S/N = 0.74 ft/s/lb ft.  
Note: No defects detected.

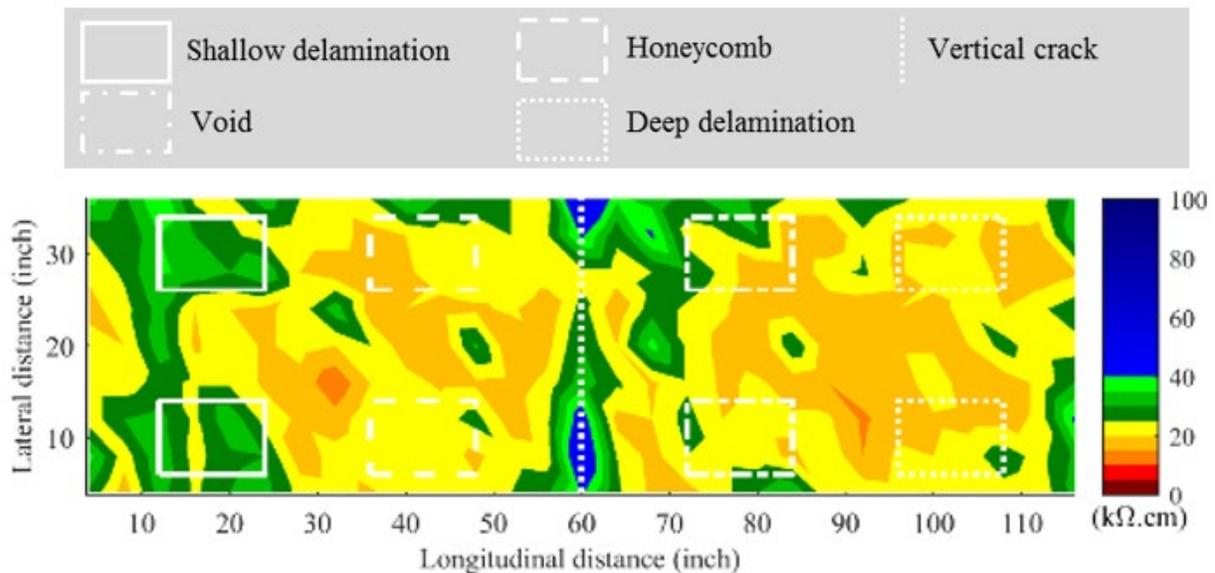
**Figure 69. Graph. NDE condition map of specimen S1 with ER before accelerated corrosion.**

The ER method measured concrete resistivity using a Wenner probe with current applied between the outer electrodes and electric potential measured between the two inner probes. Resistivity was used to characterize concrete's susceptibility to corrosion by characterizing its corrosive environment since the elevated chloride content of the corrosive environment in the concrete decreased the ER of concrete. Figure 69 shows the condition map of specimen S1 based on the ER method before applying accelerated corrosion to the specimens (figure 52 and figure 53). As shown in figure 69, areas with precorroded rebar could not be detected by the ER method. Figure 70-A through figure 70-H show the condition maps based on the ER method after the elevated chloride content environment was introduced by applying accelerated corrosion to the specimens. ER detected the elevated chloride content environment for the top layer rebar and the vertical cracks when the resistivity probe was at an angle relative to the directions of the cracks with two probes on one side of the crack and the other two probes on the other side.<sup>(47-49)</sup> The difference between the condition maps is due to the different levels and uneven distribution of chloride content introduced by the sponge saturated with NaCl solution in different specimens.

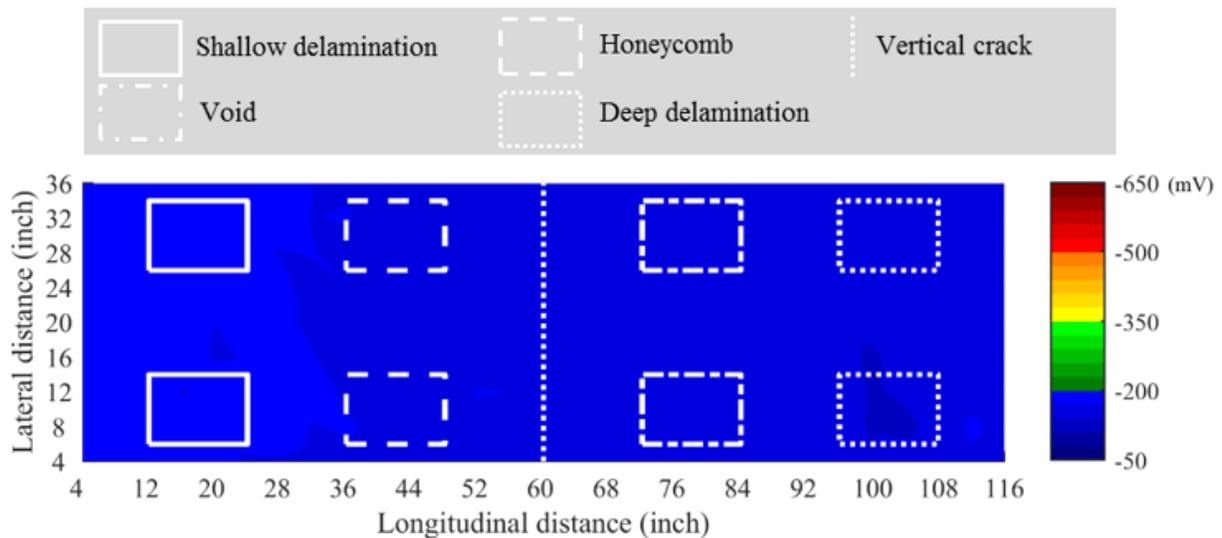
**Figure 71. Graph. NDE condition map of specimen S1 with HCP before accelerated corrosion.**

Figure 71 shows the condition map of specimen S1 based on HCP before accelerated corrosion was applied to the specimen. There was no active corrosion in the precorroded rebar. Figure 72-A through figure 72-H show the condition maps from HCP tests after active corrosion was introduced by applying accelerated corrosion to the specimens (figure 52 and figure 53). HCP detected active corrosion in the top layer rebar in all eight specimens. However, because it was more difficult for the NaCl solution to penetrate the concrete from the bottom, HCP could not detect active corrosion in the bottom layer rebar.

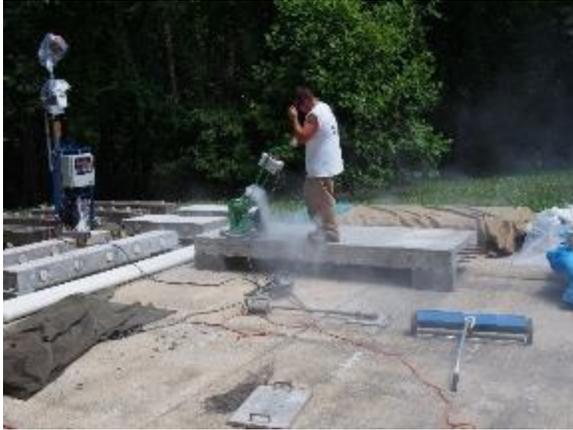
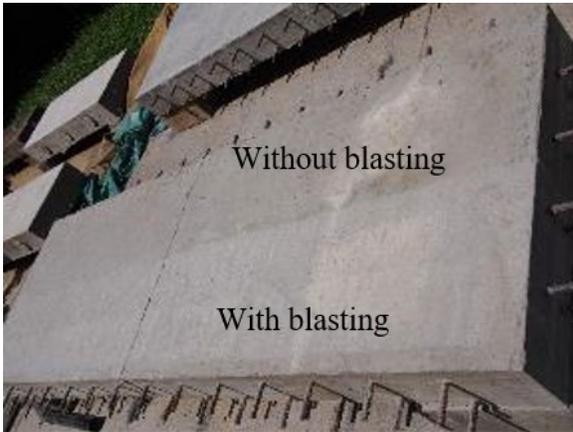
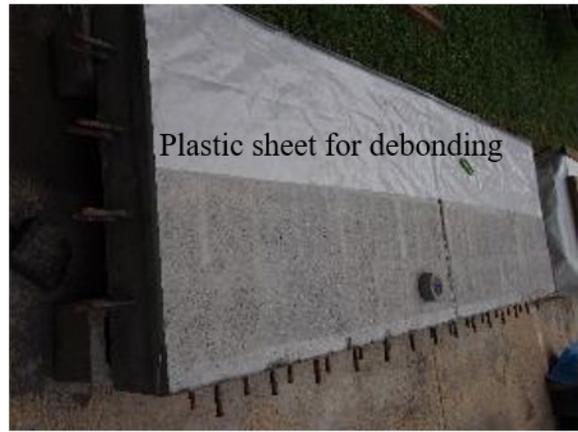
Epoxy, latex, silica fume, and polyester polymer overlays were constructed by experts in the Virginia Transportation Research Council. One half of each specimen was covered with a plastic sheet to create debonding of the overlay. The other half of each specimen was shot blasted so the overlay bonded better to the concrete, as shown in figure 75-A through figure 75-D. Each overlay was placed within 24 h after shot blasting to minimize carbonation and ensure good bonding.

A. Shot blasting.

B. After shot blasting.

D. Plastic sheet for debonding.

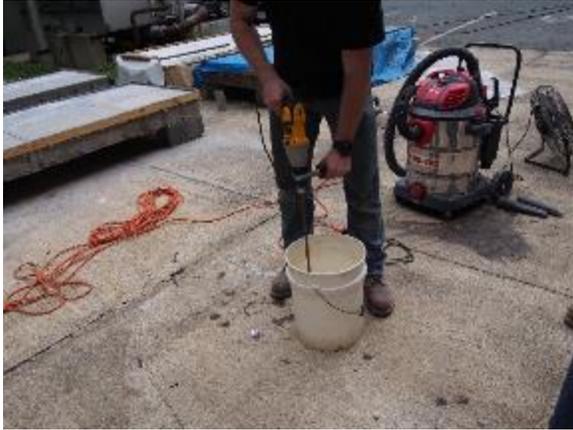
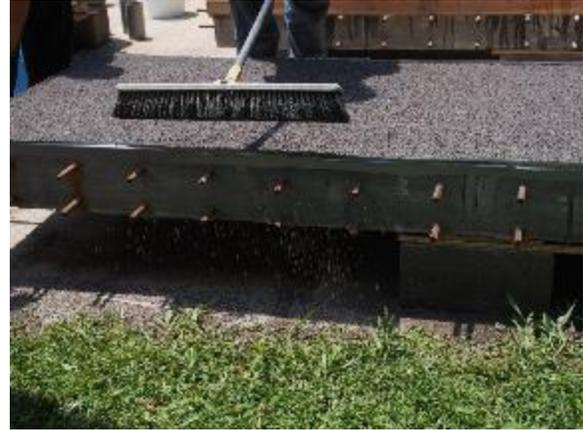
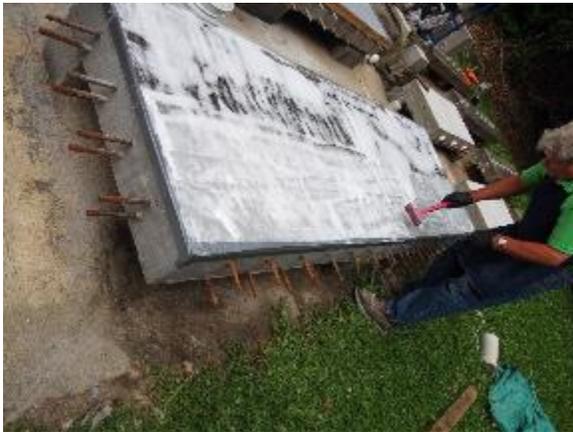
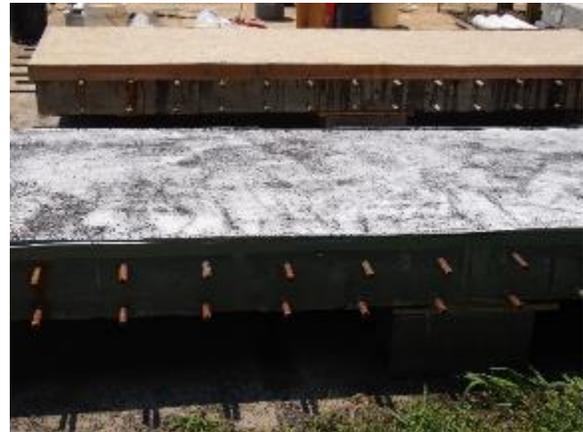
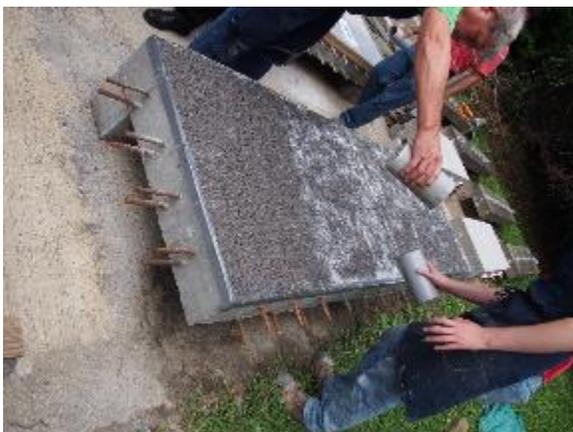
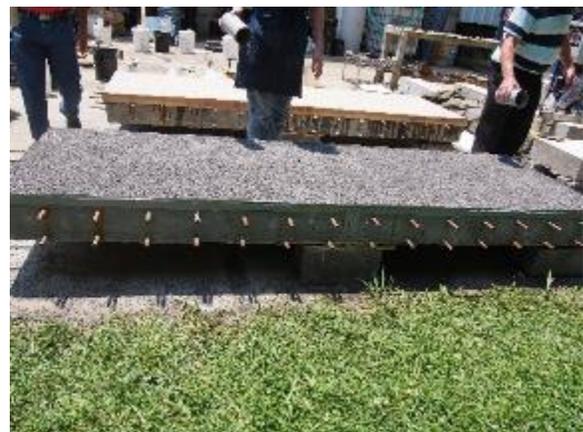
**Figure 76. Photos. Constructing an epoxy polymer overlay.**

Epoxy polymer overlay was placed in two layers on S1E, as shown in figure 76-A through figure 76-F. Epoxy application rates were 2.5 gal per 100 ft<sup>2</sup> for layer one (8 lb mixed) and 5 gal per 100 ft<sup>2</sup> for layer two (15.3 lb mixed). Shortly after spreading epoxy layer one, calcined bauxite aggregate was spread over the surface. After the epoxy cured for 30 min, excess aggregate was swept away and the procedure was repeated for the second layer of epoxy. During the application, the ambient temperature was around 89°F.

A. Epoxy mixing.

D. Sweeping away excess aggregate.

B. Epoxy layer one.

E. Epoxy layer two.

C. Aggregate layer one.

F. Aggregate layer two.

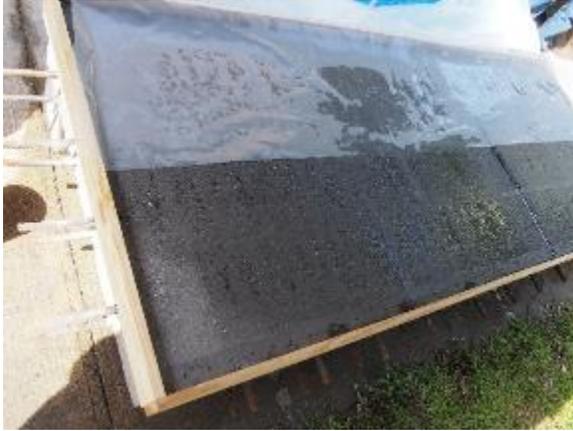
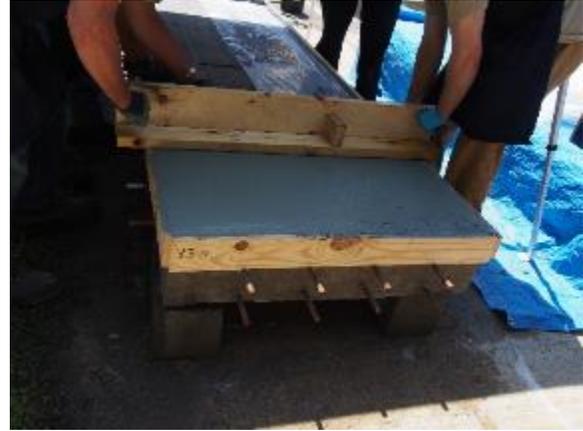
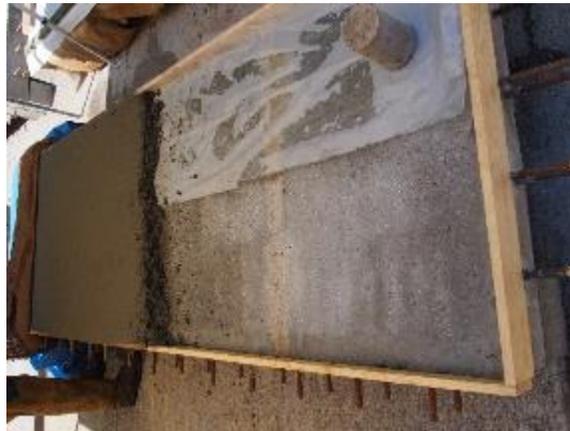
**Figure 77. Photos. Constructing latex and silica fume-modified concrete overlays.**

Latex and silica fume-modified concrete overlays with a thickness of 1.5 inches were placed on specimens S3L and S6S, respectively, as shown in figure 77-A through figure 77-C. The concrete surface was fully saturated with water before applying each overlay. The 28-d compressive strengths of the latex and silica fume overlays were 5,490 and 9,430 psi, respectively.

A. Saturated concrete surface.

B. Latex overlay.

C. Silica fume overlay.

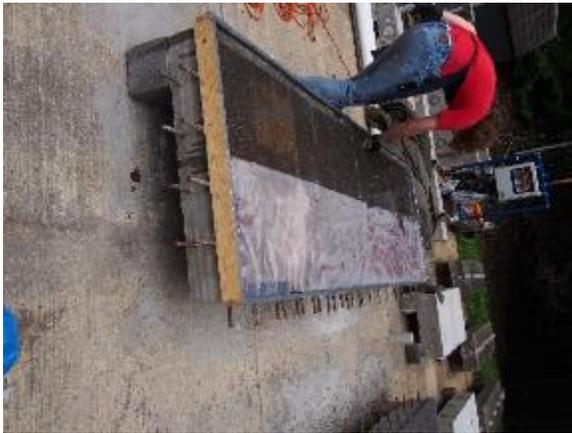
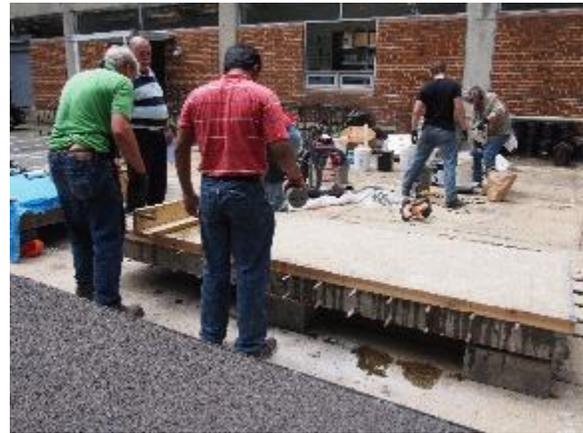
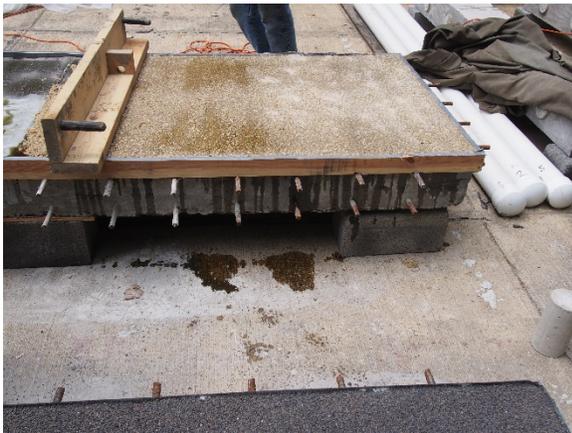
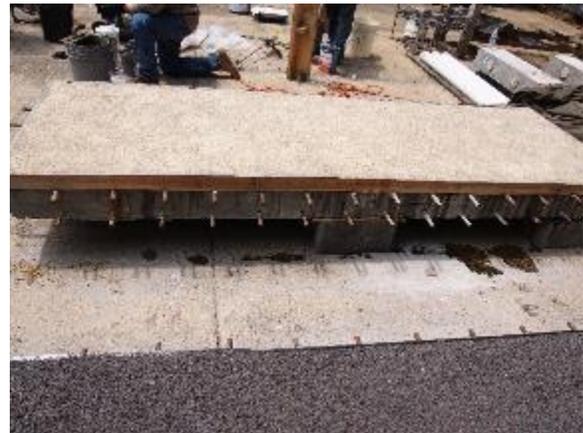
**Figure 78. Photos. Constructing a polyester polymer overlay.**

A polyester polymer overlay was applied in two layers on S8P with a total overlay thickness of 0.75 inches, as shown in figure 78-A through figure 78-D. One-third gal of high molecular weight methacrylate primer was applied to the concrete surface with a brush, and then 3 oz of polymer and 1 gal of high molecular weight methacrylate primer were mixed for 30 s. Resin and high molecular weight methacrylate primer were mixed for 2 min, and sand and rock were added and mixed for another 3 min. The mixed polyester concrete was leveled with a wooden screed. Fine sand was applied to excess after smoothing with the screed. The 28-d compressive strength of polyester polymer overlay was 6,240 psi.

A. Priming the concrete surface.

C. Spreading a thin layer of dry aggregate.

B. Applying the polyester polymer mixture.

D. Finished polyester polymer overlay.

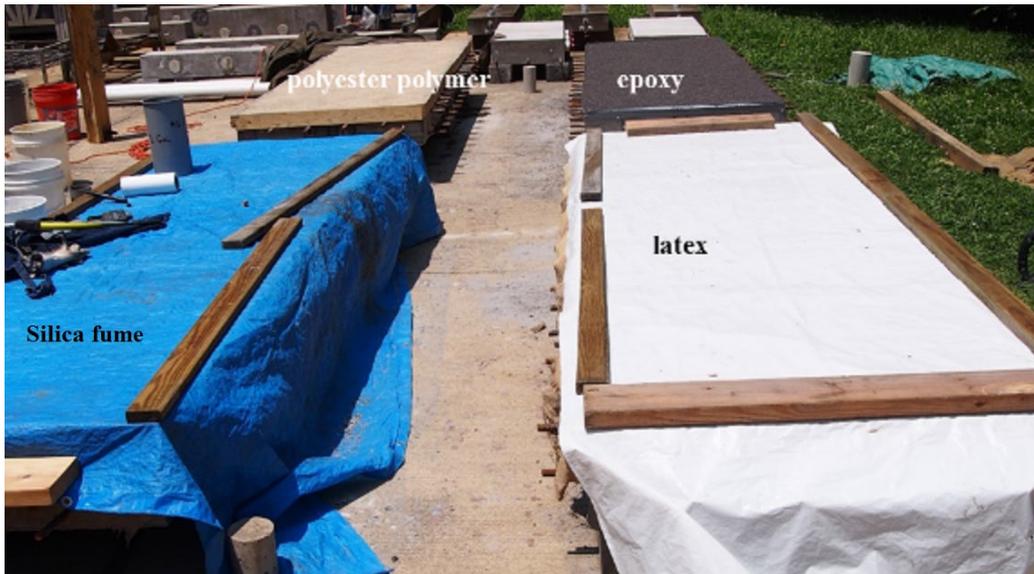
**Figure 79. Photo. Latex and silica fume overlays after construction.**

After the overlay construction, latex and silica fume-modified overlays were covered by wet burlap and plastic sheeting to allow the concrete to cure for 7 d, as shown in figure 79.

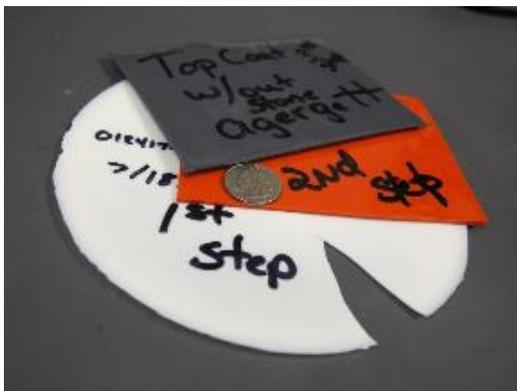
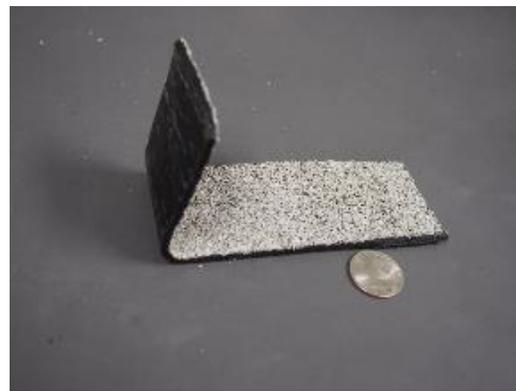
**Figure 80. Photos. Samples of liquid and sheet membranes.**

Samples of liquid and sheet membranes are shown in figure 80-A and figure 80-B, respectively. Before applying the membranes, the concrete surface was sand blasted so the overlay bonded better to the concrete. Liquid membrane, the construction of which is shown in figure 81-A through figure 81-F, was applied on specimen S5AL. The liquid membrane consisted of three layers: the bottom primer, middle membrane, and top coat. Dry aggregate was placed right after spraying the top coat, and all three layers set rapidly. Because the hot-mix asphalt was applied at a temperature as high as 300°F, parchment paper, which can withstand temperatures up to 420°F, was used to create debonding on one half of specimen S5AL.

A. Liquid membrane.

B. Sheet membrane.

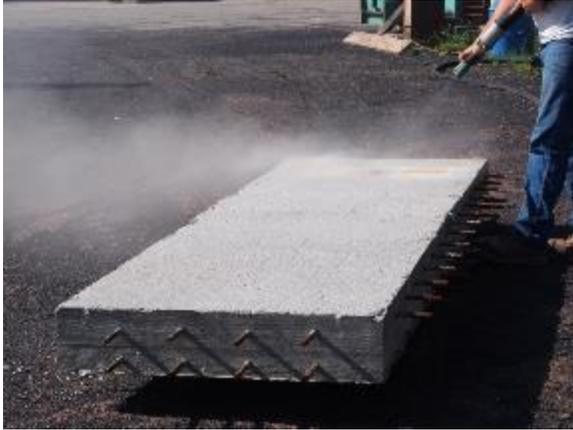
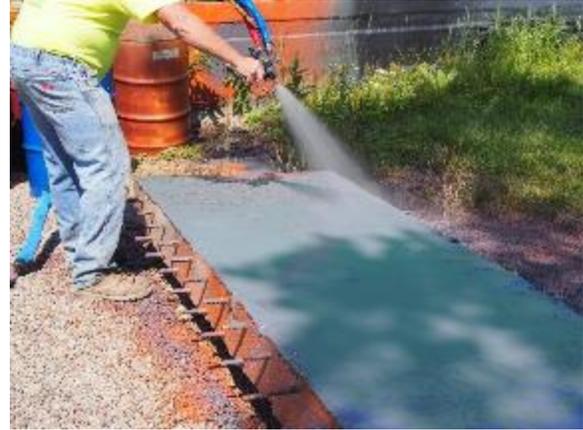
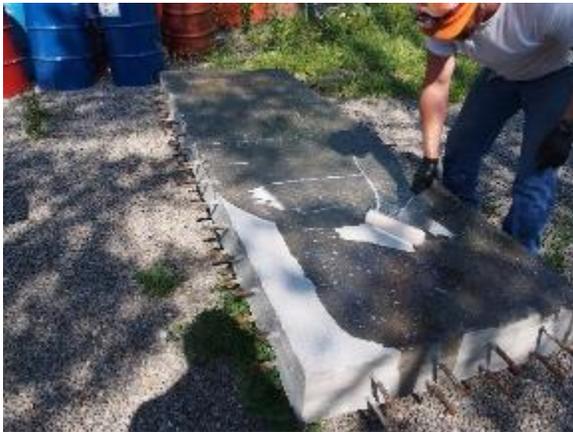
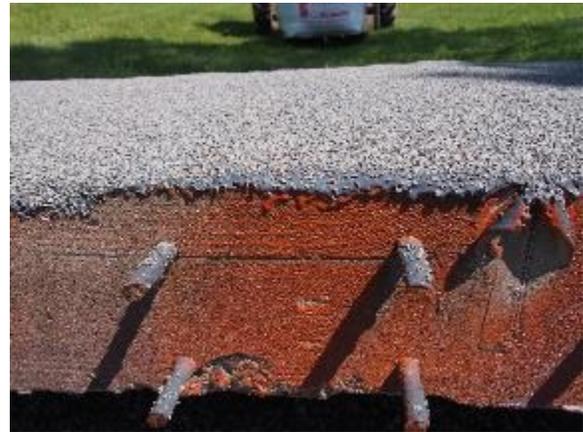
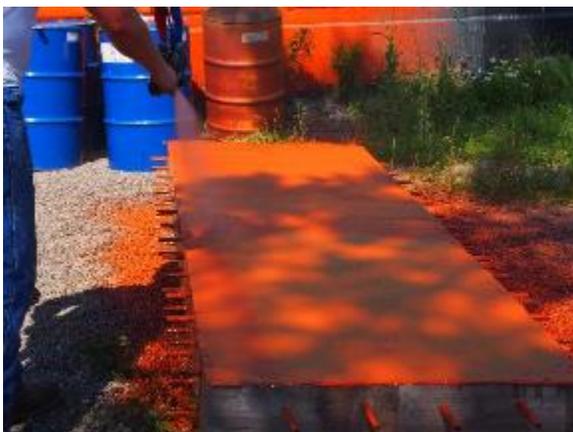
**Figure 81. Photos. Installing a liquid membrane and parchment paper for debonding.**

A. Surface preparation.

D. Top coat.

B. Bottom primer.

E. Applying a thin layer of dry aggregate.

C. Middle membrane.

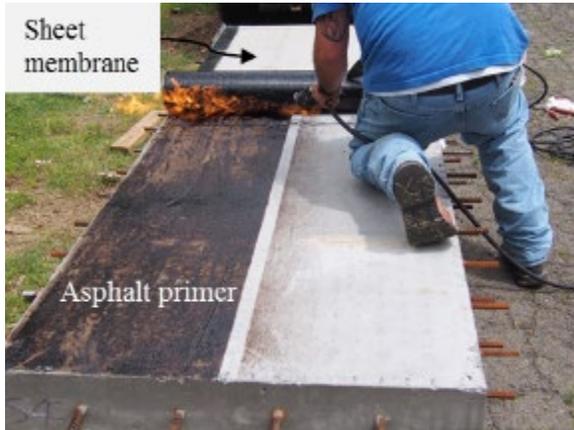
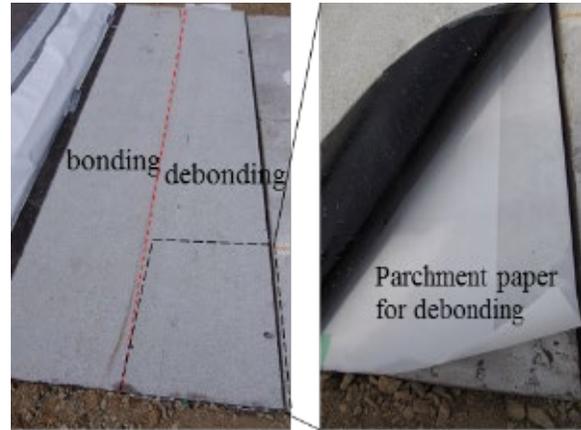
**Figure 82. Photos. Installation of sheet membrane and parchment paper for debonding.**

Sheet membrane was applied on specimen S4AS, as shown in figure 82-A and figure 82-B. A thin layer of asphalt primer was sprayed onto the concrete surface. One half of the membrane bottom was torched to ensure good bonding with the concrete surface, and the other half was not torched to create debonding. A layer of parchment paper was added between the specimen and the membrane without torching to guarantee debonding when the hot-mix asphalt was placed.

A. Installing sheet membrane.

B. Parchment paper for debonding.

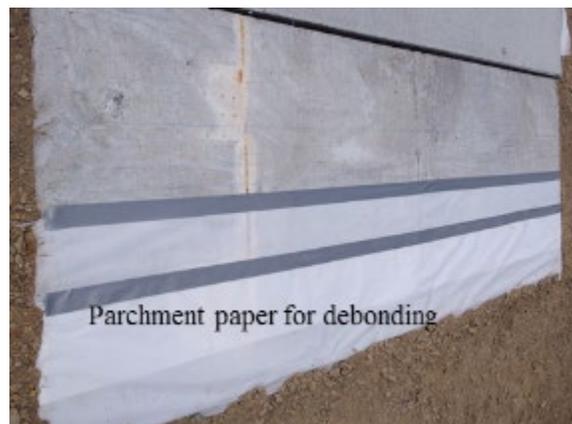
**Figure 83. Photo. Parchment paper installation for debonding on an asphalt overlay with no waterproof membrane.**

Parchment paper was also used to create debonding on one half of specimen S7A, as shown in figure 83.

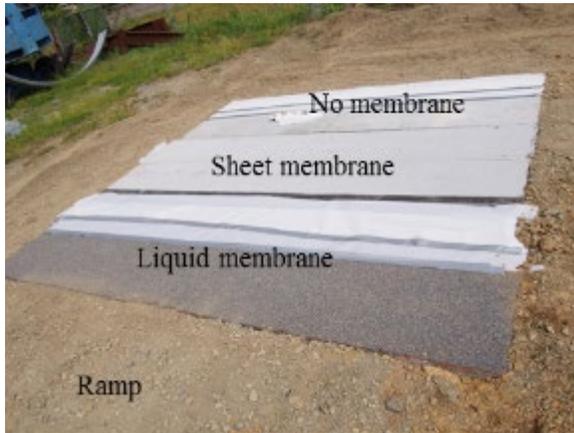
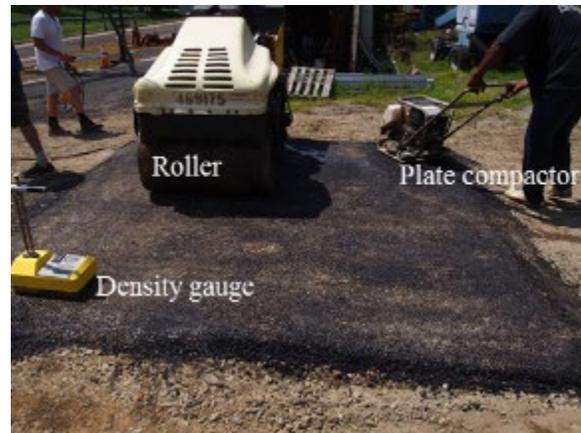
**Figure 84. Photos. Constructing asphalt overlays on three specimens.**

The construction of asphalt overlays on three specimens is shown in figure 84-A through figure 84-D. The three specimens were lined up side by side, and an aggregate ramp surrounding the specimens was built to provide access for an asphalt-compaction roller. Asphalt-coating primer was applied to the half of each specimen that needed bonding. The hot-mix asphalt with Virginia Department of Transportation mix SM-9.5A was applied by a Virginia class A paving

contractor. An asphalt-compaction roller and plate compactor compacted the asphalt, during which a nuclear density gauge was used to ensure uniform and adequate compaction. The asphalt overlay was cut along the side of each specimen using a metal-cutting saw 4 d after paving.

A. Specimens surrounded by a ramp.

D. Asphalt compaction and density measurement.

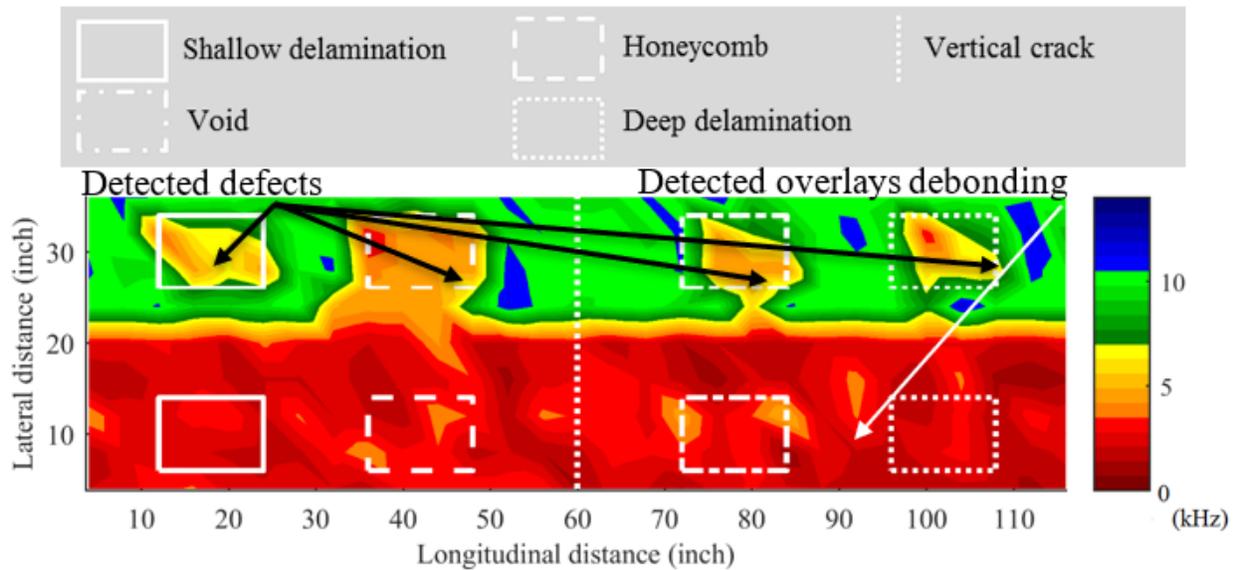
The condition maps of specimens S1E, S3L, S6S, and S8P based on the IE method are shown in figure 89-A through figure 89-D. For the bonded halves of specimens S1E, S3L, S6S, and S8P, the IE method detected debonding, shallow and deep delaminations, honeycombing, and voids. Areas with detected defects showed lower frequencies than intact areas because the dominant flexural mode with the width-to-depth ratios of the defects was greater than 1.<sup>(47)</sup> Intact areas in the bonded halves had frequencies of the thickness mode of about 10, 9.1, 7.8, and 8.5 kHz for specimens S1E, S3L, S6S, and S8P, respectively. Stress waves for the debonded halves of specimens S1E, S3L, S6S, and S8P were completely reflected at the interface. No underlying defects in the specimens could be detected, but overlay debonding was detected.

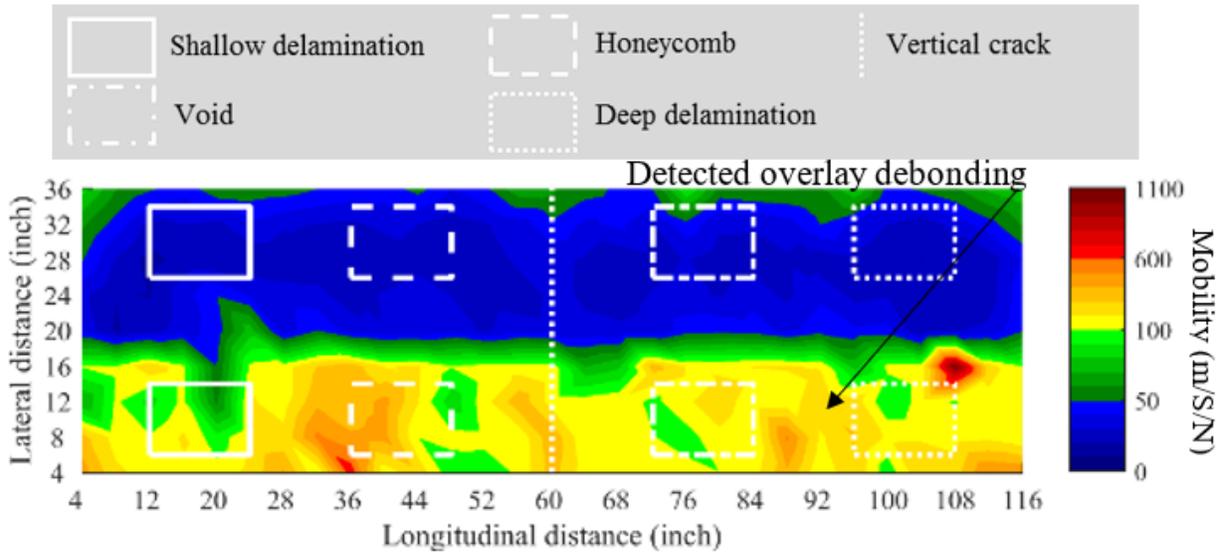
The condition maps of all seven specimens based on the IR method are shown in figure 102-A through figure 102-G. The IR method detected overlay debonding in terms of lower mobility compared to intact areas in the specimens. The IR method could not detect defects in the underlying specimens in both bonded and debonded areas due to larger depth-to-size ratios compared to specimens without overlays.

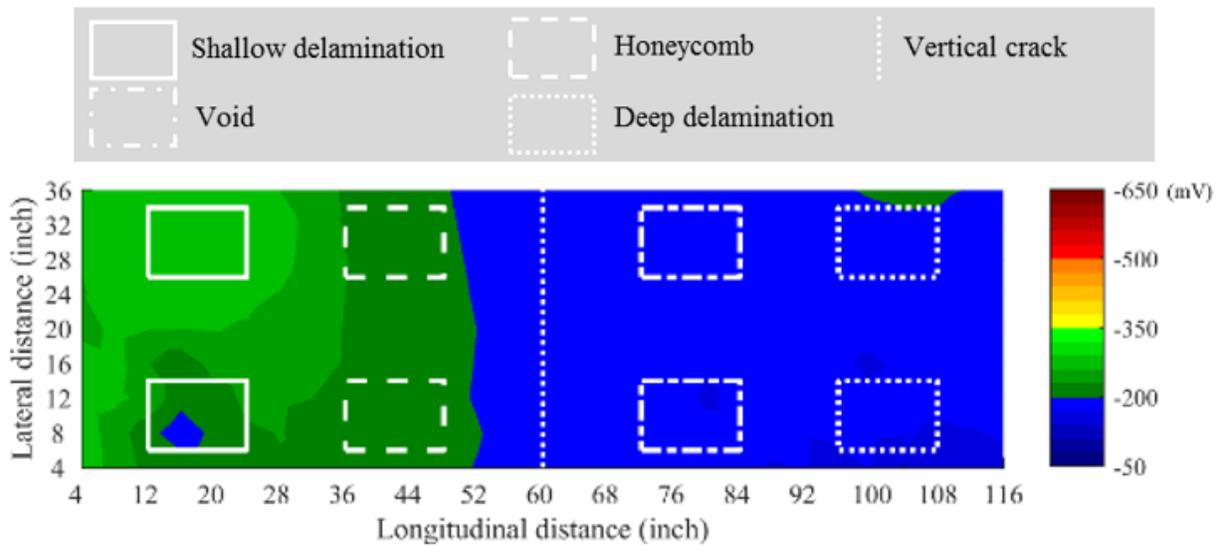
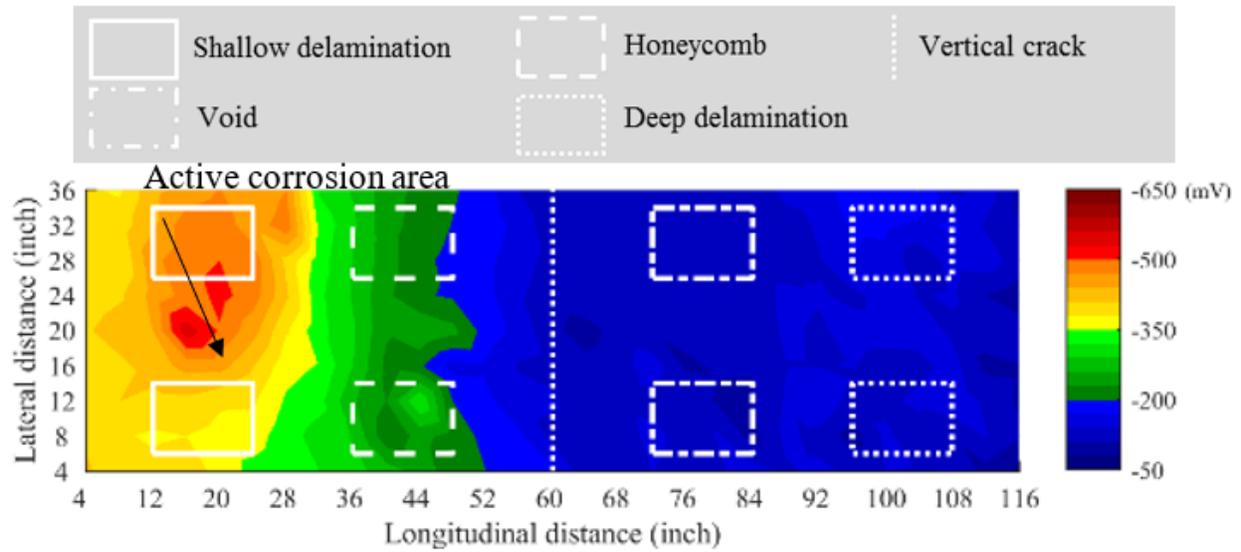
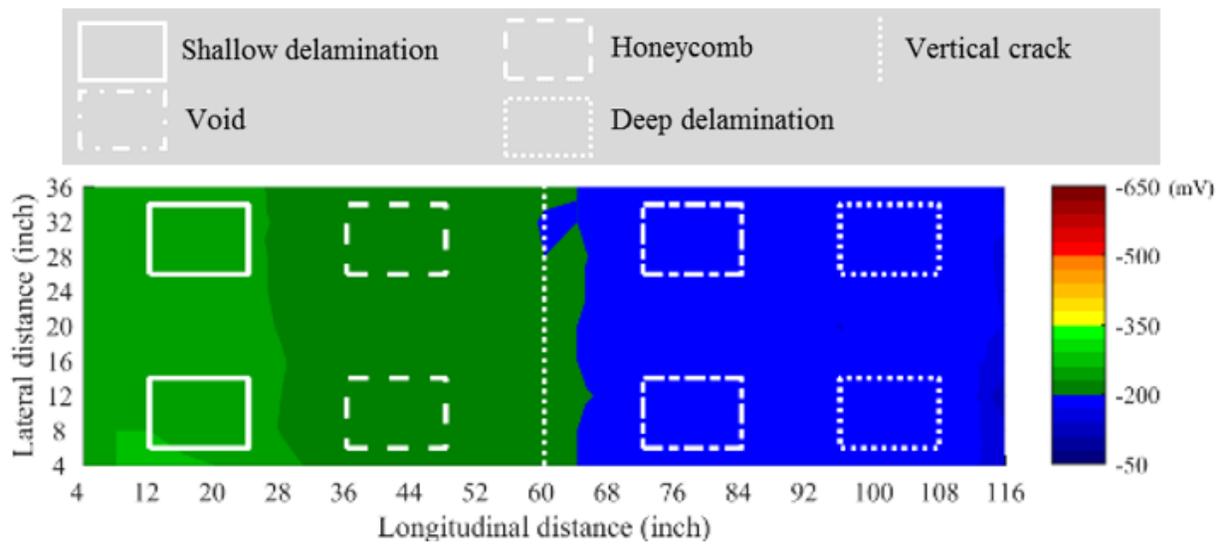
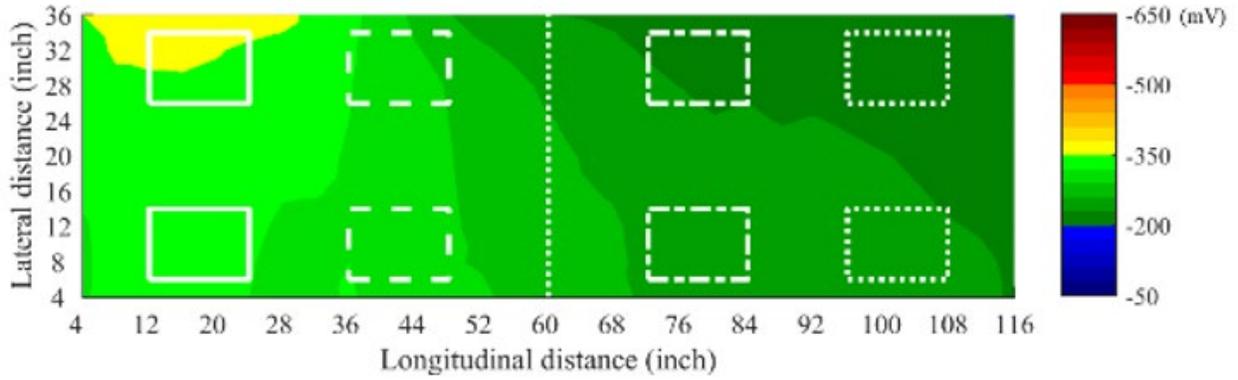
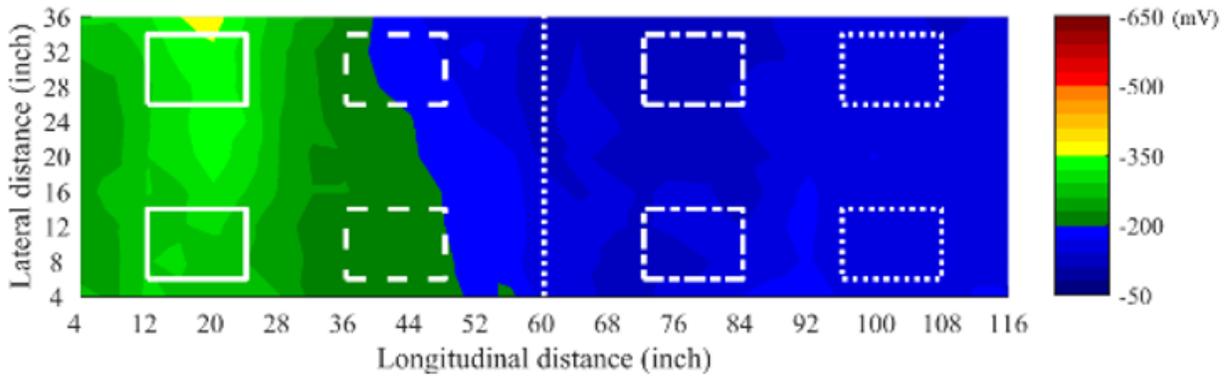
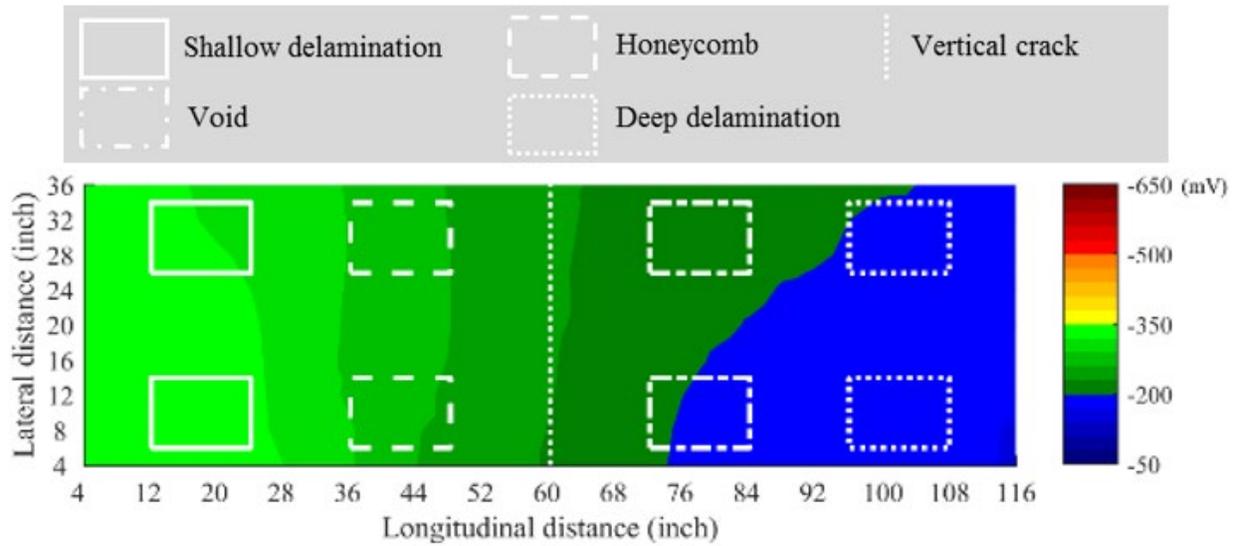
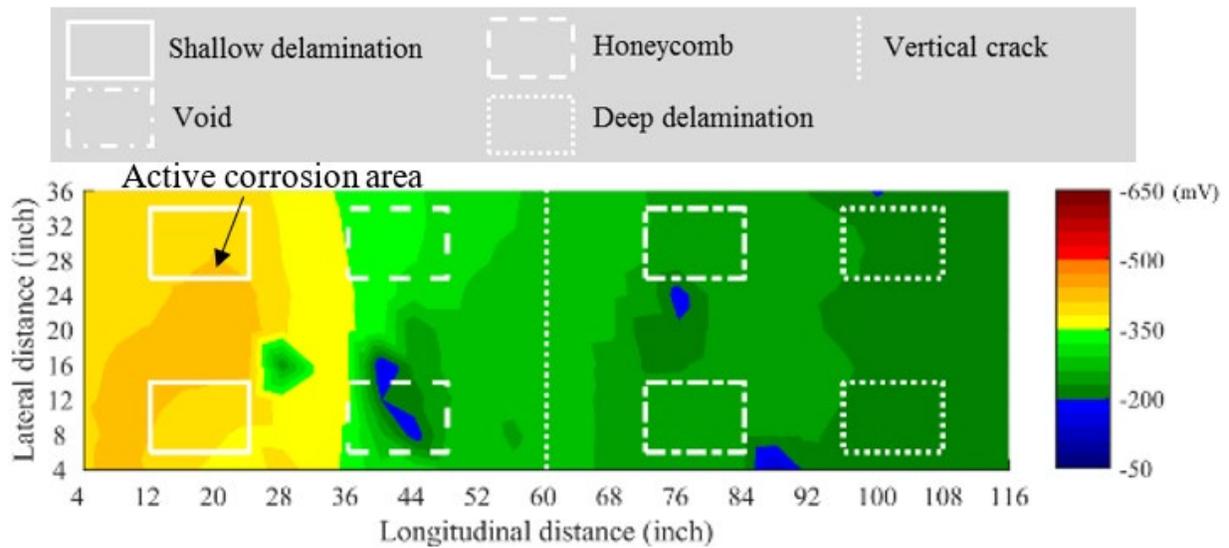
The condition maps based on the HCP method are shown in figure 108-A through figure 108-G. The HCP method detected differences in the electric potentials between the top layer of rebar in different areas. According to ASTM C876-15, potential less than  $-350$  mV means a 90-percent probability of corrosion, and active corrosion was detected in specimens S3L and S8P based on this criterion.<sup>(50)</sup> Although the areas with active corrosion in overlays had lower potential compared to intact areas, the HCP method could not detect active corrosion per ASTM C876-15. Areas with active corrosion for overlays had lower potential than the other two (i.e., latex and polyester polymer) because of the higher electric insulation of the overlay materials.

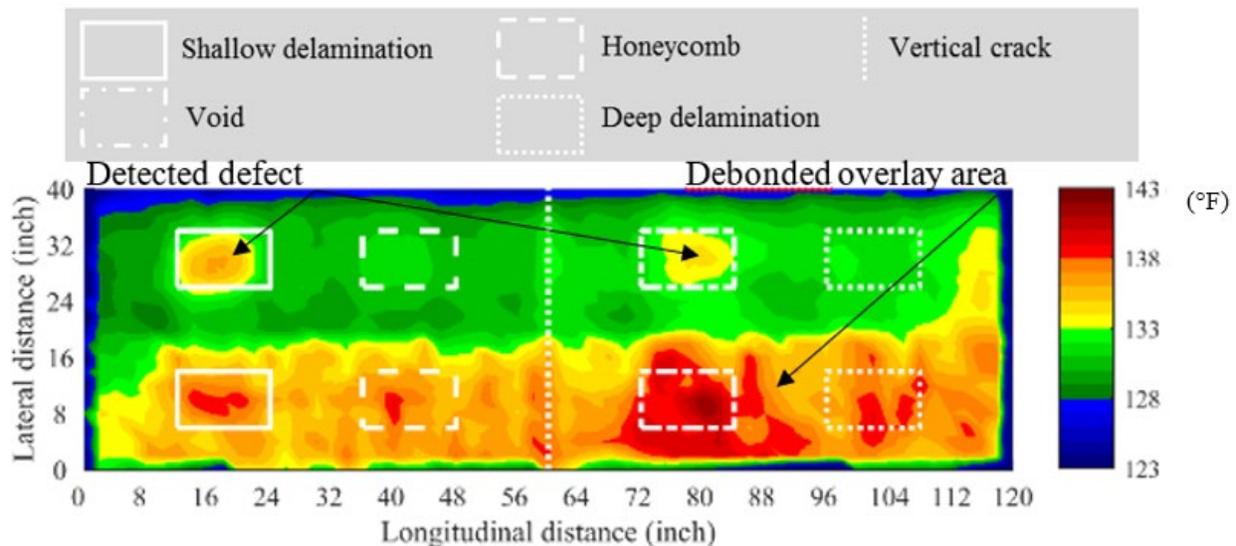
The condition maps for the temperature differences between 3:00 p.m. and 11:00 a.m. for all seven specimens are shown in figure 110-A through figure 110-G. The bonded and debonded areas were indistinguishable. For specimens S1E and S8P, bonded areas had greater temperature increases than debonded areas. For specimens S3L, S4AS, S5AL and S6S, bonded areas had lower temperature increases than debonded areas. For specimen S7A, bonded and debonded areas had similar temperature increases. For bonded areas, shallow delaminations were detected in specimens S1E, S3L, S6S, S7A, and S8P, and voids were detected in specimens S1E and S8P. No honeycombing, deep delaminations, or vertical cracks were detected. For debonded areas, shallow delaminations were detected for specimens S6S, S7A, and S8P, but no other defects were detected.

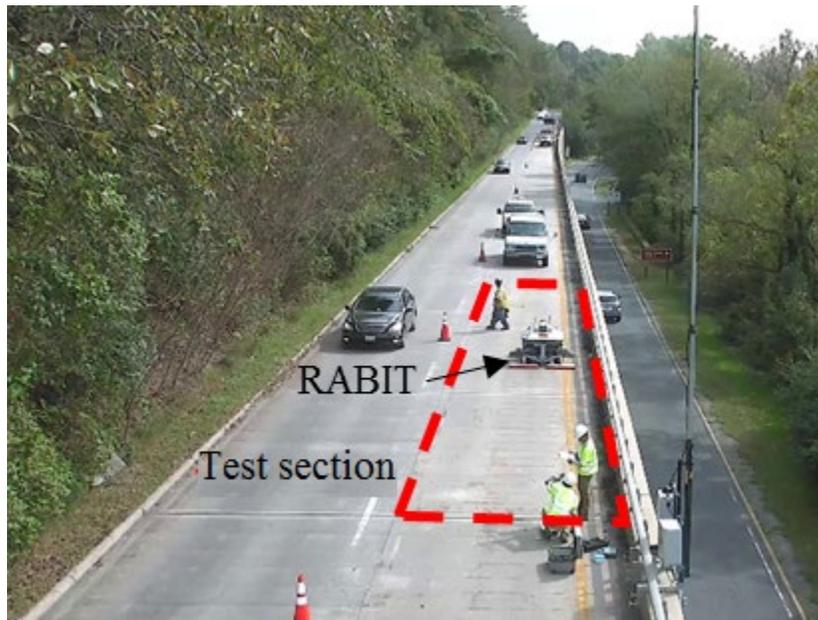
The Clara Barton Parkway cantilever structure was built in the 1950s, and the overlay was placed in 1995 with 4- to 6-inch lightweight fiber RC after removing deteriorated concrete from the cantilever surface, as shown in figure 111. The concrete of the cantilever structure had a specified minimum compressive strength of 3,000 psi, and the overlay concrete had a specified minimum compressive strength of 4,000 psi. A 10 ft wide and 100 ft long section of the Clara Barton Parkway cantilever structure was tested with the RABIT™ bridge deck assessment tool, as shown in figure 111.
