# Nondestructive Evaluation of Concrete Bridge Decks with Overlays

PUBLICATION NO. FHWA-HRT-21-023

MARCH 2021

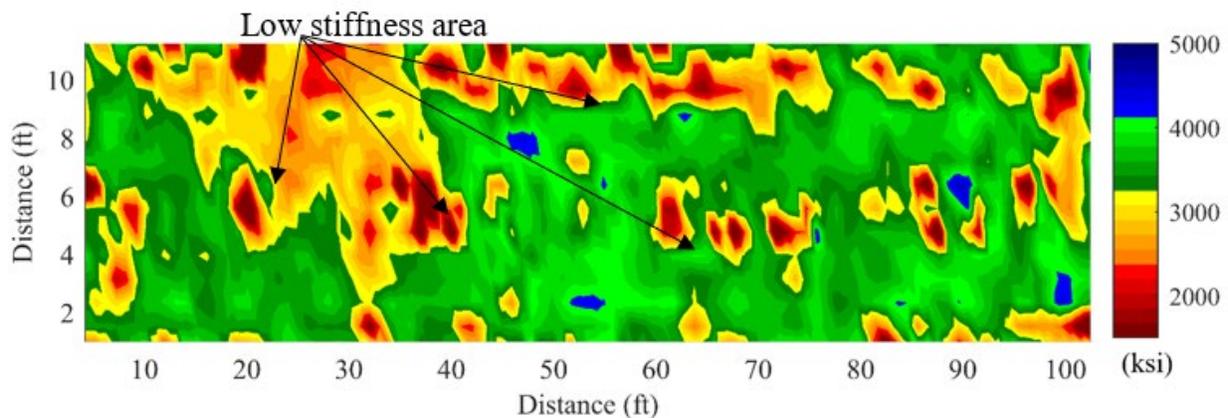
The condition map based on the moduli measured with the USW method is shown in figure 116. The USW method detected a large area of delamination from 15 to 40 ft in the longitudinal direction.

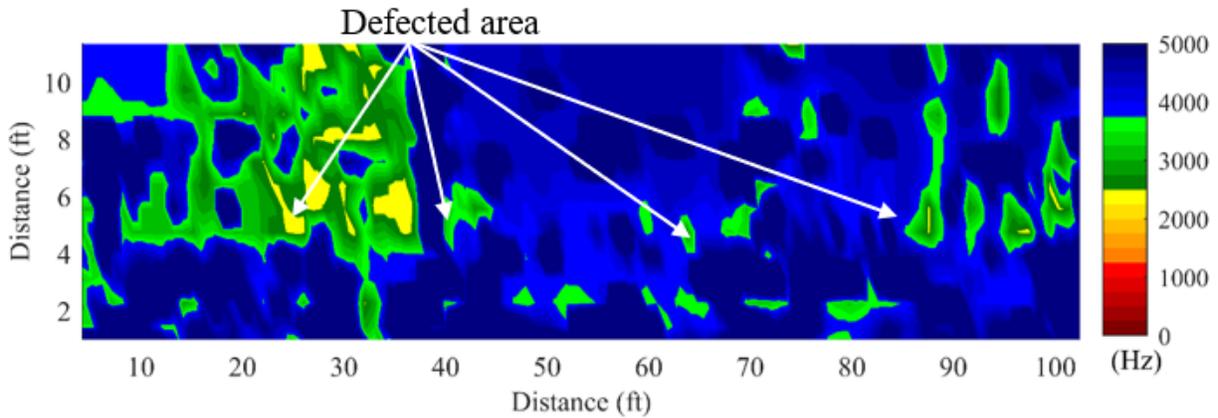
shown in figure 117. The IE method detected a large area of delamination from 15 to 40 ft in the longitudinal direction. The area with detected delamination showed lower frequencies than intact areas. Intact areas had the frequency of the thickness mode at about 7 kHz, while areas with delamination had the dominant flexural mode with a frequency at about 3 kHz.

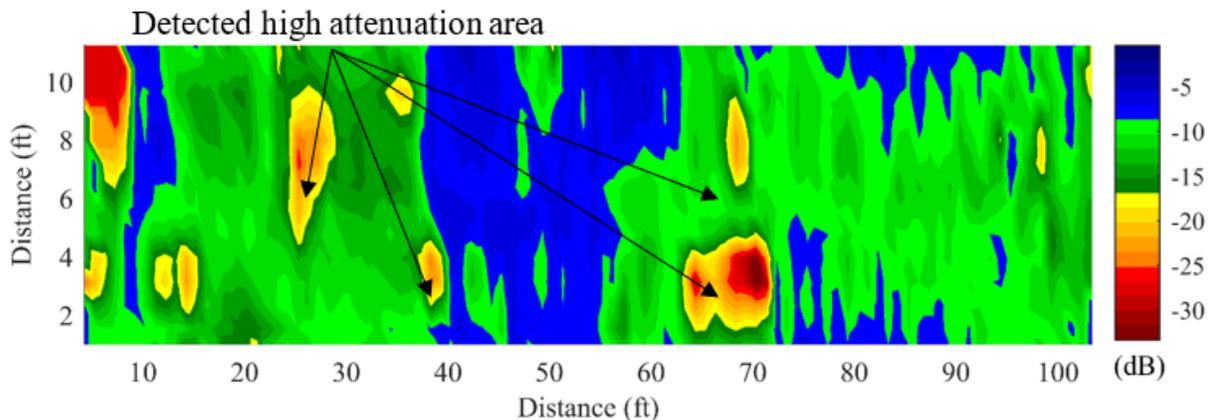
The GPR method transmitted EM waves into the concrete and recorded reflected EM waves when the  $\epsilon_r$  of reflectors (e.g., rebar, delamination) differed from those of concrete. The GPR method measured the attenuation of EM waves reflected from the top layer rebar and presented the results in a condition map to quantify the severity of the corrosive environment. The condition map using the GPR method based on the attenuation of the reflected waves from the top layer rebar is shown in figure 118. The condition map using the GPR method detected the high attenuation areas with elevated chloride contents from 0 to 40 ft and from 60 to 100 ft in the longitudinal direction.

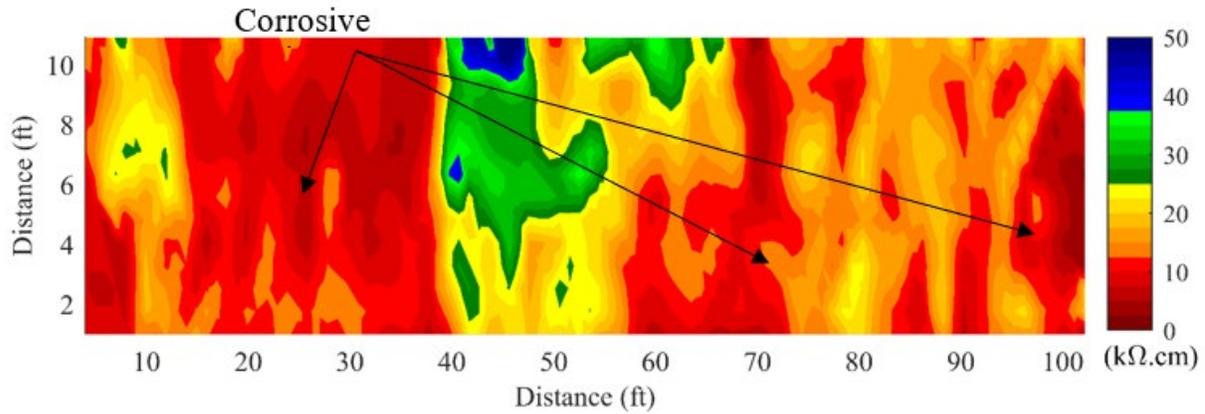
corrosive environment because the elevated chloride content of a corrosive environment in the concrete decreases the ER of concrete. Figure 119 shows the condition map based on the resistivity measured by the ER method. The ER method detected low resistivity areas with elevated chloride contents from 0 to 40 ft and from 50 to 100 ft in the longitudinal direction.
