**Emerging ISTD technology uses an innovative erosion head that more accurately measures soil erosion resistance, resulting in more cost-effective foundation designs and greater reliability and resiliency in bridge performance.**

## INTRODUCTION

The third ISTD field demonstration was held in conjunction with the 2018 National Hydraulic Engineering Conference (NHEC) in Columbus, OH. The Ohio Department of Transportation (ODOT) worked with FHWA to select a test site near the conference that had an appropriate soil testing profile and could safely accommodate a large number of conference participants interested in attending the demonstration. They eventually selected a field adjacent to a rest area off Interstate 70 located roughly 30 mi west of Columbus.

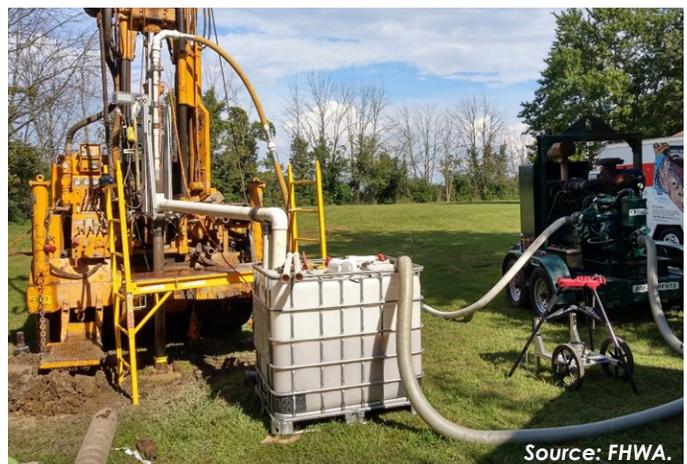
The ISTD equipment assembled in the field.

The demonstration took place on Thursday, August 30, 2018. The drill crew augered to a depth of 9 ft and then lowered the Shelby tube and casing into the borehole and pushed 14 inches. The hydraulics team then assembled their equipment, including the linear drive, water tank, hoses, pump, control box, and laptop. The first test only lasted 12 min before the erosion head became stuck. The head was removed and, as expected, excessive amounts of gravel fragments had become lodged in the passages. The recovery of the Shelby tube revealed it had been damaged during the push because of the gravel. The decision was made to switch from the thin-walled Shelby tube to a casing shoe, which is a 1-ft-long segment of casing with a tapered edge that can be directly pushed into the soil. The gravel still damaged the tapered edge of the casing shoe during each push, but its thicker walls prevented it from collapsing. The disadvantage of using the shoe was that the soil in the casing became more compressed and disturbed compared to a sample in the thin-walled Shelby tube.

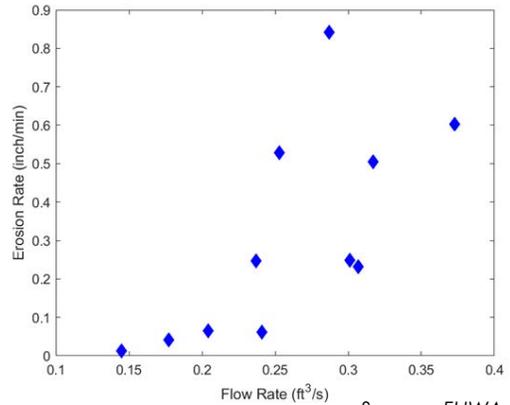
Erosion rate versus flow rate for the Columbus ISTD demonstration. With more data points, a nonlinear fitted power curve could be used to extract the critical flow rate where erosion begins.

clear out the clogged passageways. Additionally, because the clay was very stiff, the higher flow rates required for erosion occasionally forced the linear drive's motor to reach its maximum torque limit. Despite these issues, the team collected enough data to extract erosion rates from 11 different segments by calculating a best-fit line through each set of data. The corresponding mean flow rates were also calculated for each segment. The 11 data points are detailed in the Summary of Results table. With enough data points, a nonlinear power curve can be fitted to the data to determine the critical flow rate of the soil, which can be correlated to the shear stress. The plot shows the data points from testing, but more points are needed to extract the curve confidently.

Due to the presence of low erosion rates during testing, this ISTD demonstration revealed that this location could potentially have a clay layer with significant erosion resistance. However, additional testing is needed to confirm that result and produce more consistent data.

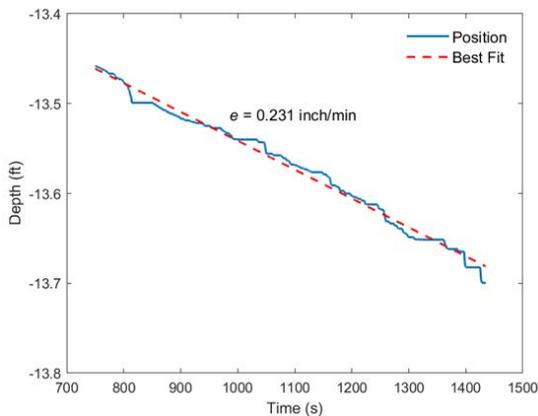
Soil layer's erosion rate ( $e$ ) calculated from the slope of the best-fit line.
