Emerging ISTD technology uses an innovative erosion head that more accurately measures soil erosion resistance, resulting in more cost-effective foundation designs and greater reliability and resiliency in bridge performance.

The ISTD is an advanced system designed by the hydraulics research team at the Turner-Fairbank Highway Research Center to measure the erosion resistance of fine-grained, cohesive soils directly in the field. It features an innovative erosion head that, when inserted into a standard drill casing, can direct a horizontal radial water flow across the surface of the soil, resulting in erosion. The erosion resistance is measured in terms of a critical shear stress, which, when coupled with the decay of hydraulic shear forces (water loads) with scour depth, is the basis of the Federal Highway Administration's (FHWA's) NextScour program for improving the accuracy of future bridge scour estimates.

The second ISTD demonstration, hosted by the Michigan Department of Transportation (MDOT), was held in a field south of the east abutment of the Lafayette Street Bridge, which crosses the East Saginaw River in Bay City, MI. MDOT had listed the bridge as scour critical and

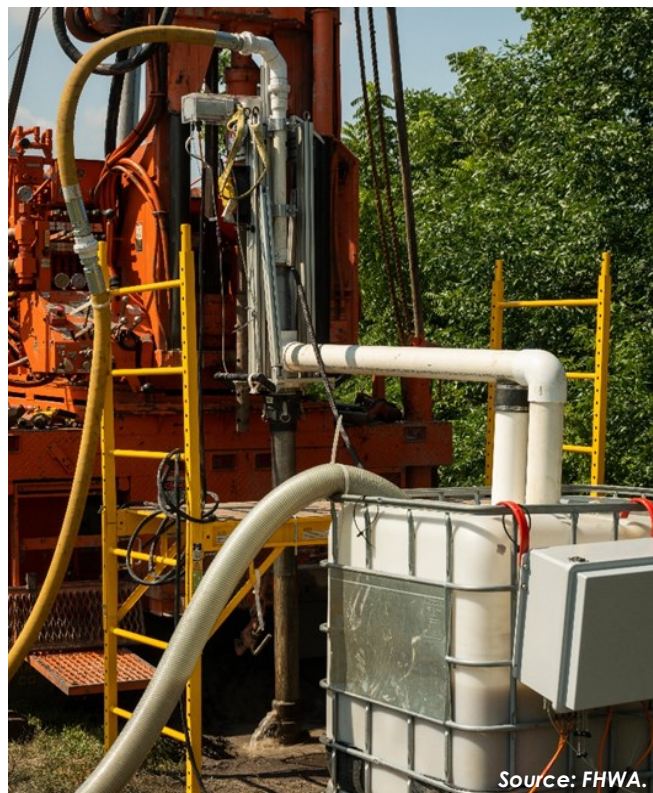
The ISTD equipment assembled in front of the drill rig.

The demonstration took place on Wednesday, July 25, 2018. The drill crew experienced difficulties when wood chips from the layer of organic material became caught in the auger teeth, which caused the Shelby tubes to crumple when pushed into the clay. The ISTD erosion test is conducted inside the Shelby tube, so this outcome was a significant setback that resulted in lengthy delays. Eventually, a new borehole was drilled and flushed with water to remove any remaining organic material. The Shelby tube and casing were lowered into the auger and successfully pushed 16 inches into the clay. The hydraulics team then assembled the remaining ISTD equipment, including the hoses, water tank, pump, piping, control box, and laptop. Finally, the erosion head was lowered into the casings to prepare for the erosion test.
