Emerging ISTD technology uses an innovative erosion head that more accurately measures soil erosion resistance, resulting in more cost-effective foundation designs and greater reliability and resiliency in bridge performance.

The Nebraska Department of Transportation (NDOT) hosted the fourth ISTD field demonstration at the northwest corner of the Farwell West Bridge. The bridge is located about 2.5 miles west of the town of Farwell, NE, and carries SR 92 over Turkey Creek. The bridge had received a poor scour critical rating in a 2013 scour assessment report and NDOT scheduled to replace the structure with a 145-ft-long concrete girder bridge.

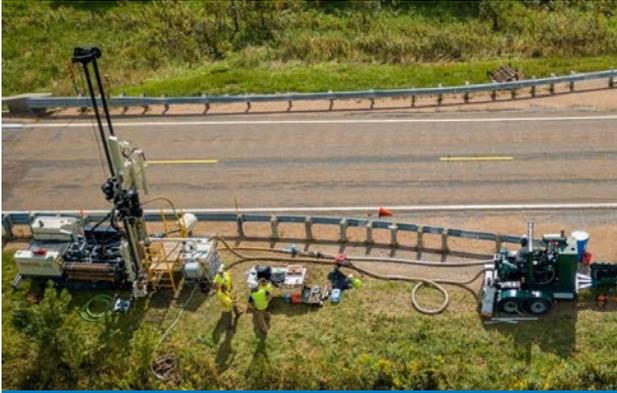
An aerial view of the Farwell demonstration site.

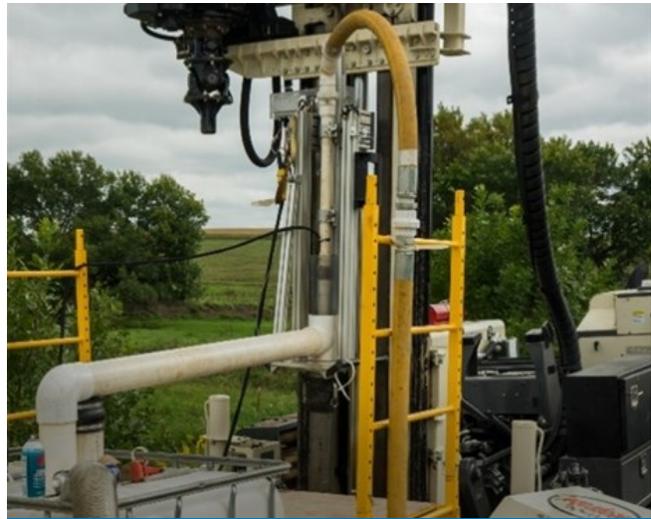
The ISTD equipment assembled in front of the drill rig.

The demonstration took place off the shoulder of SR 92 on September 13, 2018. The bridge's guardrail protected the drill rig, pump, and ISTD equipment. The drill crew augered to a depth of 11 ft and then used a Shelby tube to clean out 14 inches of material. They then mounted a new Shelby tube onto the casing and lowered it into the borehole. The hydraulics team then assembled the remaining ISTD equipment. The initial run of the equipment resulted in two different issues that caused some lengthy delays. First, the connection between the motor and the linear drive failed, causing the linear drive to shoot up from the water pressure. The team noticed that a hydraulic part on the rig mast had slowly slid down onto the motor. The weight of the hydraulic part then tilted the motor at an angle. This weakened the connection to the linear drive. Second, the team also noticed an oil film coating the piping, hoses, and water tank, which they believed came from the rental pump. Significant time was lost while the team cleaned as much of the oil out of the equipment as possible. Eventually, the drill crew augered past the previous attempt and the hydraulics team started a new test in fresh clay. This time the ISTD successfully collected erosion data.
