TECHBRIEF

Effective Practices for Routine Bridge Inspections Using Unmanned Aerial Systems

FHWA Publication No.: FHWA-HRT-21-083

This document is one in a series of technical summaries that accompany the forthcoming Federal Highway Administration report, *Collection of Data with Unmanned Aerial Systems (UAS) for Bridge Inspection and Construction Inspection*.

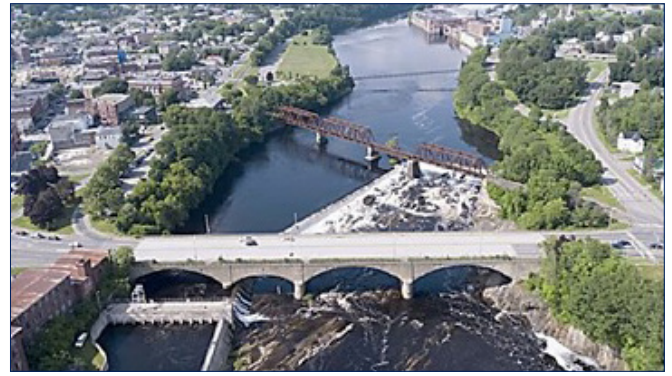
Constructed in 1936 and renovated in 1990, the Ticonic Bridge is a five-lane highway bridge connecting Wilson and Waterville, ME, along US Route 201. The bridge spans the Kennebec River, Reservoir, and Dam. It supports the passage of nearly 9,000 vehicles daily, with 5 percent of the vehicles, on average, being trucks (MaineDOT 2020).

Figure 1. Photo. UAS aerial view of the Ticonic Bridge.

One key advantage of using UAS during inspections is in reducing the exposure of the inspection team to safety hazards associated with difficult terrain at the bridge site. In some cases, the property near the bridge may have restricted access and require prior coordination and planning to maximize the performance of the UAS. Such conditions and the need for prior coordination were necessary for flying UAS around the Ticonic Bridge in Winslow, ME (figure 1).

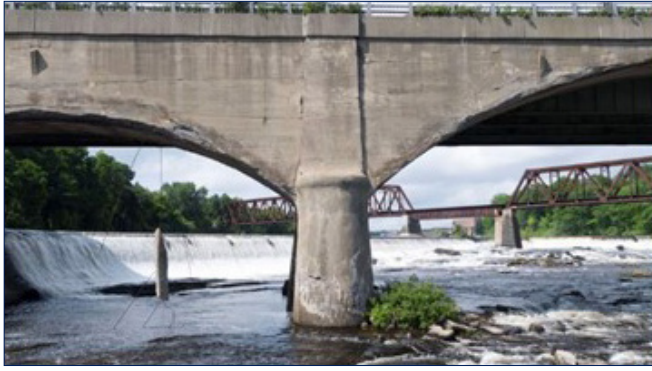
The bridge structure consists of steel-welded plate girders and riveted plate girders supporting a concrete cast-in-place bridge deck. On the south side of the bridge is a pedestrian sidewalk, which is part of the original rail bridge constructed as soil-filled spandrel arches (figure 2). The arches on the south side of the bridge cannot support the weight of a UBIT, and the bridge is too wide for a UBIT to reach the south side when positioned on the north side. Thus, UAS flights eliminated the safety hazards of using other means (typically an inspector climbing underneath the arches) to access the south side of the bridge deck to capture high-resolution imagery to assess the structural condition.

Figure 2. Photo. UAS image of Ticonic Bridge spandrel arches.

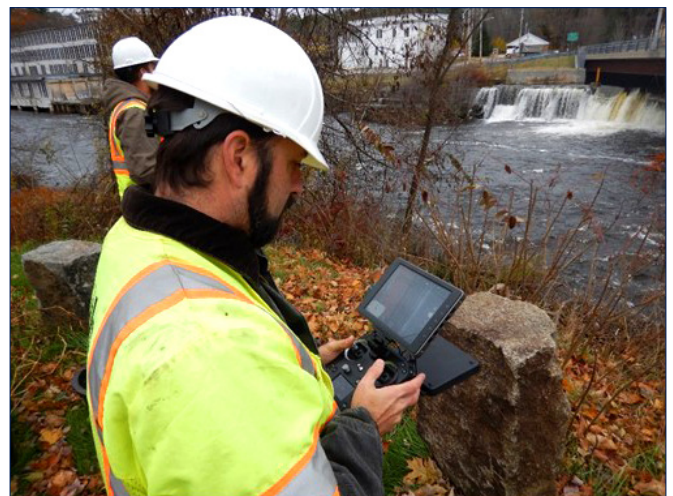
The dual-control inspection team setup consists of a UAS pilot and a sensor operator (typically the inspector or inspection team leader) performing their tasks using separate controllers. The UAS pilot controls the UAS position during flight, ensuring the safety of the platform and the surroundings, and getting the UAS in position to attain the desired images and video. There are two video feeds from the UAS in this setup: a “first-person view” camera for the UAS pilot, and a second high-resolution camera that can capture inspection video and still images. The sensor operator directs the onboard camera and can adjust, while the platform is in flight, the gimbal angle, zoom (if equipped with variable focal length lens), and multiple camera settings to achieve the highest quality inspection imagery possible.

Figure 3 depicts the inspection team at the Ticonic Bridge using this setup. The sensor operator (in the foreground) is the bridge inspector. Using the dual controls, the inspector can focus on capturing the needed images of the bridge structure while the pilot (in the background) concentrates on safely flying the aircraft.

Figure 3. Photo. Two-person inspection team using separate monitors.

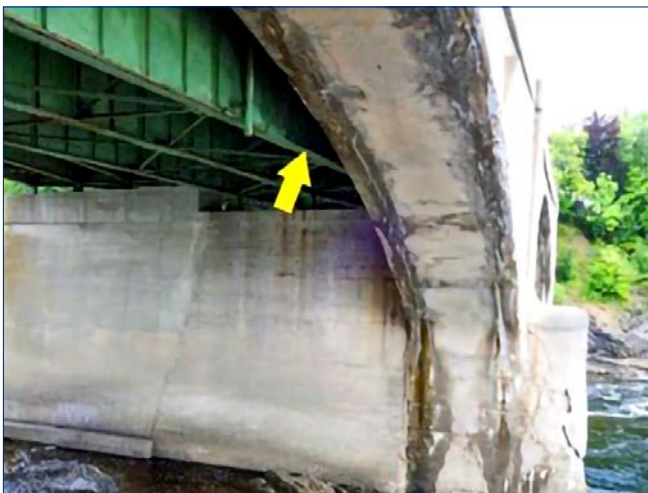
Figure 4. Photo. Key area of interest for UAS imaging.

of the structure components and identify defects for areas hazardous to access by other means (figure 4 through figure 6).

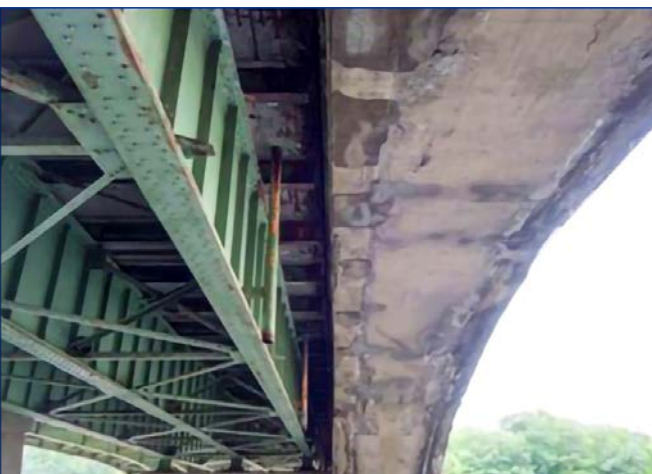
Figure 5. Photo. UAS image of space between spandrel arches and primary bridge structure.

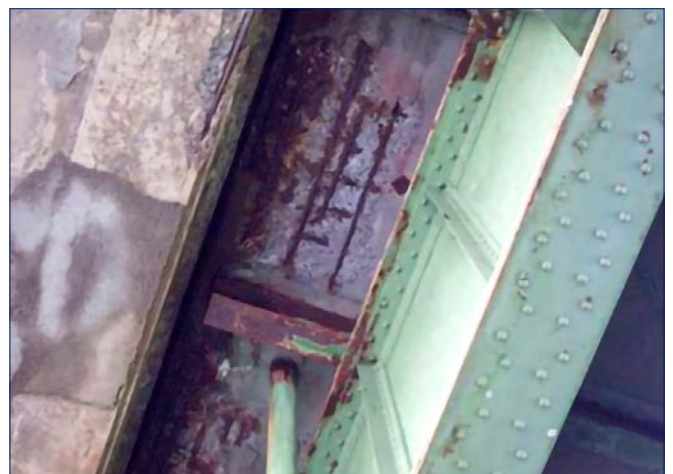
Figure 6. Photo. UAS image of deterioration between steel girders and spandrel arches.

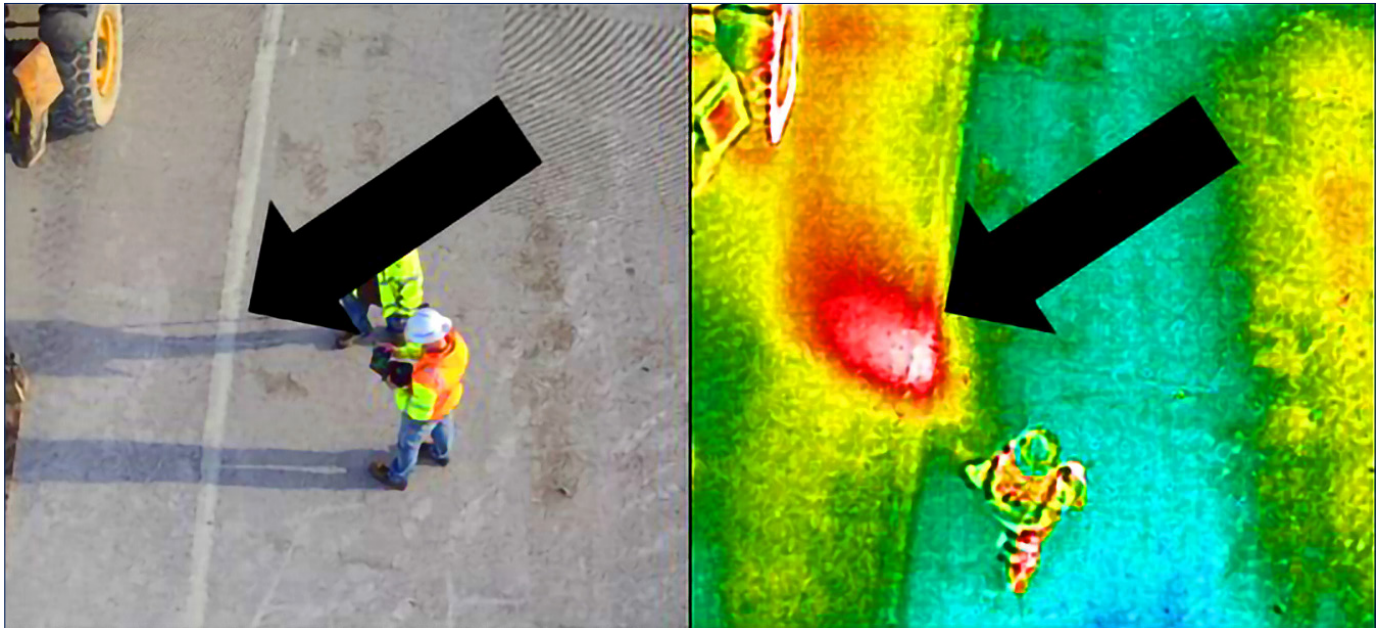
with the first camera. Using the advanced camera, the inspector in one instance was able to identify an area of delamination that had been missed using traditional inspection techniques (figure 9). This previously undiscovered delamination was verified when an inspector subsequently sounded the area.

Figure 9. Photo. EO and IR sensor images showing location of previously undetected delamination.

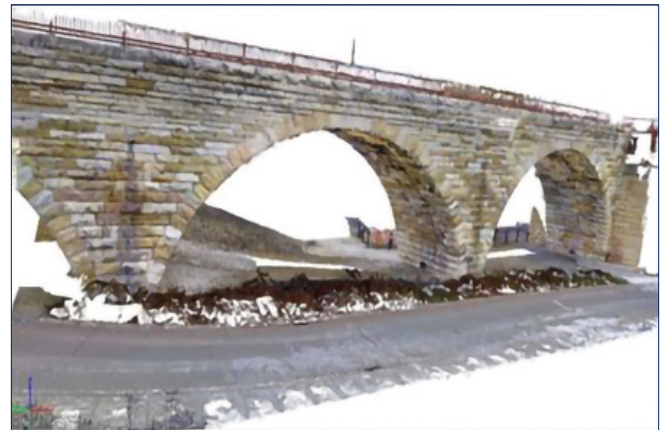
Minnesota DOT (MnDOT), during its extensive research and pilot projects, has explored the practice of flying and imaging the entire bridge to create a 3D digital model of the structure (Wells and Lovelace 2018). This practice provides the bridge owner with many advantages, including creating a structural map of the bridge in the absence of original drawings; supplementing numeric condition data with a visual representation of the condition of the entire structure, which is useful for reviewing the data accuracy; providing location specificity for defects; comparing condition changes across inspections and assessing repair needs; and electronically archiving and recalling images of specific bridge elements and defects in an easy and sharable way (figure 11).

Figure 11. Graphic. MnDOT 3D model of stone bridge.

the level of efficiency gained using UAS. The total time required to conduct a traditional inspection for the bridge depicted in figure 11 was 11 h, whereas the inspection using a UAS took over 9 h of flight time, and the postprocessing of the imagery increased the overall time invested in this bridge to over 17 h (Wells and Lovelace 2018).

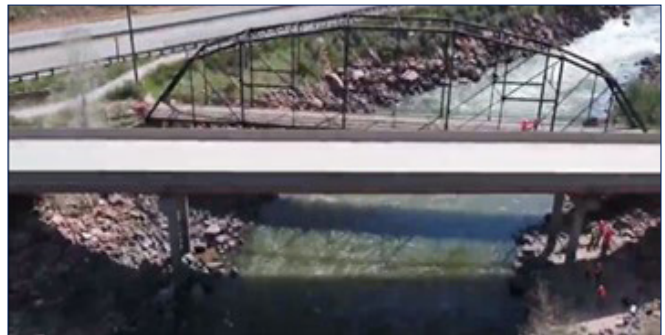
Creating a 3D model using UAS imagery does not work well for all bridge structures. One such bridge structure was discovered during a proof-of-concept inspection in Colorado. The Glenwood Springs Bridge in Garfield County, CO, is a small road bridge located on Route 134, approximately 5.5 mi to the west of Glenwood Springs, CO. It spans the Colorado River, connecting the north and south banks with Interstate 70. It has a footpath on the northern side, a rail line on the southern side, and a footbridge on the eastern side. Figure 12 shows the geography of the surrounding area.

Figure 12. Photo. UAS image of the Glenwood Springs Bridge and surrounding terrain.

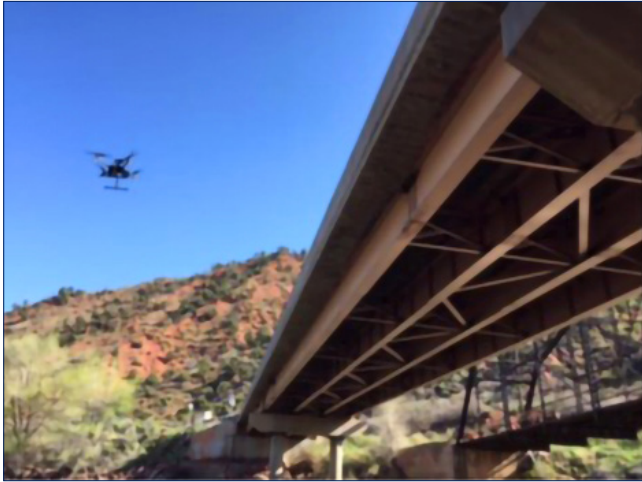
For this bridge, the UAS cameras failed to provide adequate results for creating 3D models for several reasons. It was determined that images of structures with intricate features (beams, braces, bolts, plates, and so on) and many faces are more difficult to stitch together than structures that have more basic geometry, such as a concrete bridge (figure 13). Adding to the challenge was a lack of surface features on the relatively new steel. Concrete has more variations in surface texture, which aids in the stitching process. Because of these factors and inadequate geotagging data quality, the 3D model was not usable, leaving just the video and still images for use in creating inspection products.

Figure 13. Photo. Glenwood Springs Bridge structural members being imaged by a UAS.

The UAS images captured for the Glenwood Springs inspection fell short of the intended goal of creating a 3D model of the bridge that would be used for testing their viability for visually representing conditions across the structure. This outcome was, in large part, a result of poor geotagging due to an inadequate GPS signal. The bridge is in a ravine that limited the acquisition of GPS signals, making UAS navigation and image geotagging challenging.
