**Emerging ISTD technology uses an innovative erosion head that more accurately measures soil erosion resistance, resulting in more cost-effective foundation designs and greater reliability and resiliency in bridge performance.**

Recommended citation: Federal Highway Administration, *In-Situ Scour Testing Device (ISTD), State Demonstrations of Field Soil Tests, Watkins, CO* (Washington, DC: 2021) <https://doi.org/10.21949/1521685>

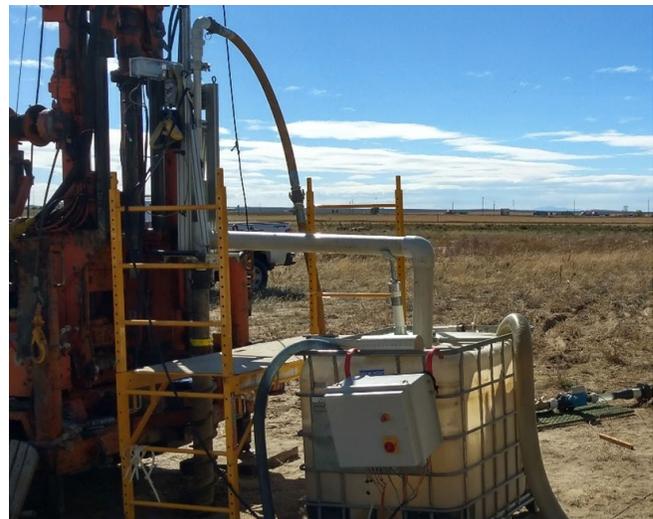
The ISTD equipment assembled in the field.

The demonstration took place on October 18, 2018. The drill crew and the hydraulics team arrived 1 day in advance to perform the SPTs and get a head start on assembling the ISTD equipment to conduct trial runs. This demonstration was the first to incorporate new accessories, including quick-snap cam and groove couplings for the hoses and new brass gate, lever, and pressure-relief valves to help control the water flow. These items needed to be fully tested before the CDOT engineers arrived. Another adjustment was made to the tank by cutting out a large rectangular access area in the top to allow for more flexibility to set up the water outlet pipe from the linear drive. A new custom outlet pipe support was also introduced. After the SPTs were conducted, the drill crew then augered to 27 ft in a new borehole and lowered in the Shelby tube and casings. The hydraulics team could then assemble the ISTD equipment, including the linear drive, water tank, hoses, and piping to conduct the erosion tests.
