Emerging ISTD technology uses an innovative erosion head that more accurately measures soil erosion resistance, resulting in more cost-effective foundation designs and greater reliability and resiliency in bridge performance.

Recommended citation: Federal Highway Administration, *In-Situ Scour Testing Device (ISTD), State Demonstrations of Field Soil Tests, Lowndesboro, AL* (Washington, DC: 2021) <https://doi.org/10.21949/1521493>.

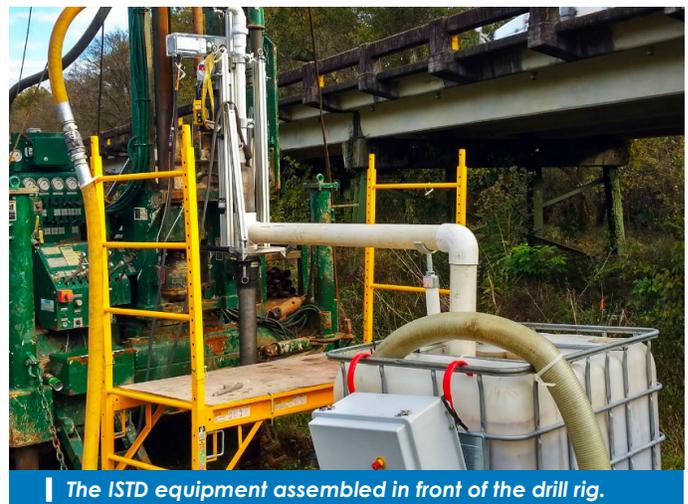
The ISTD equipment assembled in front of the drill rig.

The drill crew augered to a depth of 8 ft and lowered in the casing and Shelby tube. Subsequently, the hydraulics team assembled the remaining equipment including the linear drive, water tank, piping, hoses, and laptop. The hydraulics team successfully completed two erosion tests on the first day. The next morning the team asked the drill crew to start a new borehole at 8 ft to avoid the stiffer layer at 12 ft. The hydraulics team then completed three more erosion tests on the day of the demonstration.

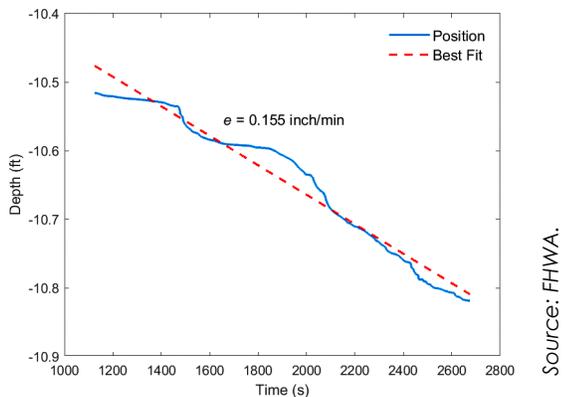
Soil layer's erosion rate (e) calculated from the slope of the best-fit line.

From the data, seven different segments were identified, and erosion rates were extracted by using a best-fit line through each set of data. The corresponding mean flow rates were also calculated for each segment. The seven data points are detailed in the Summary of Results table.

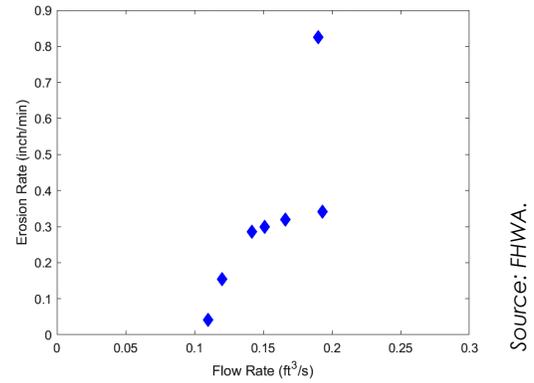
Erosion rate versus flow rate for the Lowndesboro ISTD demonstration. With more data points, a nonlinear fitted power curve could be used to extract the critical flow rate where erosion begins.

The correlation of the best-fit lines was poor for several of the runs, due to these inconsistent large drops seen with the erosion head. These large drops could be behavior typical of the clay; however, the clay was also very sticky. It is possible that pieces of the clay were adhering to the sensors and interfering with their movement. Usually, when the erosion head was stuck in place and not moving for long periods of time, a single sensor controlled the gap. It seems likely that erosion was still occurring in the tube, while clay was stuck to the controlling sensor.
