Reliability of Visual Inspection for Highway Bridges, Volume I: Final Report

FHWA-RD-01-020

JUNE 2001

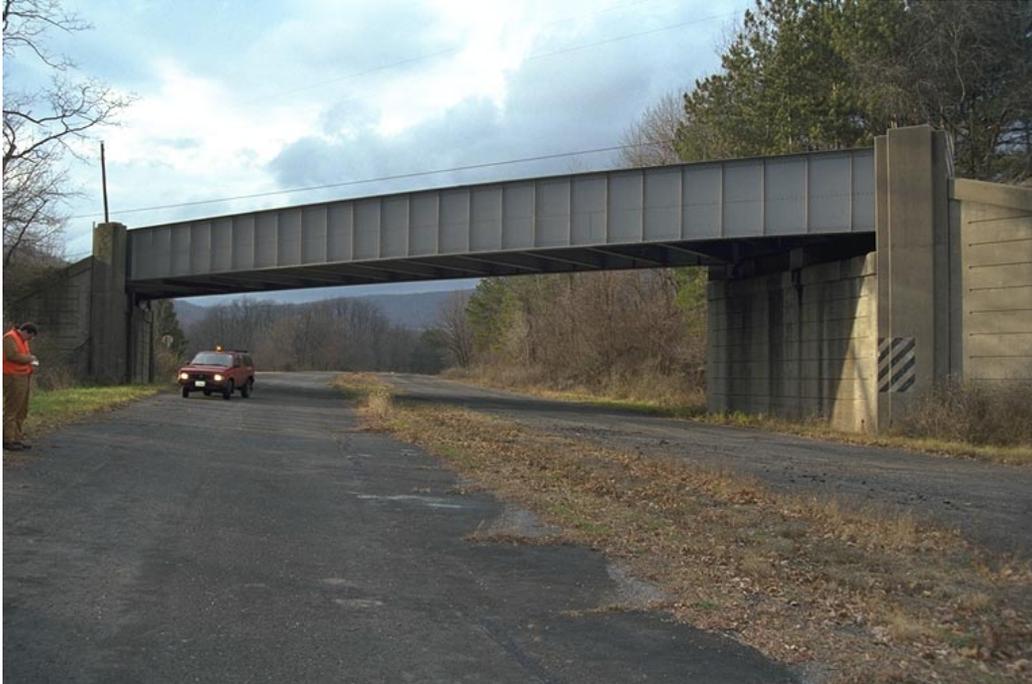
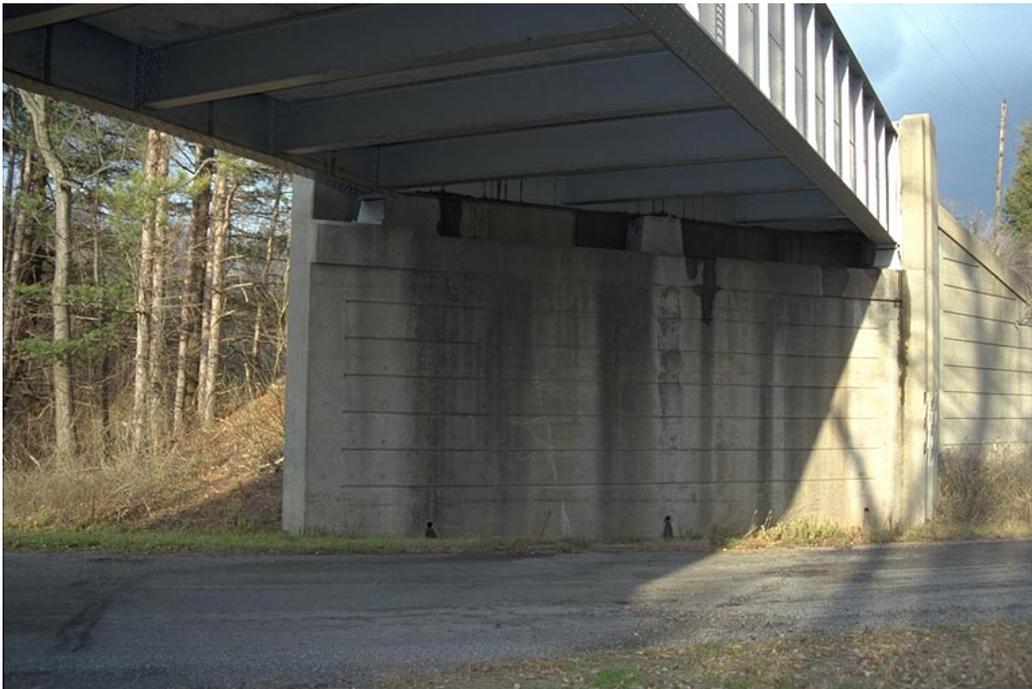
Figure 11. Bridge B521.

The exterior surface of the two longitudinal girders has minimal signs of corrosion or loose paint. The interior surfaces have some corrosion staining with pitting and efflorescence staining. The most prominent location for pitting and staining is at the floor beam-to-girder connection. Pitting is generally less than 1.5 mm deep. Moderate surface rust can also be noted at the deck-to-web interface due to water retention in those locations. Most of the floor beams are in fair condition, with some exhibiting corrosion on the horizontal surfaces due to water leakage.

The north abutment shows general water staining, with numerous 25-mm spalls at form tie locations. The remaining portions of the substructure exhibit similar conditions and are, in general, in fair condition. Appendix D in Volume II further summarizes the overall condition of Bridge B521. Note that the Condition Ratings given in Appendix D will be referred to as the Reference Condition Ratings in subsequent sections.

a. Elevation view of Bridge B521.

b. Bridge B521 superstructure and abutment.

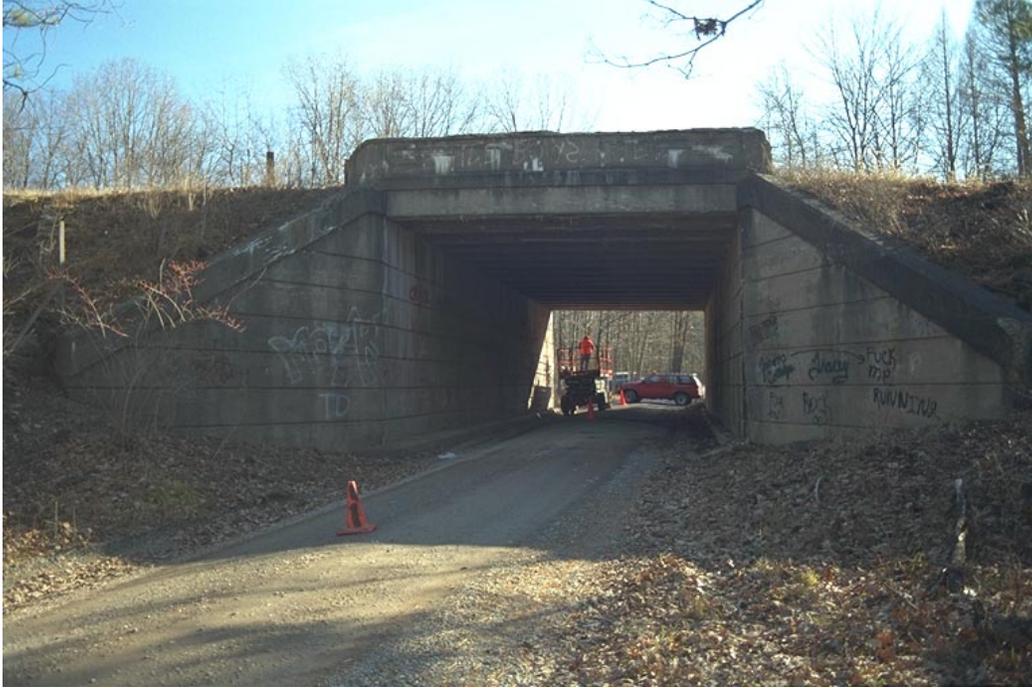
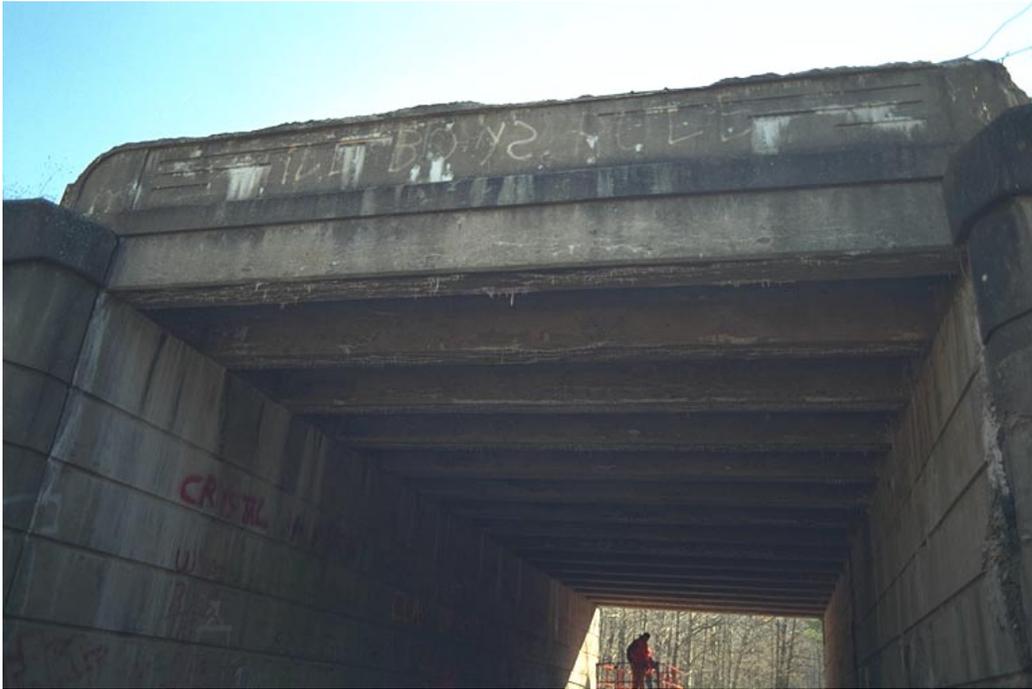
Figure 12. Bridge B101A.

The underside of the deck is generally in good condition. There is extensive damage within 610 mm of the longitudinal expansion joint where deterioration has extended as much as 100 mm into the slab thickness. Slab delaminations are usually indicated by heavy mineral deposits. Inadequate concrete cover can also be observed in the superstructure, and deterioration of the stems of the T-beams was more severe than that occurring in the deck soffit. The deterioration consisted of severe delaminations and longitudinal cracking, as evidenced by heavy mineral deposits.

The substructure has experienced deterioration from water infiltration and soil movement. A significant horizontal crack is located just above mid-height along the length of one abutment.

a. Elevation of Bridge B101A.

b. Exterior face of north parapet of Bridge 101A.

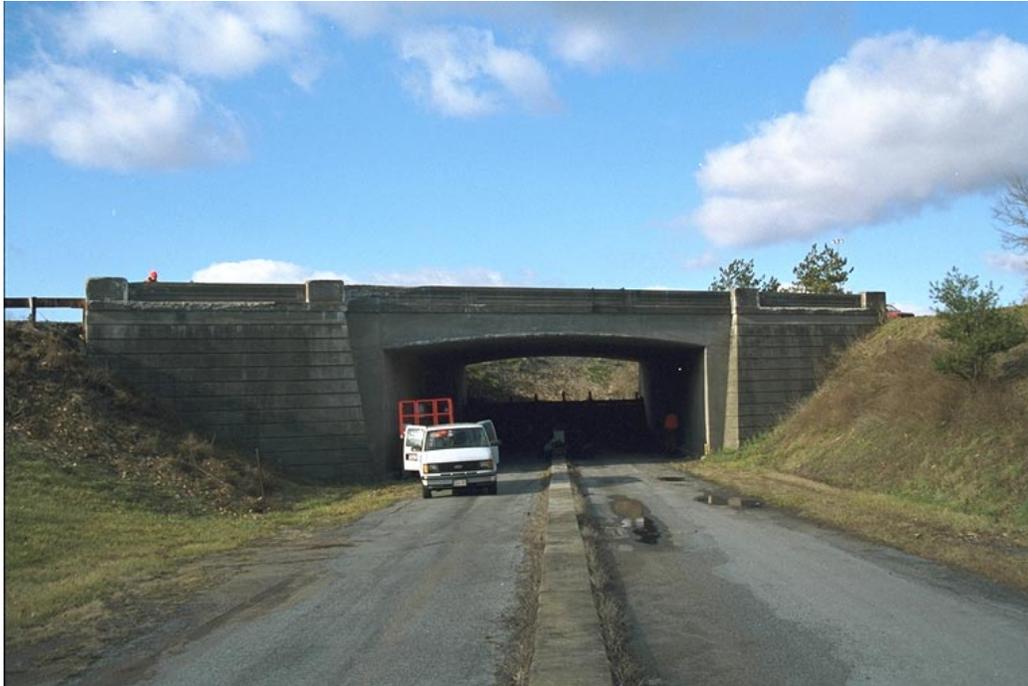
Figure 14. Bridge B543.

The westernmost bridge on the STAR facility, Bridge B543, is a single-span, cast-in-place reinforced concrete rigid frame that spans over a decommissioned access ramp. Bridge B543, shown in figure 14, is approximately 33.22 m wide and spans approximately 12.80 m at a 0.44-rad skew. The Pennsylvania Turnpike Commission uses the area directly below Bridge B543 for temporary storage of equipment and materials. The frame of the bridge consists of an arched reinforced concrete deck slab with a thickness varying from 495 mm to 990 mm. A 165-mm-thick asphalt overlay has been placed over the entire width of Bridge B543. An expansion joint and alignment shear key divide Bridge B543 down its length. The bridge abutments are constructed integrally with the deck, while the wingwalls are isolated from the abutments by a 25-mm cork-filled joint.

The deterioration of Bridge B543 is quite varied. The most significant deterioration is present in the bridge deck overlay and especially in the parapets. It could generally be described as being consistent with the other previously described STAR bridges. The superstructure and

substructure are in fair to good condition, with the exception of freeze/thaw damage observed near the slab edges. Appendix D in Volume II further summarizes the general condition of Bridge B543.

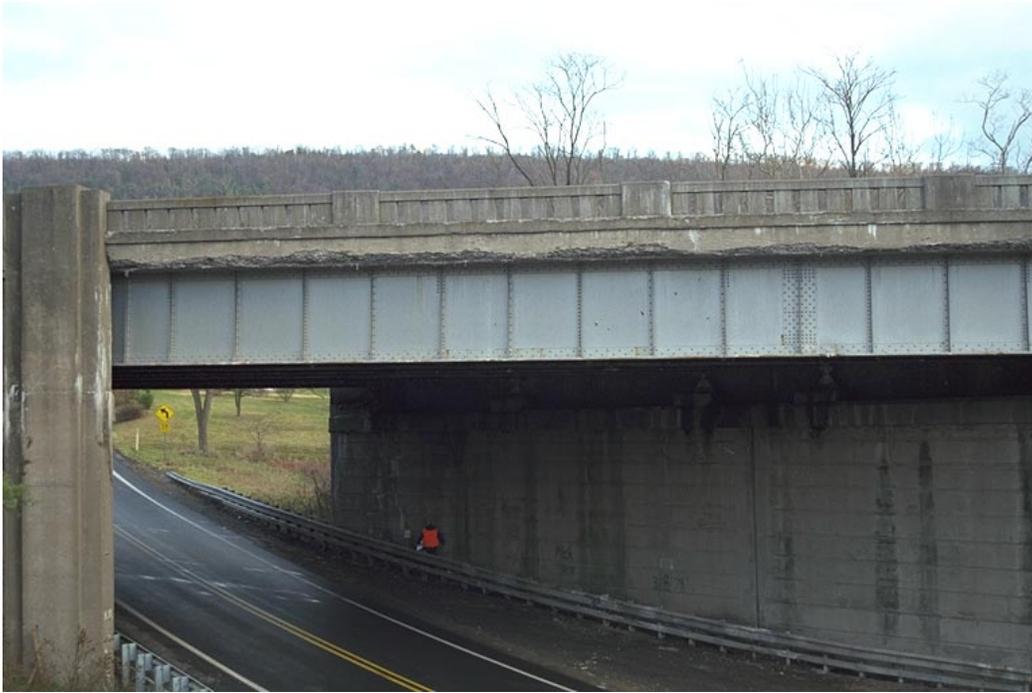
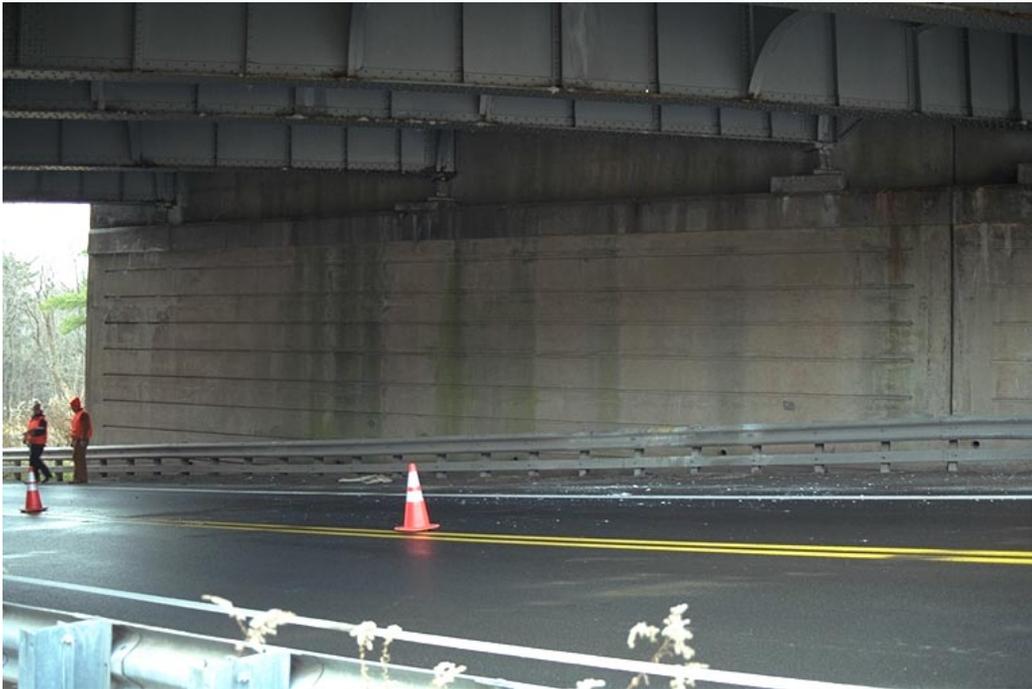
Figure 15. Bridge B544.

Bridge B544, shown in figure 15, is a decommissioned, single-span, steel plate girder bridge carrying the STAR route over U.S. Route 30. Near Bridge B544, U.S. Route 30 is a medium-to-high volume highway in a business district/rural setting. The bridge spans 28.65 m and is 21.34 m wide from curb to curb. Bridge B544 is skewed at approximately 0.91 rad and has a 230-mm-thick cast-in-place reinforced concrete slab with a 150-mm asphalt overlay riding surface. There are three expansion joints in Bridge B544 — one longitudinal joint and one at each abutment. The bridge superstructure is complex for the overall size of the structure, with each half of the deck supported by three longitudinal plate girders and a series of alternating transverse floor beams and sway frames. In addition, a W18 x 47 rolled shape runs the length of the bridge along the expansion joint. The plate girders consist of a 1.91-m-deep by 11-mm-thick web plate and

a. Elevation view of Bridge B544.

b. Bridge B544 superstructure.

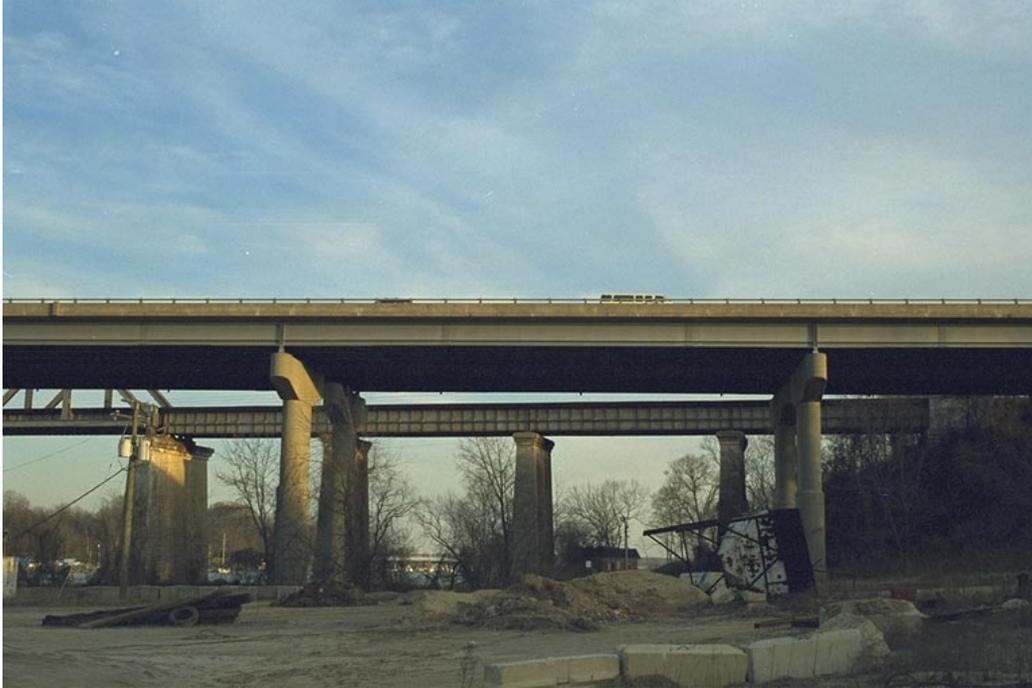
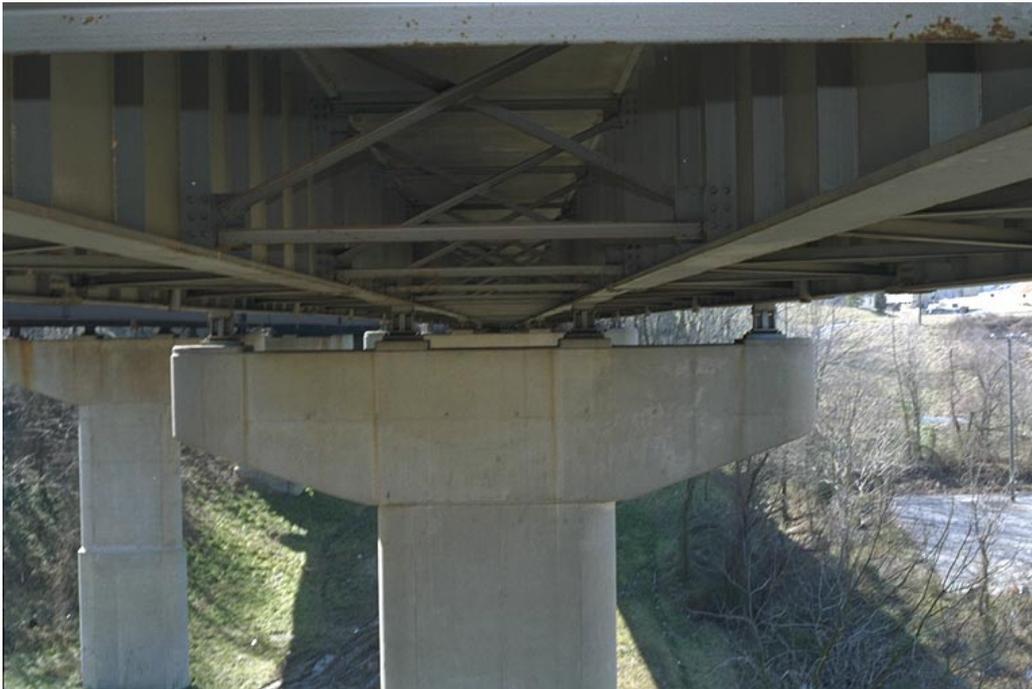
Figure 16. Test portion of U.S. Route 1 Bridge over the Occoquan River.

The U.S. Route 1 Bridge over the Occoquan River was constructed in 1975. The 335.28-m structure is divided into two independent, four-span structures as shown in figure 16. The southern four-span unit served as a test bridge for this study. The roadway is 10.97 m wide, accommodating two lanes of traffic and two shoulders. Each span measures approximately 37.0 m with a vertical clearance varying from 1 m to 18 m. This bridge has no skew. The superstructure consists of 1.83-m-deep welded plate girders with variable-thickness flange plates. Girder construction includes welded transverse and longitudinal stiffeners, bolted angle diaphragms, bolted and welded flange transitions, and an in-plane lateral bracing system comprised of WT members attached to lateral gusset plates that are welded to the girder webs

a. Overall view of bridge (foreground).

b. View of superstructure.

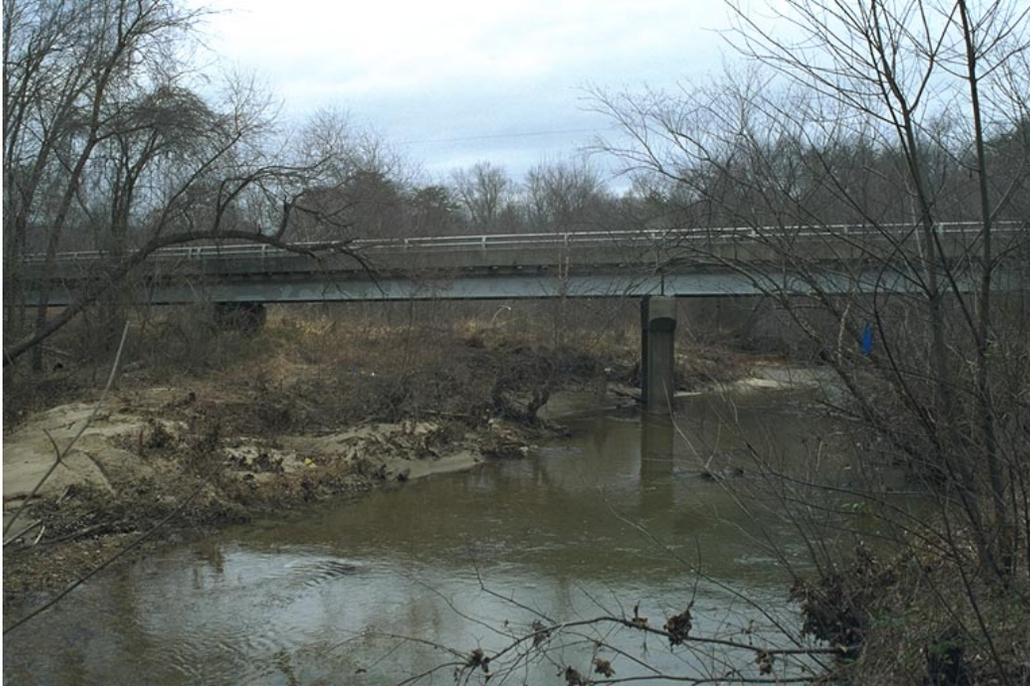
Figure 17. Van Buren Road Bridge.

The Van Buren Road Bridge over the Quantico Creek, shown in figure 17, was constructed around 1960 and consists of three spans, each simply supported, with a span length of 18.29 m. The overall bridge is 55.65 m long and 7.67 m wide. The curb-to-curb deck width is 6.1 m and the bridge has a 0.26-rad skew. The deck is 175-mm-thick, cast-in-place reinforced concrete supported by four wide flange stringers that are composite with the deck. The steel stringers are reinforced with tapered-end, welded cover plates. The superstructure is supported by reinforced concrete piers and abutments founded on spread footings or steel H-piles.

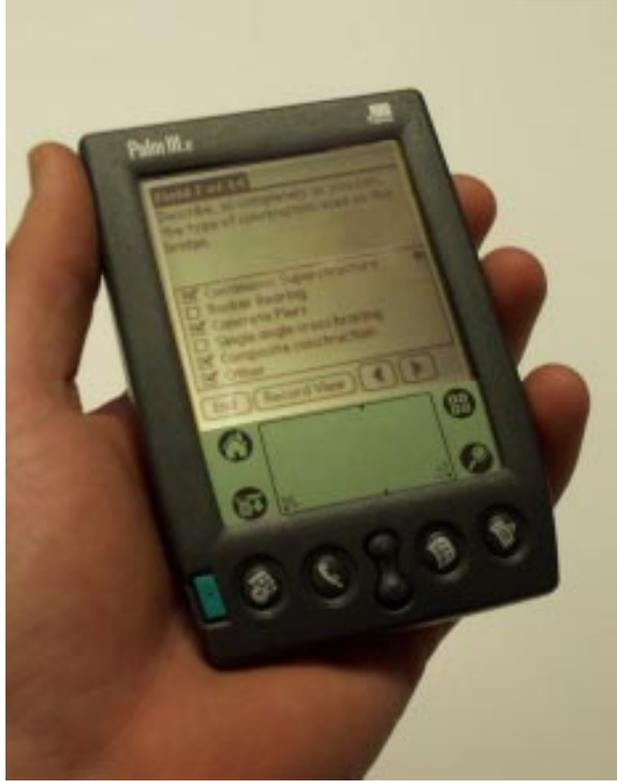
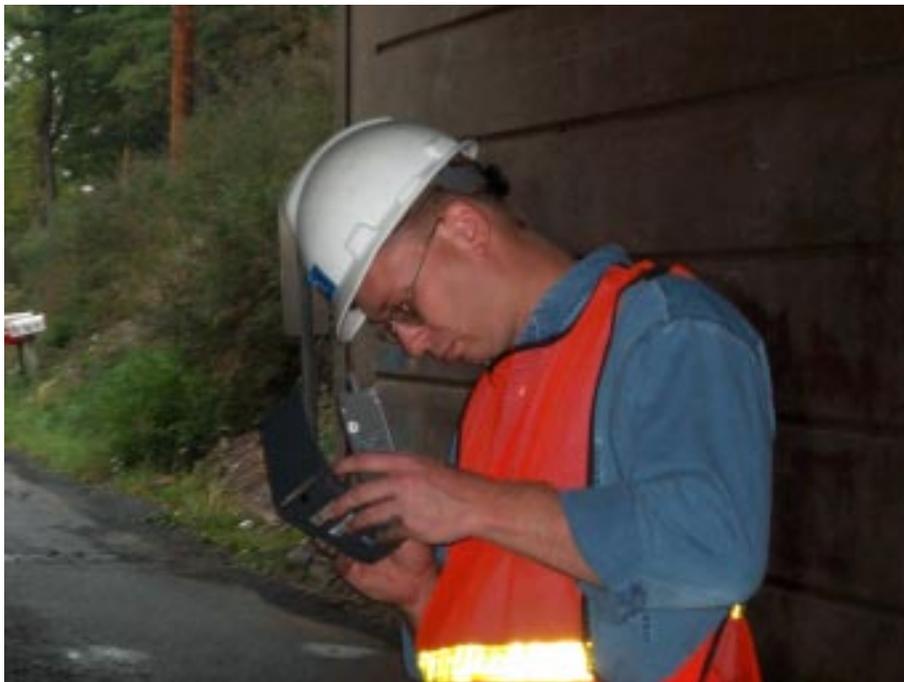
Figure 18. Palm IIIx handheld computer.

a. Palm IIIx computer.

b. NDEVC observer using Palm IIIx during field inspections.

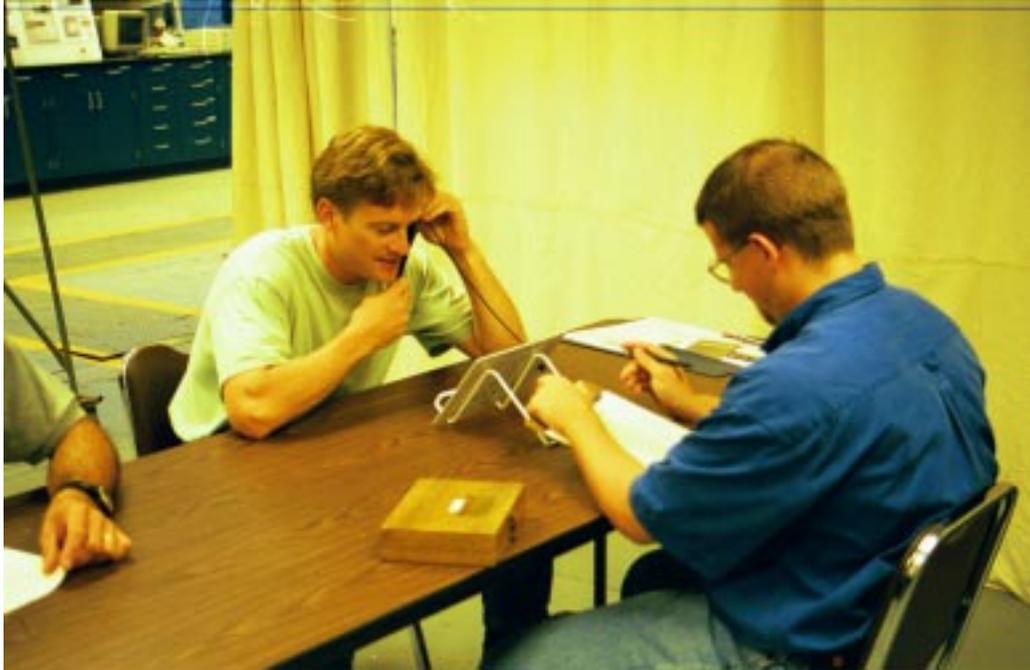
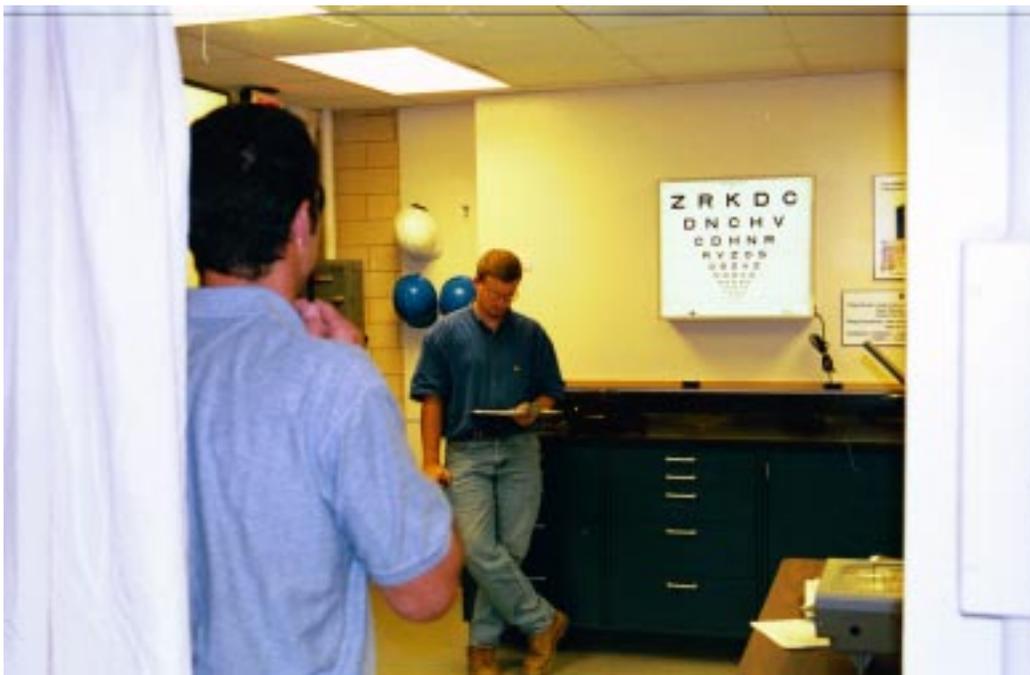
Figure 20. Direct visual acuity testing.

DIRECT VISUAL ACUITY: As discussed in Chapter 3, inspectors are typically not tested for visual acuity. NDE techniques, however, rely on an inspector's use of their eyes and observations may be influenced by how well they can see. Direct visual acuity, both near and distance, was tested using the Logarithmic Visual Acuity Chart 2000. These tests are similar to standard vision tests commonly given in a doctor's office. Figure 20 shows inspectors taking the near and distance visual acuity tests. As before, protocols were followed when administering the direct visual acuity tests and these protocols are given in Appendix G in Volume II.

a. Inspector taking the near visual acuity test.

b. Inspector taking the distance visual acuity test.

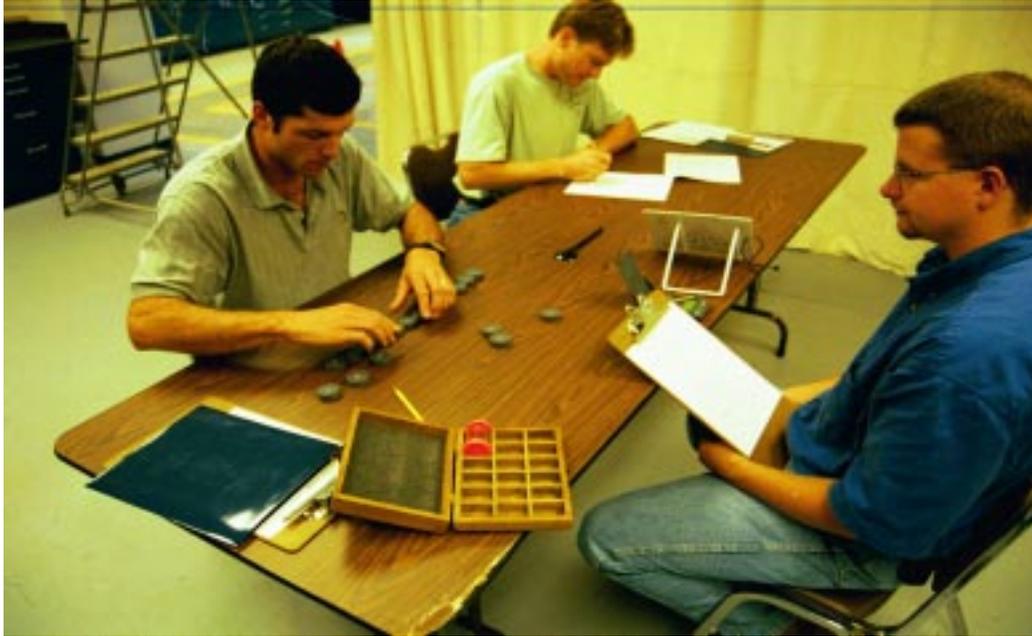
Figure 21. Inspector taking the color vision test.

The PV-16 Quantitative Color Vision Test was used to determine the type of color vision deficiency, if any. The PV-16 Quantitative Color Vision Test consists of a set of 16 test caps of various hues. The goal of the test is to orient the caps in such a way that adjacent caps are closest in color. The PV-16 test uses large cap sizes, giving more accurate color vision information because it does not rely on an inspector’s direct visual acuity. In addition, the PV-16 test is easy to administer and all types of color vision deficiencies can be rapidly identified. Figure 21 illustrates an inspector completing the PV-16 Color Vision Test. A protocol was followed for the administration of the color vision test and is given in Appendix G in Volume II.

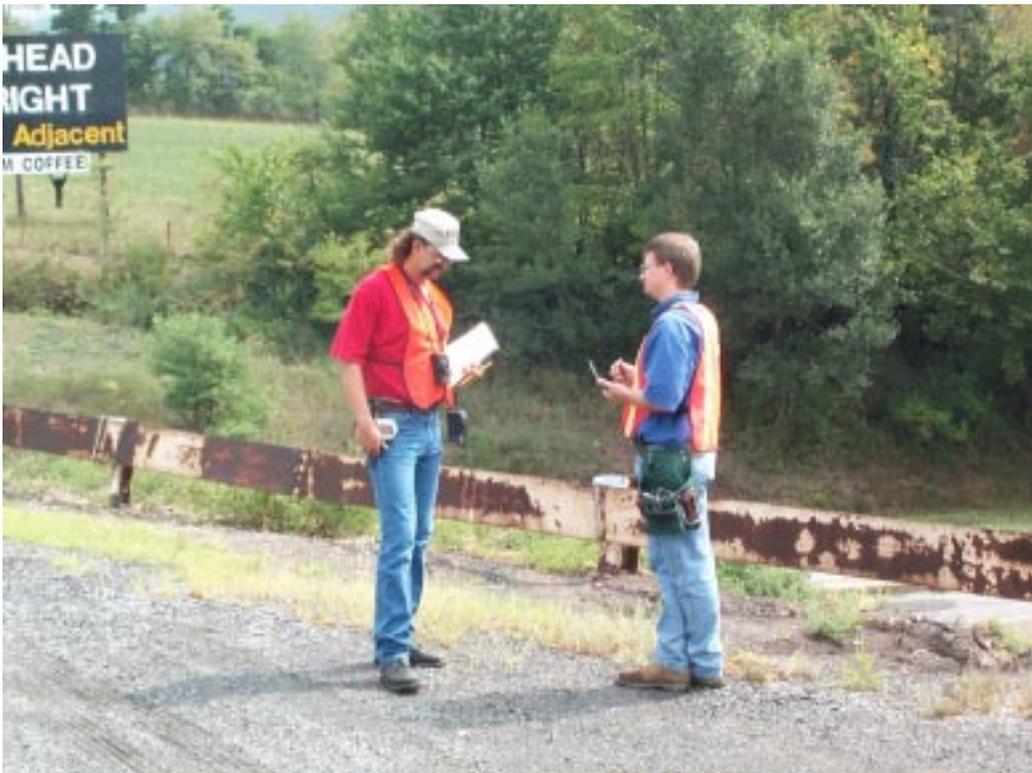
Figure 22. Observer administering a pre-task evaluation.

An orally administered pre-experimental evaluation was conducted prior to each task. This evaluation was administered in interview format and provided a baseline measure of the inspector’s physical and psychological condition at the initiation of each inspection task. In addition, information was collected to ascertain how the inspector was planning to approach the inspection. The pre-experimental evaluation forms for all tasks are represented in Appendix H in Volume II. In the actual study, this information was collected using the Palm IIIx handheld computer. Figure 22 shows an NDEVC observer administering a pre-experimental evaluation.

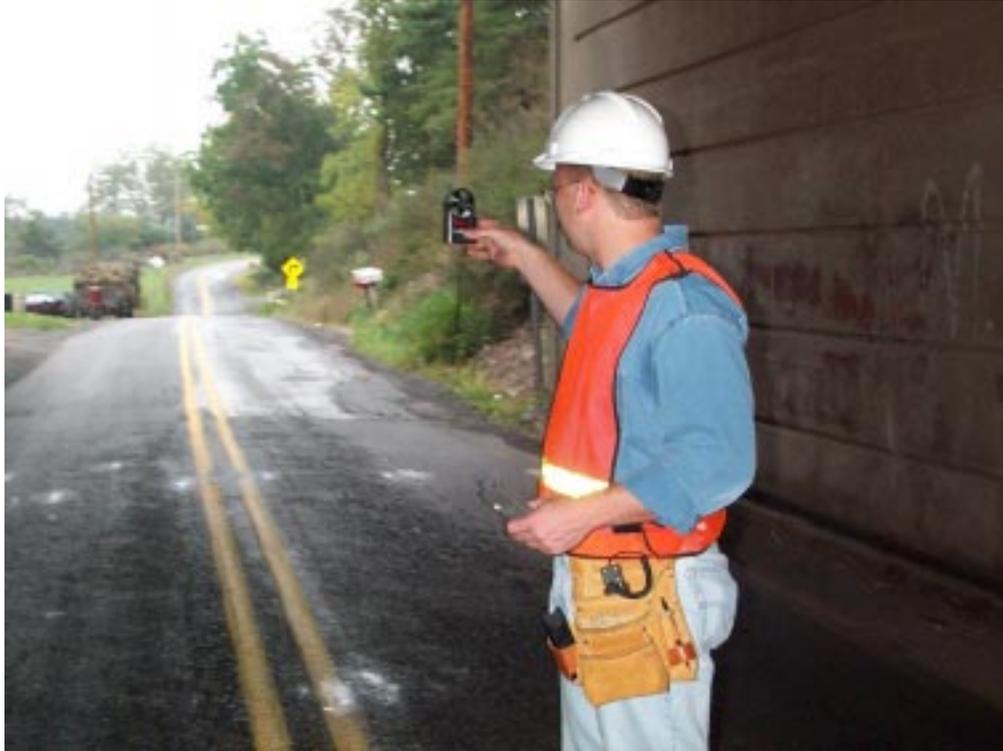
All measurements were made using standard equipment, with data recorded on the Palm IIIx via forms presented in Appendix J in Volume II. The measurements were made at consistent locations for each inspection specimen. To supplement these direct environmental measurements, qualitative assessments of the general weather conditions were also made and recorded on the forms in Appendix J. Figure 23 illustrates an observer measuring the environmental conditions.

Figure 23. Observer measuring the environmental conditions.
