TECHBRIEF

Pedestrian and Bicycle Safety

Road User Behaviors at Pedestrian Hybrid Beacons

FHWA Publication No.: FHWA-HRT-16-039

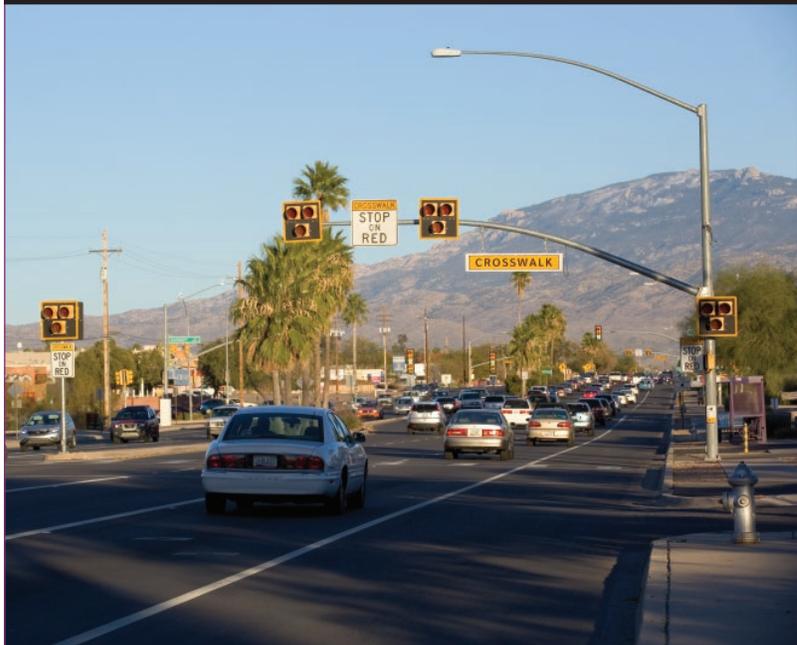
Figure 1. Example of PHB installation in Tucson, AZ.

The pedestrian hybrid beacon (PHB)—or high-intensity activated crosswalk (HAWK), as it is known in Tucson, AZ—is a traffic control device used at pedestrian crossings that was first included in the 2009 *Manual on Uniform Traffic Control Devices* (MUTCD).⁽¹⁾ The treatment typically has the crosswalk marked on only one of the major road approaches. The PHB's vehicular display faces are generally located on mast arms over the major approaches to an intersection and in some locations on the roadside. An example is shown in figure 1 for an installation in Tucson, AZ. The face of the PHB consists of two red indications above a single yellow indication. It rests in a dark mode, but when it is activated by a pedestrian, it

first displays to drivers a few seconds of flashing yellow followed by a steady yellow change interval and then displays a “walk” indication to pedestrians and a steady red indication to drivers, which creates a gap for pedestrians to cross the major roadway. During the flashing pedestrian clearance interval, the PHB displays an alternating flashing red indication to allow drivers to proceed after stopping if the pedestrians have cleared their half of the roadway, thereby reducing vehicle delays. Additional information about the PHB is available in the MUTCD.⁽¹⁾

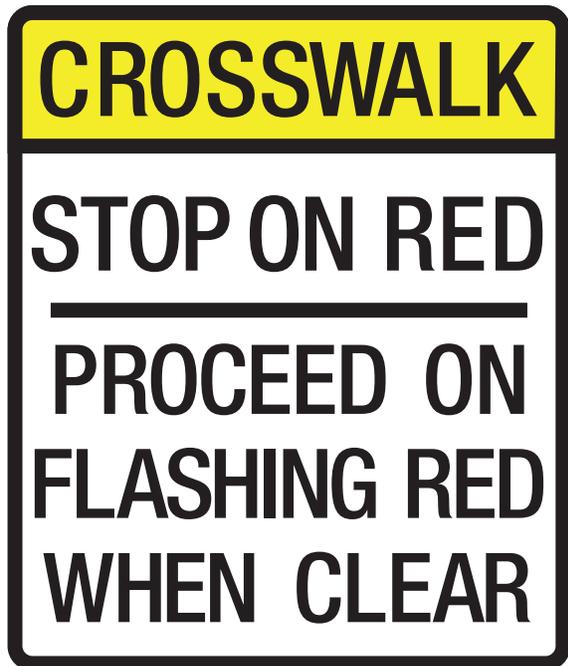
Figure 2. Sign (30 by 36 inches) recommended by FHWA to address comprehension issues with the flashing red phase.

^aFHWA has received numerous inquiries regarding how to address comprehension issues with the flashing red phase and is now recommending that if an alternative legend to the R10-23 sign is used, that it be the sign shown in figure 2.

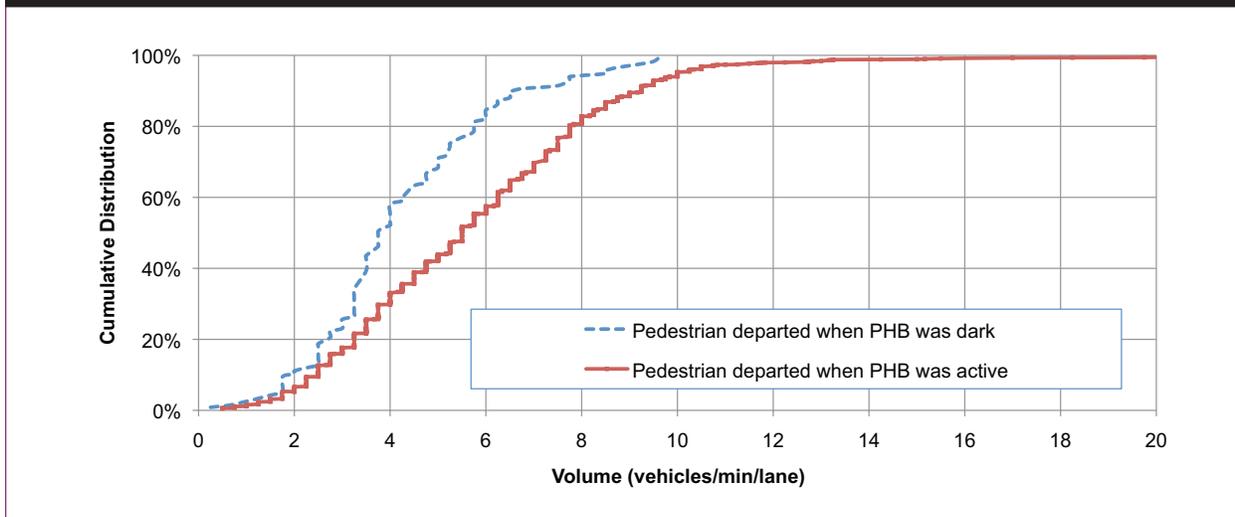
Figure 3. Volume cumulative distribution when pedestrian started.

For the pedestrian crossings observed, only 124 of the 1,689 general public pedestrians (7 percent) left during the dark indication. For the majority of these pedestrians, the roadway volume was such that the pedestrians were able to find sufficient gaps to cross (volume was less than 4 vehicles/min/lane for the majority of these crossings). Figure 3 shows the cumulative distributions of the 1-min/lane volume for those pedestrians that departed during the dark phase (blue dashed line) and those that departed during an active phase (red solid line). Pedestrians were more likely to wait for the PHB to be active before starting to cross at the higher roadway volumes, as shown by the location of the red solid line to the right of the blue dashed line.
