TECHBRIEF

Enhancing Conspicuity for Standard Signs and Retroreflectivity Strips on Posts

FHWA Publication No.: FHWA-HRT-22-066

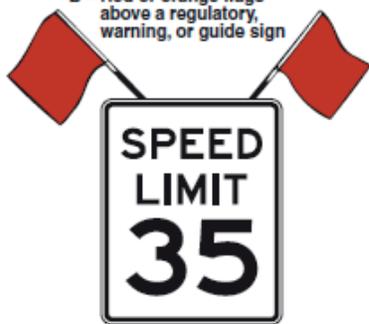
Figure 3. Graphic. Example of enhanced conspicuity for signs: W16-18P (Federal Highway Administration 2009).

C – W16-18P plaque above a regulatory sign

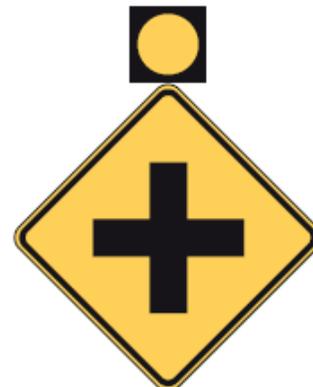
Figure 6. Graphic. Example of enhanced conspicuity for signs: supplemental beacon (Federal Highway Administration 2009).

F – Supplemental beacon

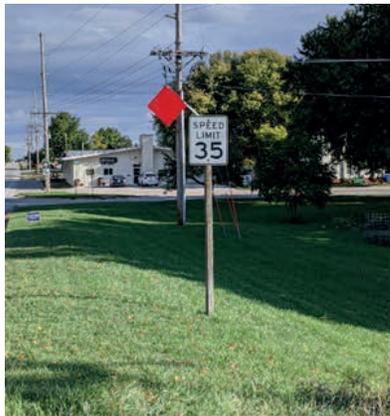
Figure 7. Photo. Treatment in Iowa: Speed Limit flag.

The Speed Limit flags site saw a small drop in mean speed downstream of the northbound Speed Limit sign in the first after-installation period and then a larger drop at the second after period. However, the decrease in mean speeds upstream of the Speed Limit sign with flags was greater than that seen downstream. For southbound traffic, speeds increased downstream of the treatment in the first after period by almost 1 mph, and a similar increase was also seen for upstream traffic. In the second after period, mean speed downstream of the treatment decreased by almost 3.5 mph; however, upstream of the treatment, mean speeds decreased by 4.8 mph. Therefore, the Speed Limit flag appears to have had little effect on vehicles' mean speeds.

The tangent section with Speed Limit flags saw decreases in 85th-percentile speed for the southbound approach in the second after period. These decreases were 5 and 4 mph slower for all vehicles and heavy vehicles upstream and 4 and 2 mph for the downstream, respectively. This decrease in speed may have been a result of drivers being more cautious in winter, even with dry pavement. Overall, however, 85th-percentile speeds downstream of the treatments saw minor decreases or increases relative to the changes seen upstream.

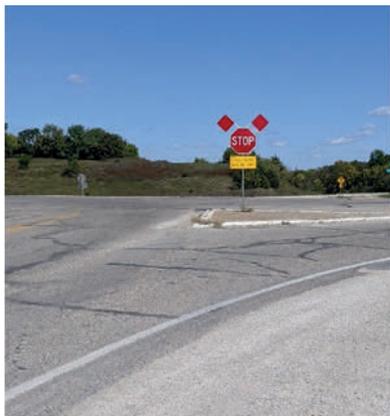
Figure 8. Photo. Treatment in Iowa: STOP-sign flags.

The STOP-sign flags site also saw a small, statistically significant decrease near the intersection in the after periods. The research team noted little to no change upstream.

The research team observed almost no change near the intersection for the STOP-sign flag site, and they saw only minor changes upstream.

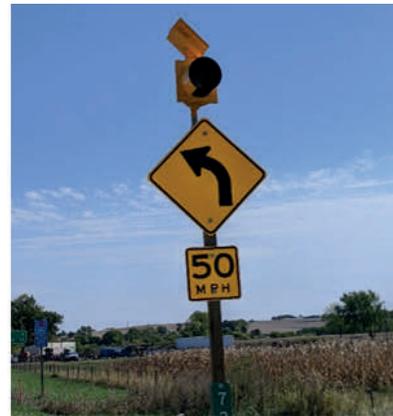
Figure 9. Photo. Treatment in Iowa: curve beacon.

As seen in table 2, the flashing beacon resulted in slower speeds at the Curve Warning sign in both after periods by 0.3–1.3 percent. Speeds at the center of the curve saw no statistically significant decreases in the first after period. However, in the second after period, while speeds decreased significantly for the northbound direction, they increased significantly for the southbound.

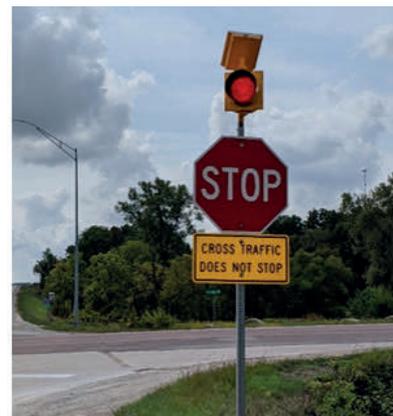
Figure 10. Photo. Treatment in Iowa: STOP-sign beacon.

The STOP-sign beacon site saw large decreases in speed near the intersection: 2.6 mph and 1.9 mph for southbound traffic for the two after-data collection periods, respectively. The beacons on the northbound approach saw statistically significant decreases in mean speeds near the intersection in the first after period; however, a significant increase in speeds occurred in the second after period. The northbound approach in the second after period saw drivers traveling at a lower mean speed at the upstream location. For the upstream location, data-collection equipment was placed on the nearest signpost located at least 100 ft upstream of the intersection.

The STOP-sign beacon saw decreases in 85th-percentile speed near the intersection for the southbound approach. All vehicles reduced 85th-percentile speed by 3 mph and 2 mph for the two after periods, while heavy vehicles reduced their 85th-percentile speeds by 7 mph and 5 mph in the two after periods, respectively.

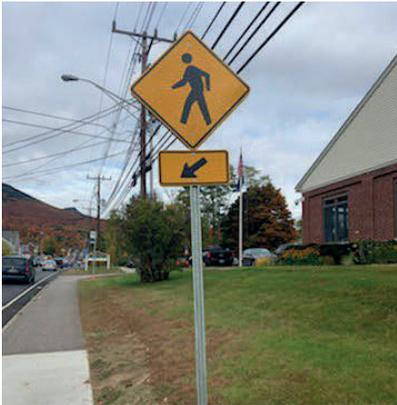
Figure 11. Photo. Before treatment: retroreflective 2.5-inch yellow strip.

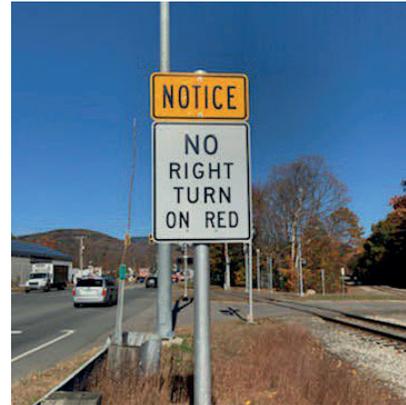
Figure 14. Photo. After treatment: fluorescent-yellow NOTICE header panel.

The research team added a fluorescent-yellow NOTICE panel to the top of the sign. There was no statistically significant difference in the number of vehicles turning on red before or after the treatment was installed.

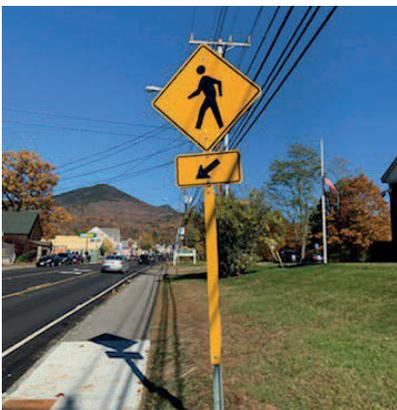
Figure 12. Photo. After treatment: retroreflective 2.5-inch yellow strip.

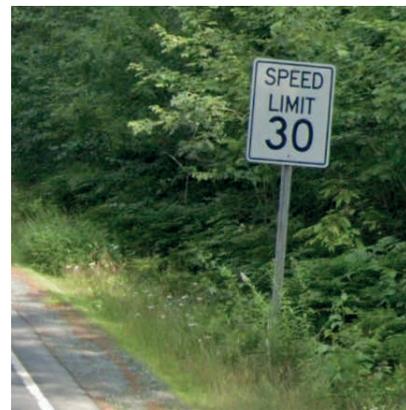
Figure 15. Photo. Before treatment: sign without retroreflective white strip.

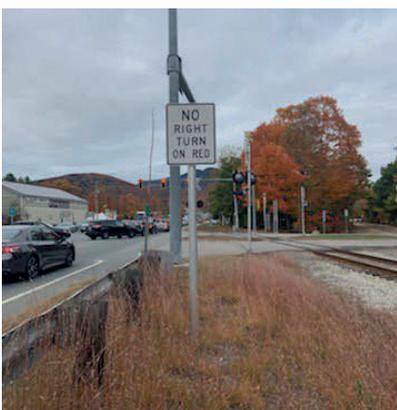
Figure 13. Photo. Before treatment: sign without header panel.

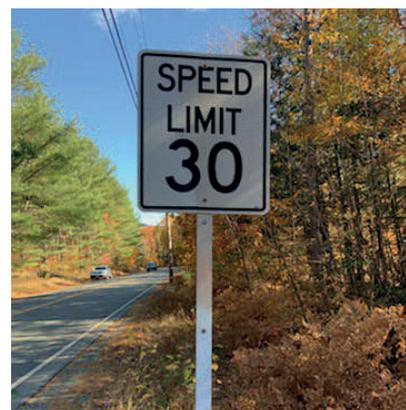
Figure 16. Photo. After treatment: sign with retroreflective white strip.

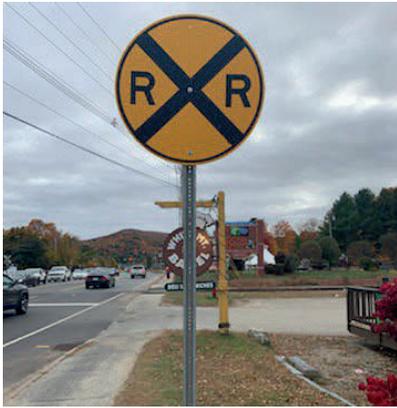
Figure 17. Photo. Before treatment: Railroad Crossing sign without retroreflective 2.5-inch yellow strip.

The research team added a yellow retroreflective strip to the signpost in the westbound direction. For the railroad crossing data, the research team determined noncompliance by considering the number of vehicles that were stopped on the tracks, given the queue was long enough to reach the railroad crossing. Data analysis indicated that noncompliance was significantly lower after the treatments were installed than before they were installed ($p_{\text{before}} = 0.54$, $p_{\text{after}} = 0.37$, chi-squared = 6.44, degrees of freedom (df) = 1, $p = 0.01$).

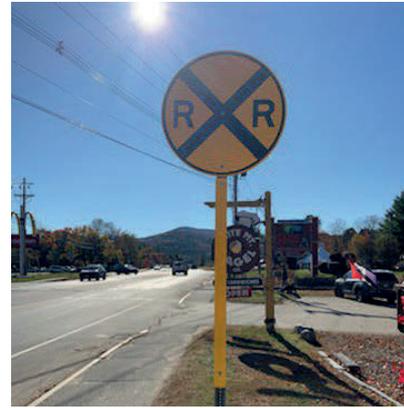
Figure 18. Photo. After treatment: Railroad Crossing sign with retroreflective 2.5-inch yellow strip.

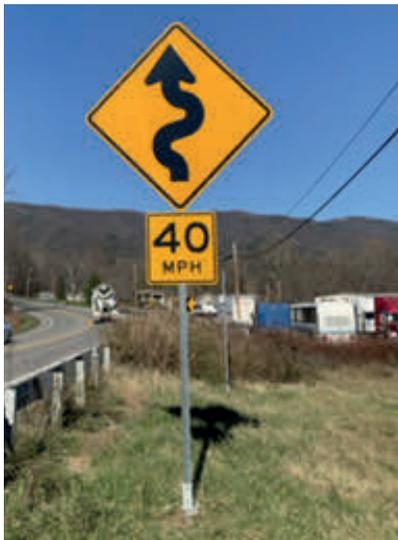
Figure 19. Photo. After treatment: oversized sign.

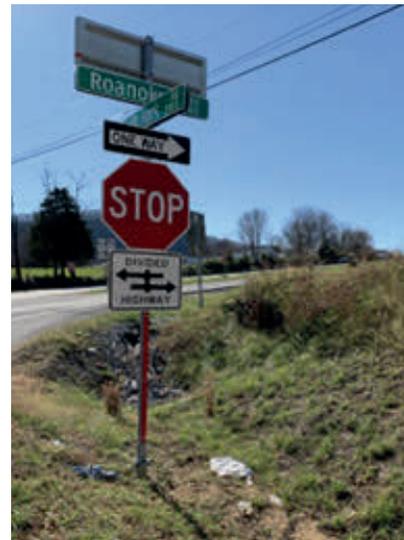
Figure 20. Photo. After treatment: red retroreflective strip.

For the STOP sign, the research team used a camera to count the number of vehicles that did and did not come to a complete stop before and after the red retroreflective strip was installed on the signpost. The research team observed this behavior for drivers who turned right from

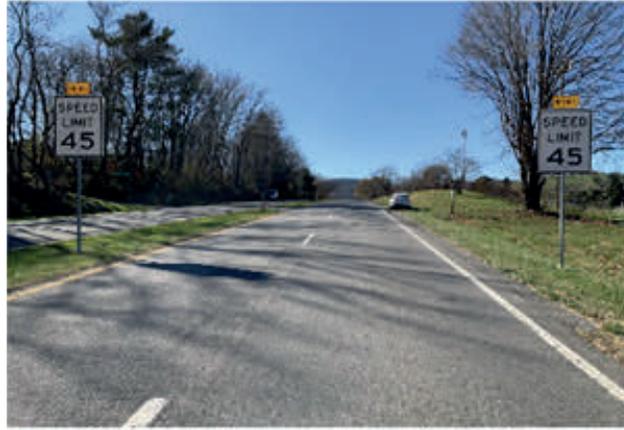
Figure 21. Photo. After treatment: fluorescent yellow NOTICE header panel.

Note: The NOTICE header panels shown in figure 21 are not compliant with the MUTCD. The MUTCD allows for only a header panel that is the full width of the sign.

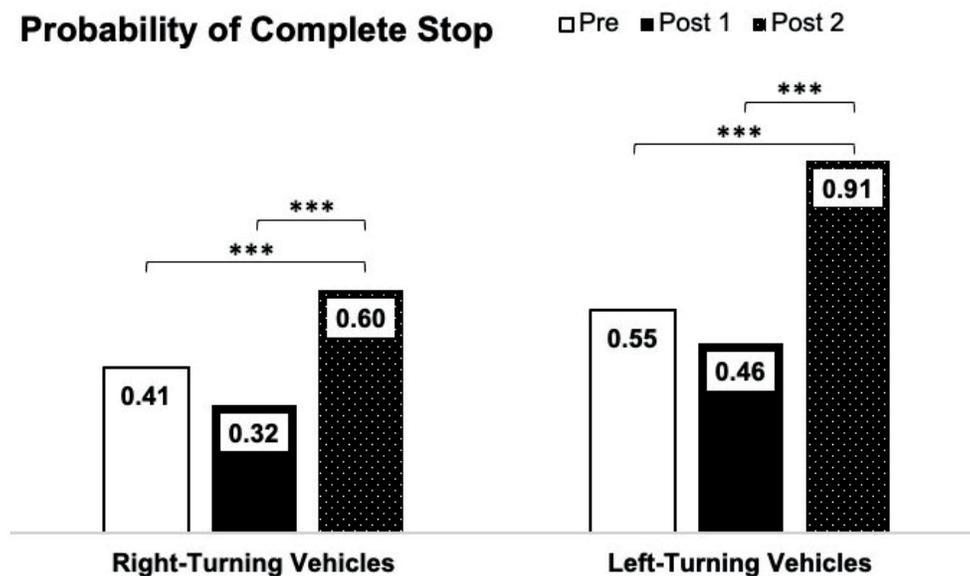
the STOP signs and drivers who turned left. As shown in figure 22, there was not a statistically significant change in complete stops in the initial after period, after which the second after period shows significantly increased rates of complete stops for each turning direction.

Figure 22. Graph. Probability of a complete stop by data collection period—Virginia.

***Statistically significant difference at the $p = 0.01$ level.

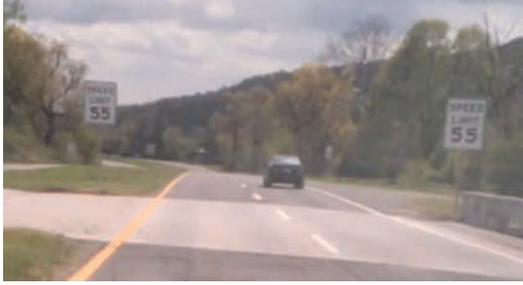
Figure 23. Photo. Conspicuity treatment: duplicate signs.

The results indicated that participants looked at sign 1 (duplicate signs) and sign 2 (fluorescent yellow NOTICE headers) more often than the control signs. Participants also looked at the speedometer more often while signs 1 and 2 were visible, compared to the control sign. Sign 3 (white retroreflective strip on signpost) did not yield statistically significant results for the number of glances to the sign or the speedometer.

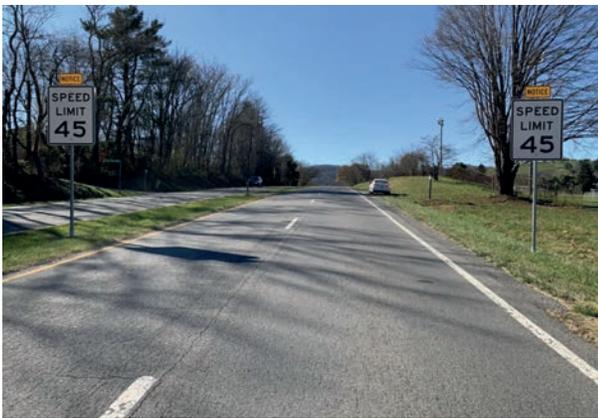
Figure 24. Photo. Conspicuity treatment: fluorescent yellow NOTICE header panels.

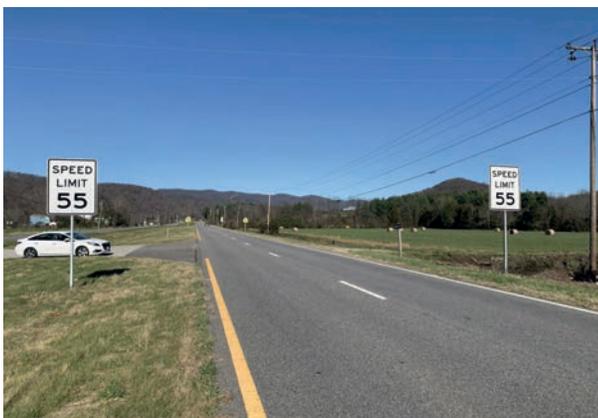
Figure 25. Photo. Conspicuity treatment: white retroreflective strip on signpost.
