Pedestrian Access to Roundabouts: Assessment of Motorists' Yielding to Visually Impaired Pedestrians and Potential Treatments To Improve Access

PUBLICATION NO. FHWA-HRT-05-080

MAY 2006

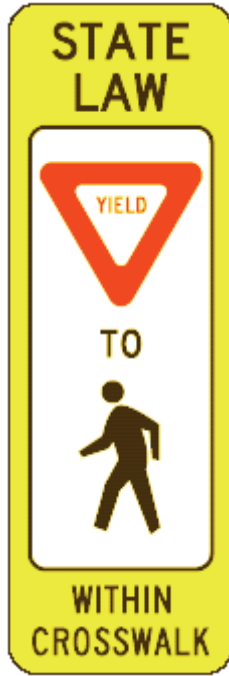
Figure 2. MUTCD R1-6.

One of these signs was placed at the upstream edge (from a vehicle perspective) of the crosswalk on the demarcation between the travel lanes. This sign, designated R1-6 in the *Manual on Uniform Traffic Control Devices* (MUTCD), was 90 centimeters (cm) (36 inches) high by 30.5 cm (12 inches) wide, with the sign bottom mounted 61 cm (23 inches) above the pavement on a breakaway post.⁽¹⁶⁾ The sign, depicted in figure 2, shows a red triangular yield icon above the word "TO," which is above a pedestrian icon, all on a white (i.e., regulatory) background. The white background is surrounded by yellow with the words "STATE LAW" above and the words "WITHIN CROSSWALK" below. Combining the words and icons in English, the sign reads, "State law, yield to pedestrian within crosswalk."

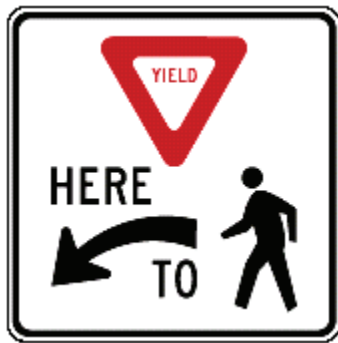
Figure 3. MUTCD R1-5.

The second sign was placed below an existing crosswalk warning sign located to the right of the crosswalk. This white sign, designated R1-5 in the MUTCD (depicted in figure 3), had an arrow that pointed, roughly, to the upstream crosswalk demarcation line, a yield symbol, the words "HERE" and "TO," and a pedestrian icon. By combining the words and icons, the sign reads, "Yield here to pedestrian." The sign was 61 cm (24 inches) square. The purpose of adding this sign was to encourage drivers to stop at the crosswalk rather than at a distance away from the crosswalk, which might prevent the pedestrian from hearing idling engines.

Because a thorough evaluation of the sound strips required that vehicles yield, and because the literature suggested that yielding might be rare, a yield sign was placed in the street between the lanes at the edge of the cross walk. In exploratory visits to the roundabout, it was observed that vehicles yielded well upstream of the crosswalk; therefore, the yield sign was supplemented with a sign that indicated where to yield (see figure 3).

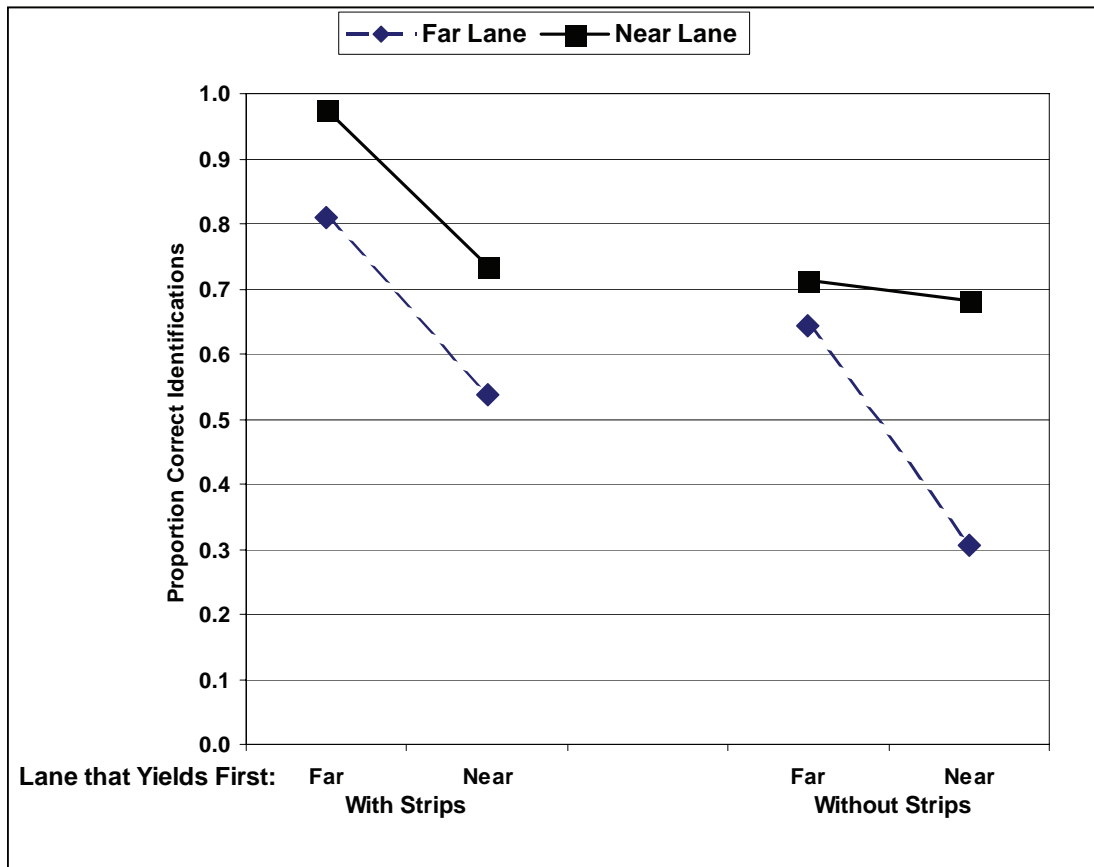
Figure 6. Proportions of correct identifications of stopped vehicles shown by test condition, the lane in which the first vehicle to yield stopped, and the lane identified.

Figure 6 shows the proportion of correct identifications of stopped vehicles by condition, lane, and the lane in which the first yield occurred. Overall, performance was better in the treatment condition than in the control ($F(1, 6) = 15.4, p < 0.01$).

Identification tended to be more accurate when the first yield was in the far lane ($F(1, 6) = 12.3, p < 0.05$). The first vehicle to yield creates noise as it idles at the crosswalk. When it idles in the near lane, that noise can mask the later arrival of a second vehicle in the far lane. Participants were able to detect only 30 percent of the vehicles that stopped in the far lane when there was a vehicle already idling in the near lane. When the first vehicle to yield is in the far lane, its idling

Overall, performance in the detection of stops was better for vehicles in the lane nearest the participant ($F(1, 6) = 8.2, p < 0.05$); however, these effects were not additive, since the three-way interaction of condition, lane to yield first, and lane was significant ($F(1, 6) = 10.4, p < 0.05$). In the control condition, detection performance for near-lane yields was affected very little by the presence of a stopped vehicle in the other lane. Conversely, in the control condition, detection performance for far lane yields was very sensitive to whether there was a vehicle already stopped in the near lane. The worst performance was for detection of vehicles stopping in the far lane when there was a vehicle idling in the near lane.

In the treatment condition, there were no interactions. Detection of stopped vehicles in the near lane was consistently better than detection of stopped vehicles in the far lane. When a vehicle was already stopped in the far lane, detection of a vehicle stopping in the near lane was nearly perfect (only one participant missed one yield in this case). The sound cue treatment appears to have had two beneficial effects: (1) the detection of the presence of vehicles improved, and (2) given detection, lane identification accuracy was improved. The near perfect detection of near lane yields when a vehicle was already stopped in the far lane is primarily attributable to the first benefit. The improvement in detection of far-lane stops when the far lane vehicle was first to stop is primarily attributable to increased accuracy in locating those stops as being in the far lane.

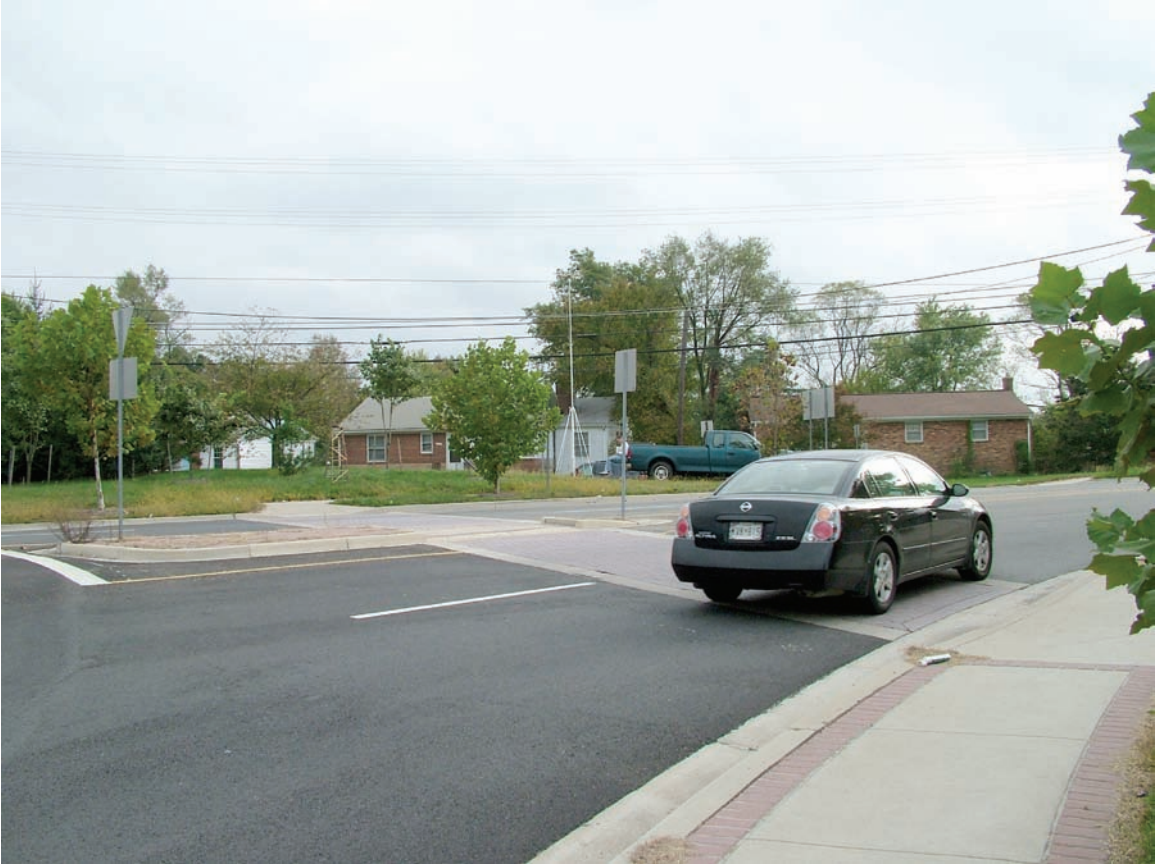
Figure 7. Roundabout exit in baseline configuration.

The roundabout exit in the control condition is shown in figure 7. Figure 8 shows the exit after the installation of the sound strips and the mount for the street sign. As in study 1, one sound strip was placed at the upstream edge of the crosswalk and extended across the road approximately 10.7 m (35 ft). The second and third strips were placed parallel to the first, 6.1 m (20 ft) and 7.3 m (24 ft) upstream, respectively. The street sign was bolted to the pavement on the lane marking at the upstream edge of the crosswalk. The sign mount can be seen in figure 8 as the opening in the pavement where the center white line meets the crosswalk.

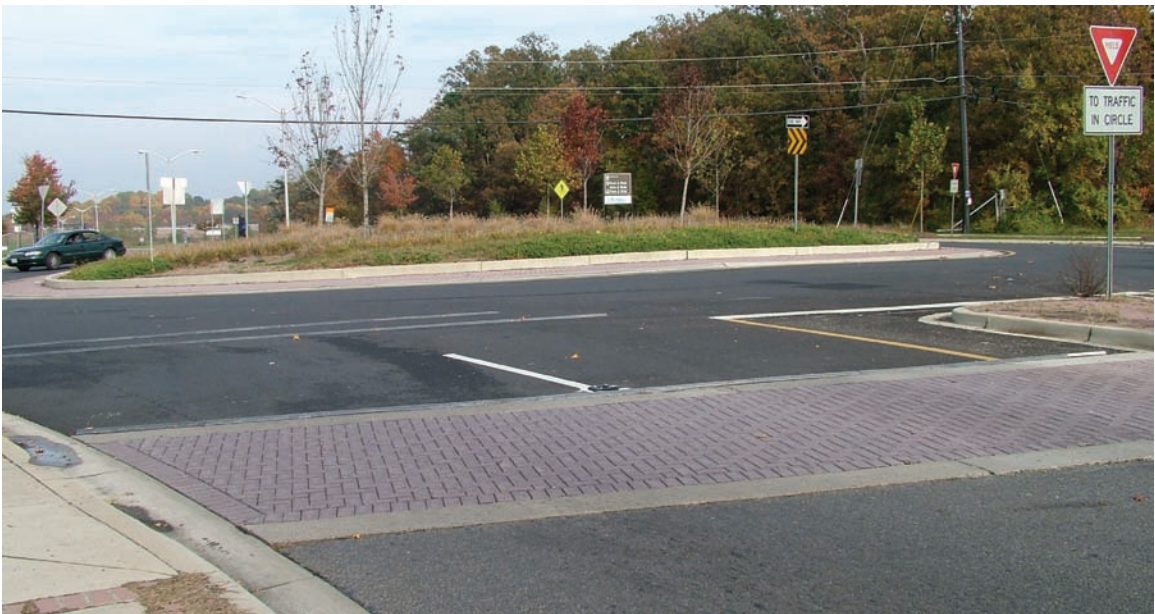
Figure 8. Sound-strip installation and mount for the street sign.

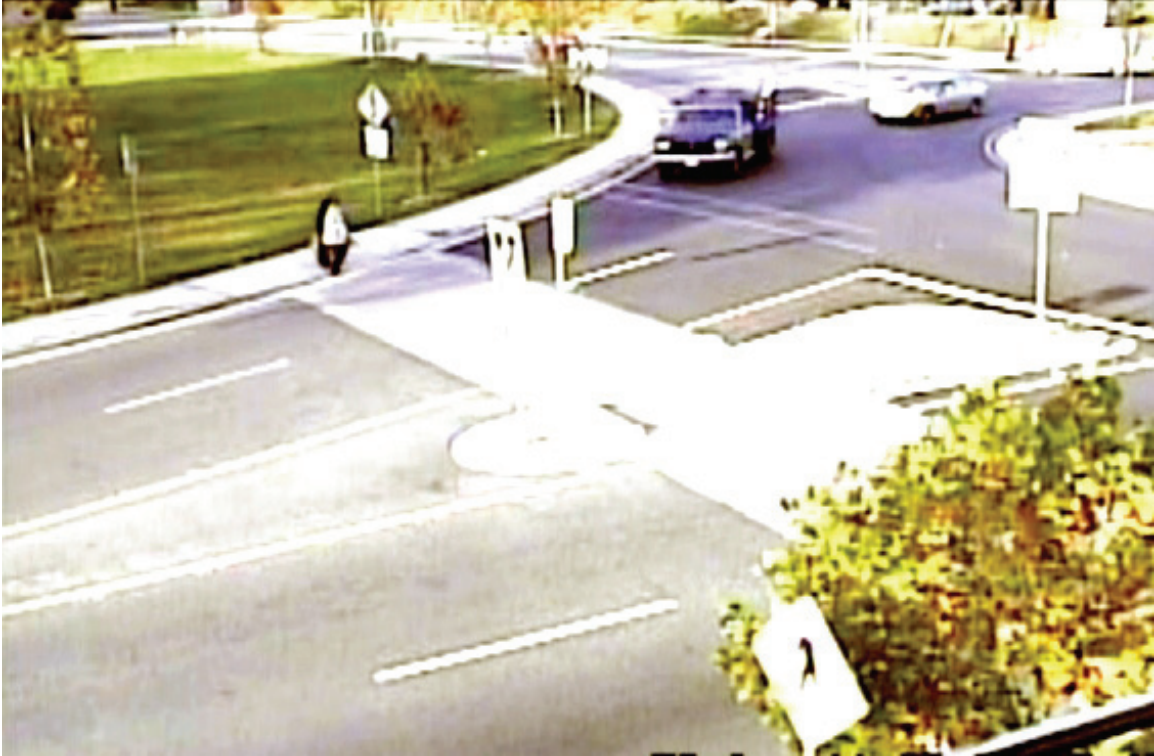
Figure 10. Two vehicles that stopped for the pedestrians.

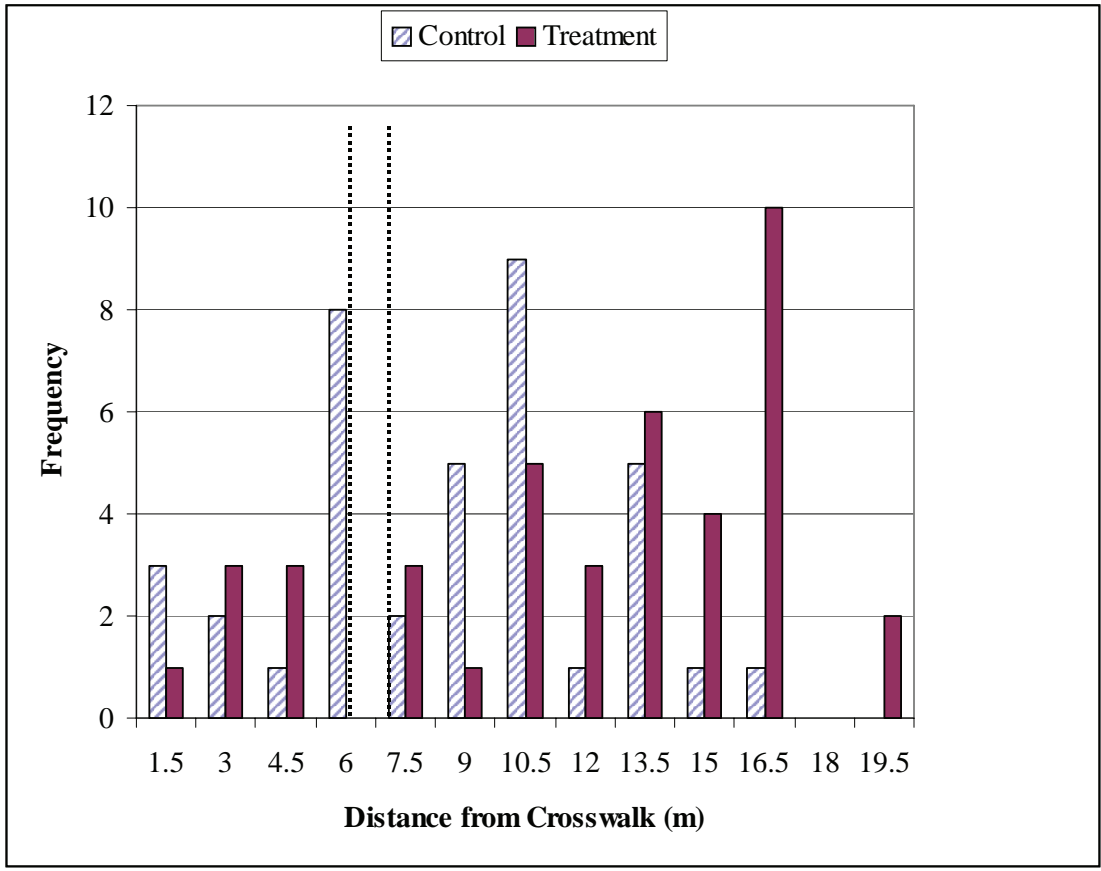
Figure 11. Distance between the crosswalk and a vehicle stopped in the far lane is shown as a function of treatment condition.

In the near lane, the stopping distance from the crosswalk did not vary significantly with treatment ($p > 0.10$). However, the vehicles that stopped in the far lane stopped farther from the crosswalk in the treatment condition than in the control condition ($t(77) = 3.4, p < 0.01$). Figure 11 shows the distribution of stopping distances for the far lane in the control and treatment conditions.

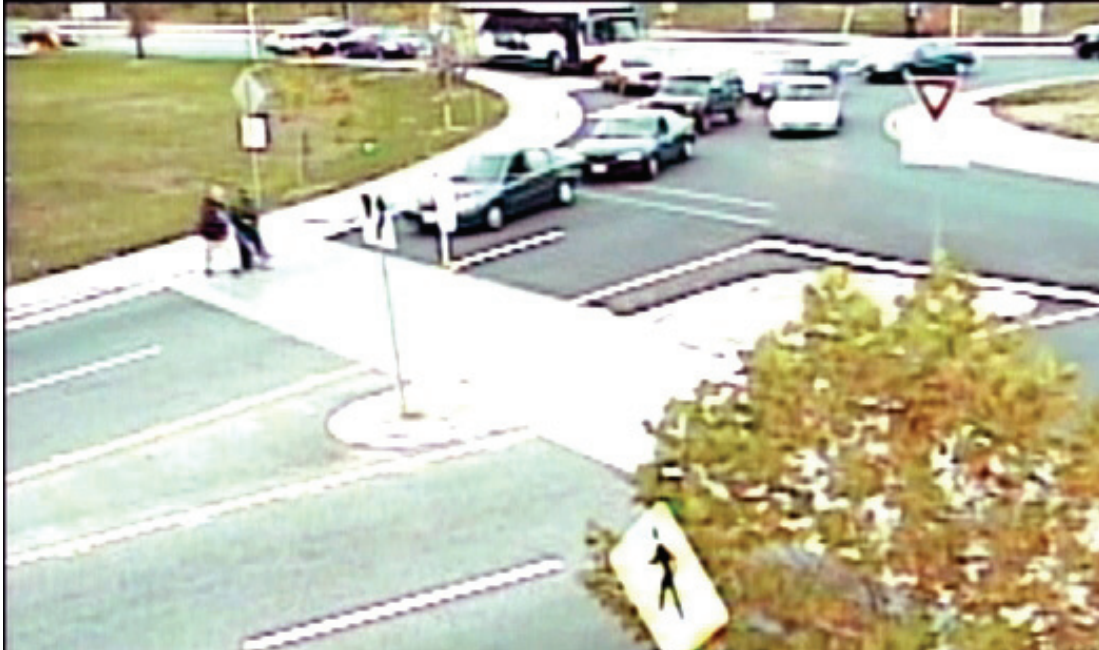
Figure 12. Pedestrians crossing after a correct detection of both lanes blocked.

The remaining categories are similar to those used in study 1. A correct identification was scored when vehicles blocked each of the lanes and the participant indicated that this was the case. Unlike the closed-course study, it was rare for two vehicles to stop side-by-side in the roundabout exit. In most cases, both lanes were considered blocked if vehicles stopped in such a way that it would be difficult for subsequent vehicles to maneuver into the roundabout exit. Figure 12 shows a video image of a treatment-condition crossing in which the participant correctly identified that both lanes were blocked. In this image, the vehicle blocking the left lane stopped about 12 m (39.4 ft) upstream of the crosswalk.

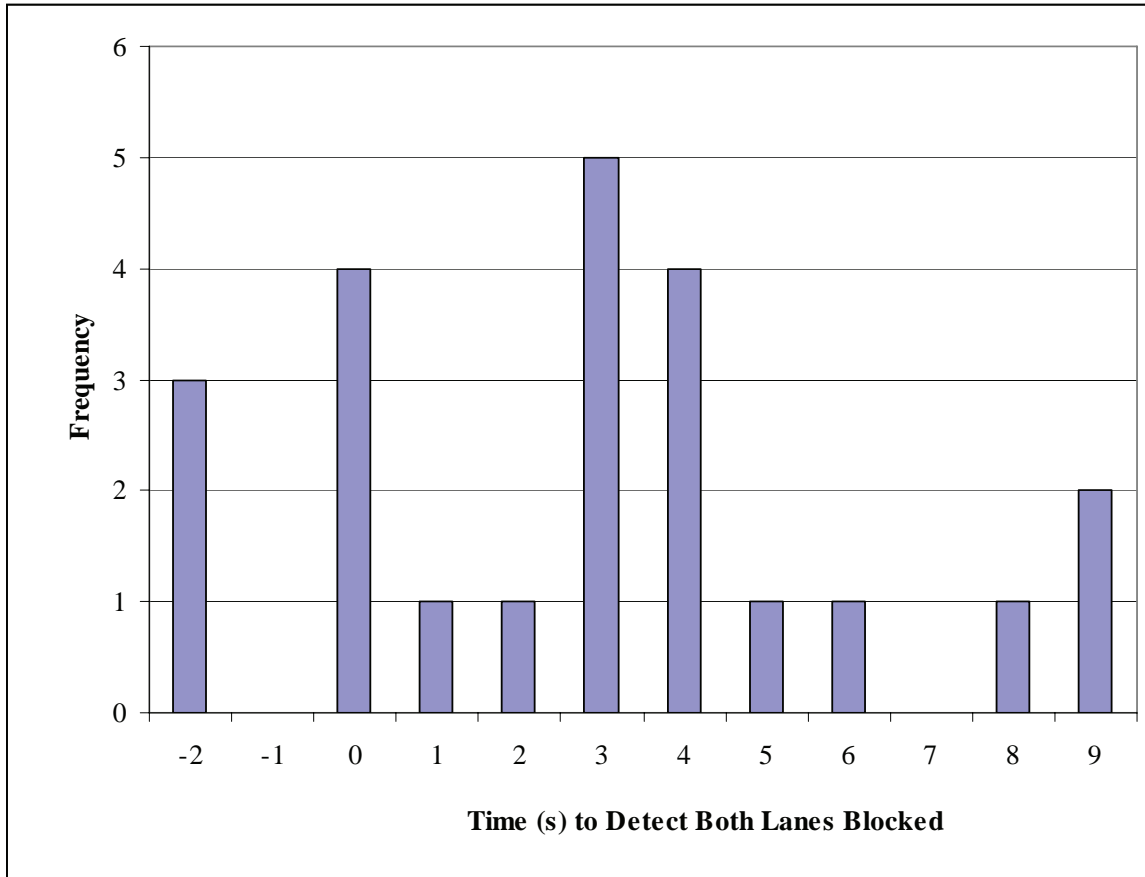
Figure 13. Frequencies of delays between the time both lanes were blocked and when participants indicated both lanes were blocked.

Although 16.7 percent of the vehicles in the treatment condition stopped for the pedestrians, most of these stops were not useful and did not result in a detected crossing opportunity. There are several possible reasons for this. One is that the pedestrians did not immediately respond when the drivers stopped. Figure 13 shows the distribution of the delays between the time both lanes were blocked by fully stopped vehicles and the time when participants indicated that the lanes were blocked. One unexpected finding was that in three cases, participants identified the blocked lanes 2 s before both vehicles came to a complete stop. This apparent anomaly may have been attributed to participants shifting from the strategy that they normally use to detect stopped vehicles (idling engines) to listening for silence after detecting approaching vehicles. This strategy worked when there was no traffic approaching the opposing entrance and when all traffic in the circle stopped. Note that in figures 10 and 12, both of which show correct detections, there were no vehicles entering the roundabout from the opposing direction. Detection times in study 2 were comparable to the detection times found in study 1.

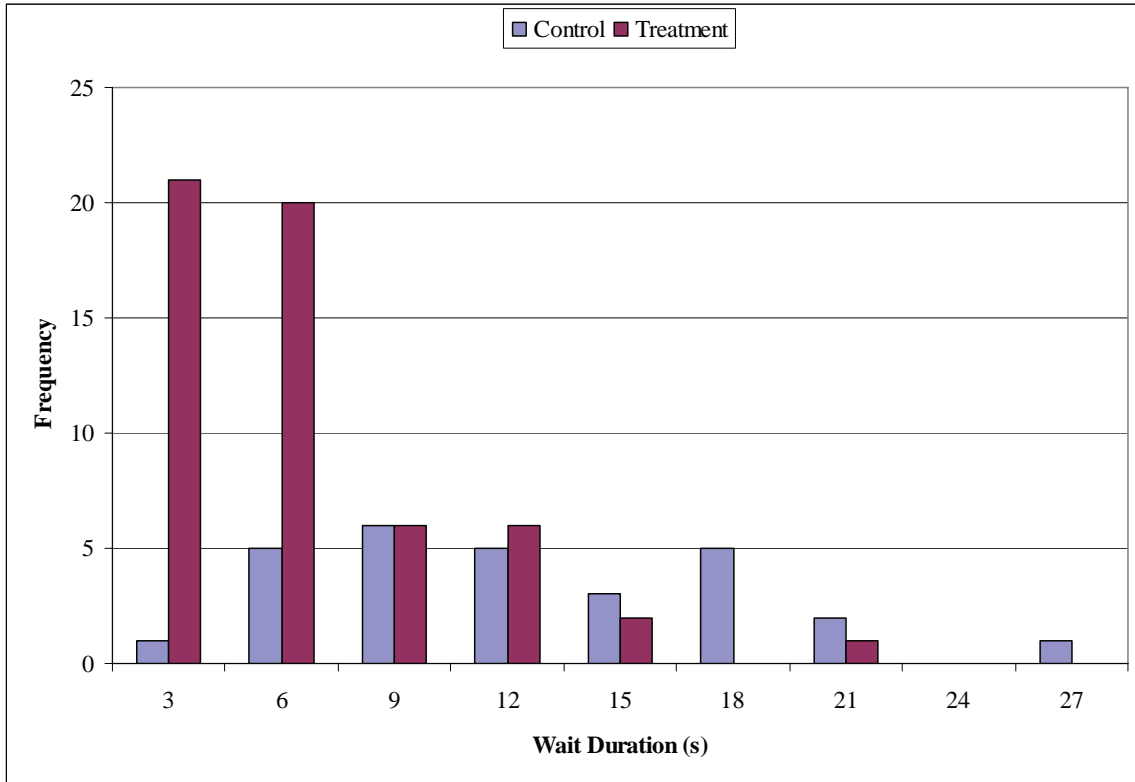
Figure 14. Amount of time drivers waited before moving on.

When pedestrians did not begin to cross immediately, drivers sometimes moved on. To estimate how long drivers may wait, the amount of time that stopped drivers waited was tabulated. If the pedestrians crossed or stepped away from the curb, then the amount of time drivers waited was not included. This procedure yielded delay times for 28 drivers in the control condition and 56 drivers in the treatment condition. A histogram of the wait times is provided in figure 14. In the control condition, drivers waited an average of 10.8 s. In the treatment condition, drivers waited an average of 4.7 s. In the control condition, wait times varied between 1 and 25 s. In the treatment condition, wait times varied between 1 and 20 s. The difference in wait times, not assuming equal variances between groups, was statistically reliable ($t(39) = 5.1, p < 0.01$). The difference in willingness to wait may have been because drivers who were induced to stop by the yield sign were not as committed to waiting as were drivers who stopped without the added inducement. If this hypothesis is correct, then the benefit for visually impaired pedestrians of yield signs is diminished. The bulk of the drivers who are influenced by the sign appear to be willing to wait only 3 to 6 s. Thus, these drivers may be pulling away just as the pedestrian with visual impairment begins to cross.
