Federal Highway Administration University Course on Bicycle and Pedestrian Transportation

Lesson 22: Tort Liability and Risk Management

July 2006

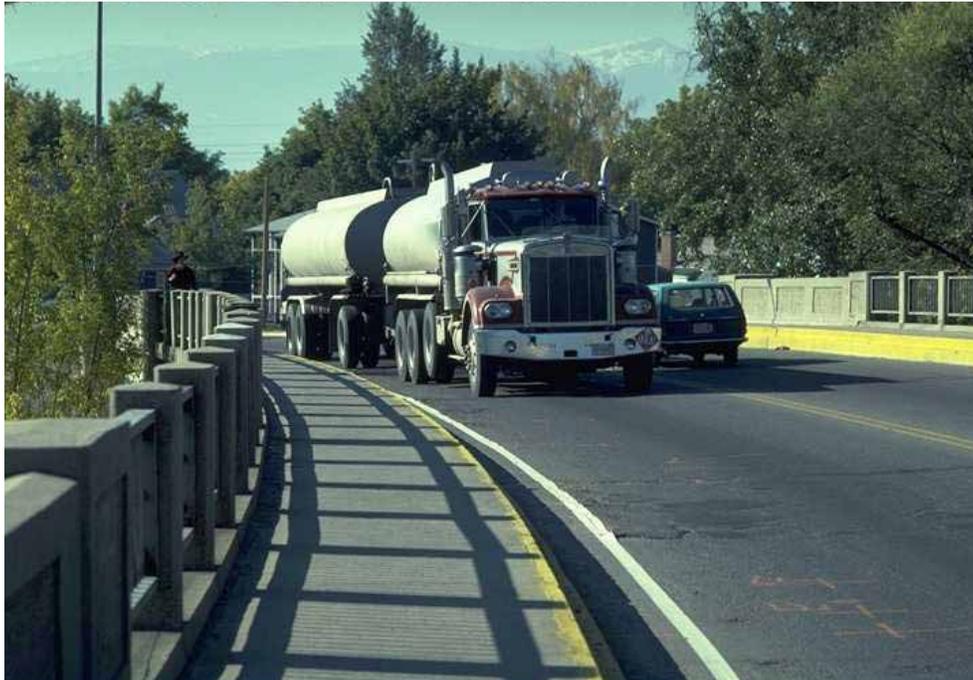
Figure 22-2. Photo. Bridges are a recurring theme in many tort liability claims.

Example Case 4. On a bridge that provides the main linkage to downtown, the surface is badly broken up, the pavement has deteriorated on the decking, and seams have been patched over, leaving dangerous ridges (see figure 22-2). This bridge is known to be heavily used by bicycles, and the city has written to the State three times asking that the bridge be repaired due to the potential hazard. Because of these and other hazards, bicyclists cannot ride too near the curb and crowd the motorists in narrow lanes. The State has not responded, despite repeated requests for action.

A semi-tractor-trailer left his air brake on. As he approached the bridge, he released his foot, activating the brake, which caused a loud noise. A 23-year-old woman bicycling across the bridge heard the noise behind her and moved closer to the curb. The trucker once again activated the brake, causing another loud noise as he approached the bicyclist. The bicyclist panicked, rode into the curb, fell, and was killed by the truck. The bicyclist's family and the truck driver's insurance company both sued the State.

Because of the letter written by the city and the length of time the condition had been present, the State settled out of court. In addition to the poor pavement conditions, it was found that the bridge sloped slightly to the right and the State had, over time, let the centerline of the roadway drift toward the right. The right-hand lane was 4.0 m (13 ft) wide, while the left-hand lane width was 5.2 m (17 ft). The bicyclist was forced to share a dangerously narrow lane with both hazardous pavement conditions and heavy truck traffic. The lesson here is to take action promptly in response to identification of hazards, even if it means only the interim measure of posting warning signs until the correction can be made.

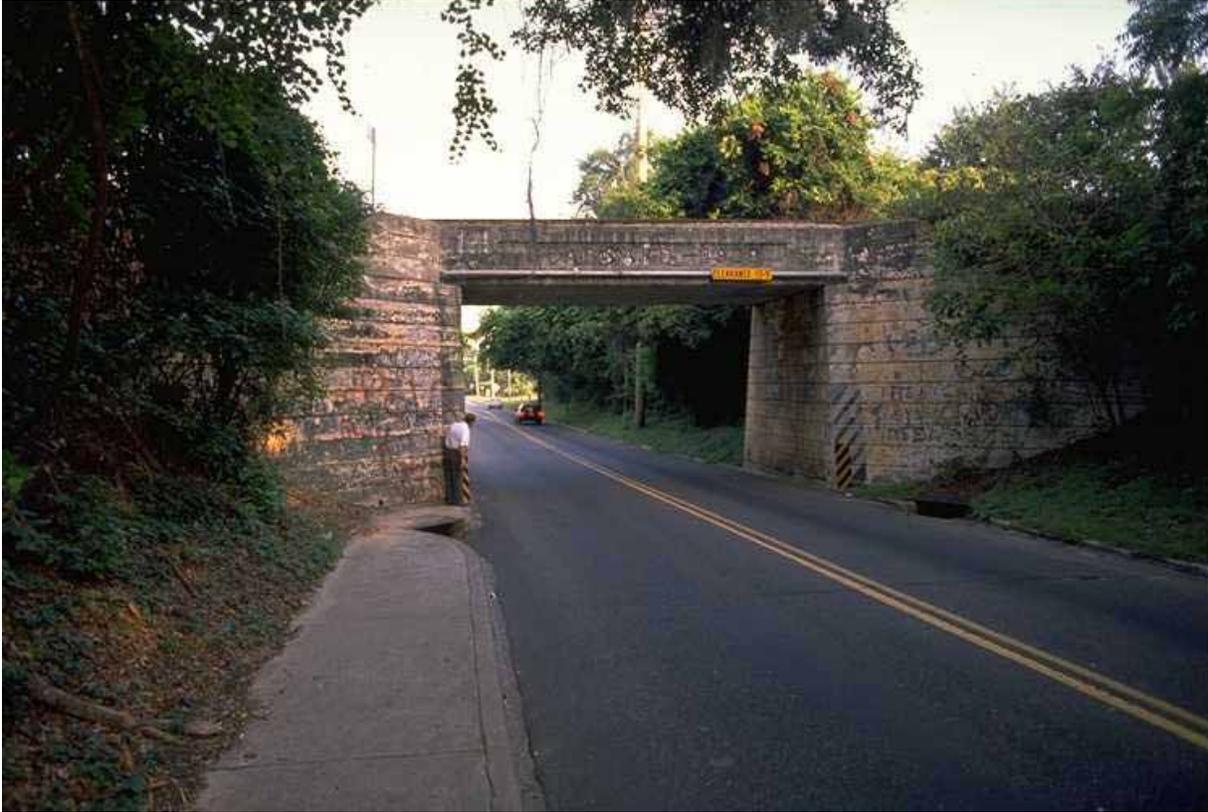
Figure 22-4. Photo. Example of a sidewalk ending at a bridge abutment with no warning or alternative path.

- **Paths that end suddenly at hazardous locations with no transition or escape route provided** (see figure 22-4 for an example). In court, you will hear that these paths “lead the customer into a trap.” All facilities should be ended logically, with a reasonable warning (e.g., “Path Ends”), a transition to an alternative route, and some design precautions taken so the inattentive path user is not launched off a cliff, slammed into a barricade around a blind corner, or otherwise penalized too harshly.

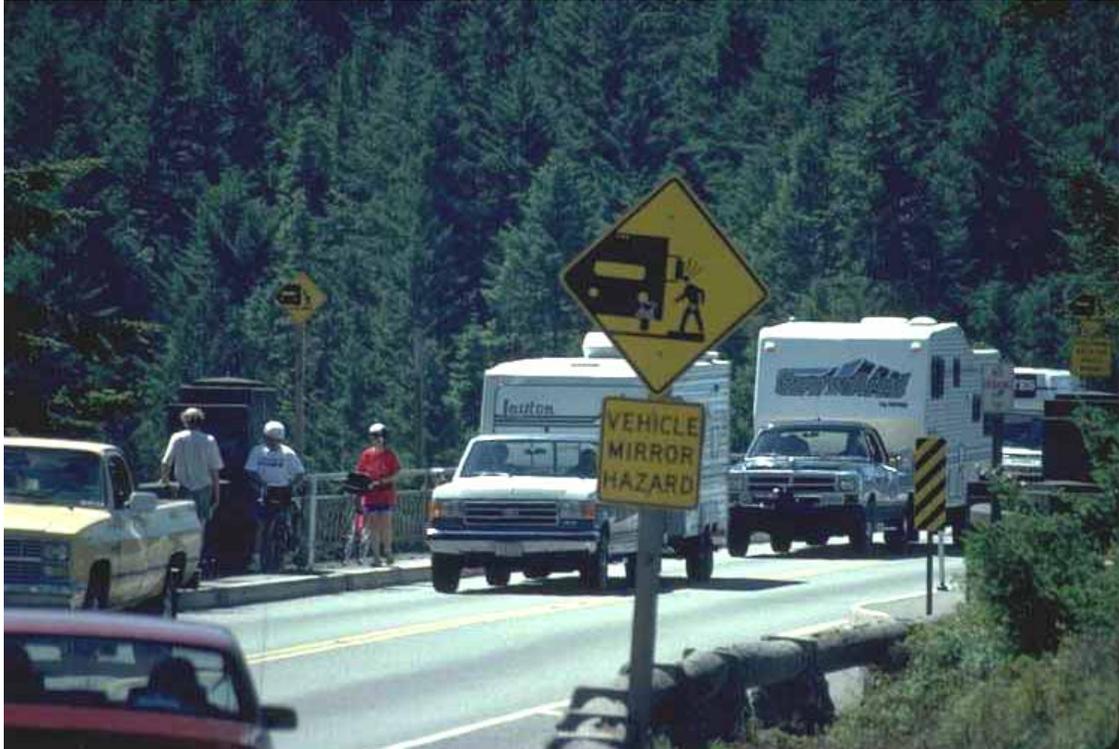
Figure 22-6. Photo. Use of signing to warn motorists and pedestrians of the potential hazard posed by vehicle mirrors on narrow bridge sidewalks.

Signing a hazardous condition has long been recognized as an important interim treatment for many conditions (see figure 22-6 for an example). Failing to sign a known condition is difficult to defend. Signing and warning offer two types of benefits: first, people are more cautious, so the number of crashes and injuries are reduced; and second, the attempt to alert the public about a potentially hazardous condition generates good will and makes it more difficult for a plaintiff's attorney to argue that the plaintiff was surprised by the condition. Signing should make use of international symbols and follow the standard signing and marking practices found in MUTCD.
