Methods for Evaluating and Treating ASR-Affected Structures: Results of Field Application and Demonstration Projects

Volume I: Summary of Findings and Recommendations

Final Report

U.S. Department of Transportation
Federal Highway Administration

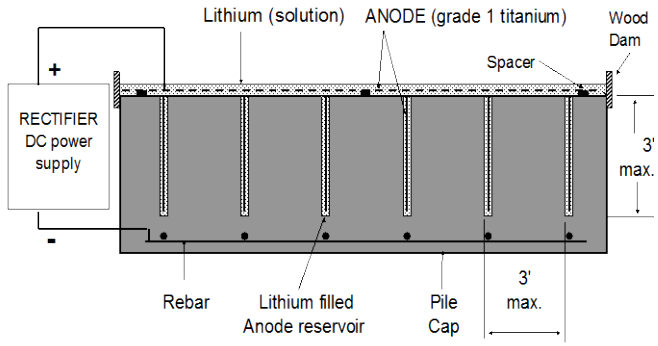
Figure 4. Repair of pier footings of a highway structure suffering from severe cracking and spalling due to ASR using an electrochemical system for lithium impregnation.
(Pictures A & B: courtesy of D.Whitmore, Vector Construction Group, Winnipeg, Canada.)

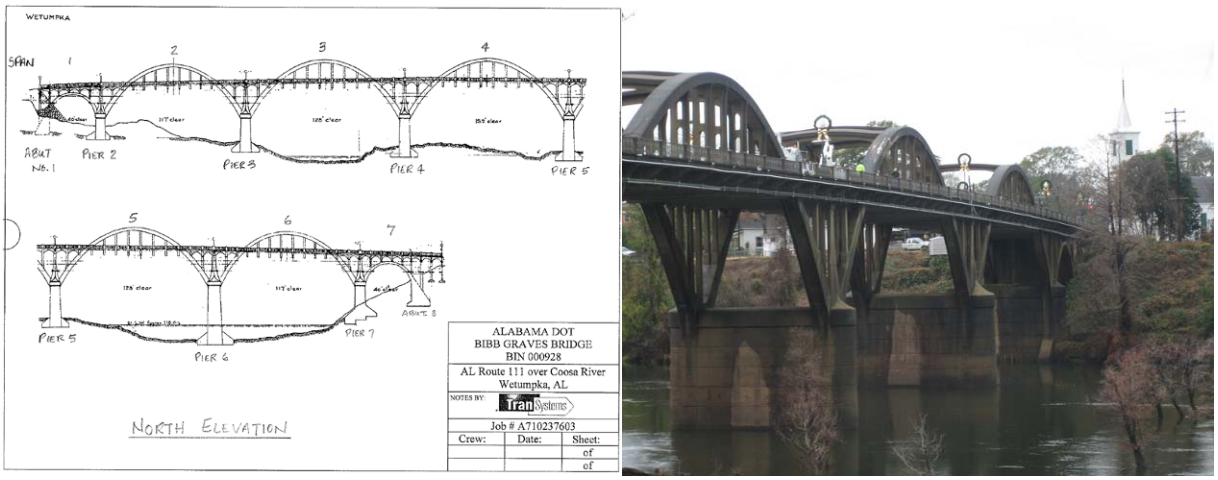
Figure 6. Sketch showing elevation and photograph of Bibb Graves Bridge (north face).

Figure 7. Cracking on top and underside of archway supporting 5th span.

Pins were installed at selected locations on the arches supporting the 4th and 5th spans in December 2005 to permit length-change measurements to be made. In December 2009, length-change measurements revealed that in some locations, the concrete in the arches supporting the5th span showed expansion rates estimated to be as high as 250 microstrains (or 0.025 percent) per year (0.120 percent length change between December 2005 and 2009). It was recommended that a detailed structural analysis be performed on the arch affected by ASR.

During the summer of 2010, Alabama DOT, FHWA, and Auburn University developed a repair procedure to retard (or stop) the ASR expansion in the arches of the 5th span, and the repair was implemented in the fall of 2010. The repair involved cleaning (water blasting) the affected concrete, applying a silane sealer, caulking all cracks greater than or equal to 1 mm (0.04 in.) in width and applying an epoxy "flood coat" to the top surface of the arch. The treatment was chosen to prevent rainwater ingress into the top surface of the concrete while allowing the concrete to dry out from the silane-treated sides and bottom faces of the arch. The treatment was performed in November 2010. Both the north and south arches of the 5th span were treated. In addition, the south arch of the 4th span was also treated in a similar manner. Instrumentation for length-change and RH/temperature measurements was installed in all 3 treated arches and the untreated north arch of the 4th span.

Given the extent of ASR, it is recommended that a structural analysis is conducted to determine the structural adequacy of the affected arches supporting the 5th span.

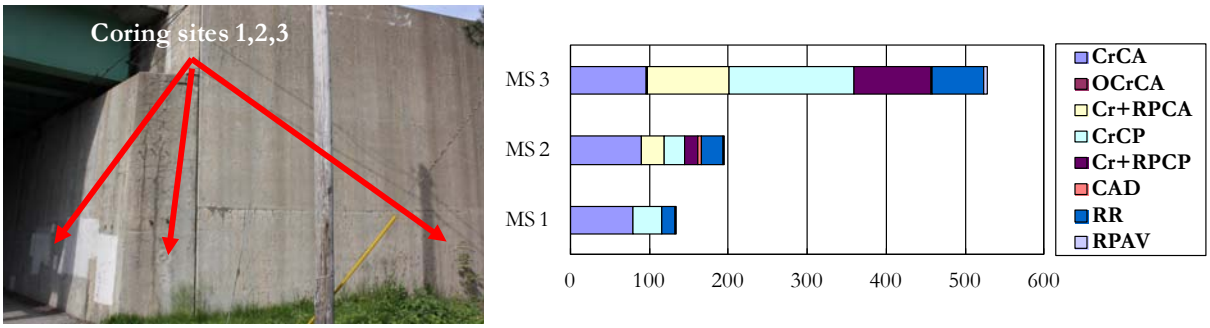
A total of 24 cores (100 mm [4 in.] in diameter) were taken from six bridges for petrographic evaluation, while 75 mm (3 in.) cores were taken from two bridges for stiffness damage testing (SDT). The presence of ASR was confirmed, and it was revealed that the concrete in all six bridges contained reactive greywacke/argillite in the coarse aggregate. DRI values ranged from 133 to 882, indicating a low to severe degree of ASR damage. SDT results also showed the extent of internal mechanical damage due to ASR ranged from low to severe. The DRI and SDT

data are generally consistent with visual observations, the more severe damage being observed for concrete in exposed areas (see Figure 10).

Figure 10. Results of petrographic analysis showing higher DRI values (i.e., higher damage) for exposed parts of the structure.

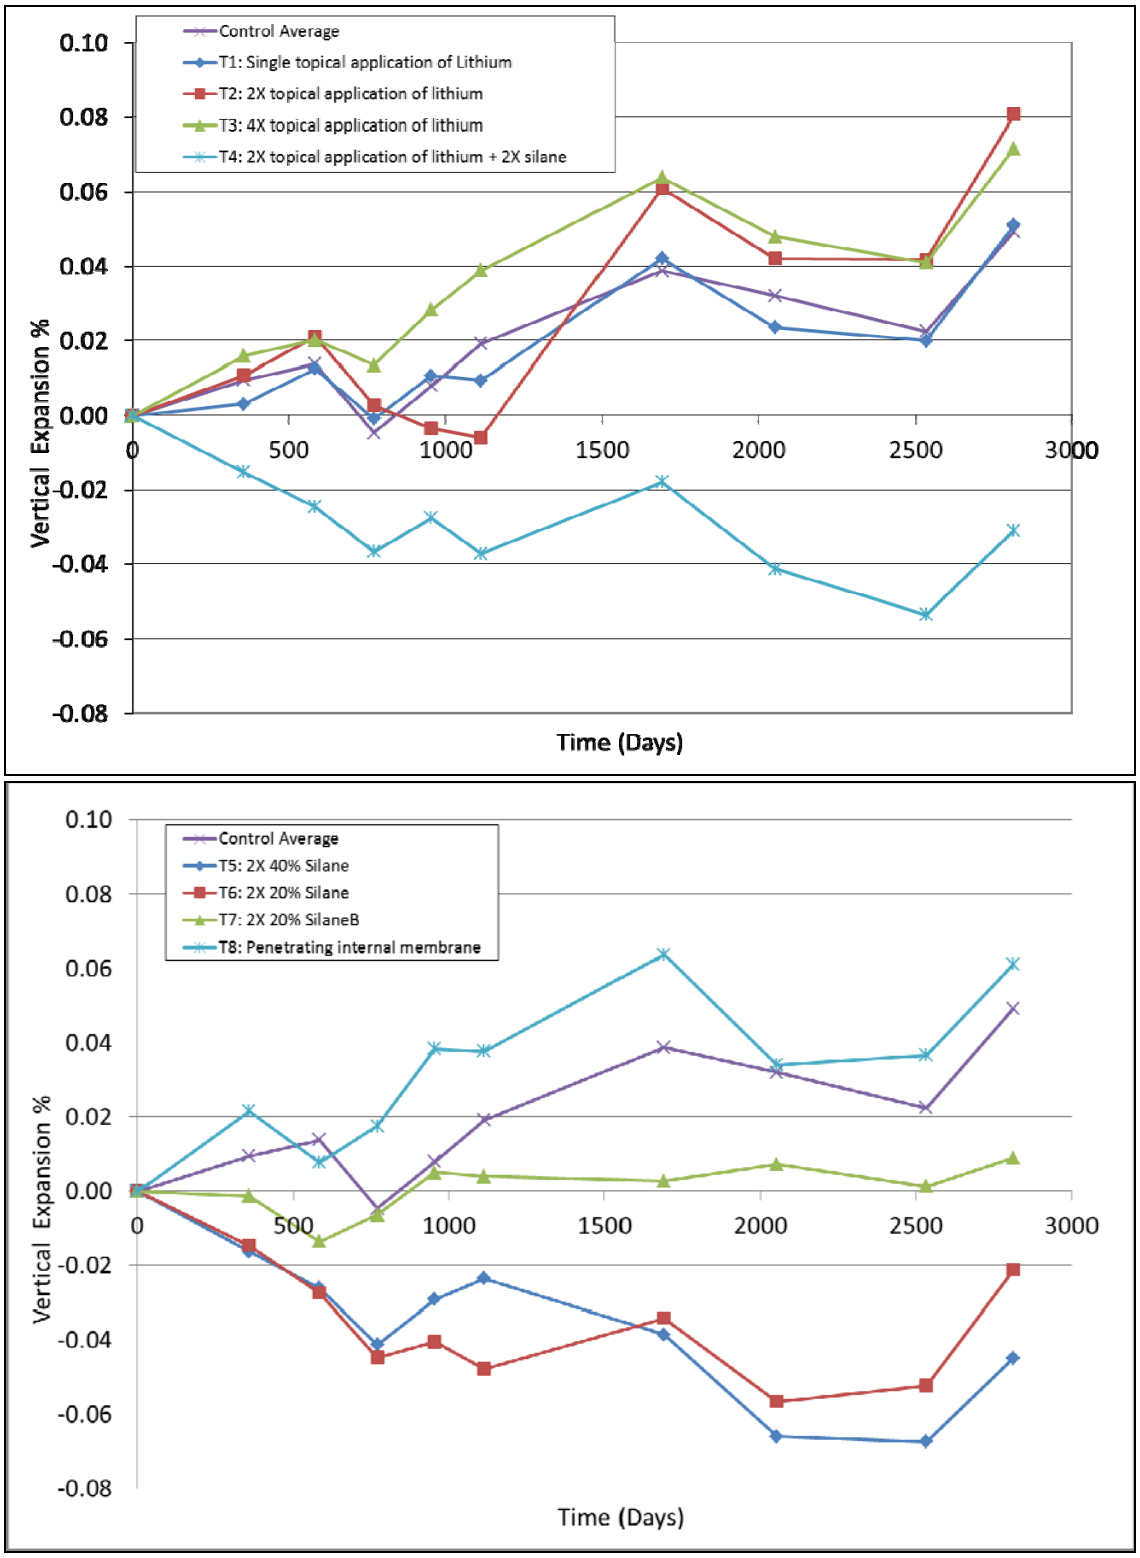
Figure 12. Average vertical expansion of treated and control barrier walls.

It would appear that the treatment of these barrier walls with a one-time topical application of silane has been effective in reducing the ongoing ASR and reducing the extent of visible deterioration (cracking). It is not known whether improvements will continue without ongoing monitoring of the barrier wall.

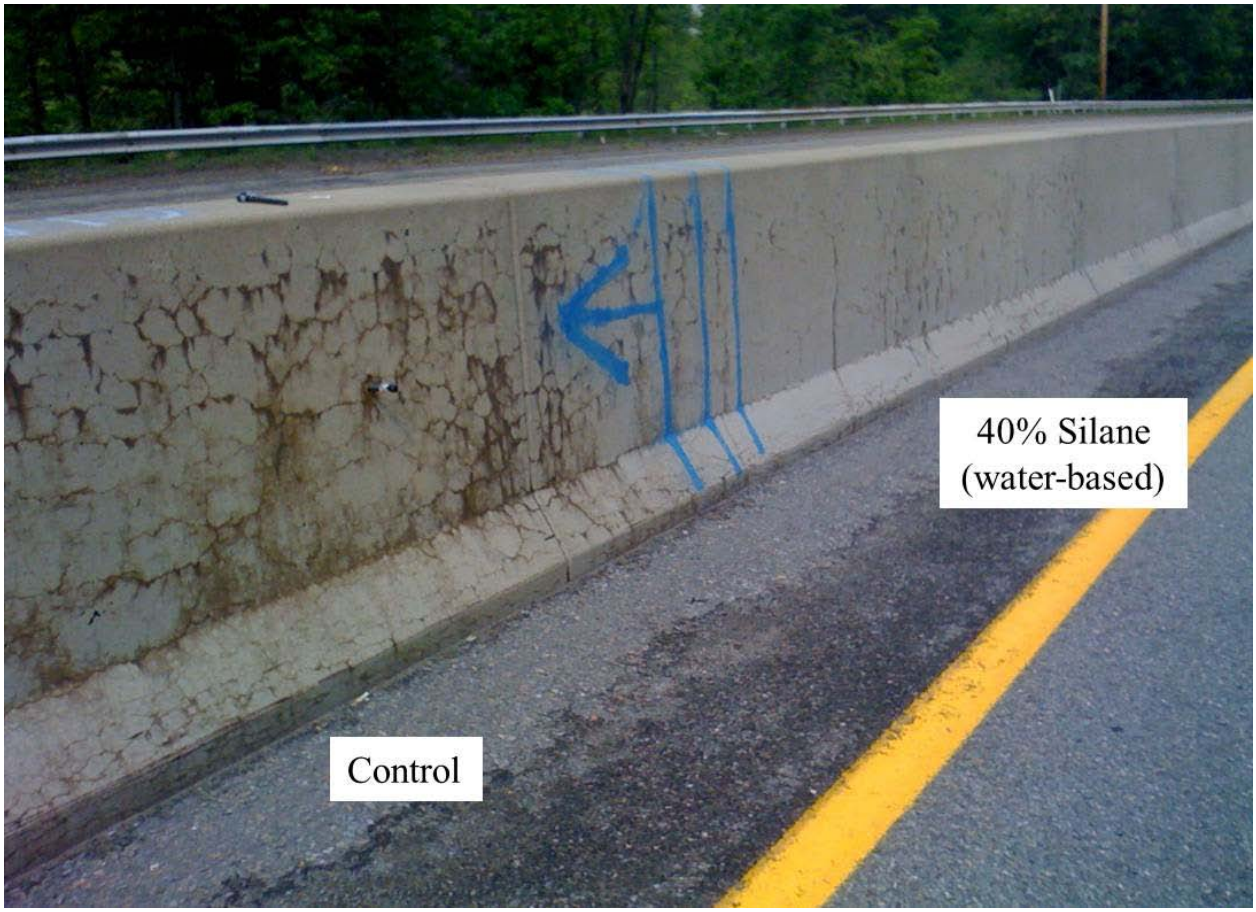
Visual differences between sections treated with any of the three silanes became visually obvious about three to four years after treatment. An example is shown in Figure 13. In the treated sections, the cracking becomes less visible as moisture and exudation activity associated with the cracks begin to disappear.

Figure 13. Visual contrast between the one of the control sections to the left and a section treated with 40% (water-based) silane by MassDOT in 2005.

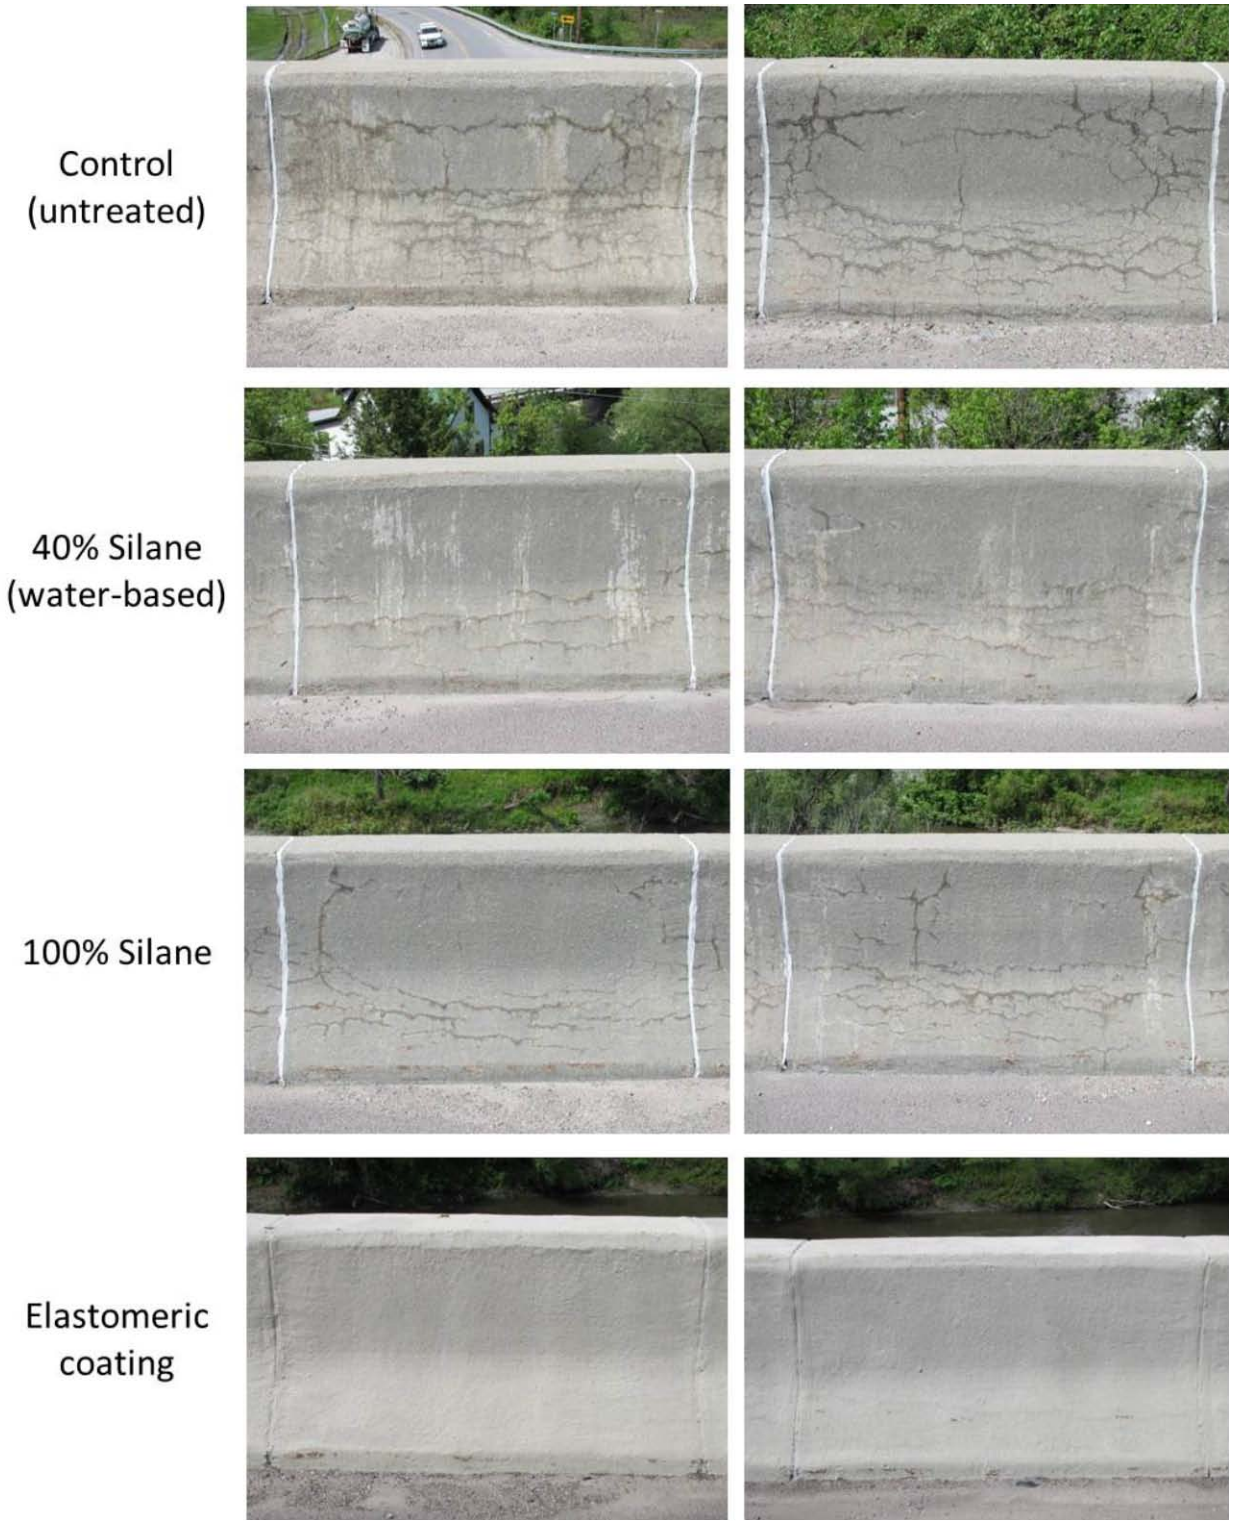
With only two years of monitoring data accumulated, it is currently too early to conclude on the efficacy of the above treatments at reducing the deleterious effects of ASR on the barrier walls treated. However, interesting trends have been identified, for instance possible reductions in the relative humidity values in the surficial portions of the barrier walls treated with penetrating sealers and elastomeric coating, and in general a better visual appearance of the treated barrier walls compared to the control sections. Long-term monitoring is expected to provide data on the effect of various types of surface treatments on the progress of ASR-related damage in the above elements. Figure 17 illustrates the barriers initially and in 2013, approximately two years after

treatment. The elastomeric coating has covered up any sign of visible cracking, and a longer evaluation period is required to determine if this is a permanent improvement. The extent of visible cracking is much less on the barrier walls treated with silanes compared to the control (untreated) sections, and this is largely the result of reducing moisture and exudation activity in the vicinity of the cracks after treatment with a hydrophobic sealer (silane). Again, a longer study period is required to fully evaluate the long-term impact of the treatments on the service life of the barriers.

Figure 17. Barriers in 2013 (approximately two years after treatment).
