TechBrief
NOVEMBER 2011 | FHWA-HIF-12-007

Jointed Full-Depth Repair of Continuously Reinforced Concrete Pavements

This TechBrief describes both conventional methods and an alternative method for making full-depth repairs in continuously reinforced concrete pavements. The alternative method, which does not utilize continuous longitudinal reinforcement in the repair area, is suitable for repairing a single lane (or two of three adjacent lanes), and results in repair areas that have performed well after several years.

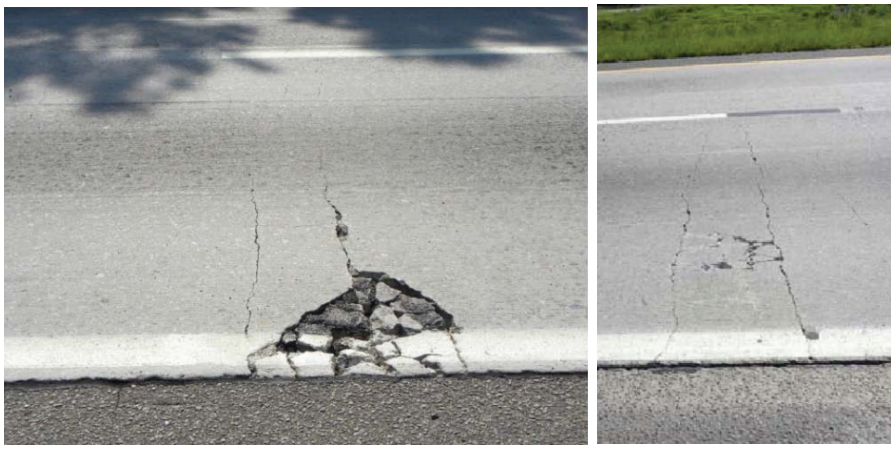
Figure 1. Steel reinforcement in CRC pavement (staggered laps of longitudinal bars shown on right).

Figure 2. Punchout distress in CRC pavement.

CRC pavement as their primary concrete pavement alternative. When designed and constructed well, CRC pavements can provide a service life of 40-plus years with minimal maintenance. The maintenance that is needed in older CRC pavements is related to the development of punchout distress (figure 2), severely distressed/spalled cracks, and steel rupture. These distresses impact ride quality and safety. A common corrective action for these distress types is FDR. The repairs must be performed correctly; otherwise the likelihood of their early failure will be high.

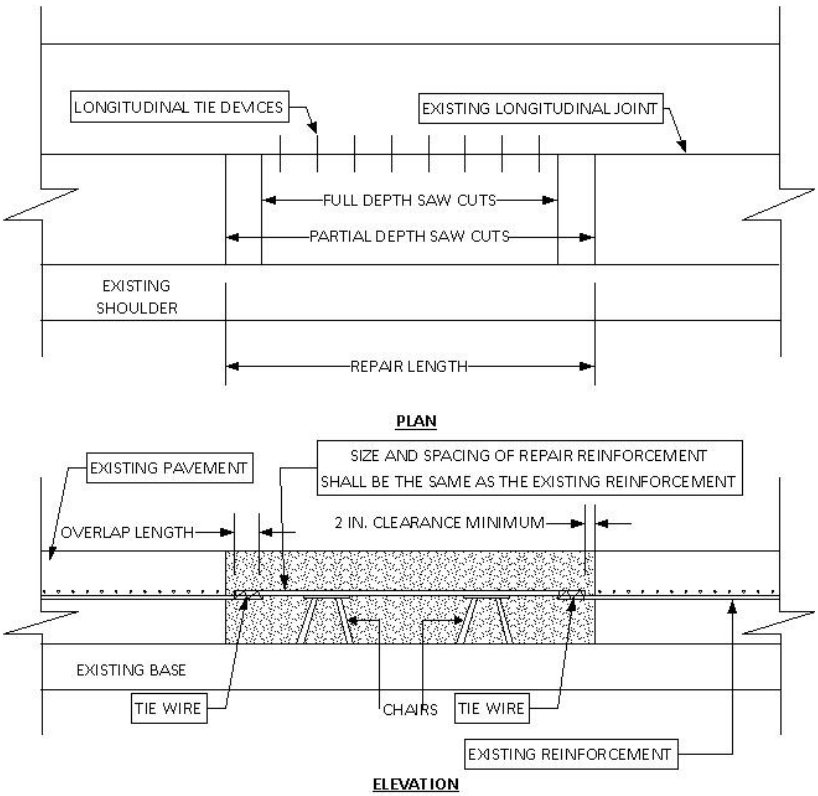
Figure 3. Schematic of conventional CRC pavement FDR.

Many agencies have developed standard techniques for performing FDR of CRC pavements. Most of the techniques are based on maintaining the continuity of the longitudinal steel within the patch area, as illustrated in figure 3. The steps involved in such FDRs are as follows:

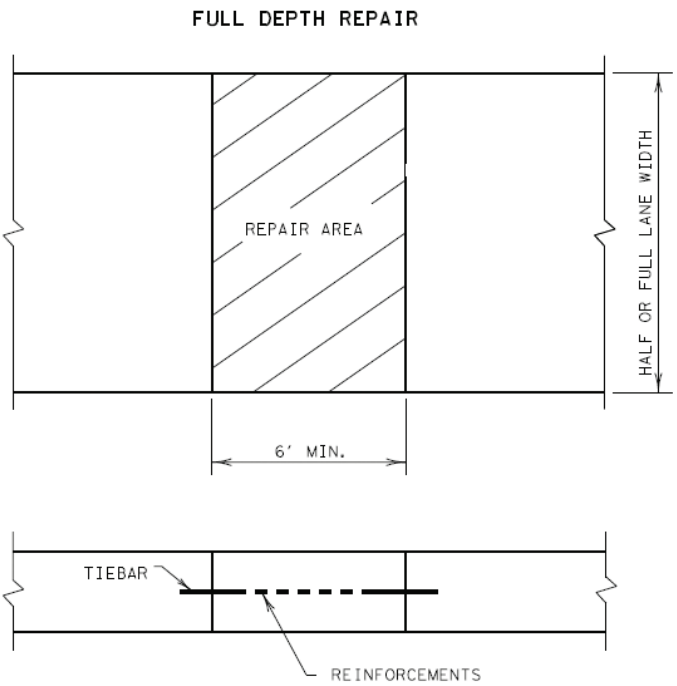
Figure 6. Plan and cross section of the Texas FDR of CRC pavements.

The Texas method, illustrated in figure 6, shortens the time for preparing the repair area and allows for restoration of the base within the entire repair area. However, the performance of this alternate FDR method has also been mixed, primarily because the tie bars across the full-depth sawcut transverse edges of the repair area do not provide adequate load transfer under heavy truck loading.
