Hydrologic & Hydraulic News

April 2014
Vol. 2, Issue 1

Scour and the Test of Time: Herbert C. Bonner Bridge Crossing Oregon Inlet, North Carolina

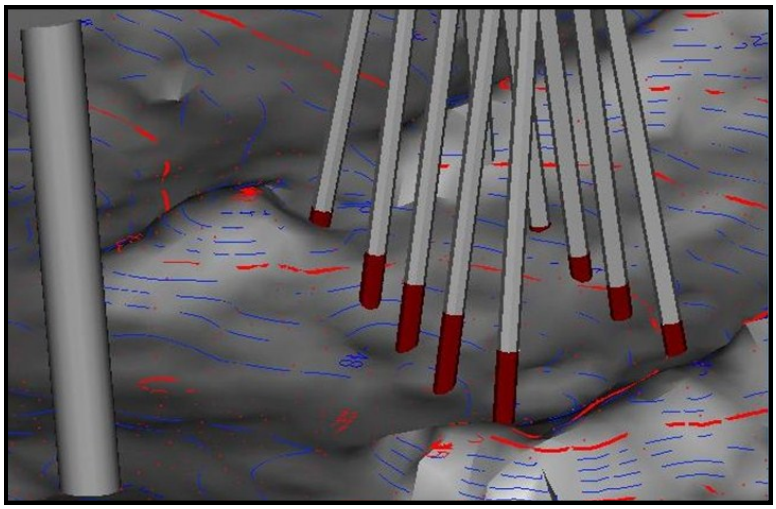
Figure 8 - Bonner Bridge Bent 166 Sonar Survey
(red indicates scour critical elevation)

Structural decay and scour have long plagued the bridge. Bonner Bridge has been identified as scour critical with a comprehensive and aggressive monitoring plan. Hydrographic surveys and underwater inspection performed monthly and post storm event have been conducted for more than two decades. In 2012 NCDOT initiated monthly side scan sonar monitoring (Figure 8). The October 2013 survey identified a change in conditions south of the navigation span. Monitoring was stepped up to weekly inspection. The November 29th inspection revealed bed elevation approached scour critical condition at Bent #166. Daily monitoring was implemented. On Tuesday December 3, the sonar survey and underwater dive team inspection revealed that the ten pile cluster at Bent 166 had 9 piles with embedment below scour critical elevation. Three of the piles had less than 4' embedment. NCDOT immediately implemented bridge closure in accordance to the monitoring plan of action (POA).

NCDOT formulated a three phase strategy for structural countermeasure response. The strategy addressed immediate action to stabilize the scour, intermediate countermeasure installation, and long term integrity of Bent 166. Long term stability involved construction of a crutch bent with installation of longer piles to provide required embedment. The crutch bent required lead time for pile fabrication, precast pile/bent cap, and geotechnical investigation which may require test pile installation. The intermediate action would stack three tiers of A-jacks® to form a perimeter around Bent 166. Geotextile sandbags, 3'cube and 4' cube, would be placed inside the battered pile cluster to avoid damage to the existing concrete piles. The configuration would trap sand available in the high sediment transport of diurnal tidal exchange. NCDOT contacted suppliers and manufactures for availability and delivery. Geotextiles would require 5–7 days to be delivered. The A-jacks® components would require 12-14 days for delivery to the site. The immediate need was large volume of sand and a delivery system within 72 hours.
