China Earthquake Reconnaissance Report: Performance of Transportation Structures During the May 12, 2008, M7.9 Wenchuan Earthquake

PUBLICATION NO. FHWA-HRT-11-029

OCTOBER 2011

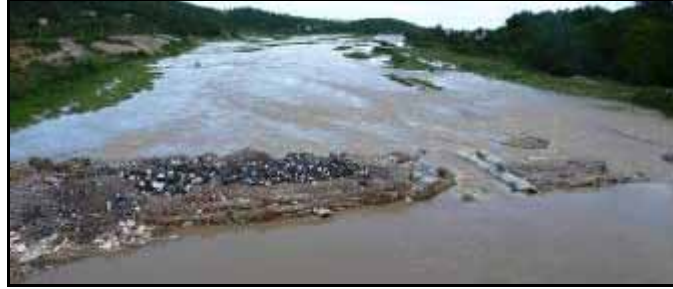
Although the damage was relatively minor, traffic was restricted to the middle of the deck, as shown in figure 28, as a precautionary measure. An attempt was made to build a roadway with embankment materials and pipe culverts to serve as a detour over the river, as shown in figure 29. However, it appeared that the building of the detour was abandoned because the river flow was too strong and the roadway was rapidly washed away.

Figure 29. Photo. Temporary Roadway over the River.

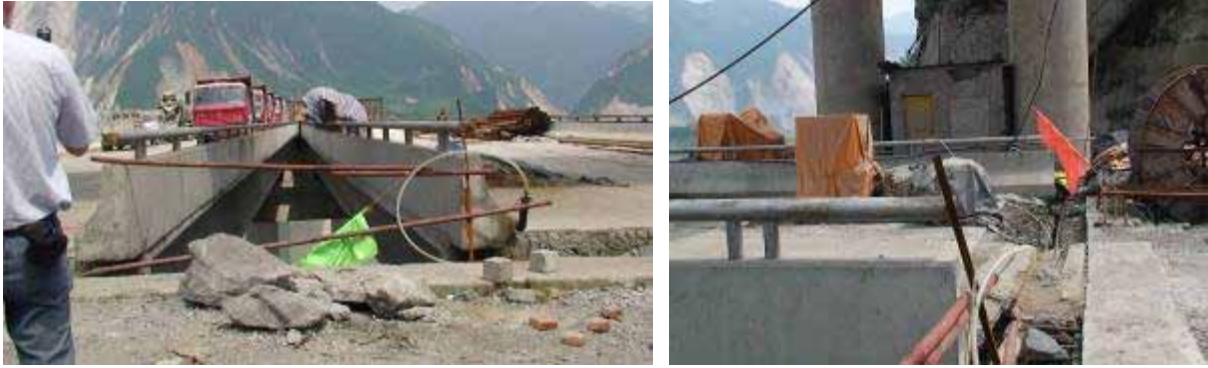
The end of Miaozhiping Bridge near the tunnel is divided into two parallel elevated structures to guide traffic in two directions through the twin tunnels, as shown in figure 58. Over the southeast approach is a four-span RC girder bridge built in 2004. The bridge supports the old highway from Dujiangyan to Wenchuan and Juzhaigou. The old highway was built along the mountain terrain perpendicular to the Zhipingpu Highway at Zhipingpu Town. The bridge showed shear key failures and embankment cracking (see figure 59).

Figure 58. Photo. End of Miaozhiping Bridge and its Overpass for the Old Highway.

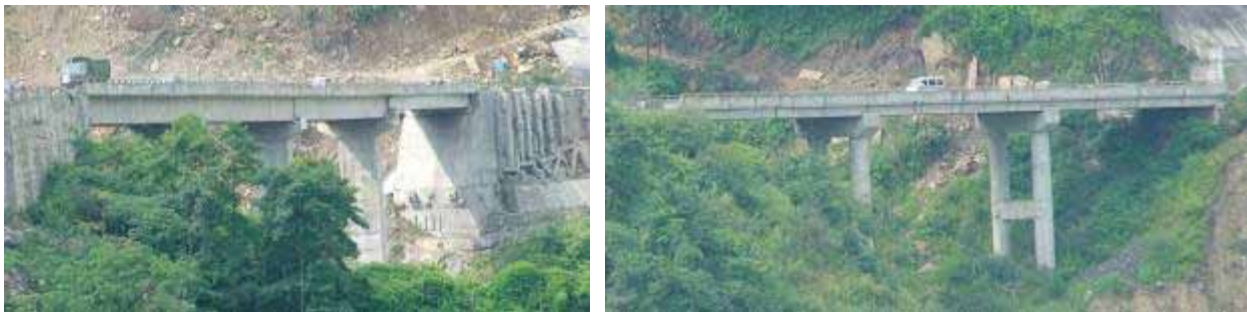
There are several RC girder bridges in the vicinity of Miaozhiping Bridge, as shown in figure 60. These bridges appeared to suffer little damage. No weight limits were posted on these bridges.

Figure 60. Photo. Bridges in the Vicinity of Miaozhiping Bridge.
