MISSOURI STATE HIGHWAY PATROL ACCIDENT RECONSTRUCTION REPORT

| Date of Report: | October 27, 2011 |

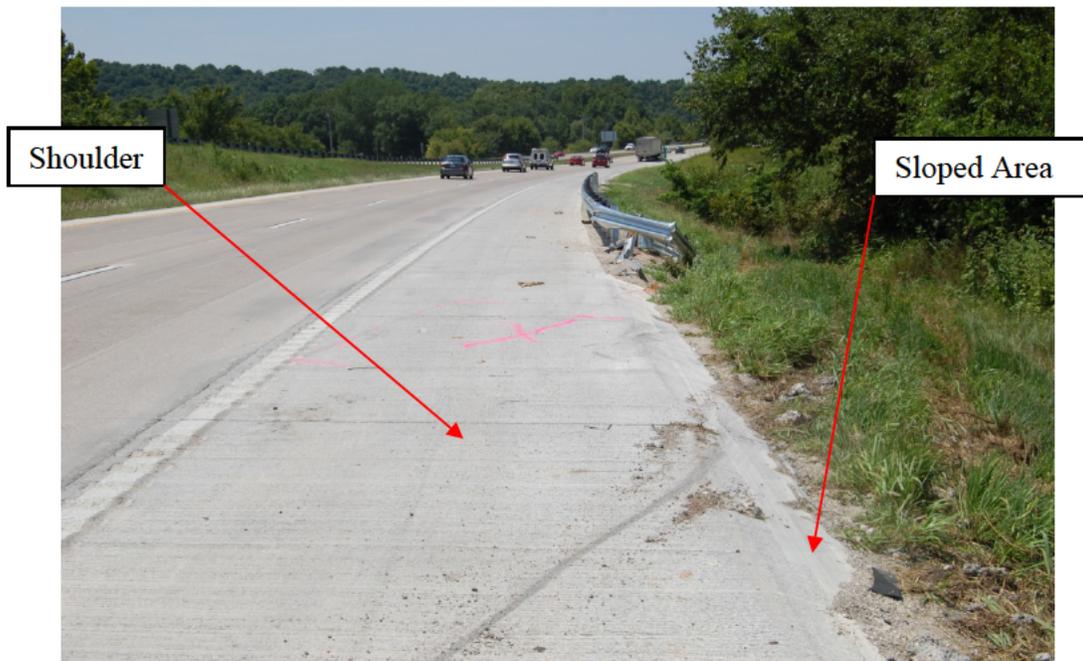
DSC_0035.jpg

In the area vehicle # 1 traveled off the north side of the road, the westbound lanes of Interstate 44 were approximately 25.5 feet wide. The westbound inner shoulder was approximately 3.3 feet wide with an additional concrete sloped surface that was approximately 1.4 feet wide between the south shoulder edge and the grassy area south of the road. The westbound outer shoulder was approximately 9.0 feet wide with an additional concrete sloped surface that was approximately 1.8 feet wide between the north shoulder edge and the grassy area north of the road. The photograph below shows the outer shoulder and sloped surface.

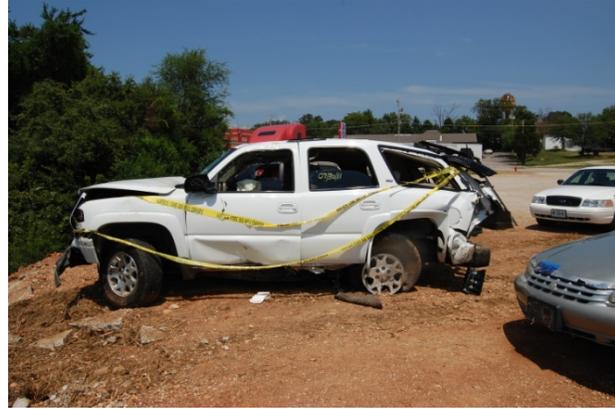
DSC_0020.jpg

Most of the remainder of vehicle # 1 sustained contact and induced damage as it traveled down the embankment and overturned.

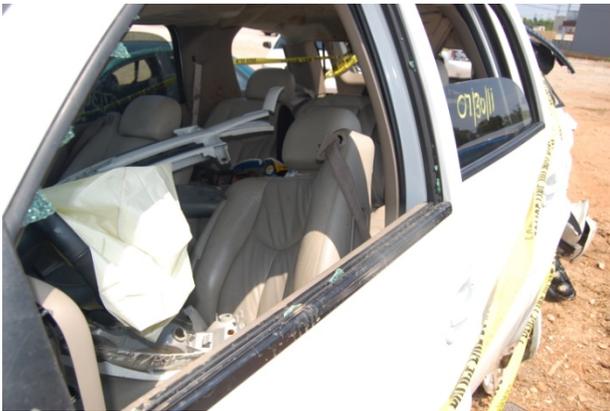
DSC_0024.jpg

Vehicle # 1's seatbacks were also broke down (rearward) during the collision sequence.

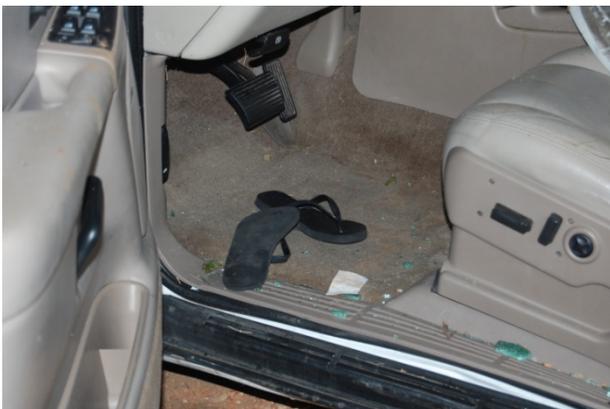
DSC_0051.jpg

While examining vehicle # 1, I noticed a pair of "flip-flops" on the driver's side front floorboard. It is unknown if those "flip-flops" belonged to the driver of vehicle # 1 or if they were placed there by the tow company as they cleaned up debris around the collision scene. The "flip-flops" appeared to be size "7-8."

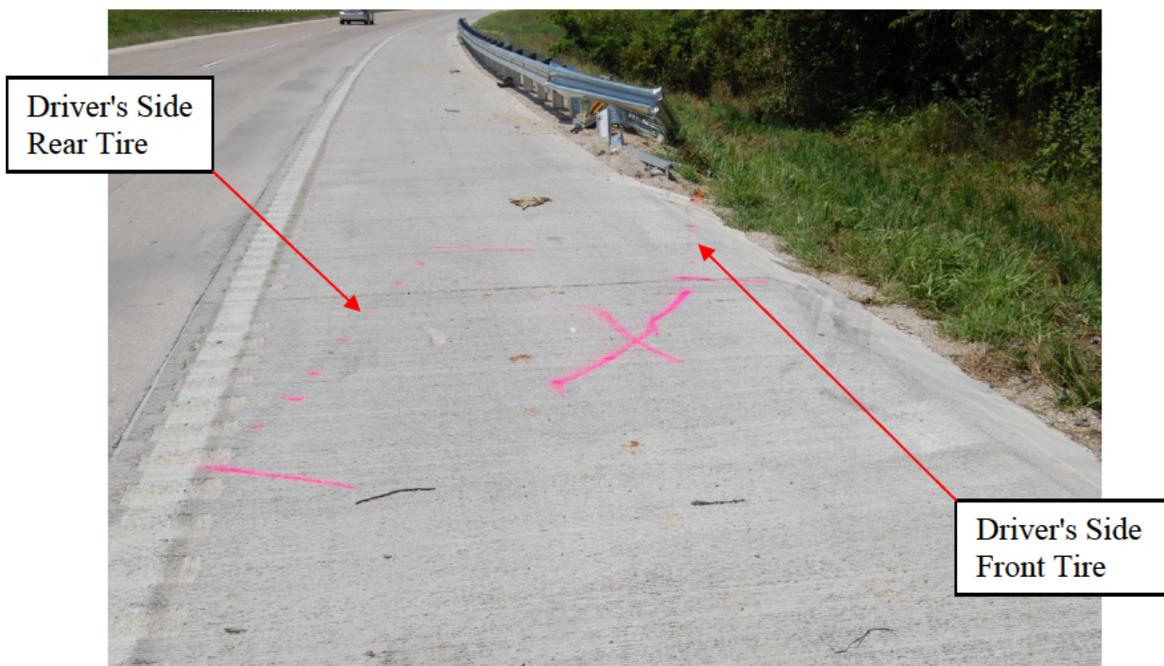
DSC_0036.jpg

Vehicle # 1 made a pre-impact tire mark with its driver's side rear tire that first became visible 442.8 feet west of the reference line, 0.5 foot north of the westbound outer fog line. It was no longer visible 452.1 feet west of the reference line, 3.0 feet north of the westbound outer fog line.

Vehicle # 1 made a pre-impact tire mark with its driver's side front tire that first became visible 450.2 feet west of the reference line, 8.2 feet north of the westbound outer fog line. It was no longer visible 464.6 feet west of the reference line, 12.6 feet north of the westbound outer fog line.

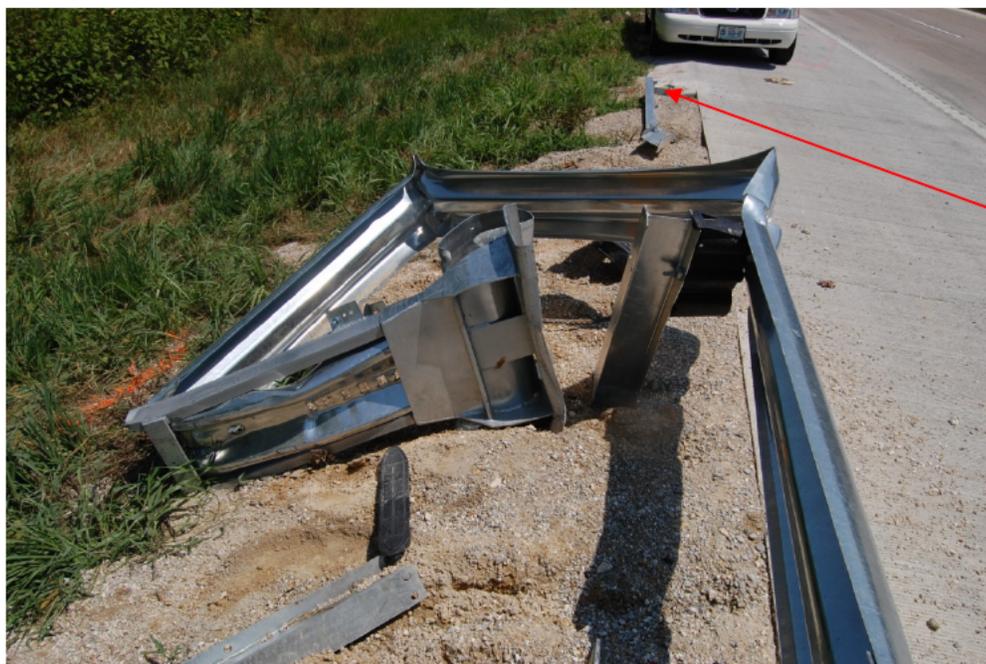
DSC_0034.jpg

As vehicle # 1 traveled off the north side of the roadway it struck a guardrail. The easternmost guardrail post was 462.9 feet west of the reference line, 10.5 feet north of the westbound outer fog line.

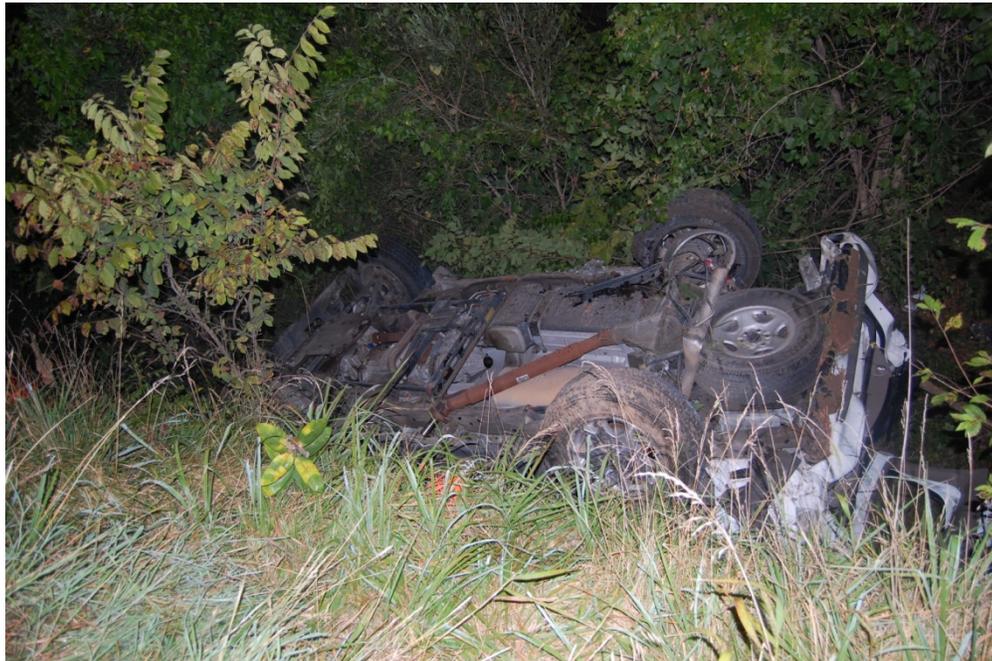
DSC_0003.jpg

Vehicle # 1 came to rest on its top at the bottom of a steep embankment. Its exact final rest location was not marked, but the approximate locations of its front and rear were marked on the ground above the embankment. The rear of vehicle # 1 was located approximately 543.5 feet west of the reference line while its front was located approximately 552.5 feet west of the reference line.
