MISSOURI STATE HIGHWAY PATROL CRASH RECONSTRUCTION REPORT

Original Investigating Officer:	Trooper Q. D. Bland,
Troop Reconstructionist(s):	
Assisting Officer(s):	Sergeant G. Q. Billings
Assisting Agency(ies):	
Level IV Reconstructionist(s):	Corporal G. D. Ward
Date of Report:	April 5, 2013

Section I - Synopsis

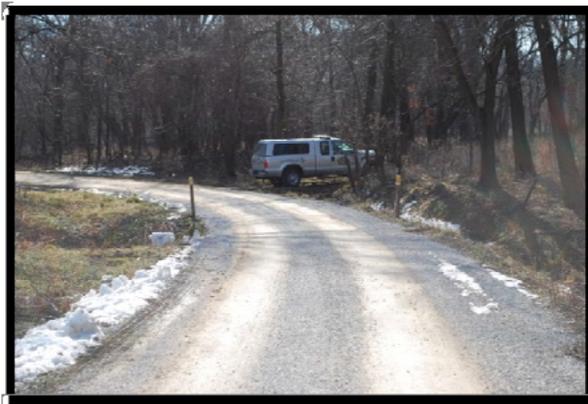
DSC_0040.JPG - View looking southeast

This [REDACTED], a single undivided gravel roadway measuring roughly 14 feet wide and classed as part of the St. Clair County road system. The roadway is in a rural setting in the southwestern portion of the county. The roadway is without shoulders and modest grass ditches and trees adjoin the road. [REDACTED]

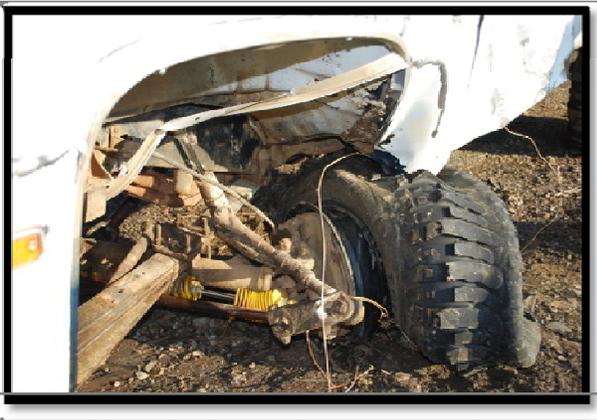
The Vehicle #1 front bumper was partially detached, as was the right marker light. Both sides of the truck and its hood were crumpled. The roof was crumpled and forced downward. The frame was bent as was obvious by the large gap between the bed and cab on the right side of the vehicle. The truck's right tail light cover was completely detached. The front left wheel and suspension system were bent and pushed rearward into contact with the vehicle body. The front left tire was deflated and displayed a large rip in the outside sidewall of the tire, attributable to striking the bridge rail end. All other tires remained inflated. Both front tires were worn smooth near the center of the tire tread pattern. All of the truck's glass was gone except for the right door glass.

DSC_0018.JPG - Wheel Assembly Pushed Rearward

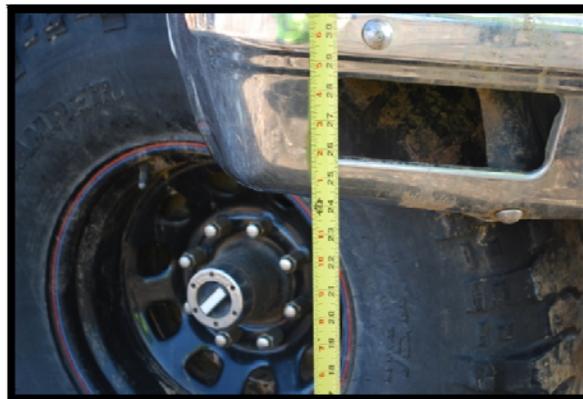
A measurement was taken at the right front bumper which revealed the bumper height was approximately 24 inches.

DSC_0032.JPG - Measurement of Bumper (24 inches)

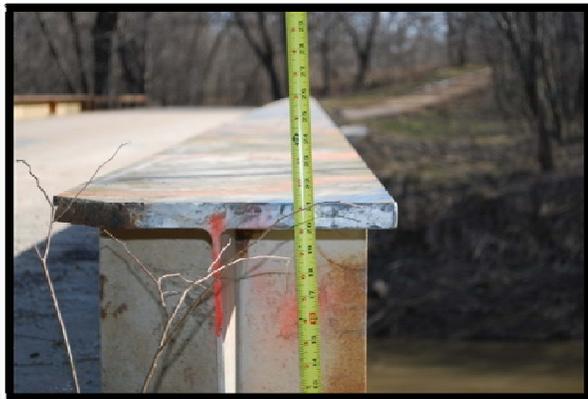
A large tire scuff attributable to Vehicle #1's impact with the end of the bridge rail was observed. The scuff mark began at the southwest bridge rail at the point of reference. A measurement to determine the height of the bridge rail revealed the rail was 21 inches.

DSC_0032.JPG - [REDACTED] Bridge Rail (21 inches)

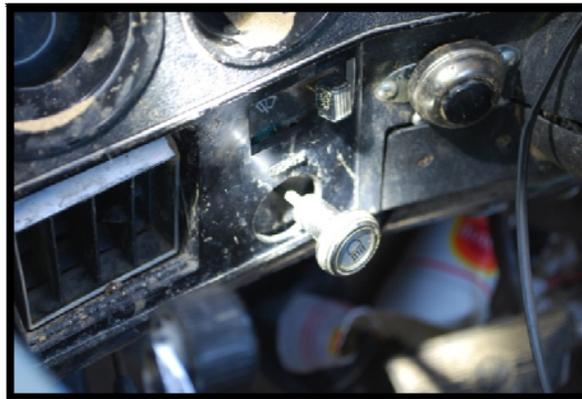
Inspection of the Vehicle #1 dashboard indicates the headlight switch was pulled out, suggesting the lights were activated at the time of the crash.

DSC_0015.JPG - Headlight Switch in "On" Position
