Guardrail Terminal Crashes Reconstructed by both Missouri and FHWA

Additional Guardrail Terminal Crashes Identified by Motorists in Missouri

Additional Guardrail Terminal Crashes Identified by Missouri DOT Officials

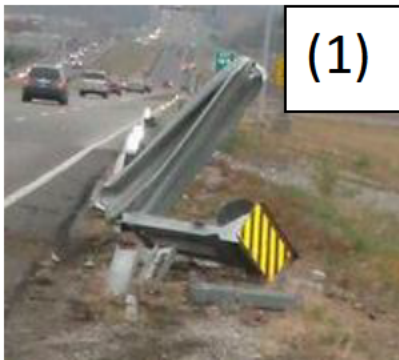
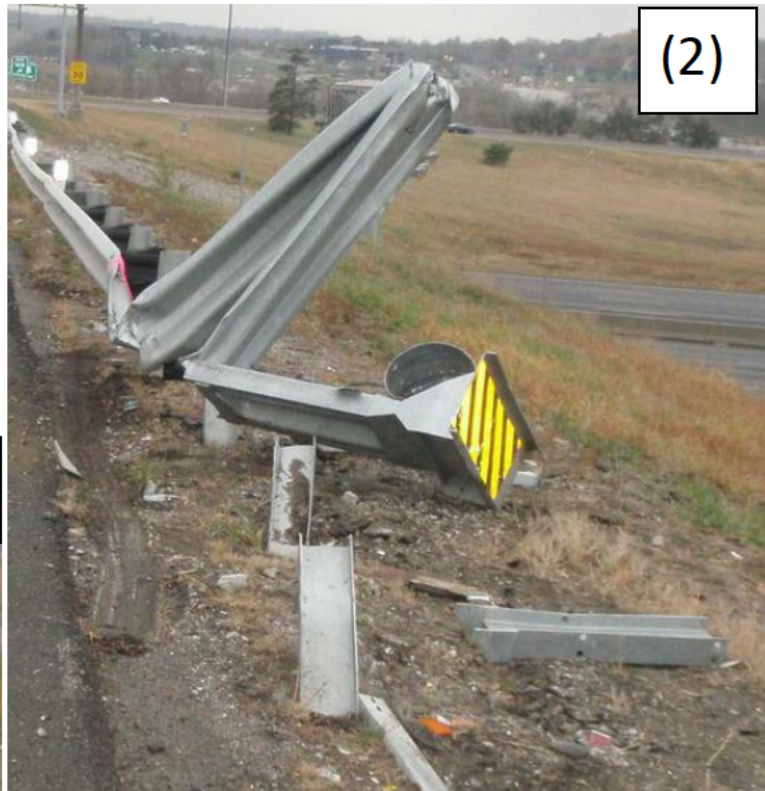
Description: This crash involved a 4" ET-Plus. The rail extruded approximately 2 to 3 feet. The impact speed was approximately 35 mph, according to the driver. Tire skid marks next to the terminal indicate that the vehicle hit the terminal head on and probably close to the center line of the vehicle. The driver stated that his tires began to slide causing him to leave the roadway to the right. The scene diagram shows that the vehicle came to rest in front of the terminal. The rail buckled in two locations (disqualifying gating), which also indicates that the resistive force in the terminal was greater than the compressive capacity of the rail. Therefore, the terminal locked up and did not perform properly. The occupant was uninjured.

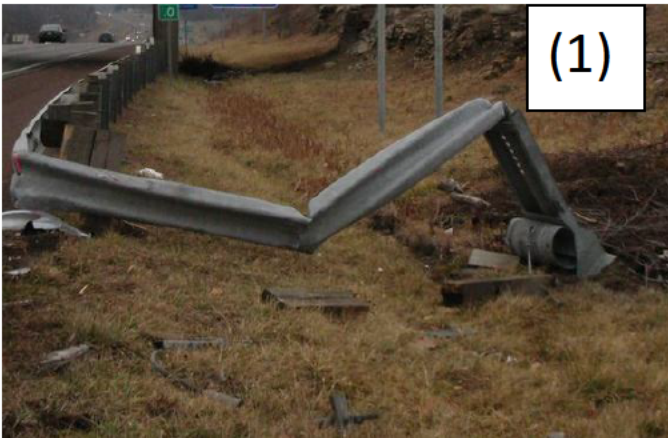
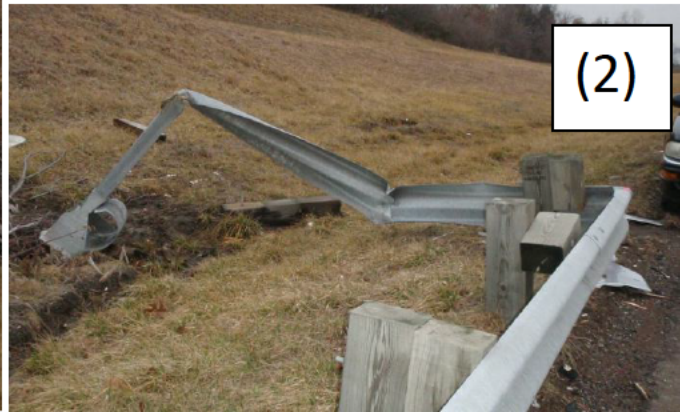
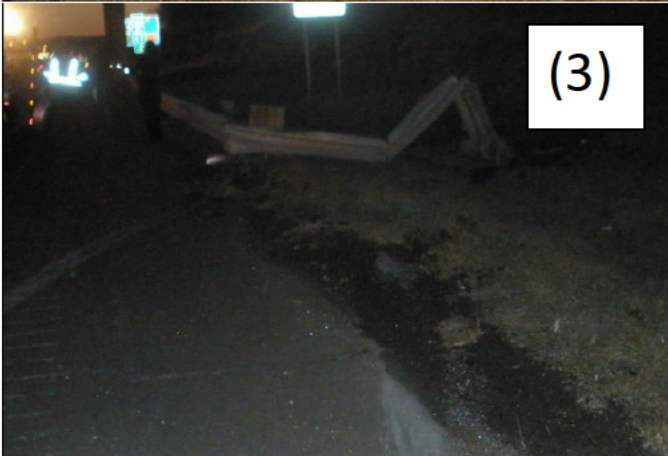
File: 12

Description: This crash involved a 4" ET-Plus. The rail extruded approximately 2 to 3 feet. The impact with the guardrail was the second event, preceded by a lane-change collision with another vehicle. From witness and driver accounts, after the two-car contact was made, the driver of the subject vehicle then struck a guardrail, leading one to believe that this was an over-correction maneuver, which is also evidenced in picture 3 via distinct tire skid marks. Not only was this a high-angle hit, but the width of those skid marks would indicate that the vehicle was partially sideways. The terminal extruded a small amount of rail before gating open, as designed. The occupant sustained level "C" injuries.

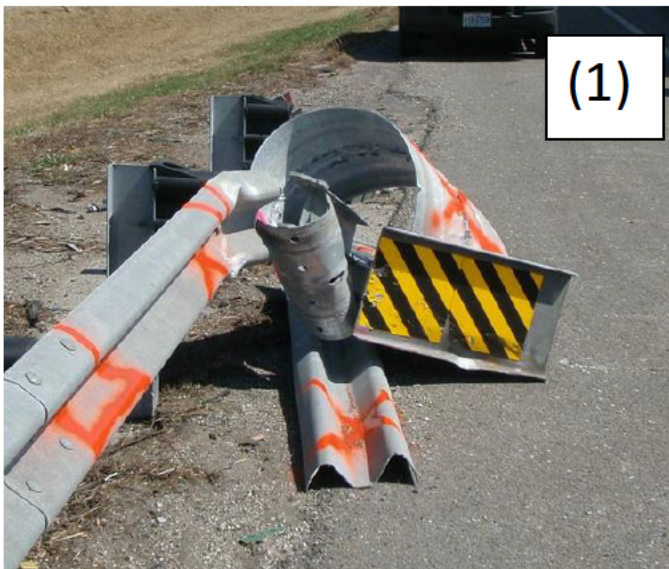
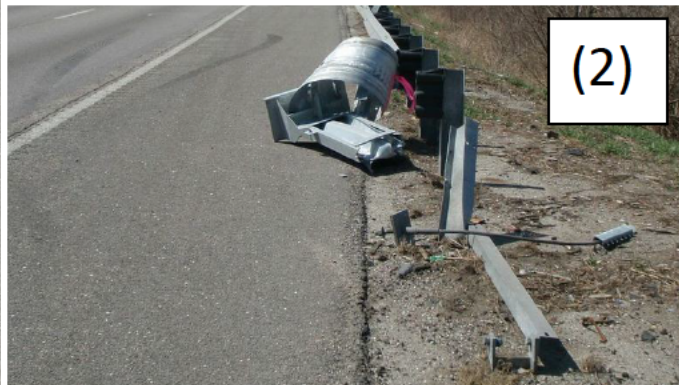
File: 13

Description: This crash involved a 4" ET-Plus. The rail extruded approximately 10 to 12 feet. The second post is not bent to the ground substantially, and the third post isn't bent at all. This indicates that contact with the terminal head was made by the outside edge of the passenger side front bumper. It appears that the vehicle began to yaw clockwise in an extreme manner, as evidenced by the tire marks in picture 2. Upon doing so, the vehicle overturned. The terminal head folded over on the guardrail as in a gating crash. The fact that the vehicle rolled is a possible indicator that the vehicle was already yawing prior to impact. Therefore, this terminal likely performed as intended. The occupant's injuries were labeled as level "B".

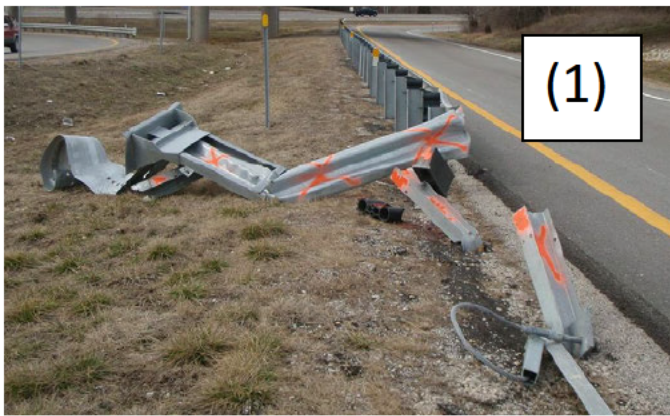
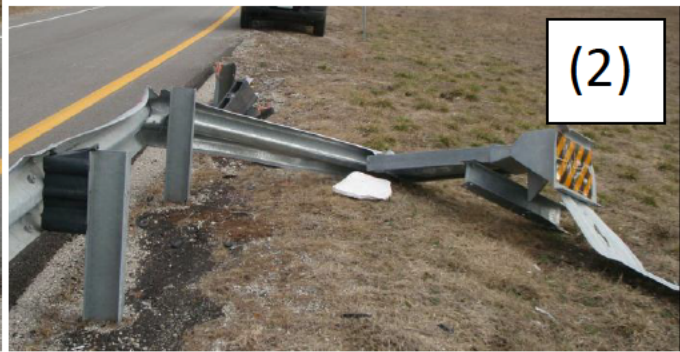
File: 14

Description: This crash involved a 4" ET-Plus. The rail extruded approximately 10 to 12 feet. There was no crash report. However, the guardrail visible in the window of the terminal head (picture 1) demonstrates buckling modes indicative of very high forces. Therefore, it is likely that this terminal locked up, causing the rail to buckle and form a potential spear. This terminal did not perform as intended.

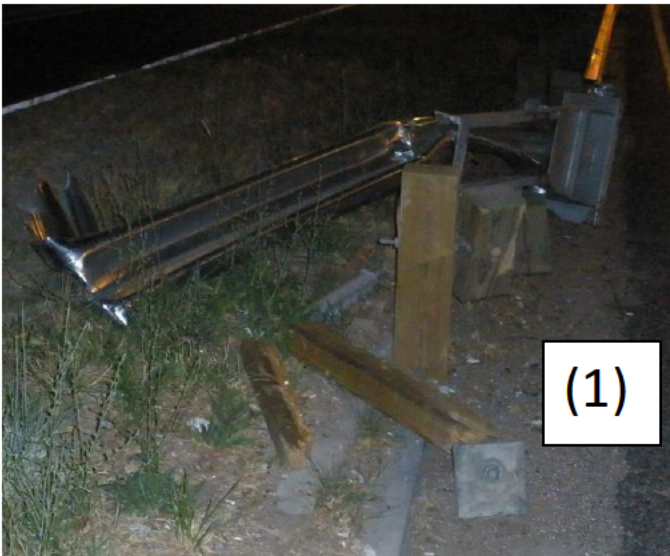
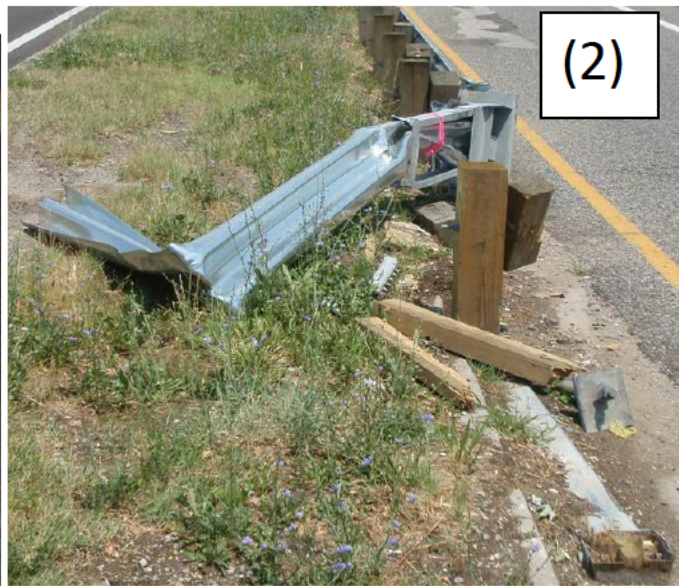
File: 17

Description: This crash involved a 5" ET-Plus. The guardrail appears to be cut several feet upstream of the terminal head (picture 1 shows a clean severance). This is not likely to occur in the event of the crash. However, the rail inside the window of the terminal head is deformed in a manner that would suggest a moment that acted about a horizontal axis was applied to the head, causing the bottom corrugations to fold (picture 2). Therefore, this terminal did not perform as intended. However, the crash report highlights a second collision with a utility pole. Therefore, it is uncertain what lead to the injuries (level "B") sustained by the driver.

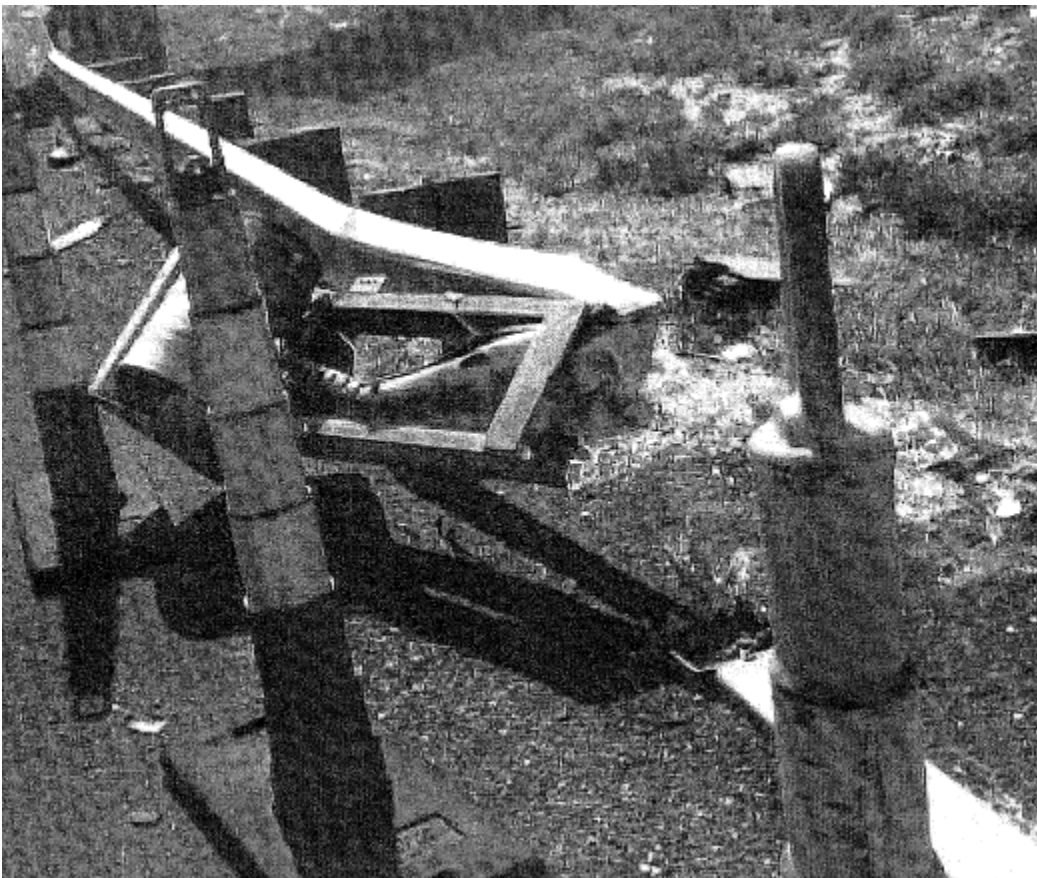
File: 18

Description: With this picture, it is difficult to identify the system. It is of the ET-family and most likely an ET-2000. There is very little extrusion, and the rail inside the guide channels is deformed abnormally, suggesting that this terminal did not perform as intended. Consequently, the rail buckled, forming a potential spear.

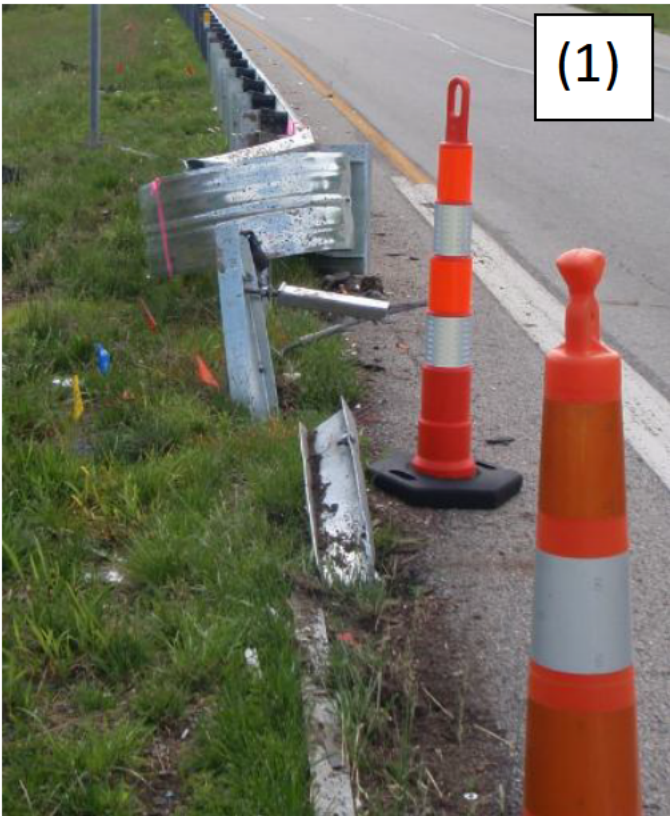
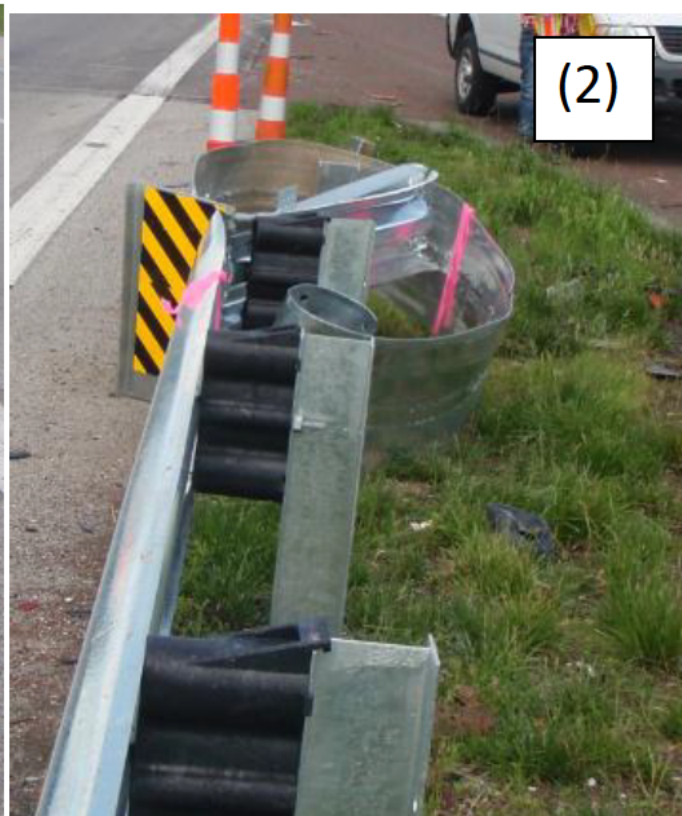
File: 19

Description: This crash involved a 4" ET-Plus (the variable height difference at the inlet is barely visible in picture 2). The rail extruded approximately 10 to 12 feet. The posts are lying down roughly parallel with the untouched upstream guardrail. The terminal head itself is adjacent to the barrier. Therefore, this was a head-on or low angle impact and probably an offset impact on the front bumper. This would facilitate a spin-out away from the upstream guardrail. The terminal appears to have performed as intended. The driver of this vehicle was not harmed.

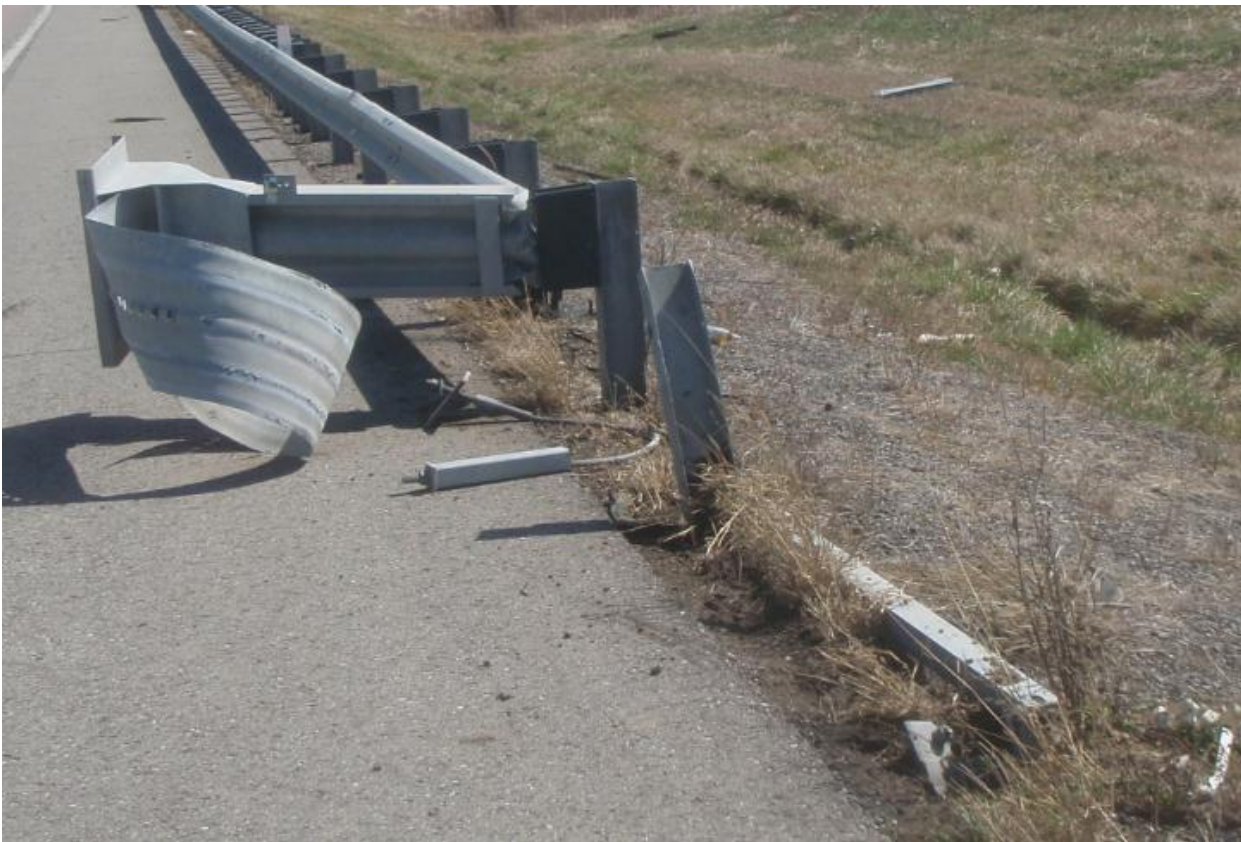
Description: This crash involved a 4" ET-Plus. Rail extruded approximately 6 to 7 feet. A pickup truck towing a trailer jack knifed, and the sliding trailer struck the terminal. The cable appeared to release properly. Rail was extruded without evidence of locking up. This terminal performed as intended. No one was injured.

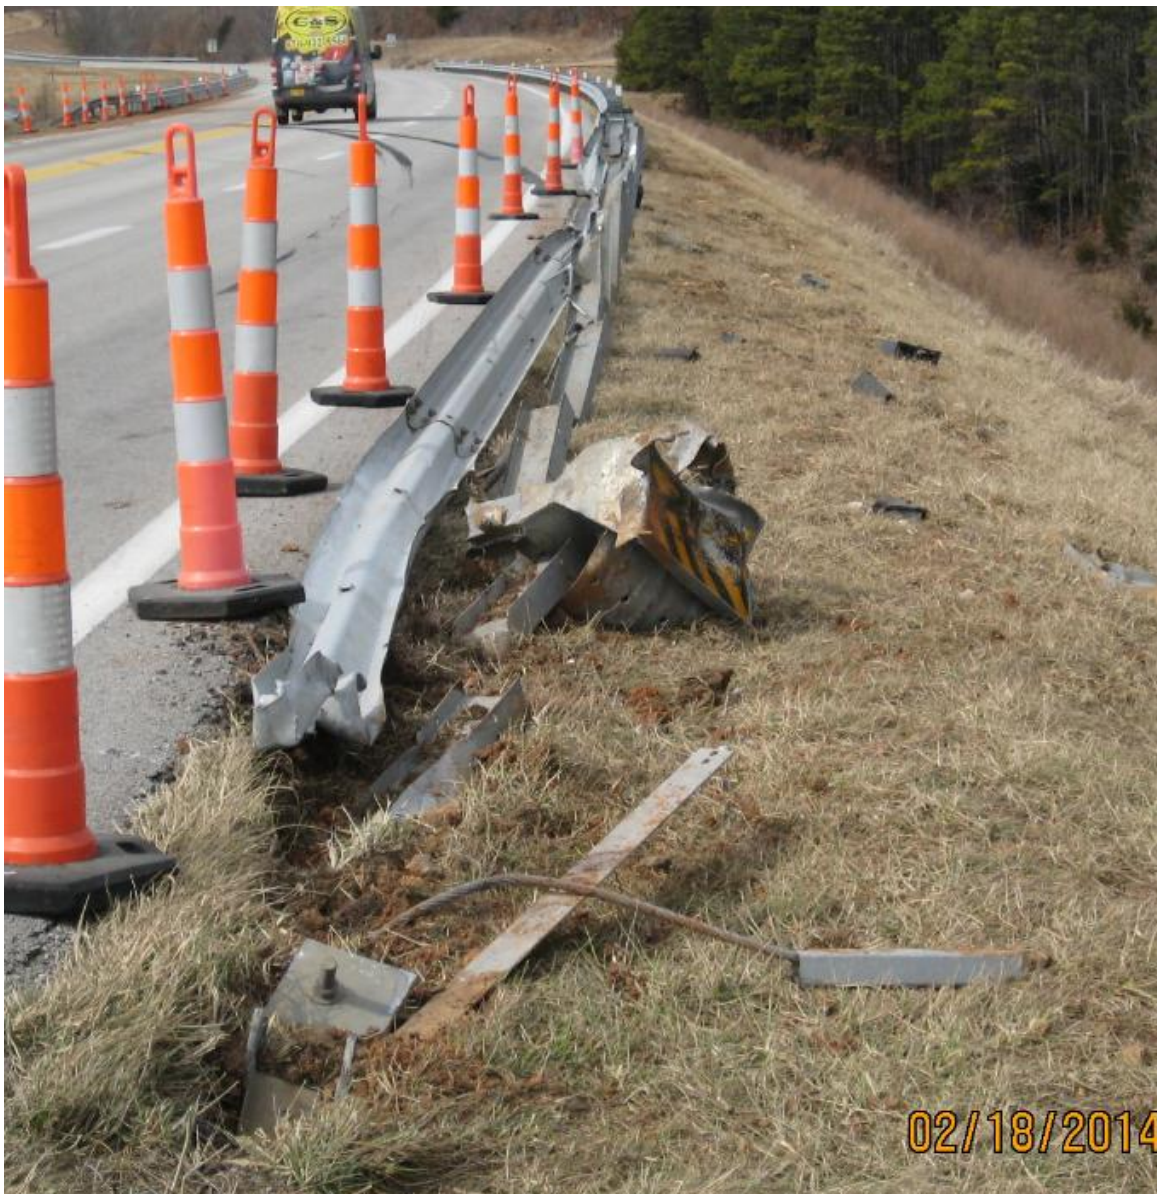
Description: This crash involved a 4" ET-Plus. Very little rail extruded. However, this terminal was struck by a semi tractor-trailer. The cable should release almost immediately regardless of the energy imparted on the terminal during a crash. In this case, the cable and bearing plate are next to the first anchor post, which also shows signs of large soil displacement. This indicates that the cable did not release right away. Therefore, even though the vehicle was well outside the design constraints, the terminal did not perform correctly. There were no injuries.

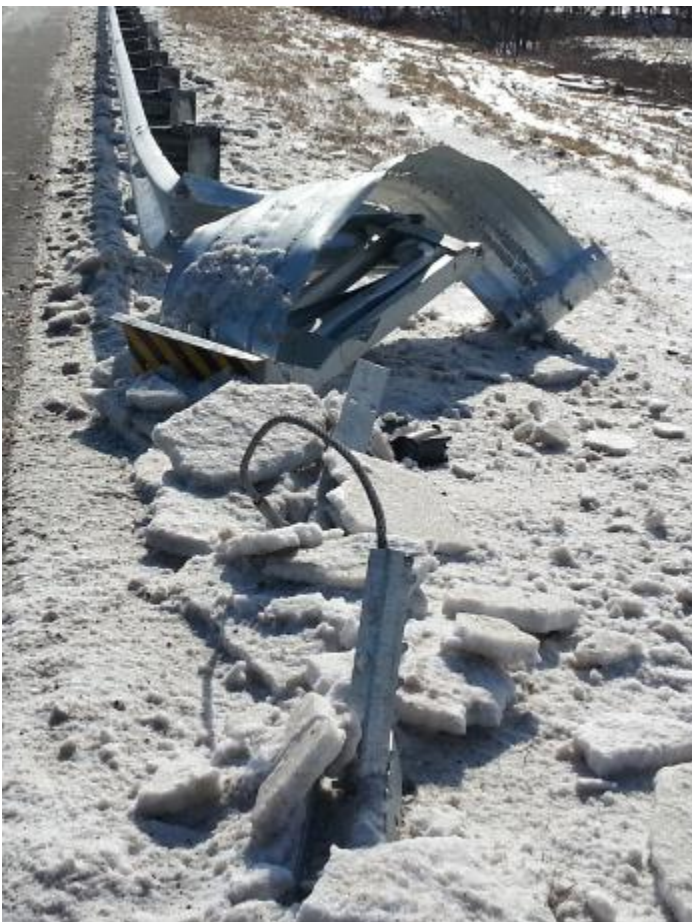
File: 25

Description: This crash involved a 4" ET-Plus. Rail extruded approximately 10 feet. The snow makes it impossible to discern if the cable anchor was at fault. However, the guardrail that is lodged in the window of the terminal head shows that the head stopped moving down the guardrail and began to pitch downward, crushing the guardrail. This indicates that the terminal did not perform properly.

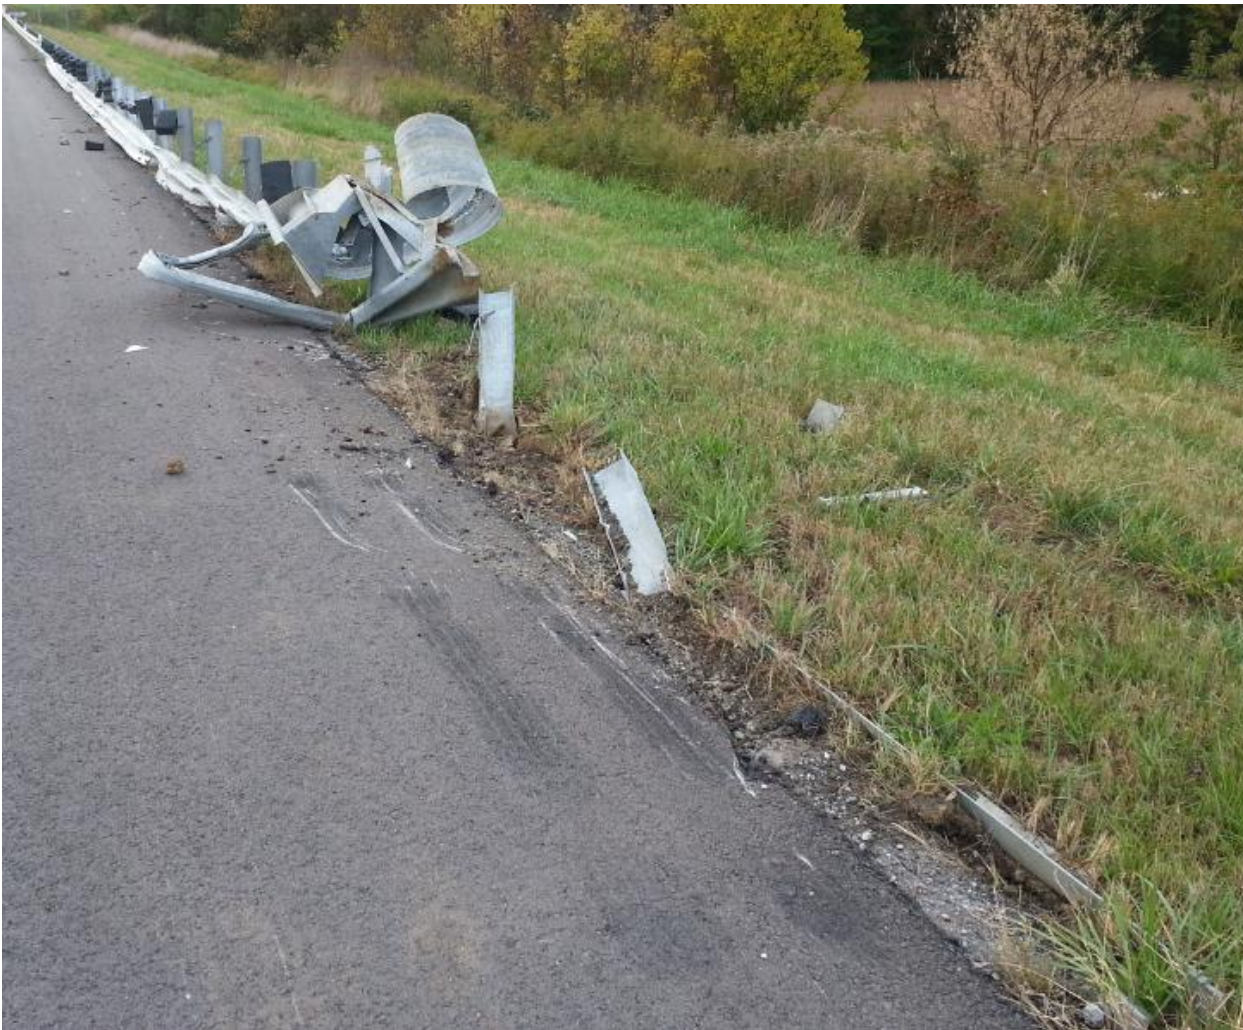
File: 26

Description: This crash involved a 4" ET-Plus. Rail extruded approximately 10 feet. Normally, deformation in the guide channels indicates a cable release malfunction. However, this case looks more like a semi tractor-trailer struck the terminal and pinned it underneath the truck, causing the guide channels to fold over, as shown in the picture. This is very similar to the Peterbilt crash in Report No. 140099432 (File 24). Unlike in that case, there is no available information at the point of the first anchor post. Therefore, a tentative conclusion was made that the terminal performed as intended.

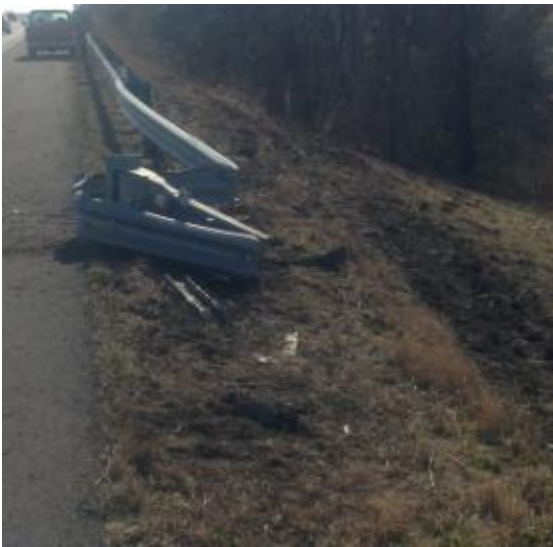
Description: This crash involved a 4" ET-Plus. Rail extruded approximately 3 feet. The terminal was struck by a semi tractor-trailer, which proceeded behind and beyond the terminal, colliding with the trees shown in the background of the picture. The terminal buckled in 3 places, indicating a large compressive force in the rail. The higher energy level should have simply extruded more rail than the standard 50-ft length. However, that did not happen, leading one to believe that this terminal did not function properly. No one was injured.

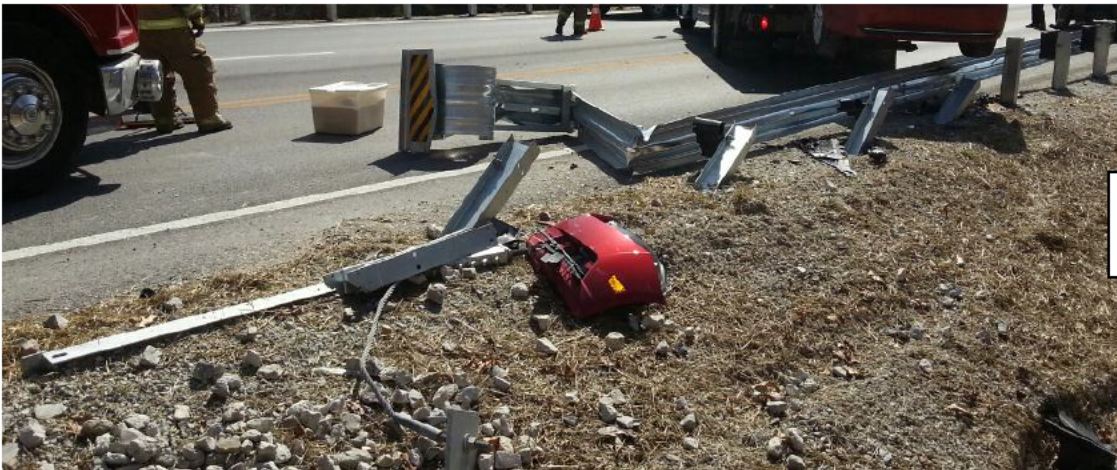
(1)

Description: This crash involved an ET-Plus, but the camera angles prevent the positive distinction between 4" and 5". The crash report indicates that a rock barrier was struck first, causing the vehicle to become partially airborne just before hitting the guardrail terminal. This vertical undulation at impact would have increased the propensity for the rail to buckle by adding vertical displacements and possibly torsional loading (via the suspension of the vehicle), depending on how the vehicle interacted with the rail. After the two buckles formed, the vehicle continued down the rail, coming to rest on the guardrail. This indicates a head-on collision where gating was not expected. Last, the rail that is visible in the window of the terminal head indicates that the bottom guide channel was forced up, crushing the bottom corrugation, then down, crushing the top corrugation. This is consistent with the airborne statement from the witness. Altogether, under these loading conditions, the terminal performed as well as it could have. There were no injuries.

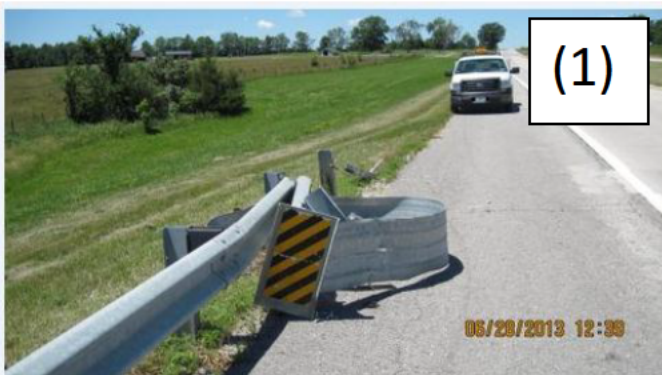
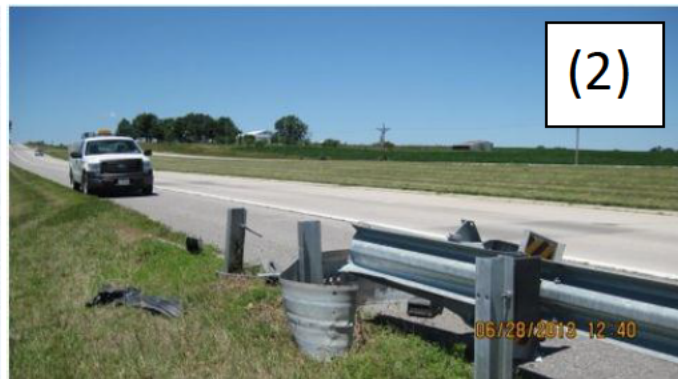
Description: This crash appeared to have involved an ET-Plus (the photos could not be used to distinguish between the 4" and 5" versions). The rail extruded approximately 17 feet before the terminal appeared to gate towards the road. This may have occurred if the vehicle was in a maneuver to return to the road prior to the impact with the terminal. Therefore, this terminal appeared to function properly.

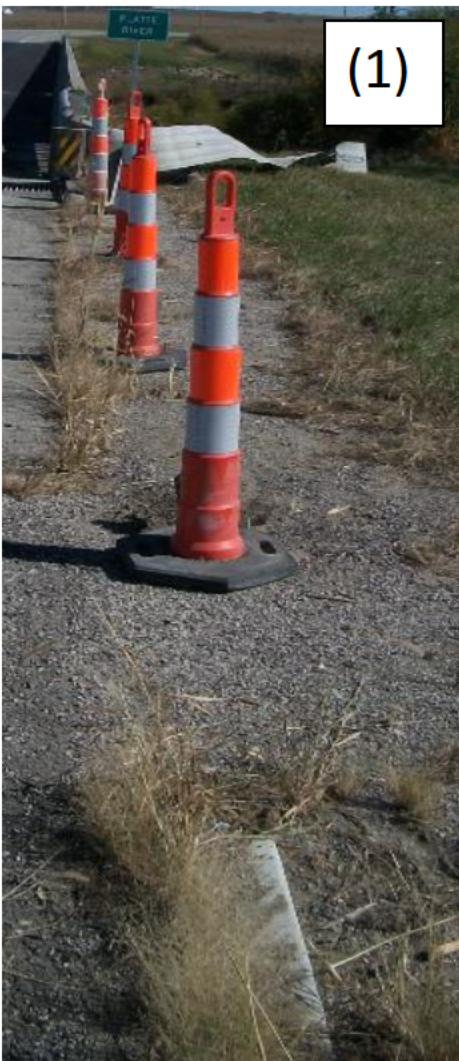
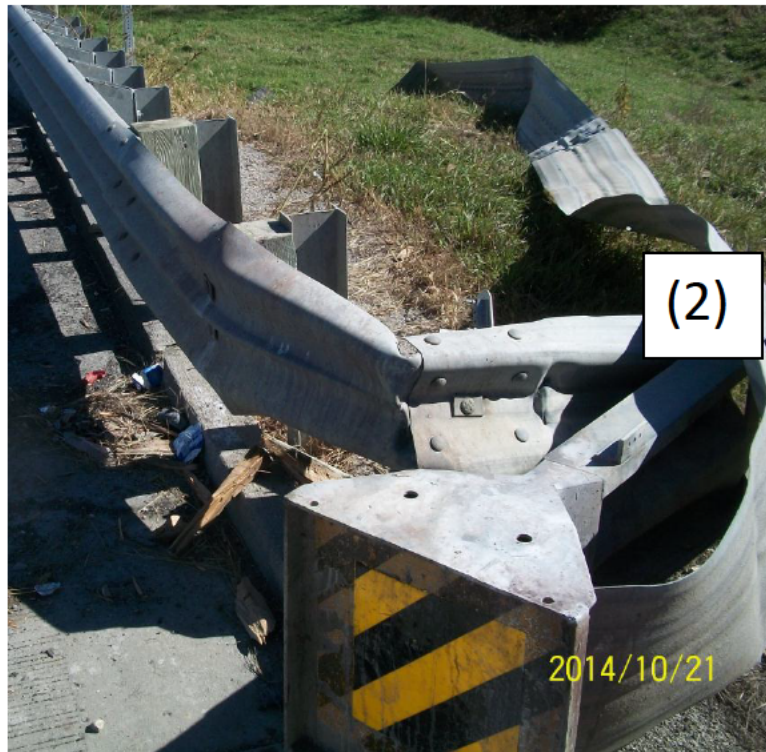
File: 35

Description: This crash involved an ET-2000. The terminal extruded nearly 50 feet of rail prior to buckling. This indicates a high-energy impact where the vehicle struck the terminal at an angle very close to 0 degrees and centered on the front bumper. Also, the rail buckled only when the rail began to transition to three-beam. This terminal not only performed as intended, but appeared to exemplify the desired outcome of a high-energy crash.
