# NCHRP Report 350 Test Report Compilation

## Full-Scale Crash Evaluations of the ET Plus<sup>®</sup> End Terminal with 4-inch Wide Guide Channel Installed with a Rail Height of 27¾ Inches

Tests: ET27-33, ET27-31, ET27-32 and ET27-30

SwRI<sup>®</sup> Project No. 18.20887

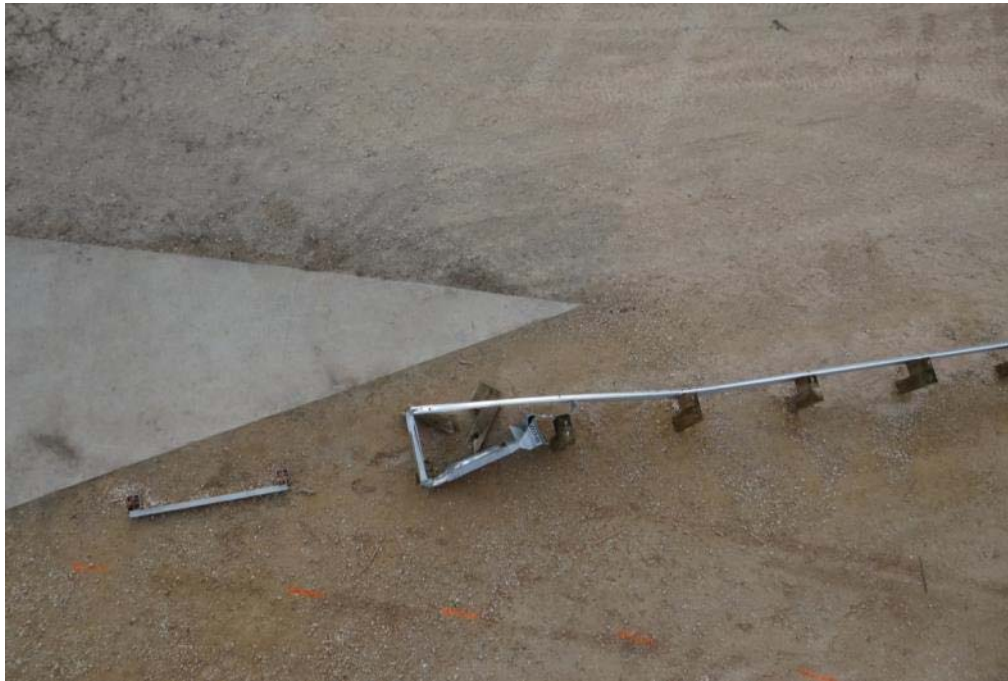
**Figure 3.6: Post Test – Overhead View**

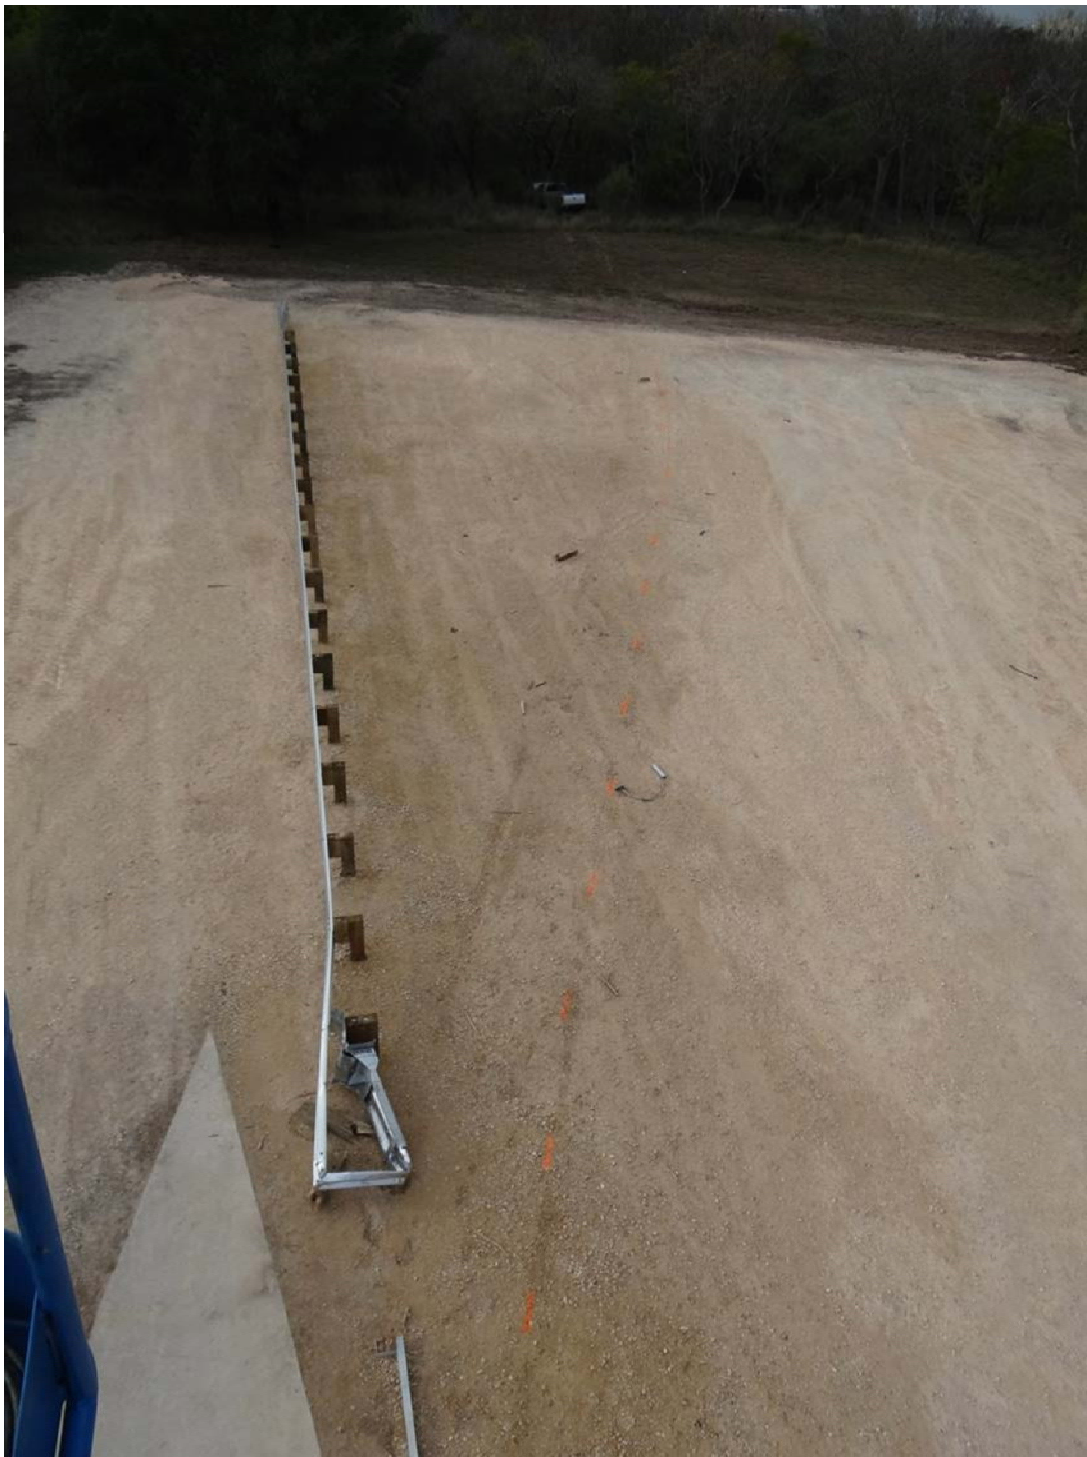
Figure 3.10: Post Test – Debris Field on Non-Traffic Side

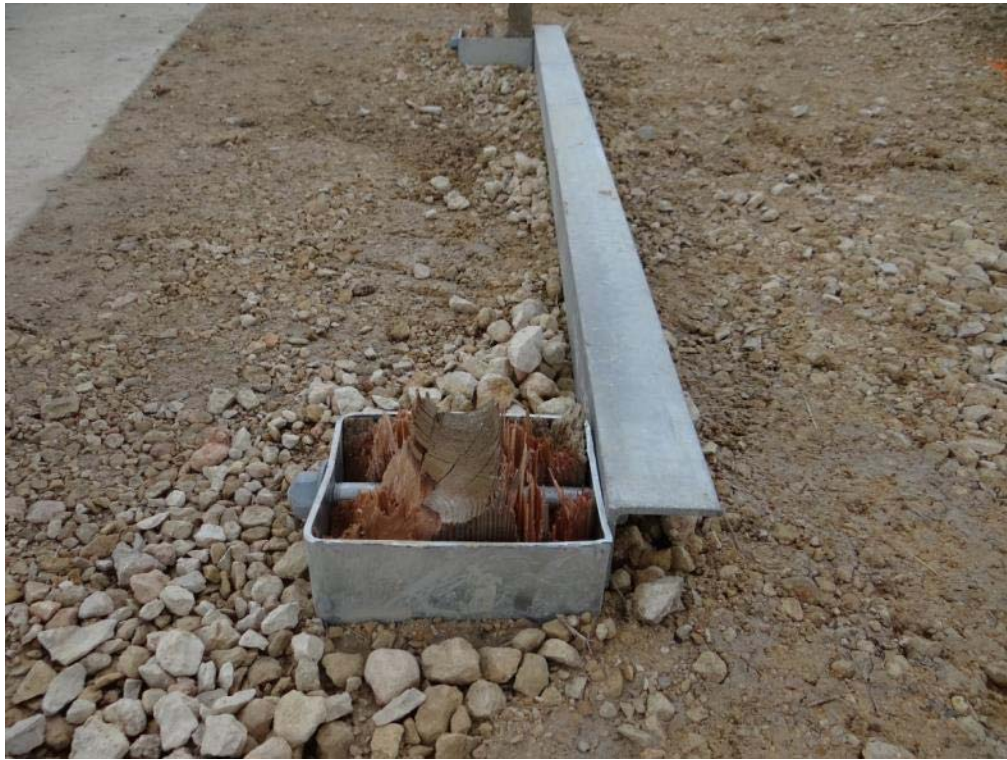
**Figure 3.11: Post Test – Foundation Sleeve at Post 1**

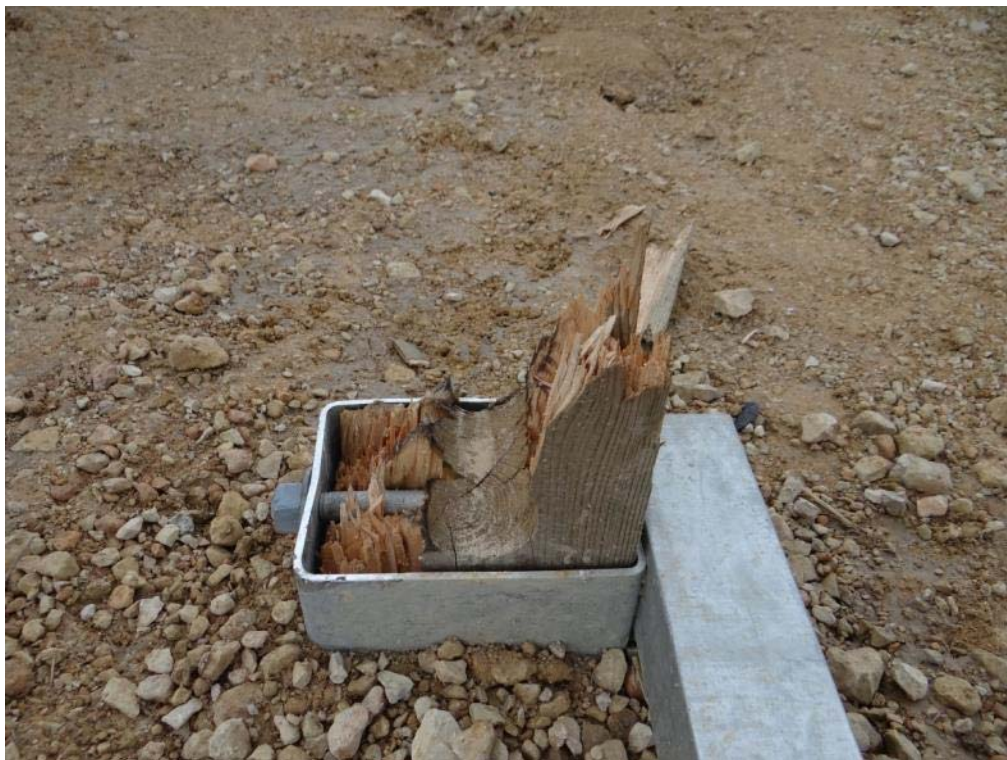
**Figure 3.12: Post Test – Foundation Sleeve at Post 2**

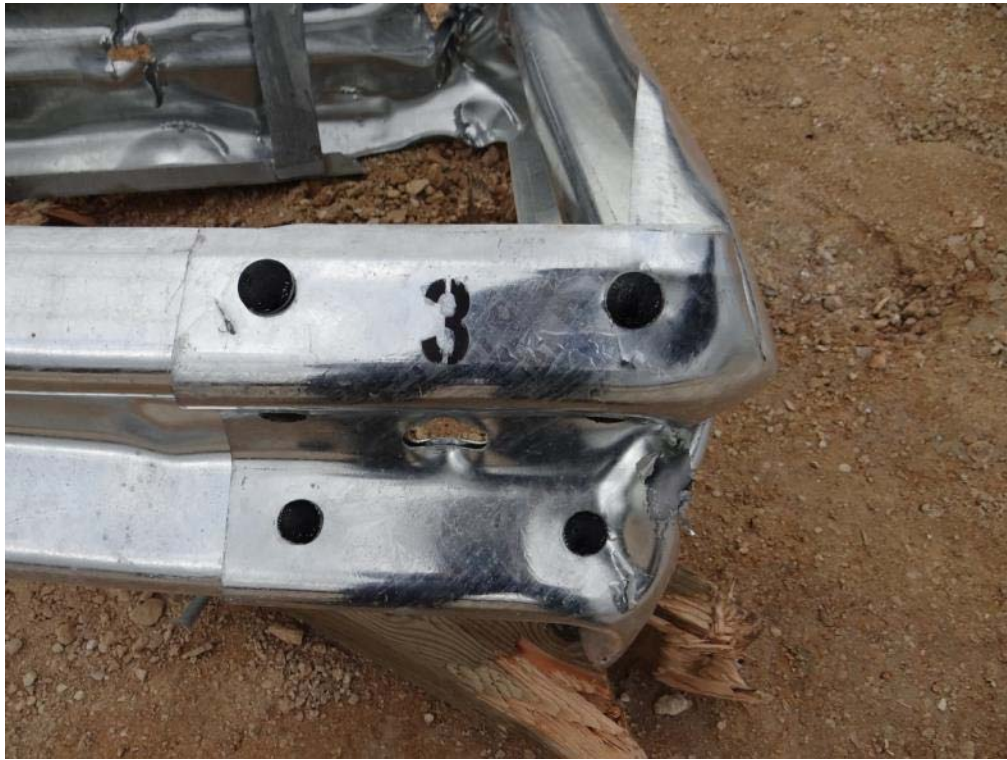
**Figure 3.13: Post Test – First Splice at Post 3 (Splice Bolts Painted for Visibility in Video)**

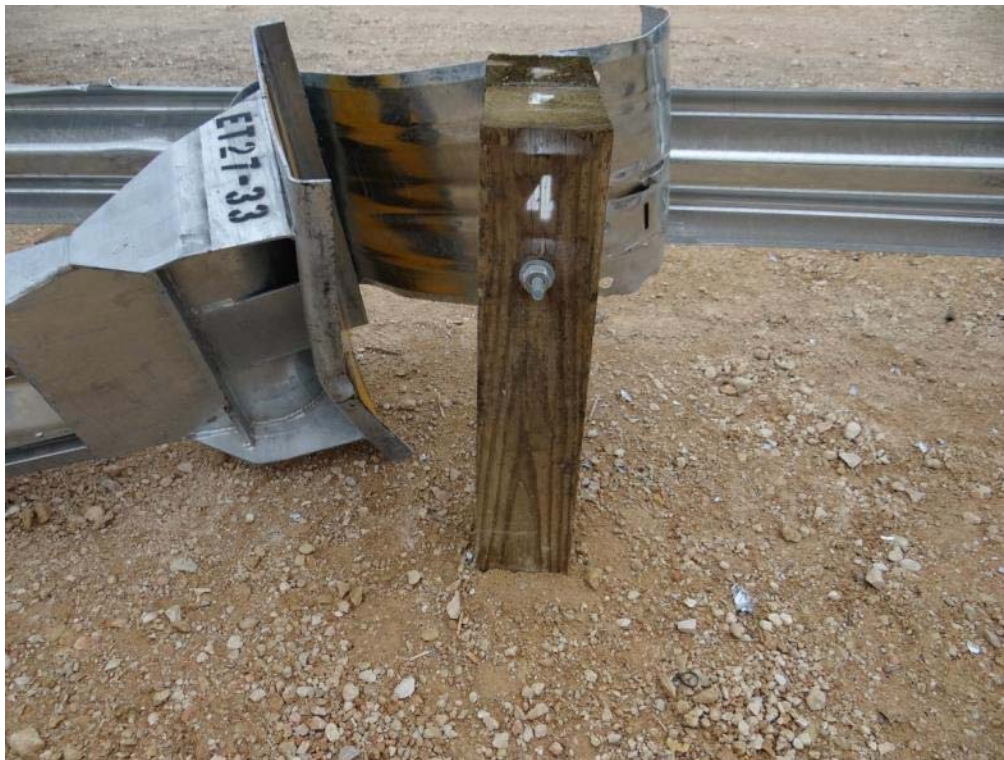
Figure 3.15: Post Test – View of Post 4 from Non-Traffic Side

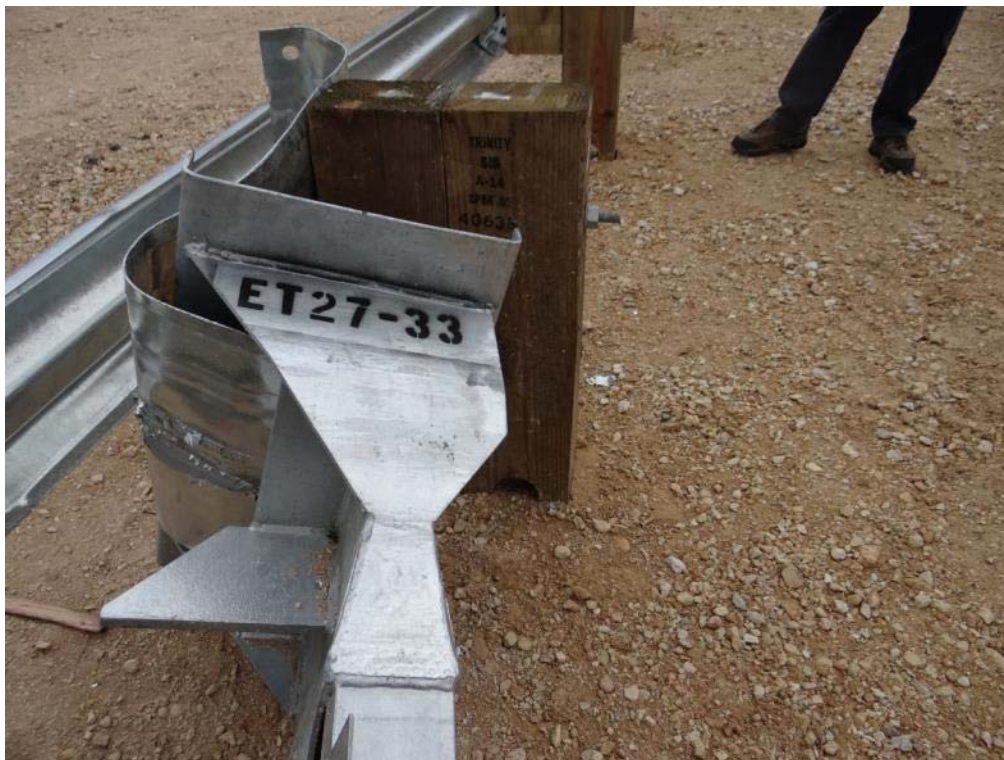
Figure 3.16: Post Test – Side View of Post 4

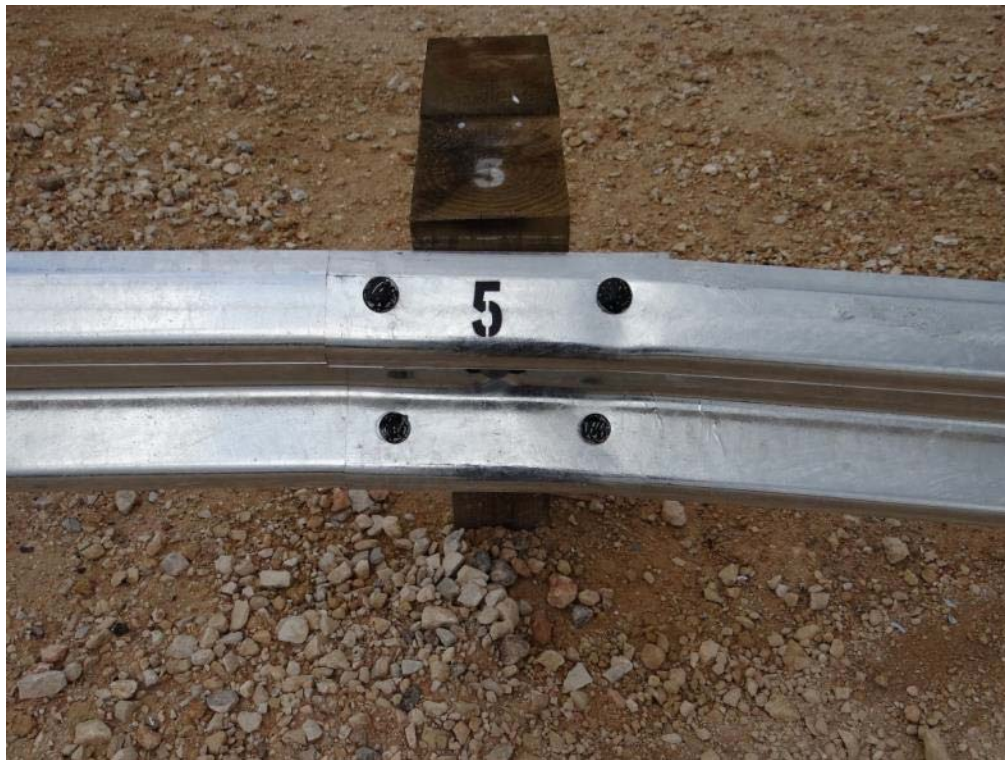
**Figure 3.17: Post-Test – Traffic Side View of Splice at Post 5**

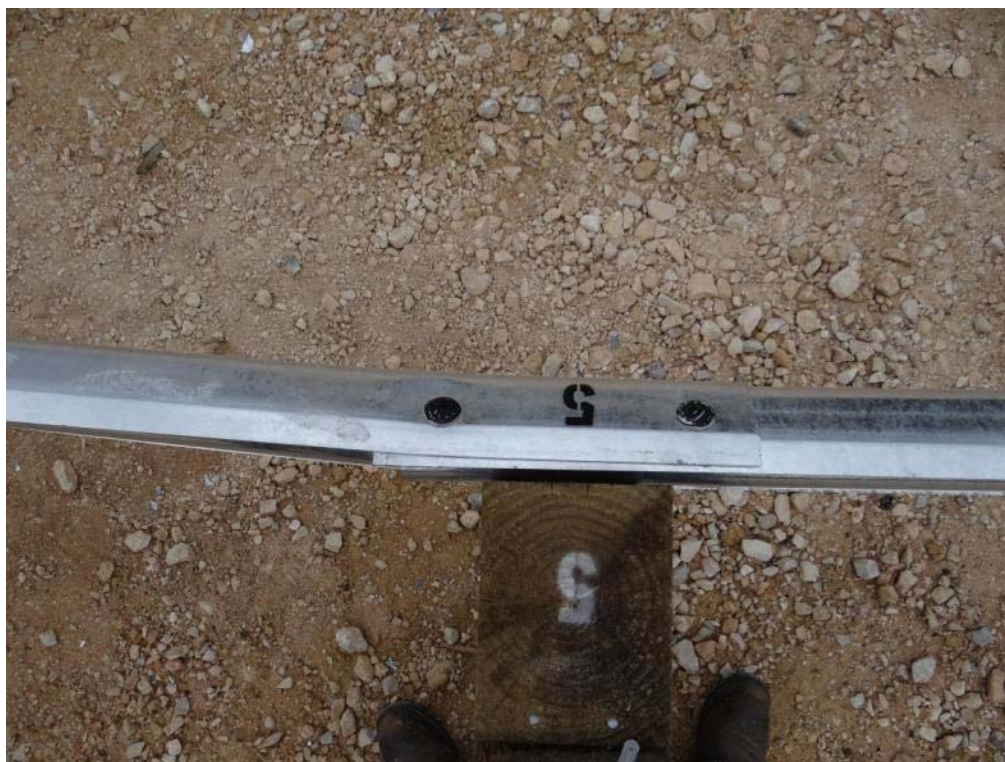
**Figure 3.18: Post Test – Top View of Post 5**

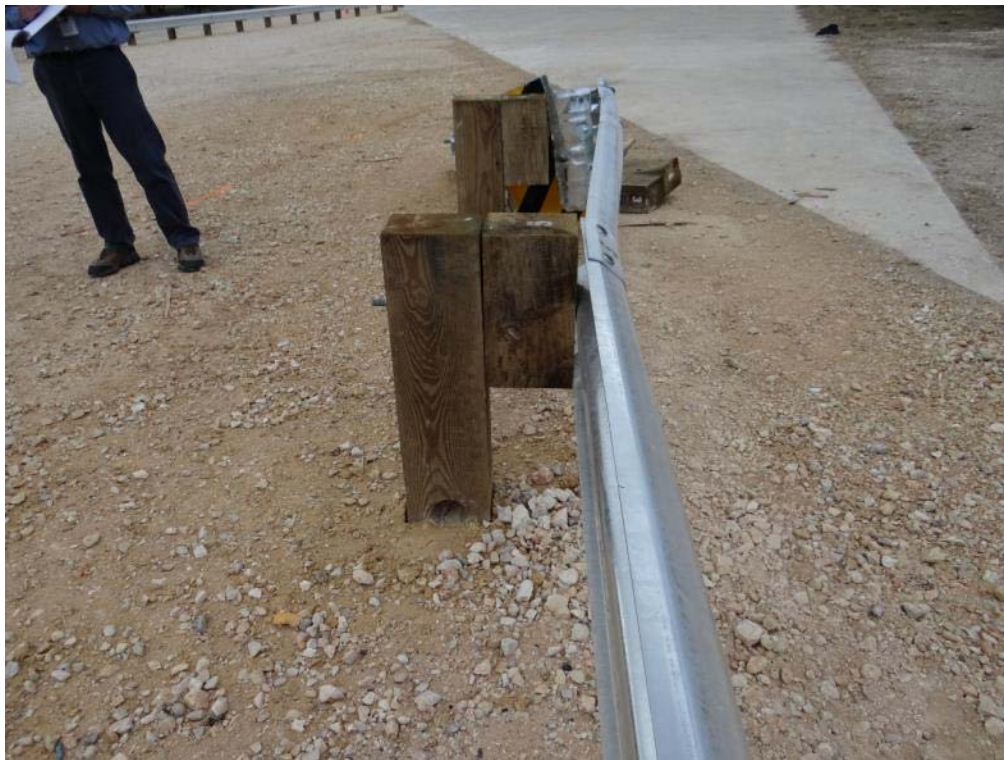
**Figure 3.19: Post Test – Downstream View of Post 5**

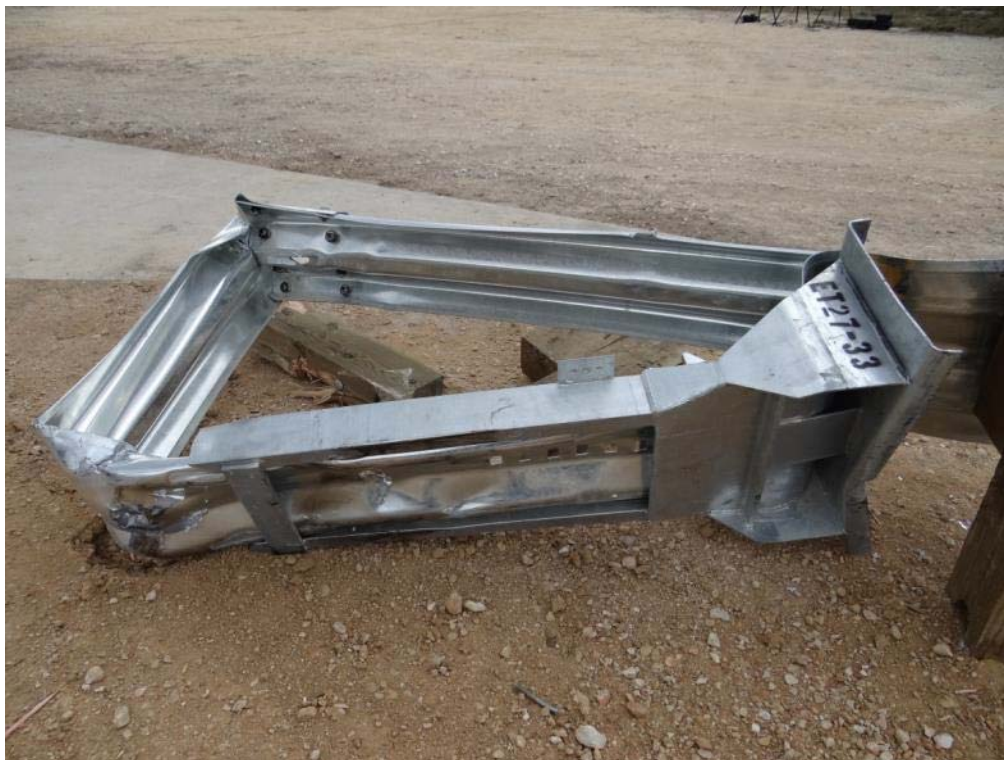
**Figure 3.20: Post Test – Gated Guardrail**

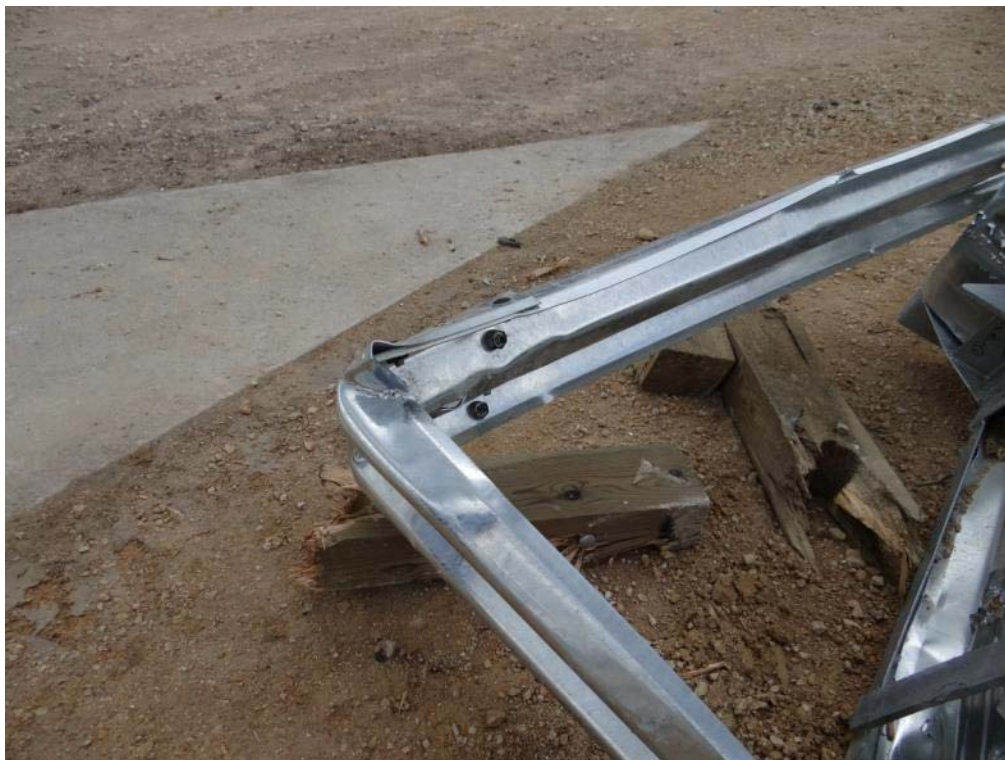
**Figure 3.22: Post Test – First Splice at Post 3 from Non-Traffic Side**

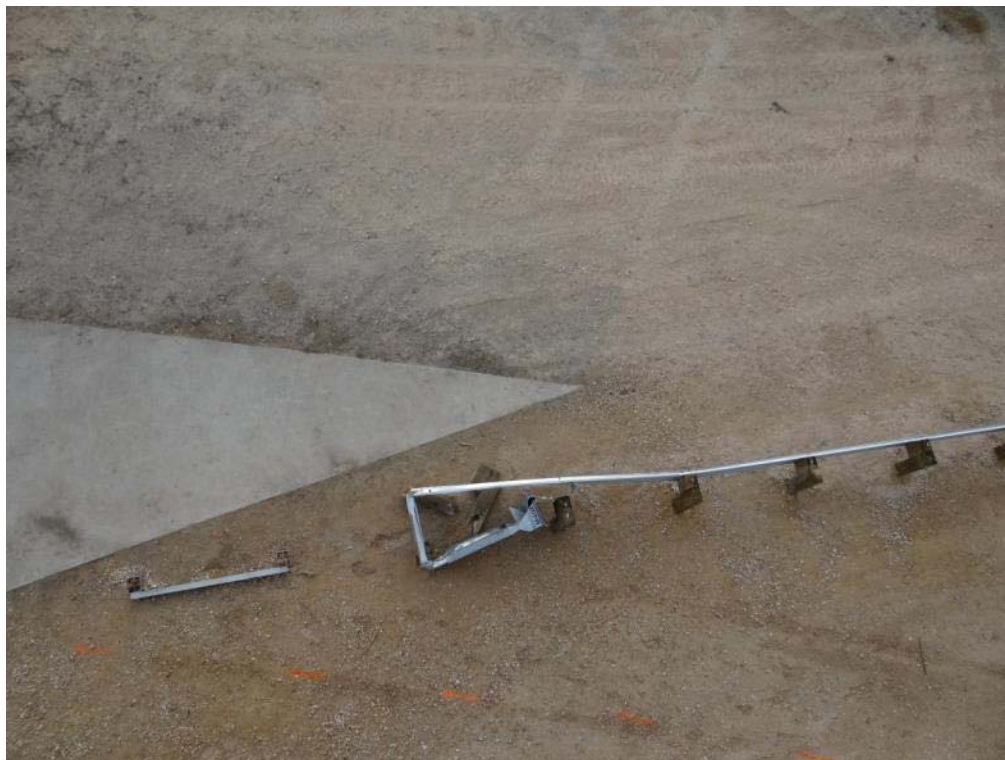
**Figure 3.24: Post Test – Overhead View**

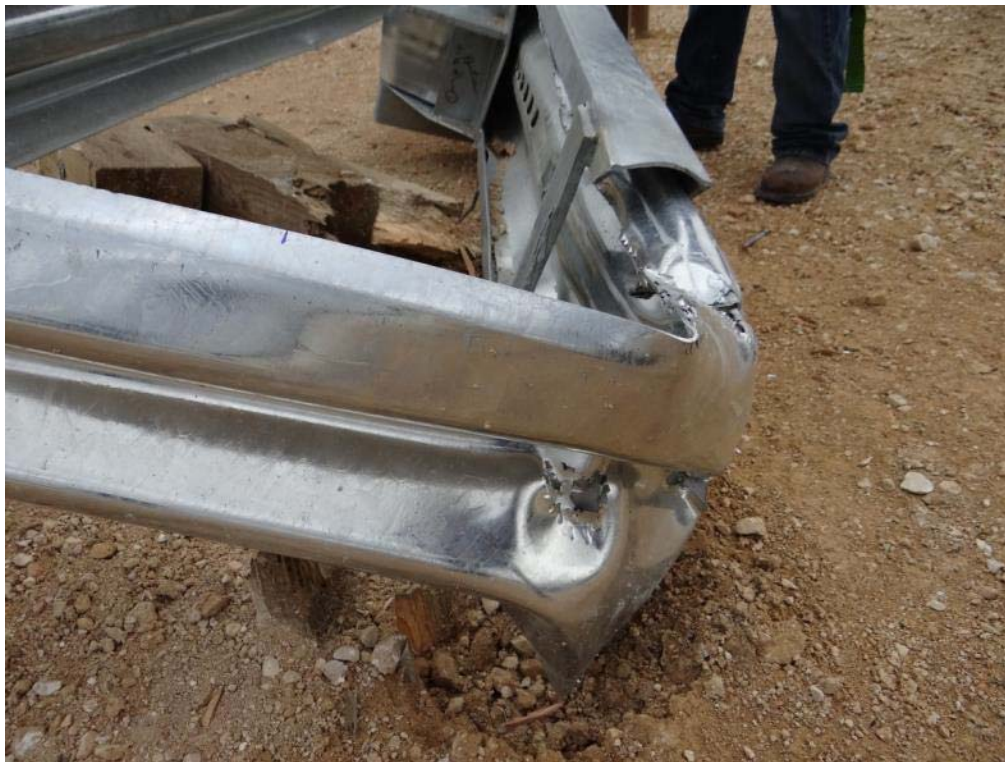
**Figure 3.26: Post Test – ET Plus Head Guide Chute Entrance**

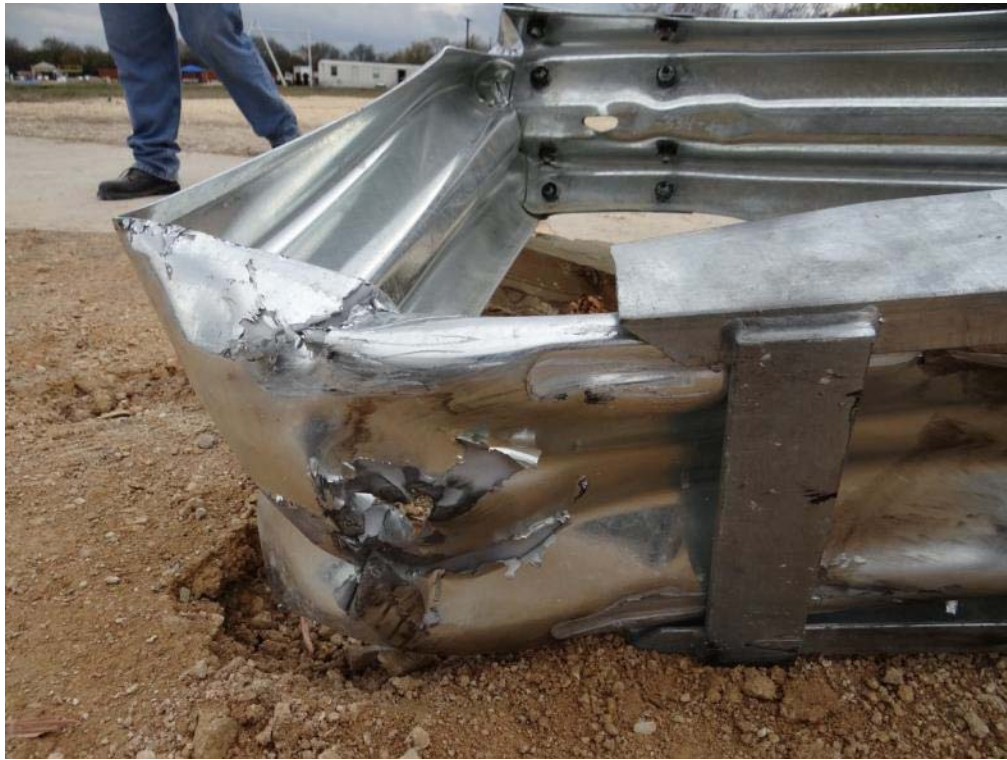
**Figure 3.27: Post Test – Side View of Guide Chute Entrance**

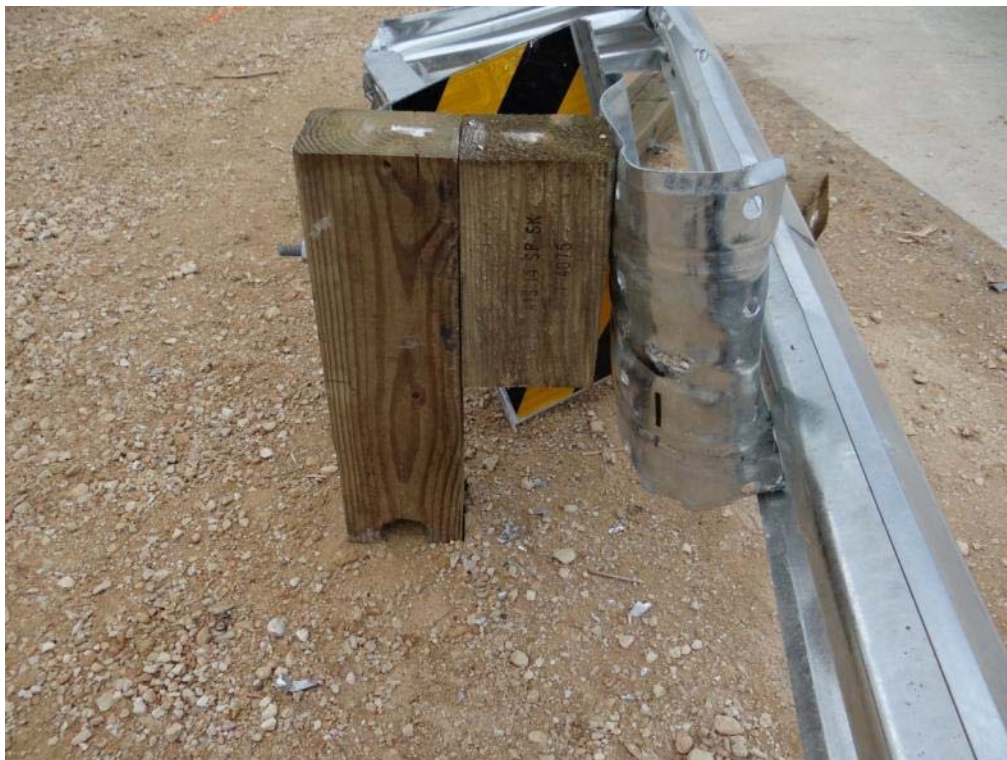
**Figure 3.28: Post Test – Extruded Tail of W beam**

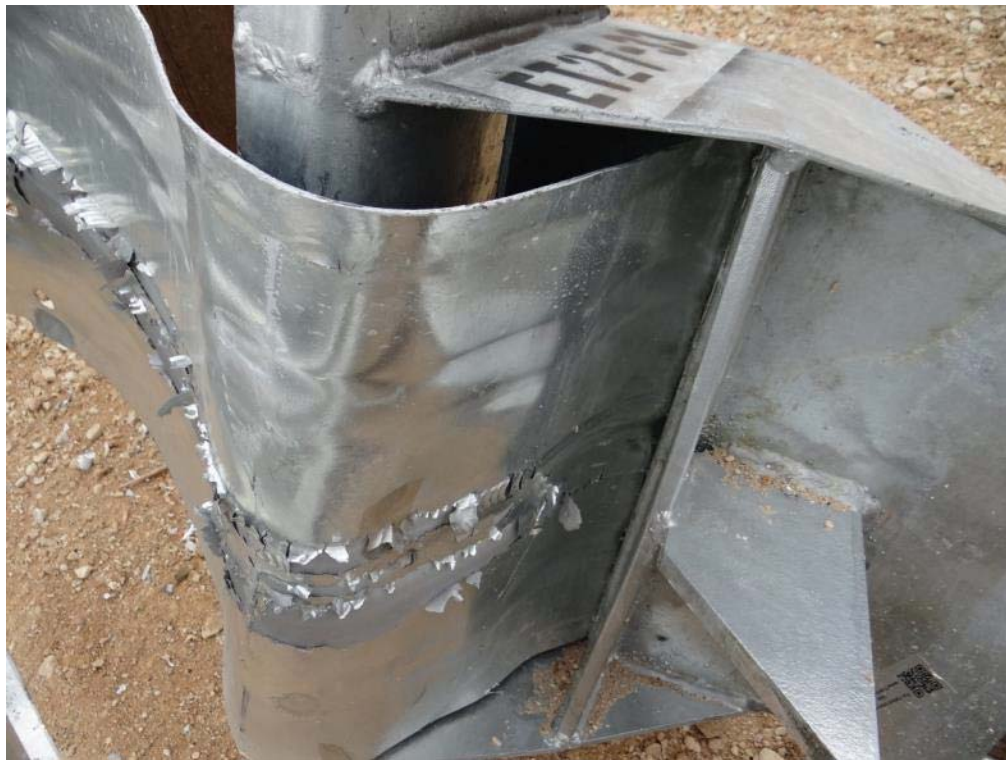
**Figure 3.29: Post Test – Extruded W beam at Exit Chute**

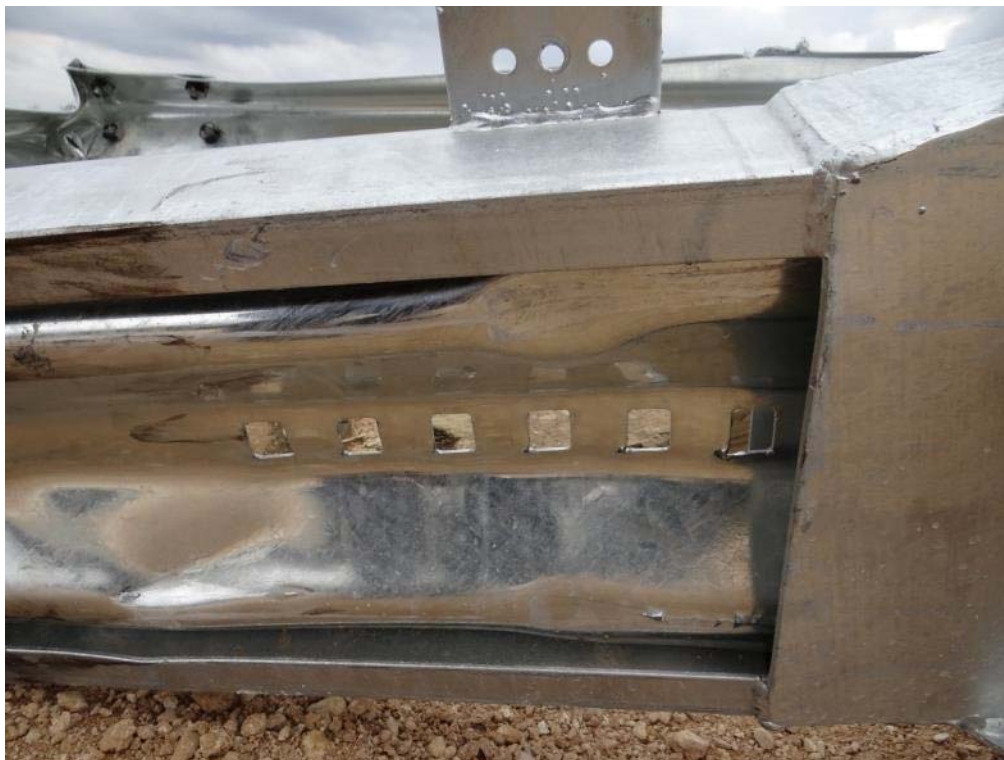
**Figure 3.32: Post Test – ET Plus Head Guide Chute Exit, Traffic Side**

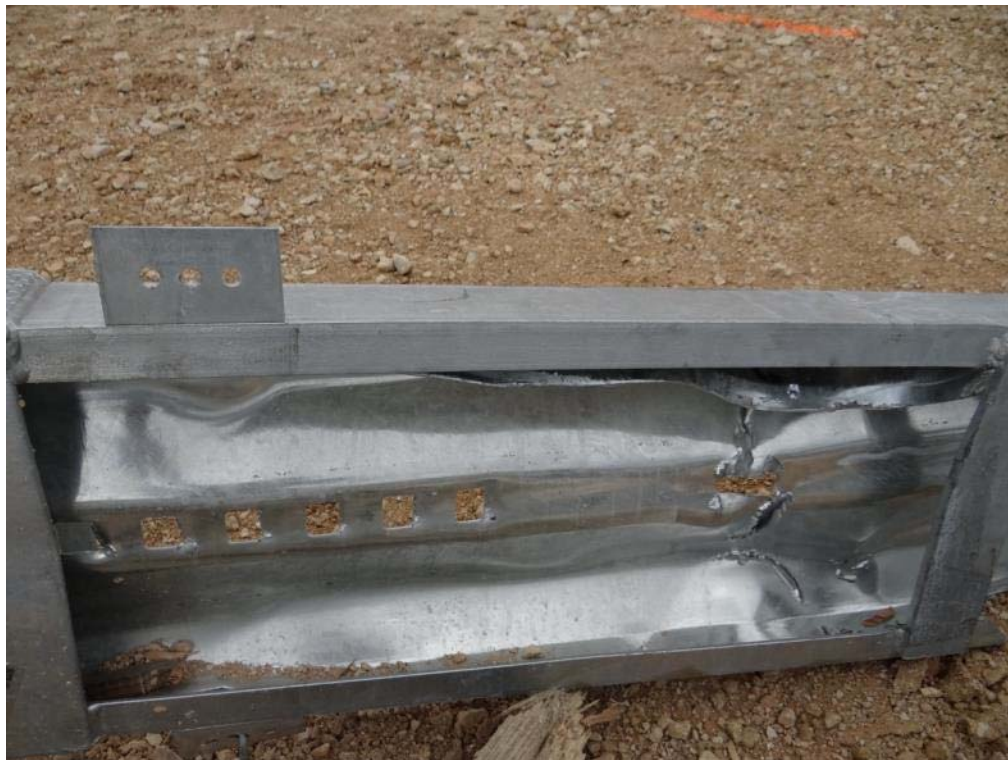
**Figure 3.35: Post Test – ET Plus Head Guide Channel, Non-Traffic Side**

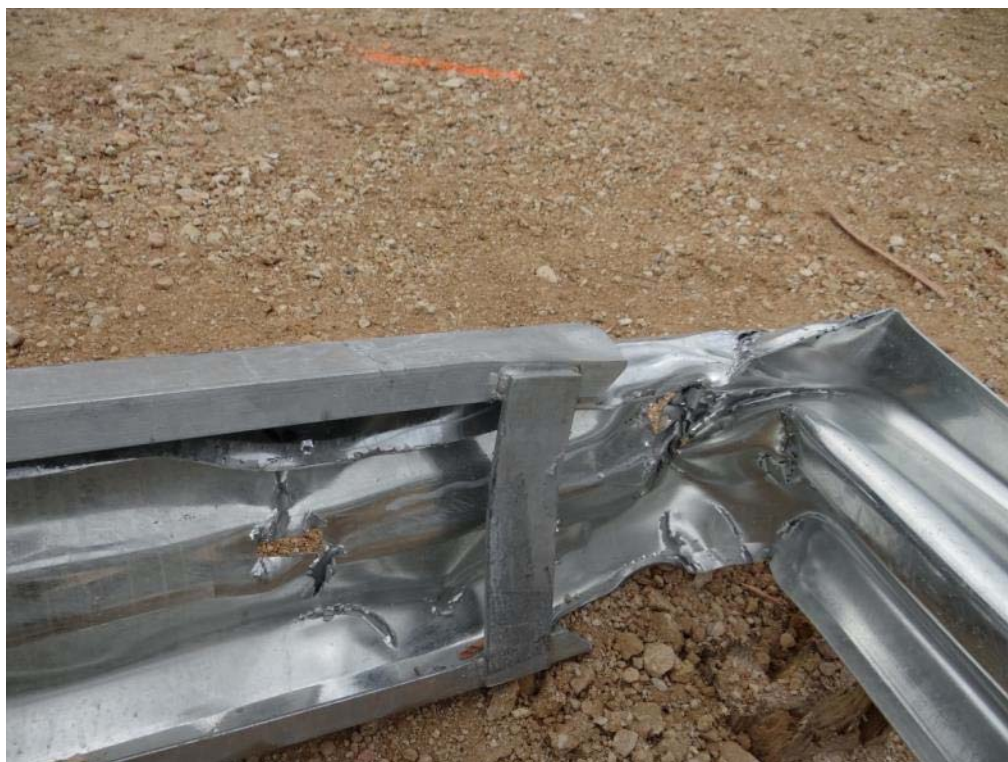
**Figure 3.36: Post Test – ET Plus Head Guide Chute Entrance, Non-Traffic Side**

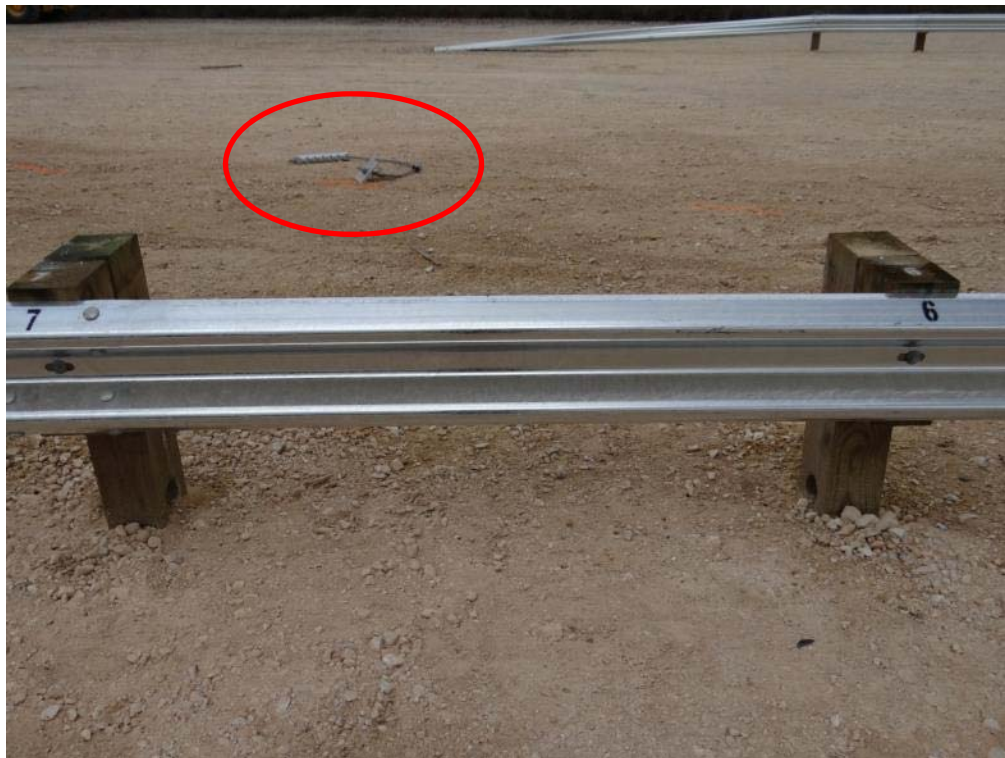
**Figure 3.37: Post-Test Location of Anchor Cable**

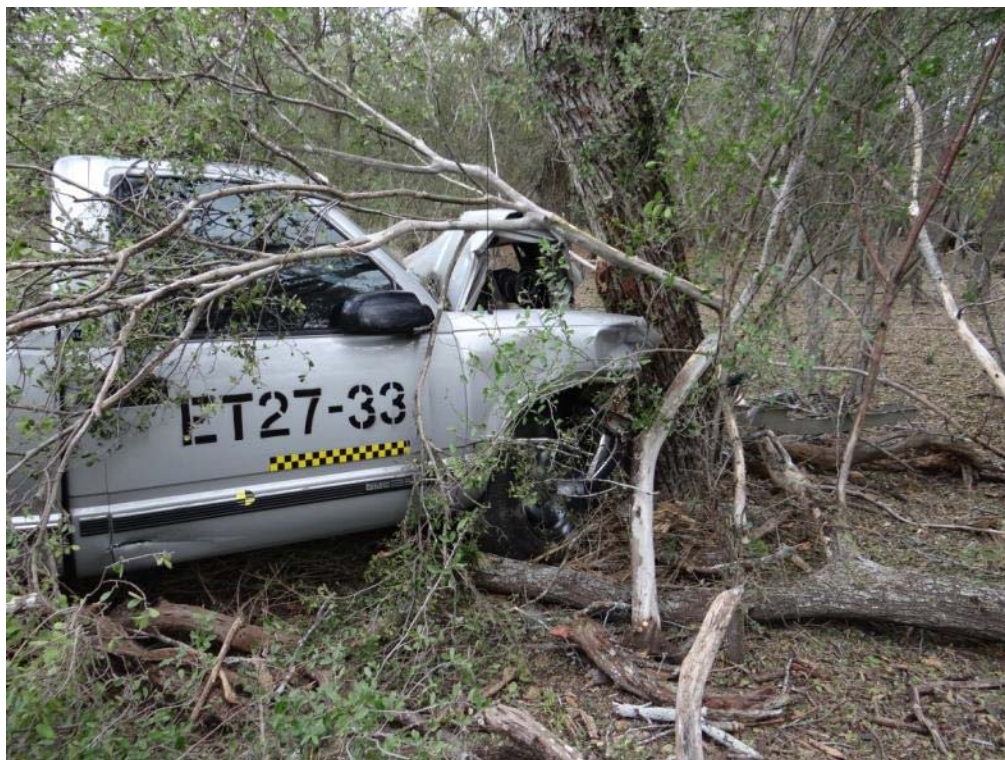
**Figure 3.43: Test Vehicle Impacted Tree**

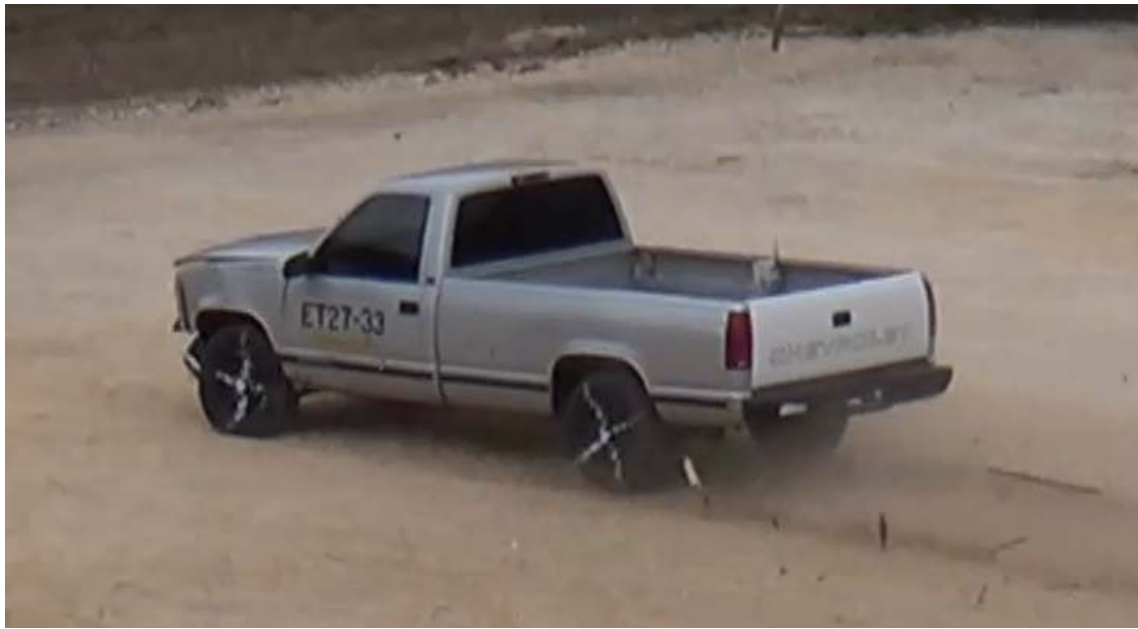
**Figure 3.45: Left Side of Vehicle Following ET Plus Impact**

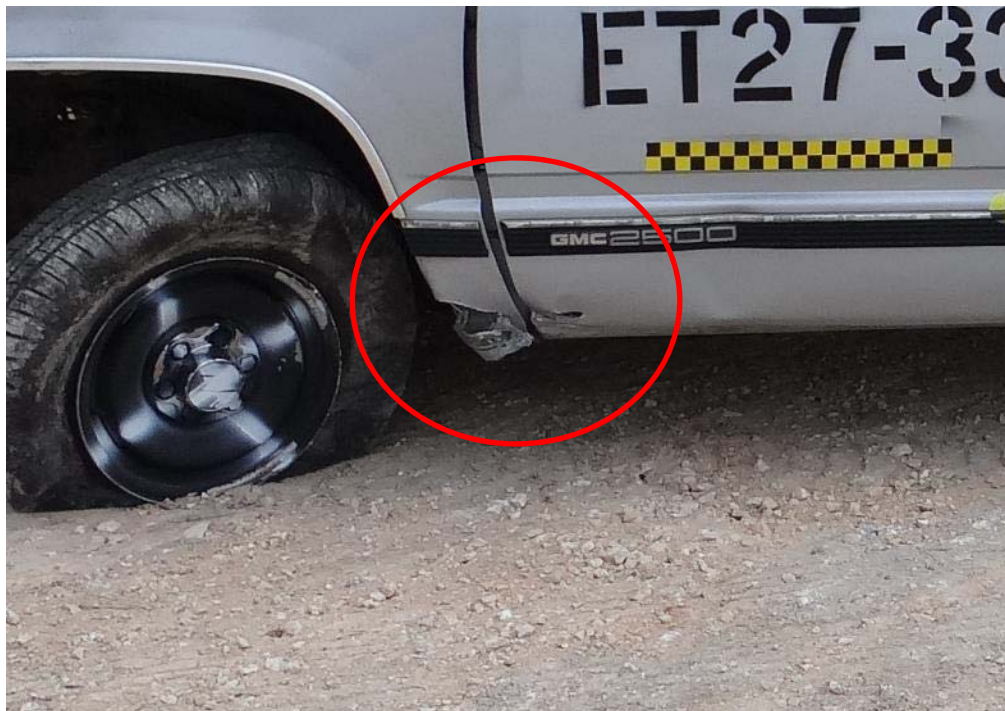
**Figure 3.47: Left Side Damage – Close-up**

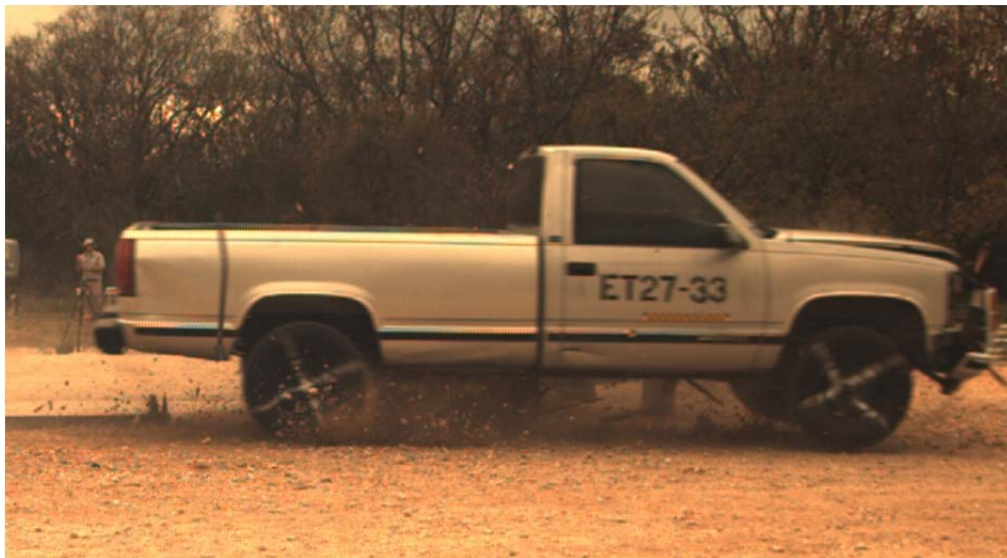
**Figure 3.50: Right Side of Vehicle Following ET Plus Impact**

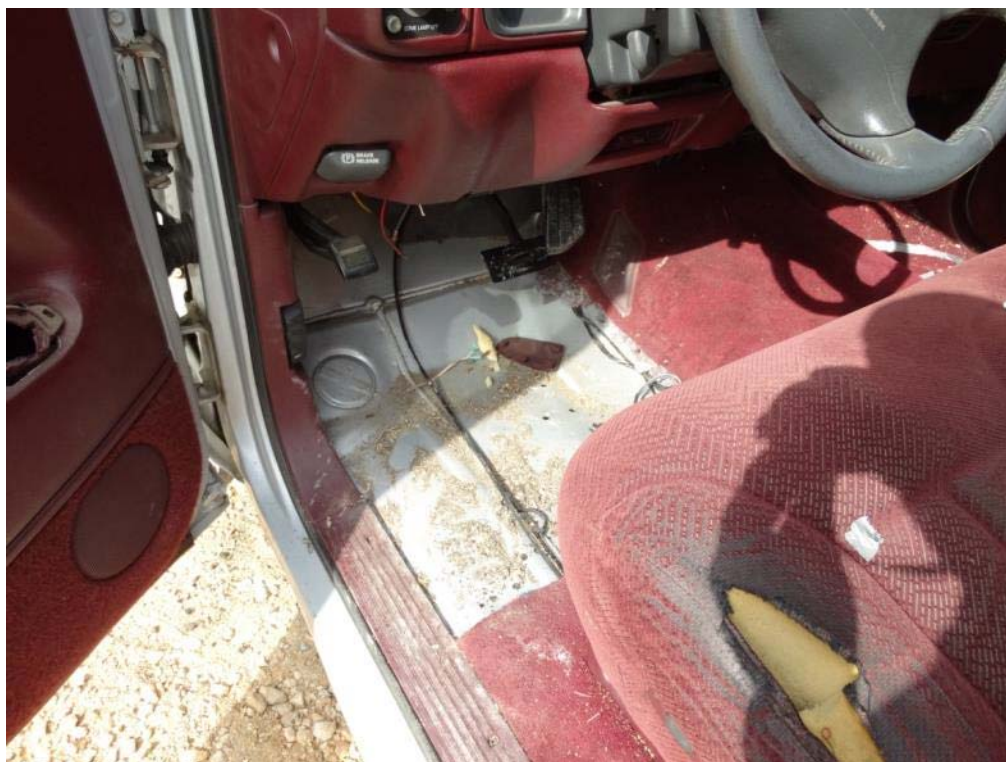
**Figure 3.54: Post-Test – Driver Side Floorboard**

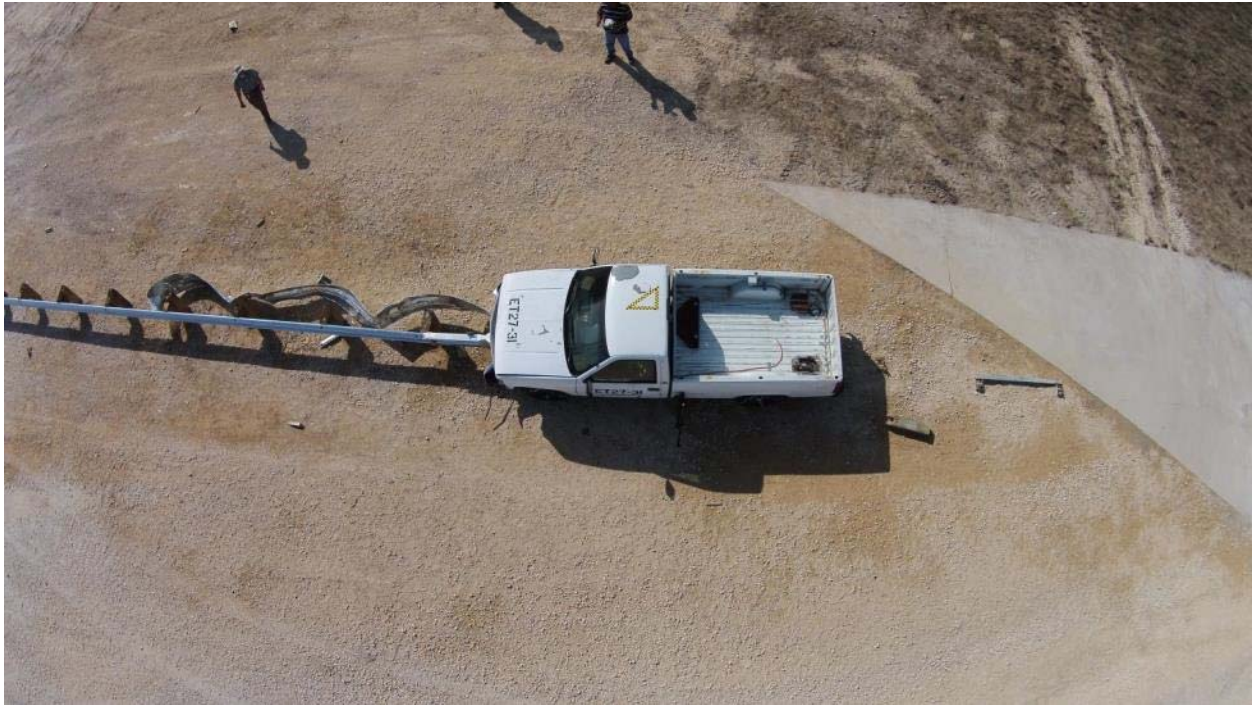
**Figure 3.6: Post-Impact Condition of the Test Article and Vehicle**

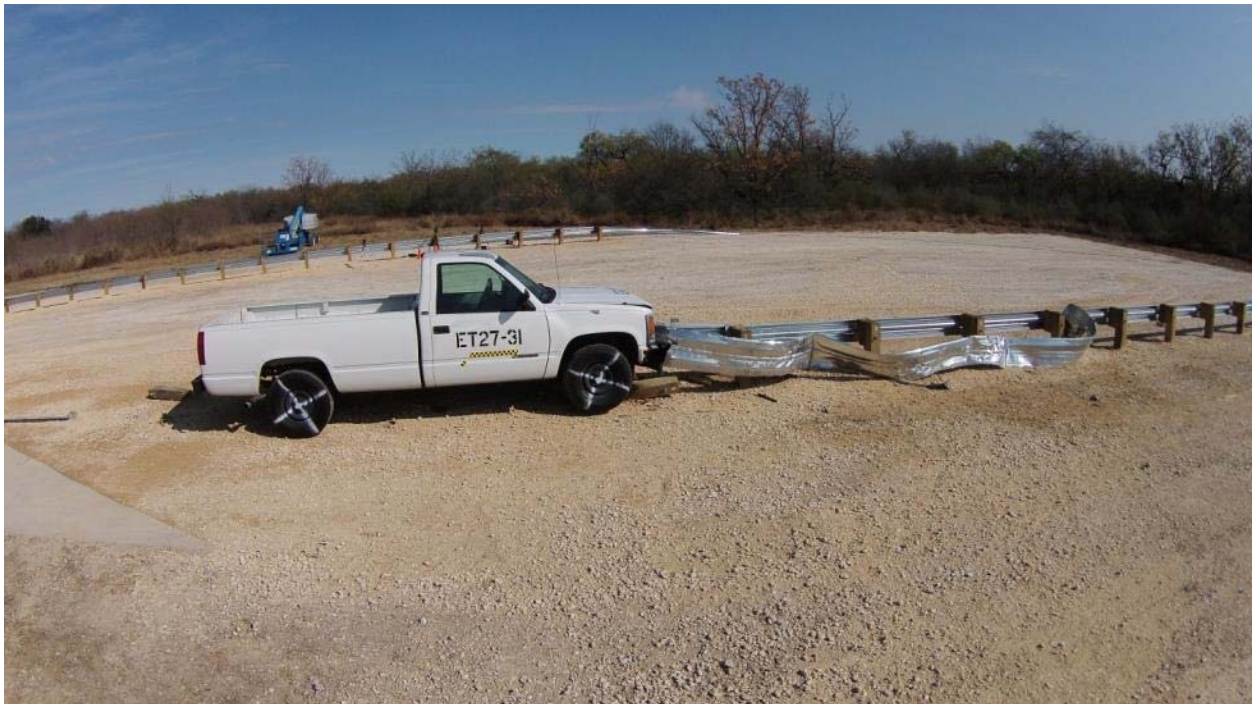
**Figure 3.7: Post-Impact Condition of the Test Article and Vehicle**

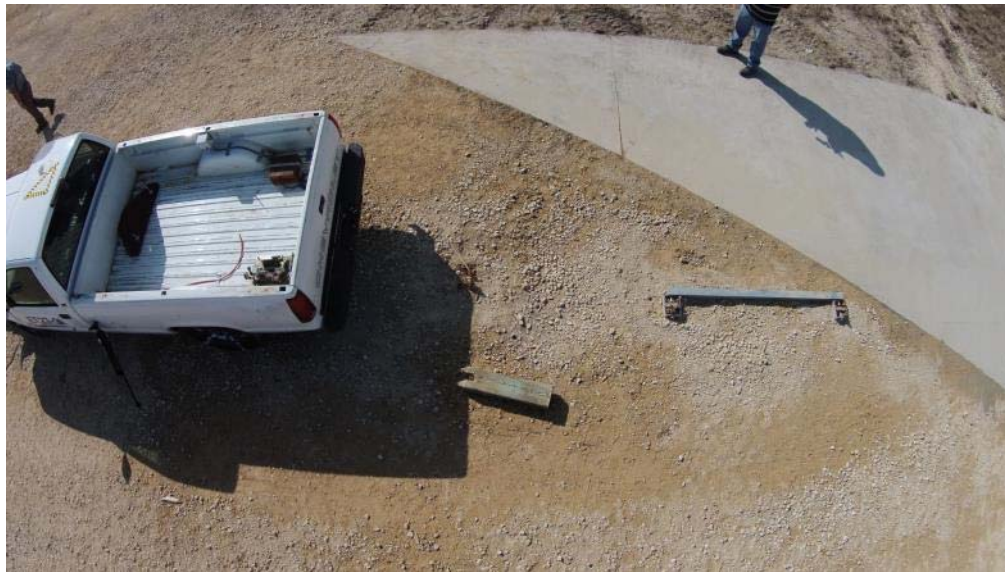
**Figure 3.8: Post Test – Post 1 and 2 Foundation Sleeves and Strut**
