# NCHRP Report 350 Test Report Compilation

## Full-Scale Crash Evaluations of the ET Plus<sup>®</sup> End Terminal with 4-inch Wide Guide Channel Installed with a Rail Height of 27¾ Inches

Tests: ET27-33, ET27-31, ET27-32 and ET27-30

SwRI<sup>®</sup> Project No. 18.20887

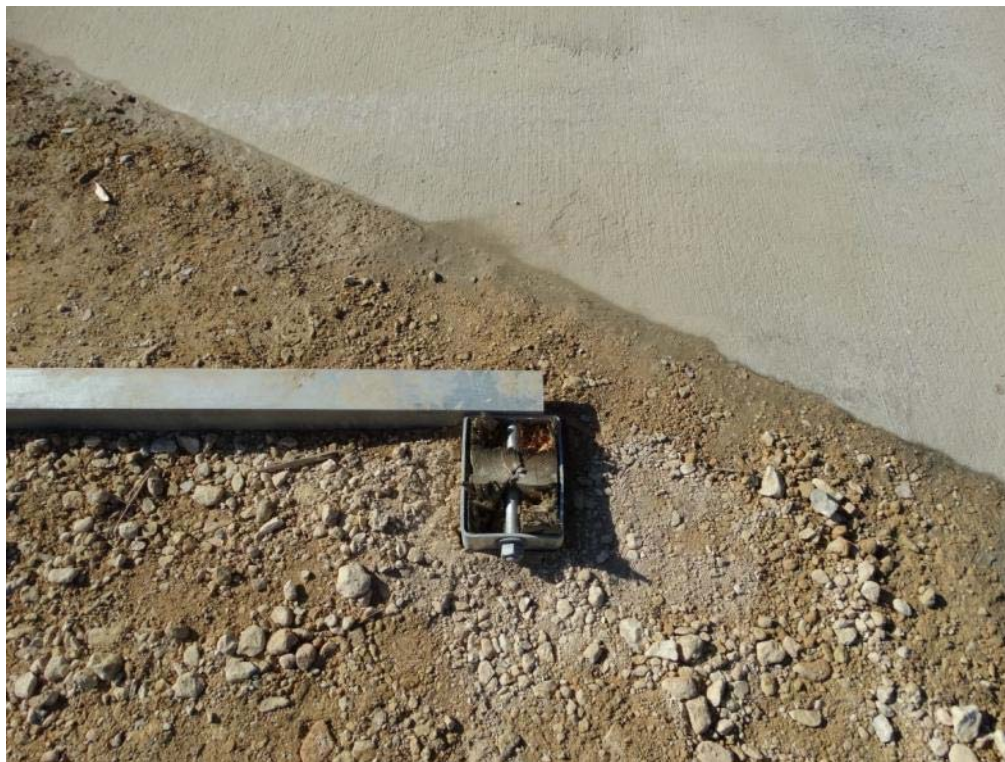
**Figure 3.9: Post Test – Post 1 Foundation Sleeve**

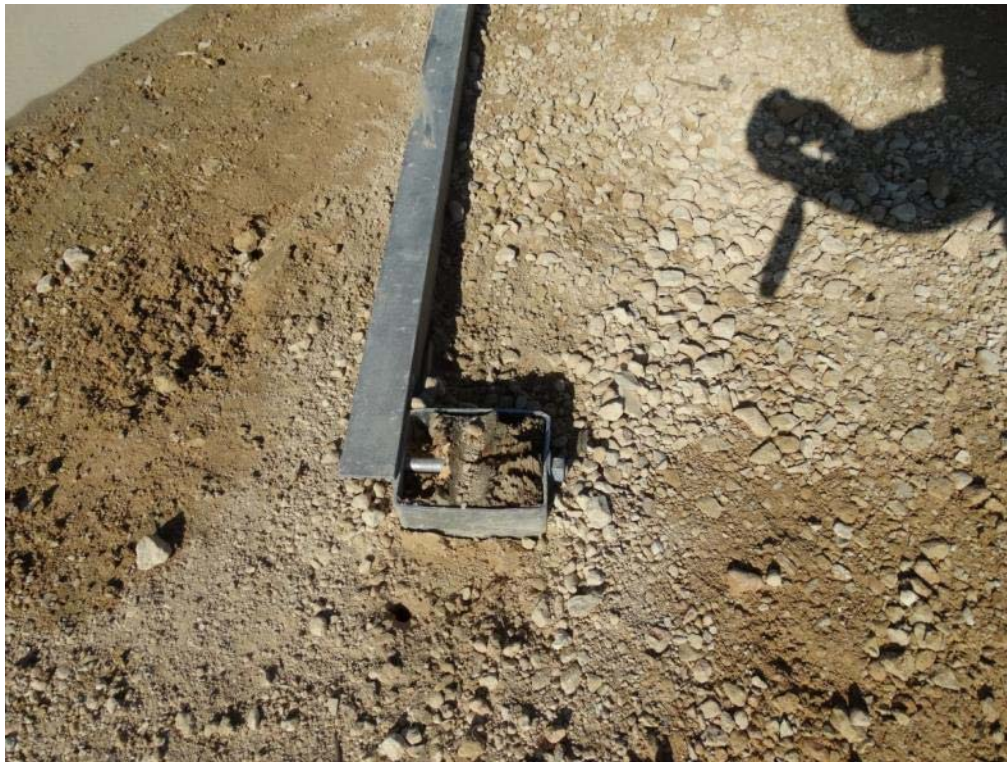
**Figure 3.10: Post Test – Post 2 Foundation Sleeve**

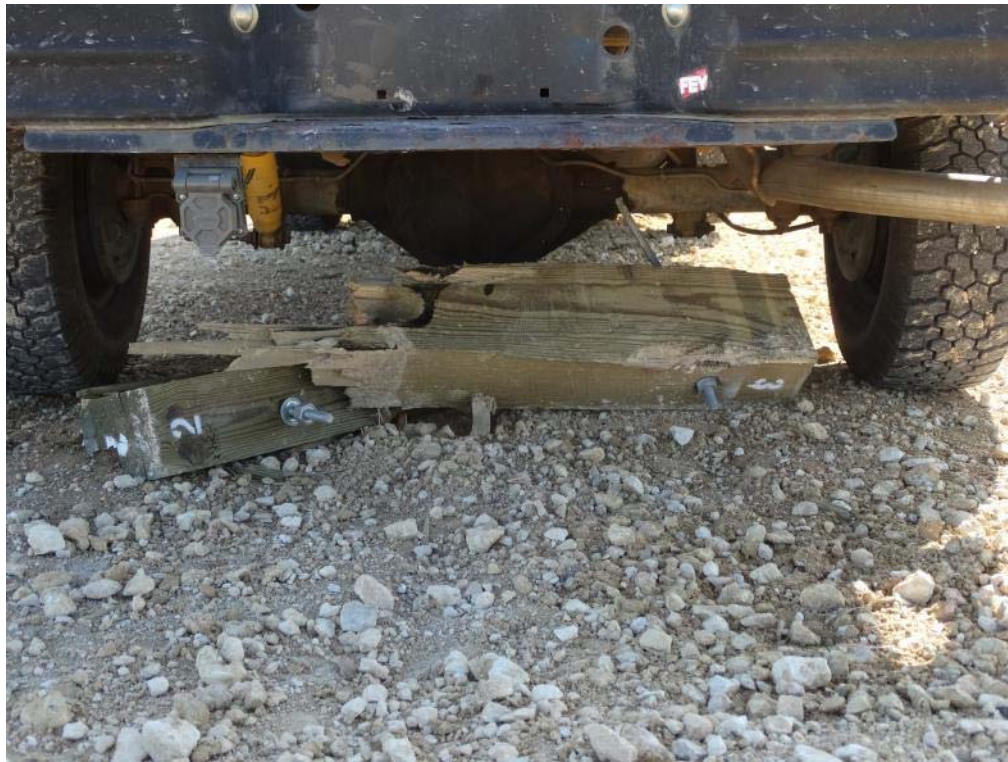
**Figure 3.12: Post Test – Posts 2 and 3 Under Vehicle, Close-up**

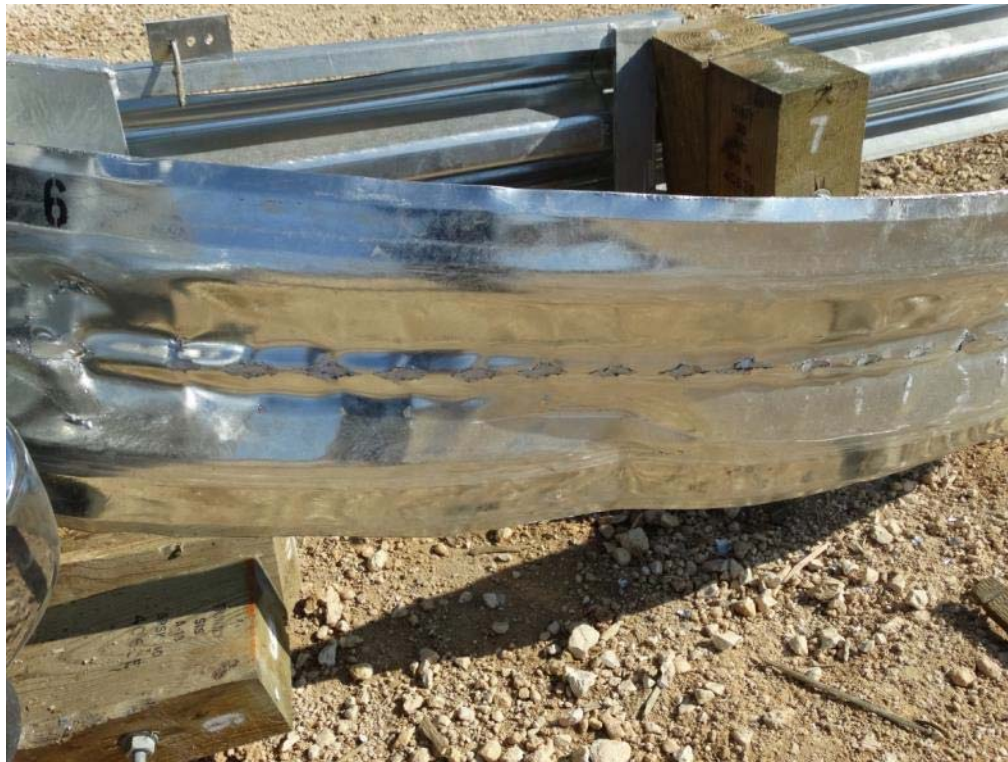
**Figure 3.18: Post Test – Extruder Head at Post 7, Blockout Twisted**

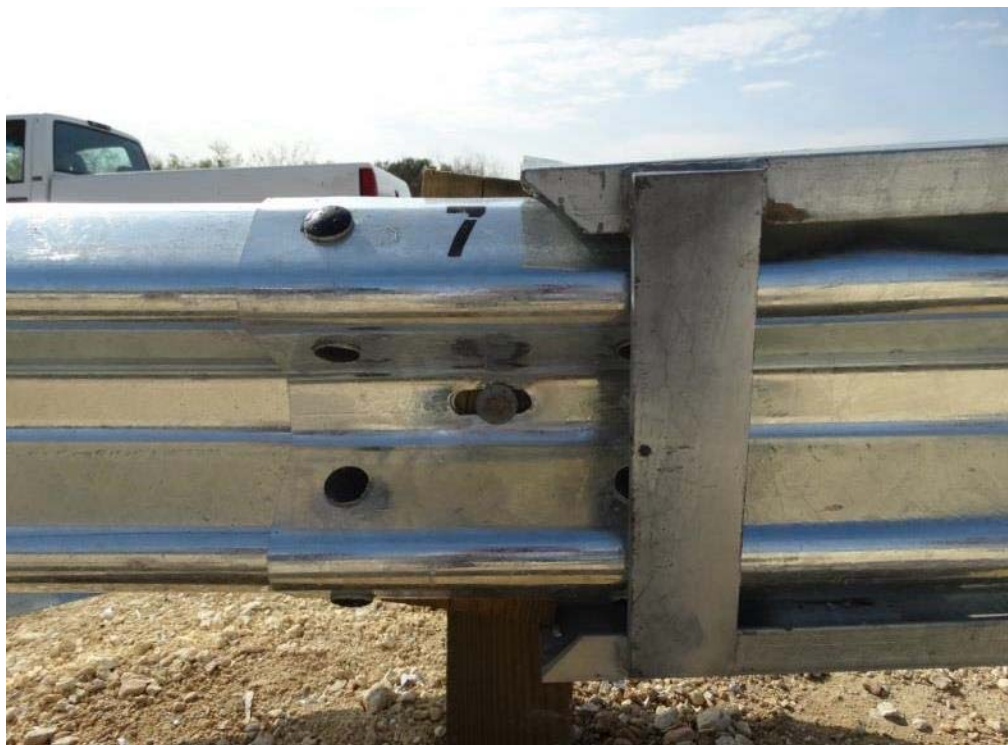
**Figure 3.19: Post Test – Extruder Head at Post 7 (Splice Bolts Painted for Visibility in Video)**

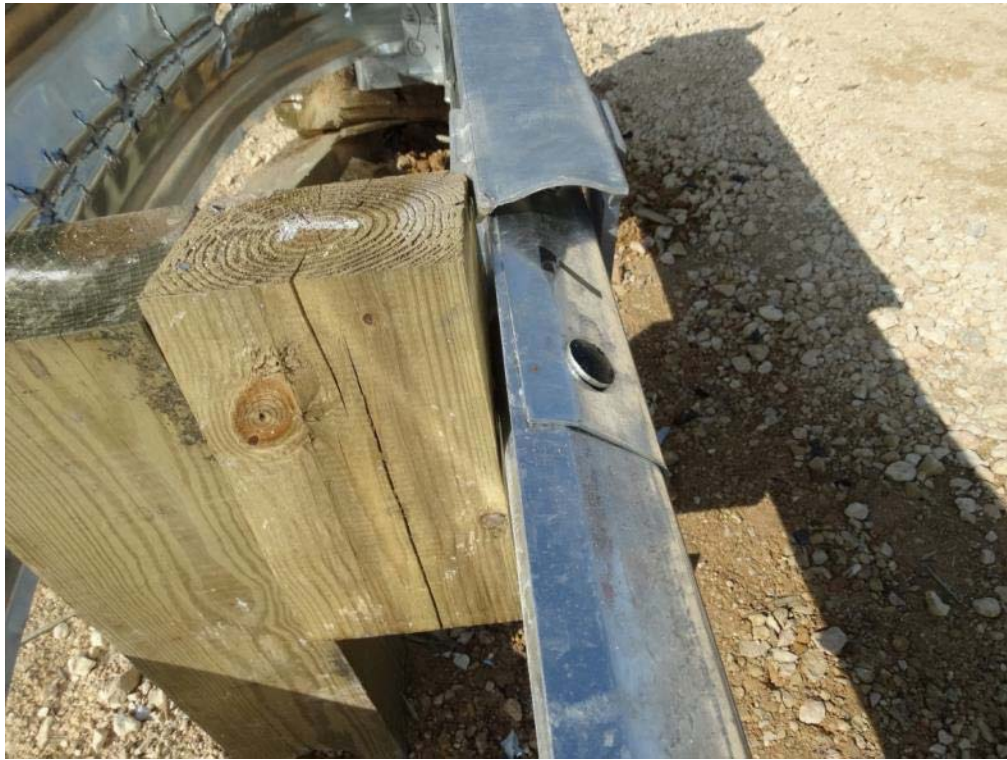
**Figure 3.20: Post Test – Extruder Head at Post 7, Top View**

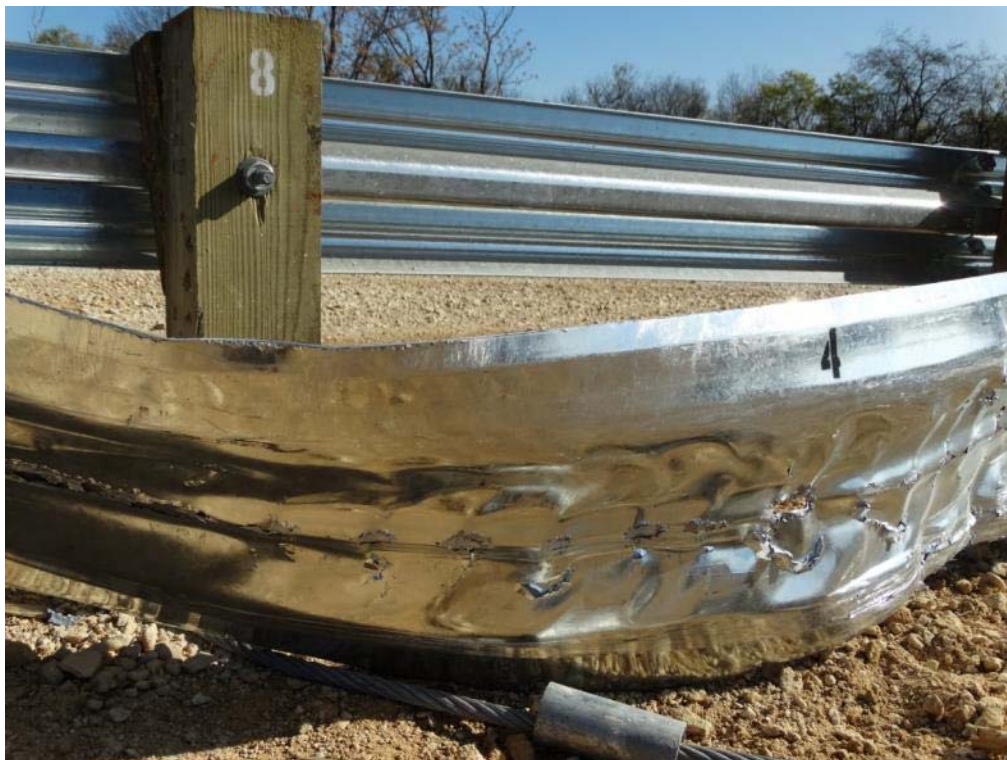
**Figure 3.21: Post Test – Extruded Guardrail**

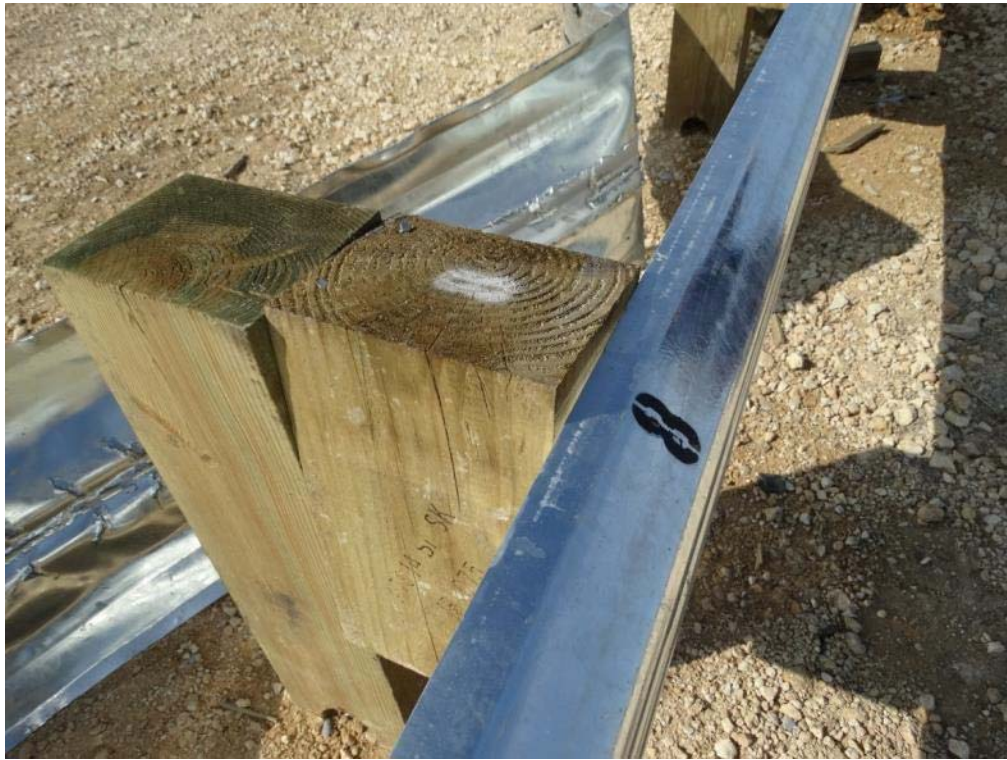
**Figure 3.22: Post Test – Post 8 Blockout Twisted**

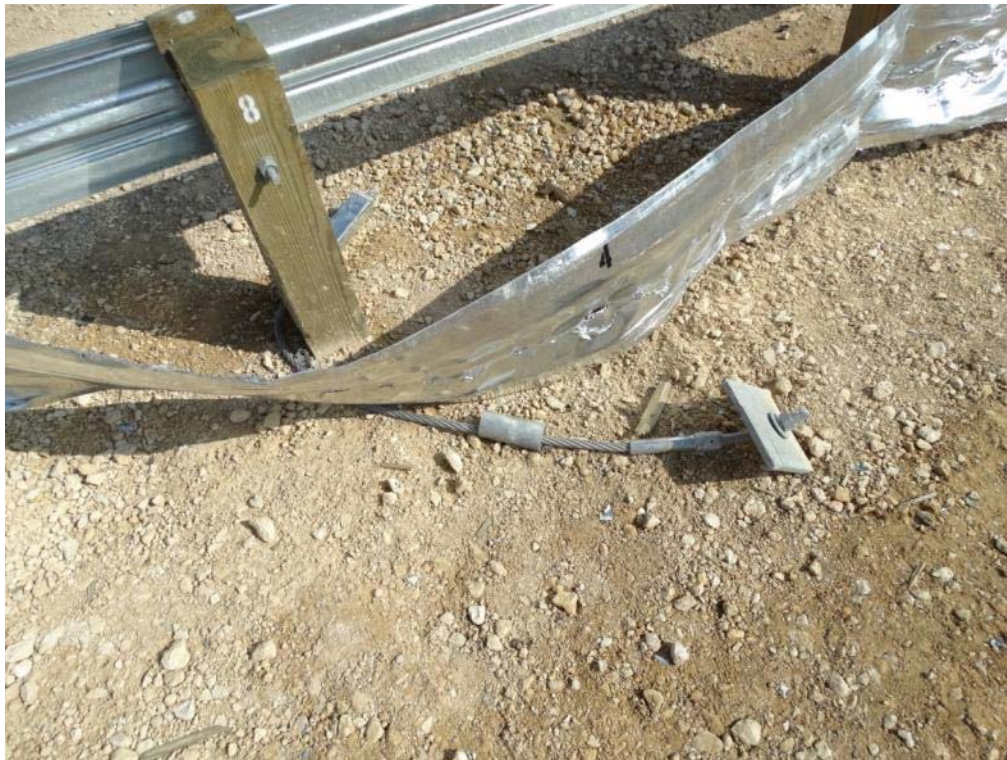
**Figure 3.23: Post Test Location of Anchor Cable**

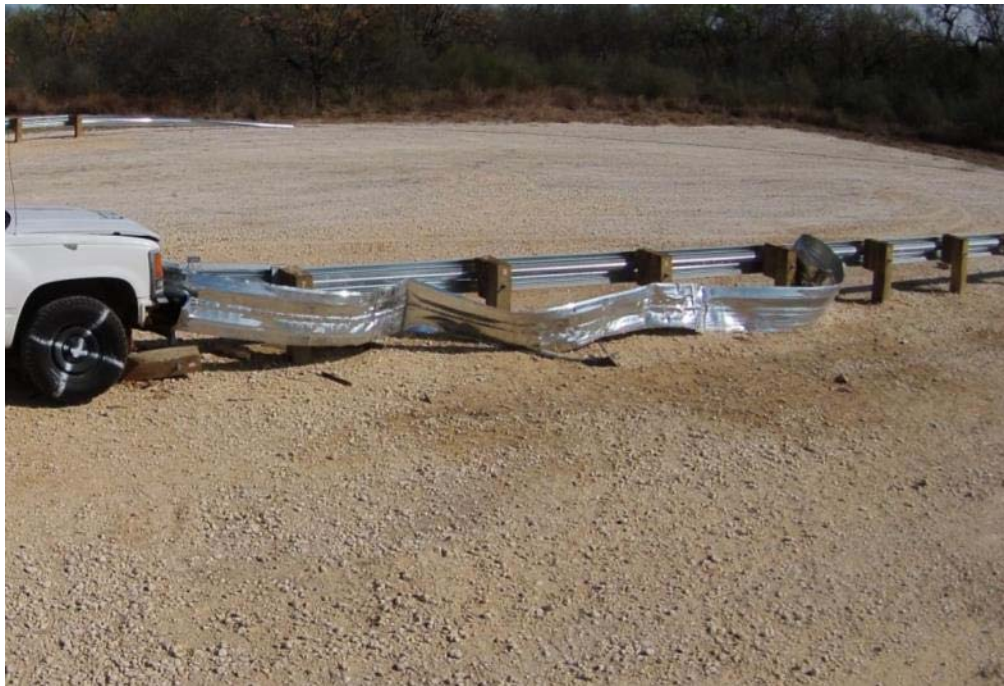
**Figure 3.24: Post Test – Extruded Guardrail**

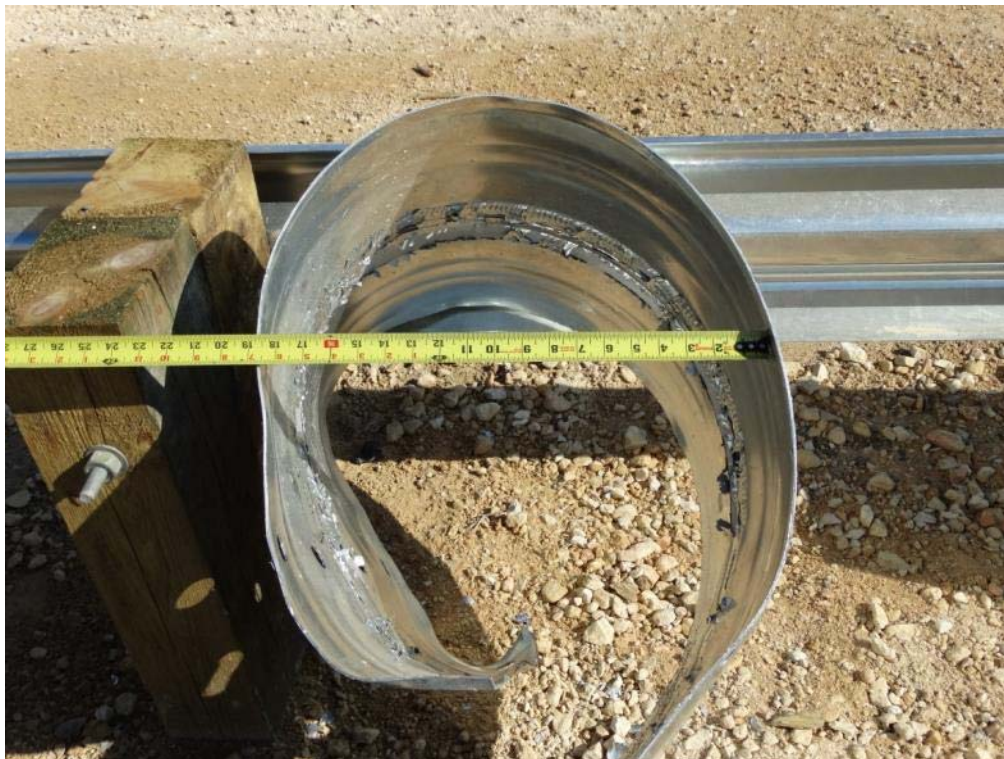
**Figure 3.25: Post Test – Extruded Guardrail Coil**

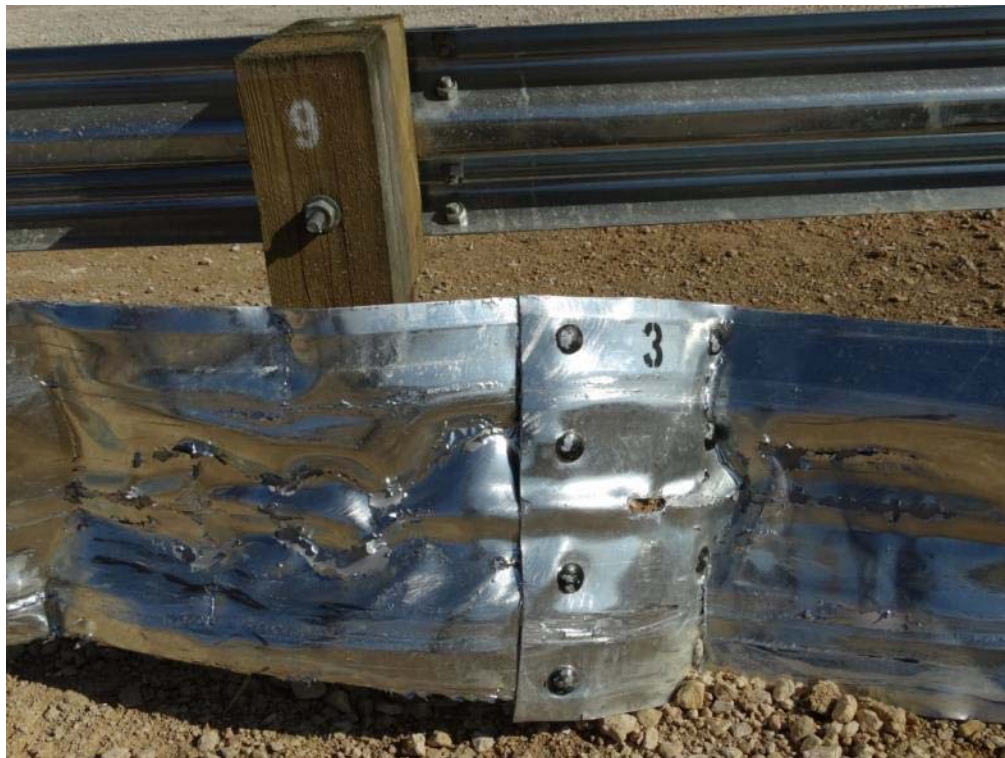
**Figure 3.26: Post Test – Extruded Guardrail Splice from Post 3, Splice Bolts**

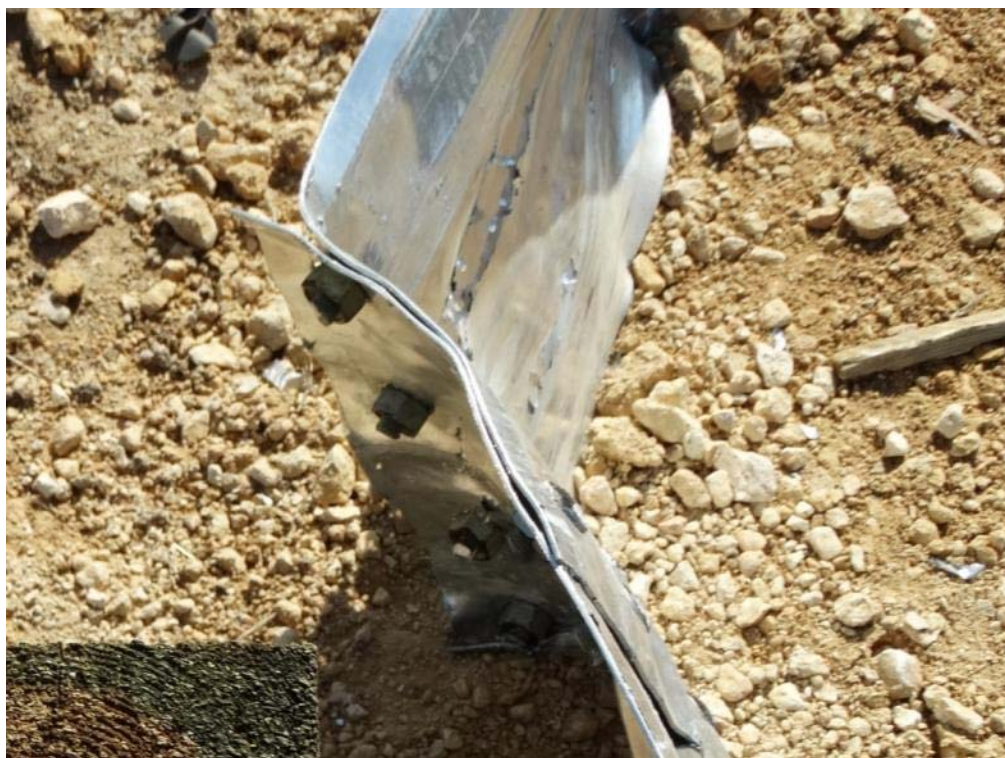
**Figure 3.27: Post Test – Extruded Guardrail Splice from Post 3, Splice Nuts**

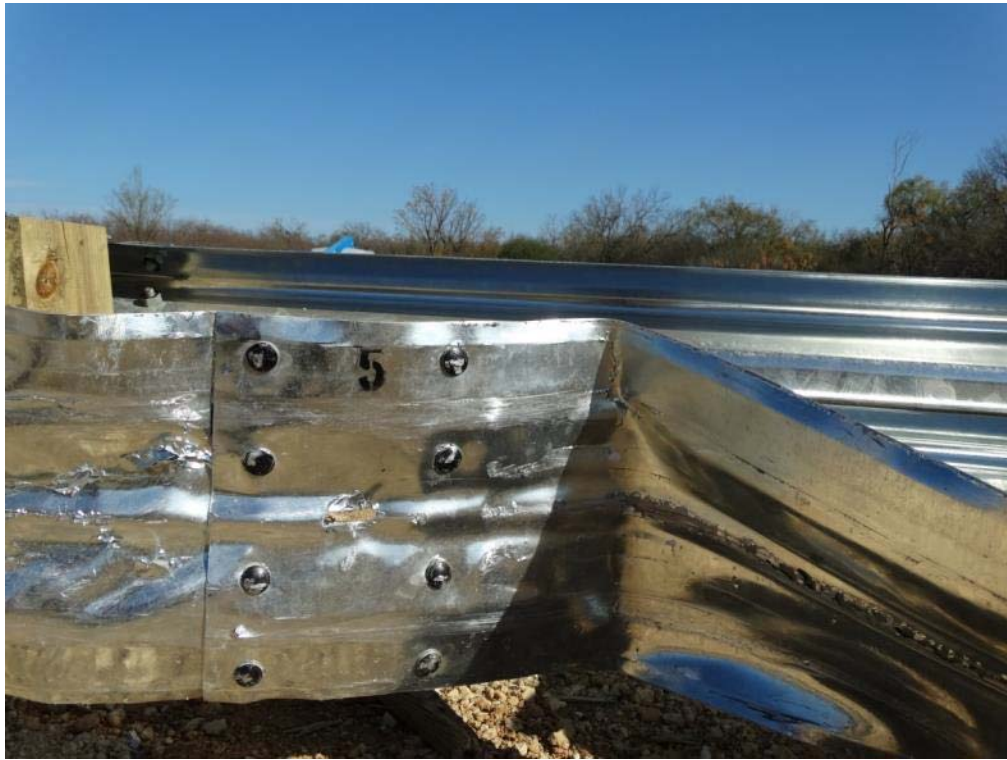
**Figure 3.28: Post Test – Extruded Guardrail Splice from Post 5, Splice Bolts**

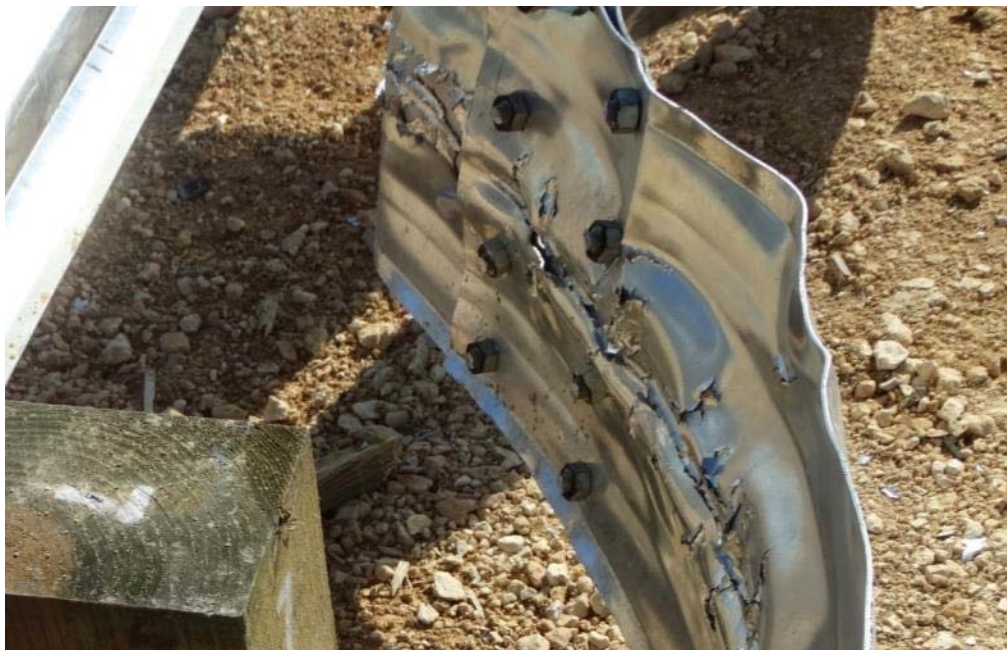
**Figure 3.29: Post Test – Extruded Guardrail Splice from Post 5, Splice Nuts**

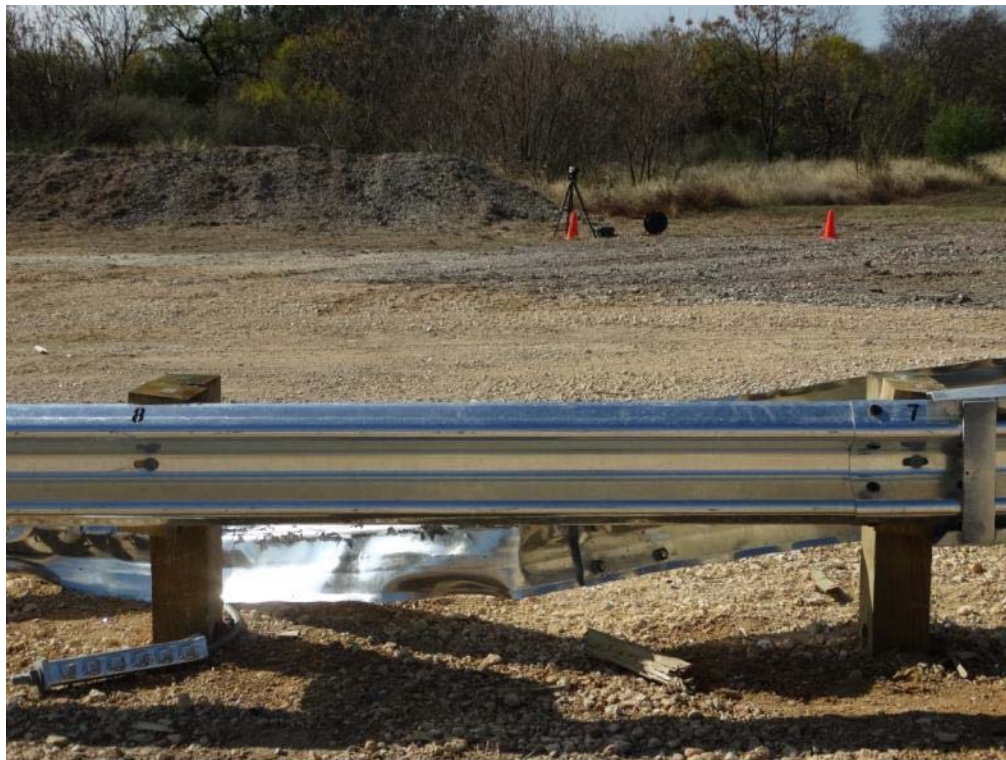
**Figure 3.30: Post Test – Line Posts 7 and 8**

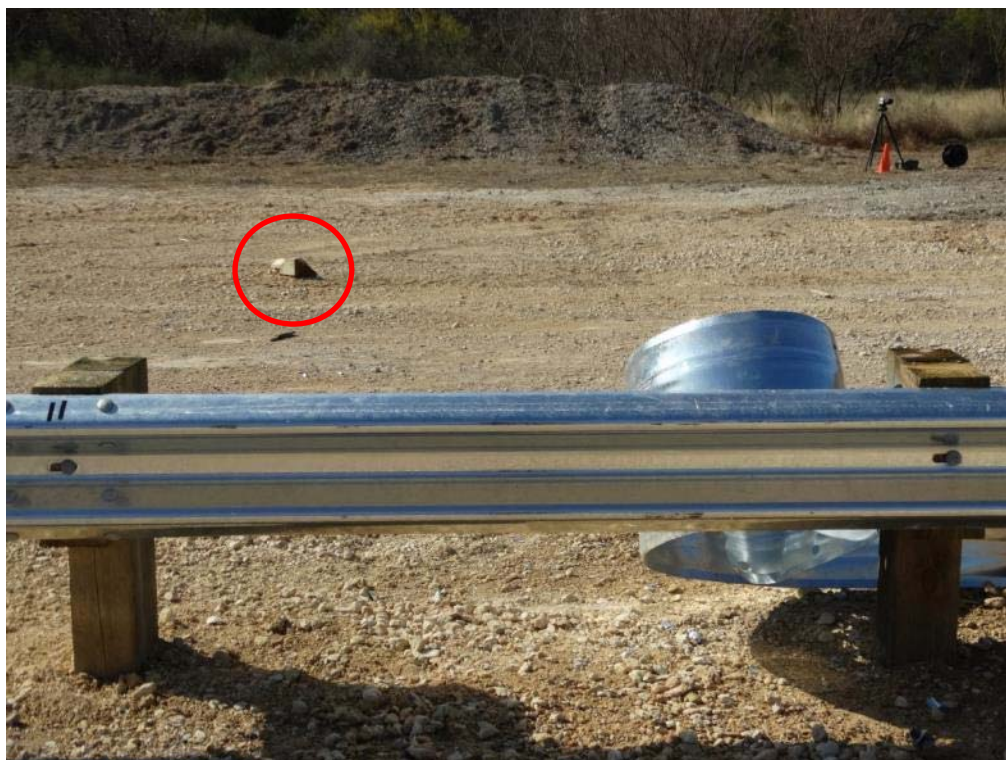
**Figure 3.31: Post Test – Line Posts 10 & 11 and Debris**

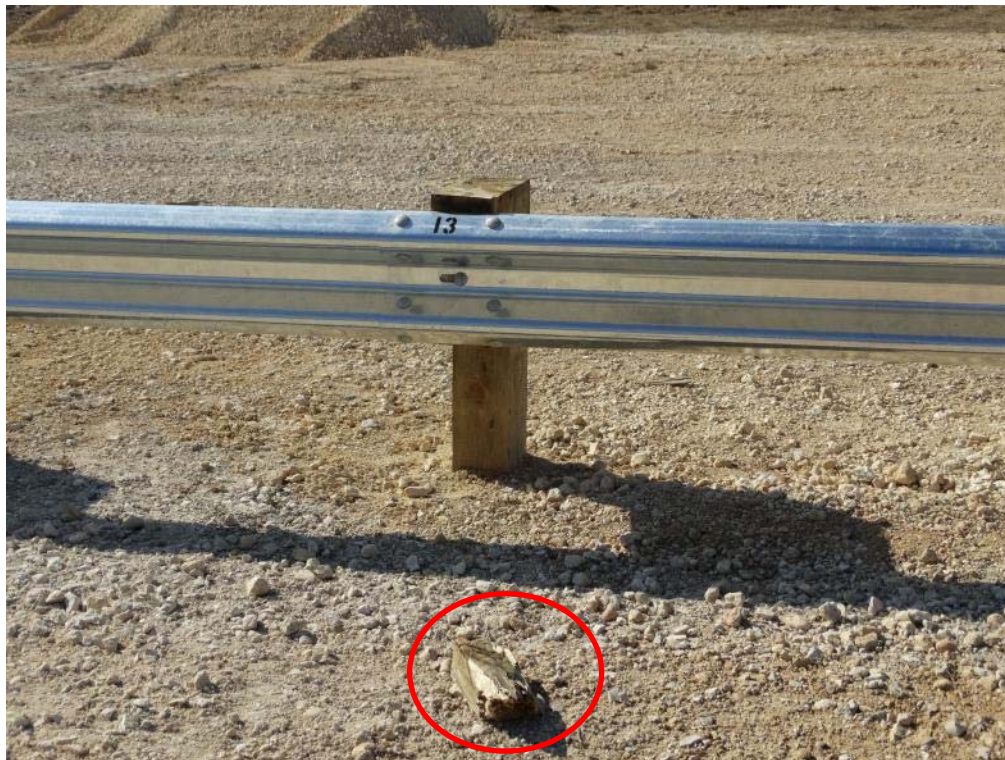
**Figure 3.32: Post Test – Line Post 13 and Traffic-Side Debris**

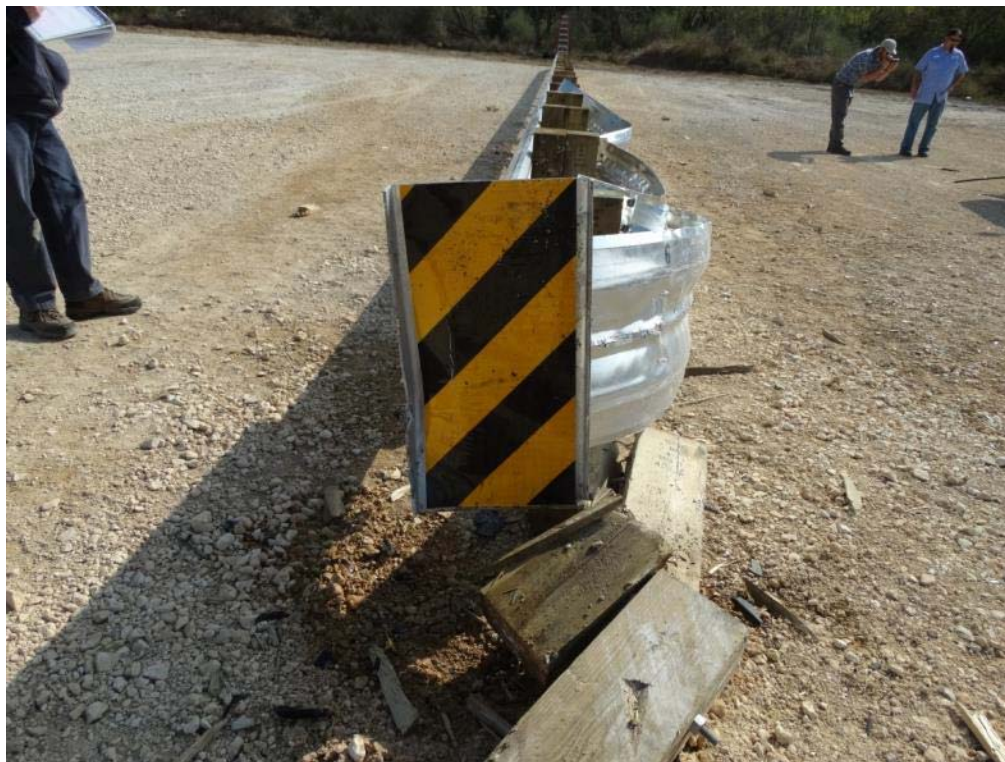
**Figure 3.33: Post-Impact Test Article after Vehicle Removed**

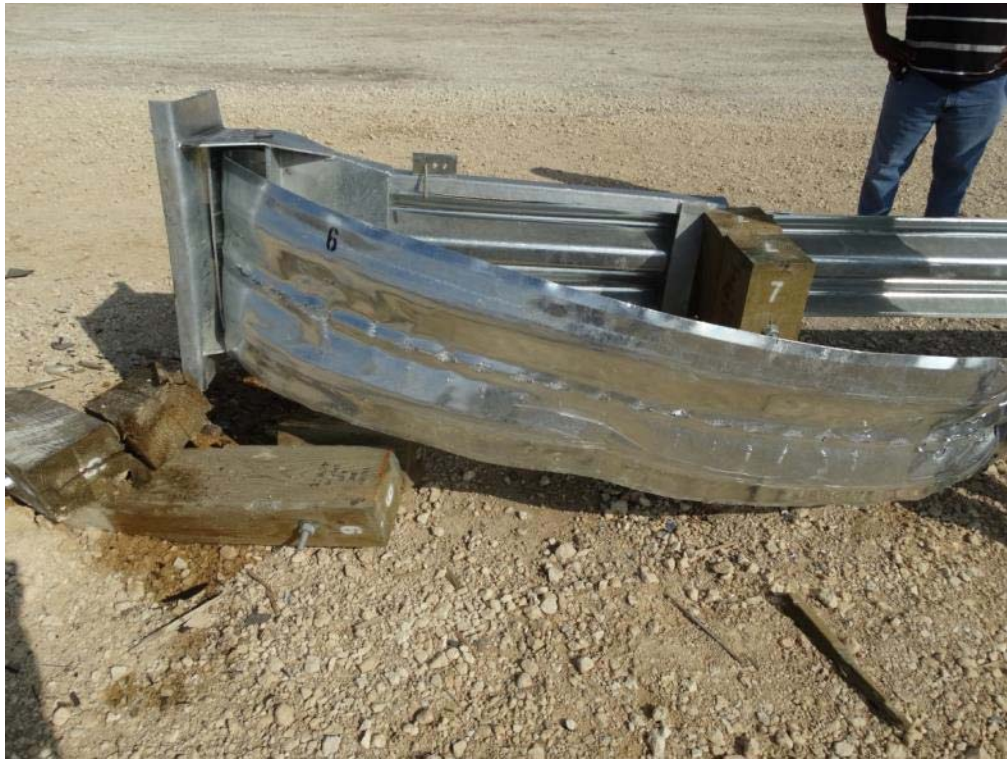
**Figure 3.36: Post-Impact Test Article after Vehicle Removed – Non-Traffic Side View**

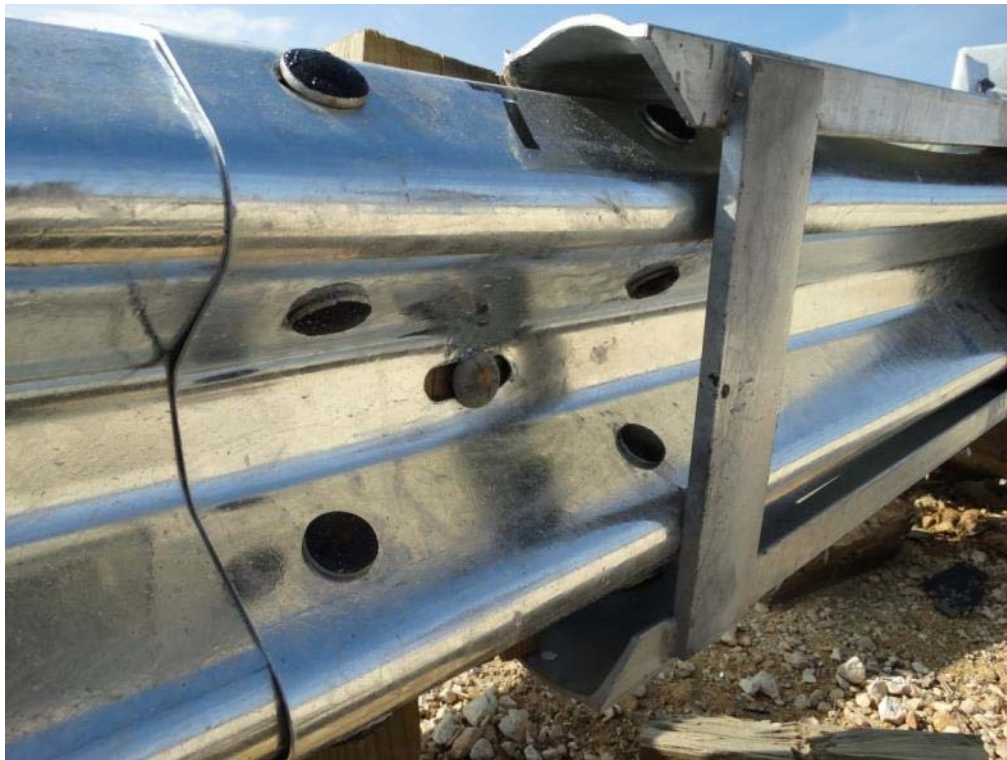
**Figure 3.37: Post-Impact Test Article after Vehicle Removed –Guide Channel Entrance**

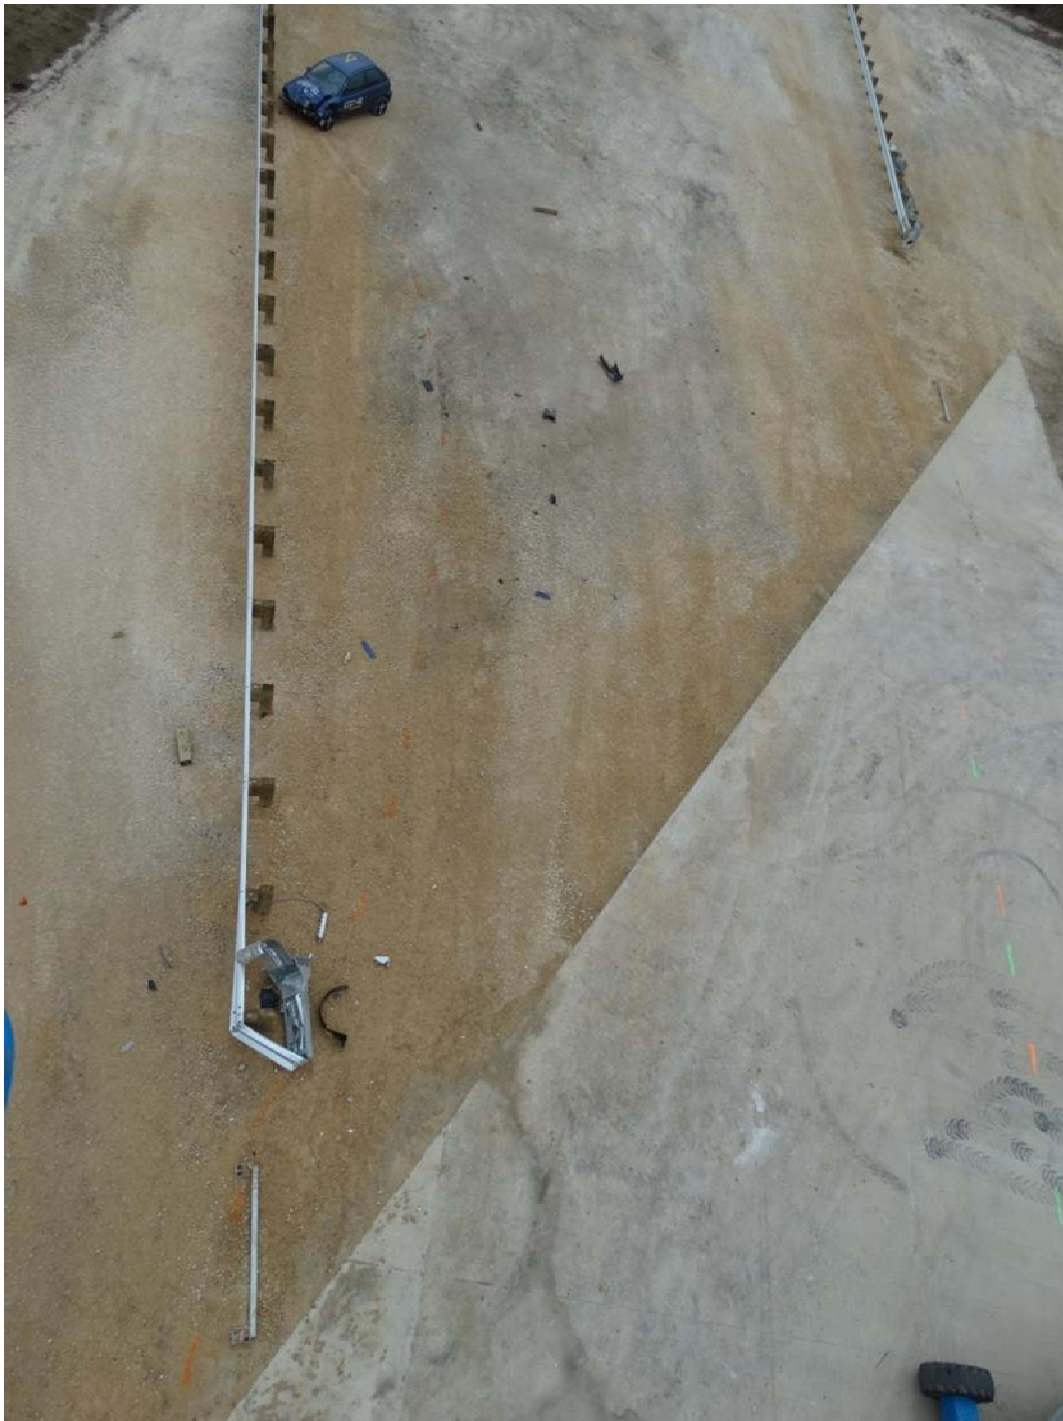
**Figure 3.2: Post-Impact Condition of the Test Article and Vehicle**

Figure 3.2 is an overhead photograph showing the post-test condition and location of the test article and test vehicle. Figure 3.3 through Figure 3.5 show that the test vehicle impacted the end terminal at a nominal 15° angle. The impact velocity of the test as measured by SwRI's speed trap system and verified by high-speed film analysis was determined to be 98.3 km/hr (61.1 mph). As a result of the test, the ET Plus extruder head moved 5.3 m (17.3 ft) longitudinally (downstream) and 1.1 m (3.5 ft) laterally as measured from its as-installed position. The total system deformation (i.e. longitudinal distance to closest point) measured after the impact was 3.7 m (12.3 ft) from the initial point of contact.

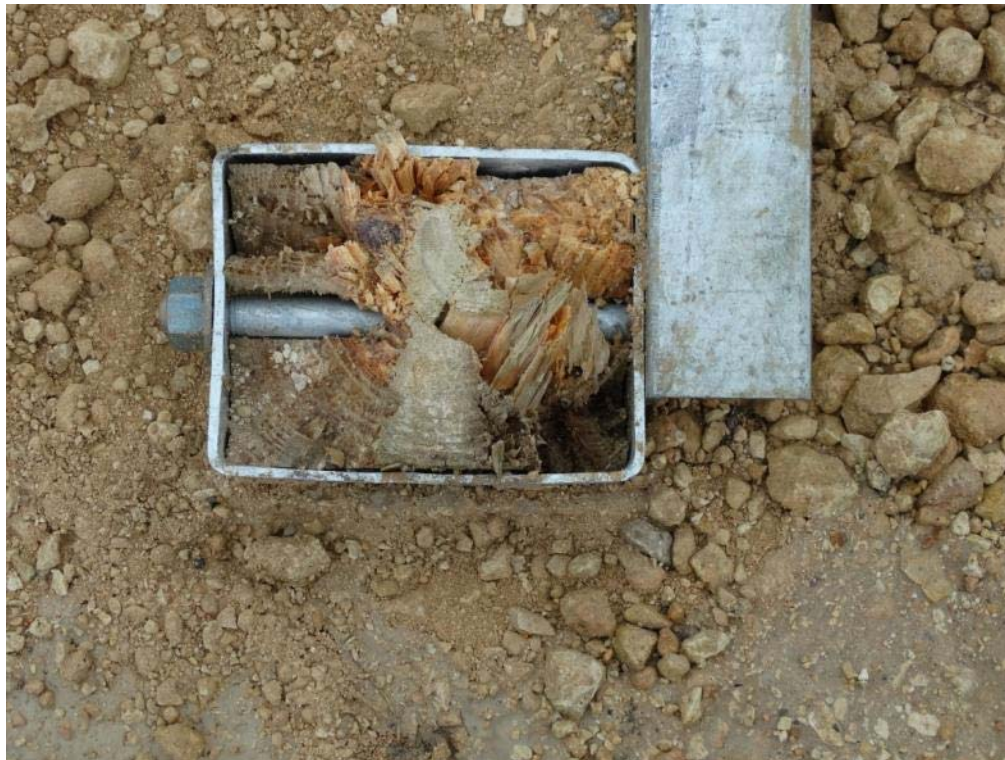
**Figure 3.8: Post Test – Foundation Sleeve at Post 1**

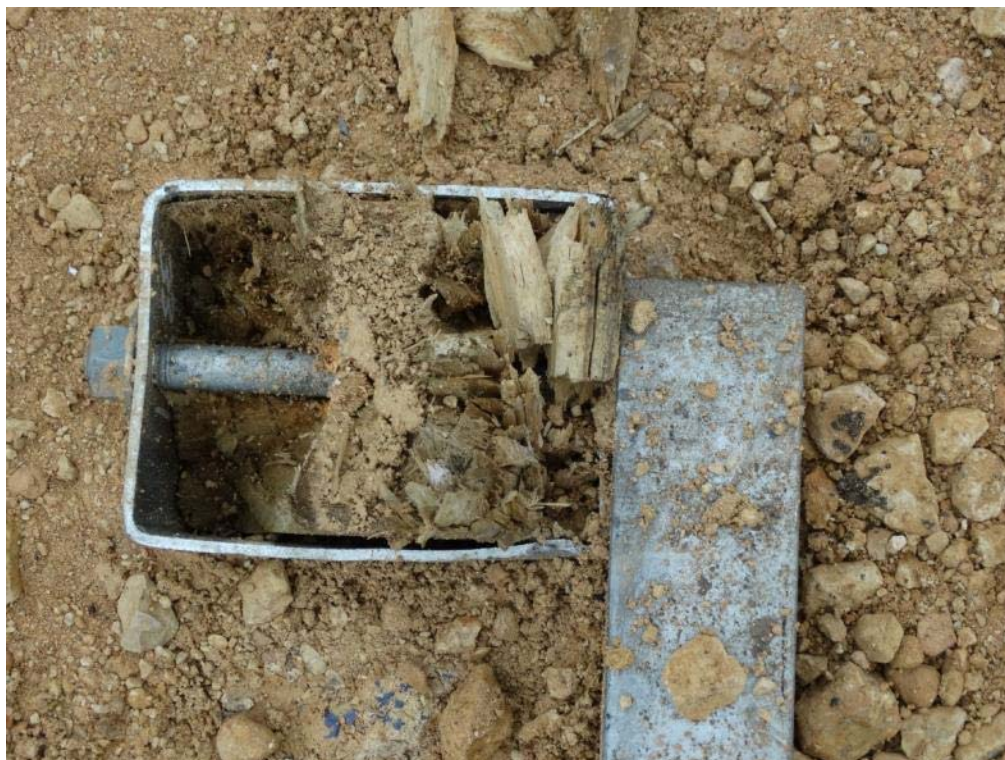
**Figure 3.9: Post Test – Foundation Sleeve at Post 2**

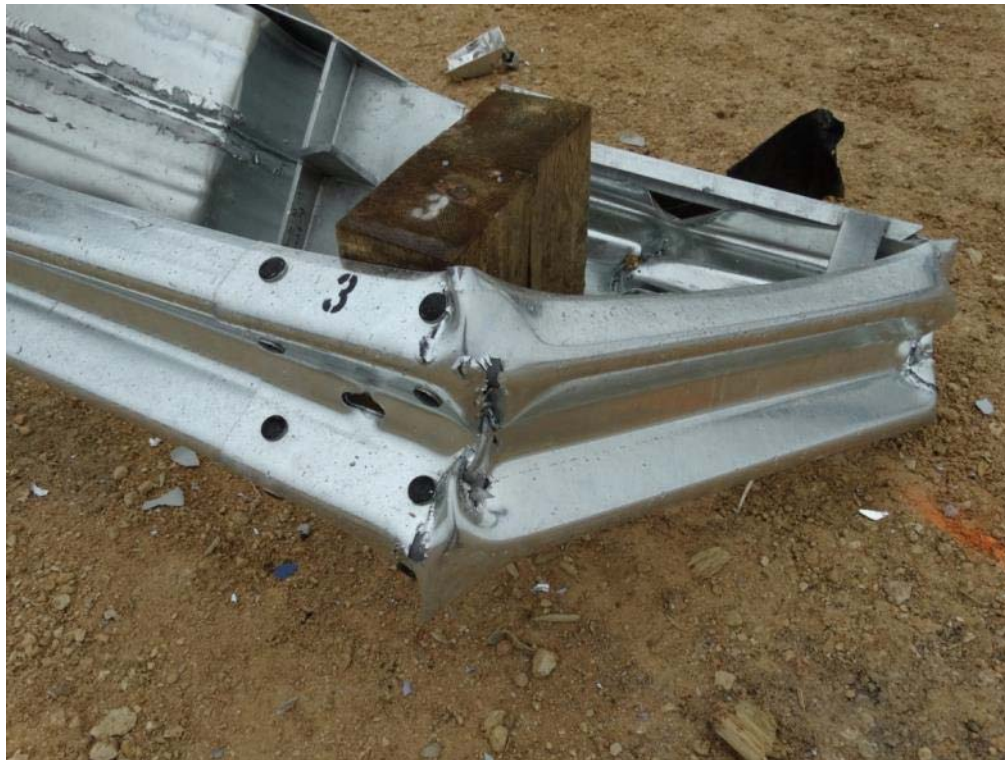
**Figure 3.14: Post Test – Gated Guardrail**

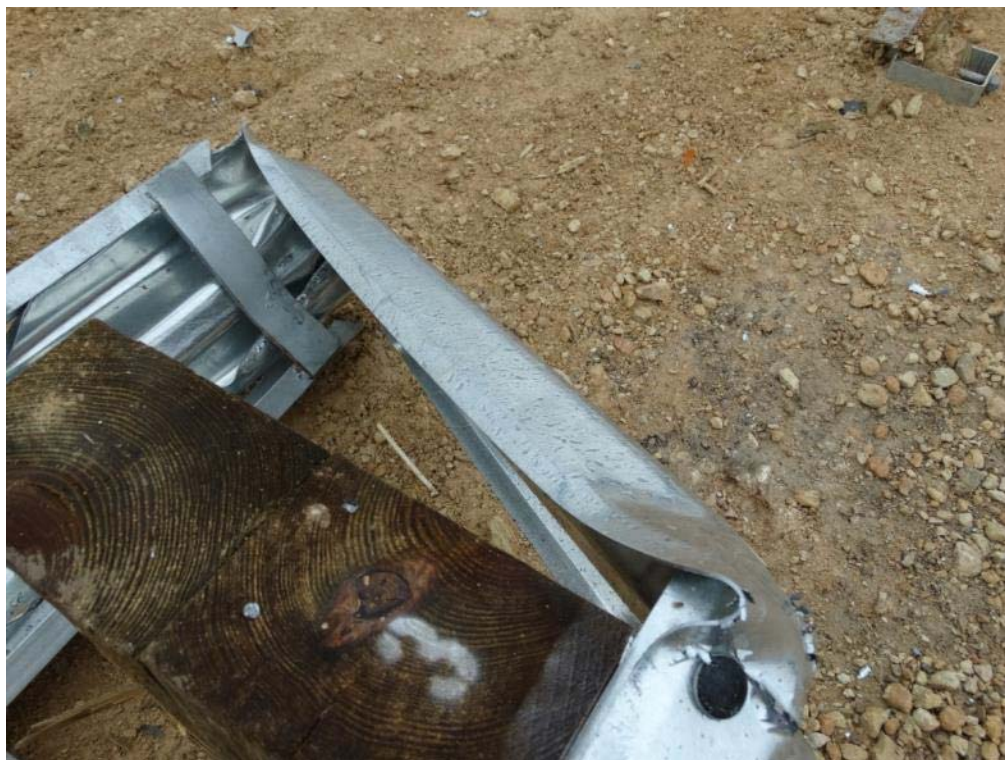
**Figure 3.15: Post Test – Gated Guardrail**

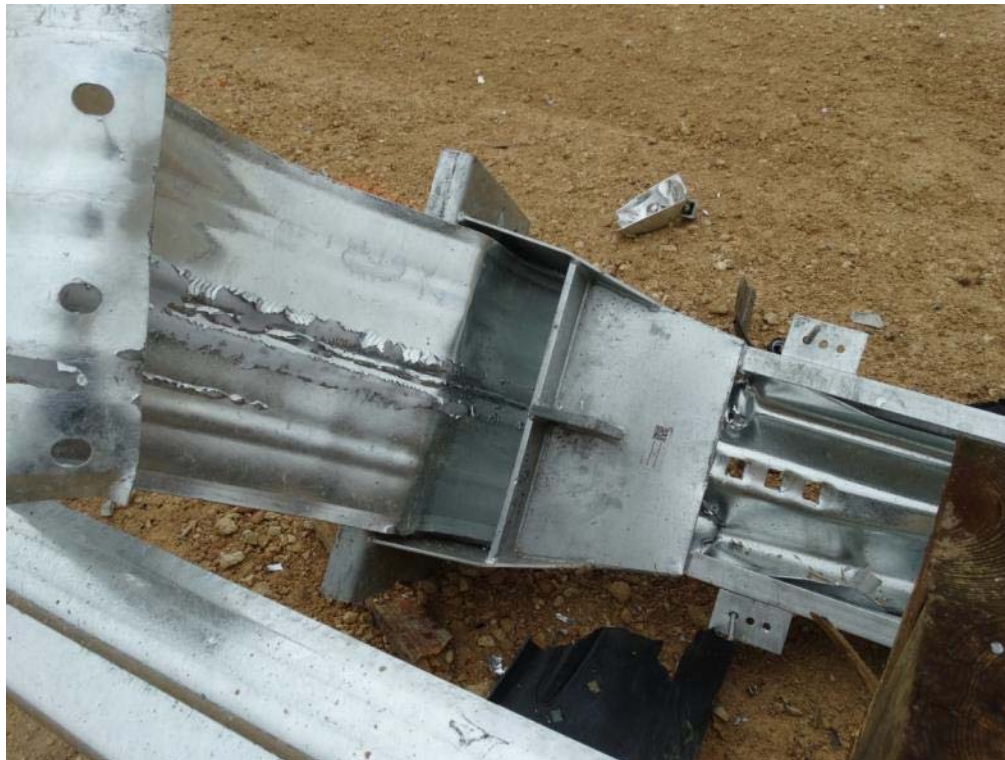
**Figure 3.16: Post Test – Extruded Tail of W-Beam**

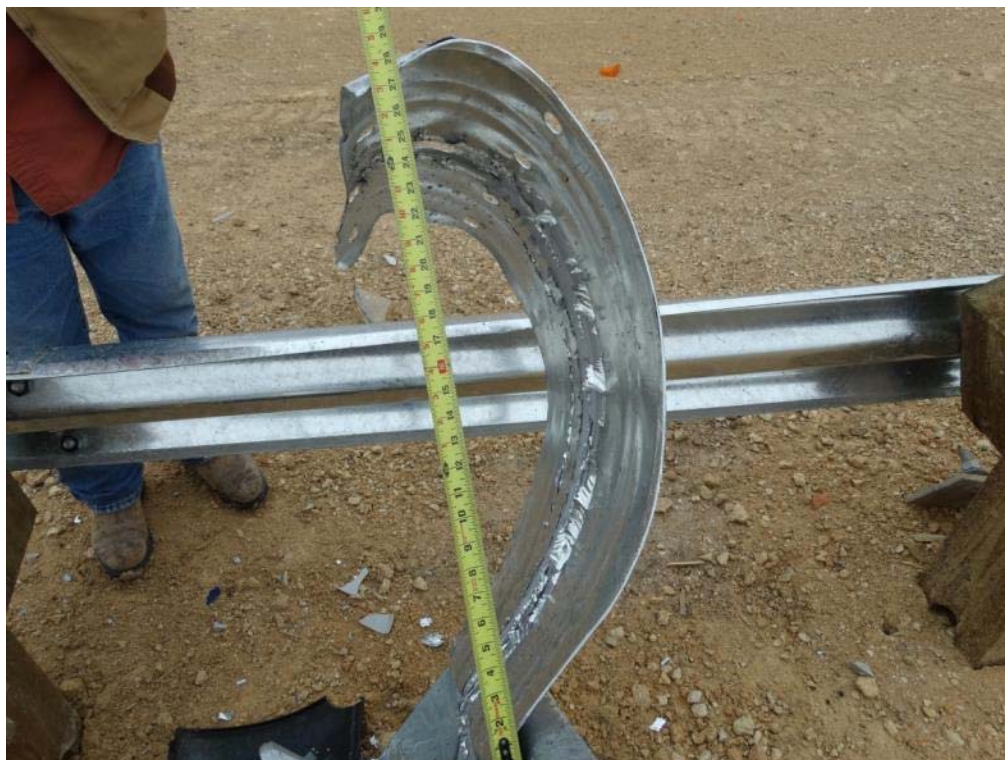
**Figure 3.17: Post Test – Extruded Guardrail Tail**
