# NCHRP Report 350 Test Report Compilation

## Full-Scale Crash Evaluations of the ET Plus<sup>®</sup> End Terminal with 4-inch Wide Guide Channel Installed with a Rail Height of 27¾ Inches

Tests: ET27-33, ET27-31, ET27-32 and ET27-30

SwRI<sup>®</sup> Project No. 18.20887

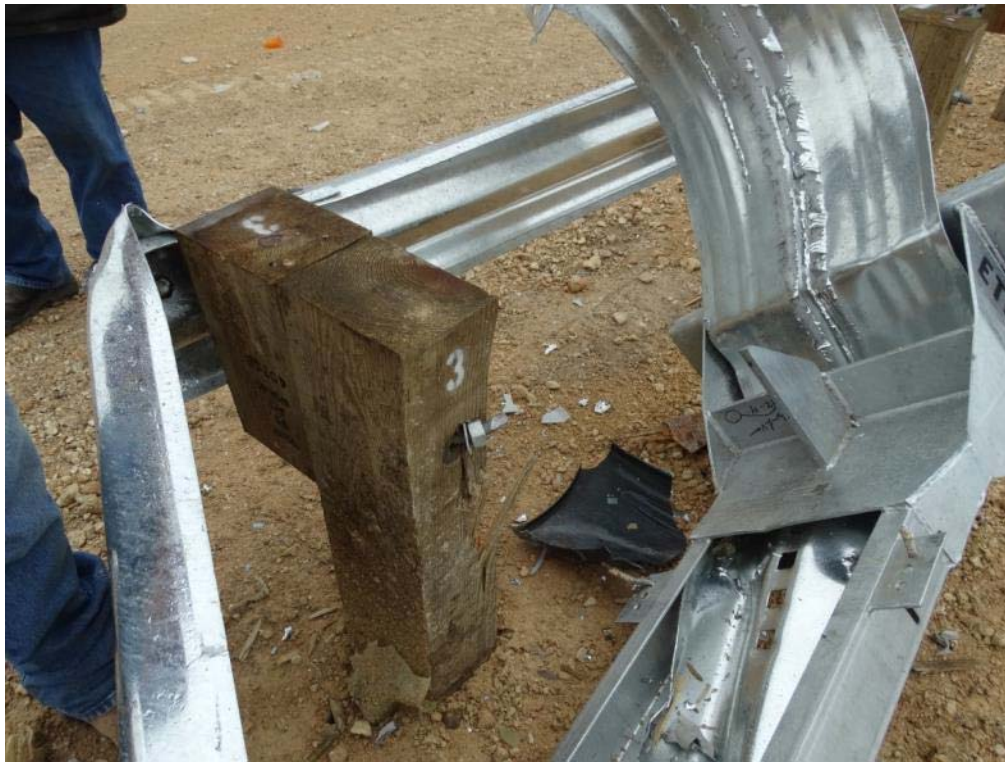
**Figure 3.18: Post Test – Extruded Guardrail**

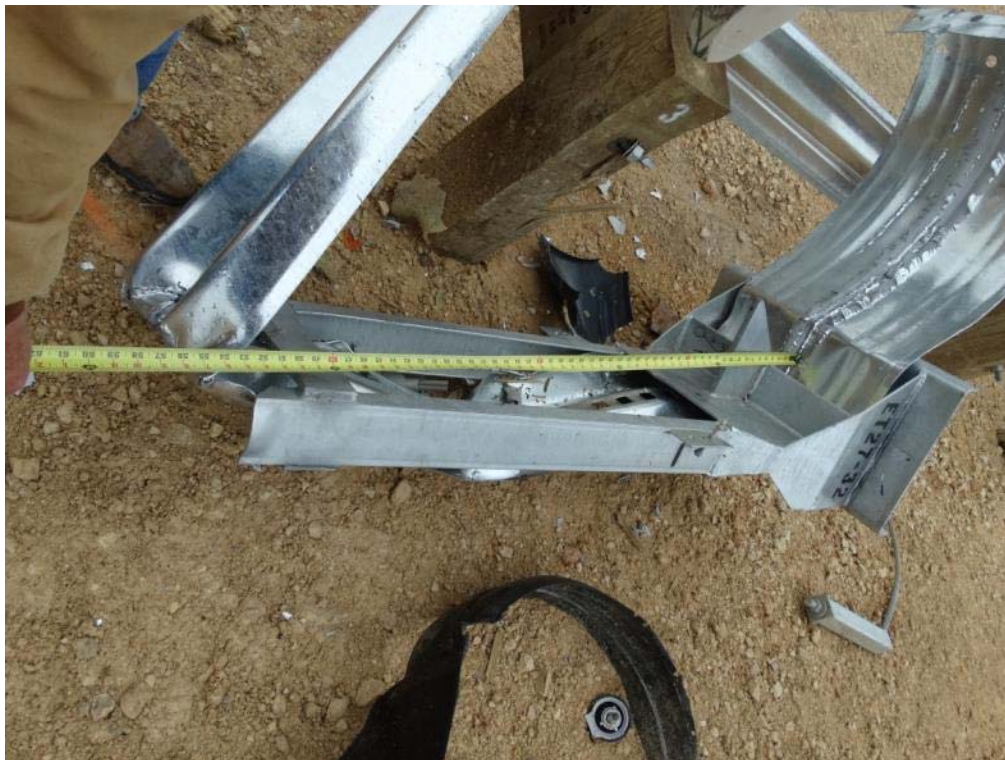
**Figure 3.19: Post Test – Gating Between Posts 2 and 3**

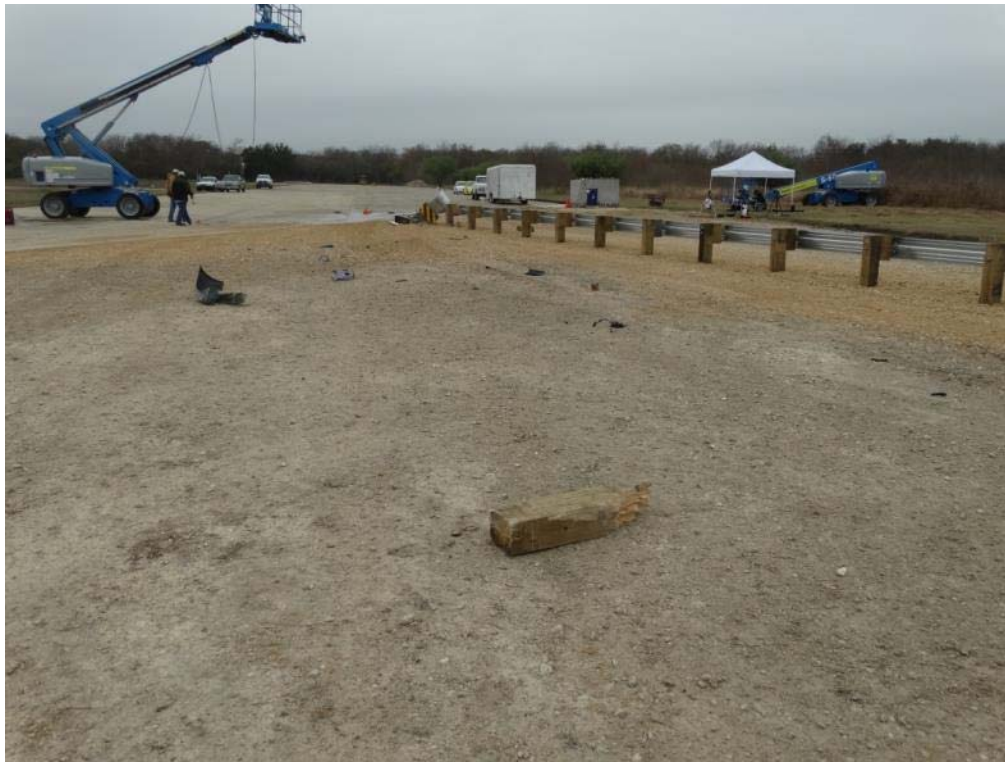
**Figure 3.23: Post Test – Debris Field on Non-Traffic Side**

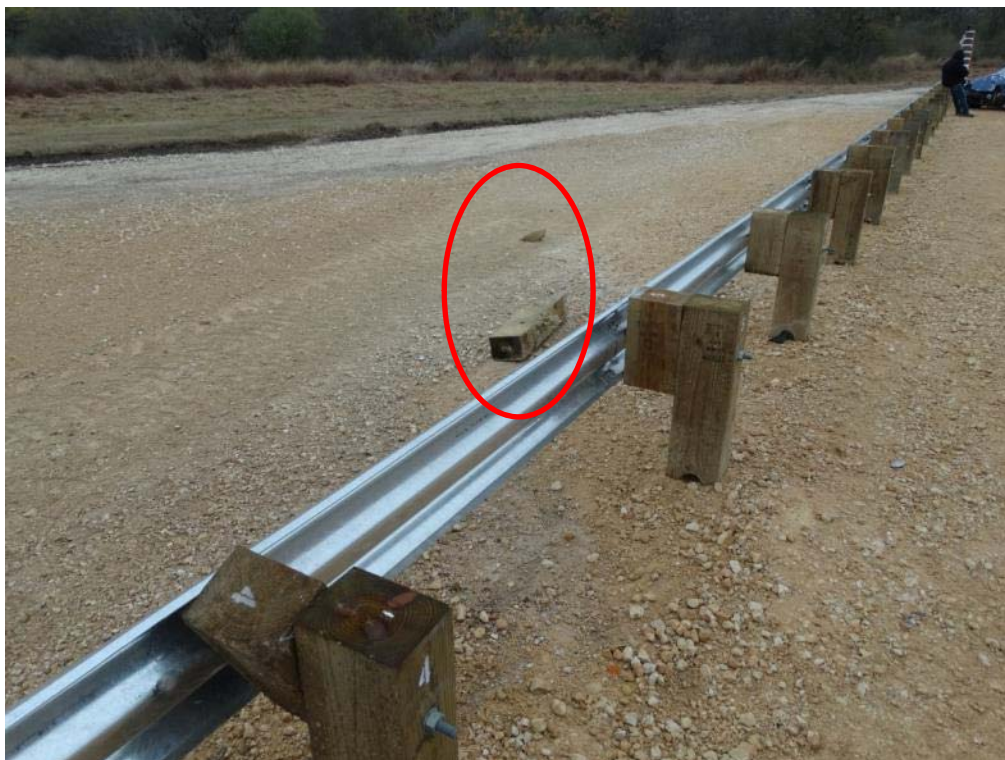
**Figure 3.24: Post Test – Debris on Traffic Side**

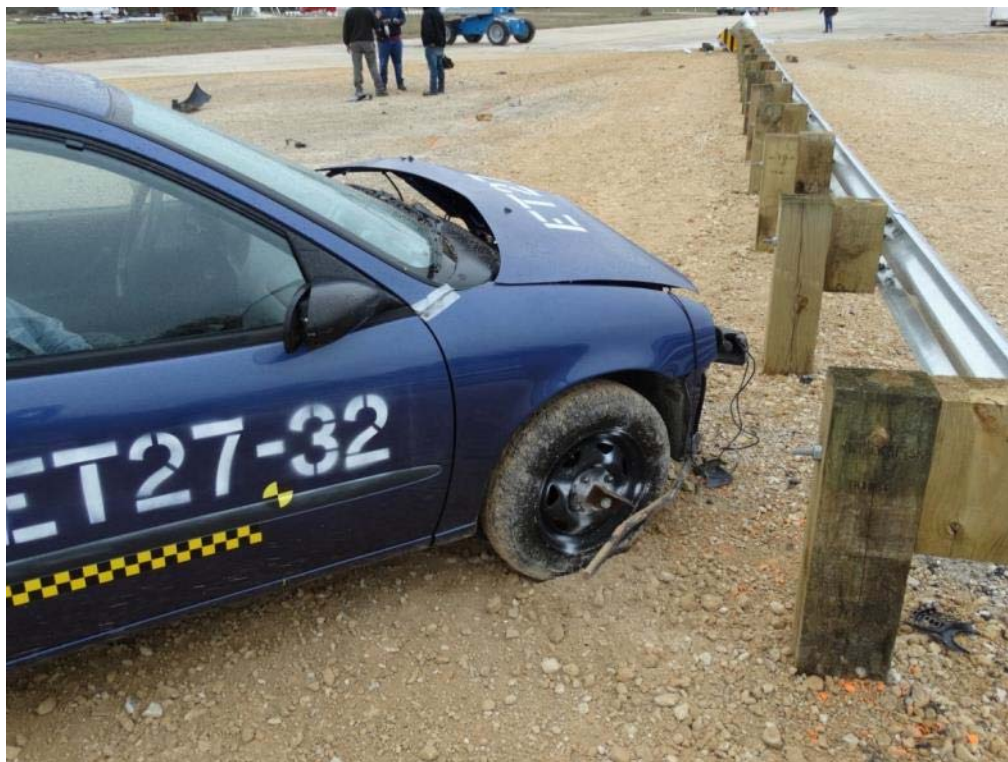
**Figure 3.36: Damaged Test Vehicle – Right Side**

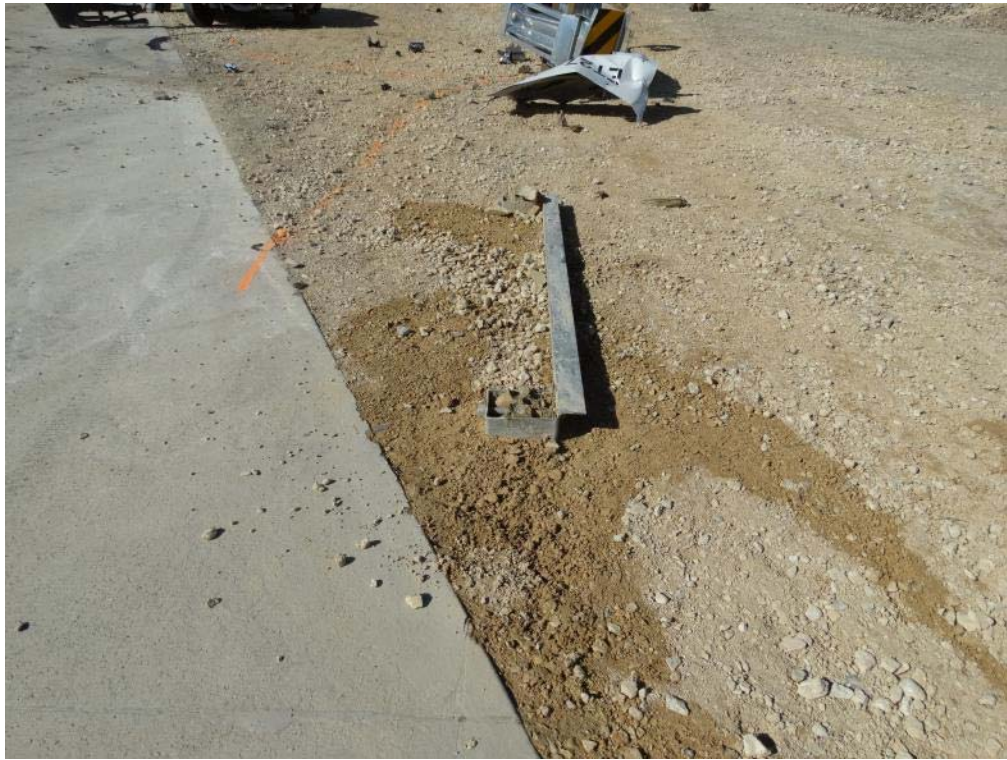
**Figure 3.7: Post Test – Foundation Sleeves at Posts 1 and 2**

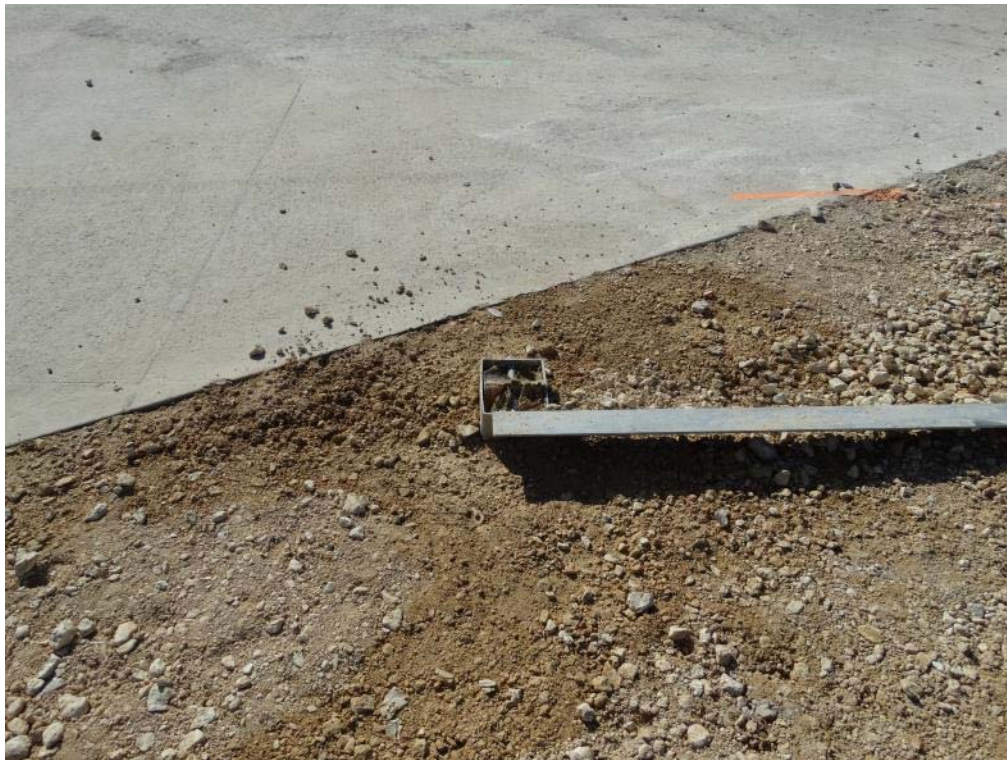
**Figure 3.8: Post Test – Foundation Sleeve at Post 1**

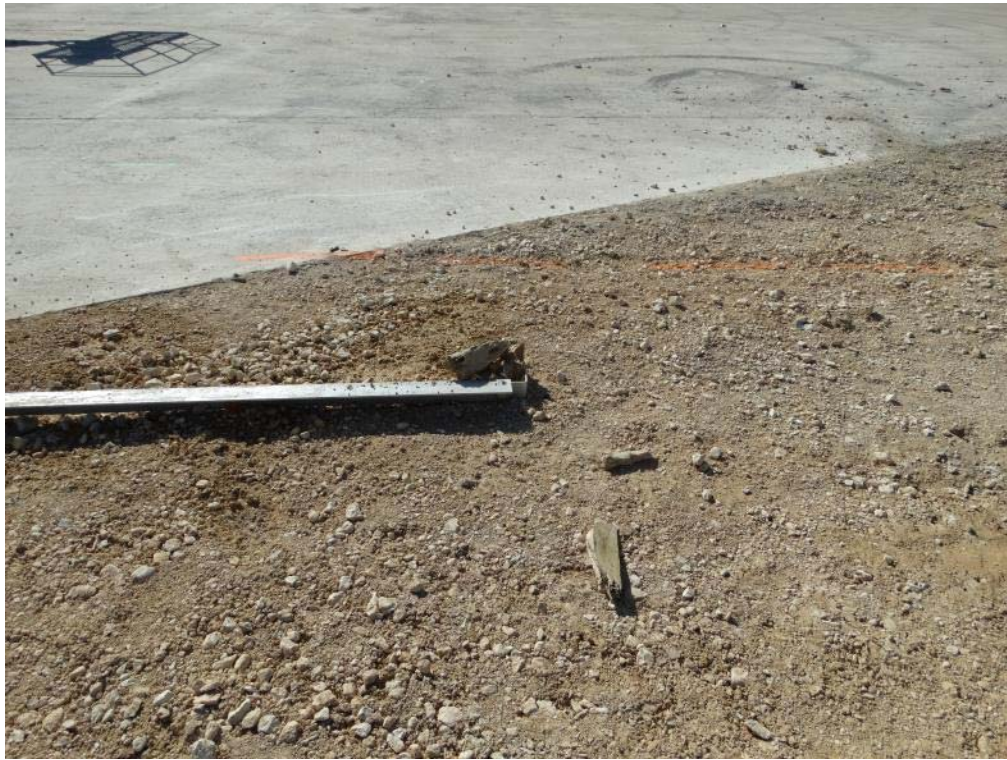
**Figure 3.9: Post Test – Foundation Sleeve at Post 2**

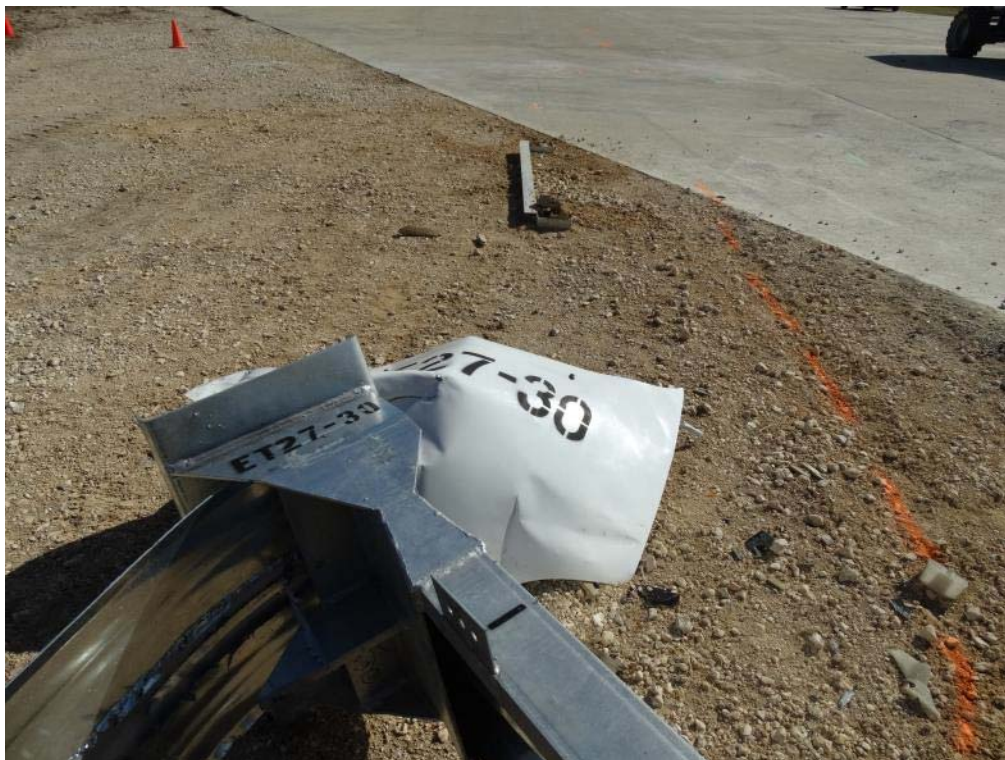
**Figure 3.12: Post Test – Upstream View of Extruder Head**

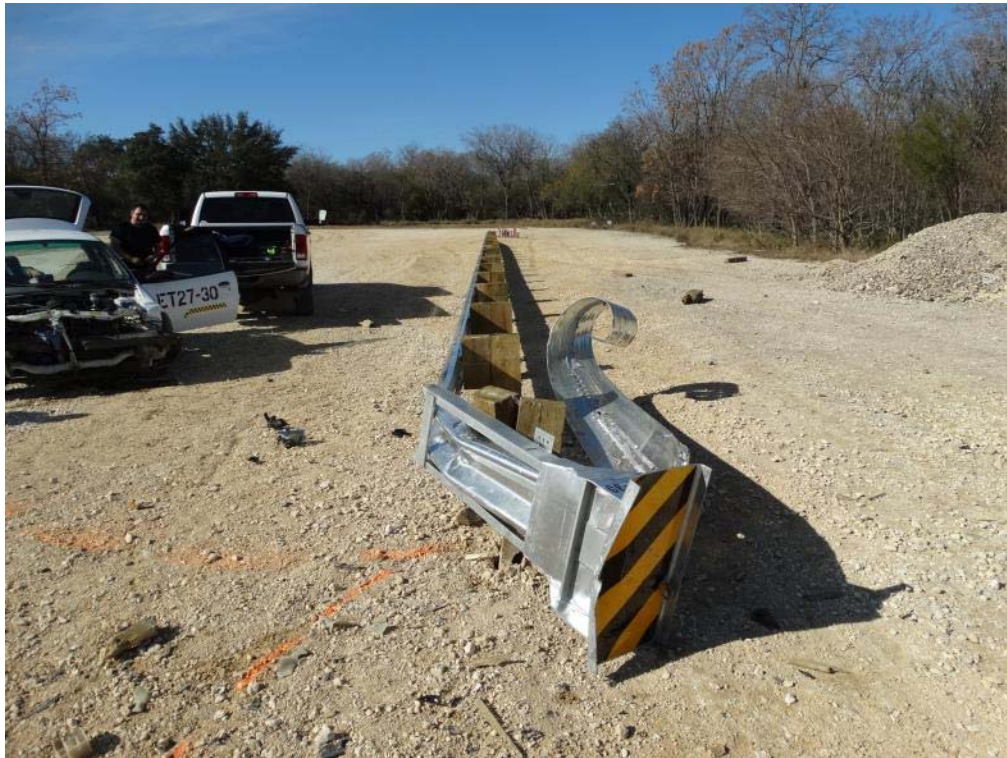
**Figure 3.15: Post Test – Downstream View**

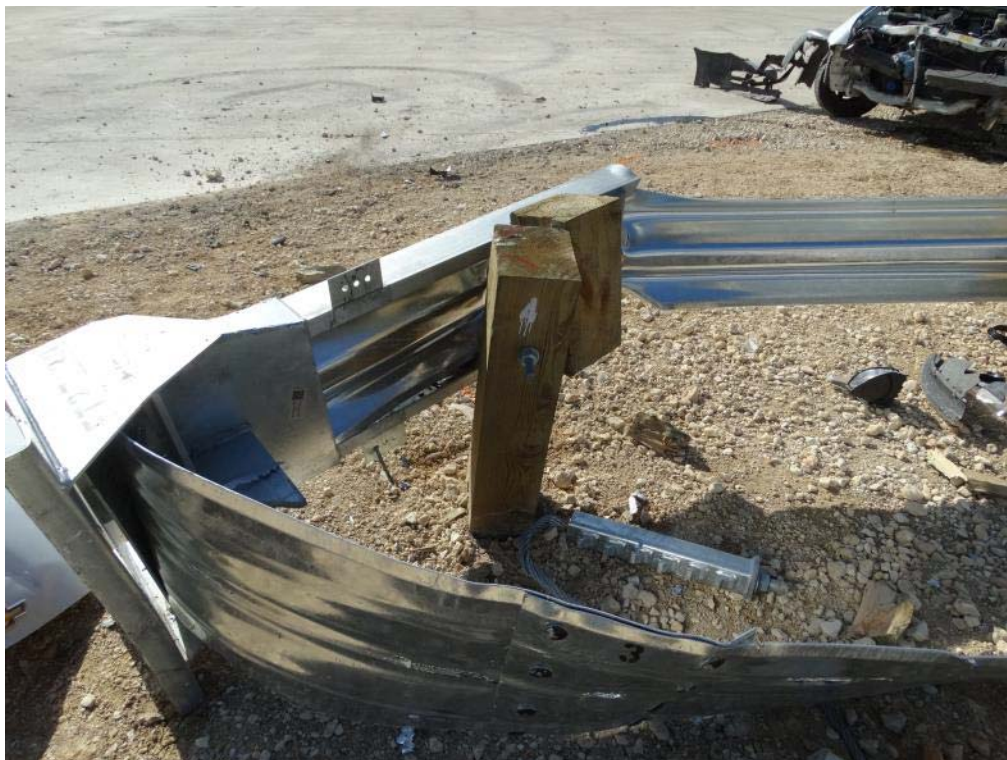
**Figure 3.16: Post Test – Non-Traffic Side of Post 4**

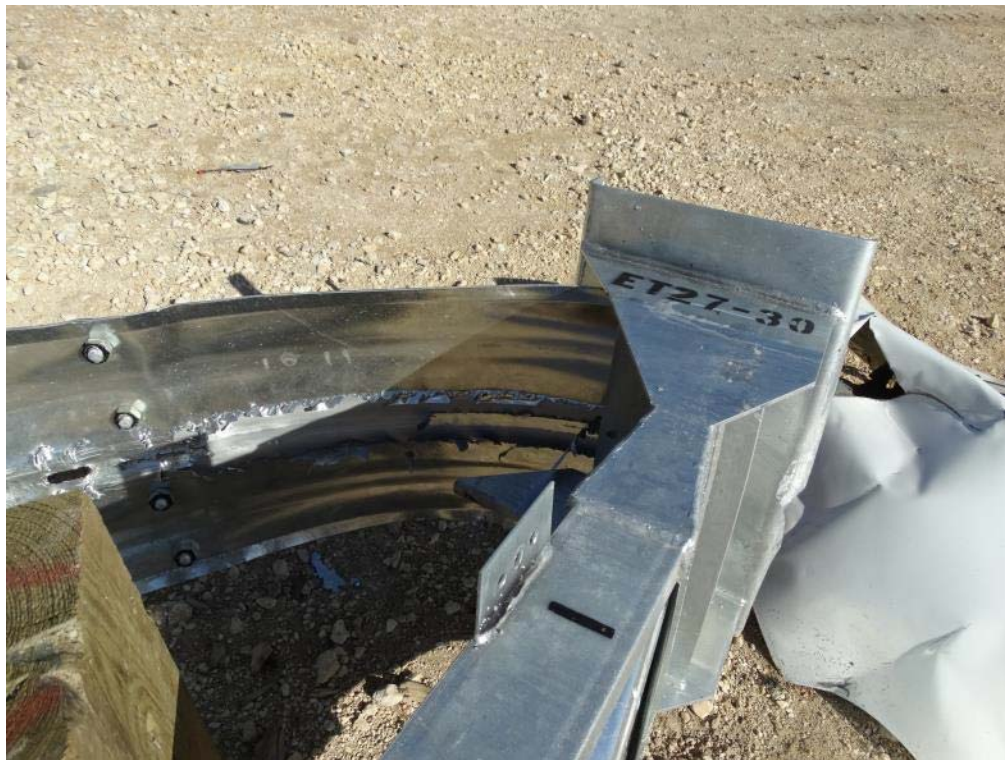
**Figure 3.17: Post Test – Extruded Guardrail at Extruder Head**

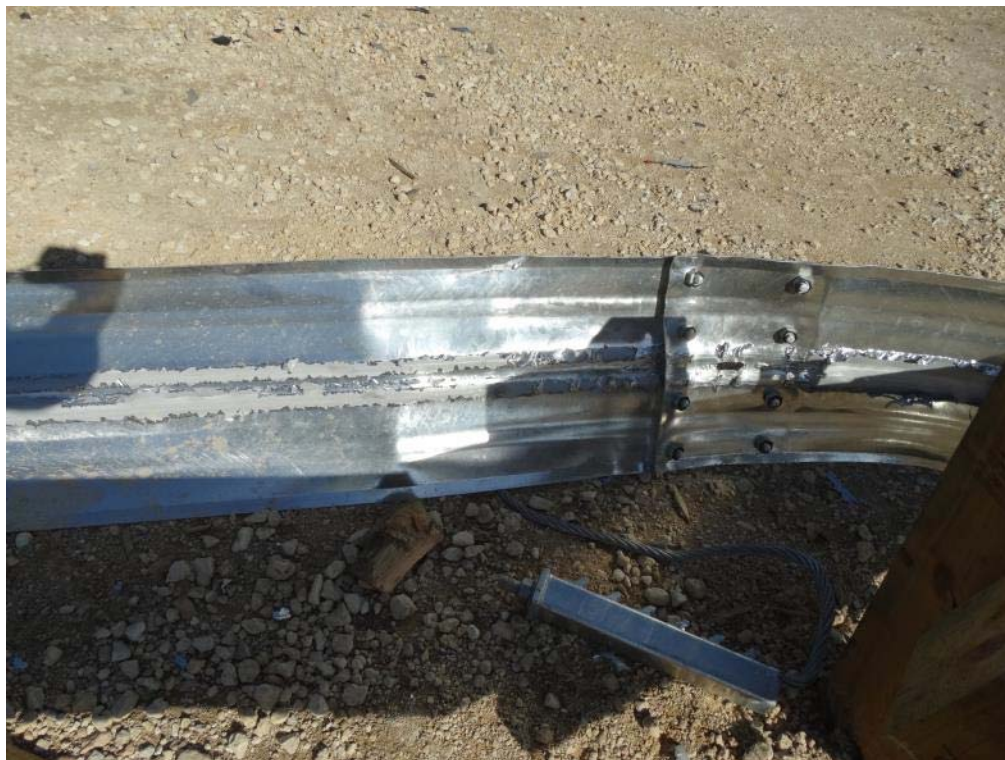
**Figure 3.18: Post Test – Extruded Guardrail Splice**

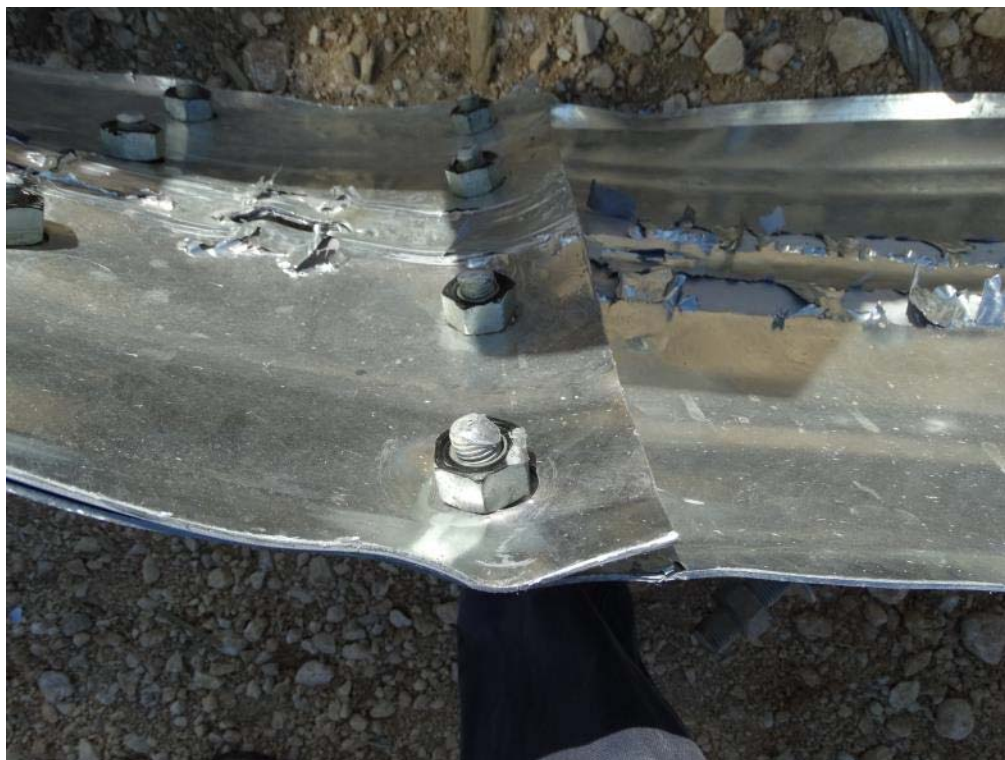
**Figure 3.19: Post Test – Extruded Guardrail Splice**

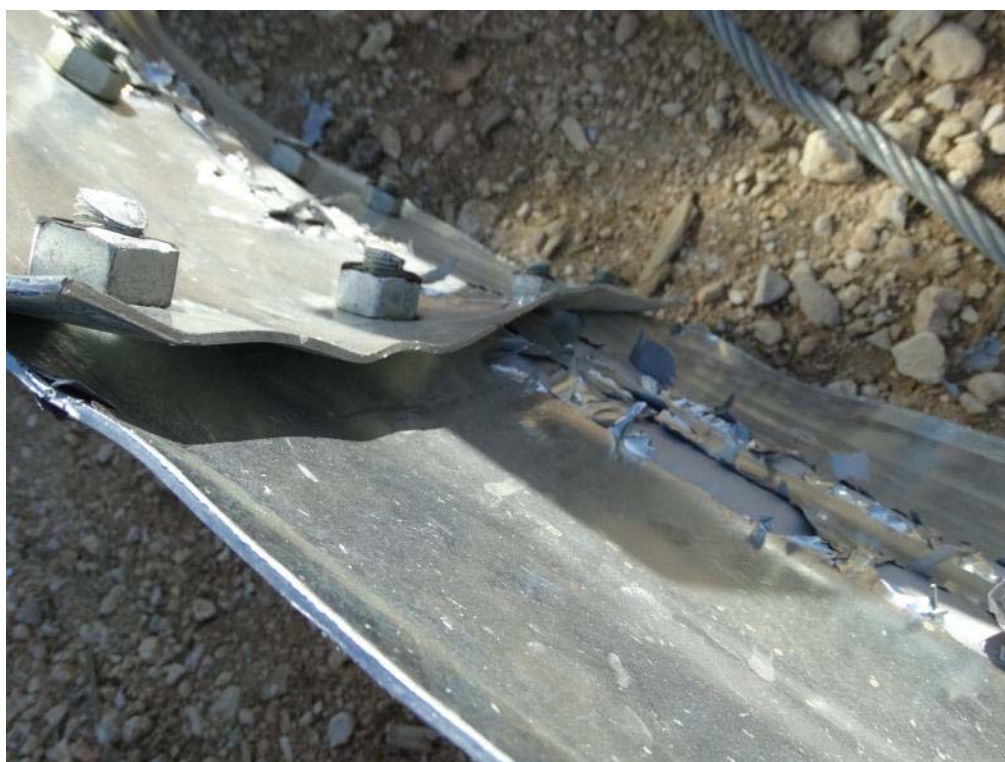
**Figure 3.20: Post Test – Extruded Guardrail Splice**

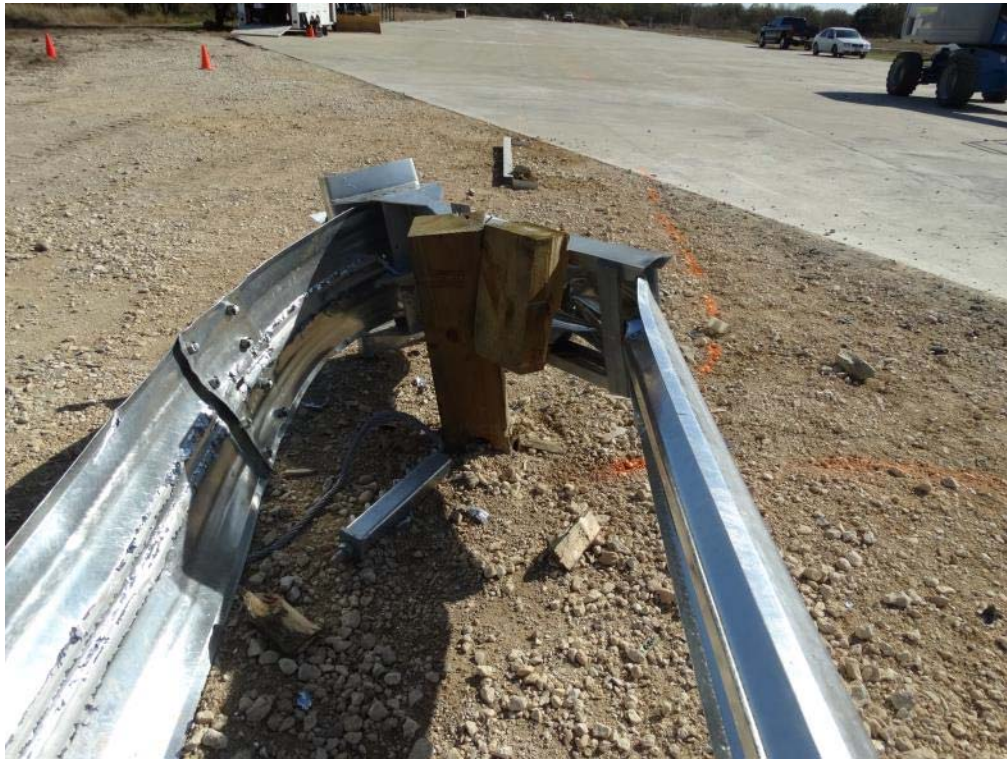
**Figure 3.21: Post Test – Upstream View of Post 4**

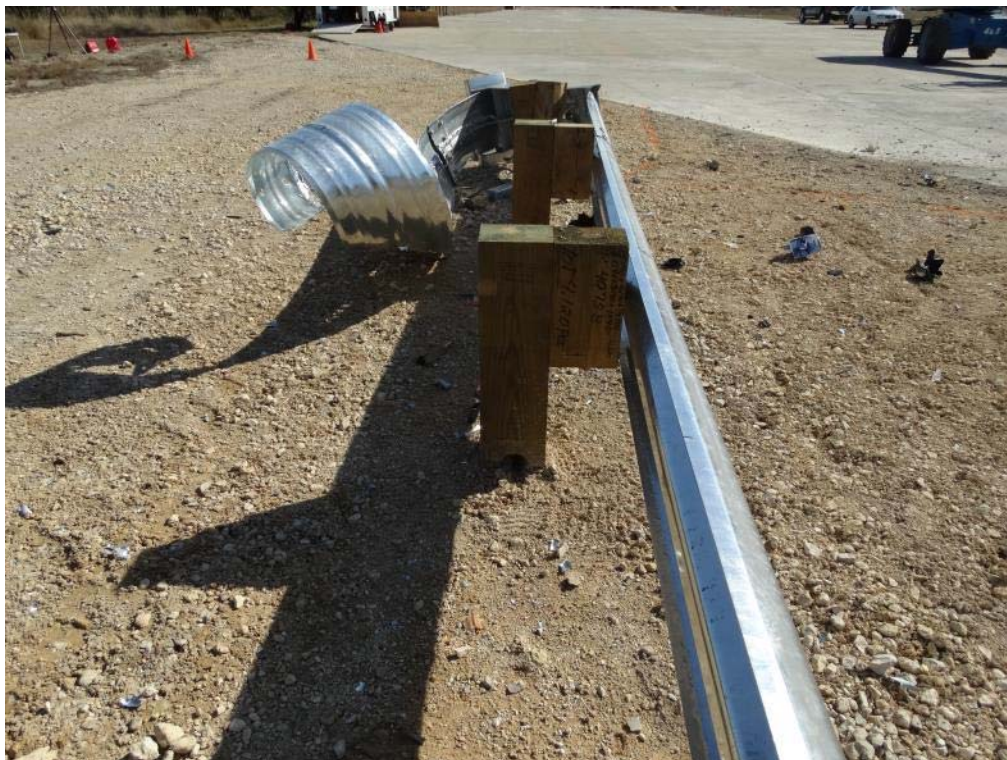
**Figure 3.22: Post Test – Upstream of Posts 4, 5 and 6**

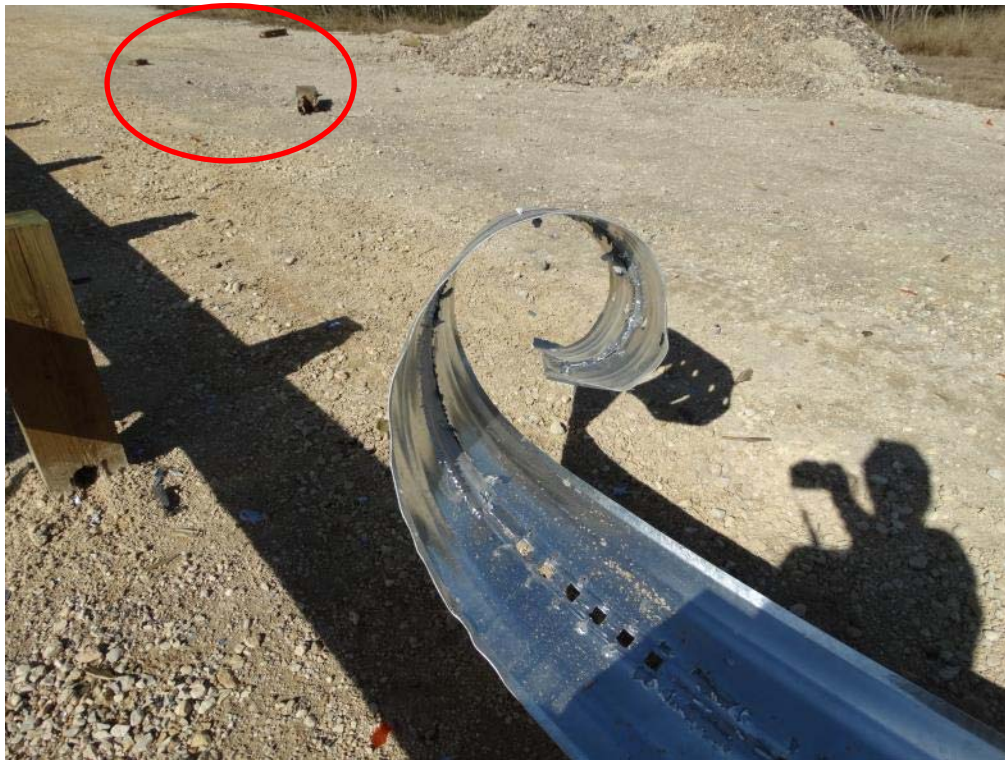
**Figure 3.23: Post Test – Extruded Guardrail Coil and Post Debris**

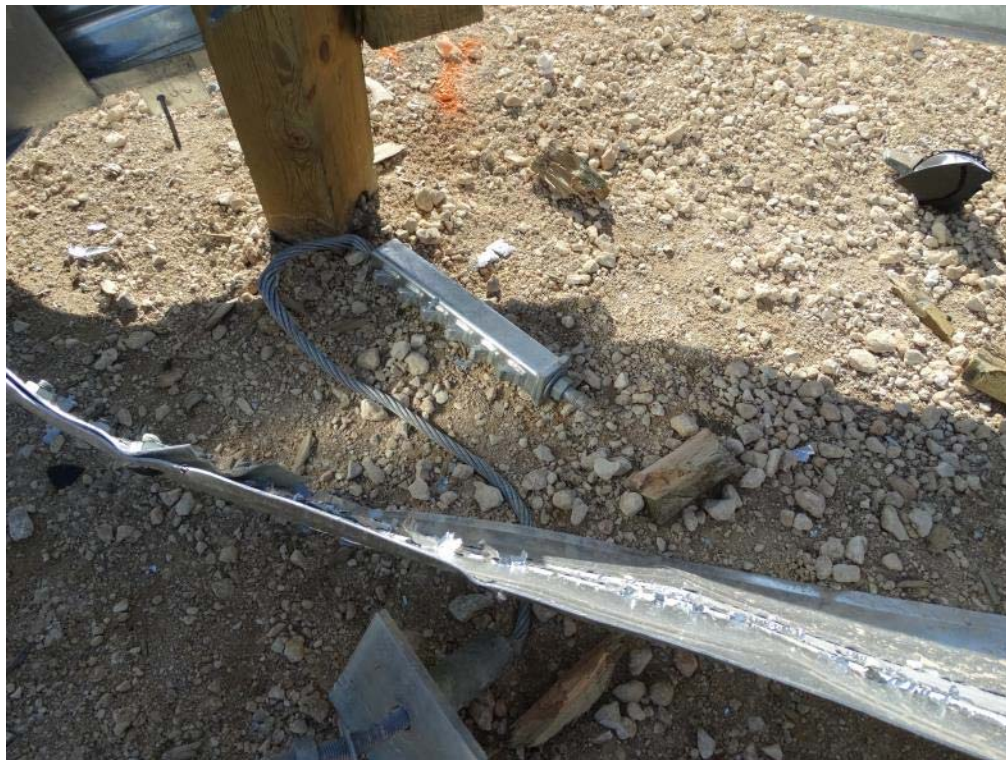
**Figure 3.25: Post Test Location of Anchor Cable**

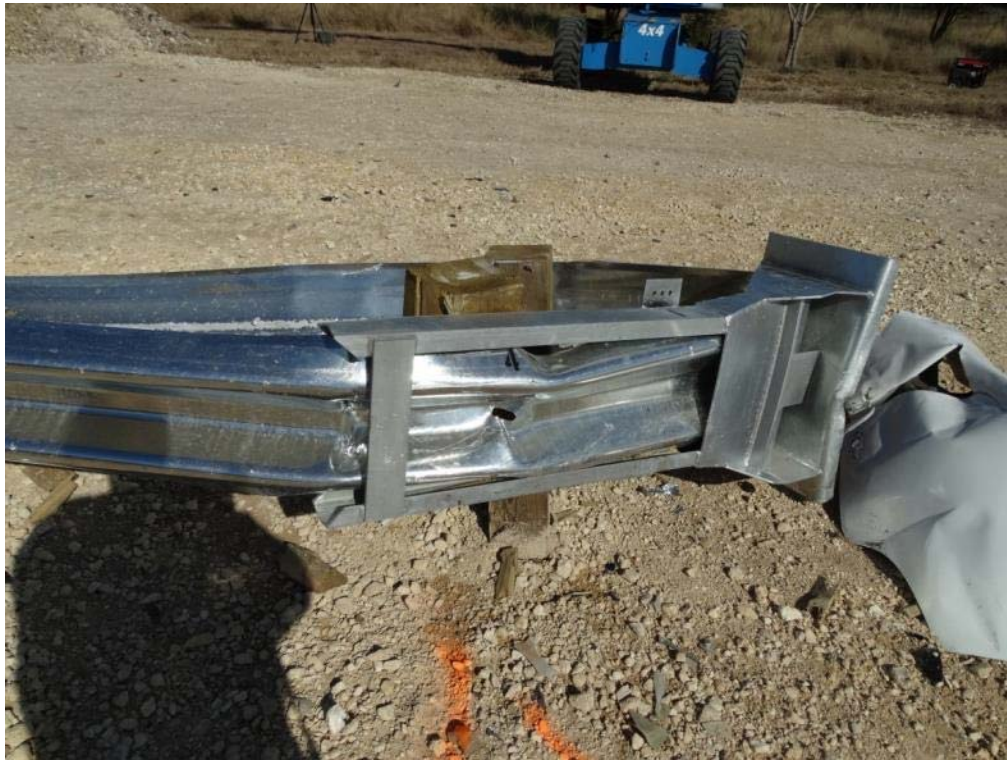
**Figure 3.27: Extruder Head Post Test – Traffic Side**

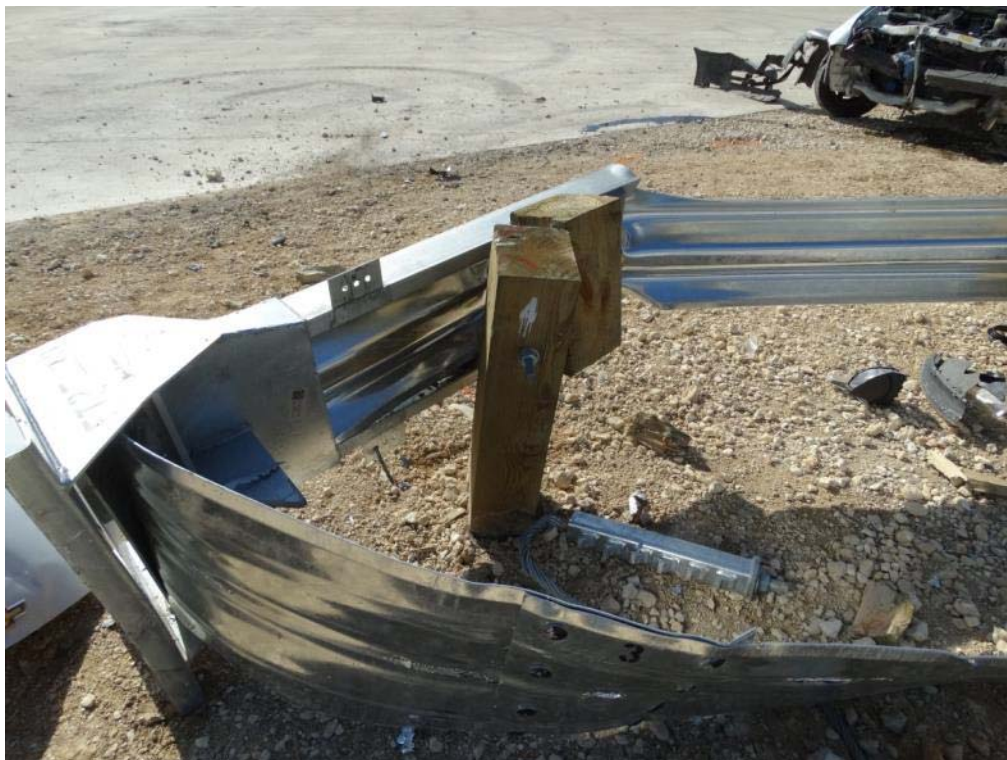
**Figure 3.28: Extruder Head Post Test – Non-Traffic Side**

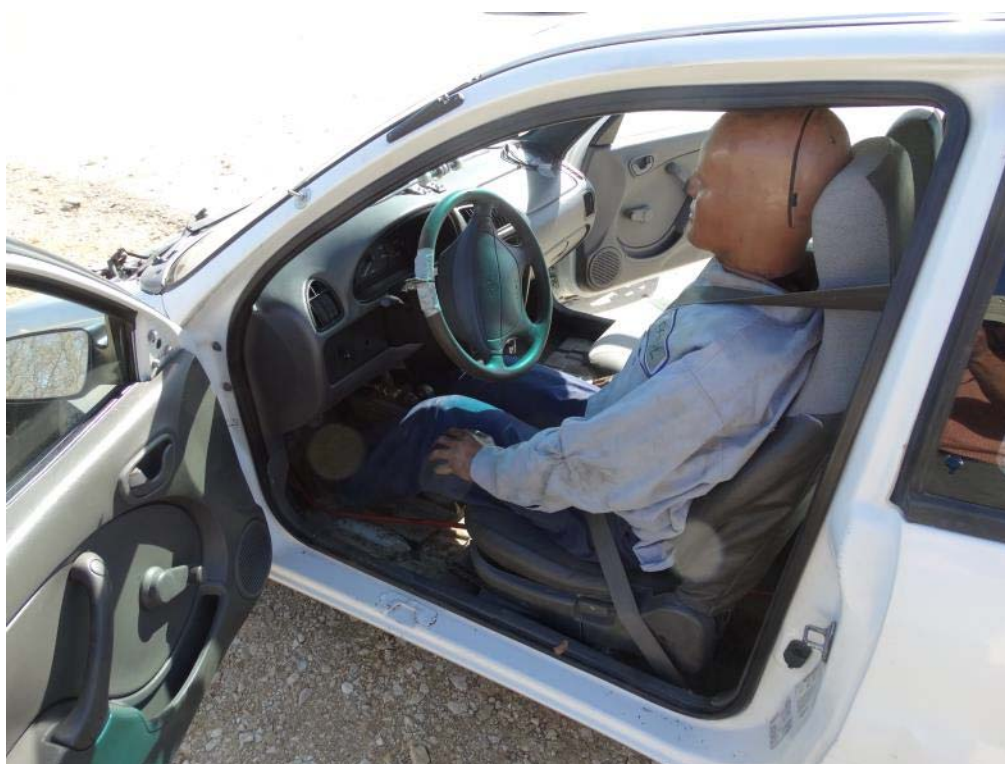
**Figure 3.36: Post-Test – Occupant Compartment**

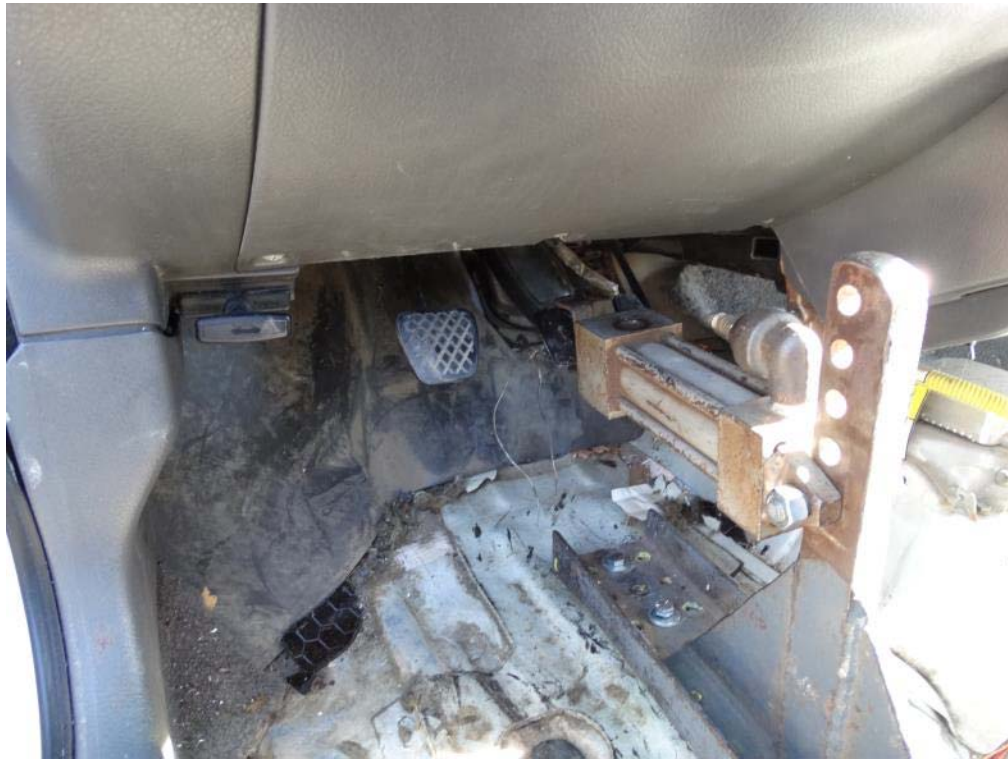
**Figure 3.37: Post-Test – Driver Side Floorboard**
