Montana Demonstration Project: Innovative Culvert Rehabilitation Using Trenchless Technologies

> Final Report June 2009

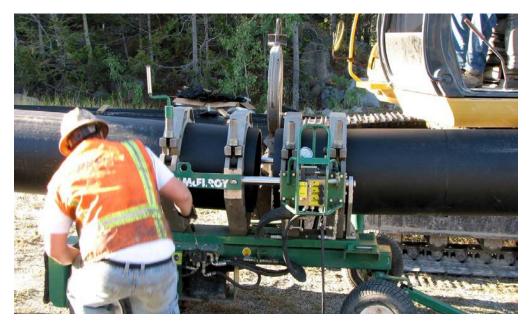
Figure 4. View of the pipe fuser apparatus.

The HDPEP sections were delivered to the job site in 25-foot (ft) (7.6-meter (m)) segments. The pipe sections were welded together to a proper length using a device called a plastic pipe fuser (figure 4). Before the fusing phase, the ends of the pipes were trimmed with a special rotary cutting tool equipped with three razors to remove any imperfections, dirt, or grease and ensure a good-quality weld.

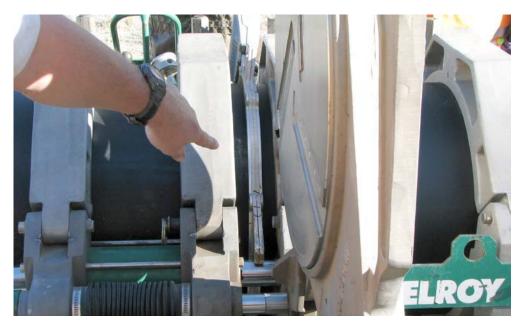
Figure 5. View of the preheated iron during the fusion process.

Next, a preheated round electric iron with an average temperature of 425 degrees Fahrenheit (°F) (218 degrees Celsius (°C)) was placed between the two pipe sections (figure 5). The pipes were compressed against the heated iron for about 2 to 3 minutes until the pipes started to melt and form a circular bead (figure 6).

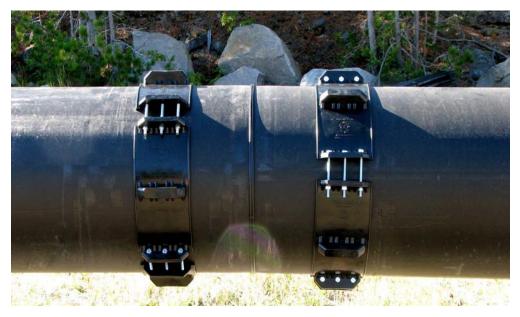
Figure 6. View of the welded pipes and spacers.

After all the sections were fused together to a proper length, spacers were attached along the pipe at intervals of 8 to 10 ft (2.4 to 3 m). The primary purpose of the spacers is to facilitate efficient insertion of the new pipe and placement of the cementitious grout, which was pumped between the existing CSP and the new liner. Figure 6 shows the formed bead after fusion and the spacers. Figure 7 shows the welded pipe liner ready for installation.

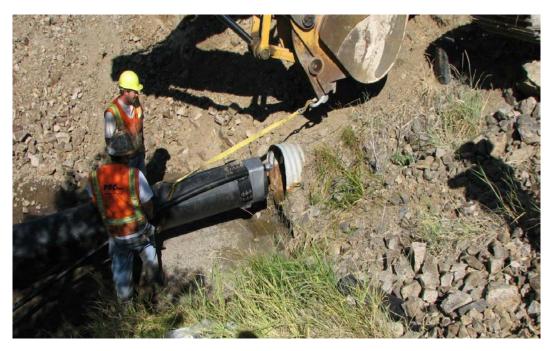
Figure 8. Pulling the liner and PVC tube into the existing pipe.

Before the liner was inserted, a PVC tube was attached along the entire length of the pipe to allow pumping of the cementitious grout material from the pumping station. As the grout was pumped, completely filling the space between the liner and the existing pipe, the PVC tube was pulled back slowly until the grouting was complete. Figure 8, 9, and 10 illustrate the operation.

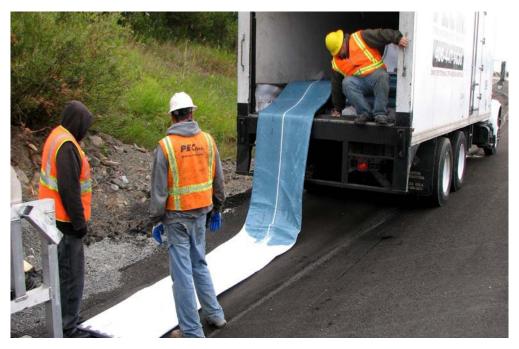
Figure 11. View of the refrigerated truck and the liner.

The CIPP liner installation at MacDonald Pass involved inserting resin-impregnated polyester felt into the existing pipes through an inversion process. The resin impregnation was done offsite at the installer's facility, and the liner was placed in a refrigerated truck for delivery to the job site (figure 11).

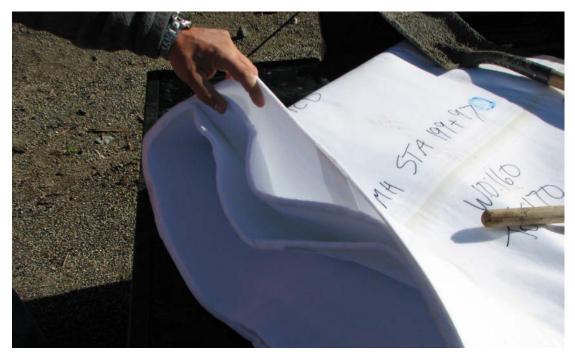
Figure 12. Closeup of the nonimpregnated polyester liner.

- The CIPP liners, specified to proper length and diameter by MDT, were delivered to the jobsite in a refrigerated truck. Several layers of ice bags were placed on the truck bed to ensure the temperature of the liner was kept low enough to impede setting until the steam curing phase.
- The nonresin-impregnated liner system has three separate layers, with the outer layer having a denser weave than the two inner layers. Once cured, all layers are bonded together, forming a monolithic layer that becomes the new interior surface of the existing culvert. Figure 12 shows a closeup of the three layers of the nonresin-impregnated polyester.

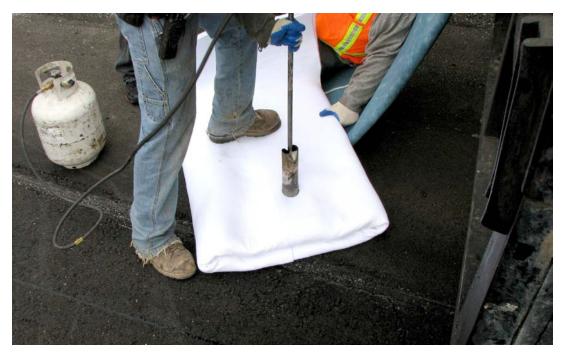
Figure 13. Inserting a circular hole into the liner using a heated core.

• A propane heated core was used to place a 3-in (76.2-mm) diameter hole in the liner, for attaching a bracket and an air hose to the liner (figure 13). In preparation for installation, the contractor cut slots in the liner layers to be hooked onto the inversion apparatus, facilitating the inversion of the liner. All five CIPP liners were inserted at the intake or upstream ends of the culverts.

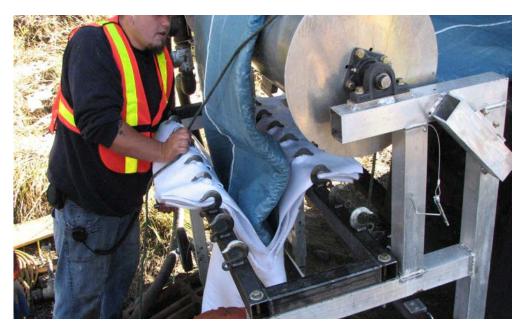
Figure 14. View of the inversion apparatus.

• The inversion apparatus is equipped with two rows of hooks to hold the liner in place while the liner is pressurized for its travel through the existing CSP culvert. Figure 14 shows the process of attaching the liner to the hooks of the inversion apparatus.

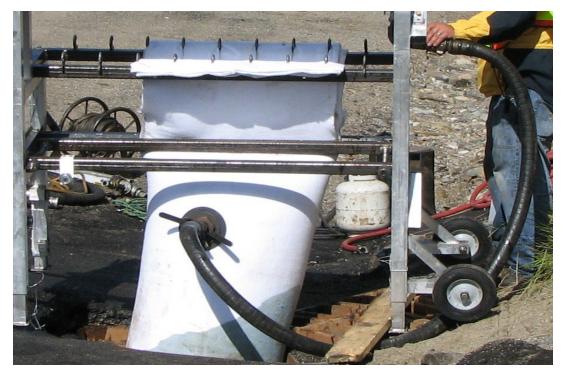
Figure 15. Closeup view of compressed air application and fully inverted liner.

• To invert and force the liner through the CSP culvert, compressed air at an average pressure of 12 pounds per square inch (psi) (82.7 kilopascals (kPa)) was applied through

the bracket into the liner. Figure 15 shows application of the compressed air and a completely inverted liner at the culvert's intake.

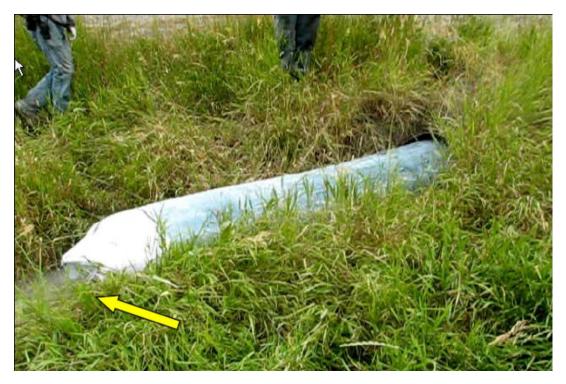
Figure 16. Fully exited liner at the outlet end.

- Figure 16 shows a fully exited liner at the culvert's outlet releasing the air pressure, which had forced it through the culvert (see the yellow arrow). Since the liner was inverted at the culvert's intake, it provided a natural plug through the entire inversion process.
- Once fully deflated, as shown in figure 17, the liner was ready for the curing phase. On average, for a 130-ft (39.6-m) CSP culvert like the ones at MacDonald Pass, it takes about 30 minutes to invert the liner from the intake to the outlet of the culvert.

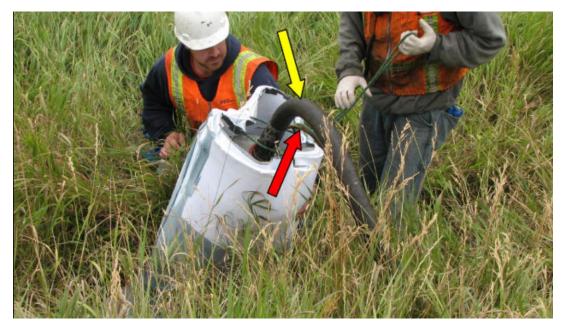
Figure 18. View of the rubber plug with air and steam line connections.

- The next step in the operation, the curing phase, entails the application of air and steam. A large-diameter rubber plug was placed inside the liner at the outlet. The plug was equipped with two connections, which allowed attachment of an air line (red arrow) and steam line (yellow line). Figure 18 shows the rubber plug attached to the air and steam lines.

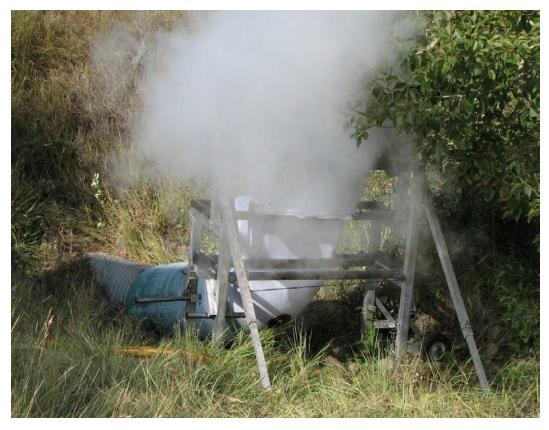
Figure 19. View of steam exiting at the intake end of the culvert.

- Figure 19 shows steam exiting at the intake end of the culvert. Curing can take place at ambient temperature, but using steam can accelerate the curing time. Applying steam reduces the curing time from several weeks to 1.5 hours.

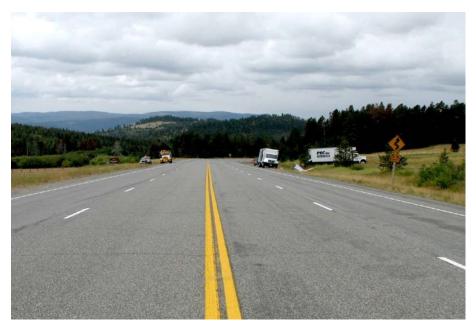
Figure 23. Typical CIPP liner installation.

Figure 23 shows a roadway during culvert rehabilitation using CIPP. No worker injuries or highway user incidents were reported during the rehabilitation of the culverts on MacDonald Pass. Overall, MDT exceeded all the safety performance goals set by HfL.
