Federal Highway Administration
Every Day Counts
Innovation Initiative

Safety Edge_{SM}
Demonstration Project
Elizabethtown,
Pennsylvania

Field Report
May 24, 2011

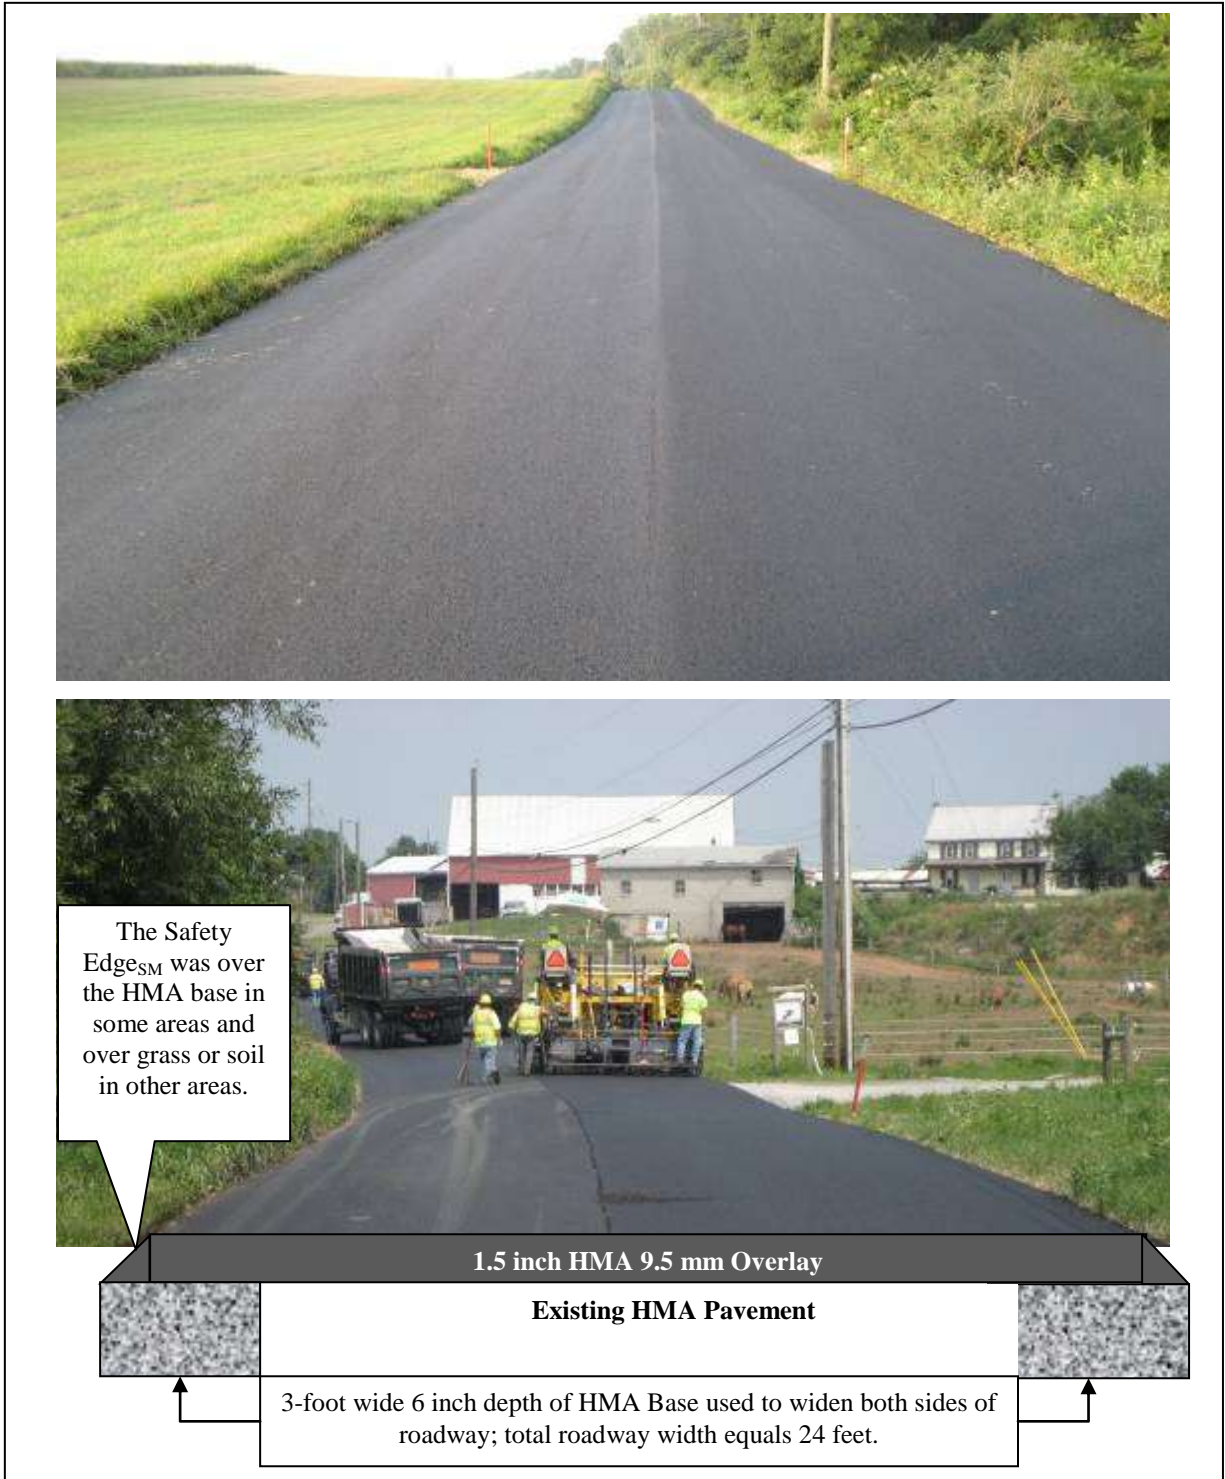
The project consisted of placing a 1.5 inch lift of a 9.5 mm HMA mix over the existing HMA pavement. Pennsylvania DOT project personnel indicated that another 1.5 inch HMA lift may be placed in the next year or two. The existing pavement was widened to include two-twelve foot lanes. Figure 2 provides a general view of the 1.5 inch HMA overlay, and typical cross section of the pavement.

The ditches along the edge of the pavement were generally shallow or almost level with the existing pavement (refer to Figure 2), with the exception of a few areas (refer to Figure 3). An HMA base mix had already been placed on both sides of the road to widen the roadway. Some areas had narrow ditches that were approximately one to two feet in depth, but were covered or hidden in grass.

The Safety Edge_{SM} backing material is planned to be HMA millings. This backing material was planned to be placed in the future and was not stored on the project site. More importantly, there are many areas where placing the HMA millings will be difficult because of the edge/shoulder condition (refer to Figures 2 and 3).

Figure 2. General overview of the 1.5 inch HMA layer placed along the project and pavement cross section provided by the Pennsylvania DOT.

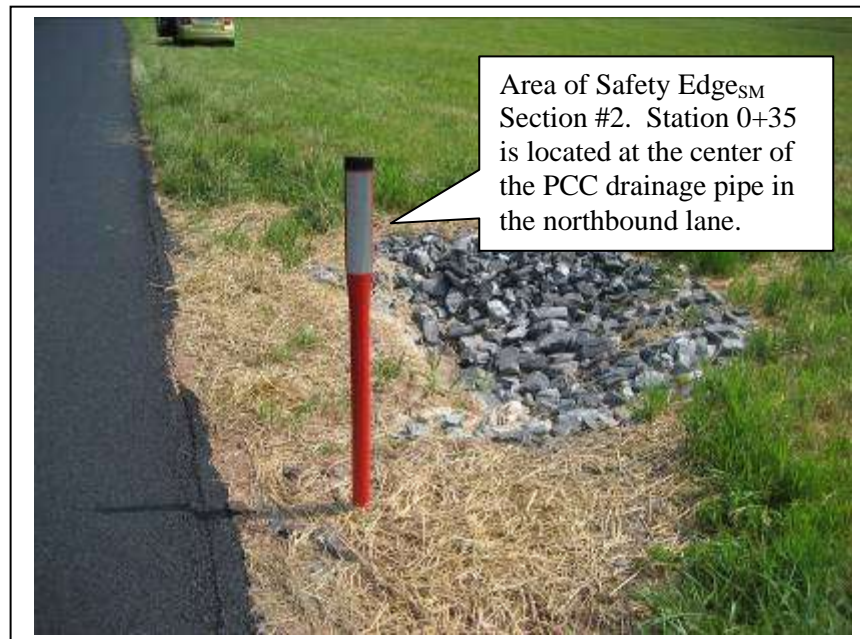
2. Non- Safety Edge_{SM} Control Section; north bound lane on the opposite side of the roadway from the Safety Edge_{SM} Section #1.
3. Safety Edge_{SM} Section #2; northbound lane, north of the intersection between Bellaire Road and Maple Dale Road – just north of 365 Bellaire Road. Station 0+35 for this section is located at the center of the culvert and PCC drainage pipe (refer to Figure 7). This section was selected because the Safety Edge_{SM} device was visually observed being used and this area is subject to erosion and future lane-shoulder drop-off.

Figure 7. Reference marker for Safety Edge_{SM} Section #2.

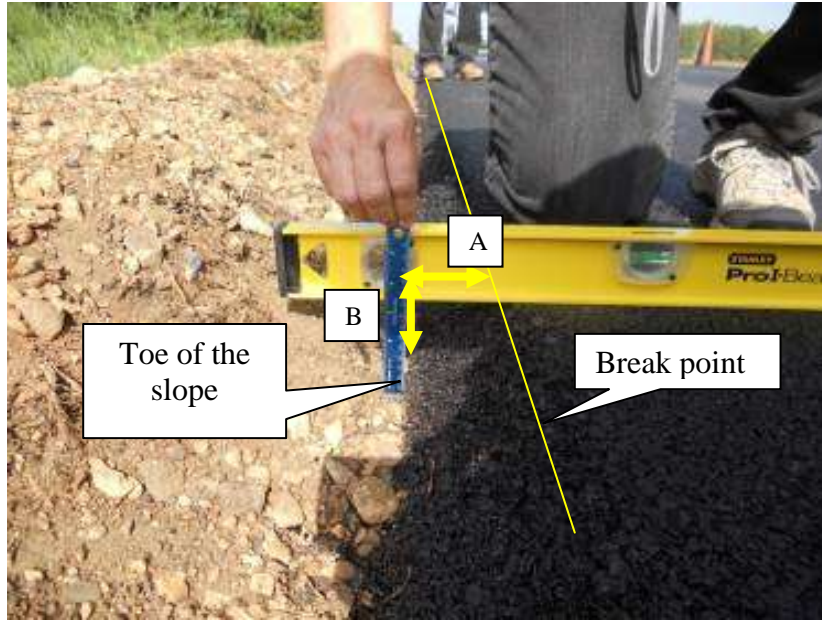
Slope measurements were taken using a straight-edge to measure the width and thickness of the taper of the Safety Edge_{SM} (refer to Figure 8). The average slope of the Safety Edge_{SM} was 48°. Table A-1 in Appendix A contains slope measurements recorded at each individual measurement location. Only one of the measurements was less than 40°. Figure 9 includes a comparison between the slope of the Safety Edge_{SM} and mat thickness at the Safety Edge_{SM} for the two test sections. As shown, there appears to be no correspondence between mat thickness and the slope of the Safety Edge_{SM}.

Figure 8. Measurement of the Safety Edges_{SM} angle.

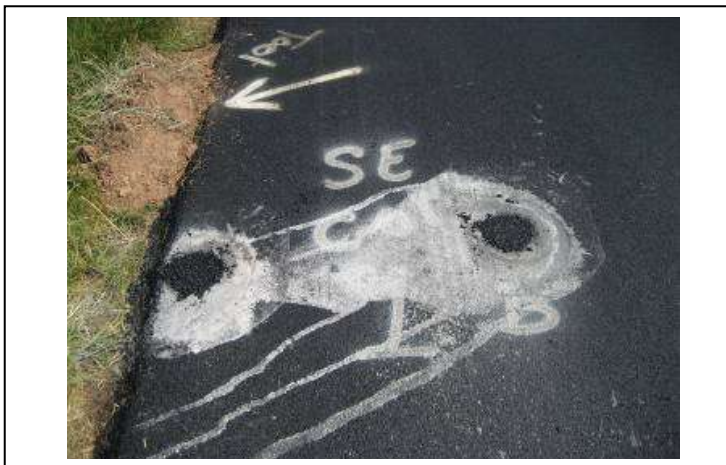
Figure 10. Location of cores and nuclear density tests.

Core #1; Safety Edge_{SM} section (A location is adjacent to the Edge; B location is near the center of the steel drum roller (about 3 feet from edge).

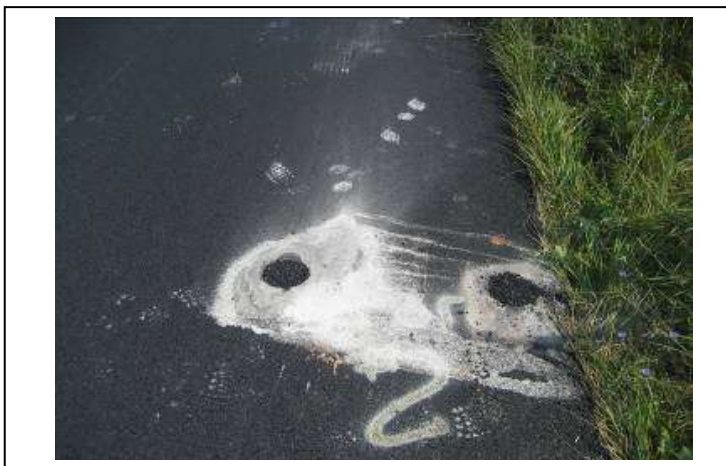
Core #2; Non-Safety Edge_{SM} section (A location is adjacent to the Edge; B location is near the center of the steel drum roller (about 3 feet from edge).

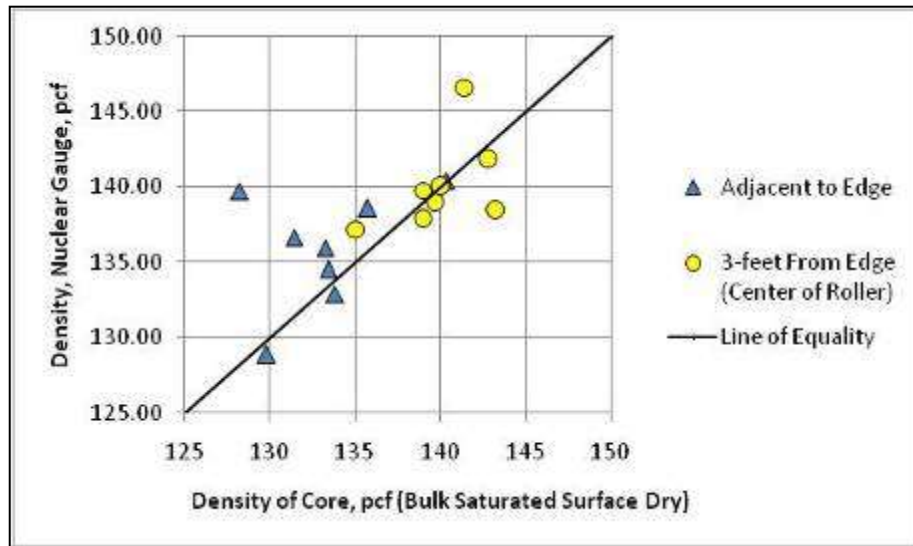
Nuclear density readings were taken at each core. Figure 12 shows a comparison of the nuclear densities and densities measured on the cores. As shown, there is close correspondence between the nuclear and core densities. Adjustment factors were determined for the nuclear density readings taken at the Safety Edge_{SM} and near the center of the steel drum roller being used to compact the HMA mat. The adjustment factors are included in Table A-3 in Appendix A and are summarized as follows:

As shown, the value near the center of the steel drum roller is unity and the value near the Safety Edge_{SM} is close to unity. These factors were used to adjust the nuclear density gauge readings to be consistent with the densities that would be measured in the laboratory.

Figure 12. Comparison of the nuclear density readings and densities measured on cores recovered from the HMA overlay.

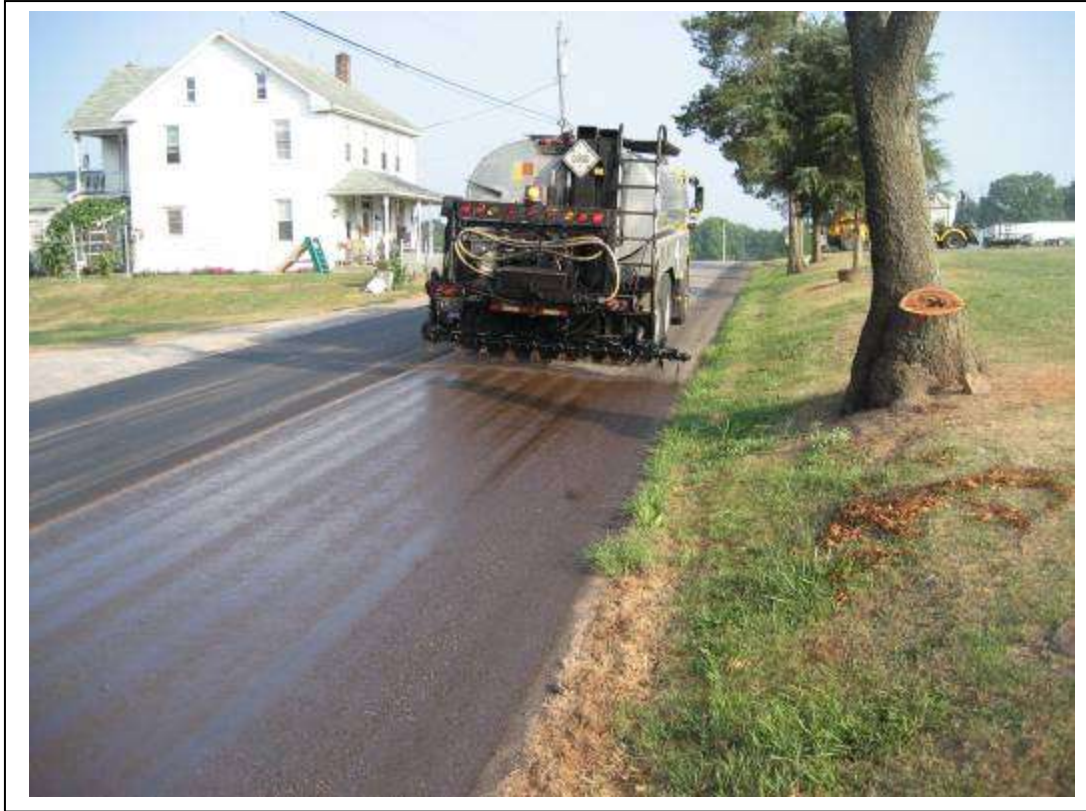
Figure 15 shows the condition of the existing pavement and the placement of the emulsion that was used as a tack coat for the HMA overlay. Figure 16 shows the paving adjacent to the shoulder.

Figure 15. An emulsion was used as a tack coat prior to HMA placement (note the material that was added to the edge of the pavement to widen the roadway).

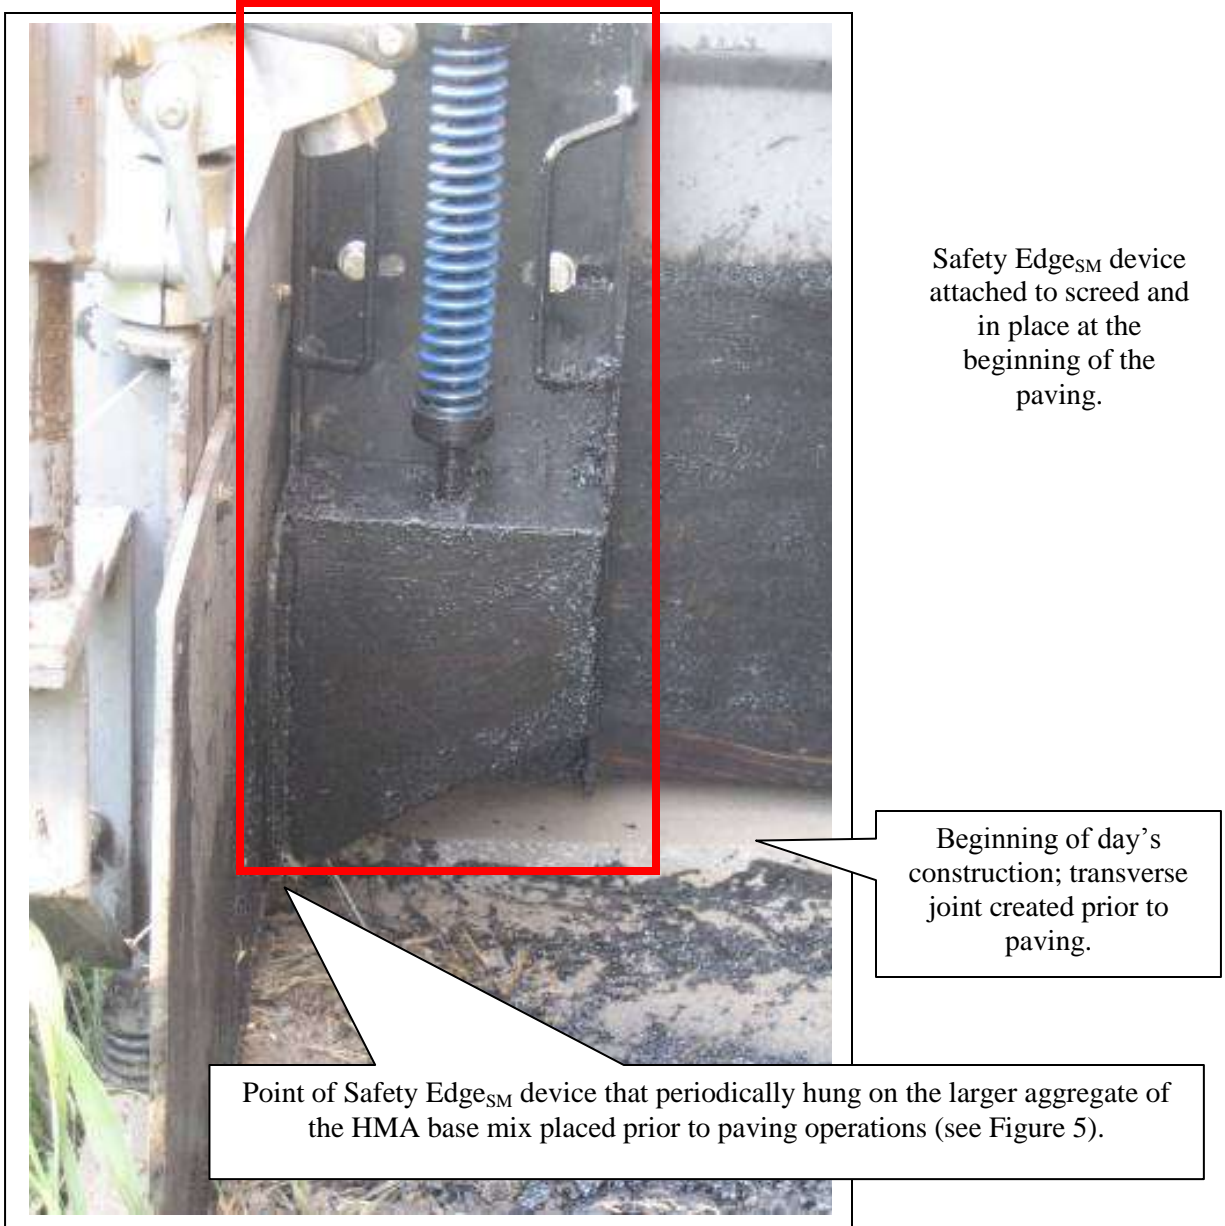
- The Safety Edge_{SM} was formed using the Advant-Edger device, which was properly bolted to the screed of the paver. Construction personnel recommended that the Safety Edge_{SM} device include an automated system for raising and lowering the device.

Figure 17. Safety Edge_{SM} device attached to the screed.
