# ND Condition Assessment of George Washington Memorial Parkway/Arlington Memorial Bridge

TRB 93<sup>rd</sup> Annual Meeting  
LTBP Program Workshop – Program Briefing  
Washington, DC – Thursday January 16, 2014

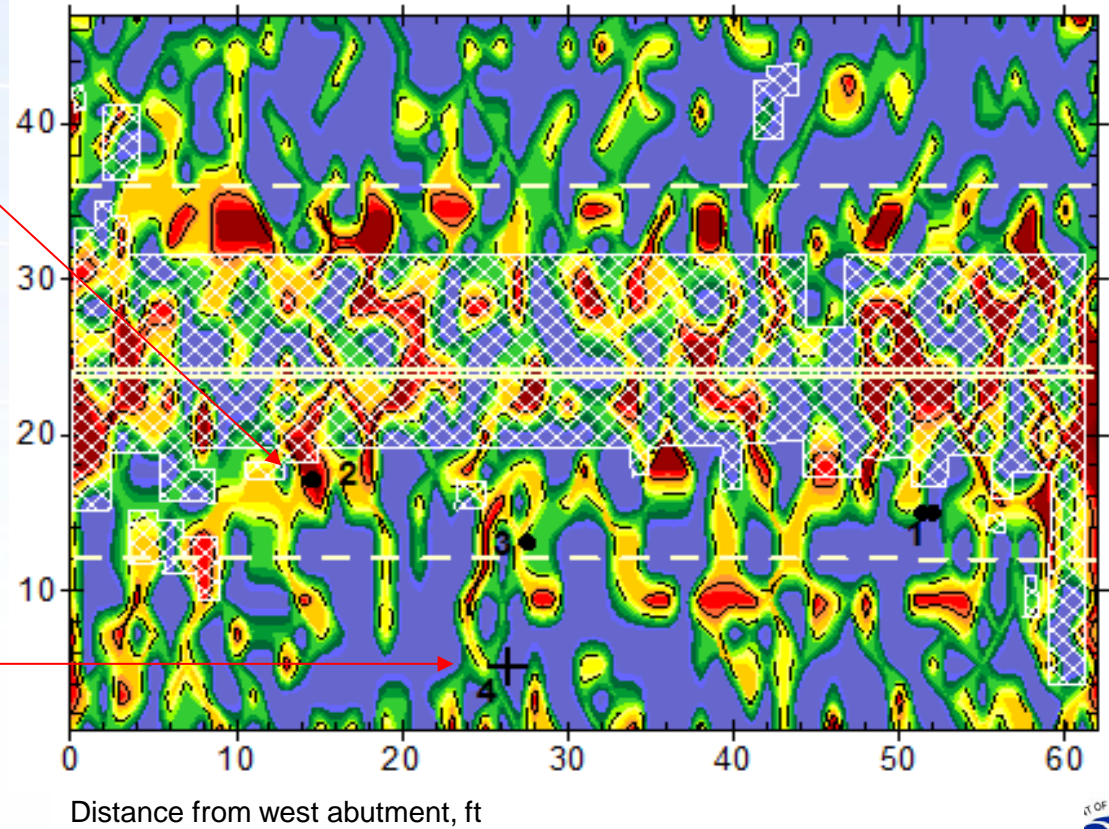
Impact-Echo (IE) Grading

Lane 1		Lane 3		Lane 6	
		Arlington	Lincoln	Arlington	Lincoln	Arlington	Lincoln
Impact Echo	Good	9%	18%	15%	19%	21%	19%
	Fair/Poor	19%	23.50%	23.50%	29%	52%	47%
	Serious	72%	58.50%	61.50%	52%	27%	34%

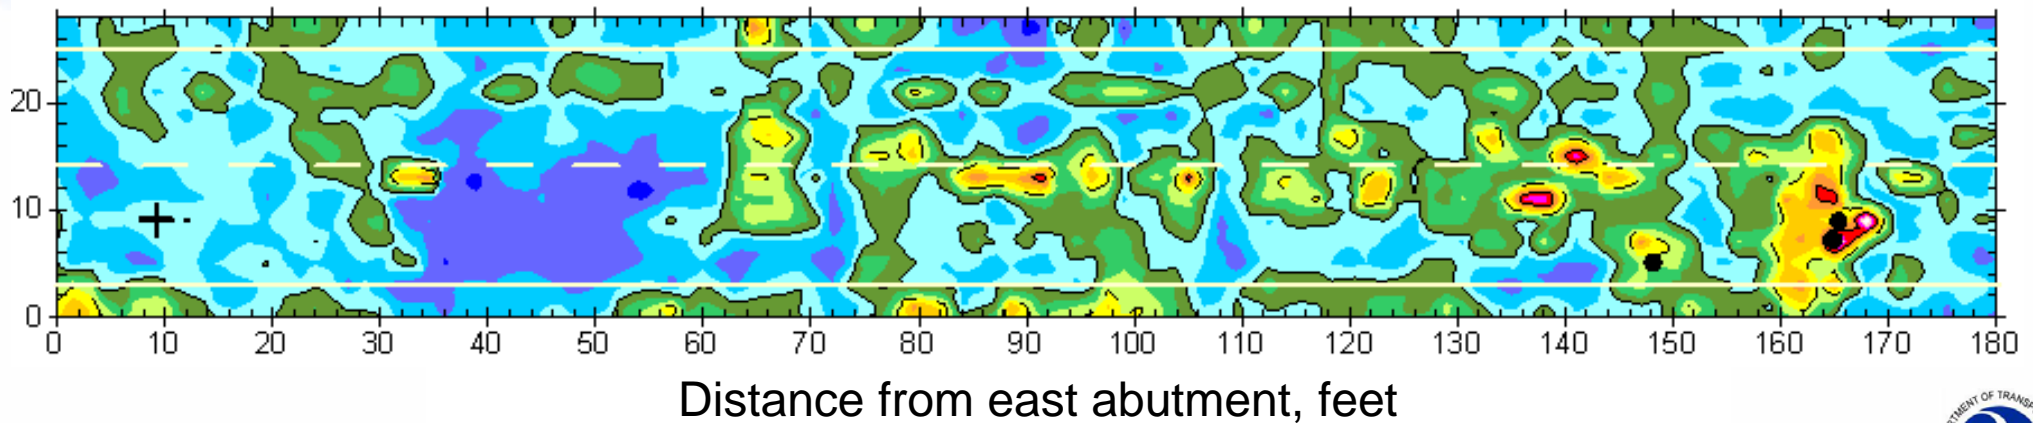
### Top Rebar Amplitude (Normalized dB) - Depth Corrected

Lane 1		Lane 3		Lane 6	
		Arlington	Lincoln	Arlington	Lincoln	Arlington	Lincoln
GPR	Good		8%		11%		11%
	Fair/Poor		67%		62%		72%
	Serious		25%		27%		17%

The GPR survey results also describe a significant percentage of the deck area to be deteriorated or/and highly corrosive. Only 10 percent of the deck area according to the GPR survey can be described as good.

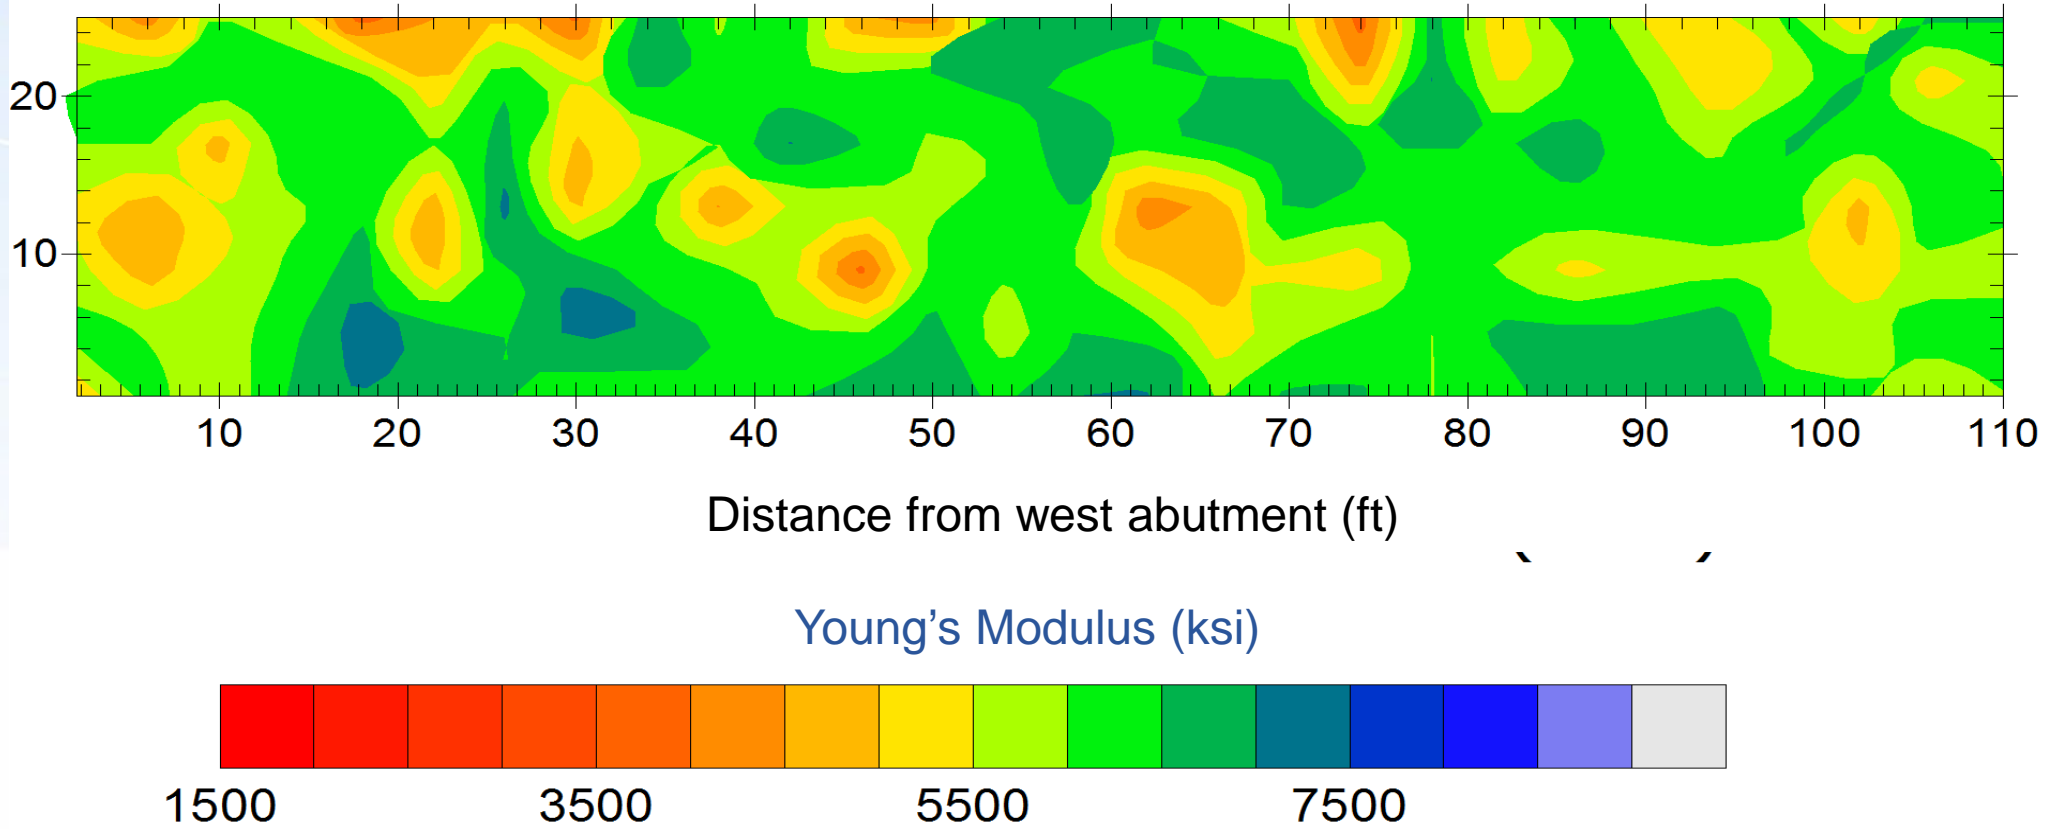
## Typical Concrete Quality Assessment Using Concrete Modulus from USW Test

Lane 1		Lane 3		Lane 6	
		Arlington	Lincoln	Arlington	Lincoln	Arlington	Lincoln
USW	Good	35%		7%		4%	
	Fair/Poor	34%		59%		17%	
	Serious	31%		34%		79%

The concrete modulus for most of the deck, about 80 percent, is less than 3000 ksi. The modulus is on the low side of typical values of concrete modulus in bridge decks, which in most cases is measured between 4000 and 6000 ksi.

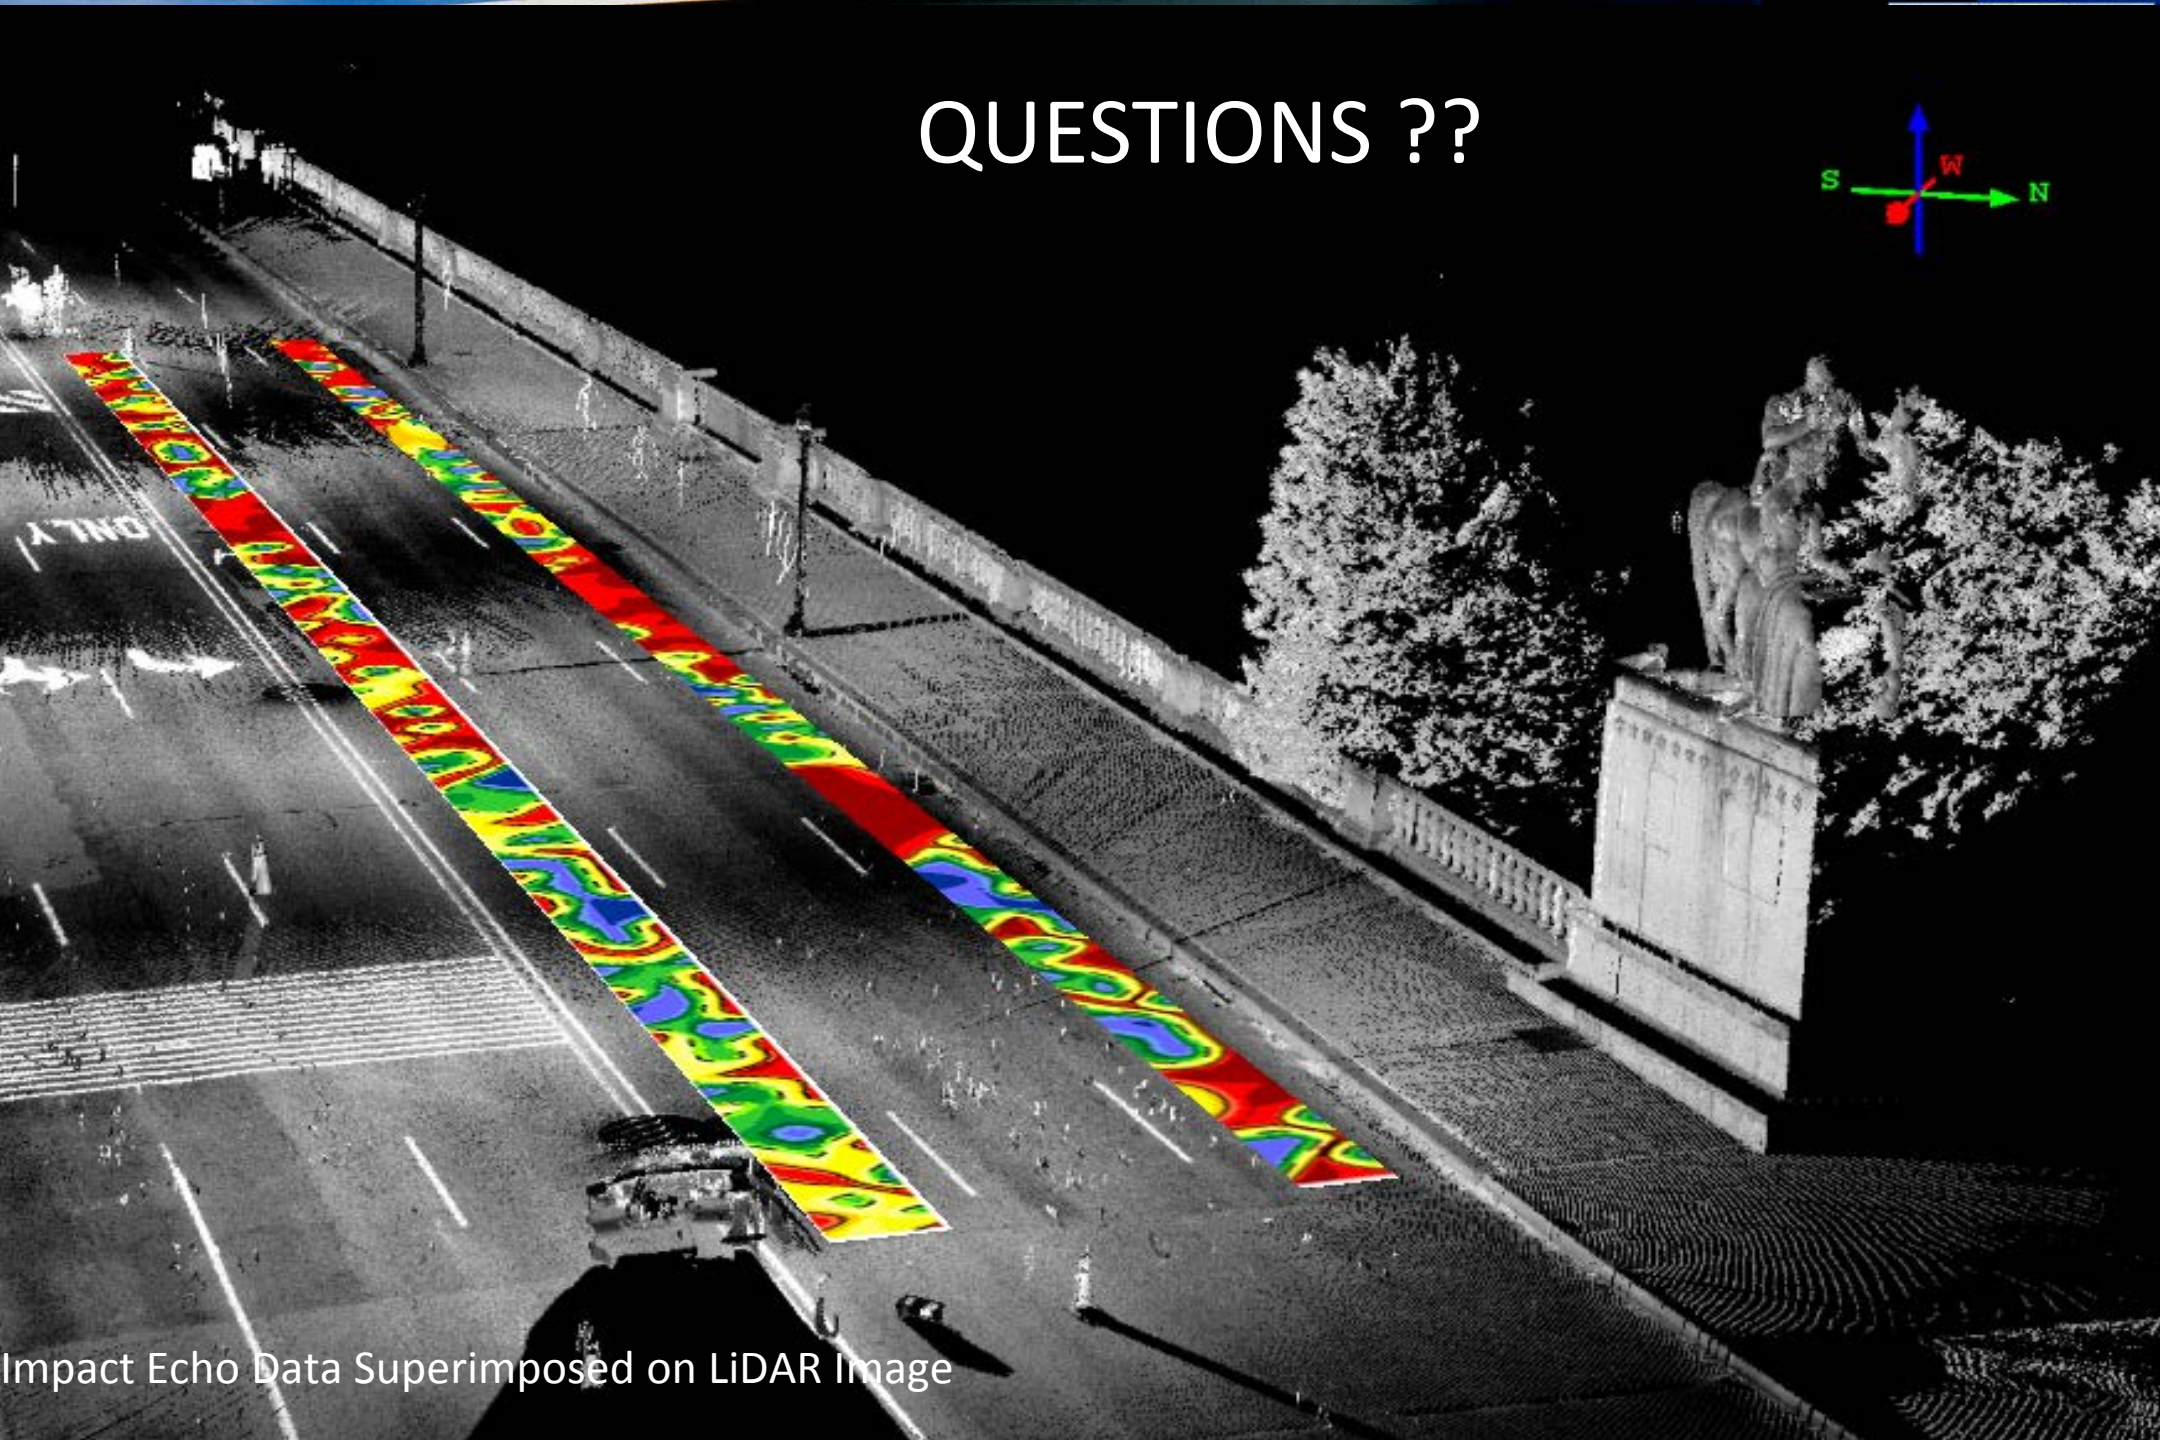
Impact Echo Data Superimposed on LiDAR Image

Based on the IE survey, almost eighty percent of the deck is delaminated or debonded. A high percentage of the deck, varying from about 30 percent on the Lane 6 side to more than 60 percent on the Lane 1 side, is already in a serious or severe condition. The delamination is more prevalent and more severe on the Lane 1 side and the delamination conditions are slightly less severe going towards Lane 6..
