Federal Highway  
Administration

# Video Inspection of Highway Edgedrain Systems

April 1998

FHWA-SA-98-044

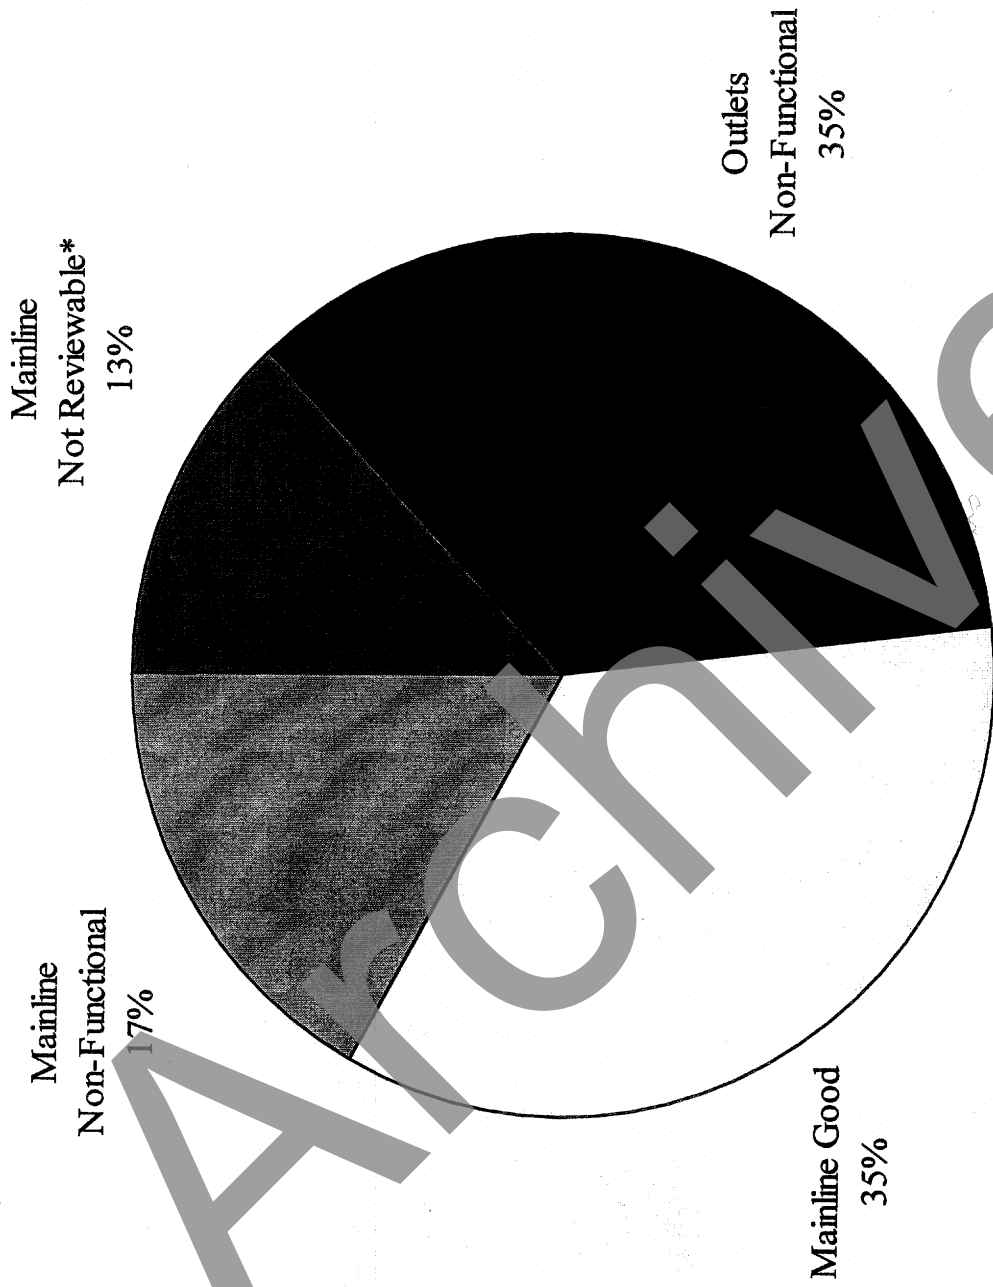
Of the 287 lateral/mainline edgedrain systems attempted, over 100 demonstrations were terminated due to defects with the laterals. Fifty-two (18%) had crushing in the lateral. Another 50 (17%) of the lateral systems were silted-in, limiting the investigations on these systems (Figure 8 and 9). In addition, 36 (13%) were composed of geocomposite sock, panel drain, drop tees, drop inlets, or no mainline systems at all (Figure 10).

\* Could not inspect geocomposite socks, panel drains, drop tees, drop inlets or systems where no mainline was installed.

Figure 10. Breakdown of Video Inspections.

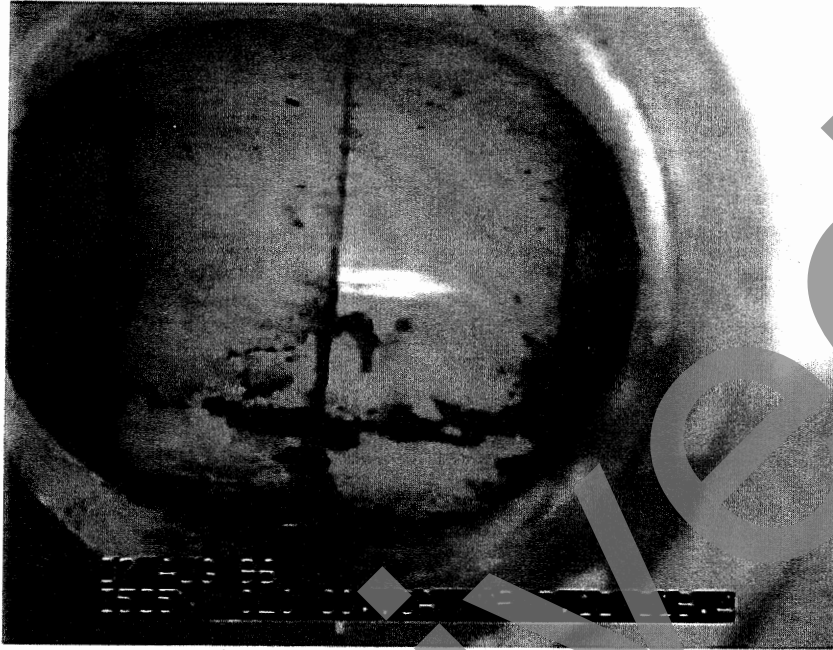
149 (52%) mainline segments were capable of inspection. Figure 11 shows a clear 90° tee junction of the lateral and mainline. Of these 149, 17% (26) were found to be crushed, silted in, or obstructed within the first 30 meters. Sixteen percent (24) of the inspections covered 30-60-meters of the mainline segment, 28% (41) went to the 60-90-meter range (Figure 12), 18% (27) were in the 90-120-meter range and 21% (31) covered 120-150-meters of the mainline (Figure 13). In many instances, a crush in the mainline system could be identified or associated with a known construction crossing prior to the opening of traffic on to a given highway.

Figure 11. Clear 90° Tee Junction of Lateral and Mainline

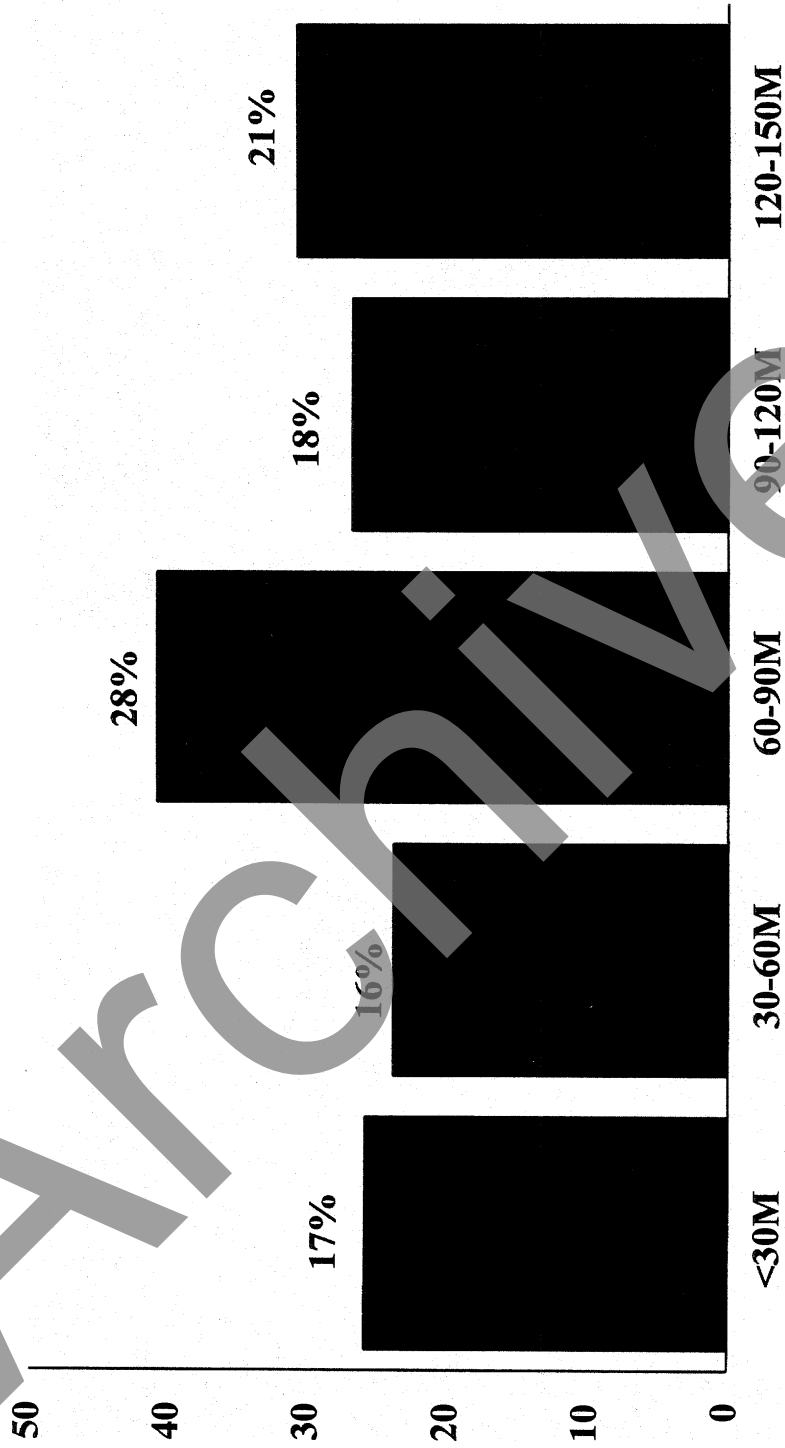
Figure 13. Mainline Demonstrations Resulting in the Following Attained Distances.

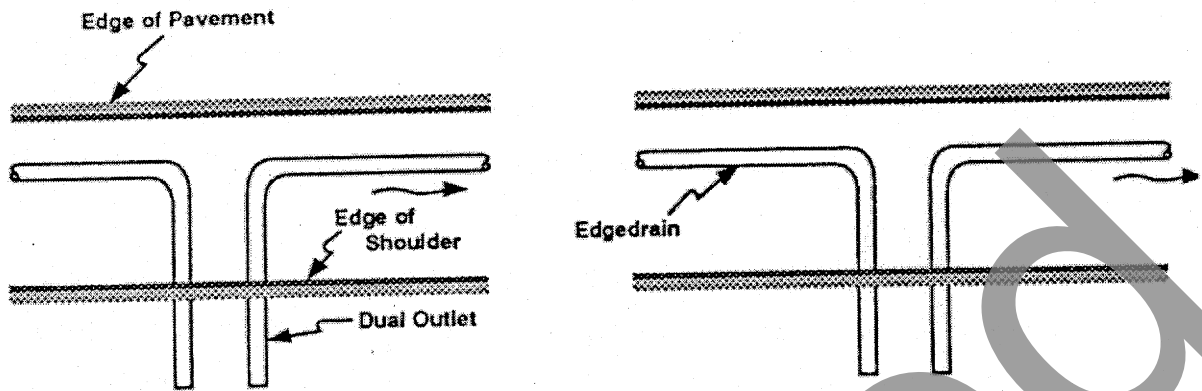
Figure 22. Edgedrain Design for Maintenance.

Edgedrain design is already experiencing changes such as less angular connections (and dual outlets Figures 22 and 23) to facilitate performance and use of inspection and clean-out equipment. From these initial demonstrations one could identify materials which appear to be better suited for use in edgedrain systems. Such a practice for selection of materials can be very misleading. Evaluations incorporating initial materials and construction costs, maintenance and replacement costs were beyond the scope of this project. However, as quality control specifications come into play, such considerations will typically find their own natural balance.

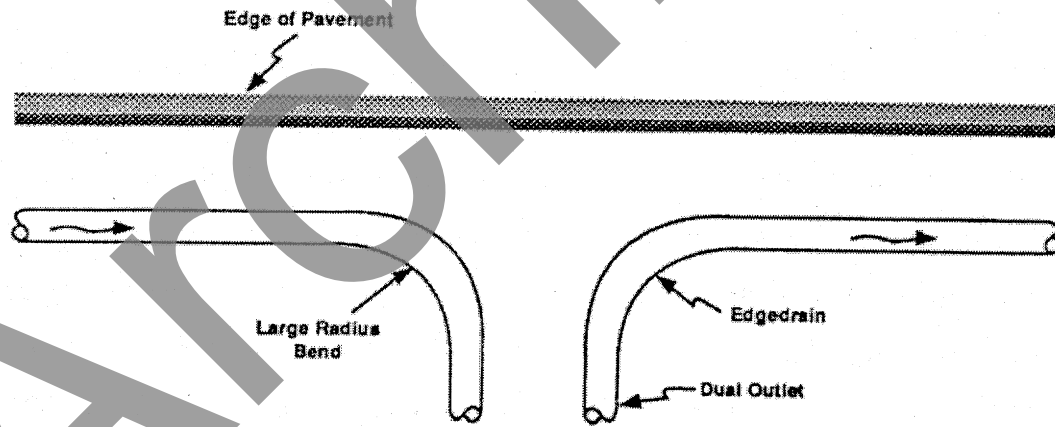
Figure 23. Smooth, Long Radius Bends for Edgedrain Outlet.
