## **5.4. STATE-DEPENDENT INSPECTION RESULTS**

### **5.4.1. State-Dependent Task Descriptions**

### 5.4.3. Task I

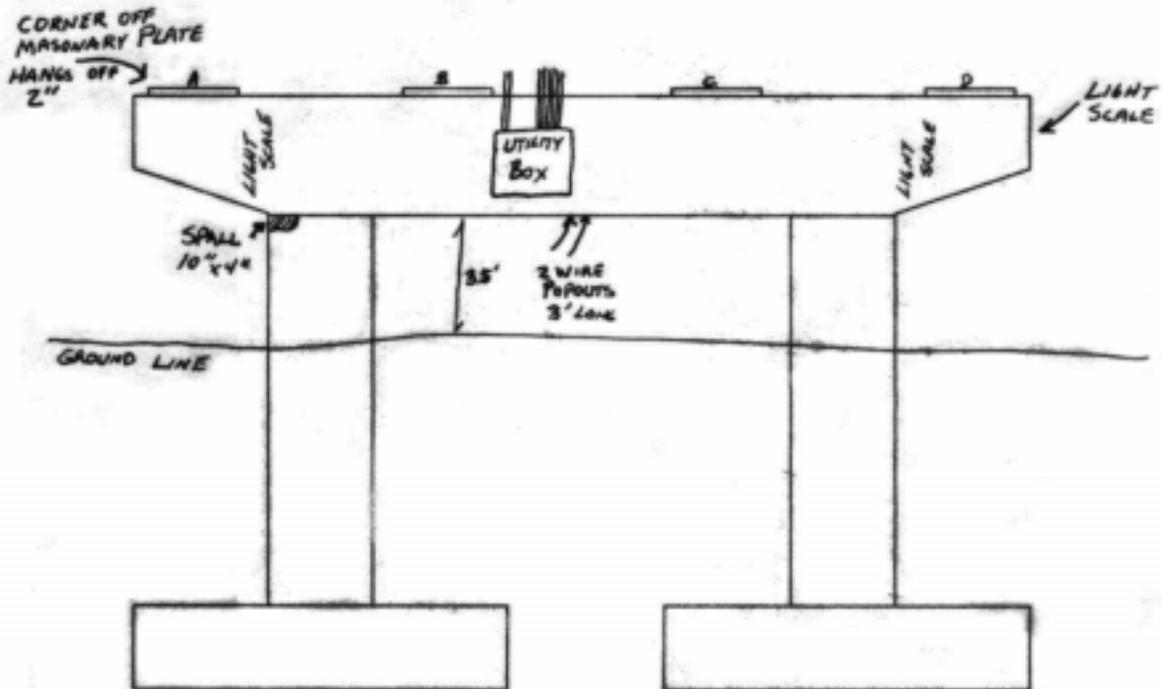
Figure 159. Sample substructure worksheet page from a field-written final report.

ELEMENT	RATING	COMMENT
CAP	G-F	LITE SCALE, Z WIRE POPOUTS ON BOTTOM
COLUMNS	G	
PLUMP	G	
FOOTINGS	NV	
BEARING	F	SLITE CORROSION, PAINT SCALE, LITE RUST

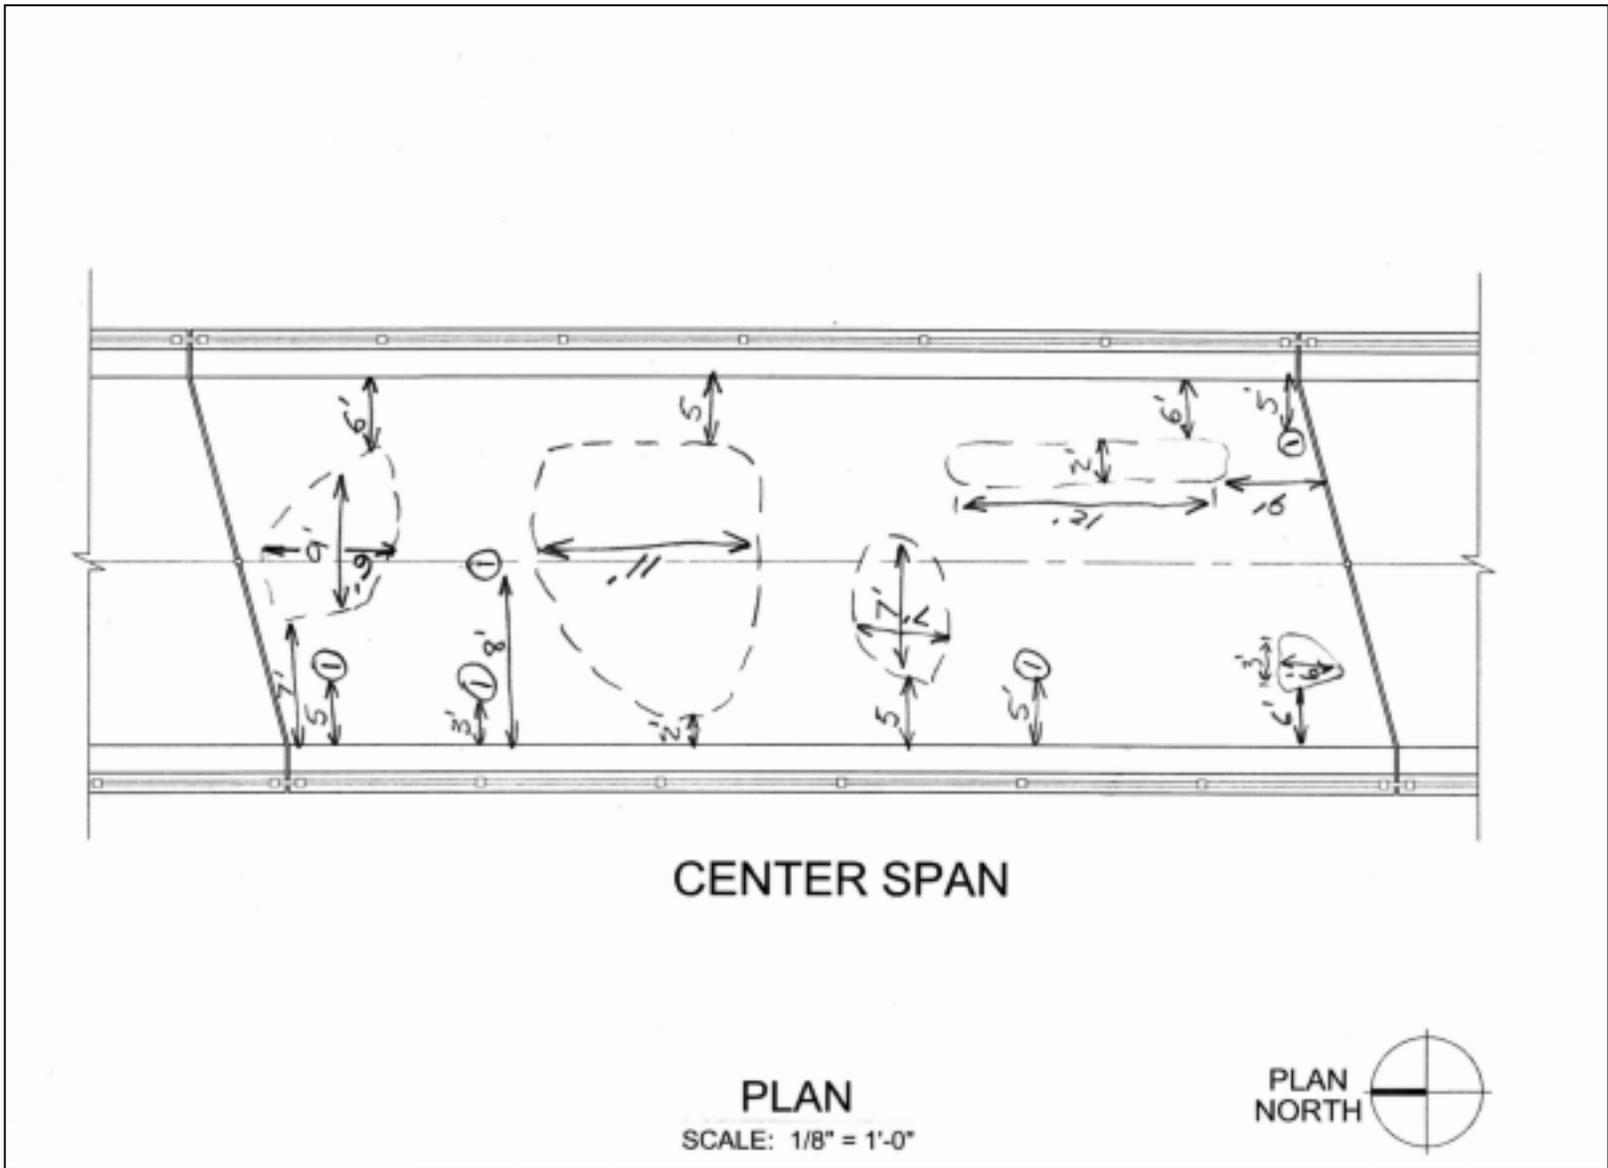
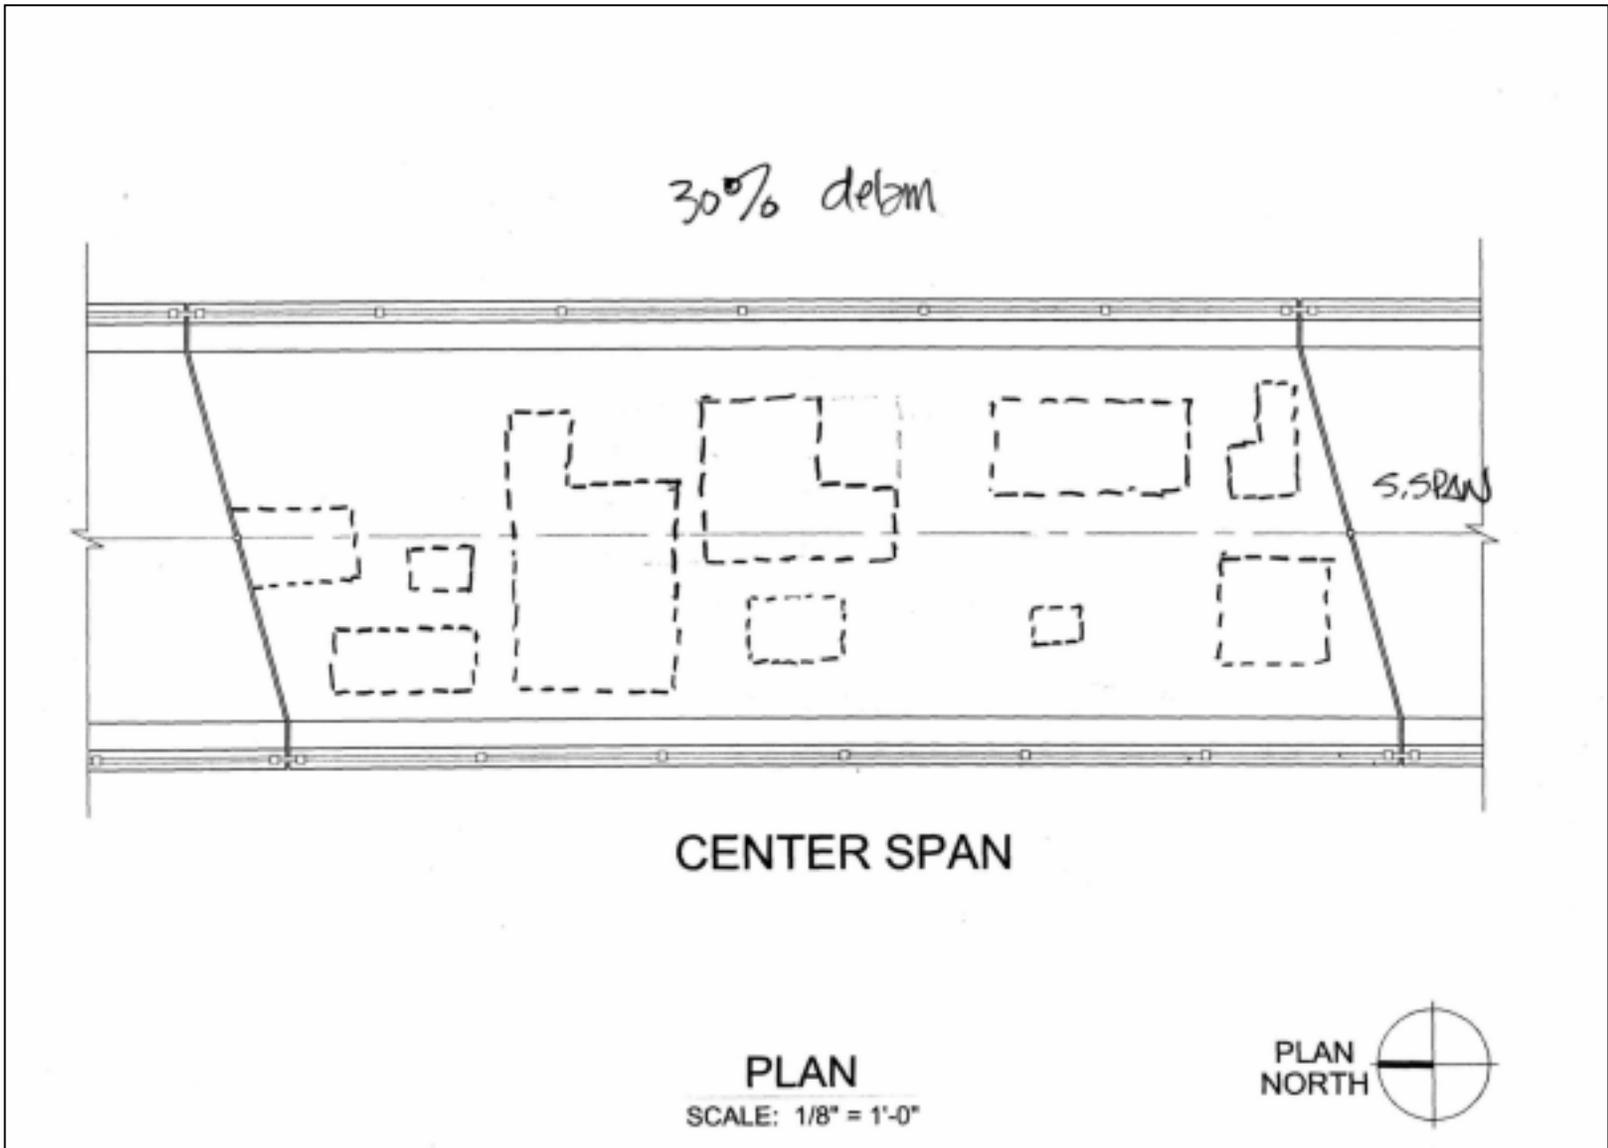
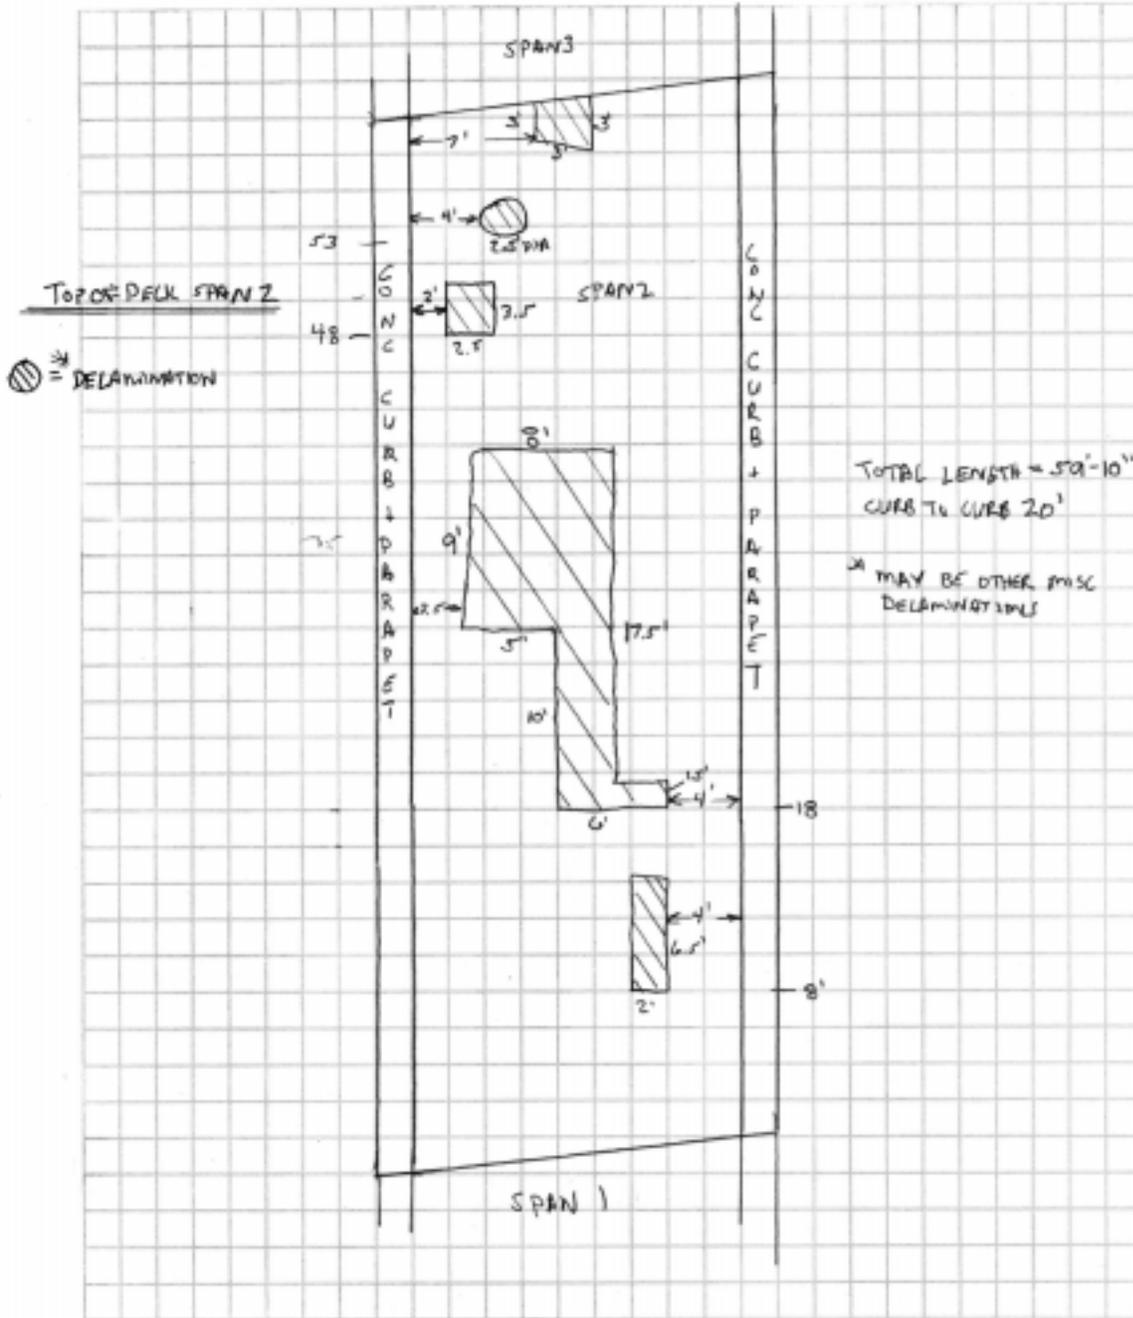
The reporting techniques varied considerably for the delamination survey. Although some teams brought along worksheets to record delaminations, most teams used the deck plans provided by the NDEVC. Twenty teams submitted delamination maps. An additional two teams provided a delamination percentage without an accompanying map. Sketches ranged from quickly drawn, schematic representations of the deterioration with no dimensions provided, to positioned sketches with dimensions provided. Only a few teams used their resulting delamination map to provide an estimate of the percentage of delaminations. To illustrate the range of sketches submitted, figures 184 through 187 show sample delamination maps. Note that none of these sketches are drawn to scale. An example of a fully-dimensioned sketch recording delamination positions, but without a total delamination quantity, is presented as figure 184. Figure 185 shows a sketch with only partial delamination positioning, which also does not provide a total delamination quantity. Figure 186 illustrates a sketch without dimensions; however, it does include an estimate of the total delamination quantity. Figure 187 shows one of the sketches made by a team on their own notepaper.

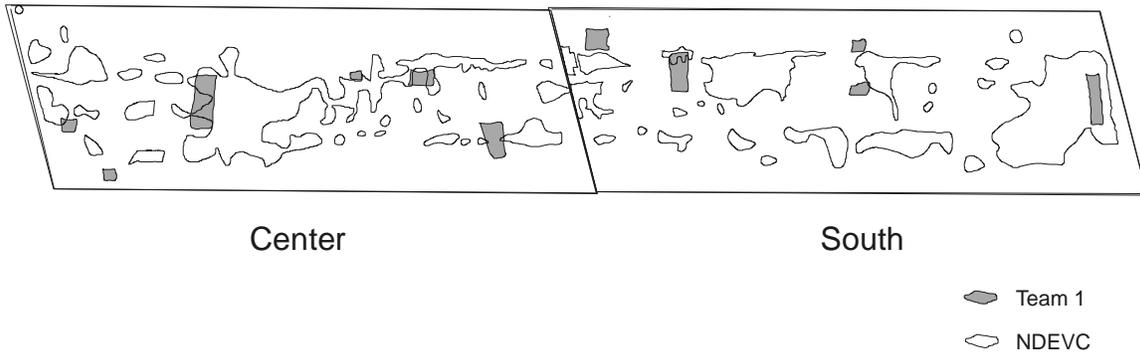
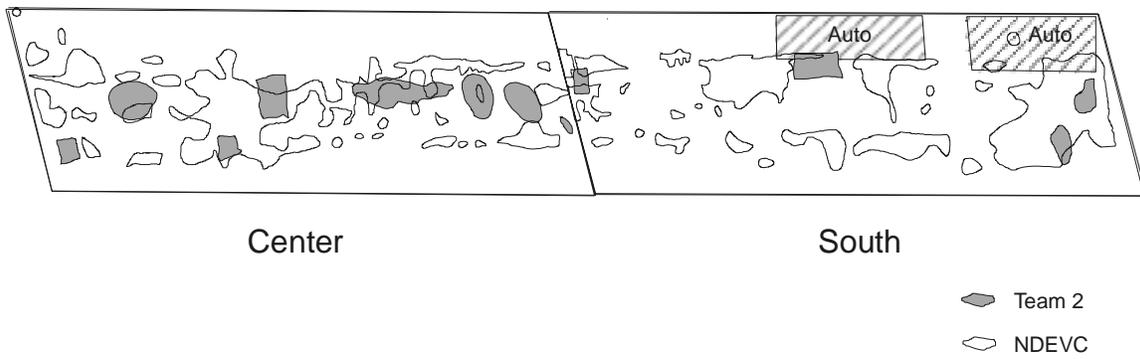
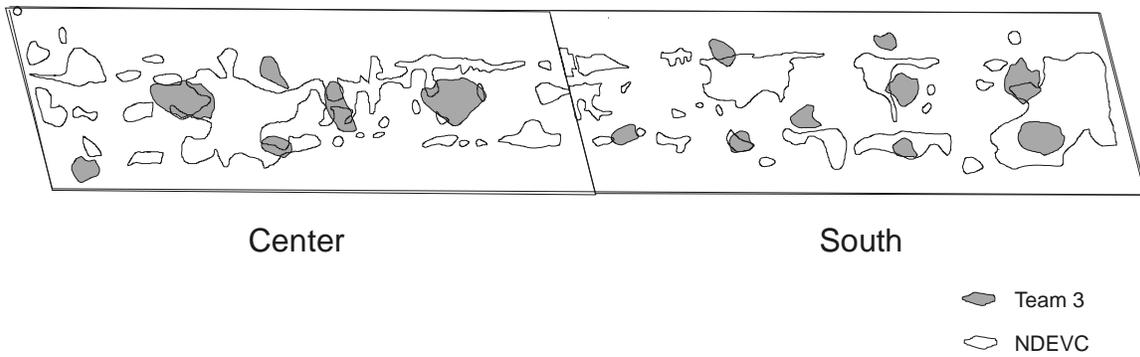
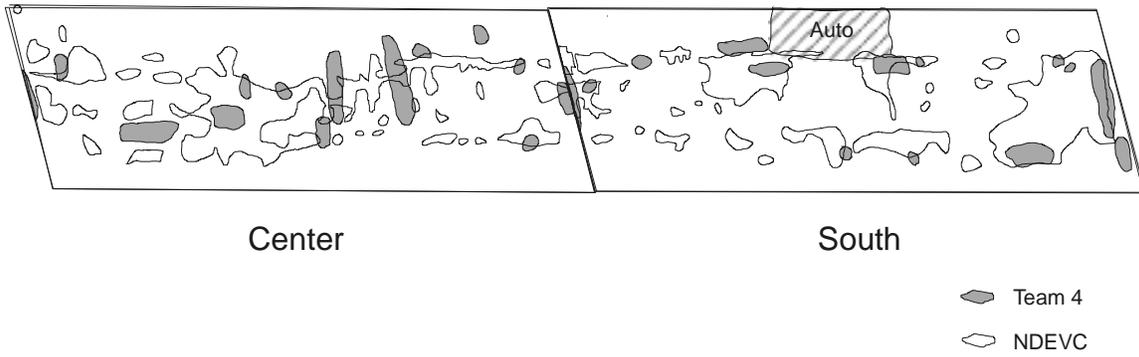
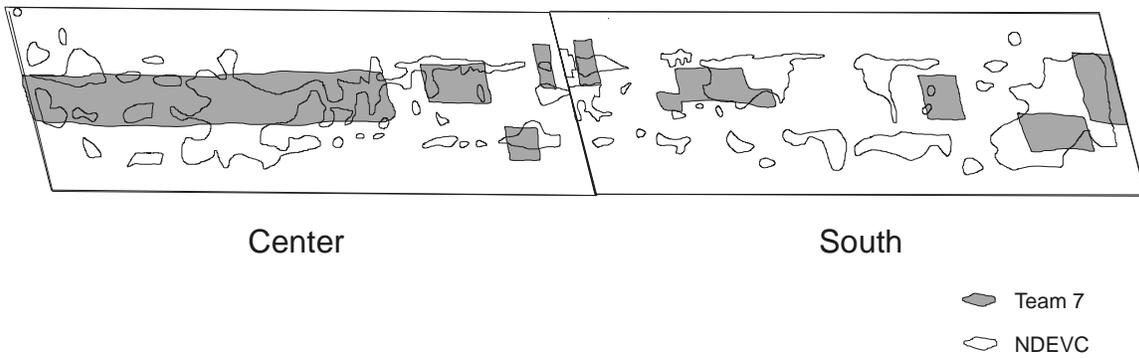
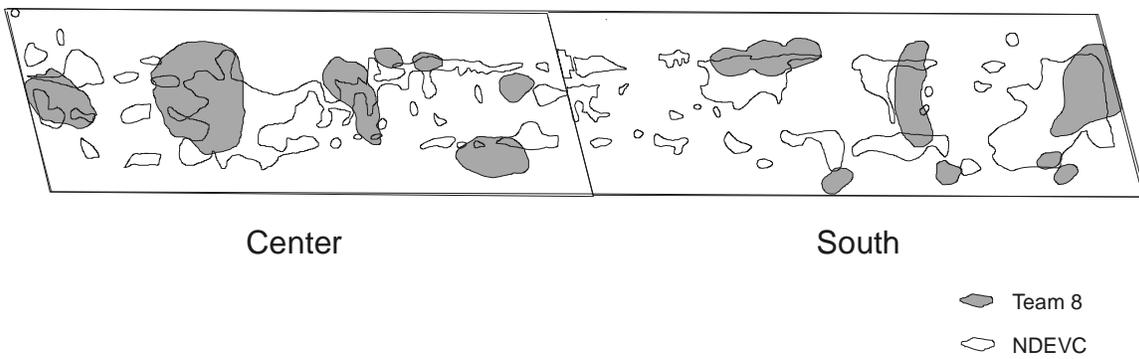
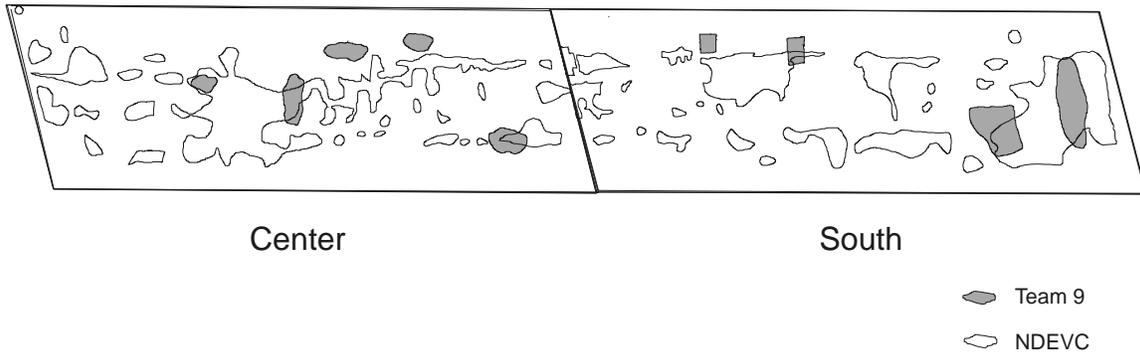
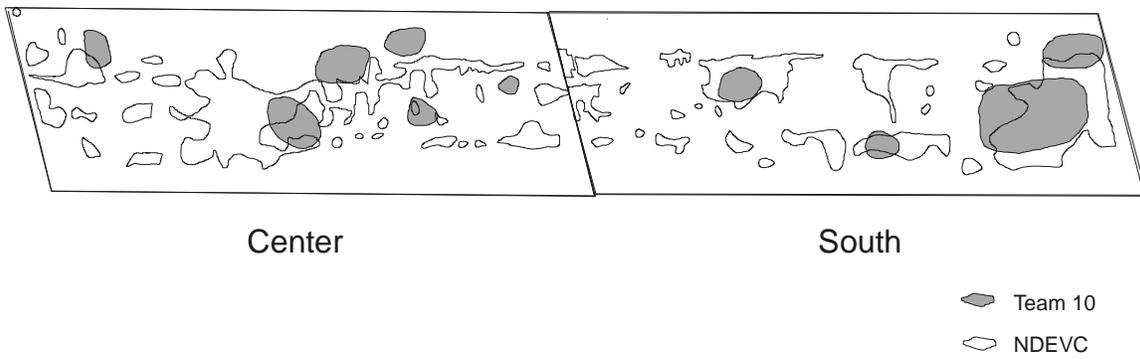
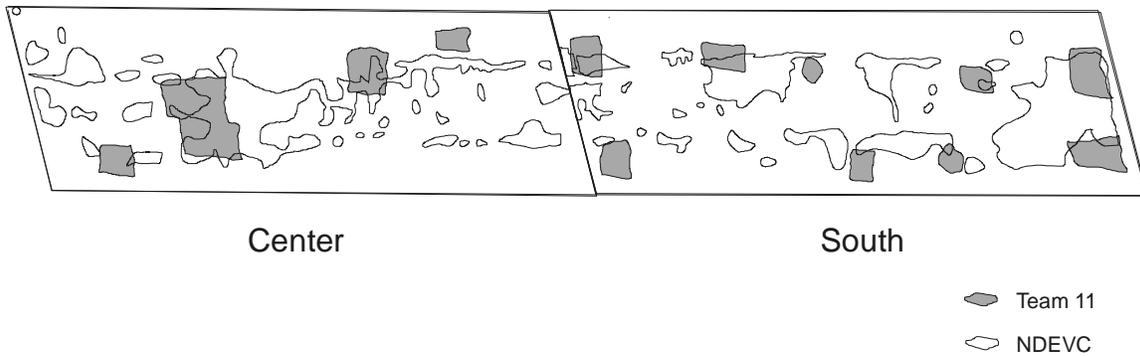
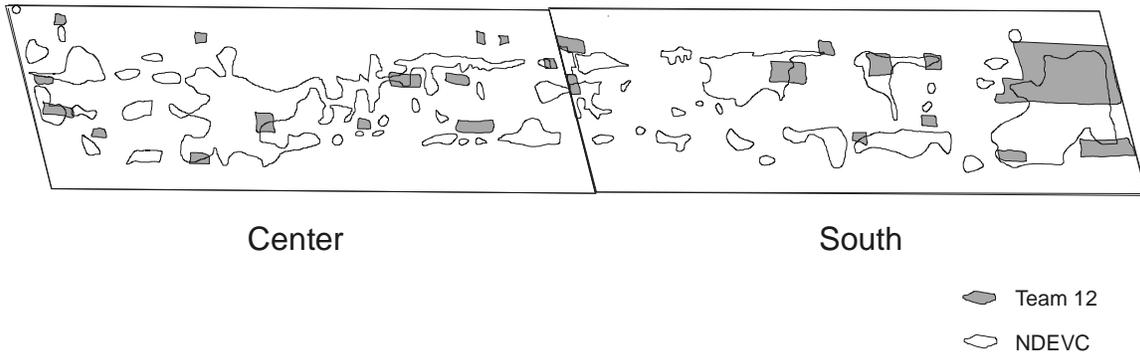
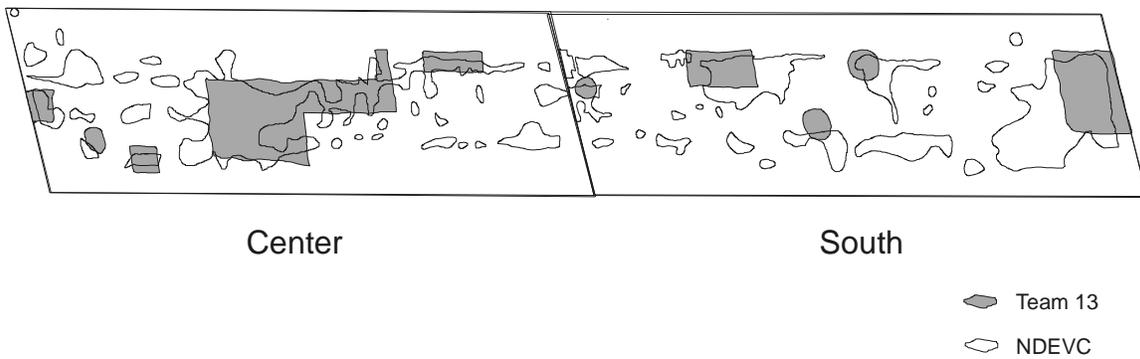
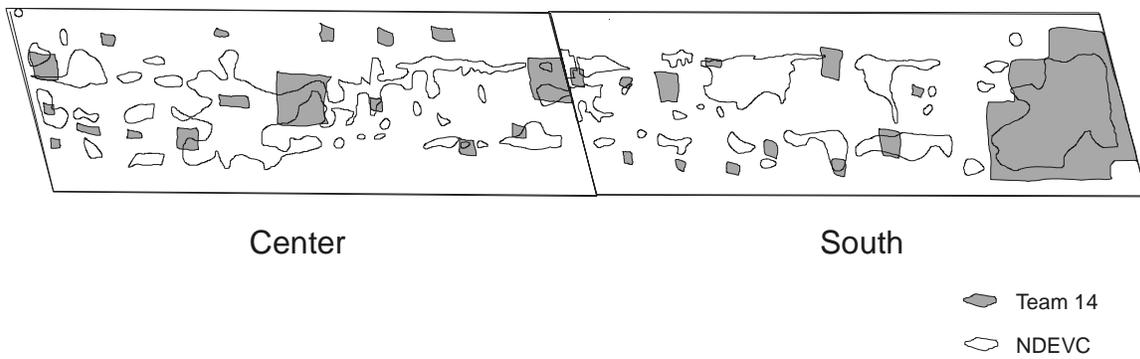
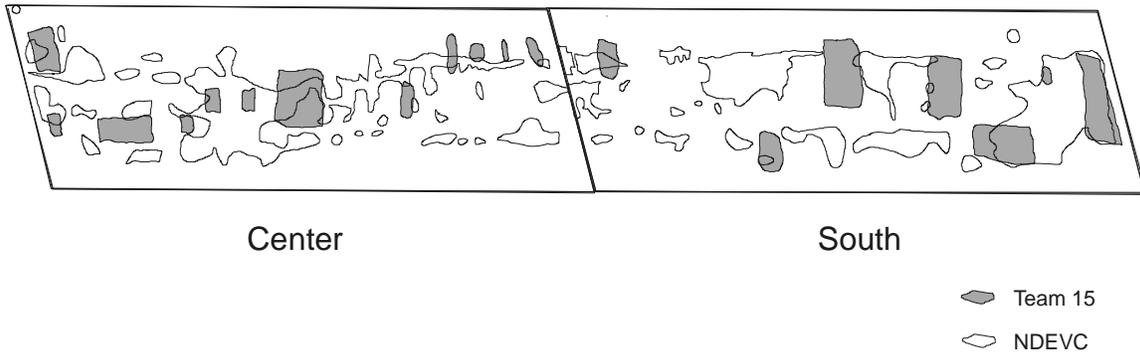
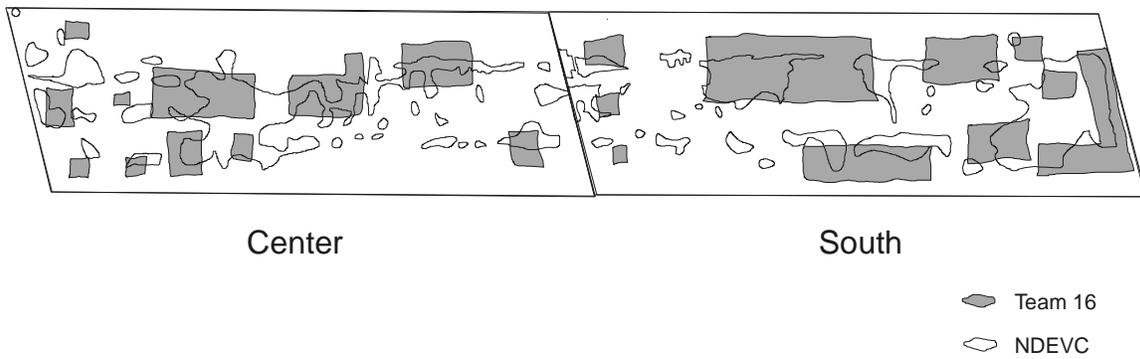
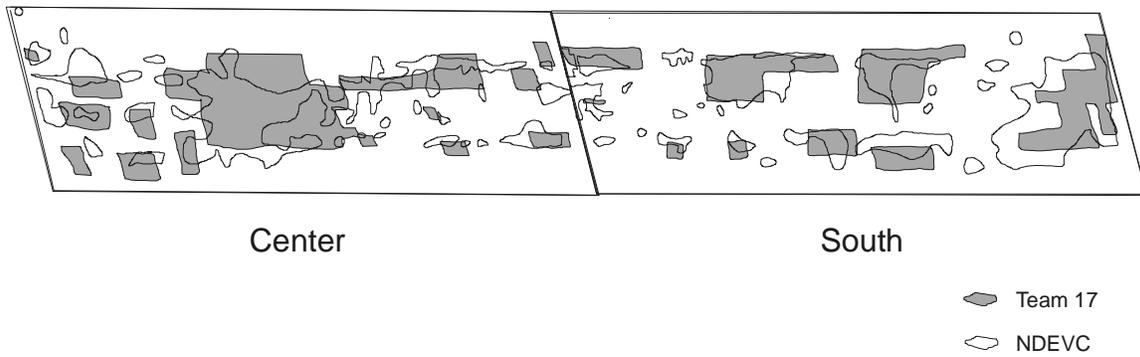
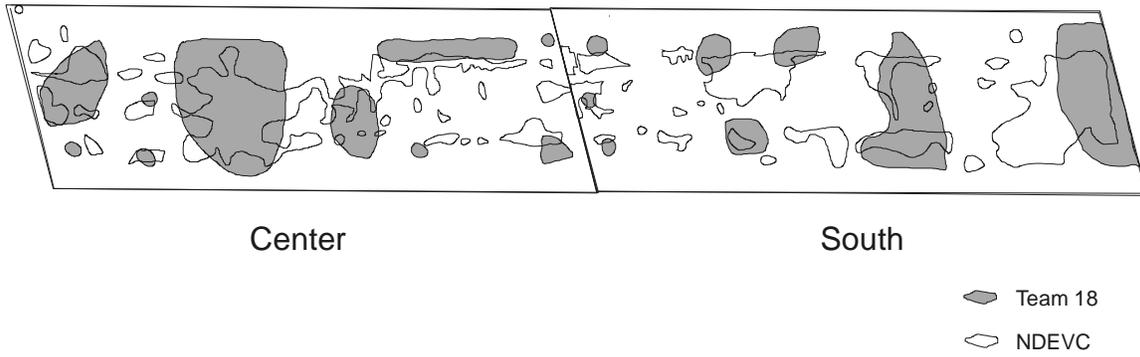
Figures 192 through 211 show overlays of the team sketches superimposed upon the delamination outlines determined by the NDEVC. These figures are identified using the same team identifiers used in table 235. Recall that Teams 5 and 6 did not submit delamination maps; therefore, data from these teams are not included in figures 192 through 211. These overlays were created assuming that the maps submitted by the teams were drawn to scale. For most of the sketches, this assumption is justifiable. However, a few of the maps were drawn to an inconsistent scale, with 0.6-m by 0.6-m dimensioned areas drawn about the same size as 1.8-m by 1.8-m dimensioned areas. Attempts were made to regenerate some of these maps using the position and size information provided, but these “corrected” maps had enough other errors in positioning and sizing that they were not considered to have improved on the original sketch that was submitted. Therefore, all areas are shown without modification. In two cases, automobiles were parked on the deck, preventing complete inspection of the deck. These areas have been noted.

*RECTANGULAR OUTLINES VERSUS ACTUAL OUTLINES:* Looking at the delamination maps presented in figures 192 through 211, it appears that two different philosophies were used to develop these sketches. One philosophy uses rectangular areas to mark the delaminations. The other philosophy uses areas that are either generally circular or oval to mark the actual outlines of the delaminations. Table 237 summarizes the delamination percentages indicated by each of these two groups. As shown in table 237, the teams that mainly seemed to indicate actual areas had a much smaller average delamination percentage than those who indicated rectangular areas. The indication from this table is that inspector accuracy of delamination percentage estimates may actually be poorer than previously reported. Although the average delamination estimates of the teams that indicated rectangular areas are much closer to the

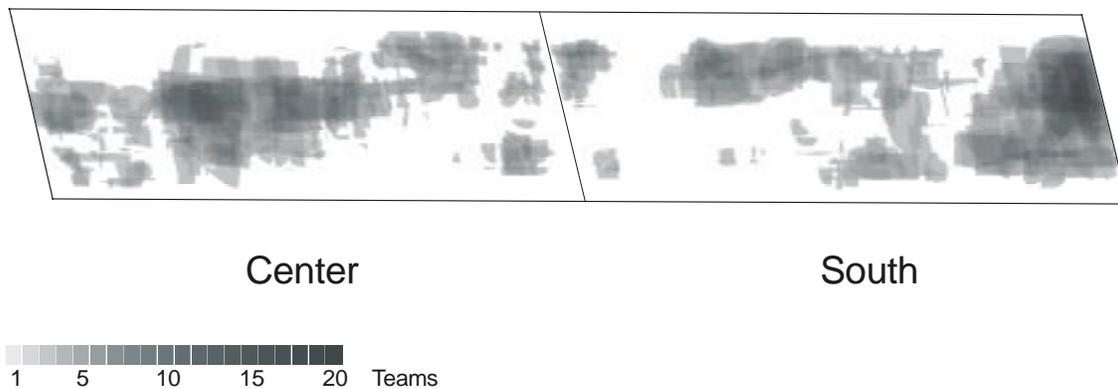
Two other commonality levels were studied graphically. First, since the delamination maps submitted by the teams were approximate, the areas indicated as being delaminated by at least three teams were investigated. This investigation may reduce some of the errors within the maps by eliminating unique delamination calls and the first intersection level, both of which may be mislocated due to positioning errors in recording the data. As shown in figure 215, the total area with at least three delamination calls covers 40 percent of the deck area. Second, it was calculated that the amount of the deck area covered by at least five delamination calls was 21 percent. This level is closest to the 19 percent indicated by the NDEVC survey. Figure 216 compares the delamination map showing at least five delamination calls with the survey performed by the NDEVC.

Figure 215. Areas indicated as containing delaminations by three or more teams.

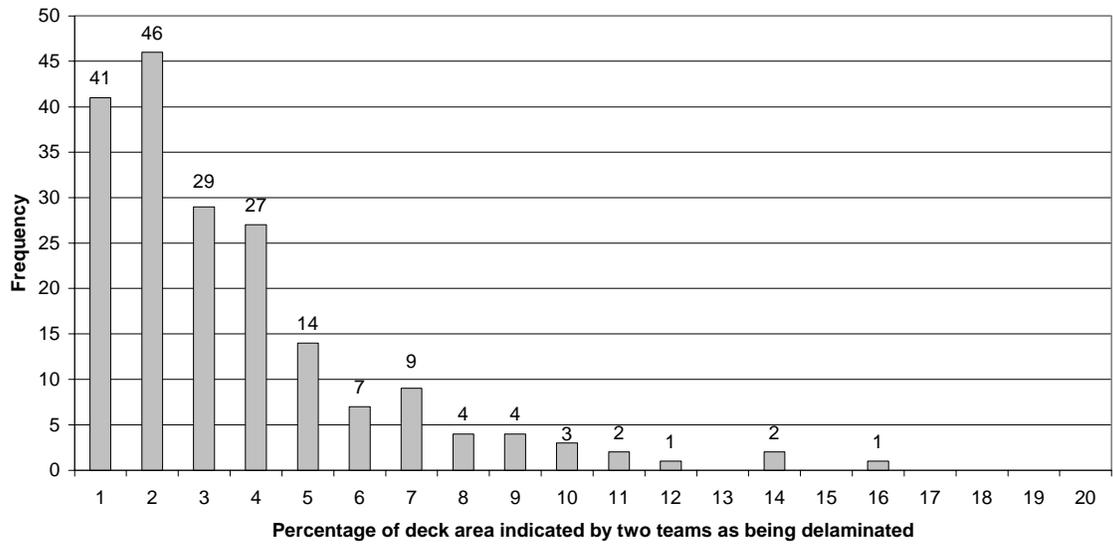
Another analysis was performed that investigated the correlation of the delamination maps between any two teams. There are 190 possible combinations of 2 different delamination maps. Figure 217 shows a histogram of the amount of intersection of the delamination areas for these combinations of two teams. The maximum amount of deck area indicated as being delaminated according to the intersection of two teams is 15.5 percent, while the most frequent amount of delamination intersection is between 1 and 2 percent.

Figure 217. Histogram of amount of deck area indicated by two teams as being delaminated.
