# Event Report

## FHWA Office of Bridges and Structures

**Subject:** Ft. Pitt Tunnel Luminaire Connection Failure

**Location:** Pittsburgh, PA

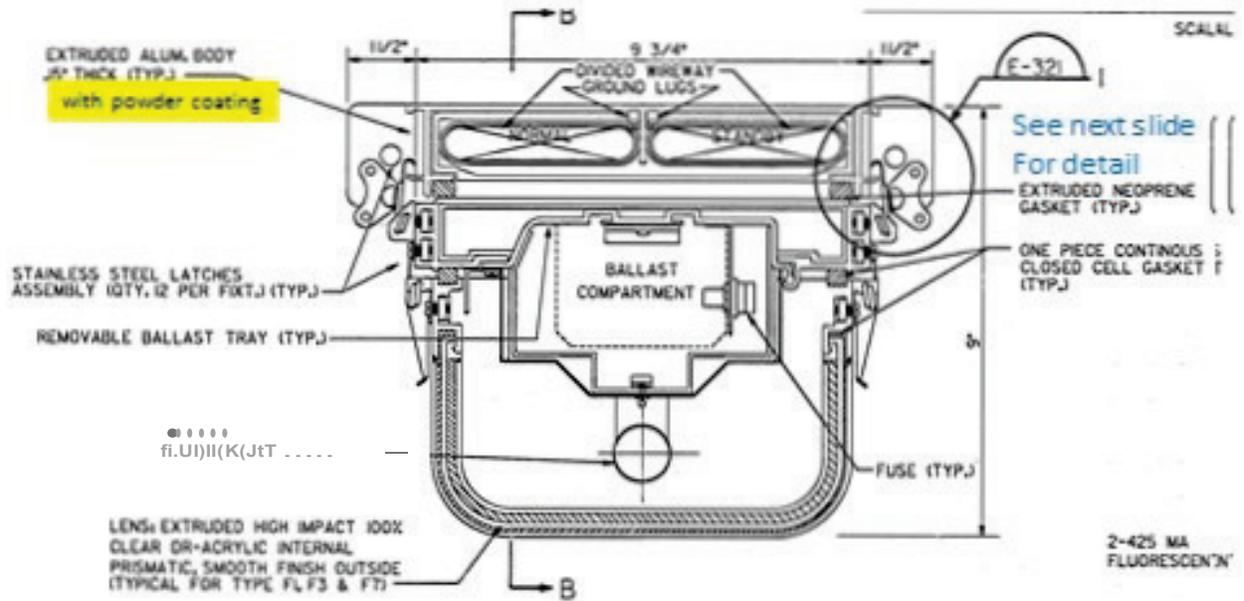
TYPE FI FIXTURE - SECTION A

The lighting fixture is as shown in the attached sketches and manufactured by NuArt Manufacturing Inc. The wireway is an 8' 2 1/2" long by 9 3/4" wide aluminum extrusion with powder coating and continuous lips on both sides where the stainless steel latches are attached to hold the lighting fixtures in place. 10 latches (5 on each side) are used to hold each 8' 2 1/2" fixture.

The metallurgical analysis of the fallen fixture revealed that significant corrosion of the lips at the locations where stainless steel clips were attached to the lips. Complete thickness of the lips was consumed by corrosion, allowing the lighting fixture to fall off from the wireway. The lighting fixture weighed about 100 pounds. Corrosion was observed in other areas along the lips, but to a lesser degree. The analysis also concluded that the corrosion was caused by (1) an aggressive chloride environment, (2) crevice corrosion at crevices created by the clamping force exerted on the aluminum lips, and (3) galvanic corrosion caused by two dissimilar metals when the coating was breached and crevices formed. The analysis further concluded that the primary cause of failure is the corrosion of the aluminum lips at tight crevices, and the galvanic corrosion played a secondary role.

As an urgent and temporary measure, the MassDOT has been performing nightly inspection to check for corrosion along the aluminum lips, and between the SS latches and aluminum lips. In areas of severe corrosion, the latches were loosened and moved a small distance to a non-corroded area of the lips. Using this method, the State was taking care of the fixtures near or over a traveled lane first. As of yesterday, MassDOT has inspected 96% of the 23,000 tunnel lighting fixtures. It is estimated that about 1.5% of the fixtures have significant corrosion problems. Most of the problems are near the portals. Inspection, analysis and solution-finding activities are ongoing.
