REHABILITATION OF THE HAMMOND BRIDGE IN MARION COUNTY, IOWA

**REPORT COMPILED BY JAN OLIVE NASH
TALLGRASS HISTORIANS L.C., IOWA CITY, IOWA**

2004

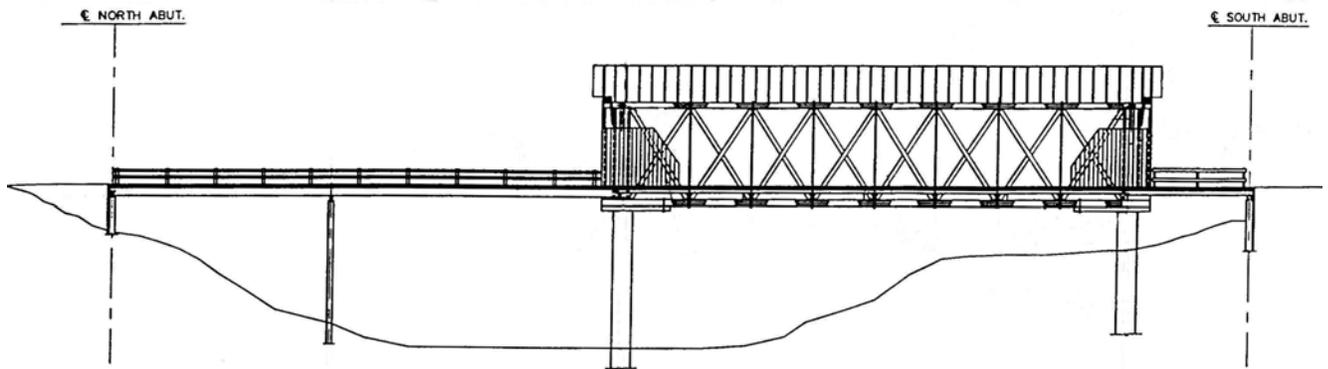
Figure 9 Current side view of Hammond Bridge and its two approach spans. Note the northern movement of the creek channel away from the covered bridge. (Adapted from Shuck-Brinson Inc. rehabilitation plans dated January 2003)

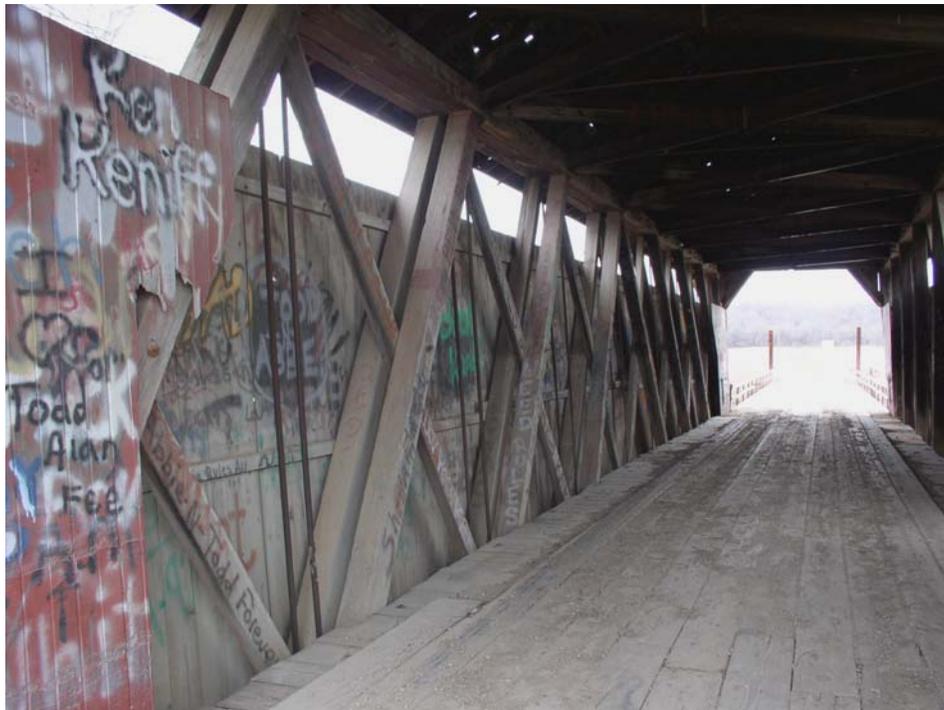
Figure 10 Pre-rehabilitation interior view of “lattice” panels or Howe truss panels, looking north from south end of the bridge. (Nash photo)
