Protocols for the Assessment and Repair of Bridge Foundations

Final Report

August 2016
FHWA HIF-17-044

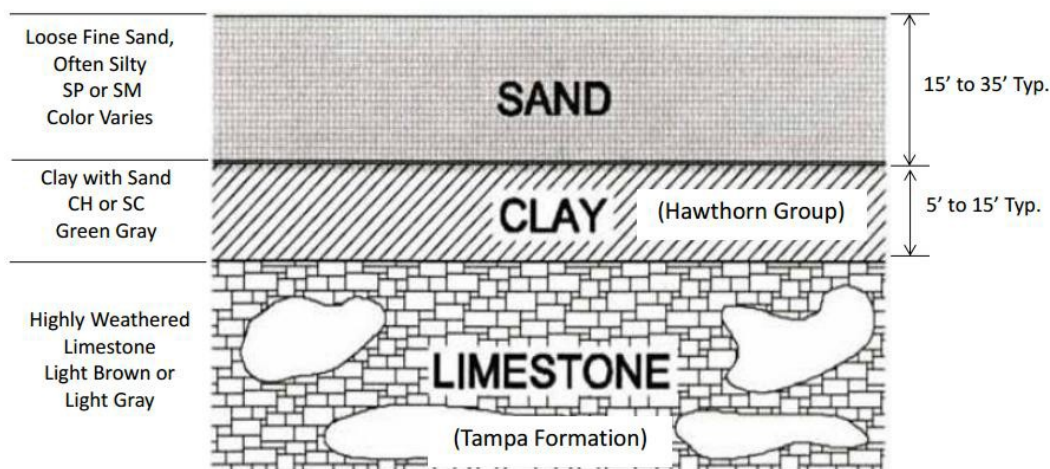
Figure A-9: Subsurface Conditions (Dapp et al., 2013)

Subsurface conditions consisted of 15 to 35 feet of recent sand and silt sediments underlain by 5 to 15 feet of marine clay and highly weathered limestone, as shown in Figure A-9. The geological conditions in this area consist of highly variable materials and strength and karstic limestone. (Dapp et al., 2013; Graham et al., 2014)

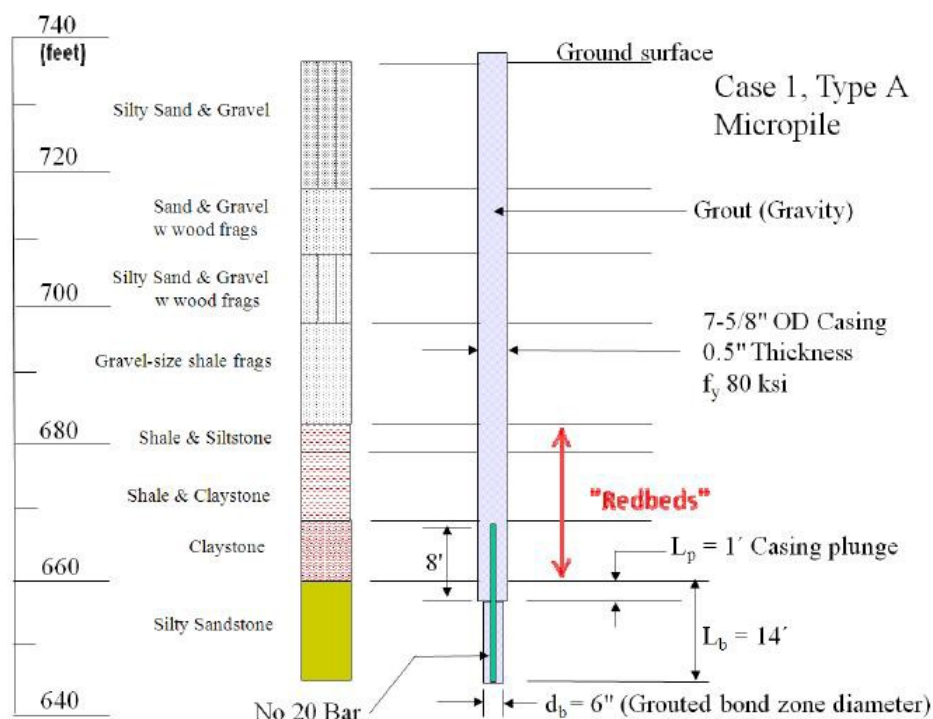
Figure A-13: Subsurface profile and test micropile dimensions (Splitstone et al., 2010)

The Birmingham Bridge in Pittsburgh, Pennsylvania carries 10,000 vehicles per day across the Monongahela River. The tied arch bridge was originally built in 1976. Piers were each supported by 48 steel H-piles. Original piles were driven to refusal, which was not always as deep as the design depth to rock due to intermittent layers of hard material and obstructions. Subsurface conditions, shown in Figure A-13, consist of approximately 30 to 40 feet of fill material underlain by layers of shale, claystone, and more competent sandstone. (Oakland Transportation Management Association, 2015; Splitstone et al., 2010)

On February 8, 2008, two spans of the bridge dropped 8 inches overnight. The bridge was closed once motorists called 911 to alert authorities about the movement. PennDOT immediately sent out 25 bridge inspectors to examine the entire bridge structure. A local general contractor and consulting engineer were brought in to analyze the superstructure and substructure and develop temporary supports. Movements were found to be due to steel rocker bearings at Pier 10S over rotating and failing, causing girders to drop onto the pier cap and damage the pier. Pier 10S had horizontal displacements up to 9 inches and cracking at the base of columns. Tiltmeters indicated that pier columns were bending and the pile cap had not rotated. Geotechnical investigations, including inductive coil testing of the two original driven piles, indicated that pile tip elevations

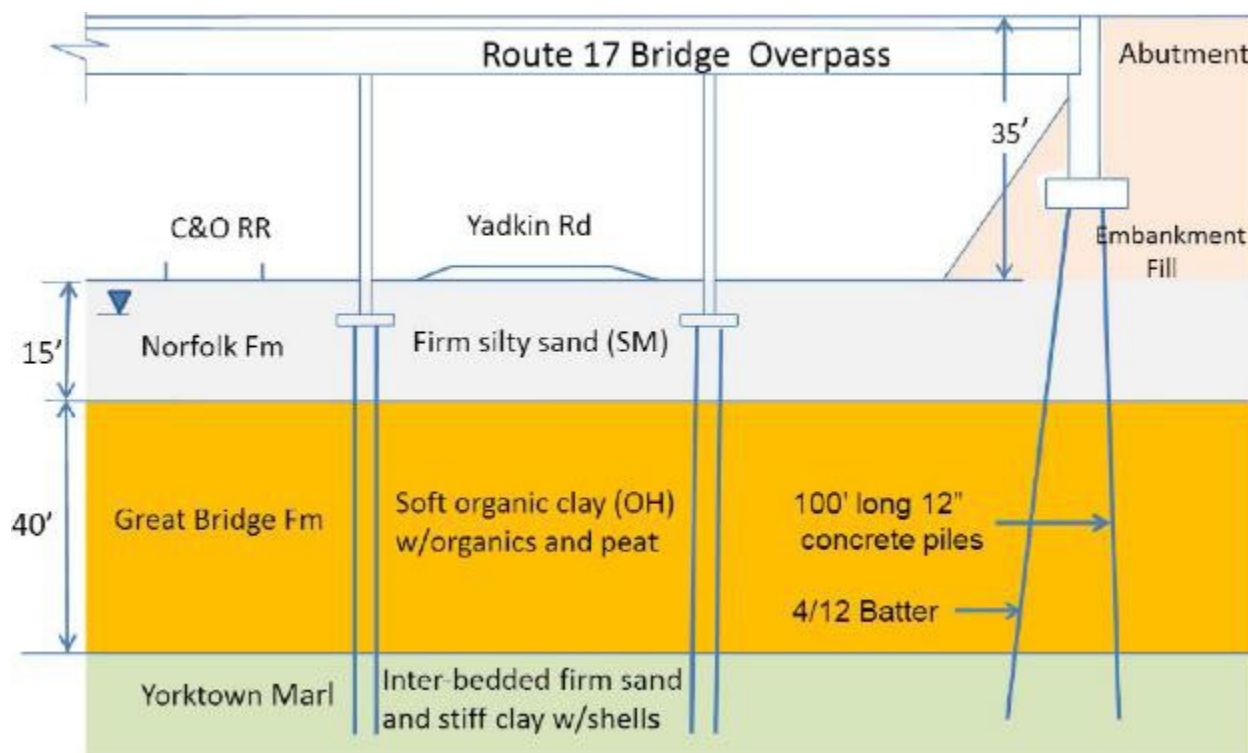
Figure A-15: Bridge Dimensions and Subsurface Conditions (DeStephen, 2015)

An overpass bridge carrying Route 17 in Chesapeake, Virginia was originally constructed in 1992. The 250-foot-long, 100 feet wide bridge was supported on 12 inch, pre-stressed, pre-cast concrete piles from 70 to 100 feet long. The approach embankments were 35 feet high and 90 feet wide on top. The subsurface conditions consisted of 15 feet of silty sand underlain by a 40-foot stratum of soft organic clay overlying firm sand and stiff clay. Figure A-15 shows original bridge dimensions and subsurface conditions. (DeStephen, 2015)

Settlements of 2.5 feet to 3.5 feet were expected from approach embankment loading during the original construction of the bridge. Since eighty percent of this settlement was expected to occur over 3 months, so the embankments were constructed and allowed to settle for 3 months before bridge construction began. However, by 2000, additional settlements of up to 2.5 to 3 feet had occurred at the approach embankments after the end of the bridge construction. Figure A-16 shows sagging of the approach at the surface from excessive embankment settlements. A study conducted in 2003 concluded that original analyses did not properly calculate anticipated settlements or account for downdrag effects on the foundation piles. Up to 22 more inches of consolidation of the soft clay layer under the existing embankment load was possible. Damage to the bridge from settlement included cracked beams, buckling of slope protection, and cracked wing walls. Investigation into the abutment foundations indicated that the piles supporting the abutment were severely damaged. Figure A-17 shows the tensile failure of a pile due to downdrag and the void beneath the abutment foundation. (DeStephen, 2015)

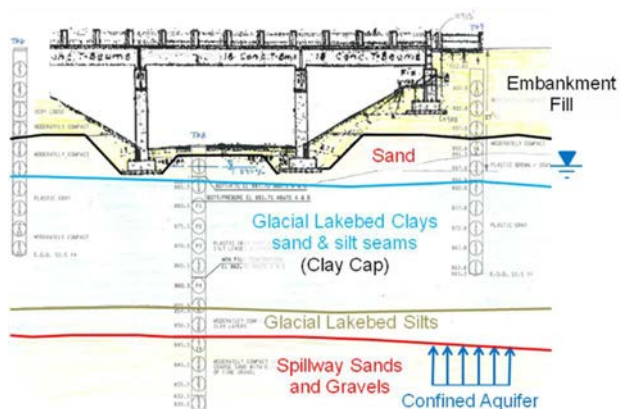
Figure A-19: General Soil and Groundwater Profile at Project Site (Thelen and Thome, 2011)

The Interstate 94 bridges over Riverside Drive were originally completed in 1958 as three-span, simply supported structures with continuous partial-height abutment walls and isolated piers supported by shallow foundations (Thelen and Thome, 2011). The geologic section was characterized by a relatively thick glacial lake bed deposit, which formed a confining layer of clay over glacial spillway sands and gravels, which were under a “near artesian” piezometric head. Typical subsurface conditions are depicted by Figure A-19.

Plans for replacement bridges were based on single-span, simply supported structures with continuous full-height abutments supported by deep foundations consisting of HP12x53 piles. Construction of the replacement bridges was to be in partial-width stages so as to maintain traffic in both directions. However, during the initial construction stage, movements were significant enough to require temporary closures and emergency stabilization of the bridges.
